National Park Service Cultural Landscapes Inventory 2021

Shirley House

Vicksburg National Military Park

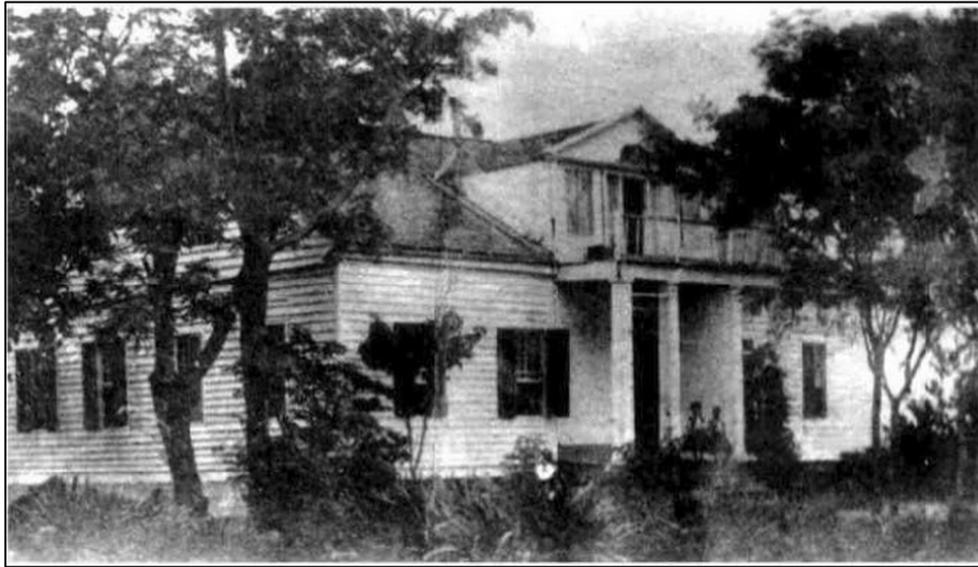
Fig 7. One of the earliest known photos of the Shirley House, circa 1863. Source: Vicksburg National Military Park archives, box 7.

The earliest known photograph of the house dates to circa 1863, which post-dates the changes made to the house by the Shirleys in 1851 and 1852 (Figure 7). It shows the house, which faced south toward Jackson Road, fronted by a single-story columned porch, with a landing above. The central porch was reached via a walkway and a flight of steps. Trees and shrubs were planted along the base of the house in irregular groupings. These may have included crape myrtle, Rose-of-Sharon, roses, and lilacs based on the recollections of Alice Shirley Eaton. Also visible in the photograph are tall grasses and what appear to be irises in the front yard.

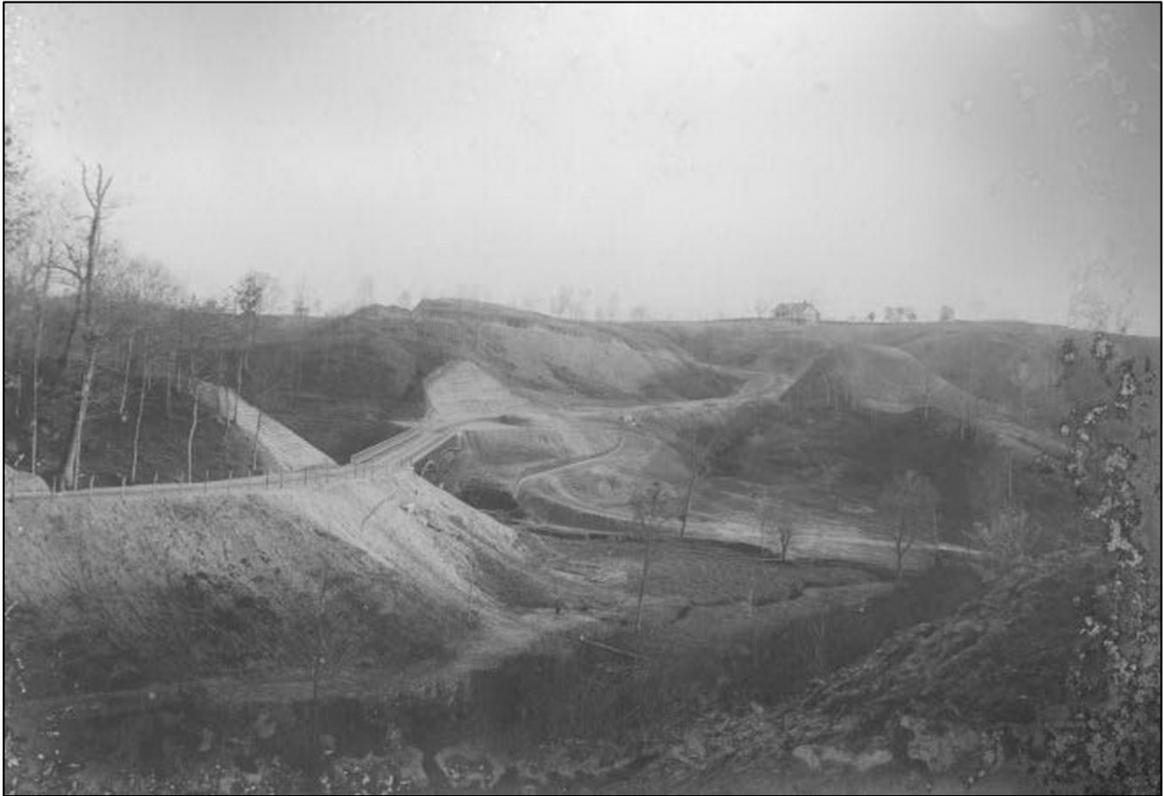
Fig 25. Bird's eye view looking northwest toward the Shirley House and Illinois State Memorial, circa 1906. Source: Mississippi Department of Archives and History.

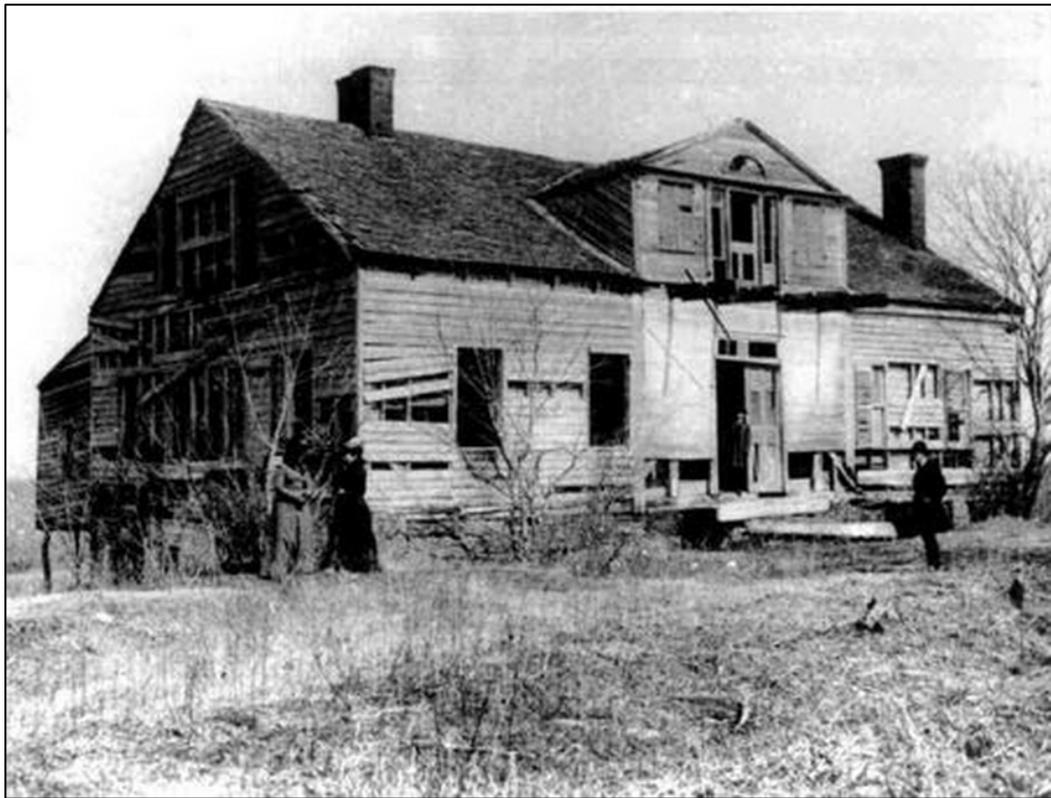
Fig 29. The deteriorated Shirley House, circa 1890. Source: HABS File No. MISS, 75-VICK, V, 3-4.

By the end of the 1800s, the Shirley House was in ruins (Figure 29 through Figure 31). Shortly after the establishment of Vicksburg National Military Park in 1899, the Federal government initiated efforts to purchase the building and grounds from Alice Shirley Eaton for the purpose of restoring the house and opening it as a war memorial (Figure 32). Commissioner Rigby contacted Mrs. Eaton to offer to buy the property at the price of \$20 per acre for inclusion in the park (Buono 2004, 18). Still upset by the treatment her family had received during and after the war, Alice Eaton replied in a letter to Rigby on March 29, 1902:

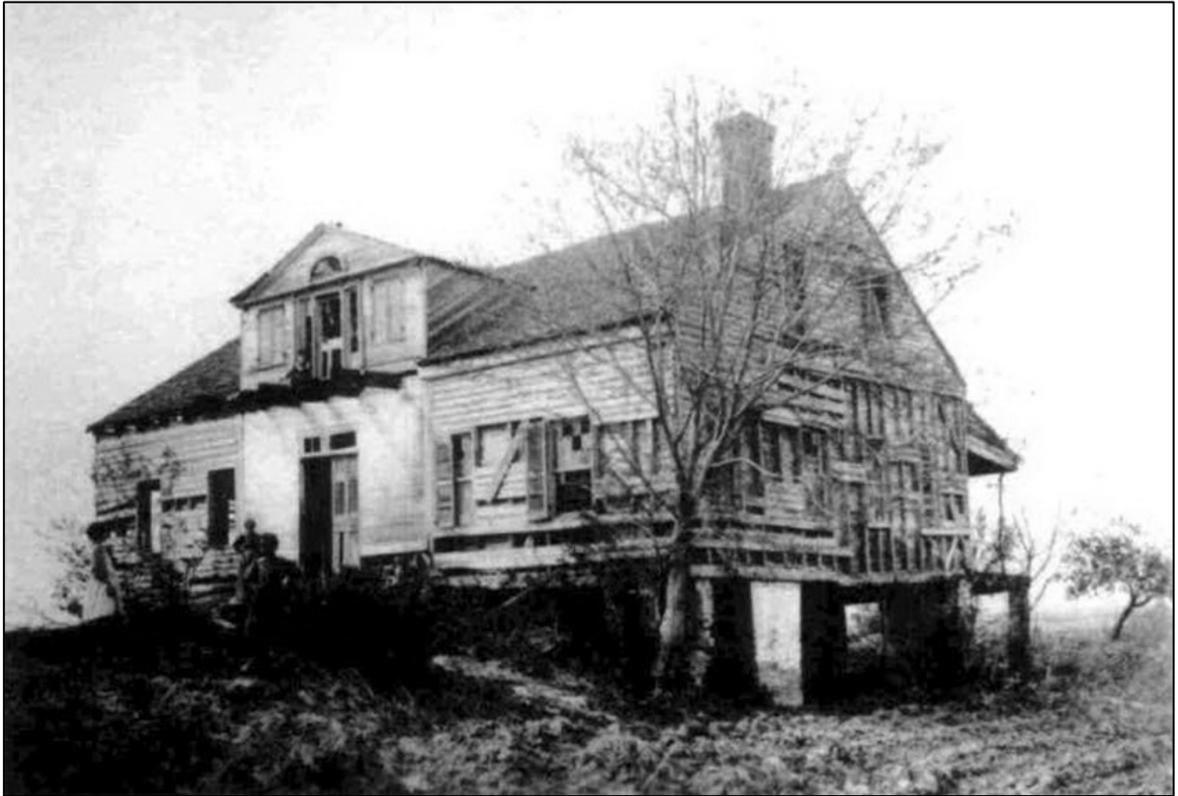
Fig 30. Another view of the deteriorated Shirley House, circa 1899. Source: HABS File No. MISS, 75-V, 3-12.

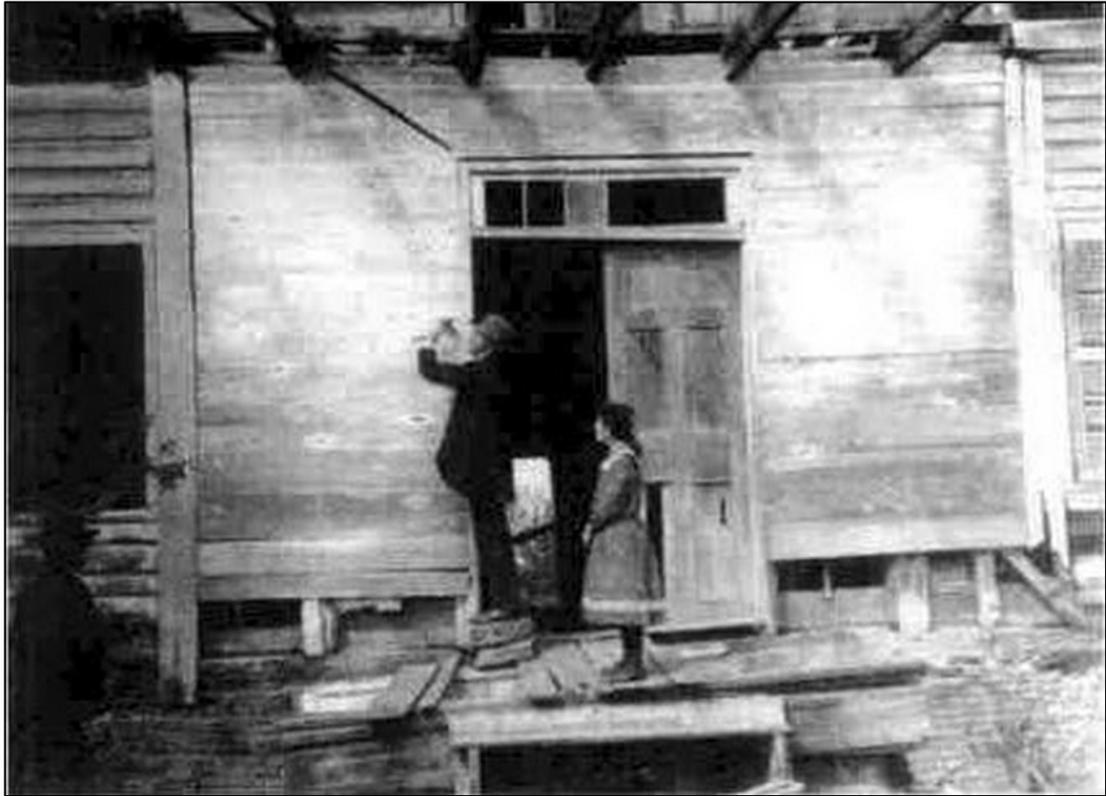
Fig 31. View of the entrance into the Shirley House, 1899. Source: Vicksburg National Military Park archives.

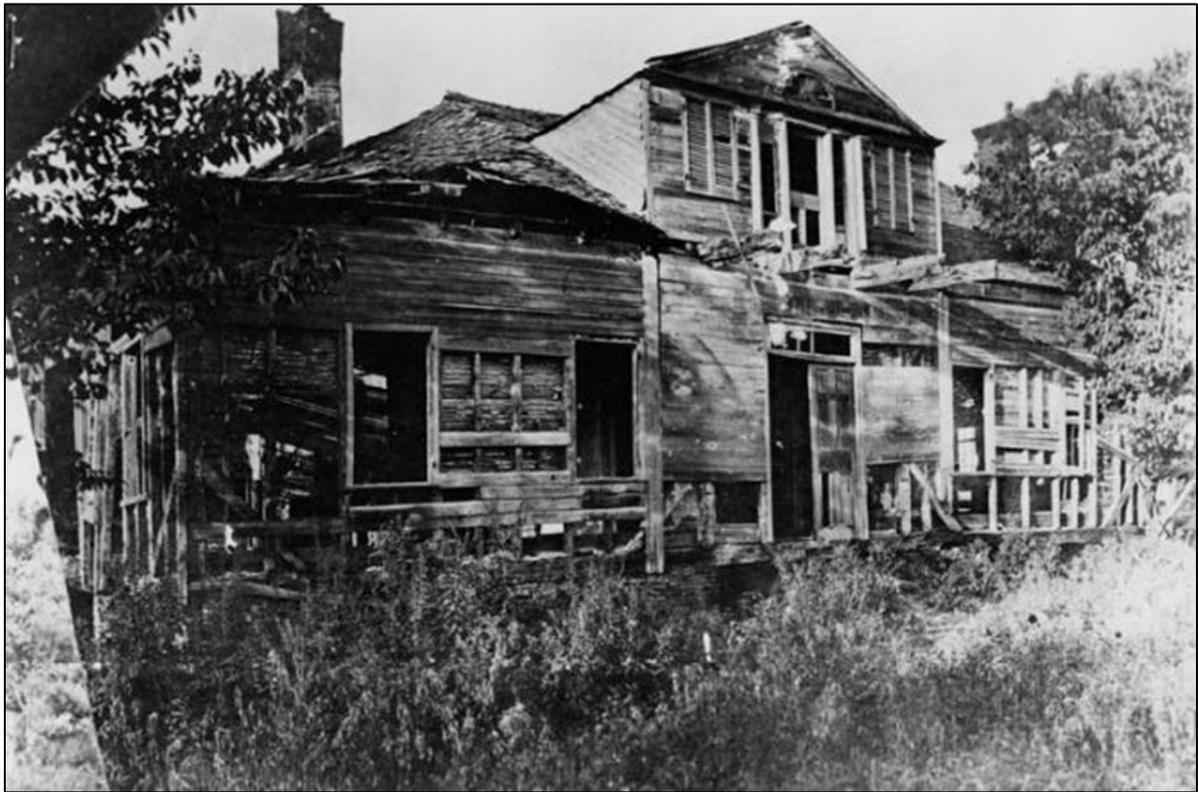
Fig 34. View of the principal facade of the Shirley House, circa 1902. Source: HABS File No. MISS, 75-V, 3-5.

By this time, the condition of the Shirley House was very poor (Figure 34). In addition to loss from neglect and decay, scavengers had stripped the house of much of its siding, the windows, and its interior woodwork. The front porch and balcony were missing along with the brick piers of the rear porch and portions of the brick foundation. The wood-shingled roof had deteriorated as well, with the west gable and most of the roof on that side having collapsed entirely.

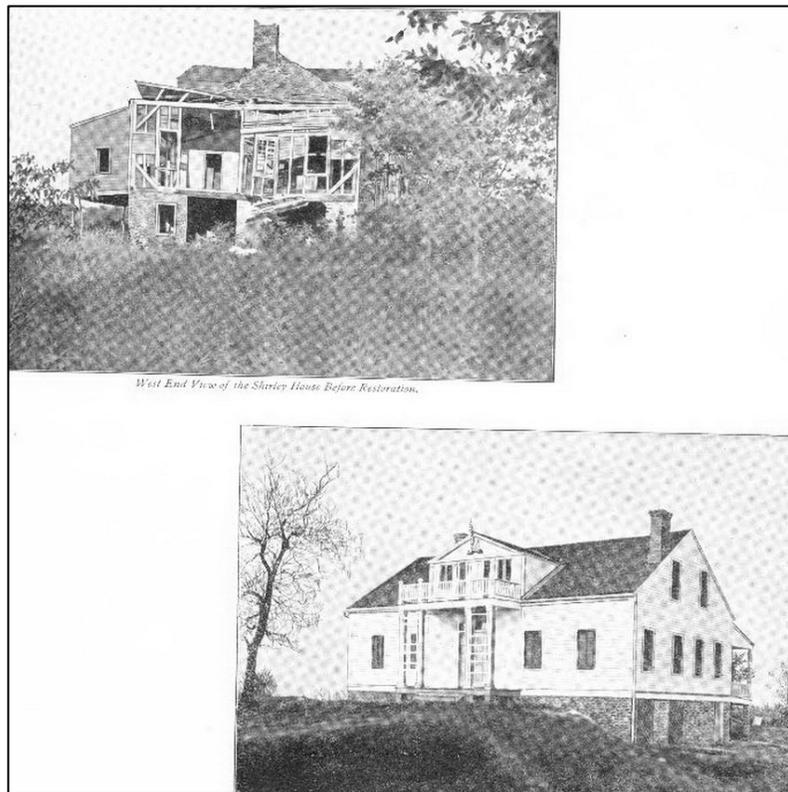
Fig 36. Before and after views of the Shirley House restoration. Source: Illinois Center Railroad Company, General Passenger Department. Chicago, Illinois: January 19, 1903.

any shortcomings, the Commission noted satisfaction with McGraw's work (Figure 35 and Figure 36), which was completed on November 15:

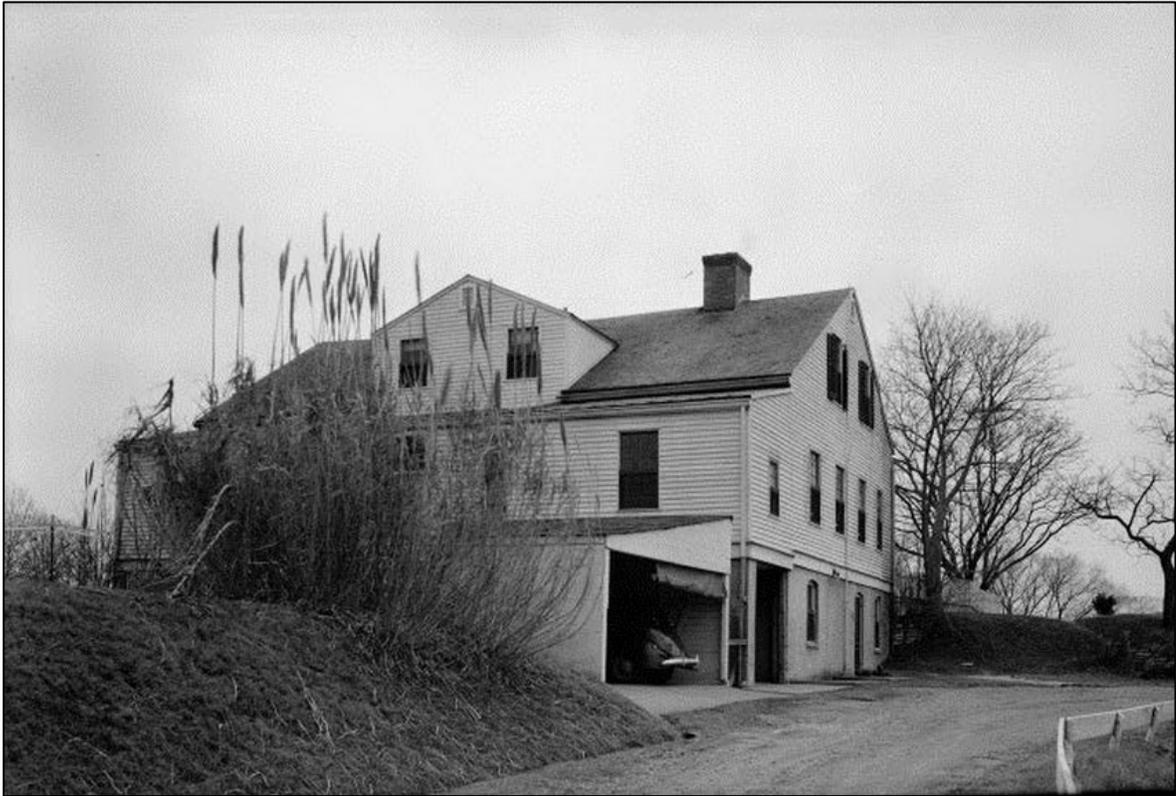
Fig 37. View of the rear of the Shirley House showing the garage. View of the rear of the Shirley House showing the garage. Source: HABS File No. MISS, 75- V, 3-19.

Exterior changes included the construction of a wood-framed garage off the northwest side of the house (Figure 37), enclosure of the space beneath the back porch for a carport, and installation of concrete steps and walkways in front of the house. Alterations were also made to the fenestration at the basement level; the back porch was screened, louvers were added to the east, west, and north gables, and the trellis was removed from the front porch (Buono 2004, 29; Wilshin 1939, 78-85).

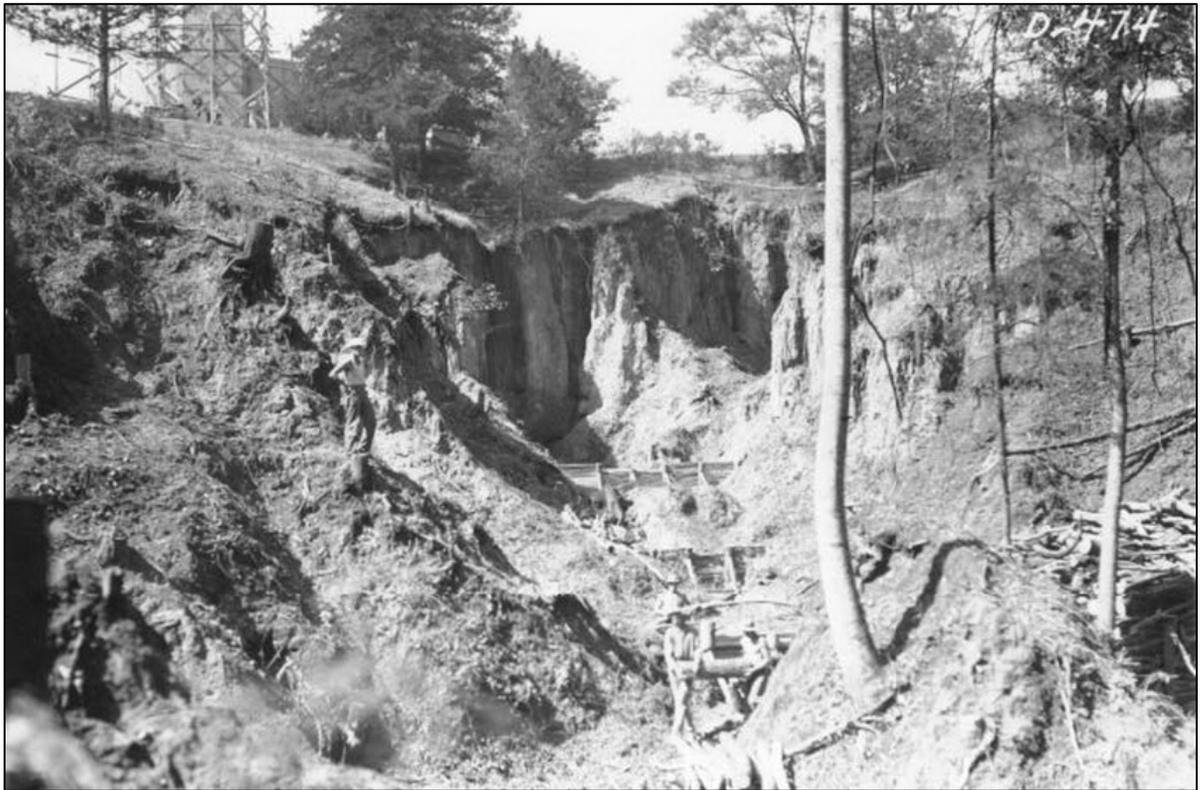
Fig 38. View looking west, showing the extent of erosion approximately 150 yards northeast of the Missouri State Memorial, October 11, 1934. Source: Vicksburg National Military Park archives, box 22, image D-474.

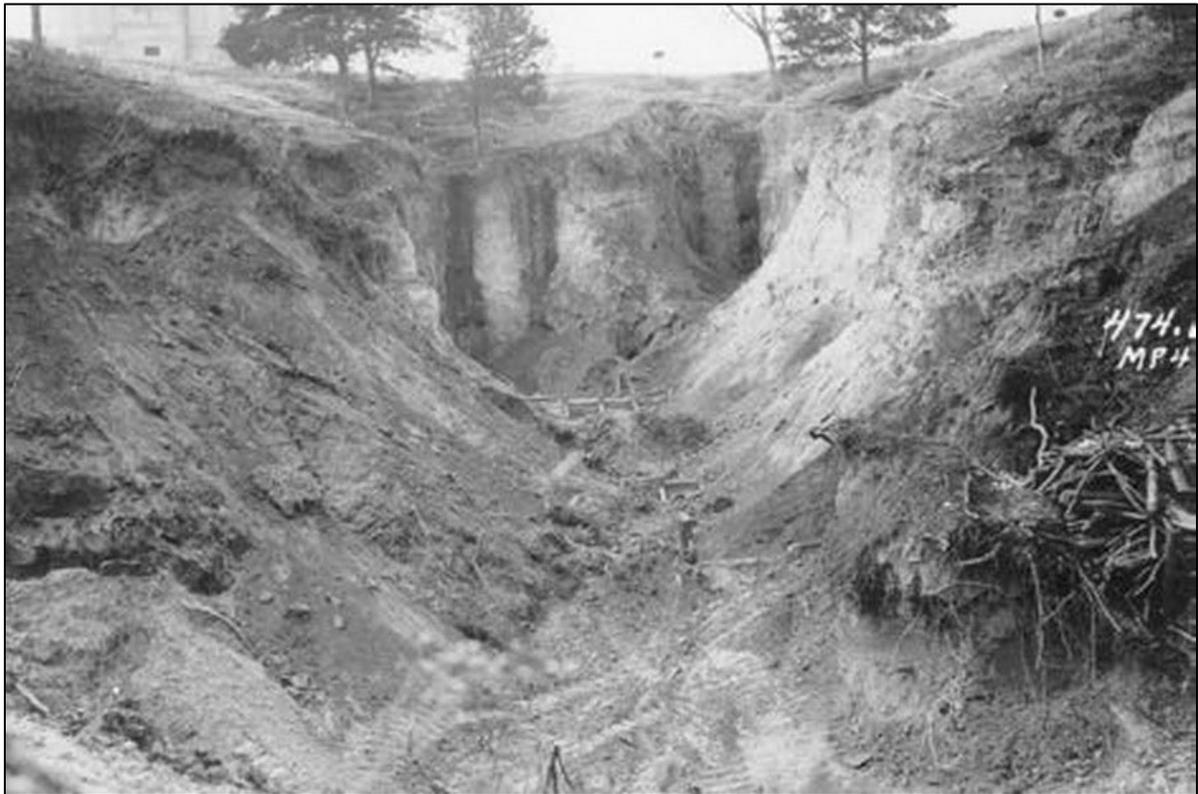
Fig 39. The same view showing initial clearing and shoring activities, February 1935. Source: Vicksburg National Military Park archives, box 22, image D-474-1.

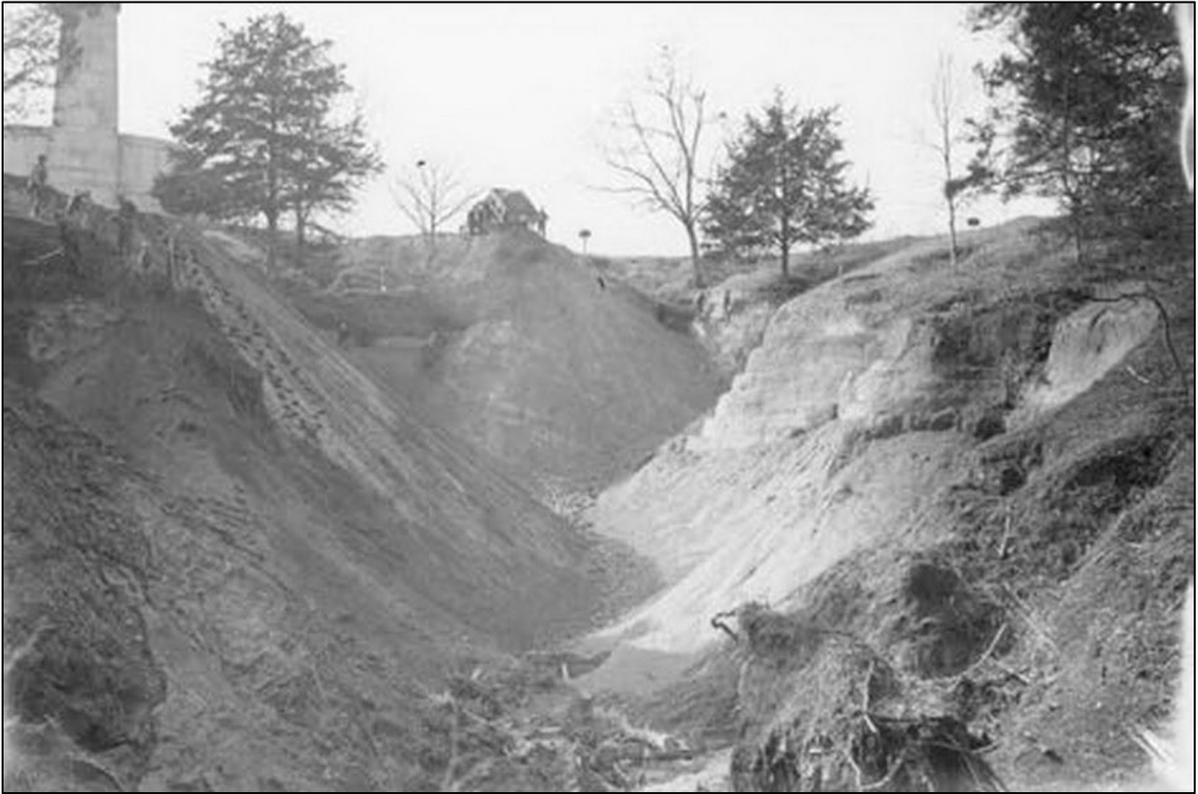
Fig 40. The same view, showing filling operations, February 1935. Source: Vicksburg National Military Park archives, box 22, image D-474-2.

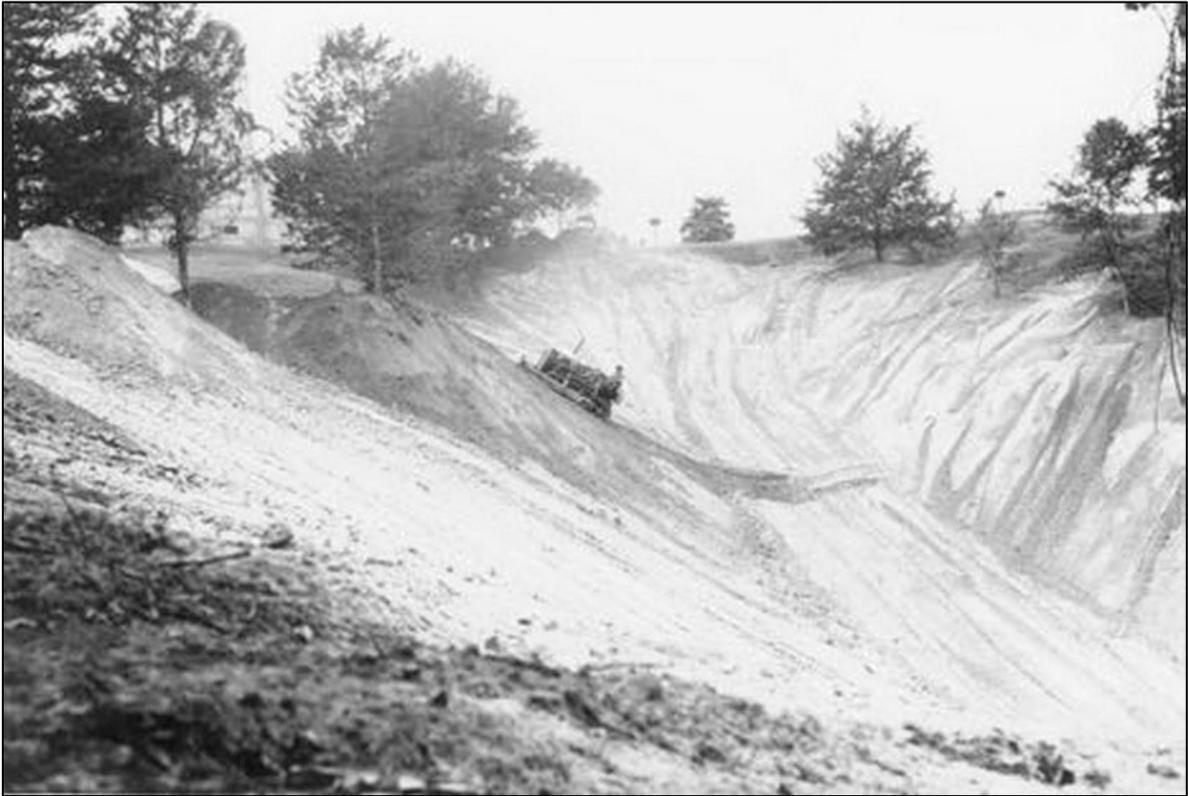
Fig 41. Earth grading operations at the same location, July 18, 1935. Source: Vicksburg National Military Park archives, box 22, image D-474-3.

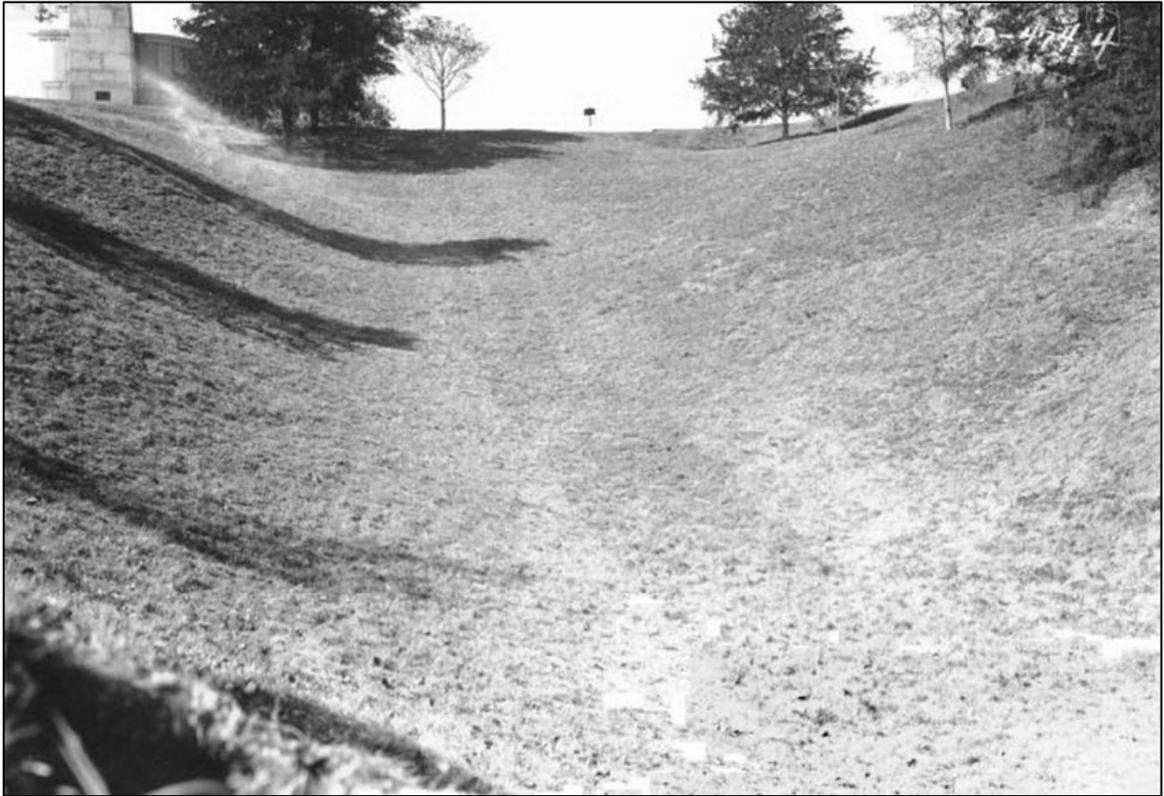
Fig 42. The finished slope following the placement of fill and re-grading, November 7, 1935. Source: Vicksburg National Military Park archives, box 22, image D-474-4.

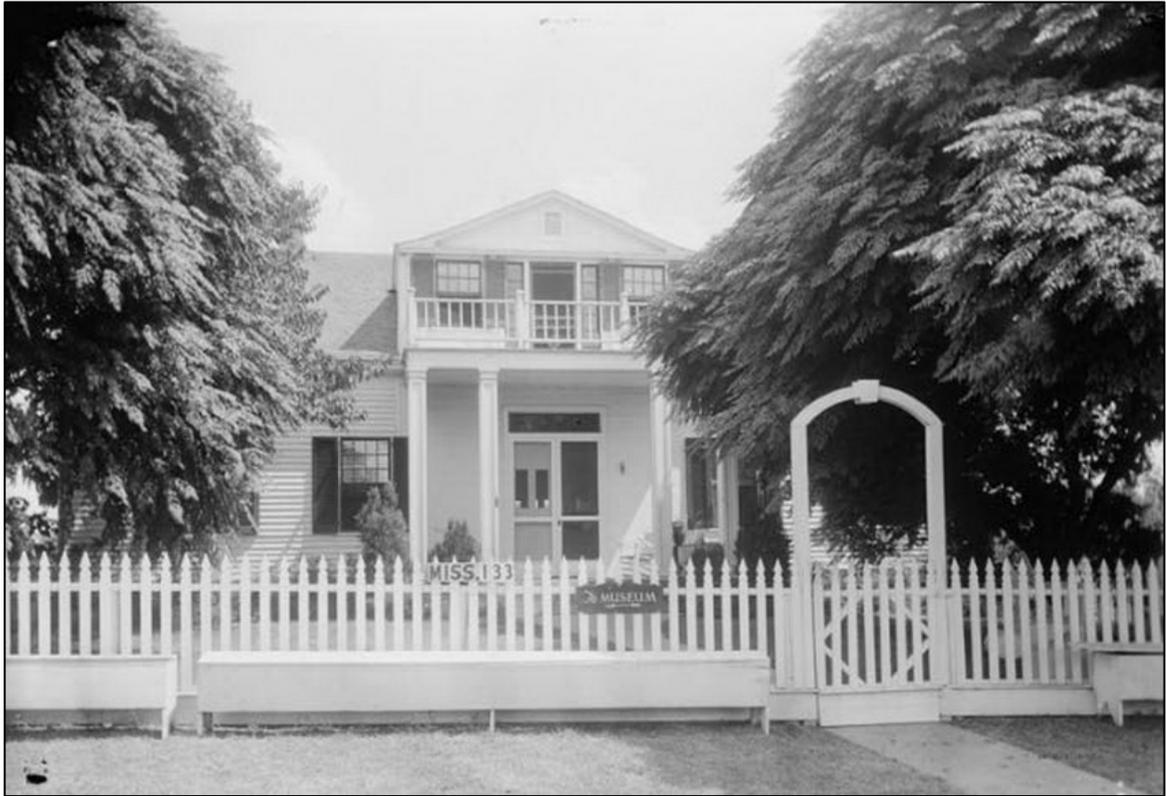
Fig 44. Circa 1936 view of the Shirley House showing the new picket fence. Source: HABS File No. MISS, 75-V, 3-16.

A picket fence was built to establish a precinct in front of the house, while a flagpole was erected in the turf lawn between the picket fence and Jackson Road (Figure 44).

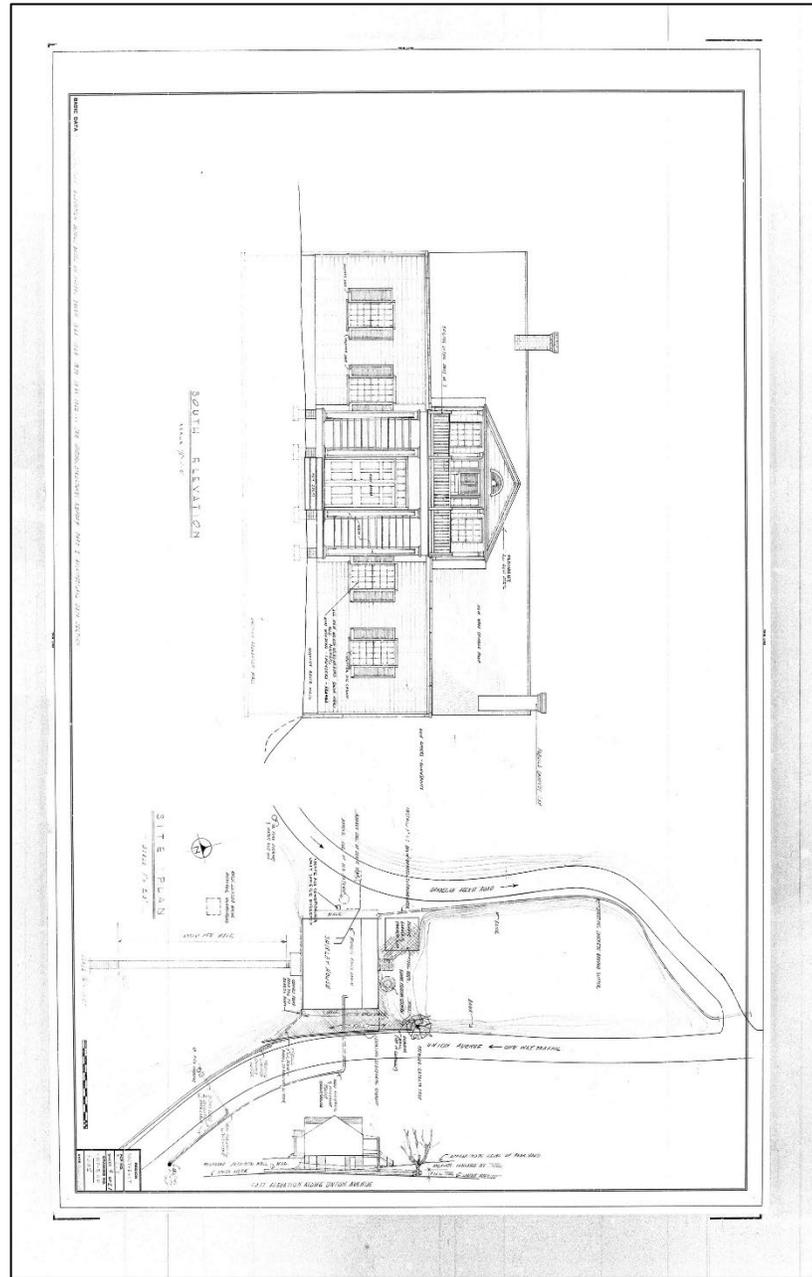
Fig 52. Restoration plans, site plan drawing, October 1965. Source: National Park Service, drawing no. NMP-VIC-3082, sheet 3.

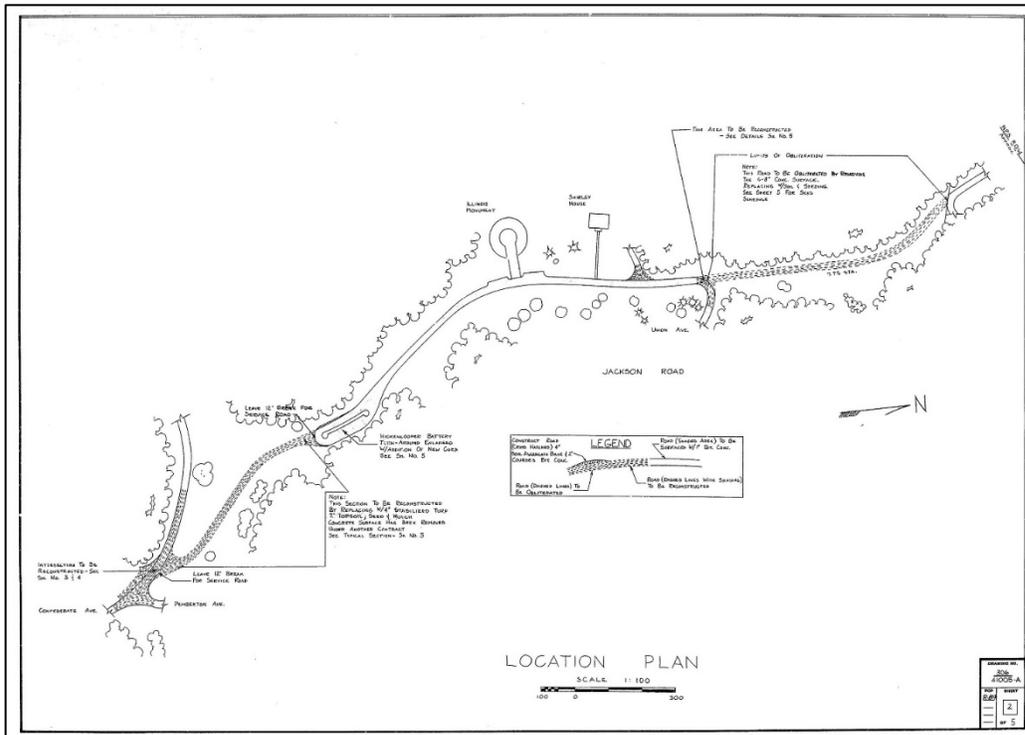
Fig 53. Site plan illustrating proposed changes along two segments of Old Jackson Road, 1972. Source: National Park Service 306/41005-A.

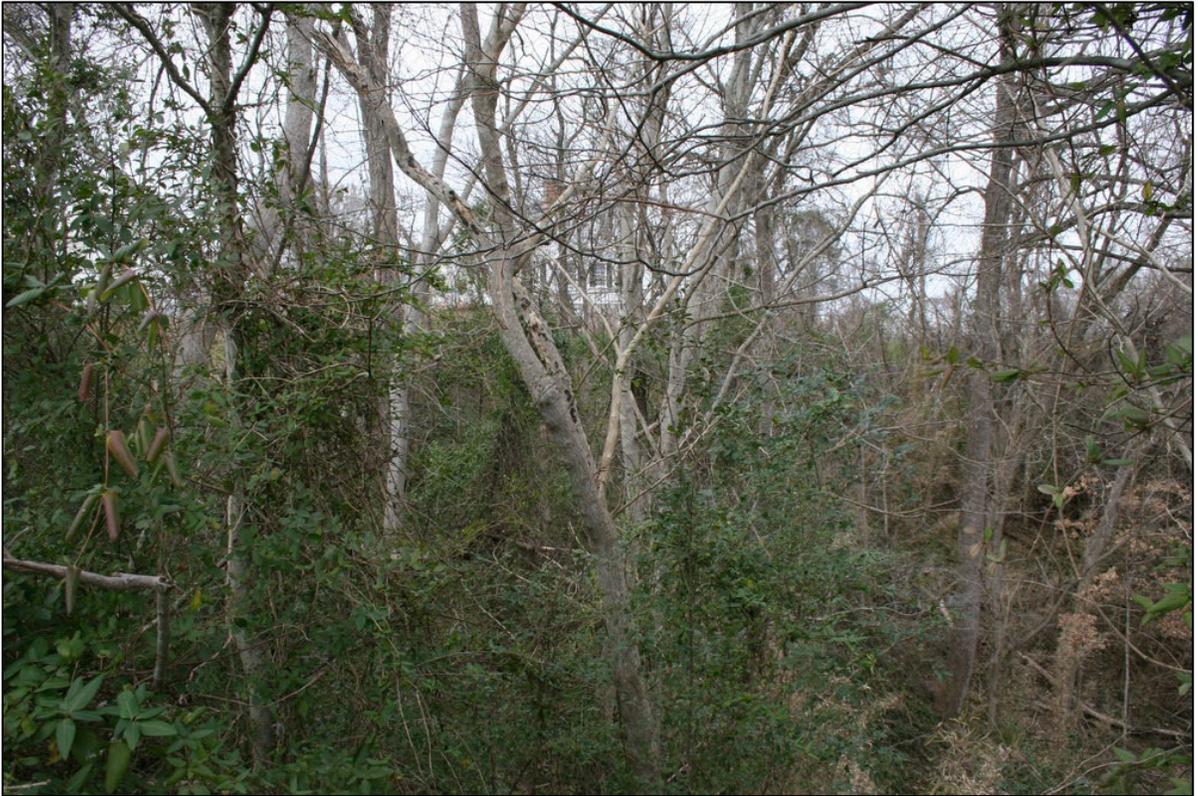
Fig 56. The ravine is currently wooded and it is difficult to see the extreme drop of the topography in this area.

The ravine is currently wooded, and it is difficult to see the extreme drop of the topography in this area (Figure 56). The Shirley House is barely visible behind the trees; during the siege, this exposed ravine was the site of many shebangs, or lean-to shelters, in which Union soldiers encamped. These features are no longer present. Successional woodland currently obscures views of the ravine landscape. The ravine landform otherwise survives from the period of significance and contributes to the significance of the historic landscape.

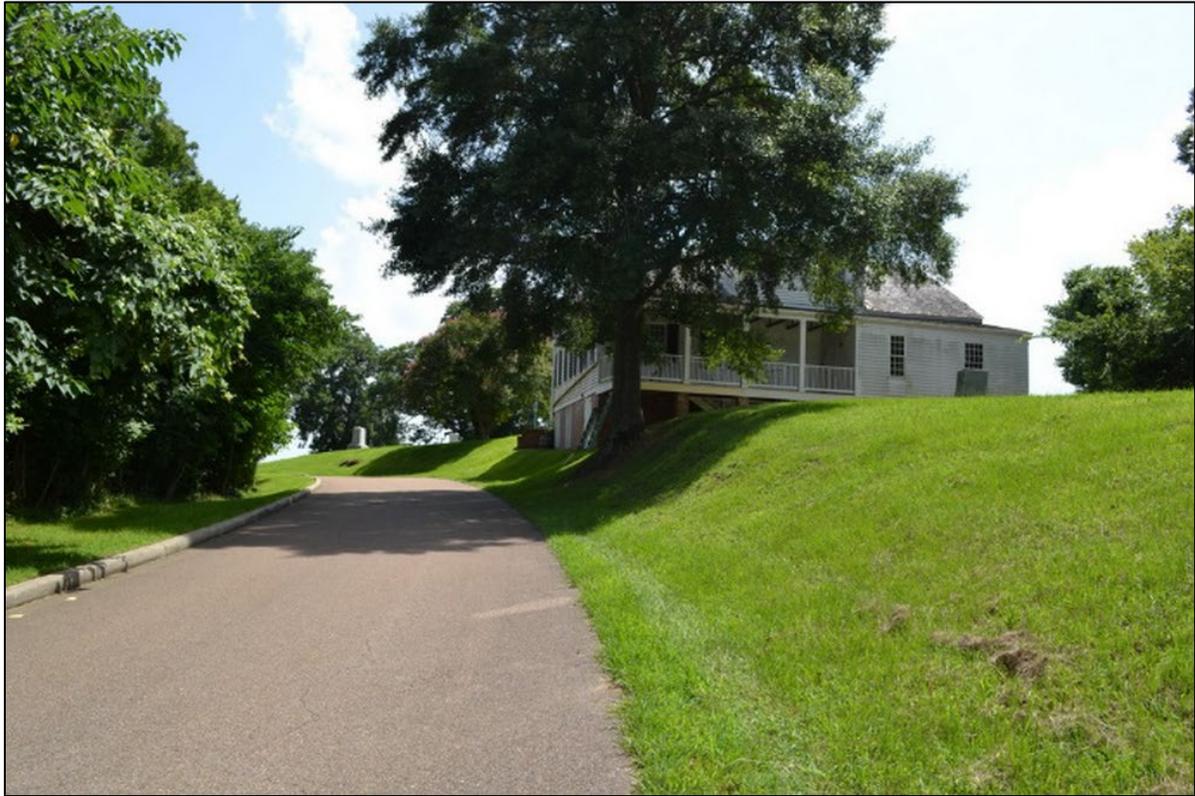
Fig 57. A grass swale is located adjacent to the west edge of Union Avenue below the knoll embankment.

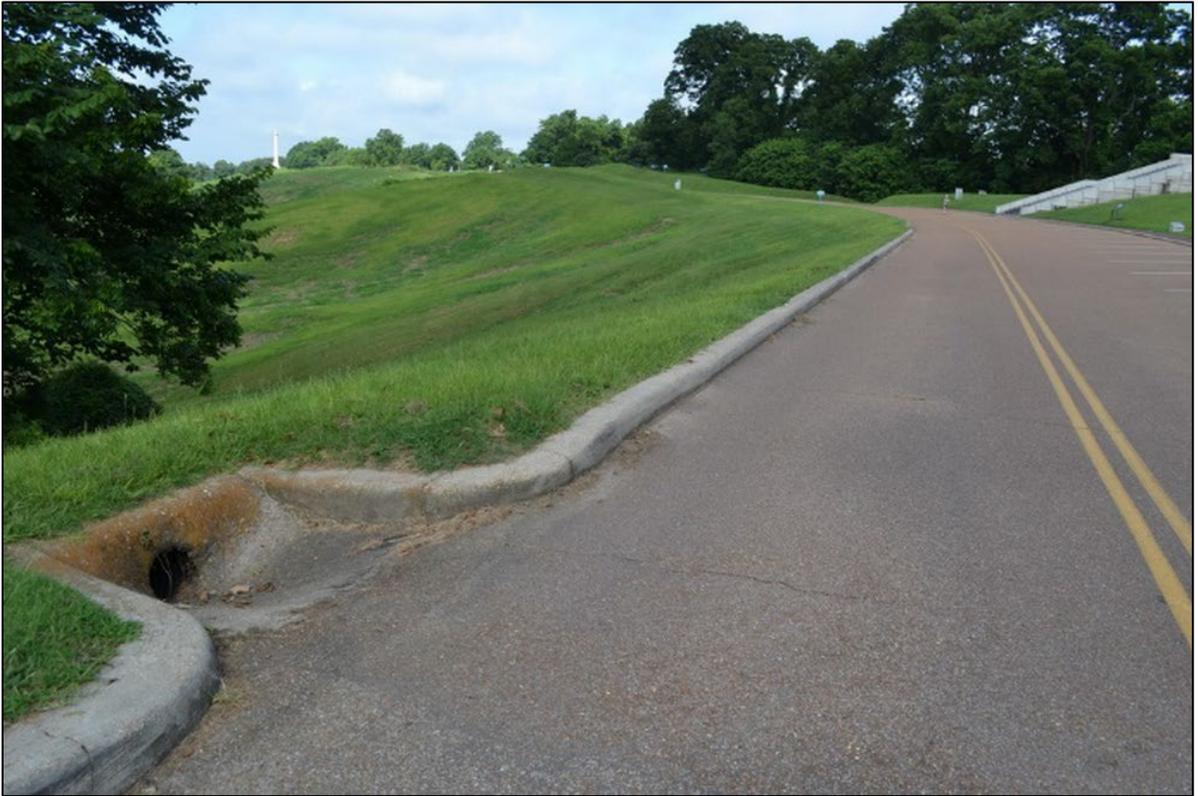
Fig 58. One of two concrete culverts with concrete curb located on the south side of the Old Jackson Road.

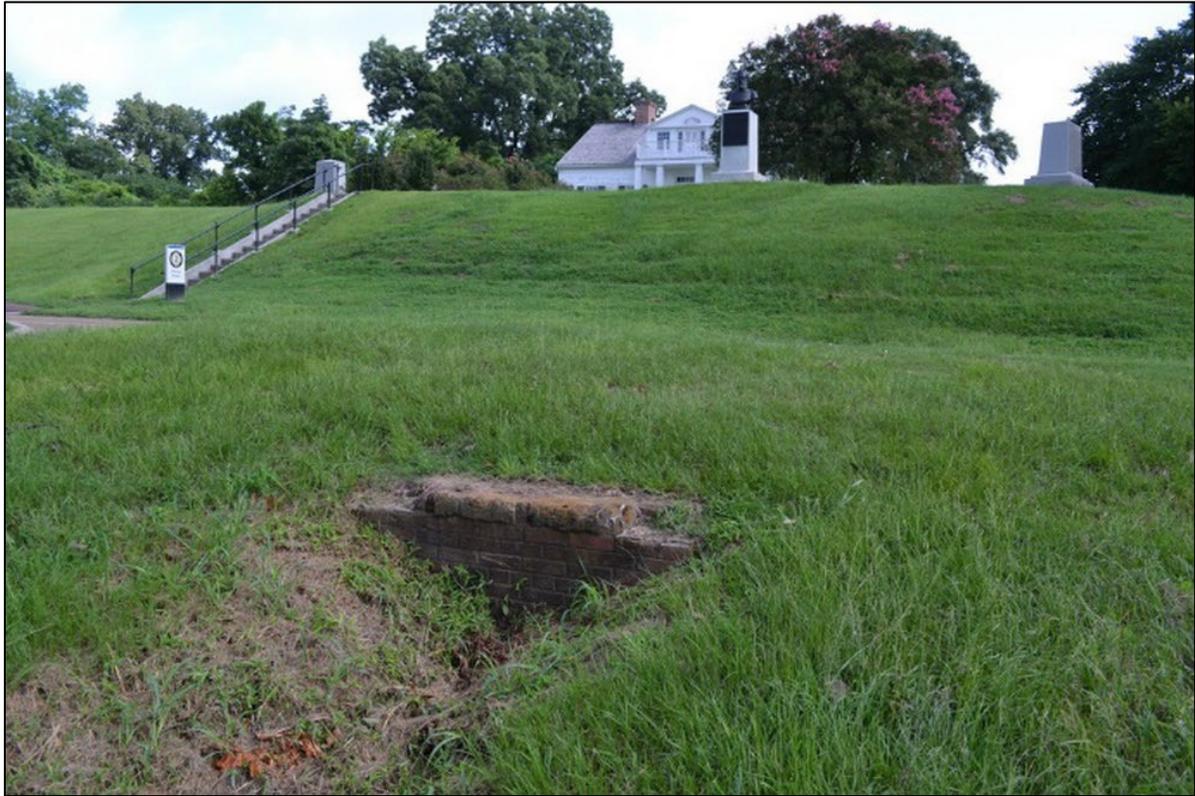
Fig 59. A brick culvert in the landscape is located south of the Old Jackson Road.

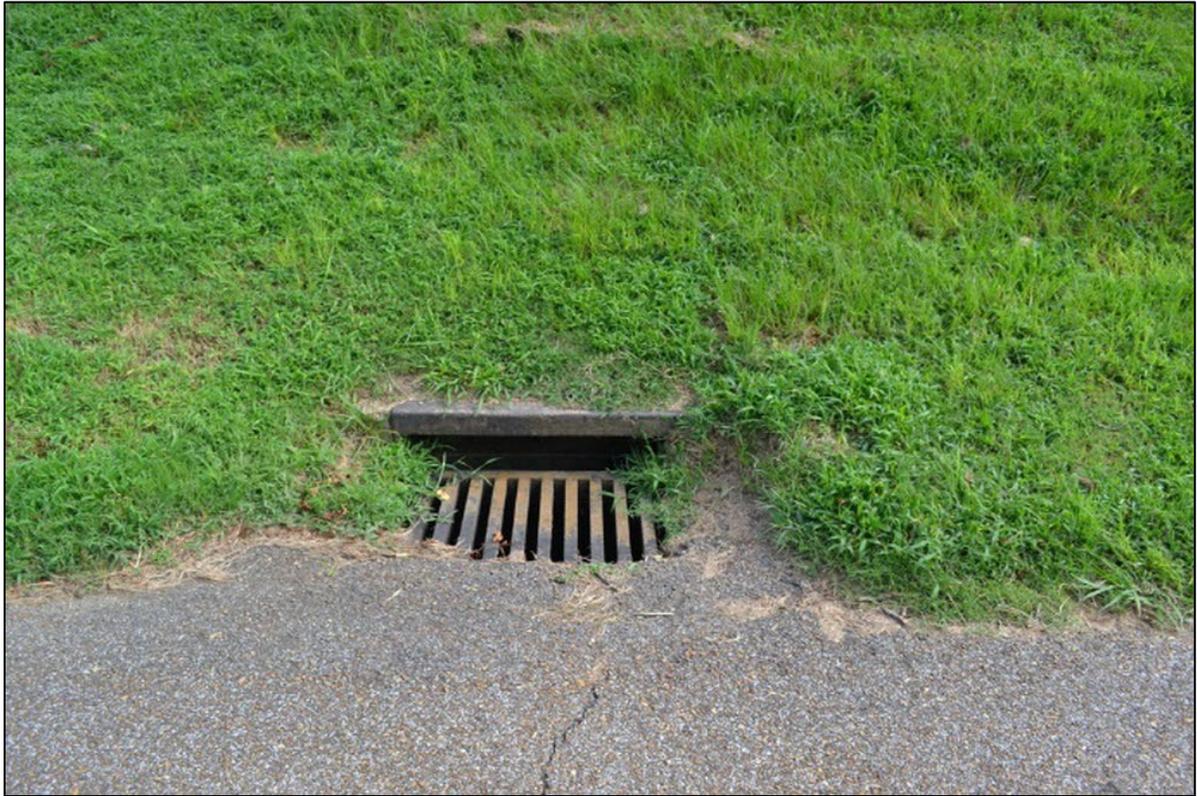
Fig 60. A metal drop inlet and grate are associated with the area of grass edging north of the Old Jackson Road at the base of the knoll.

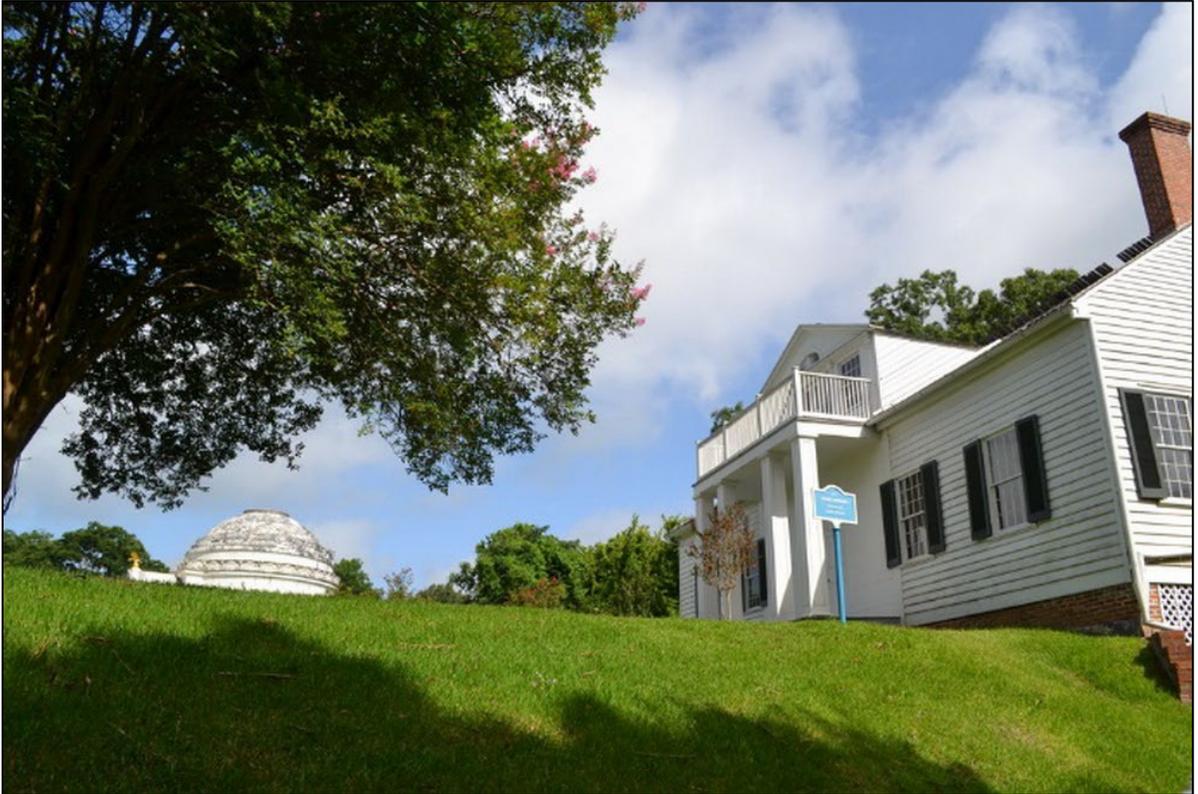
Fig 61. Shirley House is located on the high point of the small knoll and surrounded by open space within the immediate vicinity.

landscape to the south from its position atop the small knoll. The house faces the Old Jackson Road, and is oriented orthogonally to the road Corridor (Figure 61 and Figure 62).

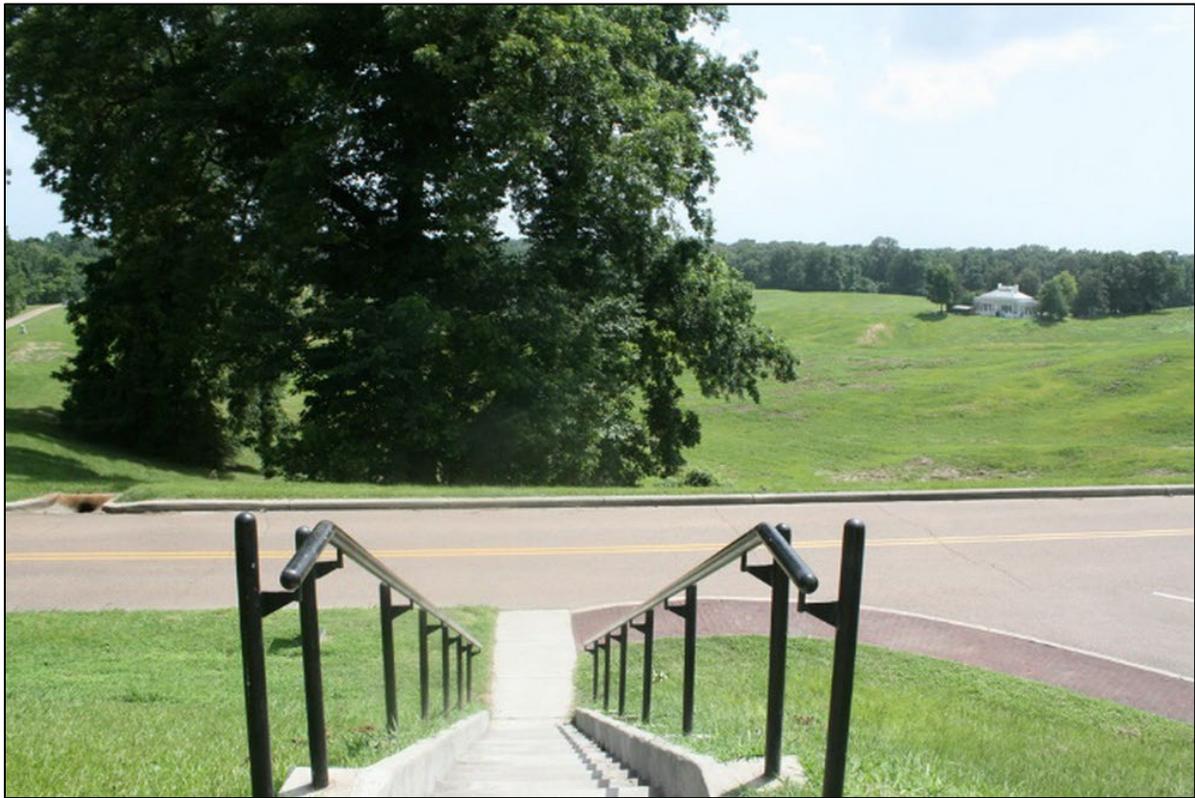
Fig 62. The house is visually connected to the open landscape to the south and faces the Old Jackson Road.
