National Park Service Cultural Landscapes Inventory 2021

Shirley House

Vicksburg National Military Park

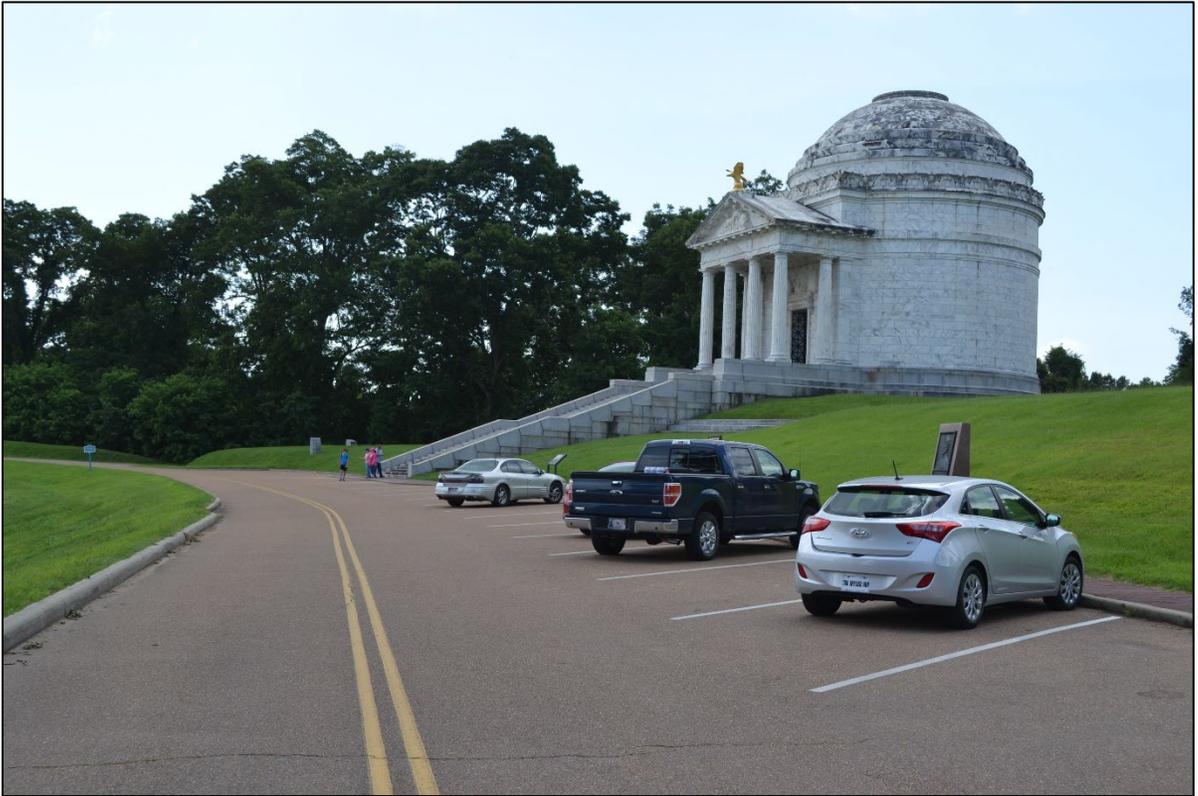
Fig 67. Grading and subsequent topographic modification for construction of Old Jackson Road and additional parking.

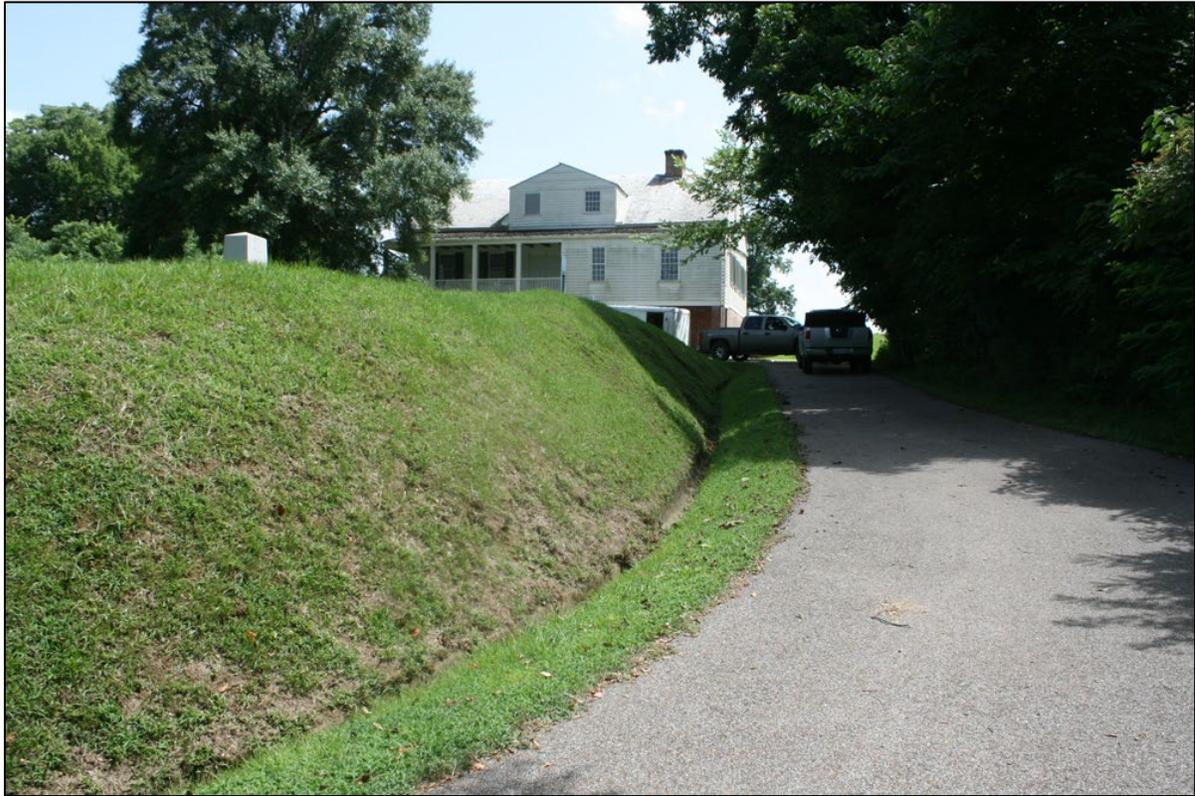
Fig 68. Grading corridor for siting of the access road south of the house.

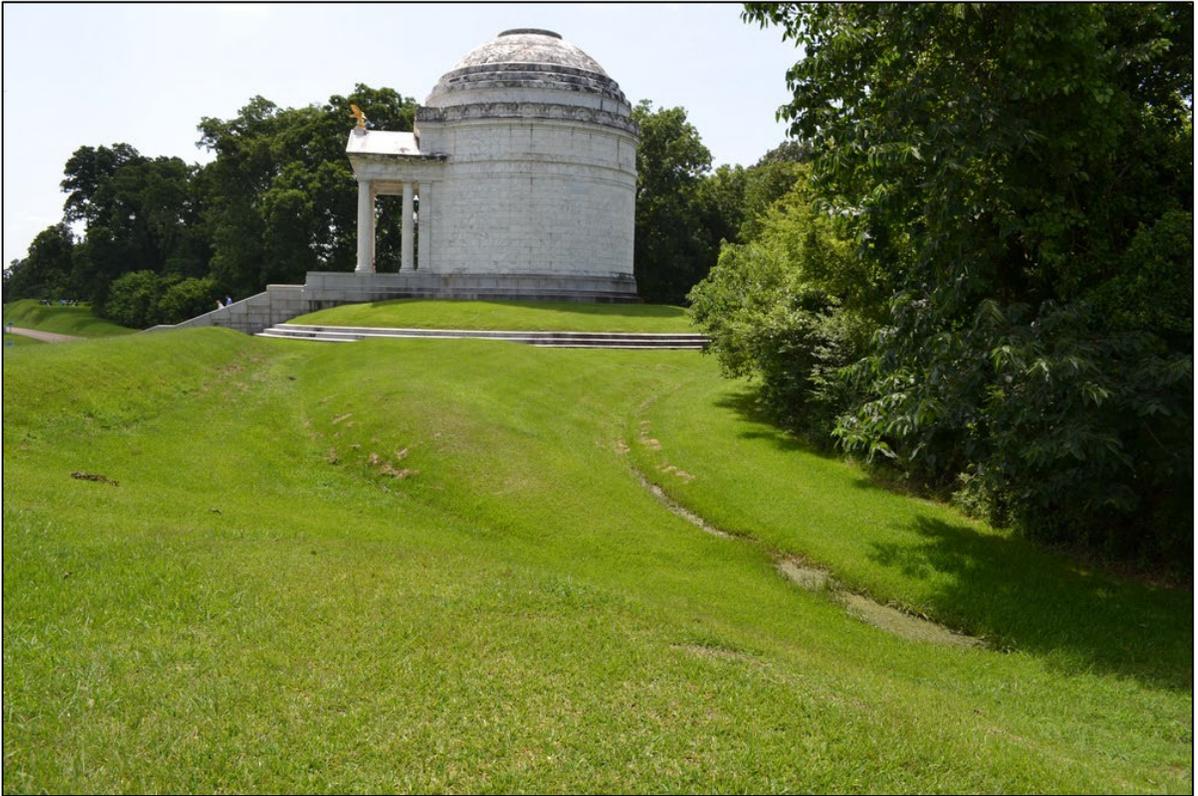
Fig 69. Topographic modification due to the grass roadbed is evident.

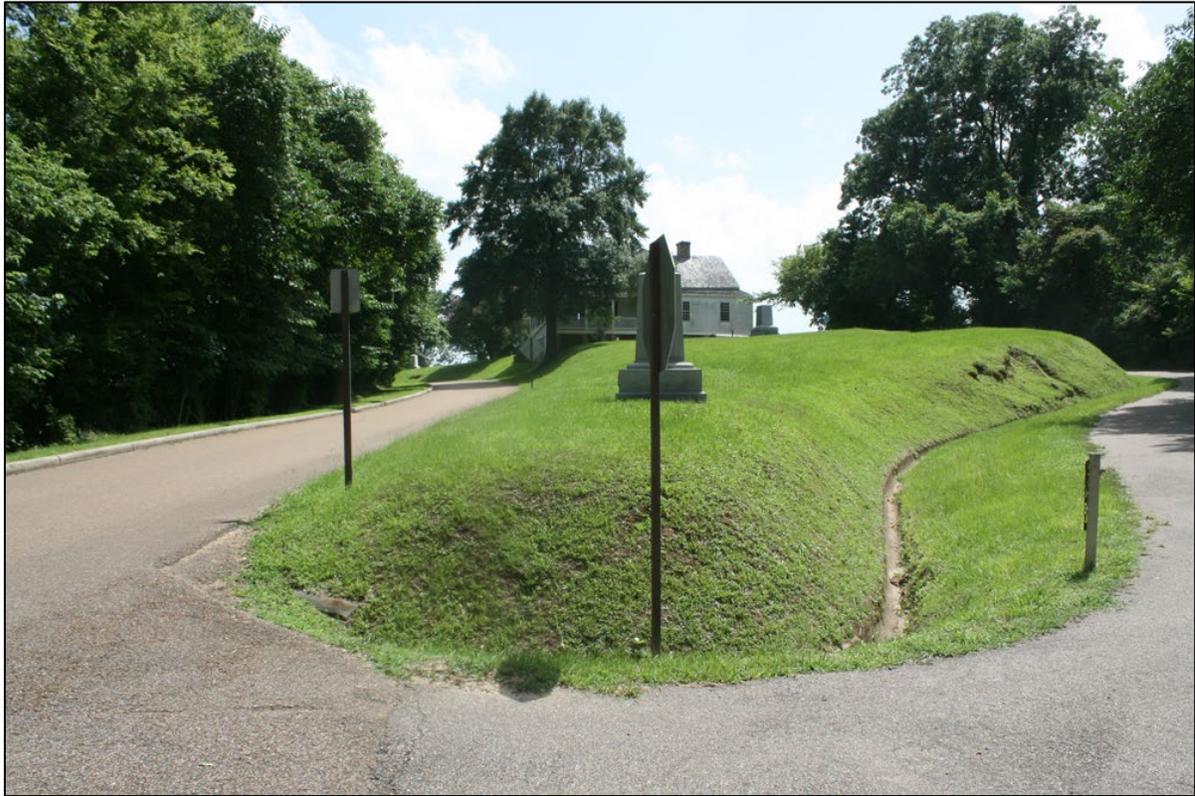
Fig 70. Erosion and slumping is evident on the embankment north of the house.

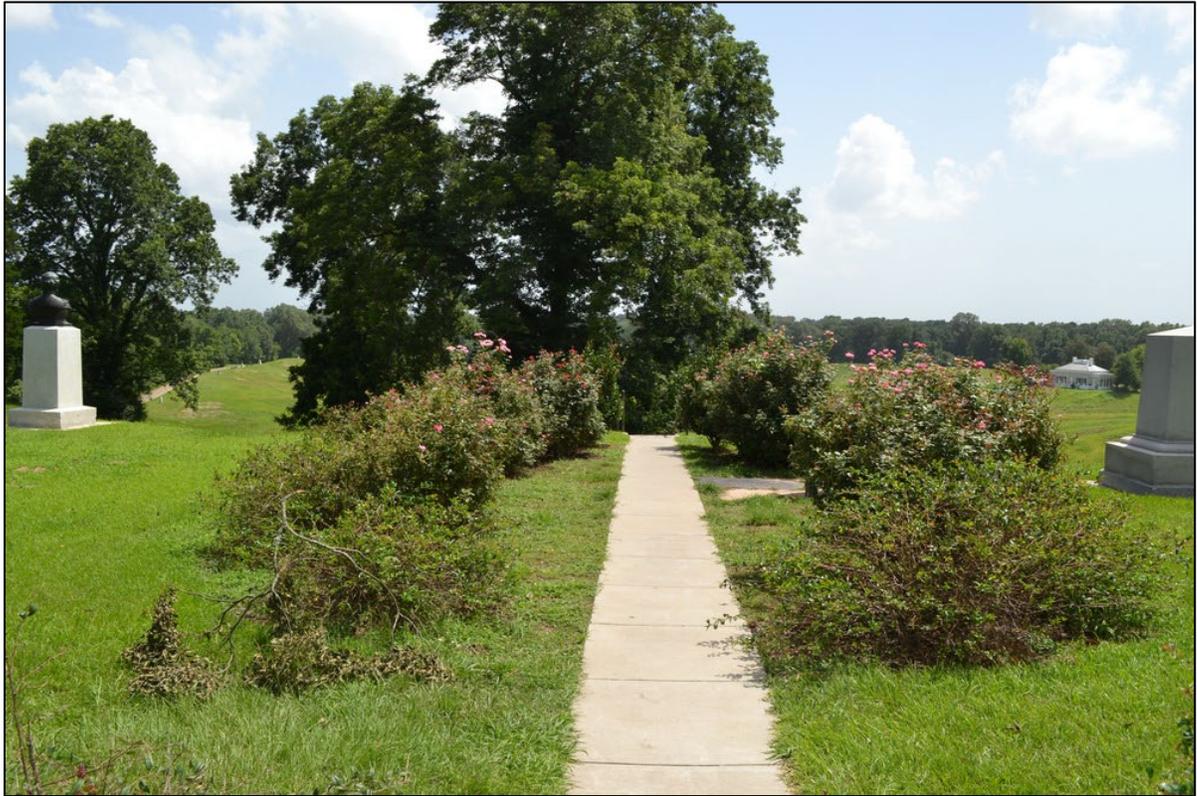
Fig 75. Ornamental plantings looking south from the Shirley House front entrance.

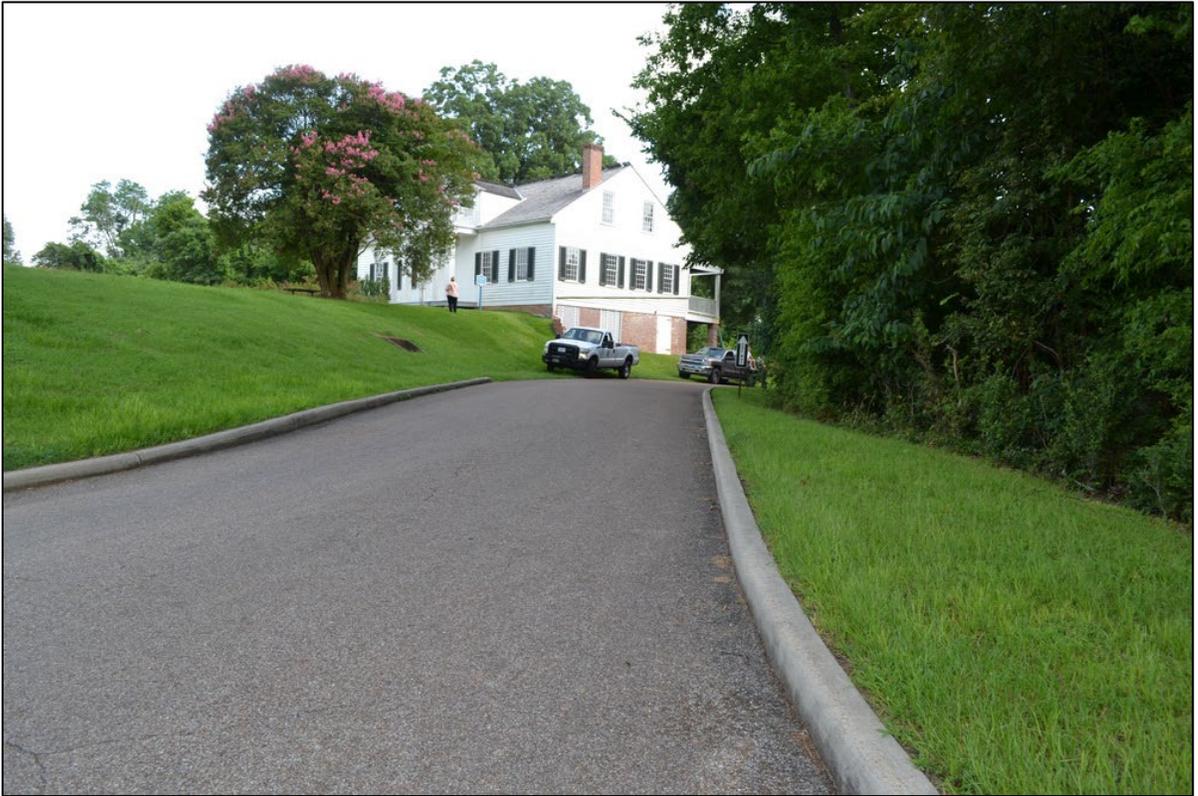
Fig 76. Segment of concrete curb on the west edge of Union Avenue adjacent to the Shirley House site.

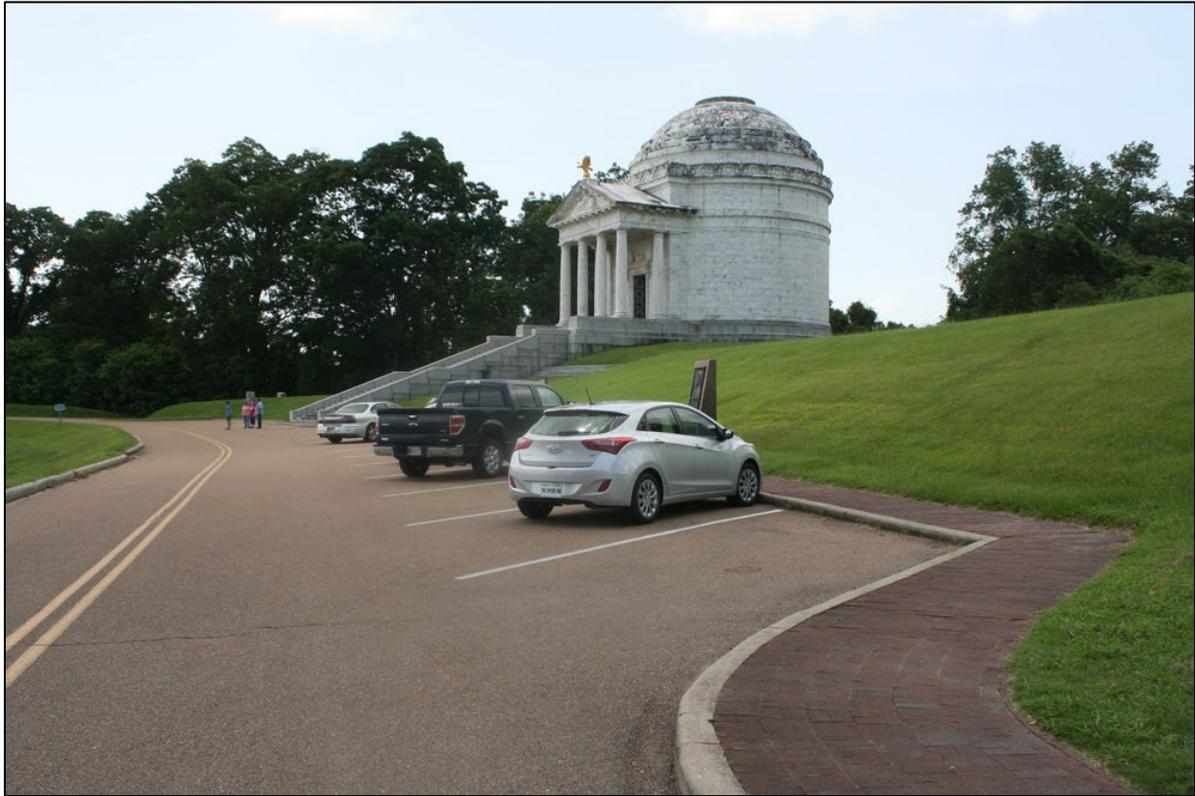
Fig 77. Old Jackson Road has associated head-in parking between the Illinois State Memorial and the Shirley House.

past the Illinois State Memorial. There are approximately thirteen spaces between the Shirley House steps and the Illinois State Memorial steps and an additional four spaces on the west side of the Illinois State Memorial steps. The corridor is edged by concrete curbing except for a small length of grass edging east of the Shirley House steps and continuing around the corner until the curb picks up again on Union Avenue. The paved road segment, curbs, and adjacent parking are in good condition (Figure 77 through Figure 78).

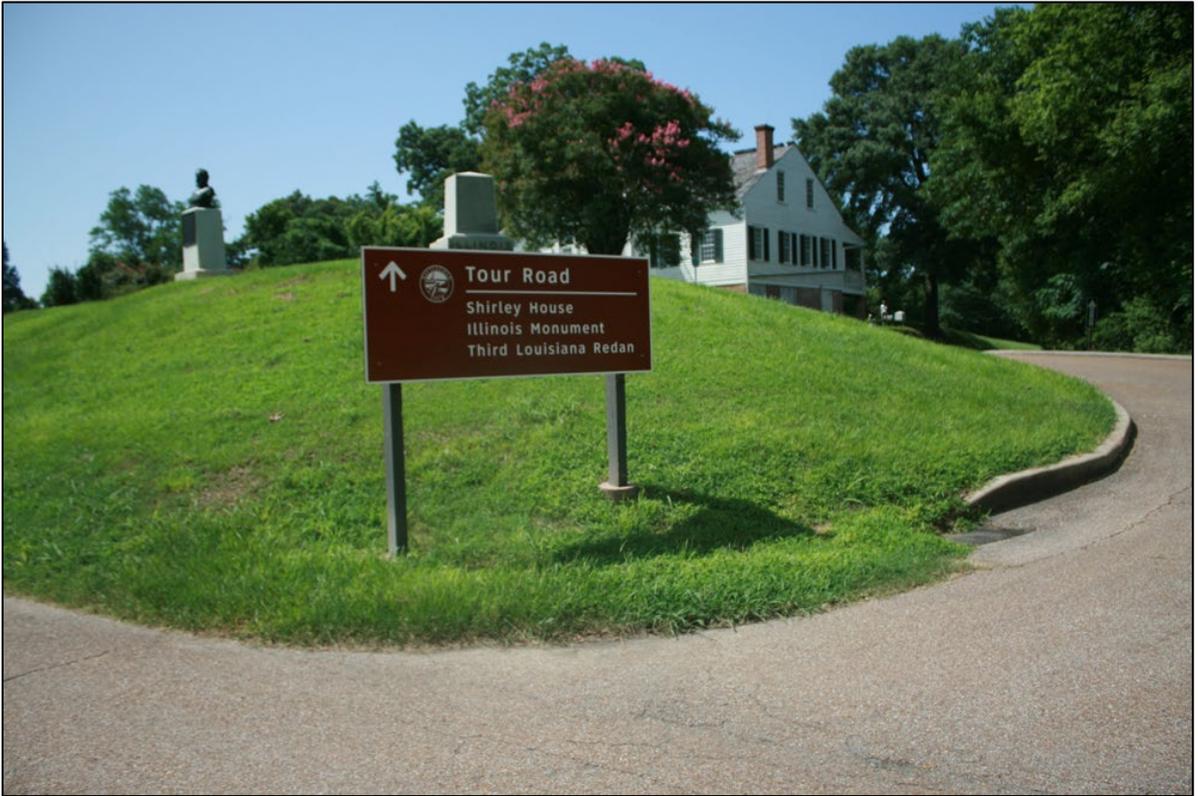
Fig 78. Road and parking are edged with a concrete curb except for the grass edge section east of the Shirley House steps and around the corner to Union Avenue.

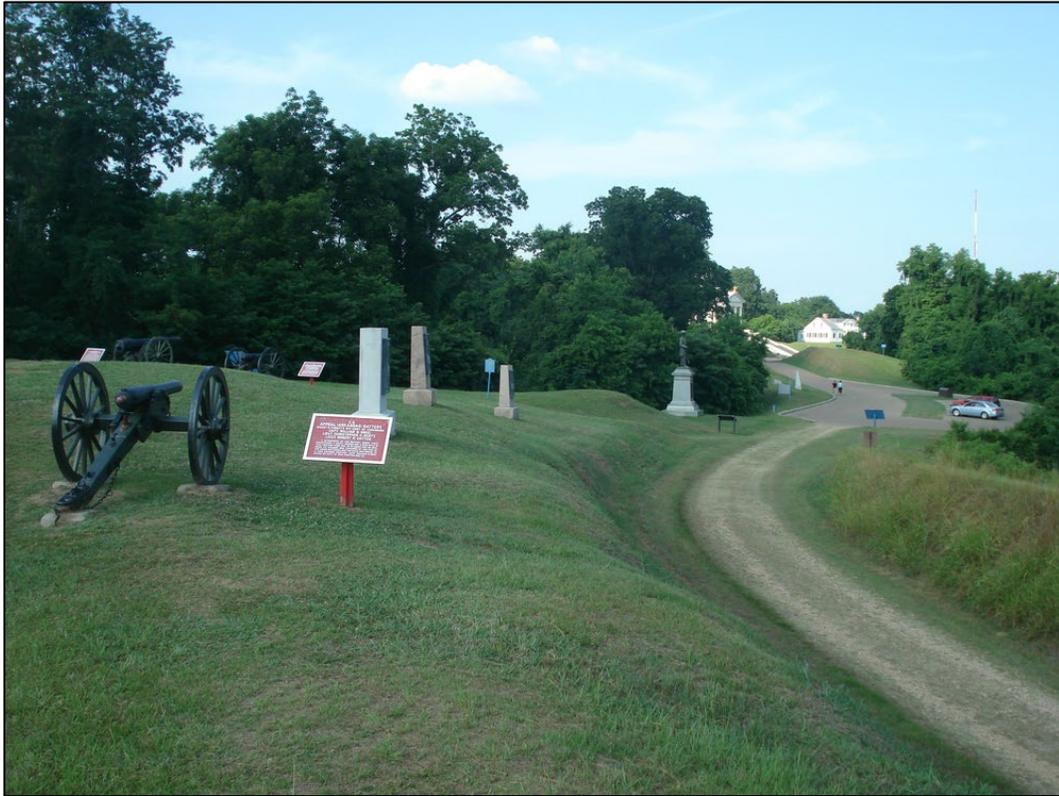
Fig 79. A spur of the tour road follows the Old Jackson Road trace and provides access to the Shirley House, Illinois State Memorial, and the Third Louisiana Redan.

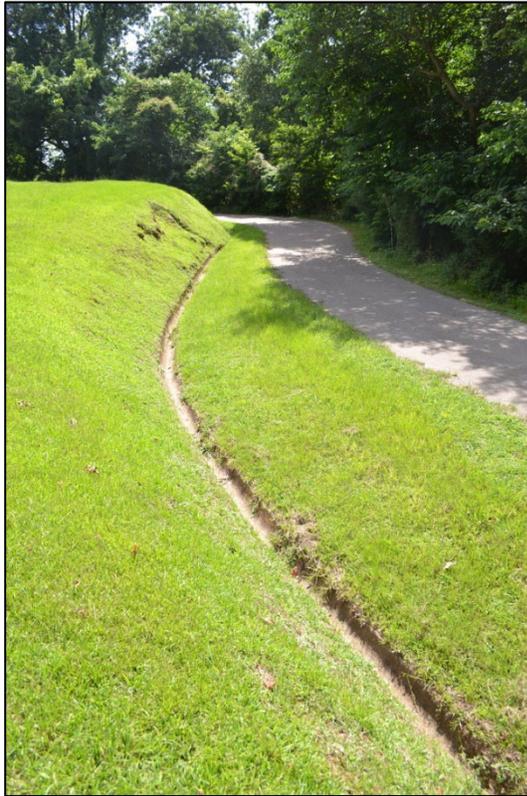
Fig 80. Asphalt access road with the concrete-lined swale.

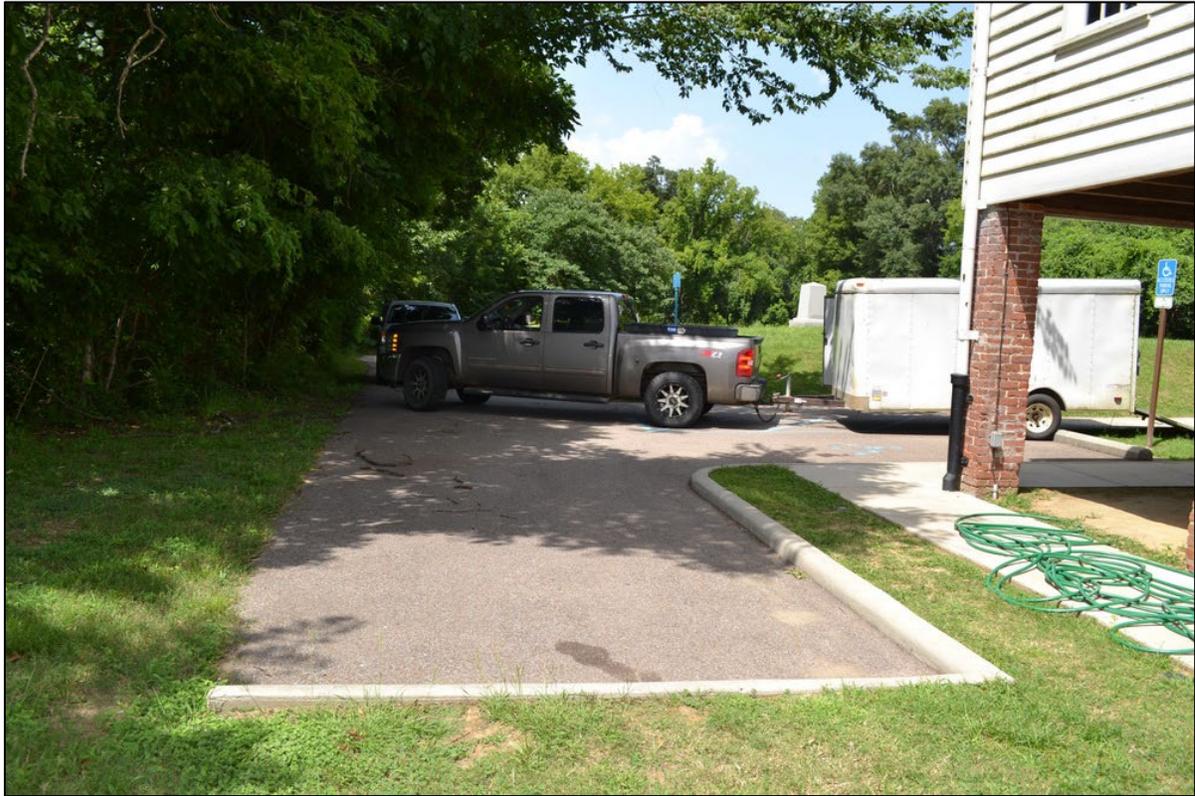
Fig 81. Road terminates in a universally accessible parking spot and a turn-around.

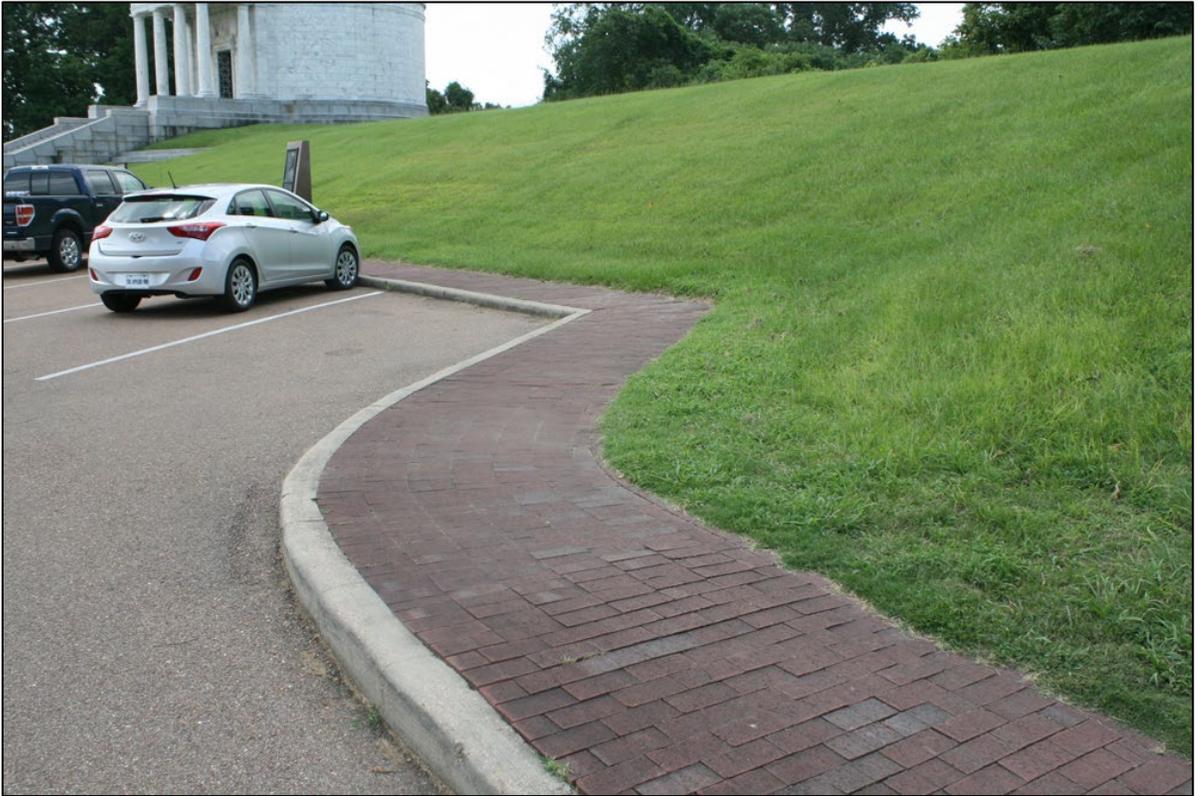
Fig 82. Visitors use the brick sidewalk once cars are parked and to access the steps to the Shirley House and the Illinois State Memorial.

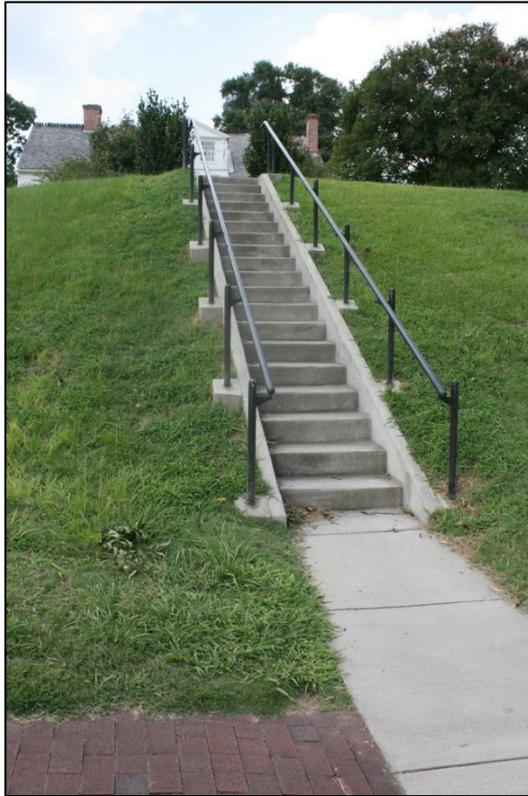
Fig 83. Concrete steps up the steep embankment to the Shirley House.

Most visitor access to the Shirley House requires climbing the concrete steps north of the house. There are 19 concrete steps with concrete cheekwalls and associated metal tube railings painted black. The railings are anchored in concrete footings on either side of the steps. The steps and front entrance to the Shirley House are not universally accessible (Figure 83). The stairs are in good condition.

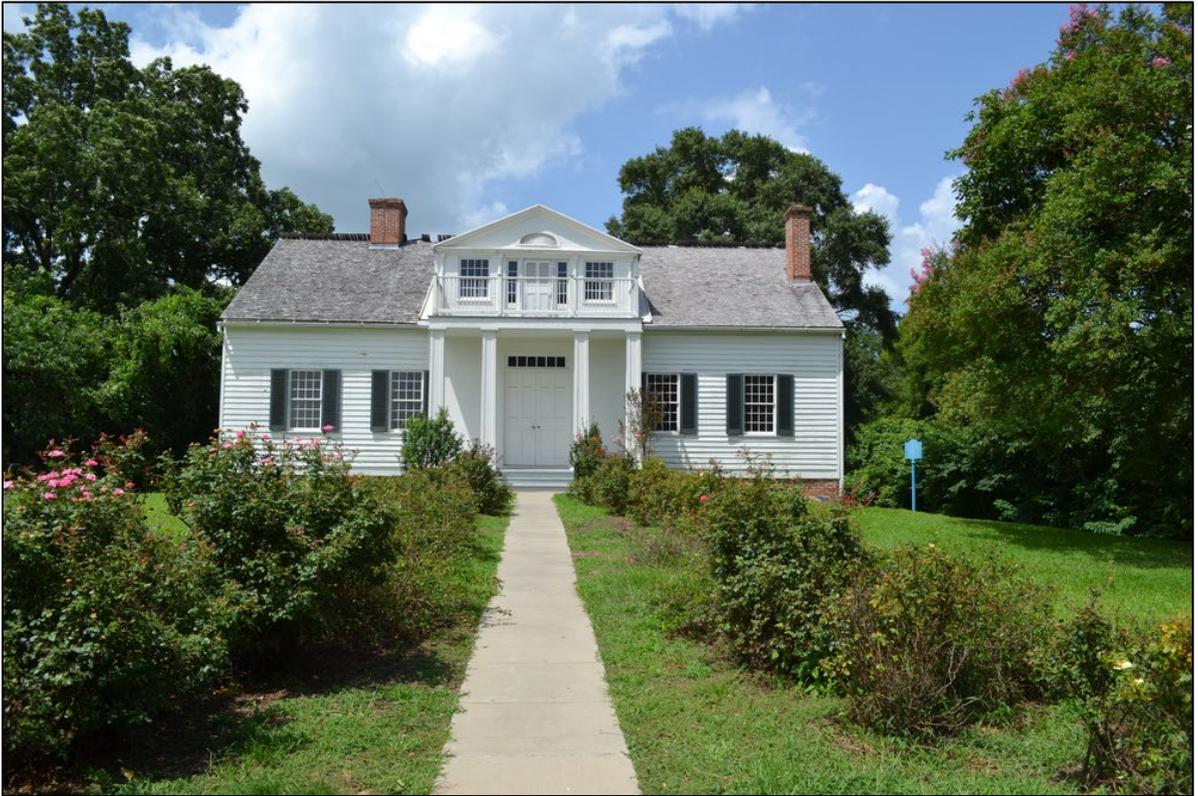
Fig 84. Concrete sidewalk flanked by Rose of Sharon and flowering quince shrubs leads to the front door of the Shirley House.

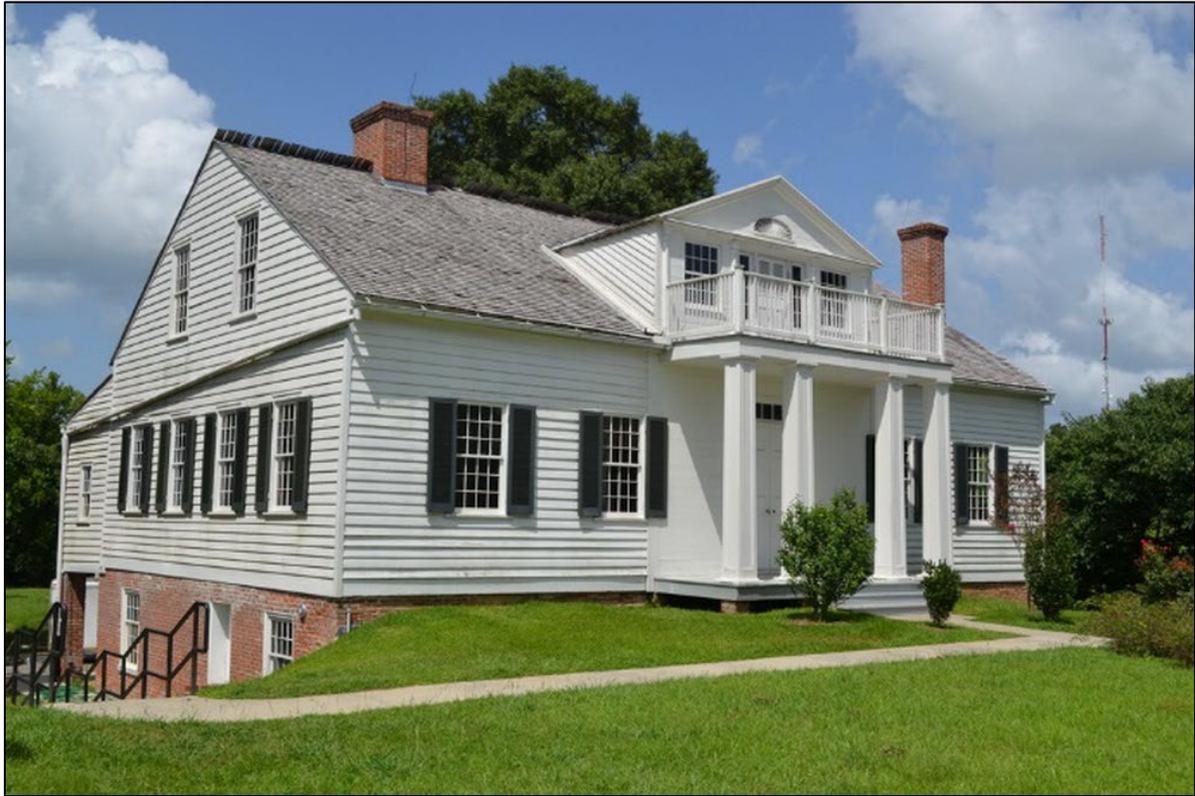
Fig 85. Concrete landing adjacent to the bottom step and the intersecting sidewalk are visible from the front yard of the Shirley House.

Concrete walk and stair system on the western and northern sides of the Shirley House. The front concrete sidewalk leads to the front steps and expands to a small concrete landing immediately adjacent to the bottom step. Before the sidewalk becomes a landing, it intersects with a perpendicular concrete sidewalk that leads west to another set of stairs. These stairs descend toward the back of the house and the associated access road, parking, and additional site features. The stairs are concrete with concrete cheek walls and an associated handrail of metal tubing, painted black. The stairs alternate two steps and a landing and the railings are stabilized within the cheekwalls. The sidewalks and stairs are in good condition (Figure 85 through Figure 86).

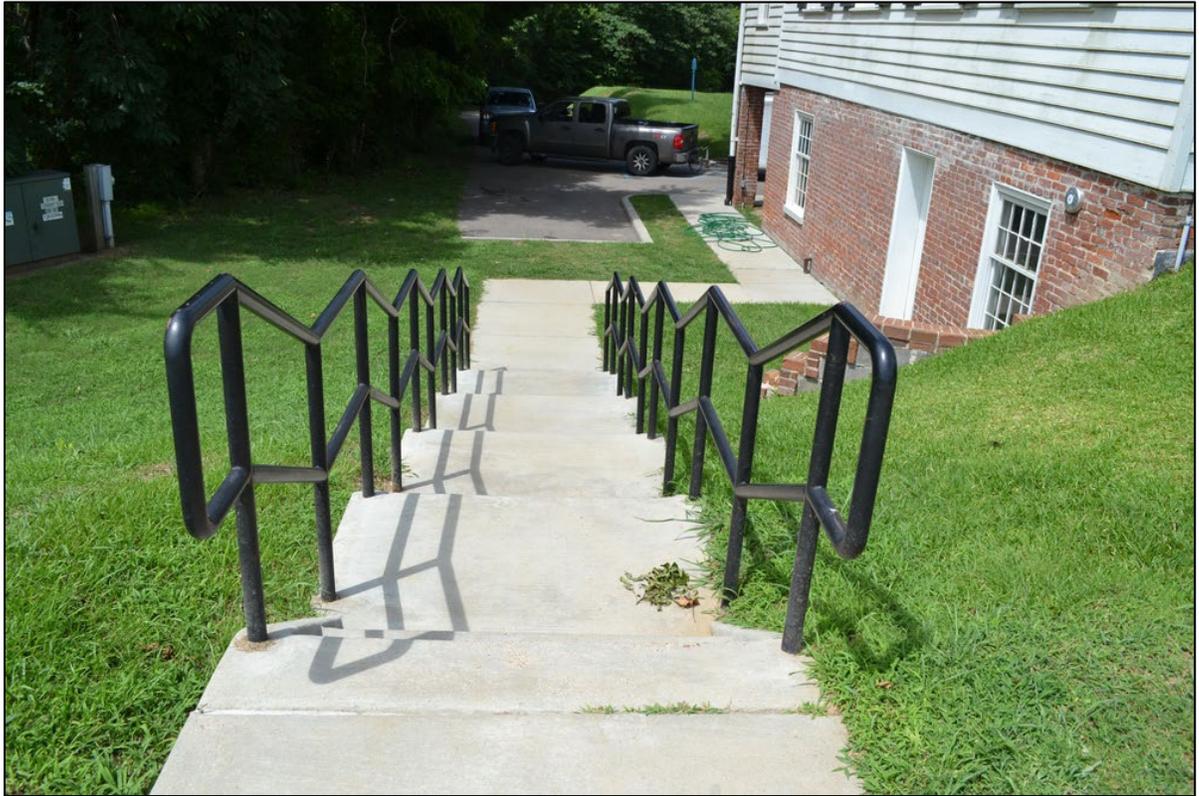
Fig 86. Concrete steps descend north toward the rear of the house.

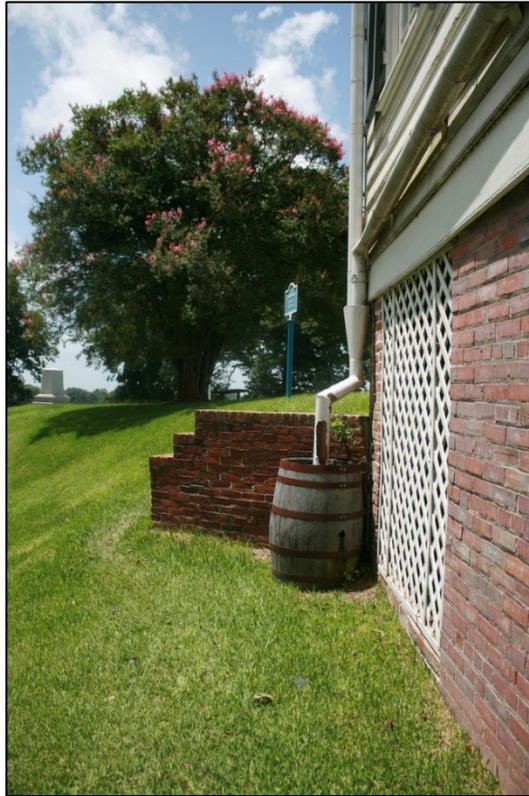
Fig 92. Brick retaining wall is connected to the east side of the dwelling and is adjacent to a rain barrel that collects water from the roof.

Brick Retaining Walls. There are two brick retaining walls that extend out from the southeast and southwest corners of the Shirley House. One of the walls is adjacent to the rain barrel connected to the roof drainage system on the house (Figure 92). The walls are in good condition.

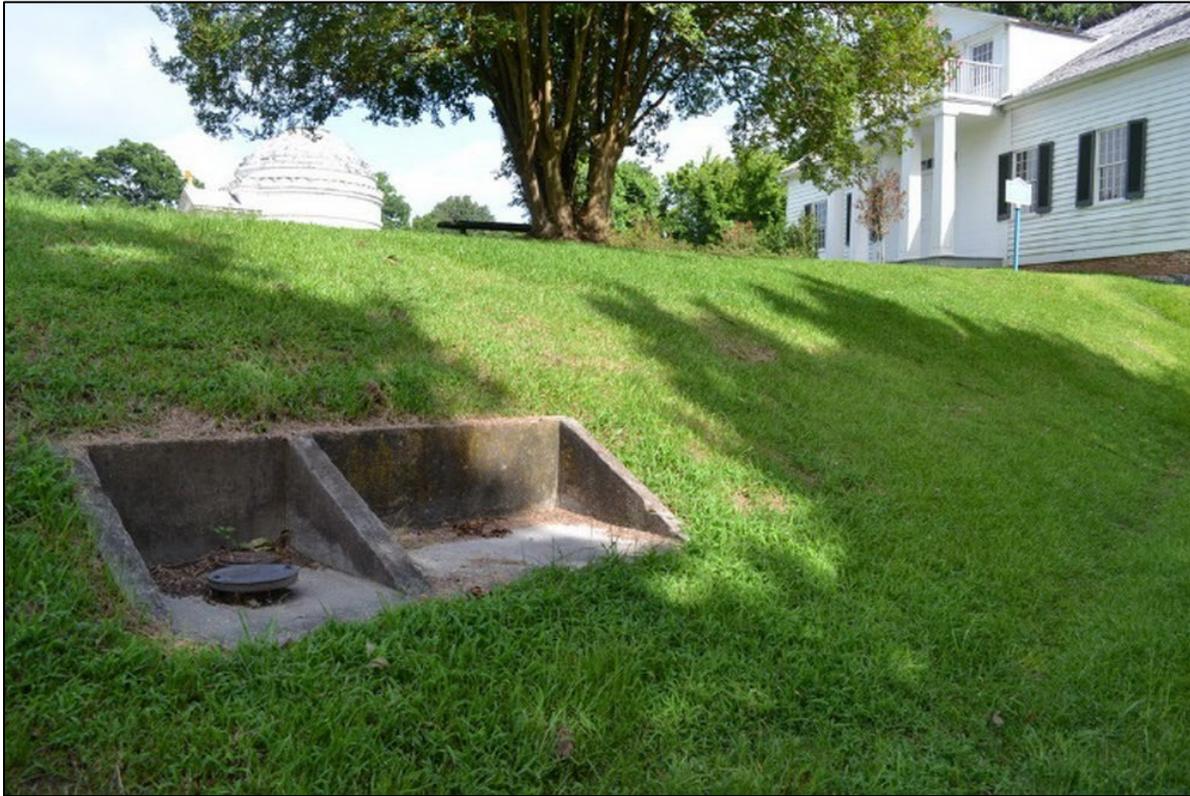
Fig 93. Concrete utility structure on the knoll embankment.

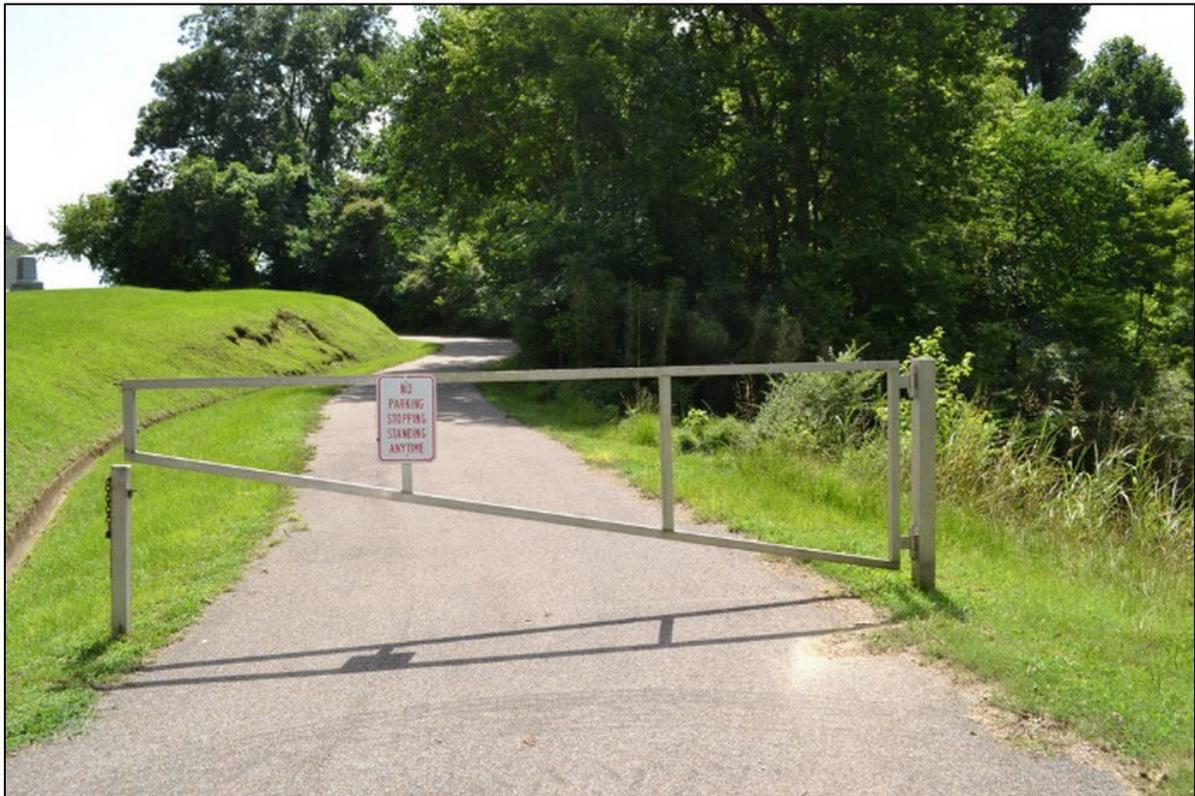
Fig 94. The metal gate controls access to the drive that leads to the Shirley House and parking.

Gate . A metal gate currently limits public access to the asphalt drive leading to the Shirley House property and the universally accessible parking (Figure 94). This gate was likely installed after public use of the Illinois Circle Road ceased. The gate is in good condition, but it postdates the period of significance and is non-contributing.

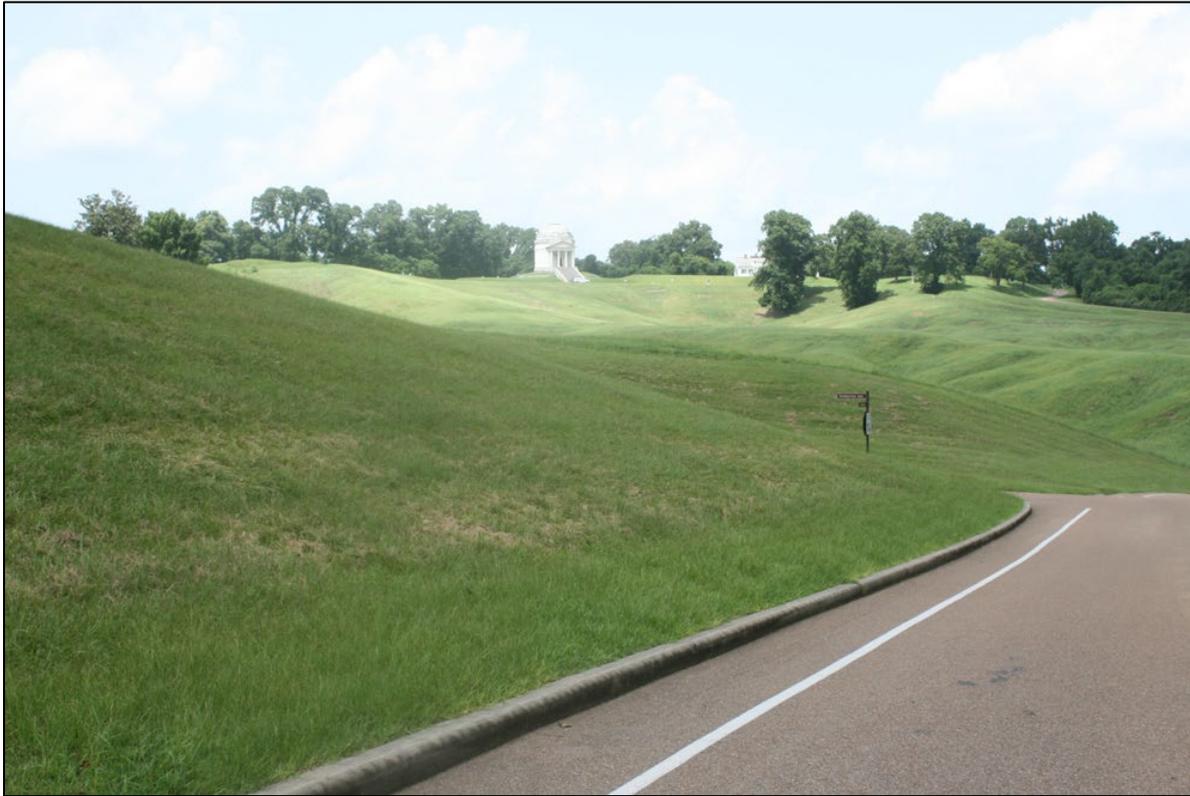
Fig 95. View north from the tour road to the Illinois State Memorial and Shirley House.

The dramatic views from the tour road north to the Shirley House and the Illinois State Memorial over cleared areas now maintained in grass remain (Figure 95). These views survive with integrity and contributes to the significance of the historic landscape.

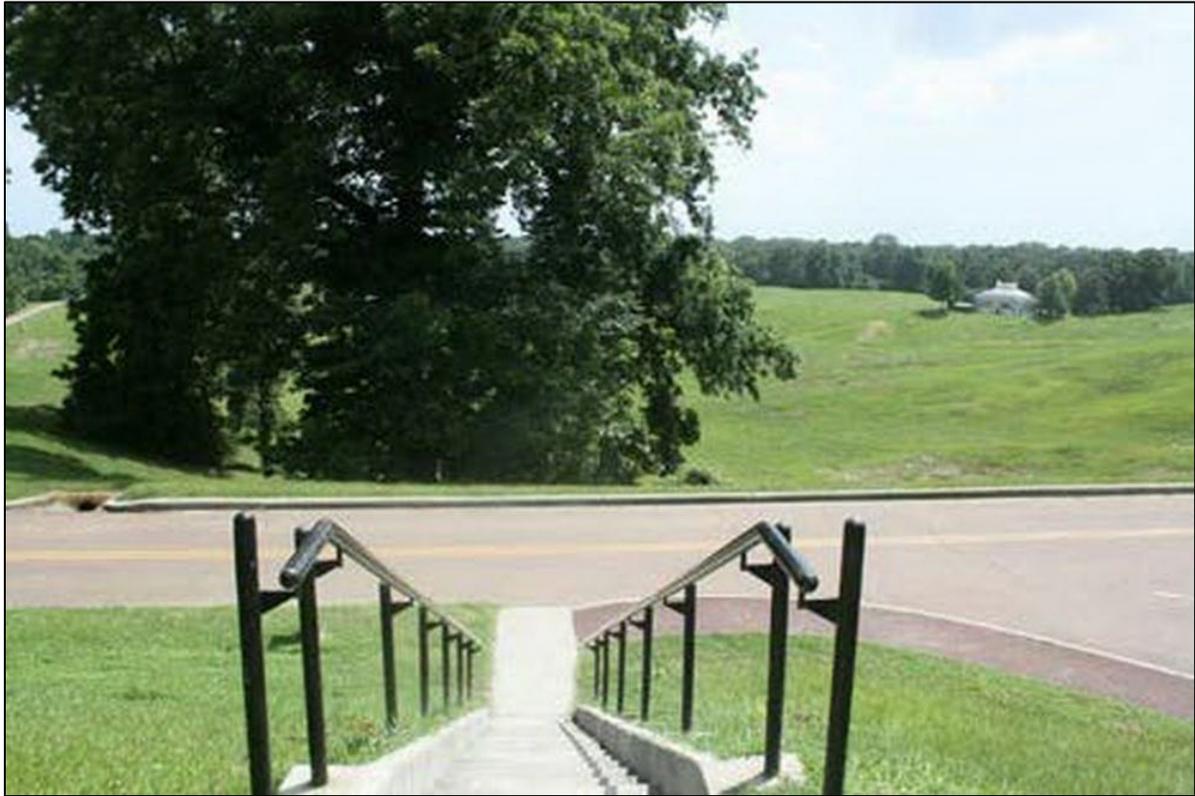
Fig 96. View south from the Shirley House over open siege landscape. View is partially blocked by a large deciduous tree.

The view south from the house and monument is over open siege landscape (Figure 96). There is also an open viewshed southwest due to clearing that occurred in 2009 from the Shirley House

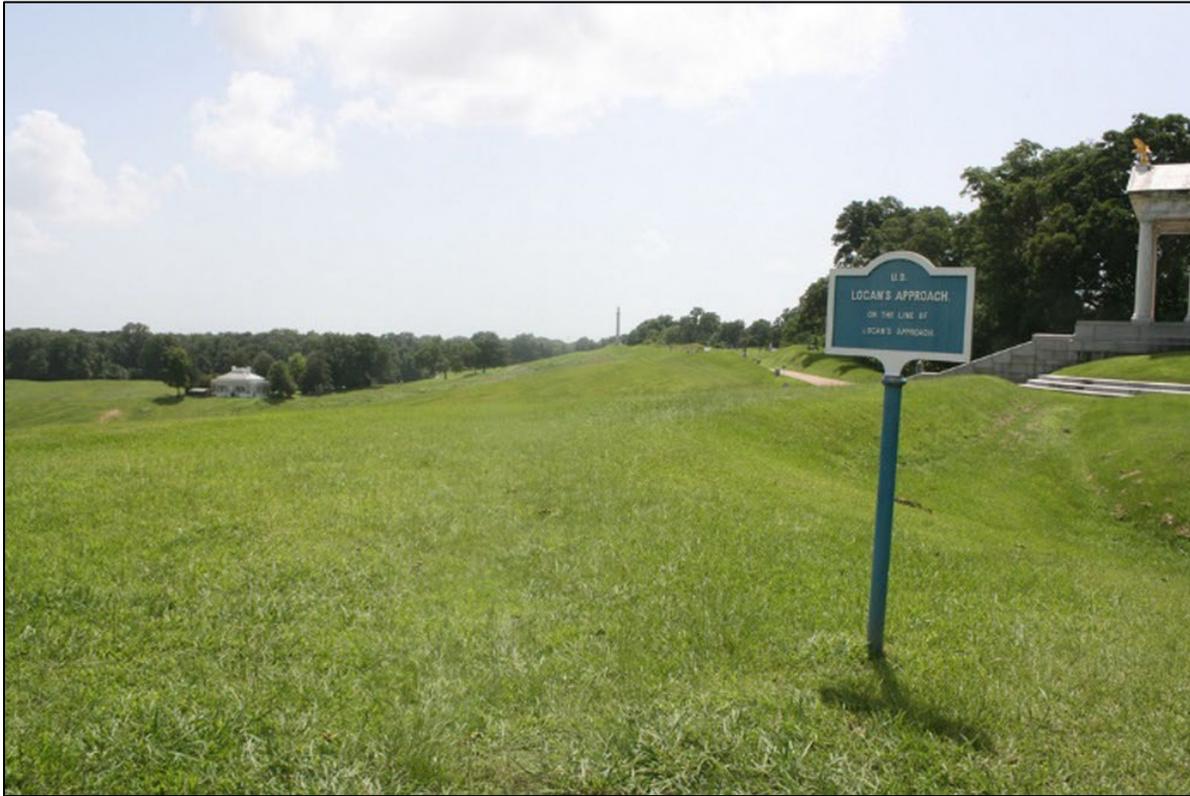
Fig 97. View southwest from the Shirley House to the Old Administration Building. (The approach to the Illinois State Memorial is visible at right.)

Views relating to the Shirley House site and associated landscape are indicative of the conditions discussed above. The viewshed west from the Shirley House to the Illinois State Memorial is unimpeded. There is also an open viewshed southwest from the Shirley House that includes the Old Administration Building (Figure 97).

that includes the Old Administration Building (Figure 97), which interferes with the interpretation of the siege landscape. This expansive view to the south remains available to visitors today based on the tree clearing efforts conducted in 2009. It survives with diminished integrity due to the views of the Old Administration Building, and contributes to the significance of the historic landscape.

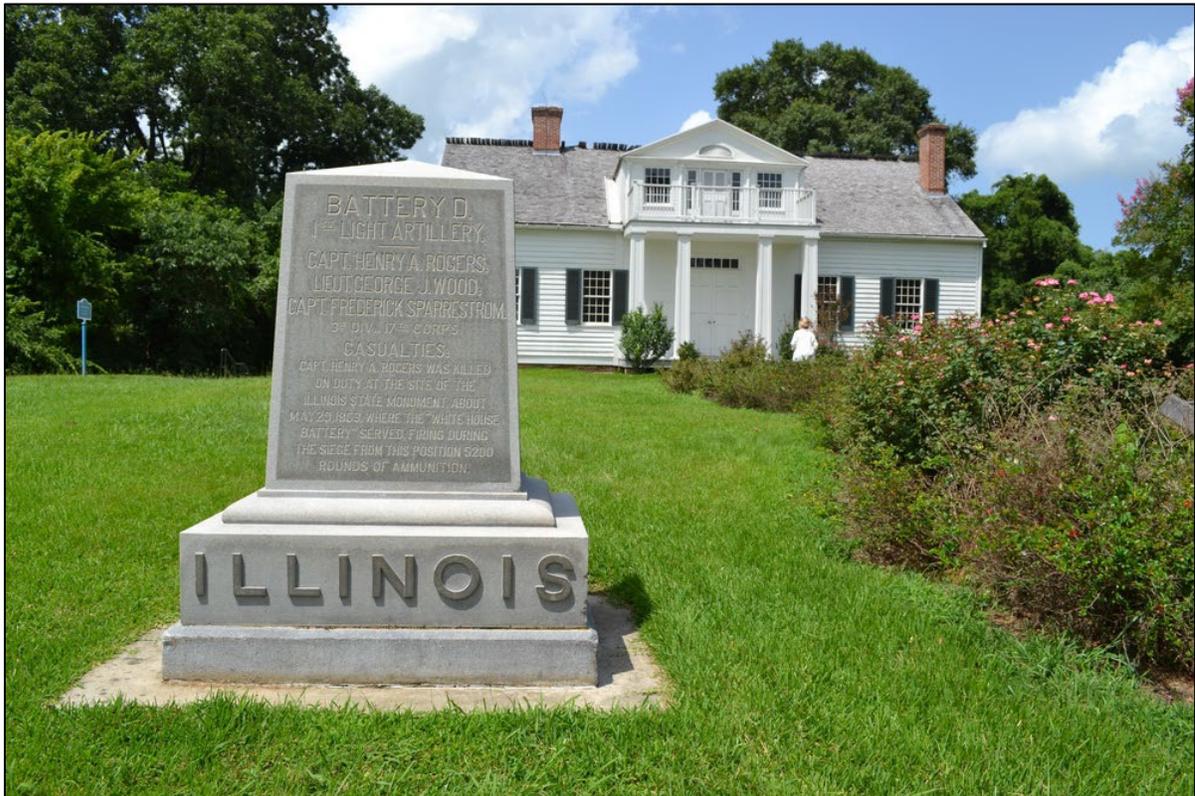
Fig 98. Battery D 1st Illinois Light Artillery Monument.

Battery D 1st Illinois Light Artillery Monument. This gray granite monument is identical to the other Illinois Infantry monuments. The monument is located on the south lawn of the Shirley House in close proximity to the front sidewalk and the associated shrub plantings. This monument is in good condition (Figure 98). This monument has lost integrity of location. It was moved several feet to the east at some time in the 1960s, possibly to allow for the installation of a water reservoir in 1964. Nevertheless, it still contributes to the significance of the historic landscape.

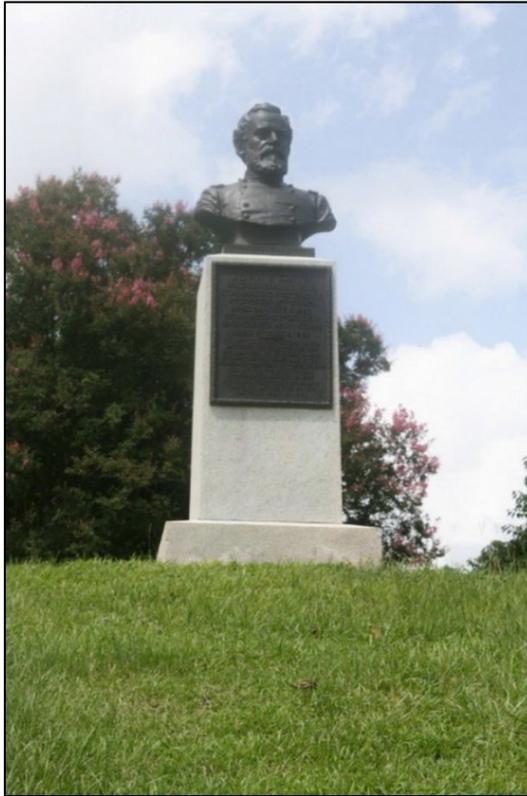
Fig 99. Brigadier General John E. Smith Bust.

to be a standard size. Notably, many of the busts and reliefs were fabricated by Tiffany and Company foundry. The light gray granite monument consists of a 44 inch square, tapered base, supporting a rectangular pedestal for a total height of 72 inches. A 36 inch by 24 inch by 52 inch bronze bust of the brigadier general rests on top. One bronze plaque is attached to the pedestal. This monument is located on the north lawn of the Shirley House and is in good condition (Figure 99).

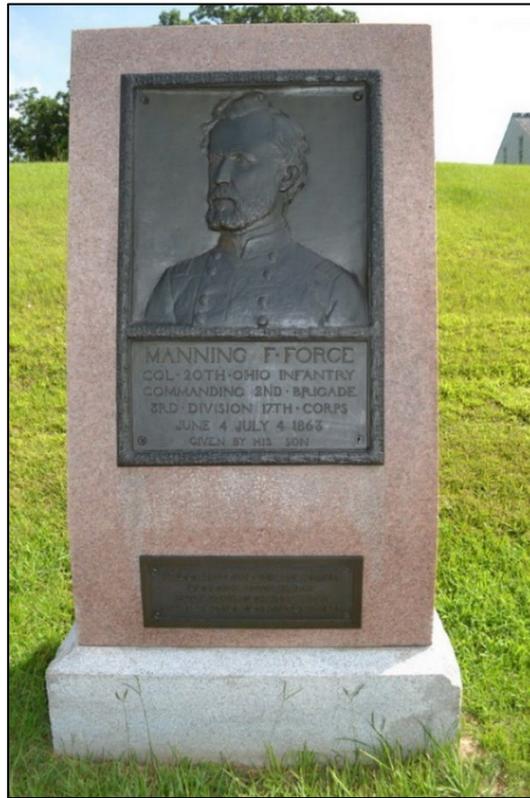
Fig 100. This relief portrait memorialized Col. Manning F. Force and was given by his son.

Col. Manning F. Force Relief Portrait. This two-piece granite monument measures 4 feet by 2 feet by 6 feet. Attached to the front of the monument is a 25 inch by 30 inch bronze relief portrait of Col. Manning F. Force. The relief panel has an inscription and a decorative border. A smaller bronze panel contains Force's service record. This monument is located adjacent to the sidewalk that connects the Shirley House and the Illinois State Memorial. There are several other small-scale features placed along the edge of this sidewalk. This feature is in good condition (Figure 100).
