National Park Service Cultural Landscapes Inventory 2021

Shirley House

Vicksburg National Military Park

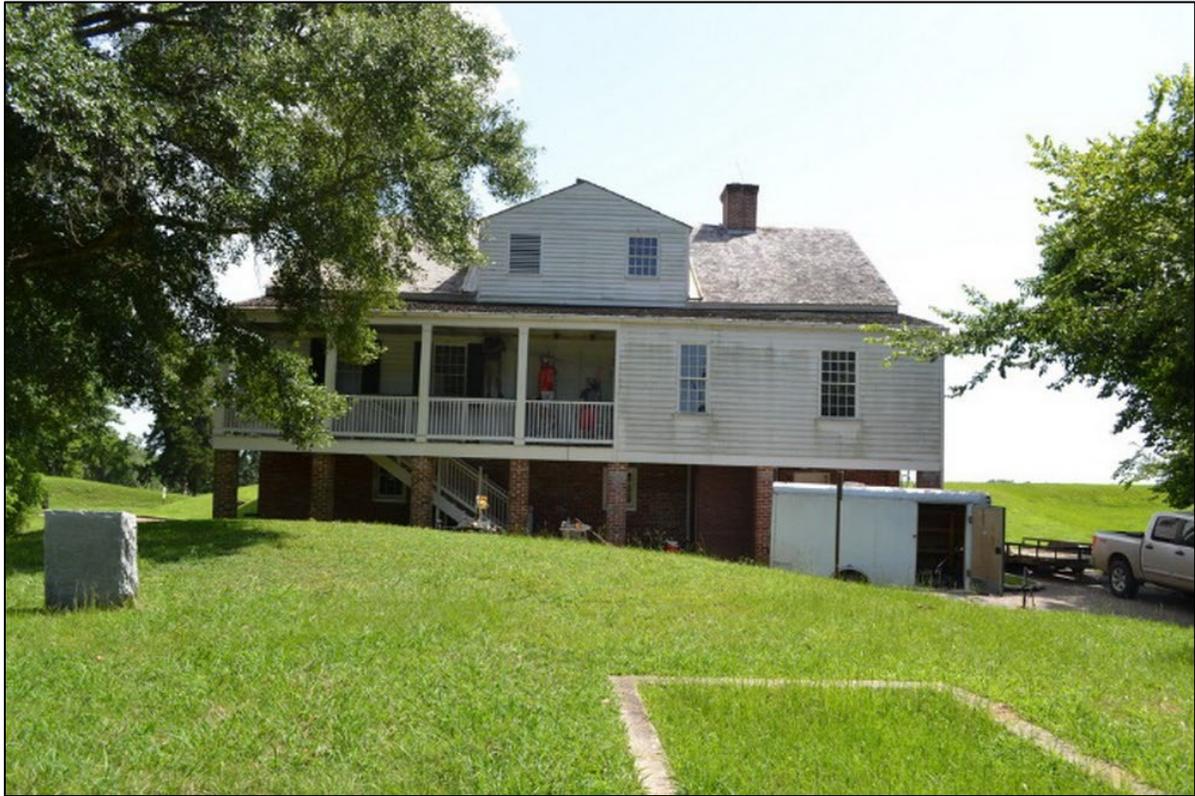
Fig 104. Concrete curb is near the grave marker on the sloping north lawn of the Shirley House.

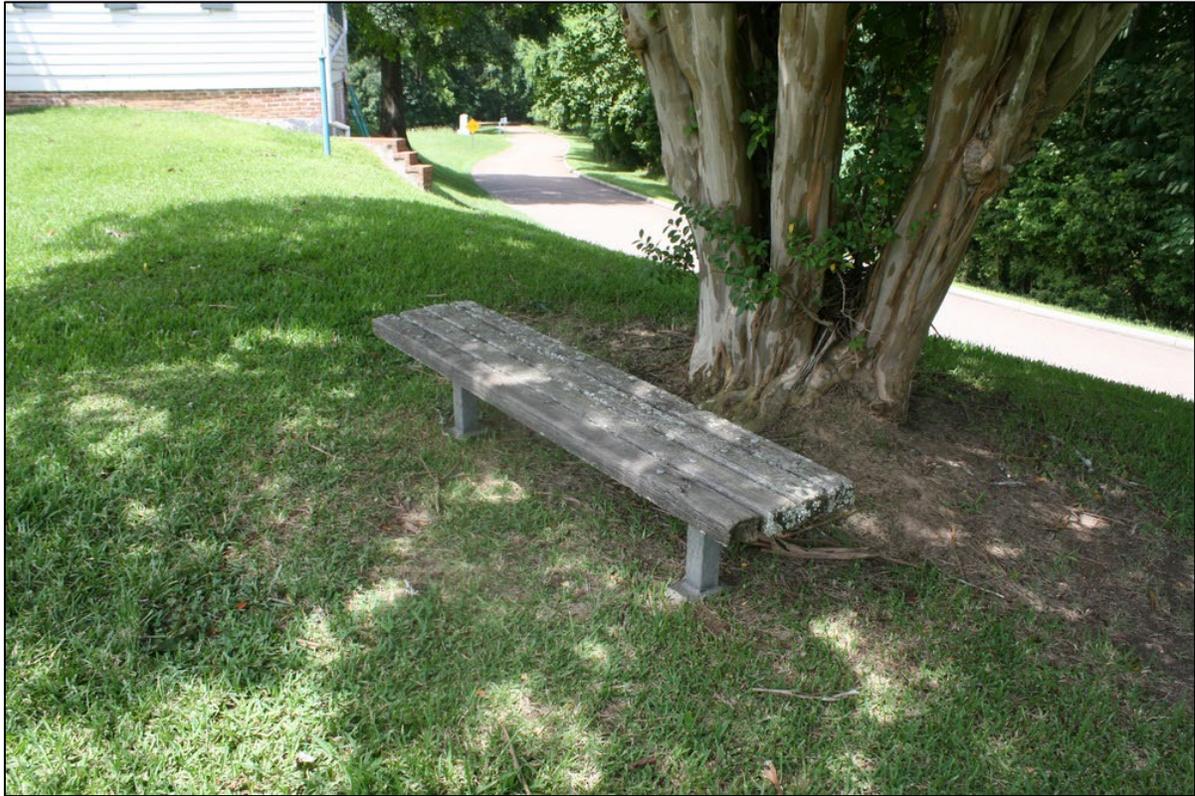
Fig 108. The bench is constructed of wood with metal posts.
