CULTURAL LANDSCAPE REPORT FOR
NATIONAL CENTER FOR PRESERVATION
TECHNOLOGY AND TRAINING

NORTHWESTERN STATE UNIVERSITY
NATCHITOCHES, LOUISIANA

Prepared by
Christopher Stevens, Olmsted Center for Landscape Preservation

National Park Service, Boston, Massachusetts, 2006

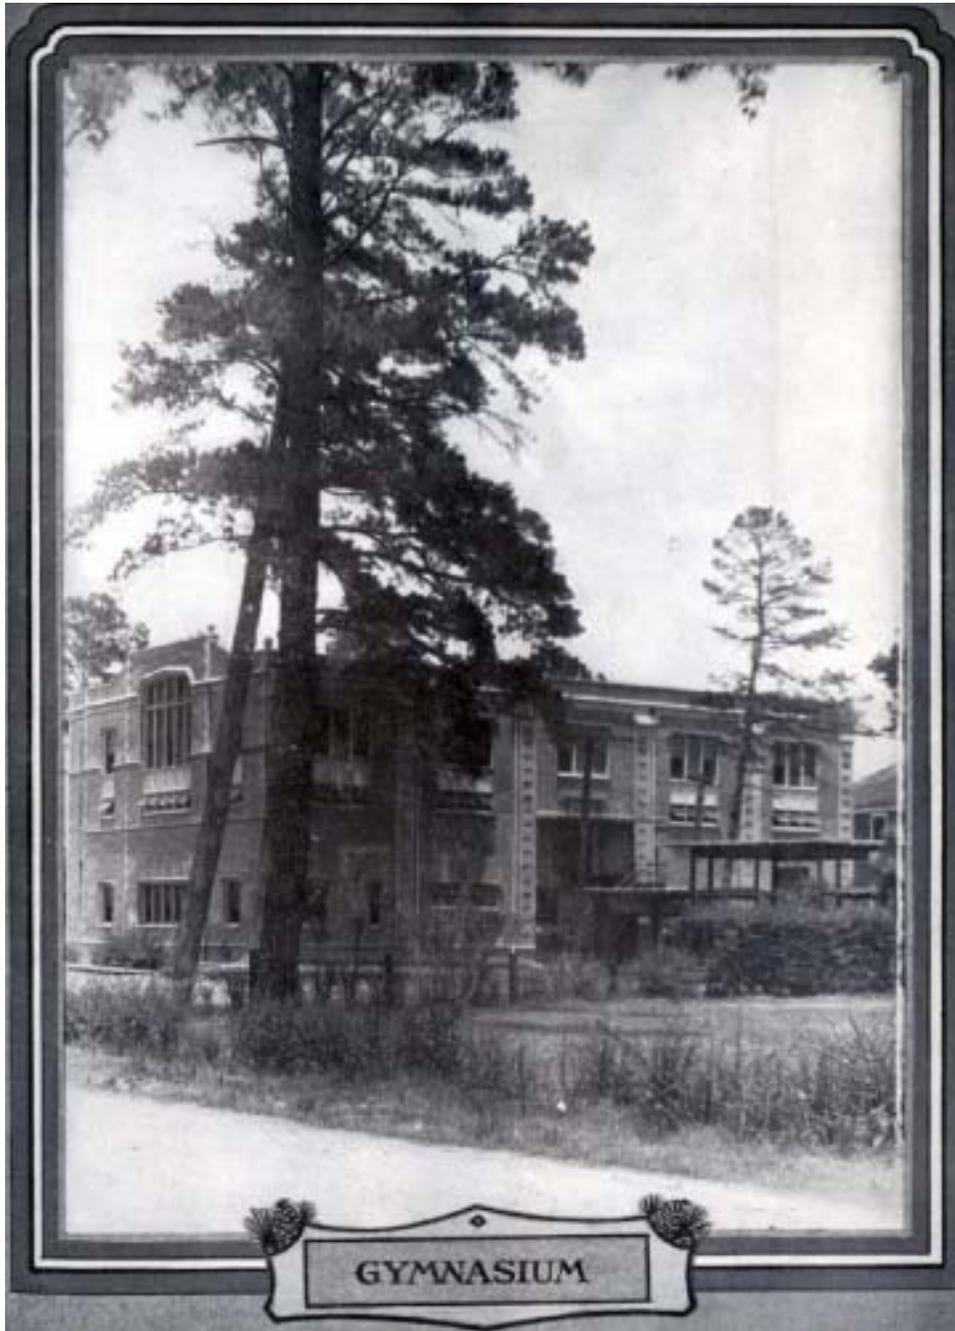
Figure 10. Southwest corner of Women's Gymnasium showing pine trees, hedges, and pergola-covered central walk to rear entrance, 1926 (Northwestern State University, Watson Memorial Library, Cammie G. Henry Research Center (Potpourri Yearbook)).

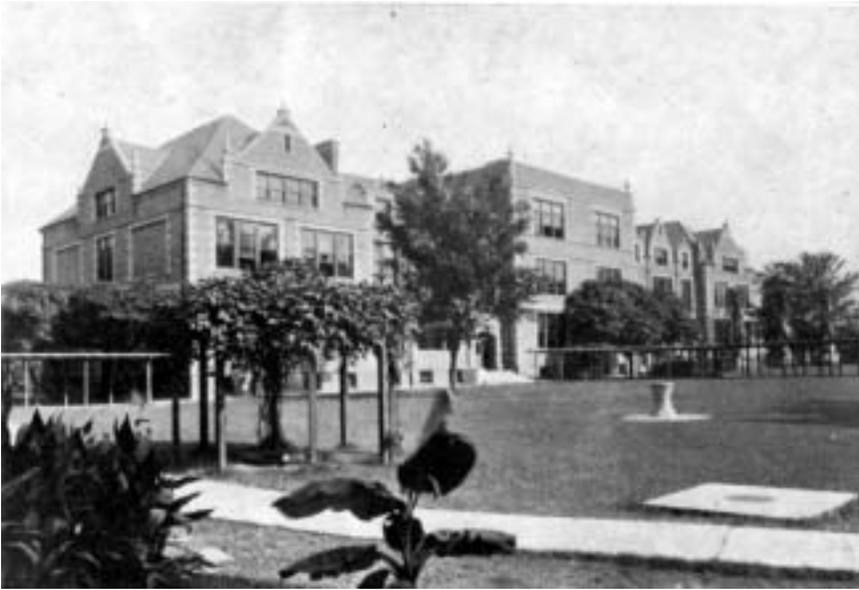
Figure 15. Planted and unplanted pergolas covering several of the college's walkways, 1927 (Northwestern State University, Watson Memorial Library, Cammie G. Henry Research Center (Potpourri Yearbook)).

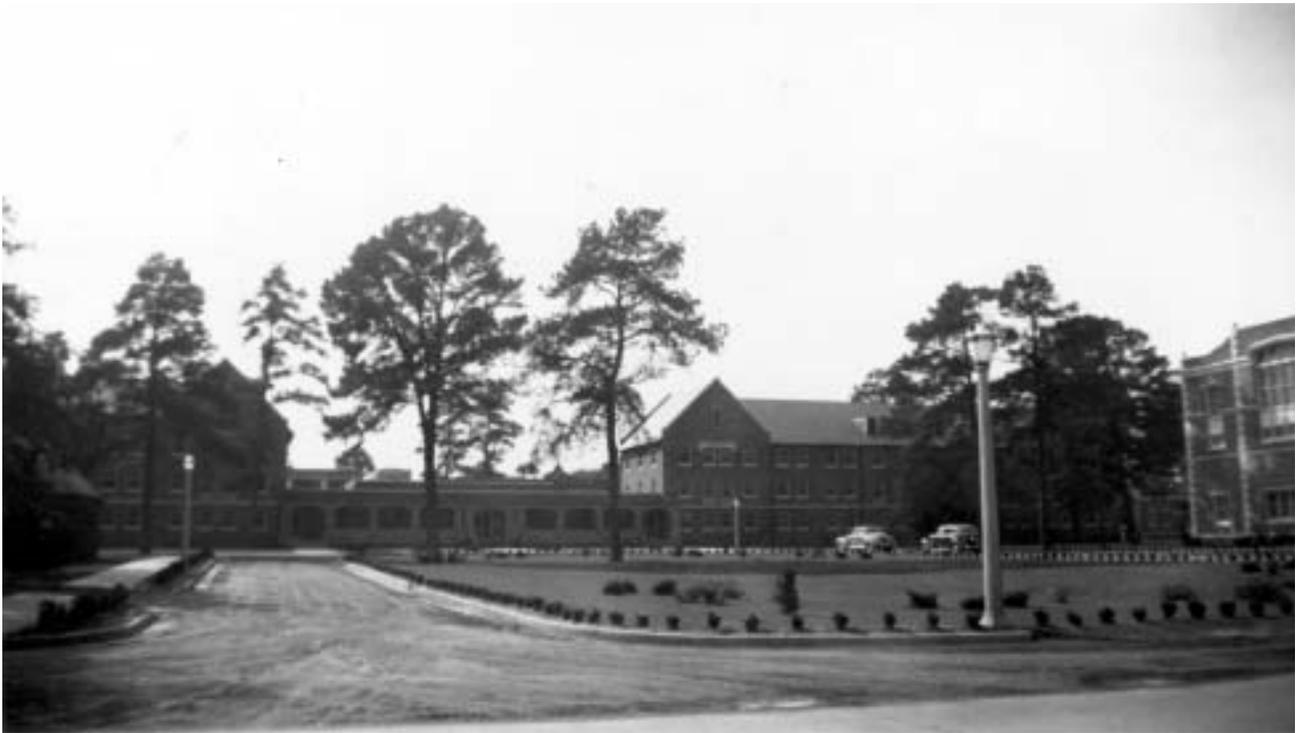
Figure 33. The newly constructed Varnado Hall and Horseshoe Drive (site of former fine arts building) with the Women's Gymnasium to the west, 1941. Note the newly planted hedge and shrub clusters (Northwestern State University, Watson Memorial Library, Cammie G. Henry Research Center (1941 Booklet-Insurance of Campus Buildings)).

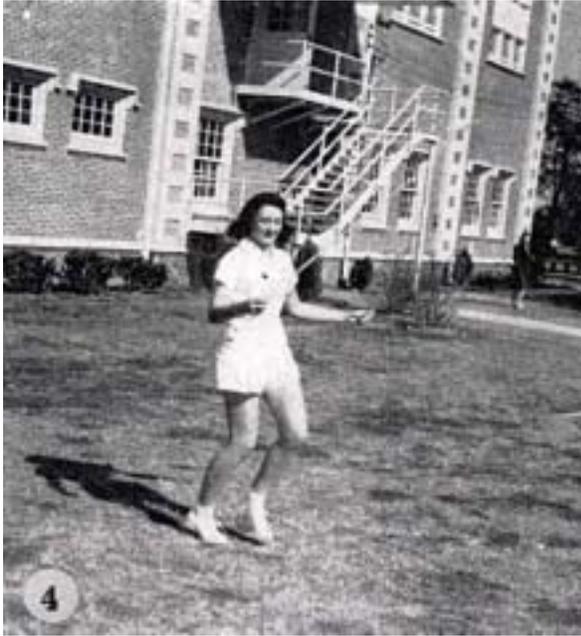
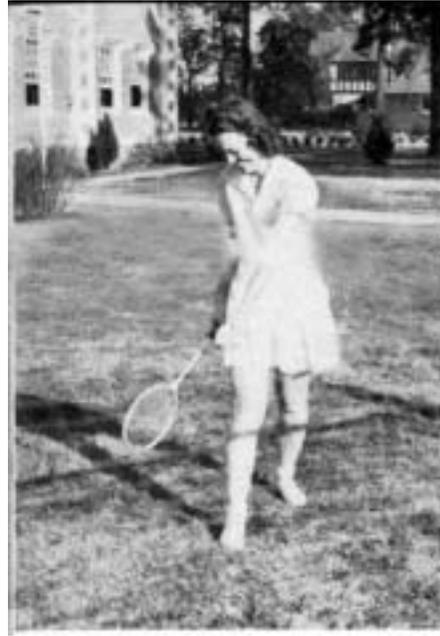
Figure 35. Jump roping and badminton on the south lawn, 1942 & 1943. Note the diagonal walkway coming from the rear entrance, the foundation shrubs, and the young hedge along Horseshoe Drive (background) (Northwestern State University, Watson Memorial Library, Cammie G. Henry Research Center (Potpourri Yearbook)).

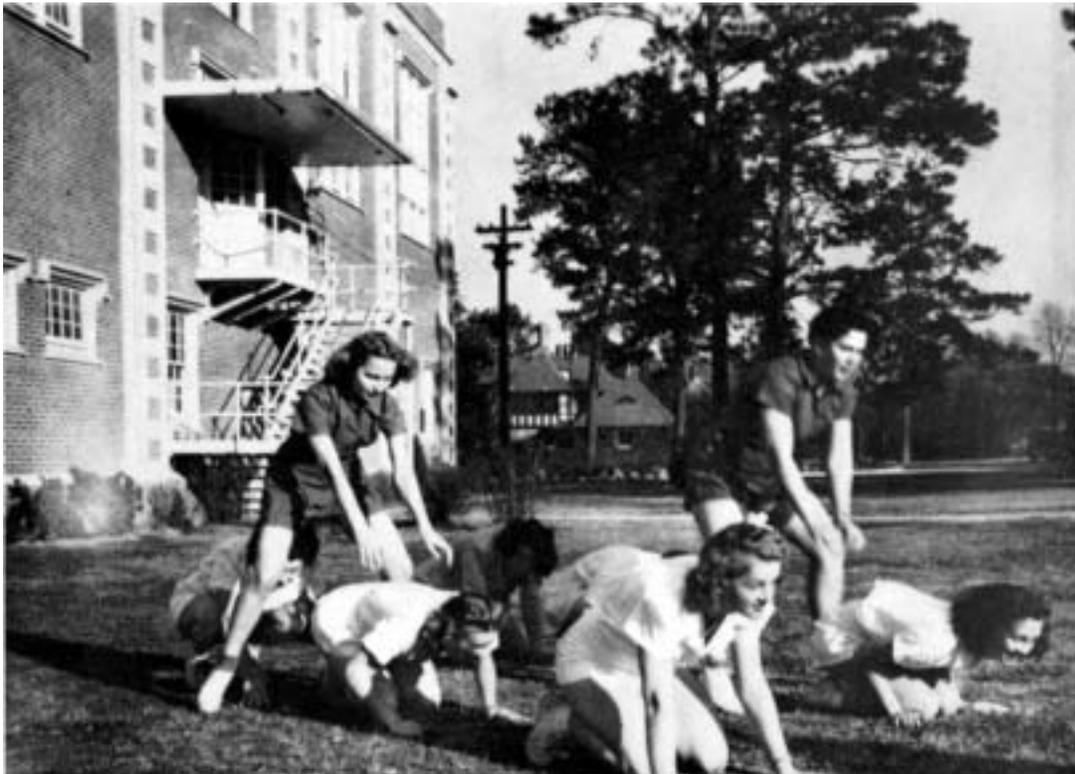
Figure 36. Leap frog on the south lawn of the Women's Gymnasium, 1943. Note the diagonal walkway coming from the rear entrance, the foundation shrubs, the large pine trees at the southeast corner, and the young hedge along Horseshoe Drive (background) (Northwestern State University, Watson Memorial Library, Cammie G. Henry Research Center (Potpourri Yearbook)).

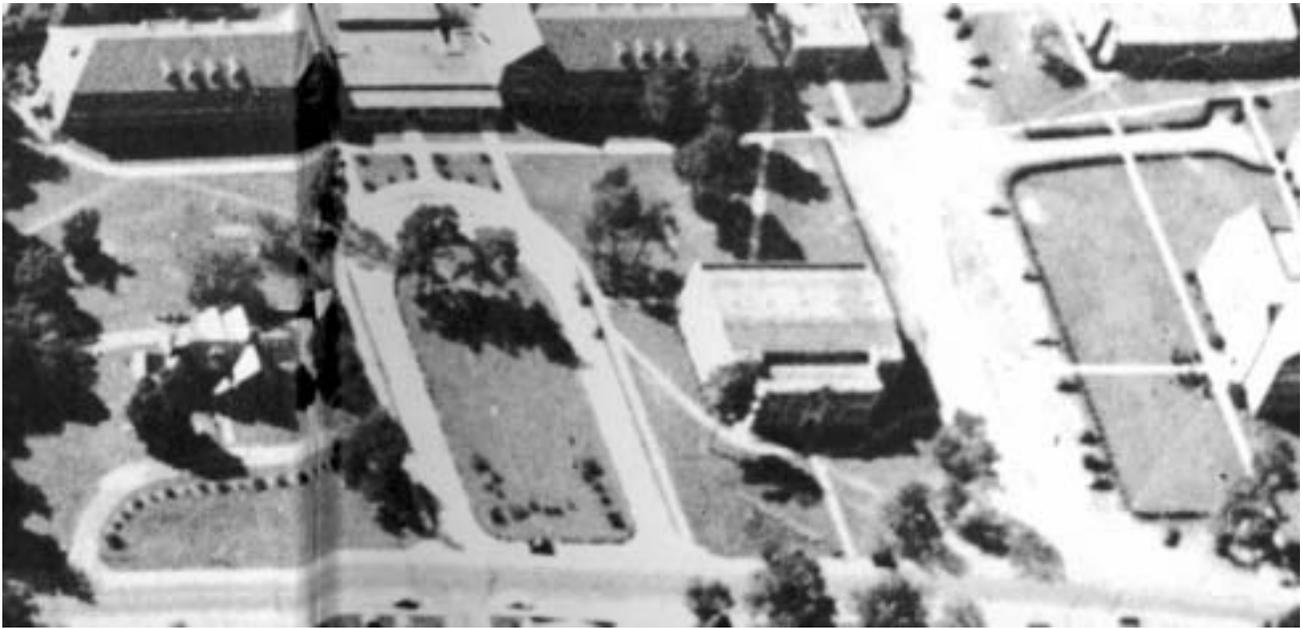
Figure 37. Aerial photograph showing from left to right, the President's Home, Horseshoe Drive, and the Women's Gymnasium, 1948. Note the extensive use of hedges on the campus including between Caspari Drive and the gym. All of the trees at the gym were pines. Varnado Hall is at the top of the image (Northwestern State University, Watson Memorial Library, Cammie G. Henry Research Center (Potpourri Yearbook)).

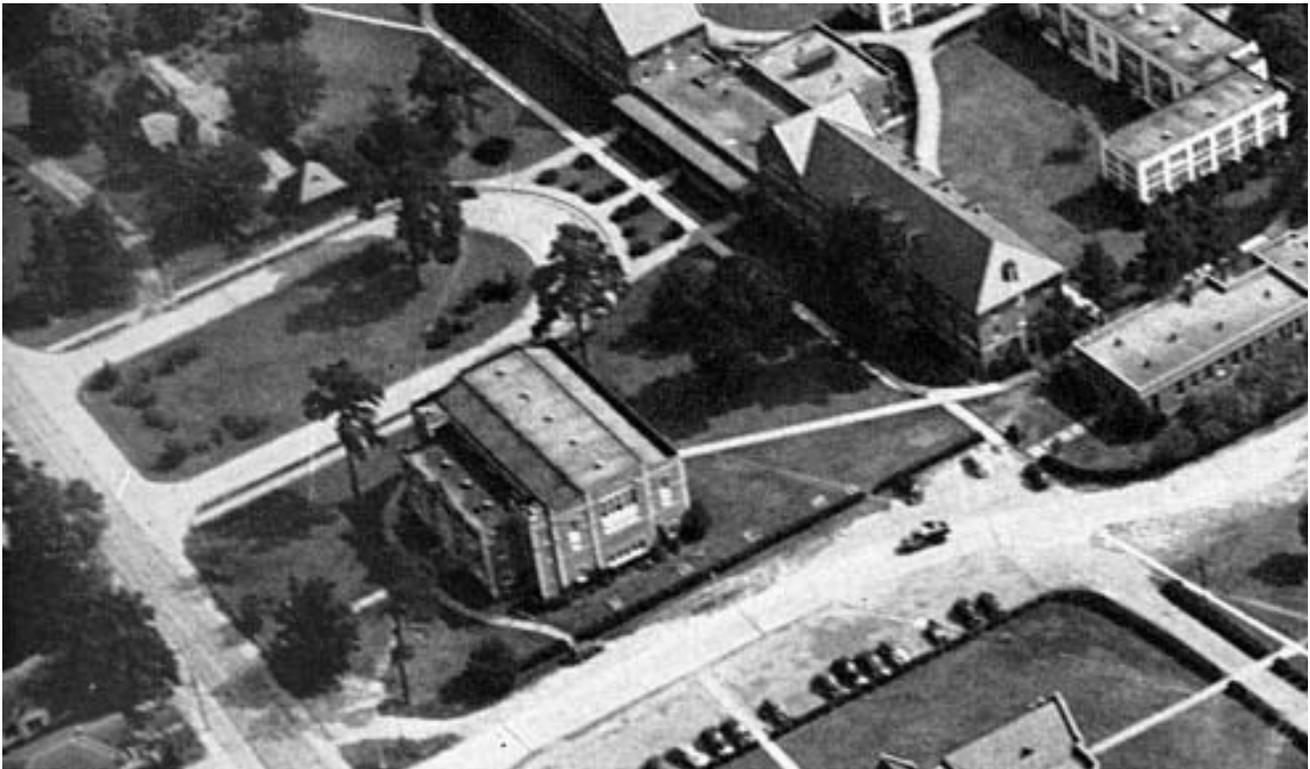
Figure 38. Aerial photograph showing from top left to bottom center, the President's Home, Horseshoe Drive, and the Women's Gymnasium, 1948. Note the extensive use of hedges on the campus including between Caspari Drive and the gym. All of the trees at the gym were pines. Varnado Hall is at the top with modern pergola-covered walkways behind (Northwestern State University, Watson Memorial Library, Cammie G. Henry Research Center (Potpourri Yearbook)).

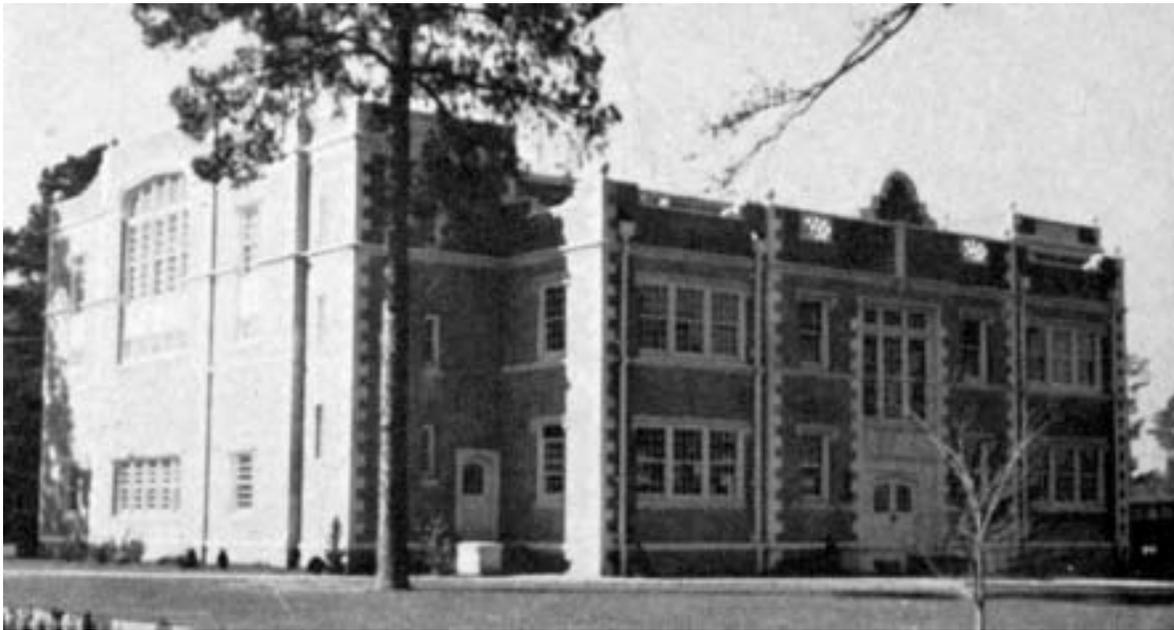
Figure 40. Eastern and northern (front) facades of the Women's Gymnasium, ca. 1950. Note the foundation plantings, the large pine tree, and the young tree in the foreground (perhaps a crapemyrtle) (Northwestern State University, Watson Memorial Library, Cammie G. Henry Research Center (Potpourri Yearbook)).

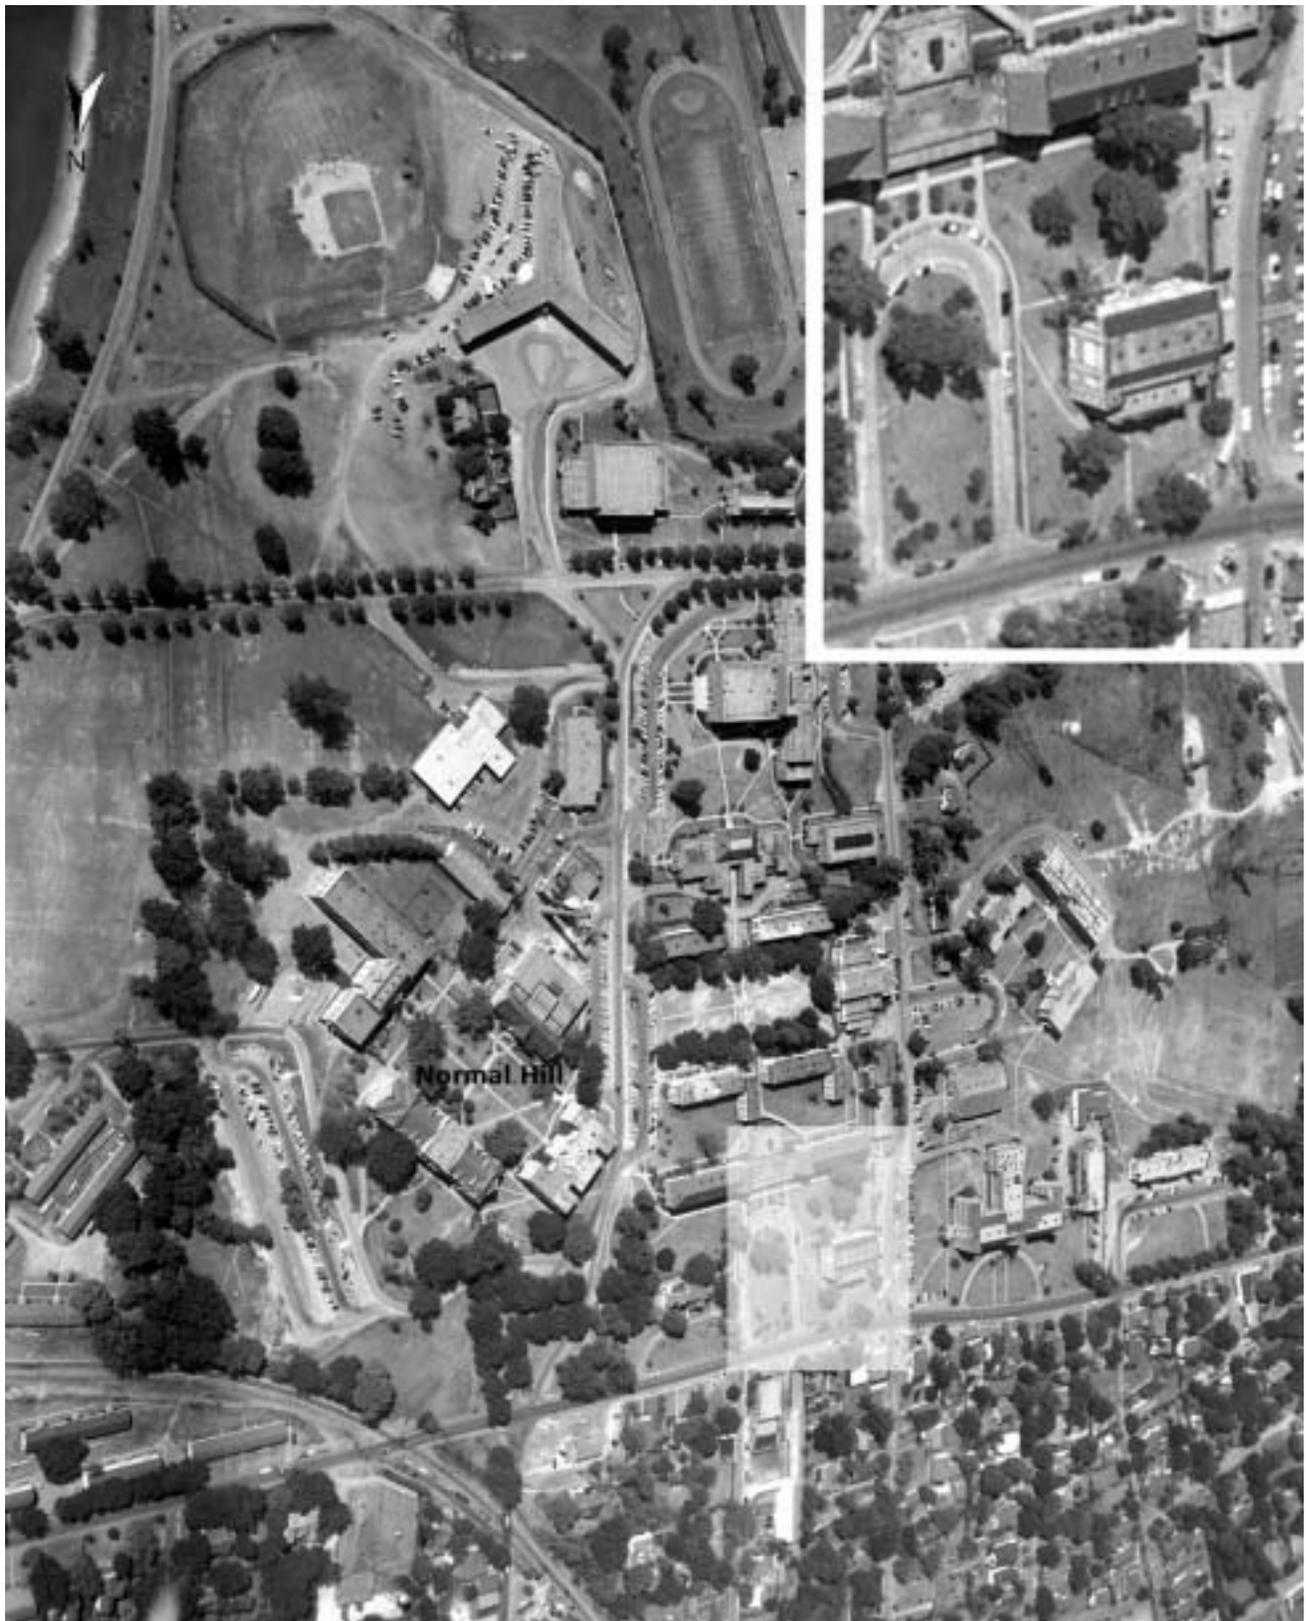
Figure 44. Aerial photograph of NSU, 1961. The Women's Gymnasium area is highlighted and magnified in the inset, upper right. Note the Pergola-covered walkways behind Varnado Hall (Northwestern State University, Watson Memorial Library, Cammie G. Henry Research Center).

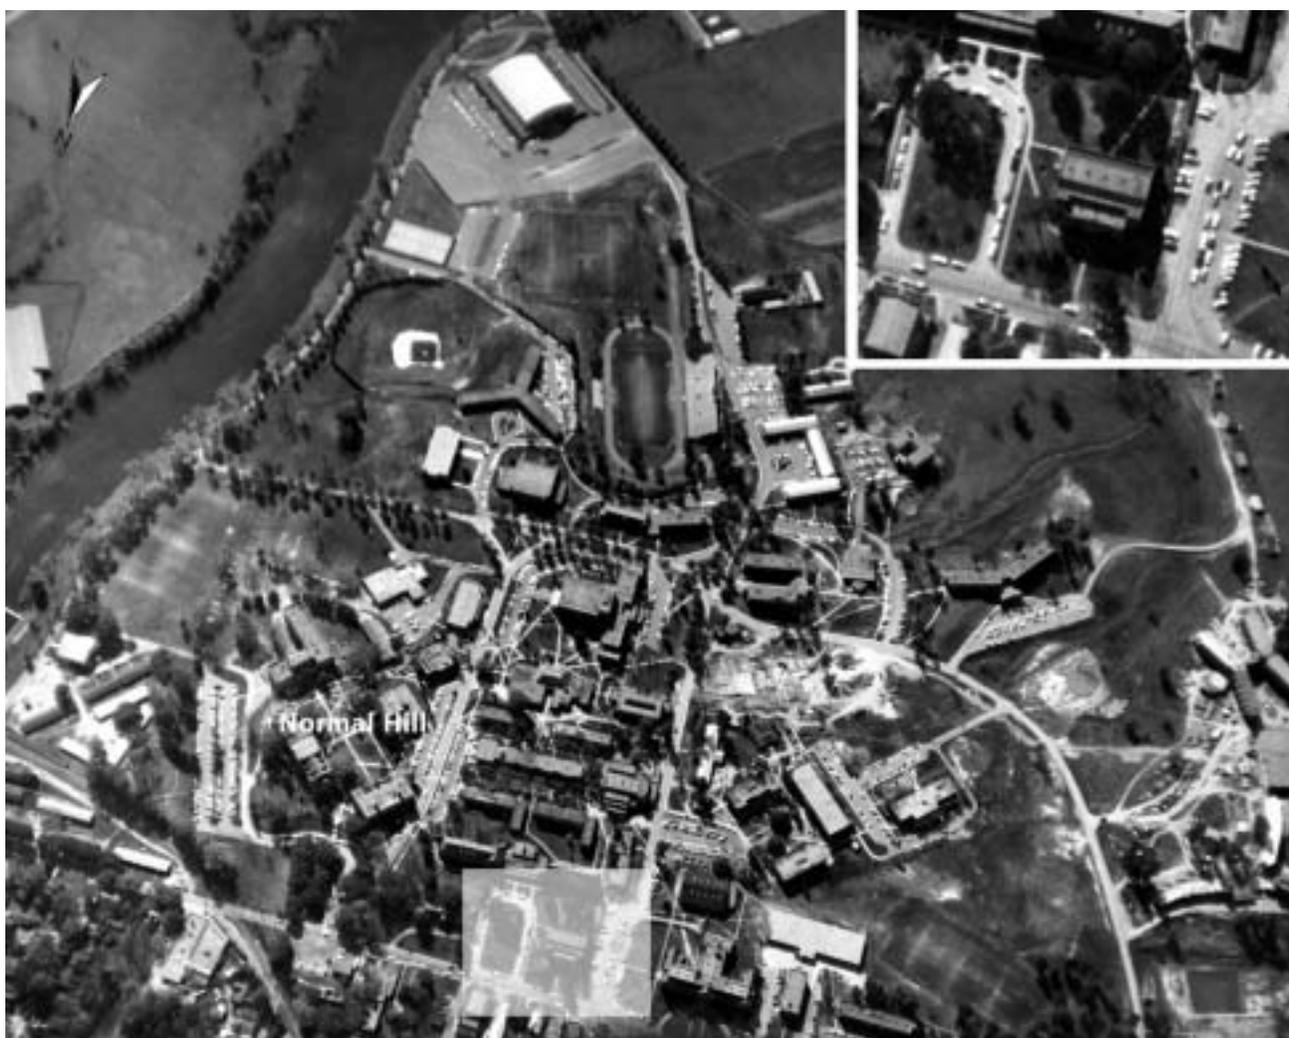
Figure 45. Aerial photograph of NSU, 1966. The Women's Gymnasium is highlighted and magnified in the inset, upper right. Note the pergola-covered walkways behind Varnado Hall (Northwestern State University, Watson Memorial Library, Cammie G. Henry Research Center (Potpourri Yearbook)).

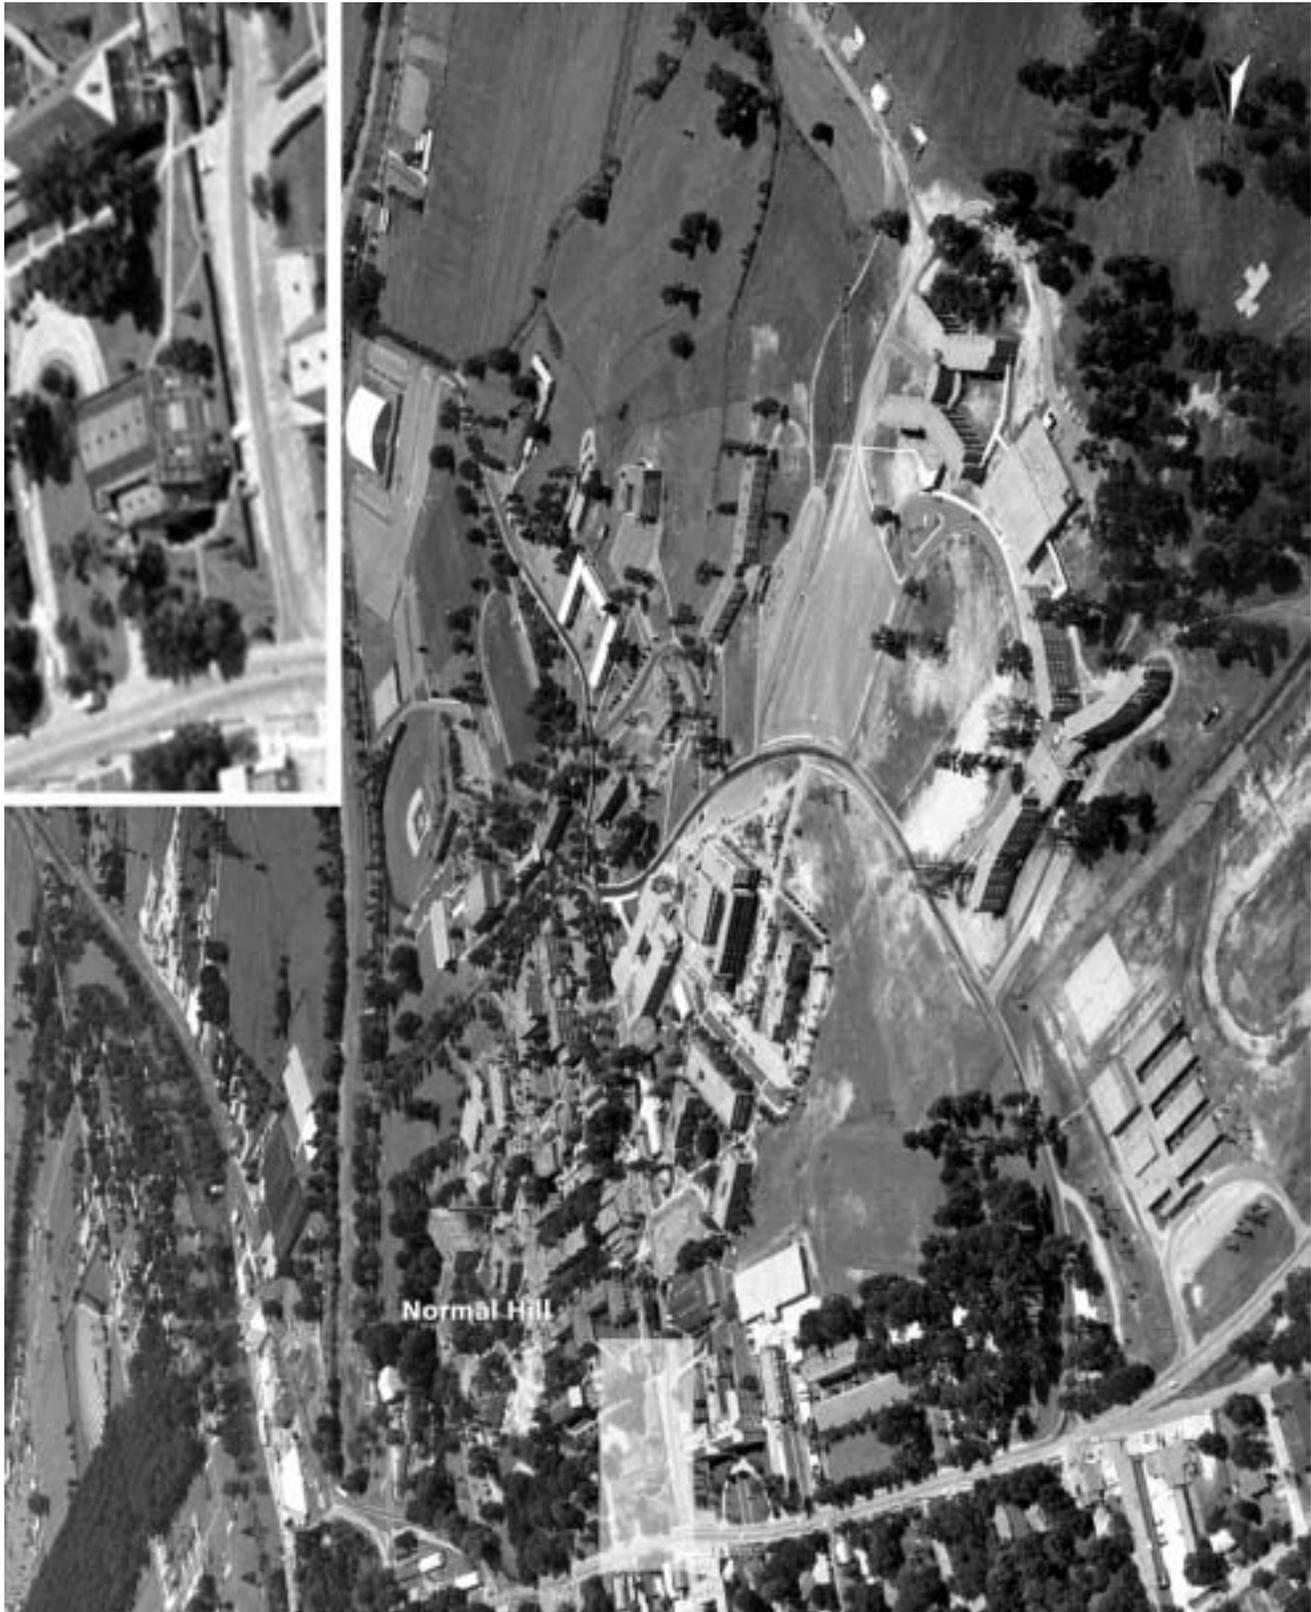
Figure 47. Aerial photograph of NSU, c. 1968. The Women's Gymnasium is highlighted and magnified in the inset, upper left. Note the pergola-covered walkways behind Varnado Hall (Northwestern State University, Watson Memorial Library, Cammie G. Henry Research Center).

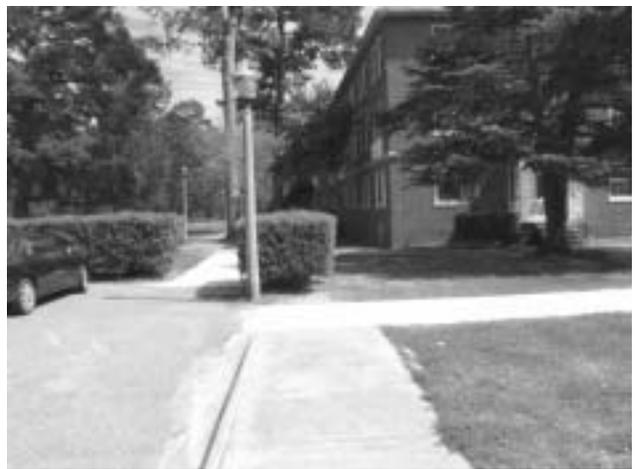
Figure 70. Sidewalk passing through waxleaf privet hedge along Varnado Hall's foundation trees and shrubs (OCLP, 2004).

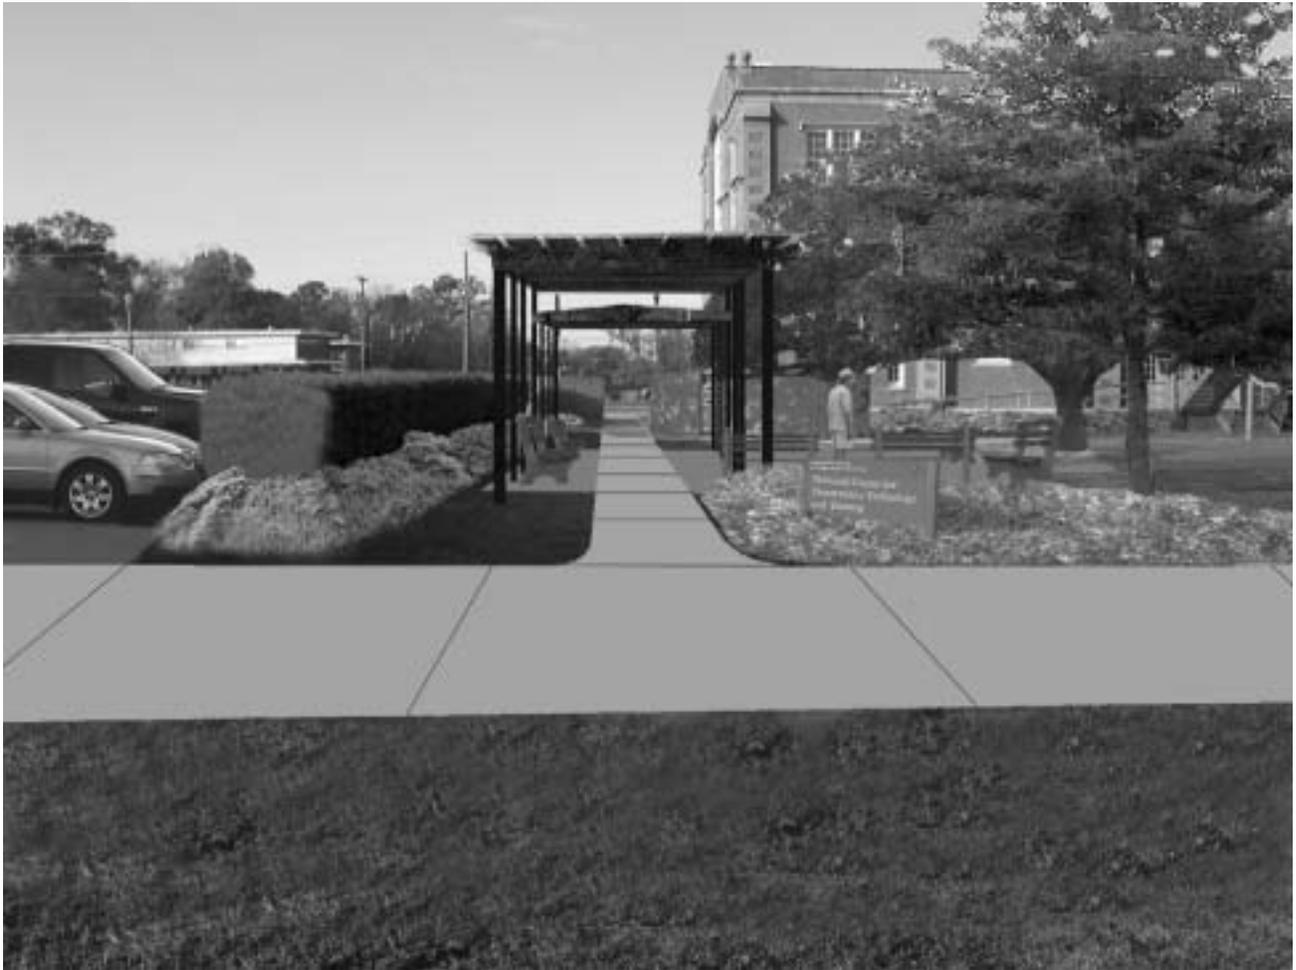
Proposed Pergola Garden Room for the southwest corner of the NCPTT property at Northwestern State University, Natchitoches, LA, 2004 (Olmsted Center for Landscape Preservation).

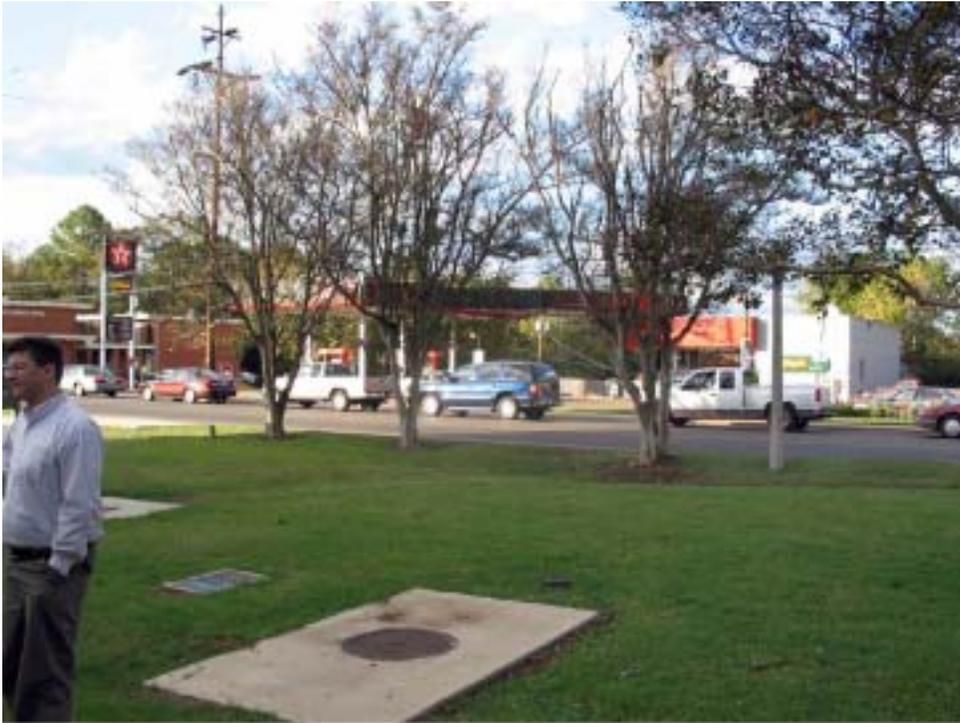
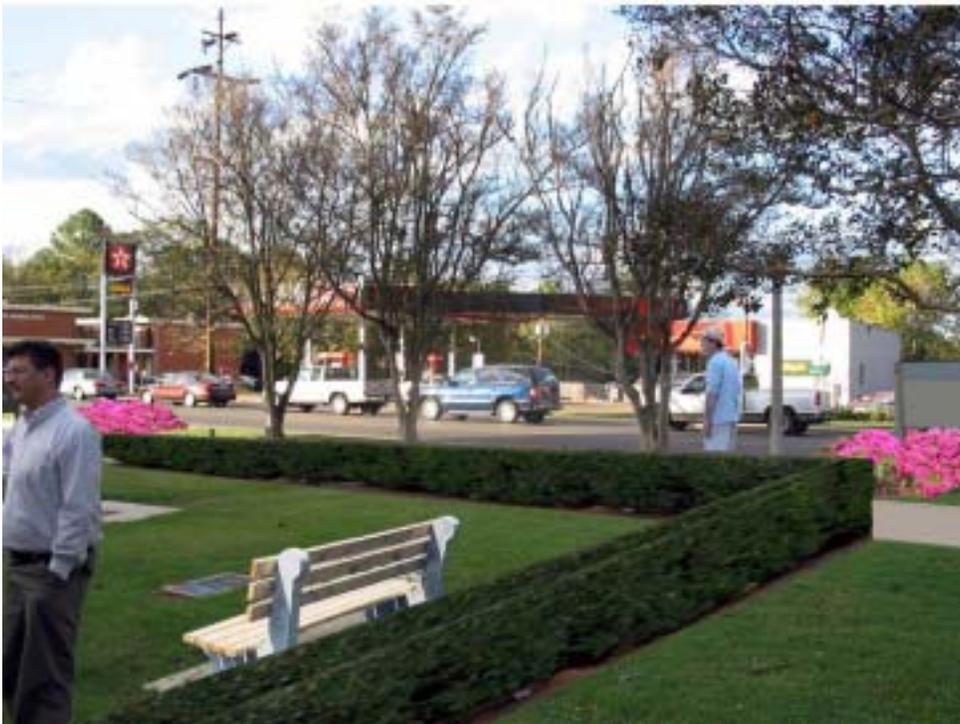
Figure 80. Top: NCPTT's existing north (front) lawn and crapemyrtles with view of College Avenue, 2003 (OCLP). Bottom: Proposed hedge row and shrub planting provides spatial definition and softens view, 2004. (OCLP).

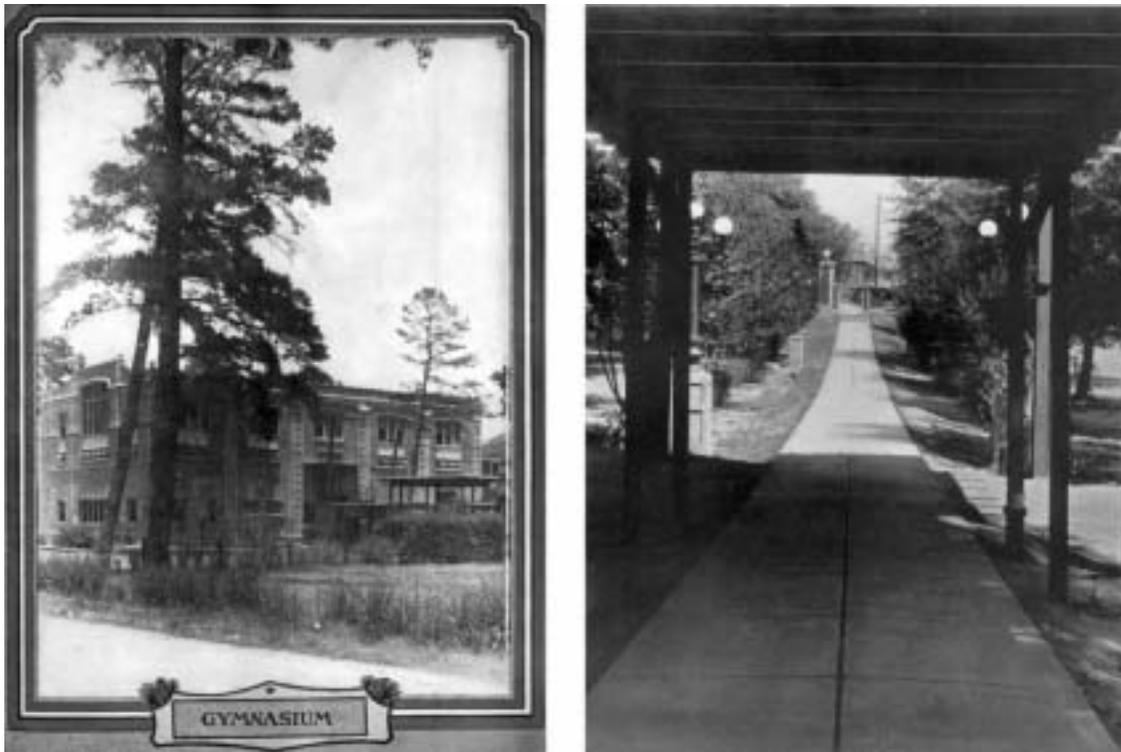
Figure 82. Left: 1926 photo showing tiered pergola covering the walkway behind the Women’s Gymnasium. Right: 1932 photo showing walkway passing through one of the campus’ many pergolas (Northwestern State University, Watson Memorial Library, Cammie G. Henry Research Center (Potpourri Yearbook)).

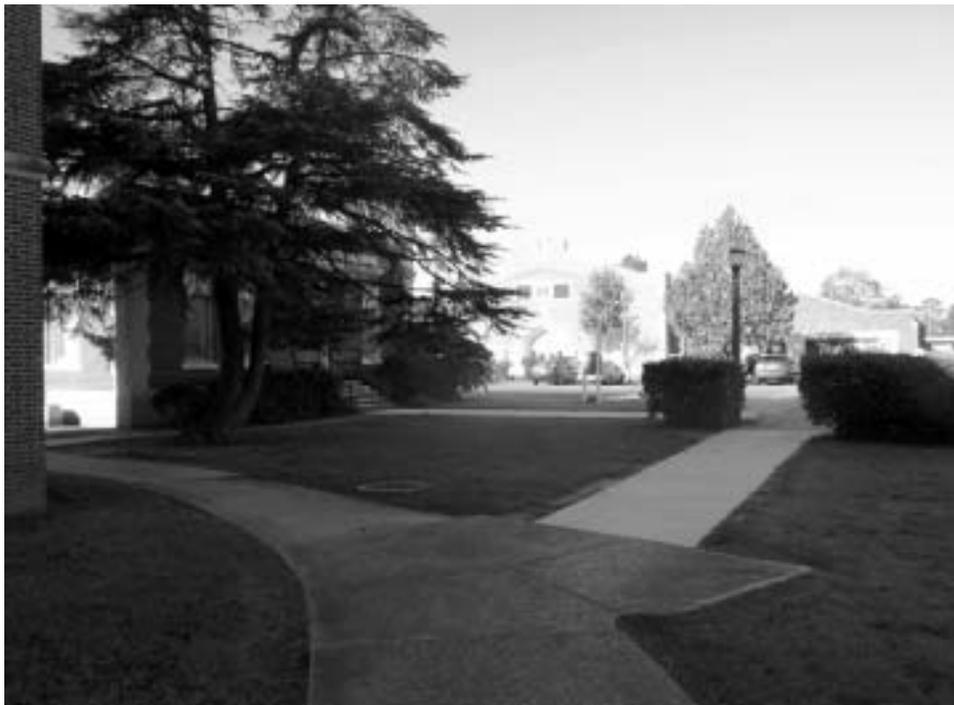
Figure 83. Existing “Demon Crossroads” southwest of the NCPTT building beside the University Health/Police building, 2003. Note the noncontiguous walkways (OCLP).

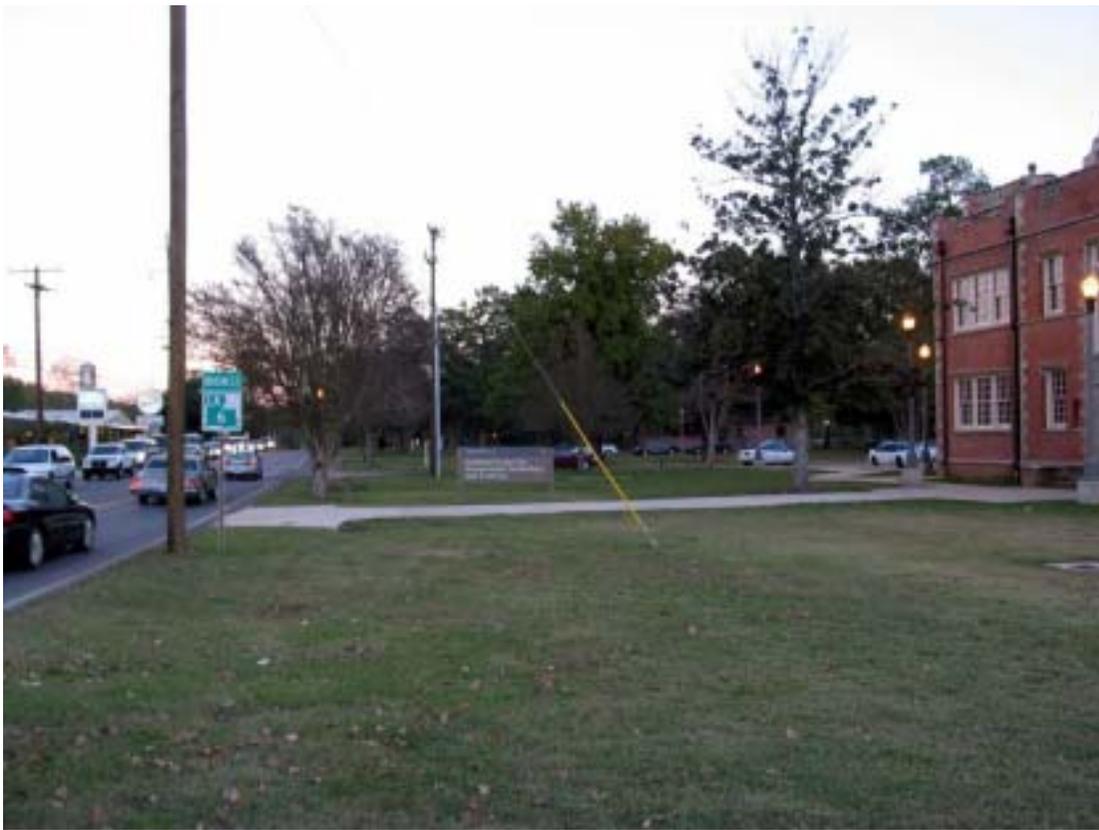
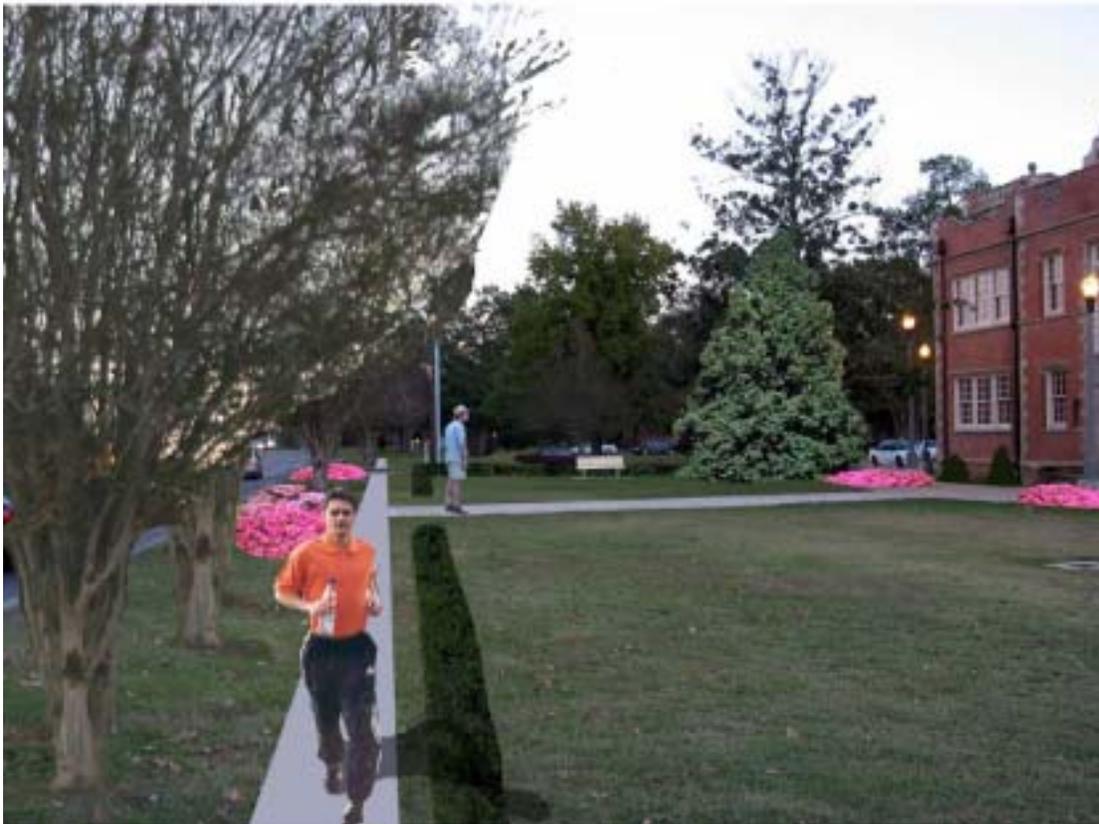
Figure 84. Top: NCPTT's existing north (front) lawn, barren with a dying magnolia tree, 2003 (OCLP). Bottom: Proposed College Avenue campus walkway, supplemental crapemyrtle trees, flowerbeds, hedge row, and American holly, 2004 (OCLP).

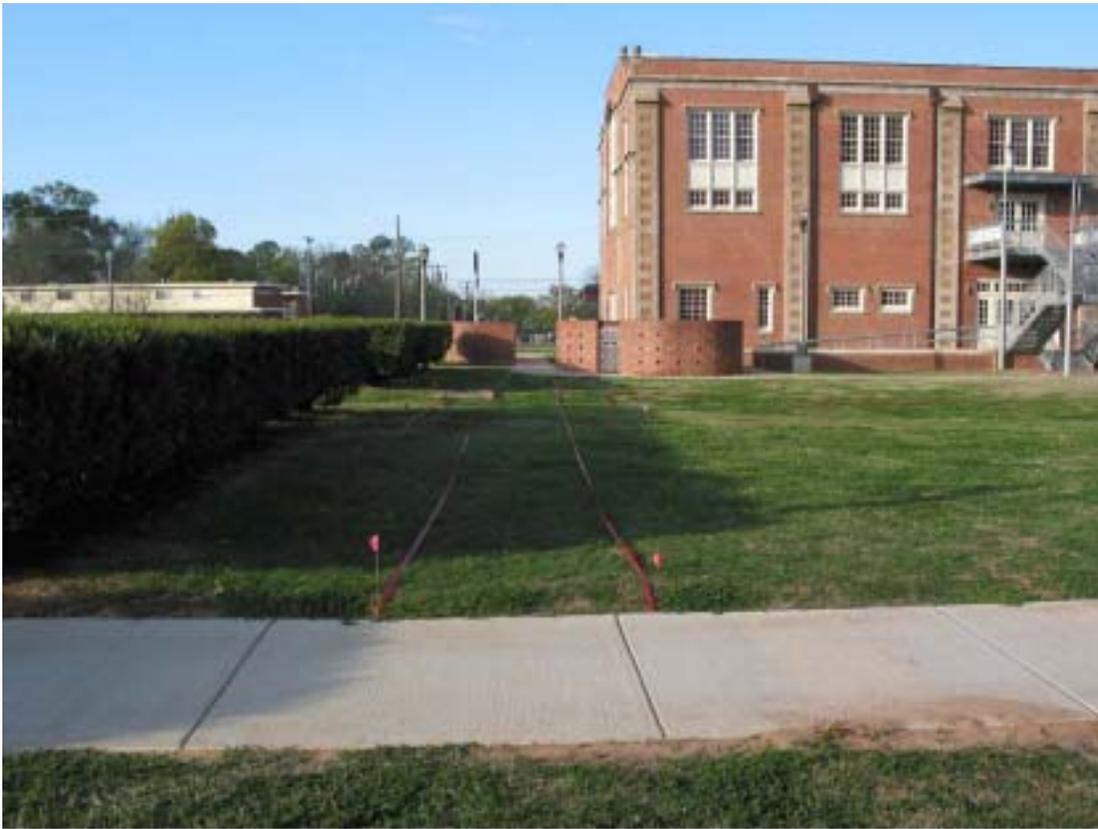
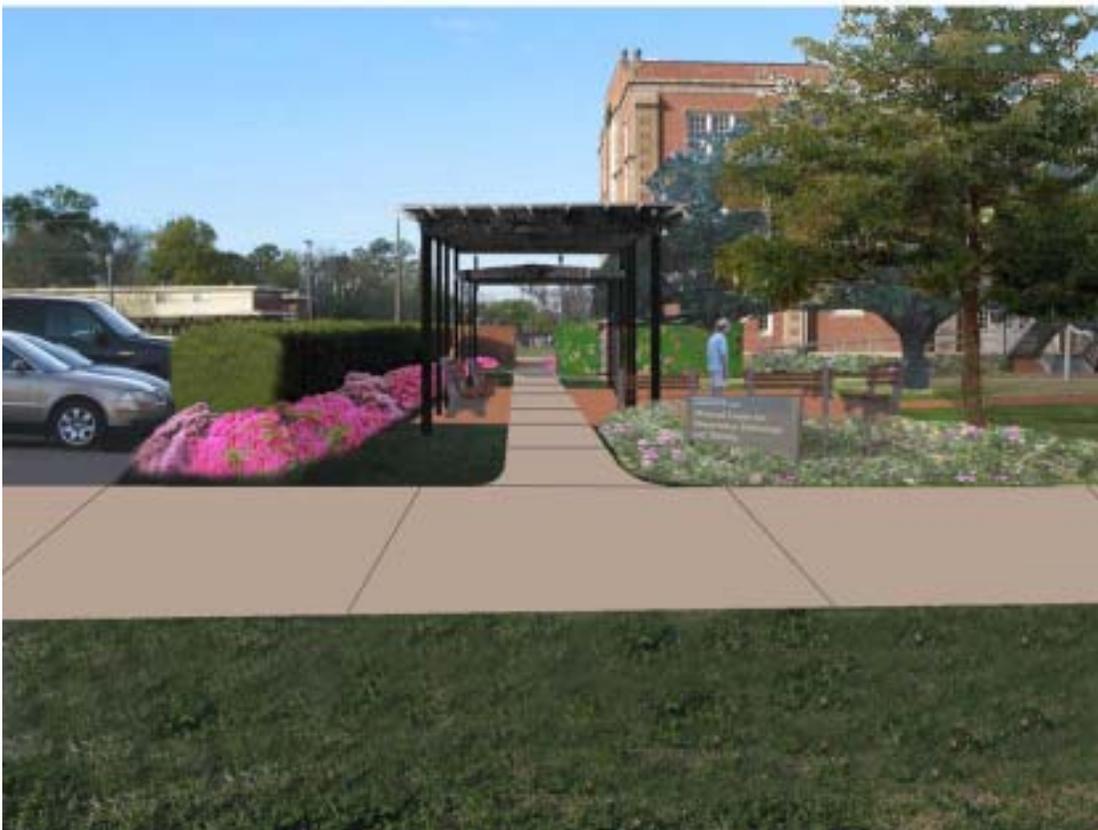
Figure 86. Top: NCPTT's existing south lawn, waxleaf privet hedge, and parking area, 2004 (OCLP). Bottom: Proposed new walkway to College Avenue lined by azaleas, Pergola Garden Room, and shade trees, 2004 (OCLP).
