# RODMAN CANDLEWORKS, DOUBLE BANK BUILDING, UNITED STATES CUSTOM HOUSE

New Bedford Whaling National Historical Park  
New Bedford, Massachusetts

**HISTORIC STRUCTURES REPORT**

Historic Architecture Program  
Northeast Region, National Park Service  
U.S. Department of Interior  
Lowell, Massachusetts

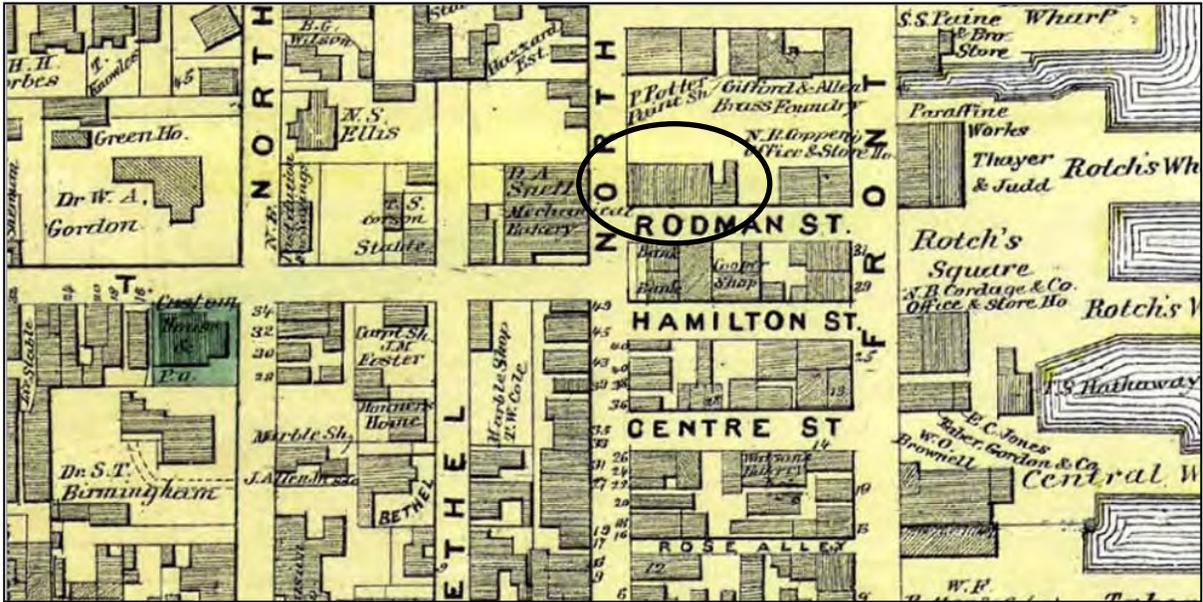
Figure 8. Map of the city of New Bedford in 1871 published by F.W. Beers and Co. Note reversed L-shaped appendage on the east side of the Rodman Candleworks building.

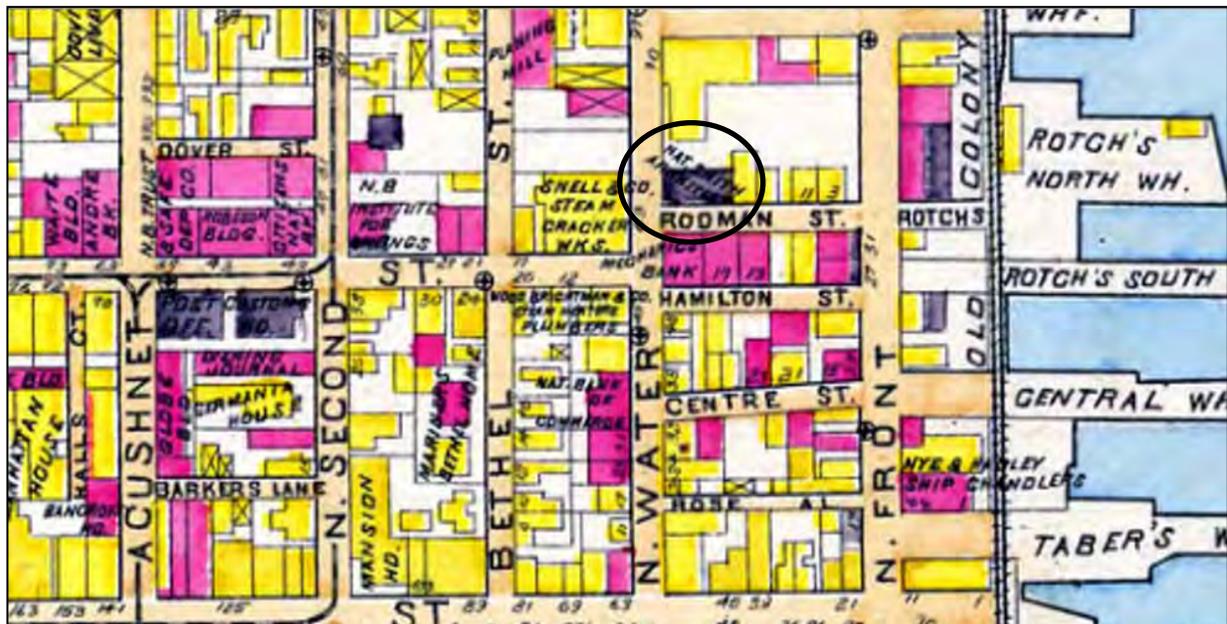
Figure 12. Map of the city of New Bedford in 1895 published by Everts and Richards. Note two wooden structures attached to the east elevation of the Rodman Candleworks building.

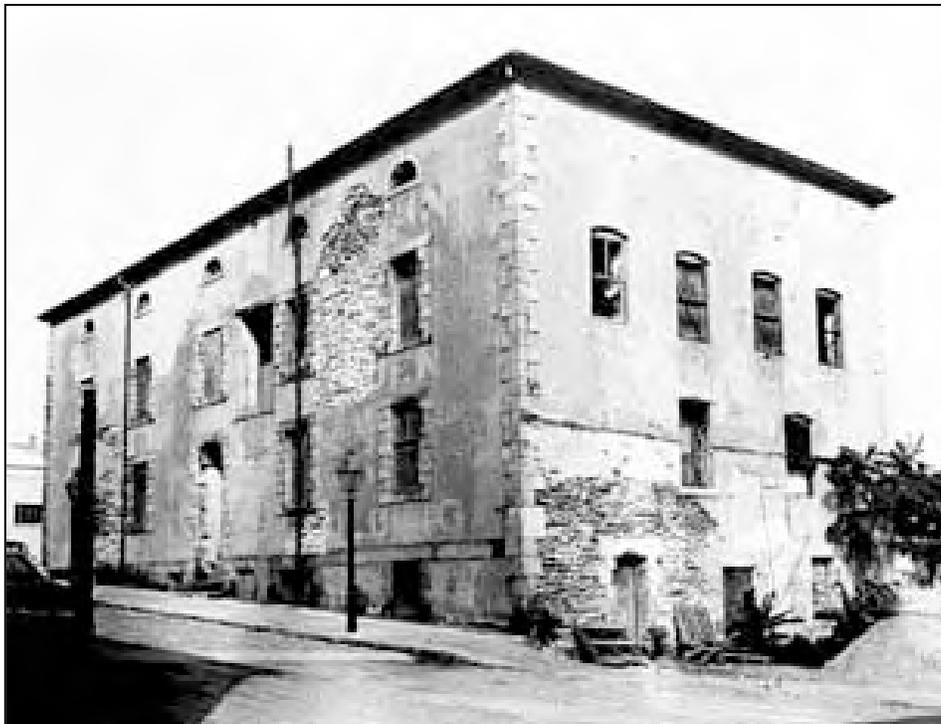
Figure 15. East elevation of the Rodman Candleworks building showing a clear break in material one third from the bottom up indicating a previous extant east elevation addition/appendage, ca. 1960s-70s.

The existence of an east addition is also supported by a historic photograph taken sometime before the late 1970s-rehabilitation (fig. 15). In this photograph the east elevation is visible which illustrates a change in material approximately one third up from the bottom of the wall. It appears that the stucco is missing from the bottom third of the elevation, indicating that an addition was present at some point in the building's history, presumably ca. 1871, according to the first documented appearance of an addition in this location.

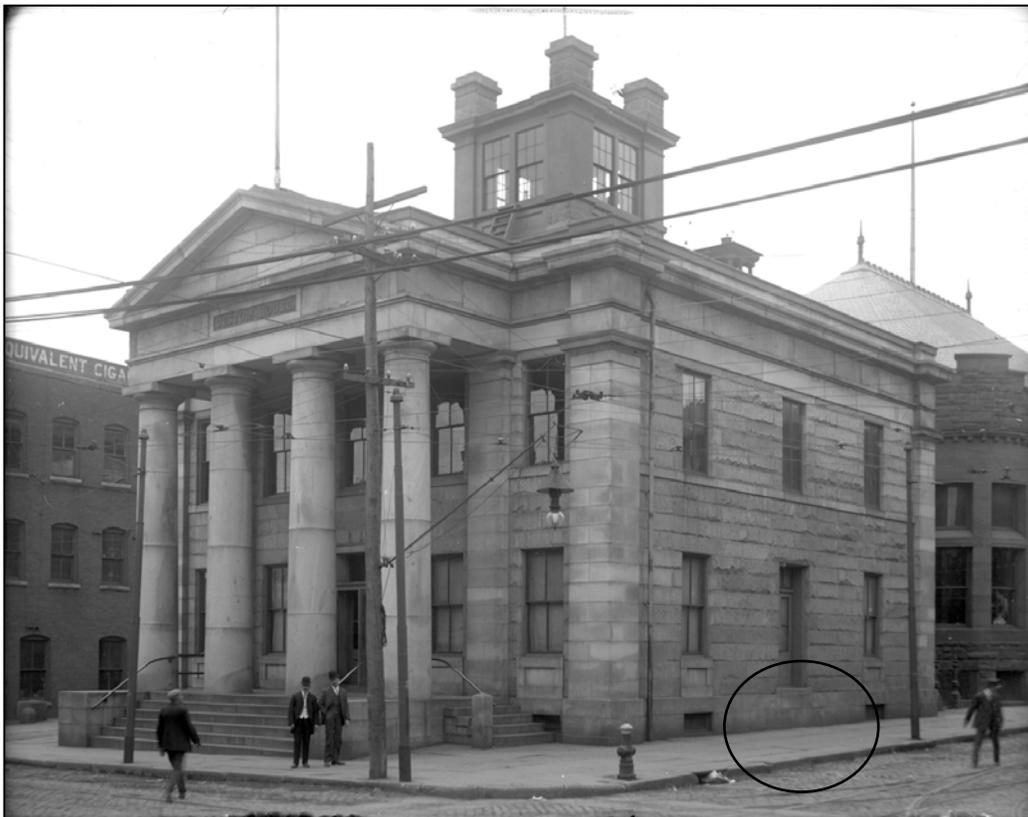
**Figure 36.** Photographs of the northeast elevation of the U.S. Custom House in New Bedford, MA, taken in 1886 (upper view) and in 1905 (lower view). Note absence of the stairway below D102 in 1905 (circled).

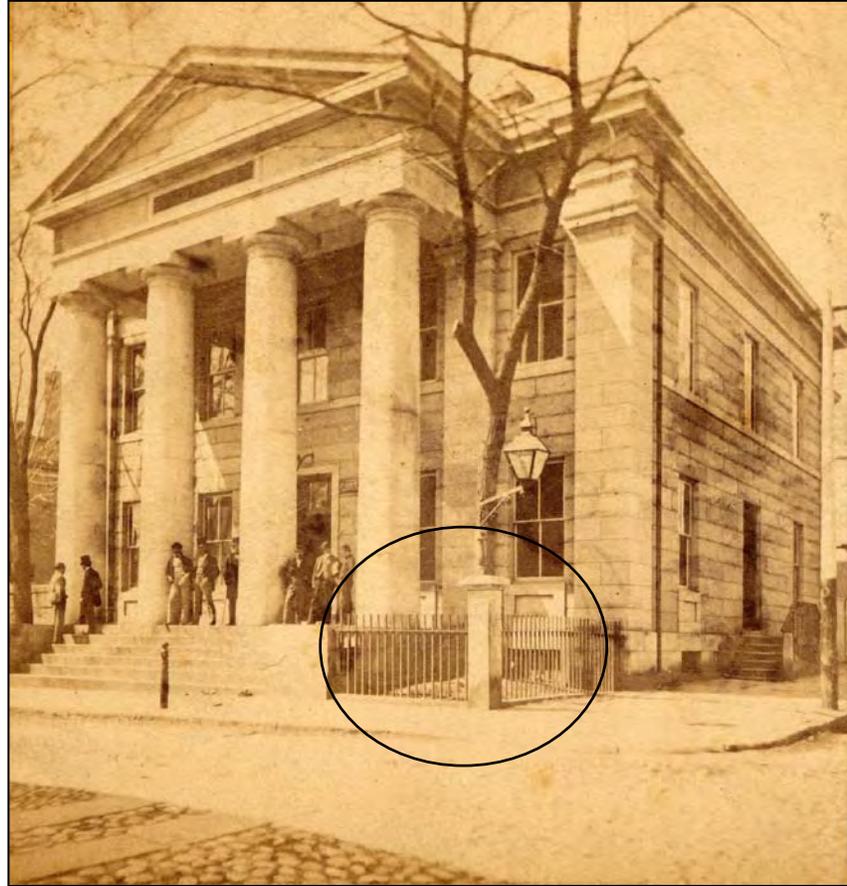
**Figure 38.** Photographs of the U.S. Custom House in New Bedford, MA, taken in 1875 (upper view) and 1886 (lower view). Note the absence of the stairs at the north elevation of the portico in 1875 (circled) and the presence of the stairs in 1886.

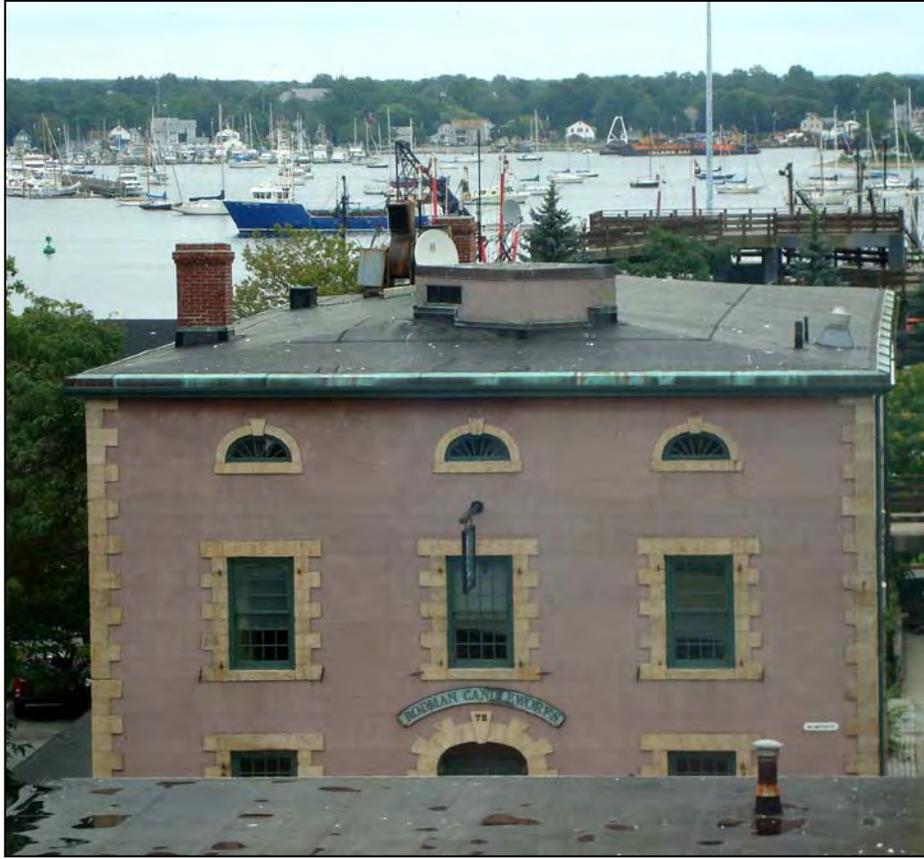
**Figure 54.** Low-pitched tar hip roof of the Rodman Candleworks (2008).

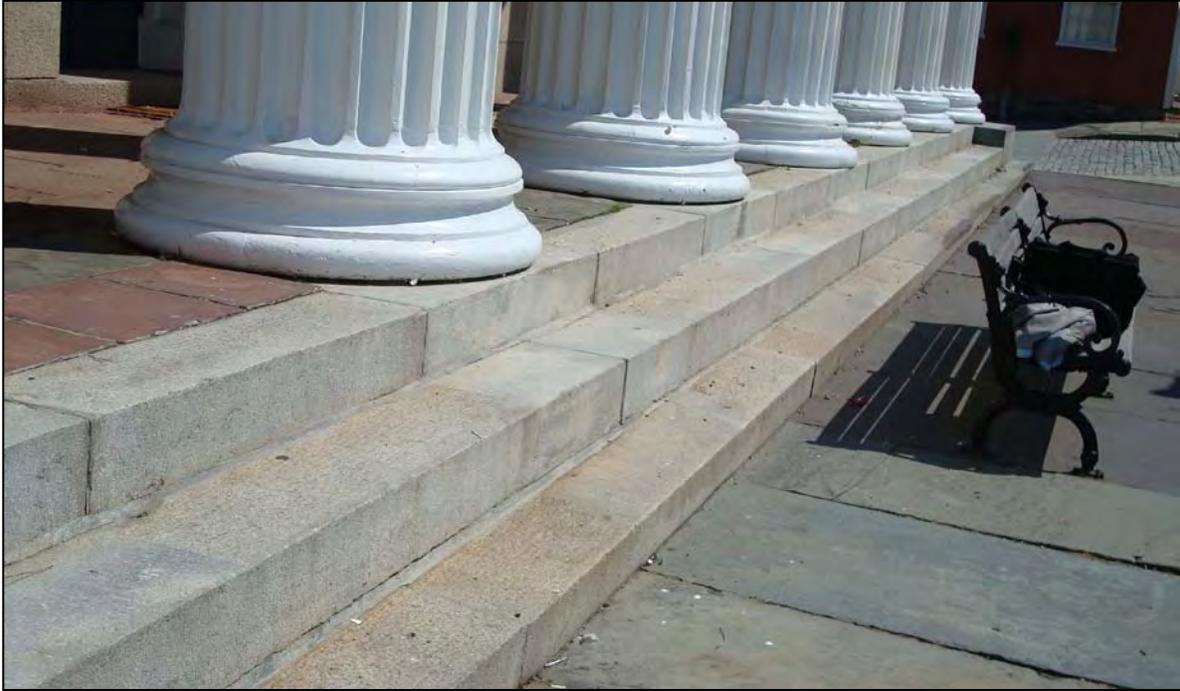
**Figure 62.** Granite steps that span the length of the west elevation of the Double Bank Building (2008).

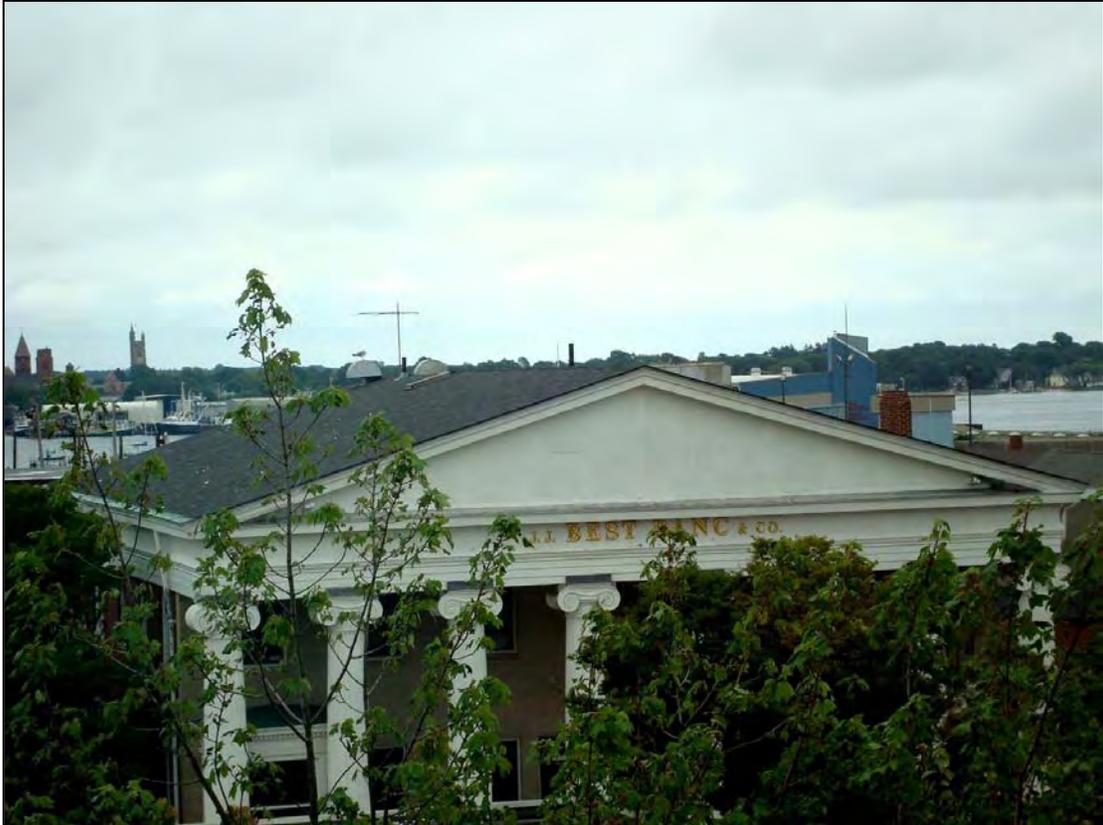
**Figure 78.** A low-pitch, asphalt-clad gable roof covers the main mass of the Double Bank Building (2008).

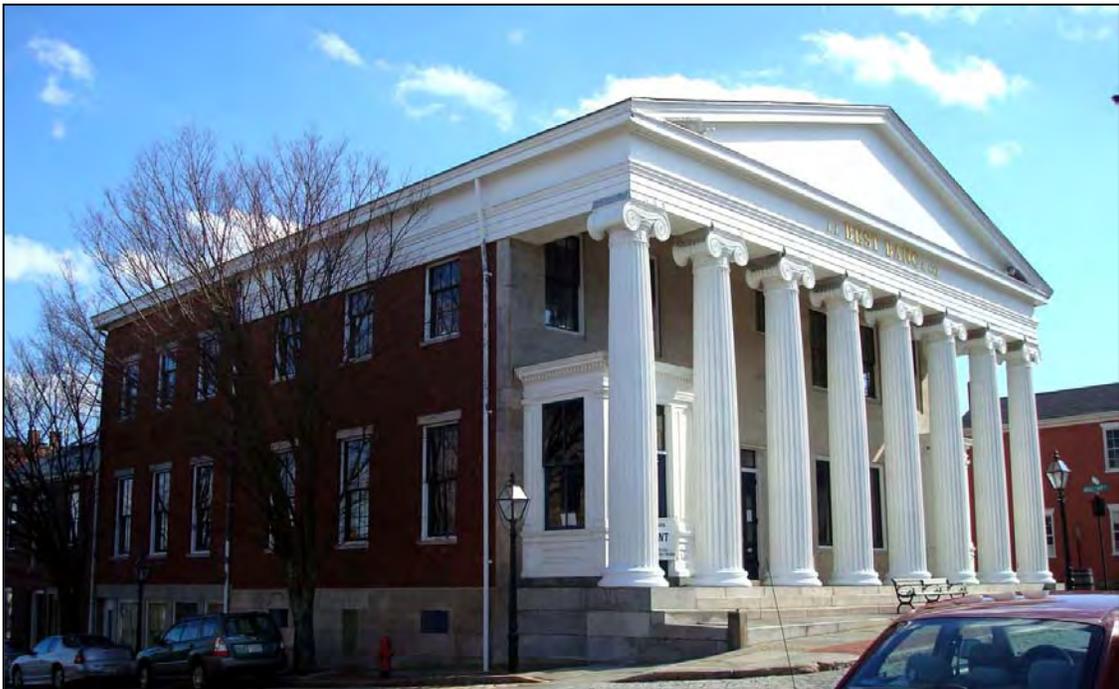
**Figure 79.** The portico is on the west side of the Double Bank Building (2008).

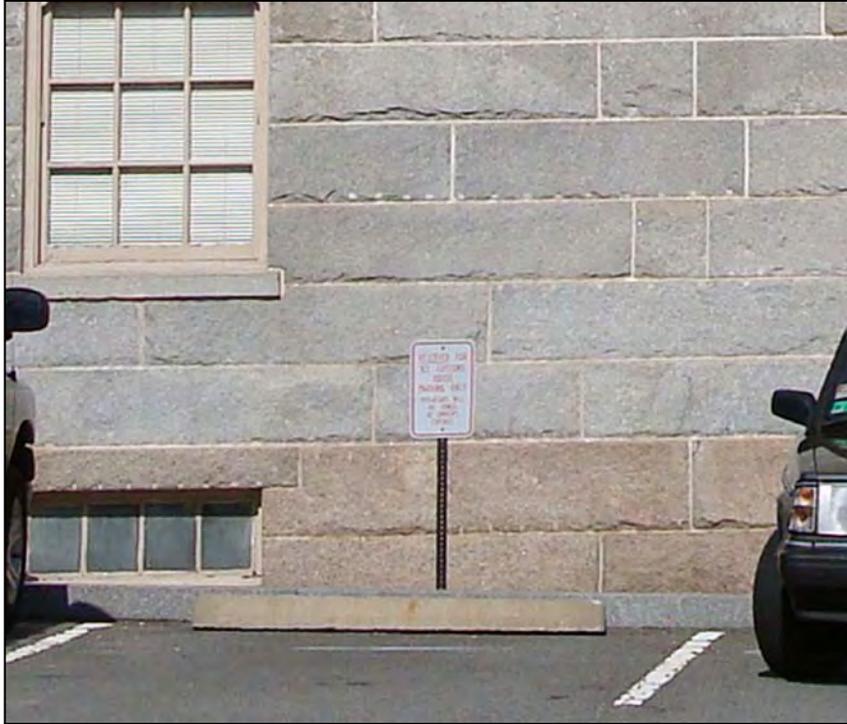
**Figure 87.** Foundation of the south elevation, U.S. Custom House (2008).

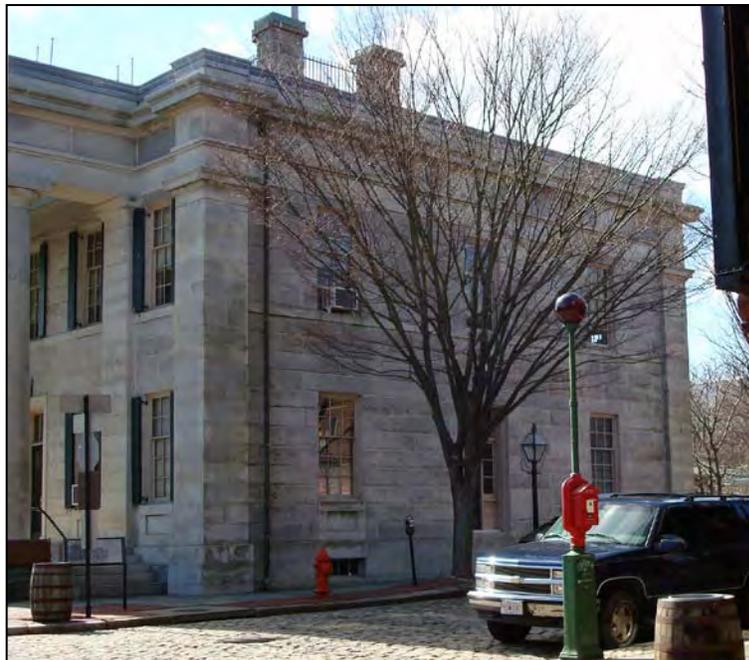
**Figure 88.** North and east elevations of the U.S. Custom House. Note the two pilasters at the northwest and northeast corners of the building (2008).

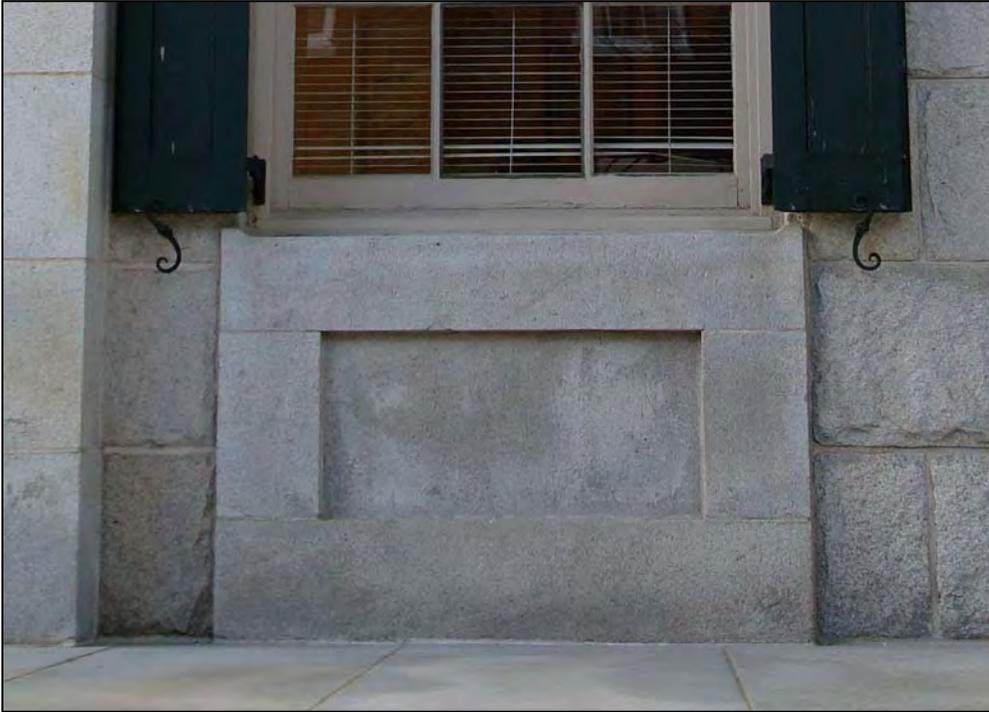
**Figure 89.** Smooth granite dado panel below window W102 in the east elevation of the U.S. Custom House (2008).

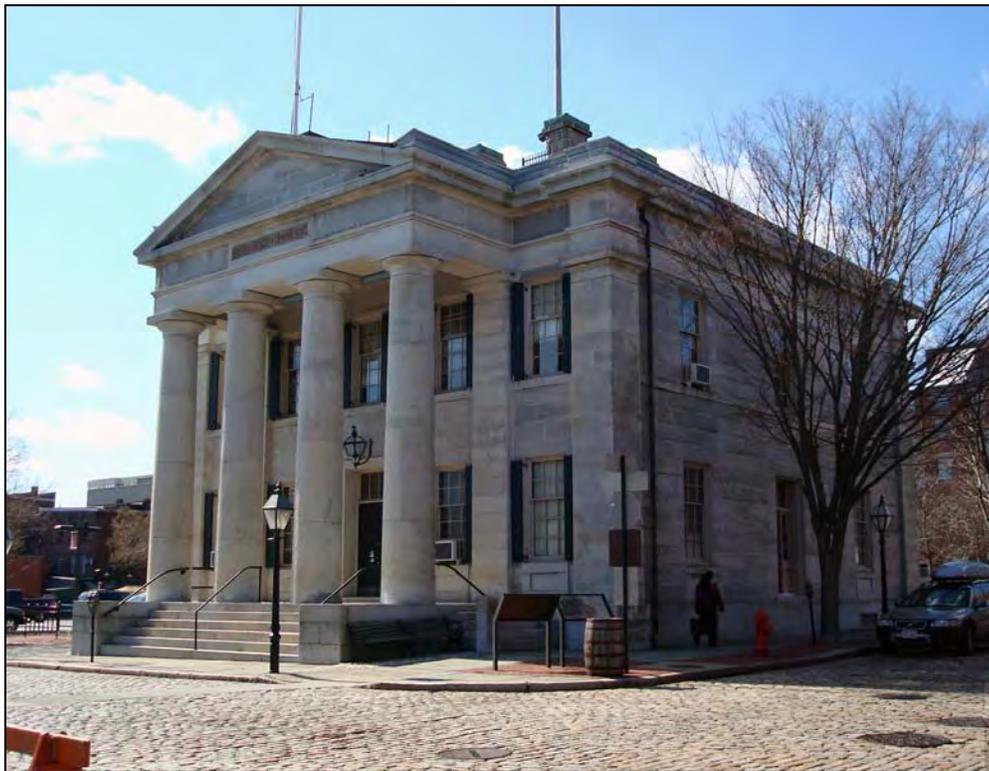
**Figure 90.** Front façade and north elevations of the U.S. Custom House. Note the projecting band of granite below the second-story windows (2008).

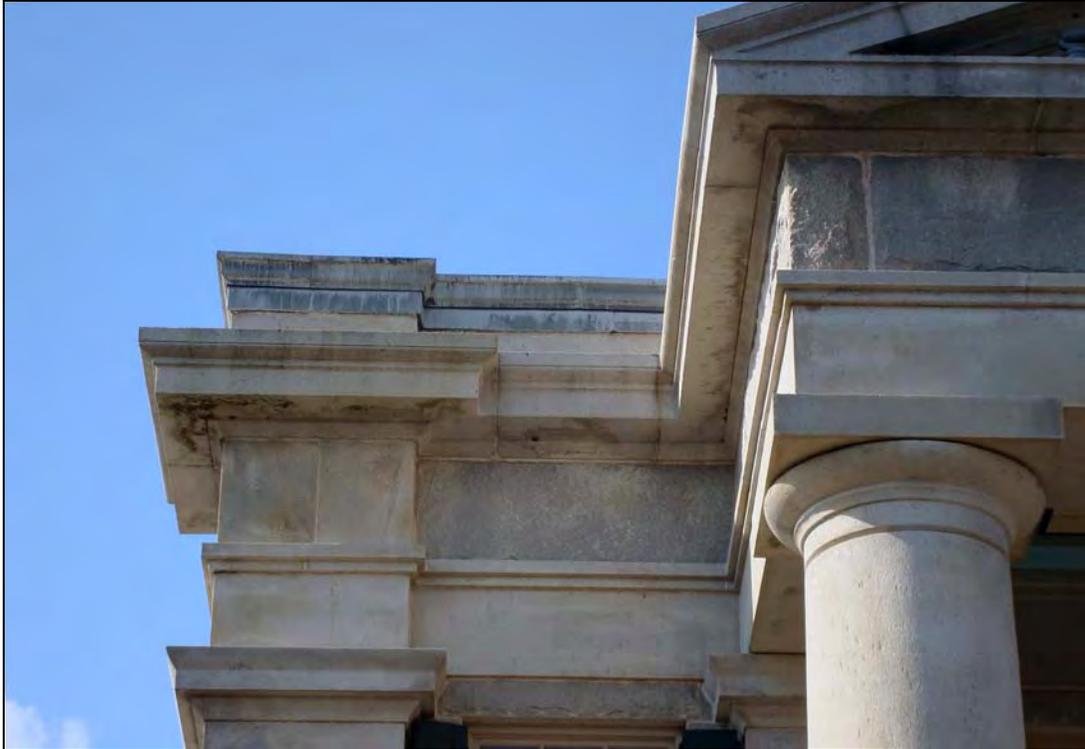
**Figure 91.** Front (east) façade of the U.S. Custom House. Note the granite parapet capped with copper (2008).

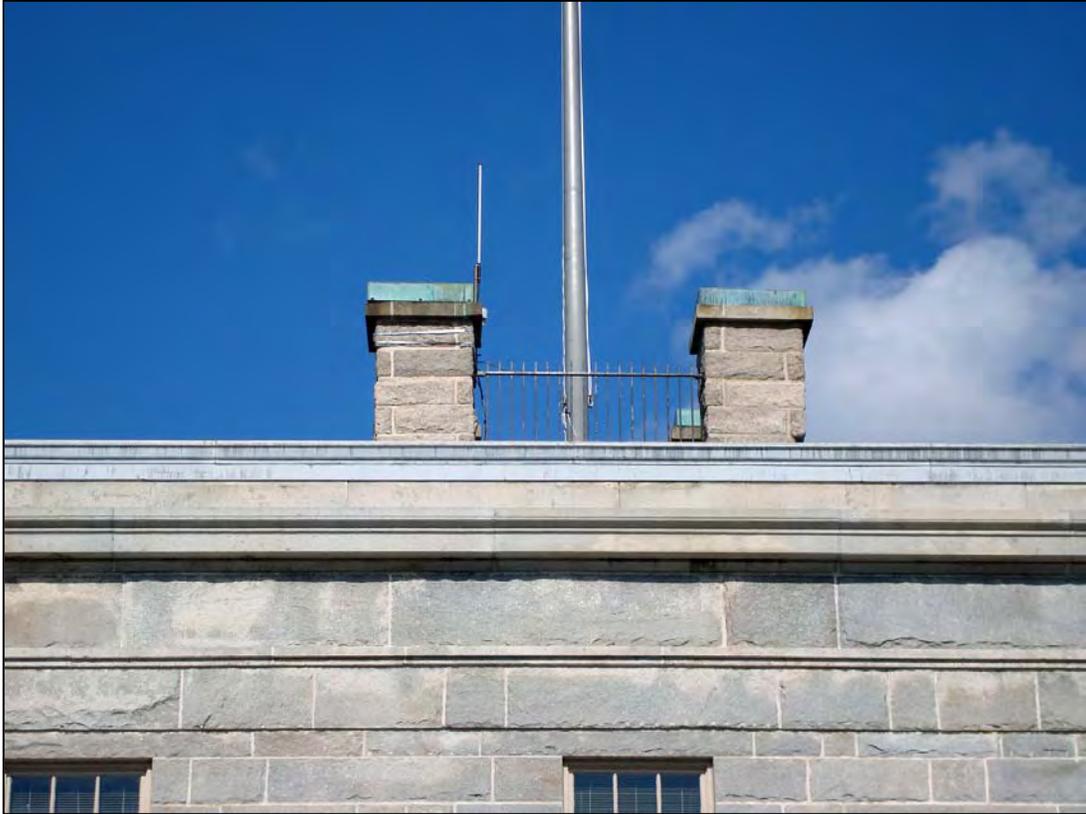
**Figure 107.** Central observatory on the roof of the U.S. Custom House (2008).

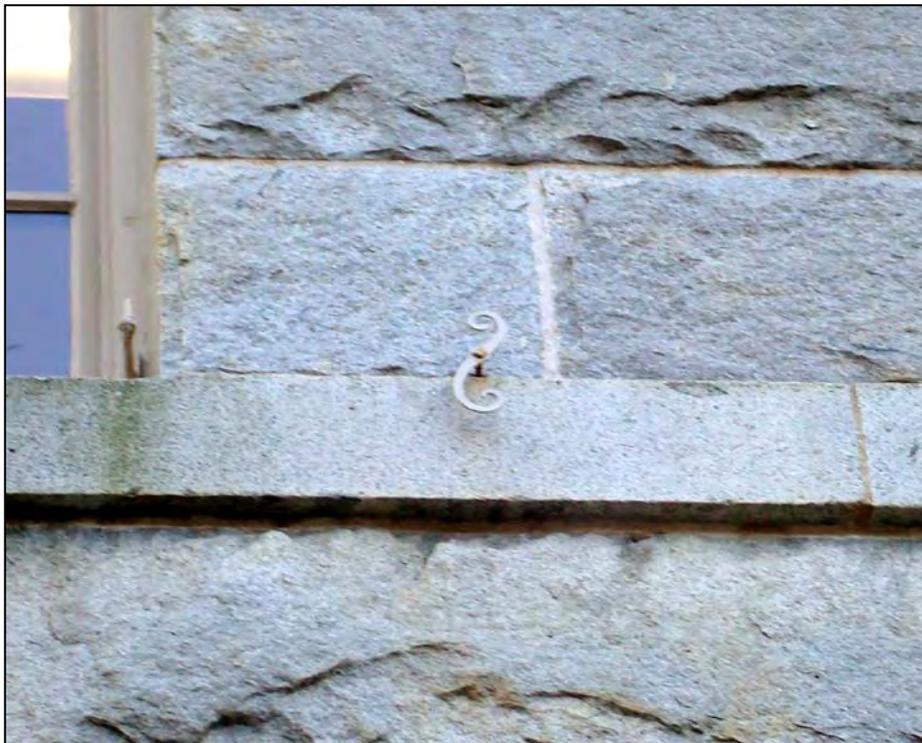
**Figure 110.** Shutter dog painted cream at the north elevation of the U.S. Custom House (2008).

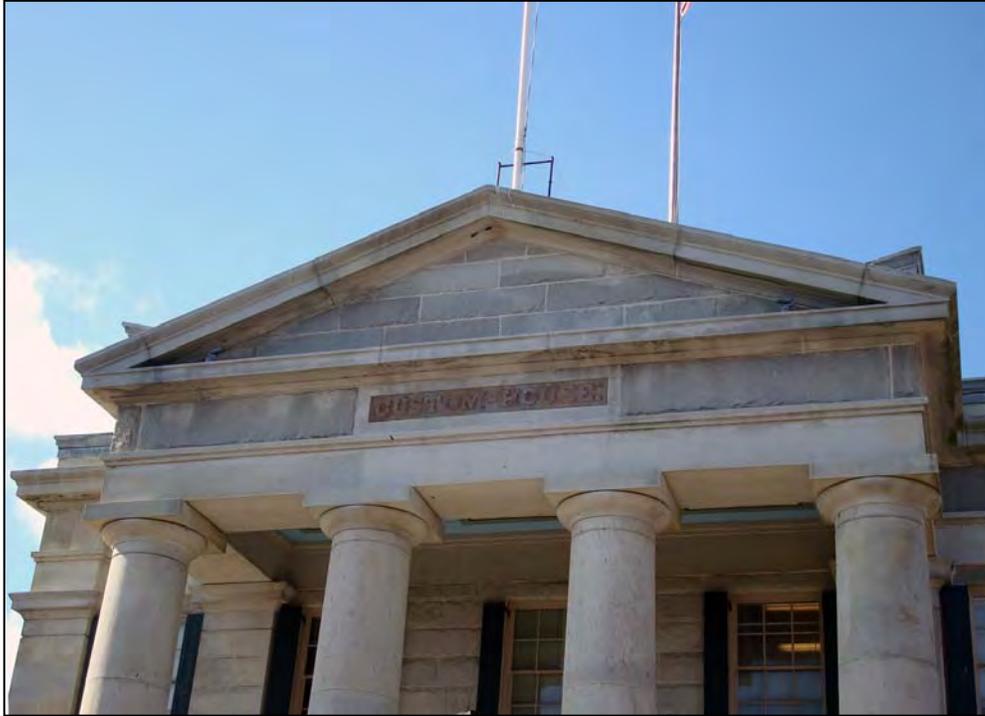
**Figure 113.** Pediment of the east portico, U.S. Custom House (2008).

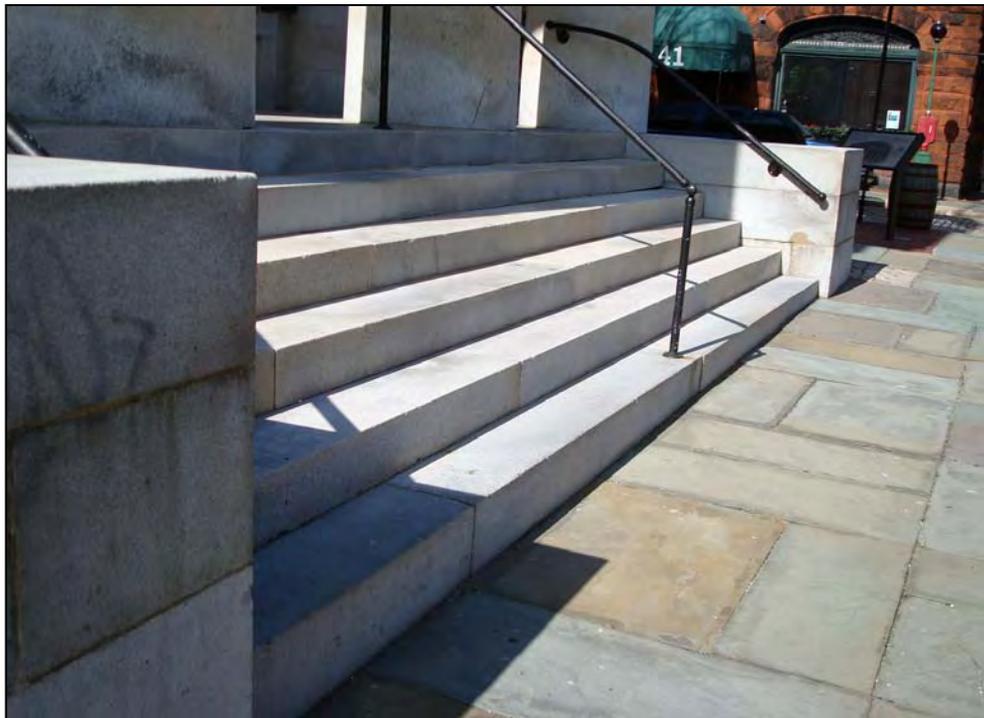
**Figure 114.** Five granite steps supported by granite cheek walls at the front entrance of the U.S. Custom House (2008).

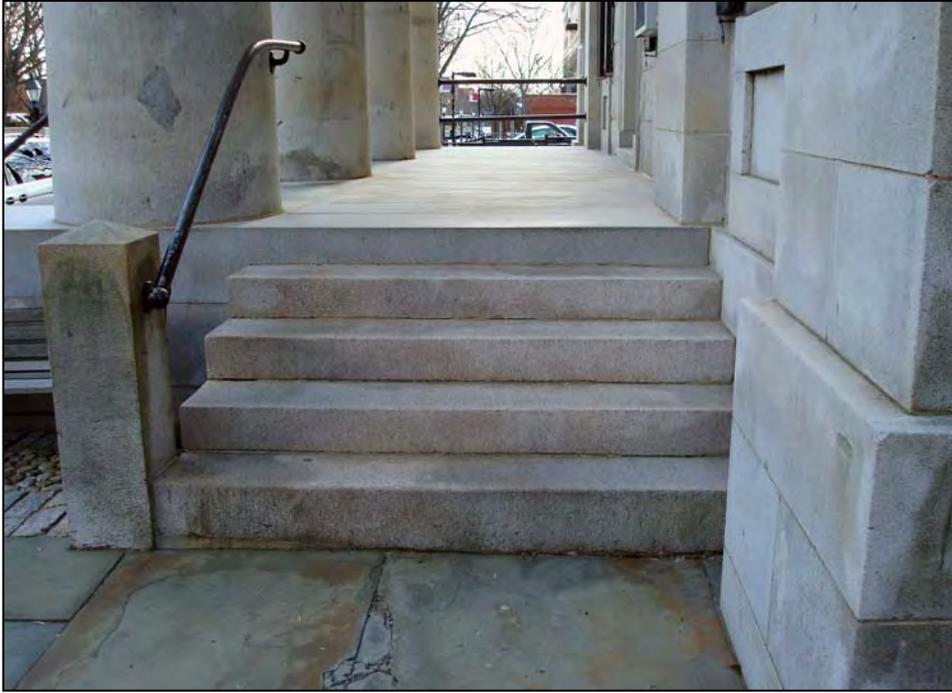
**Figure 115.** Four granite steps on the north side of the portico, U.S. Custom House (2008).

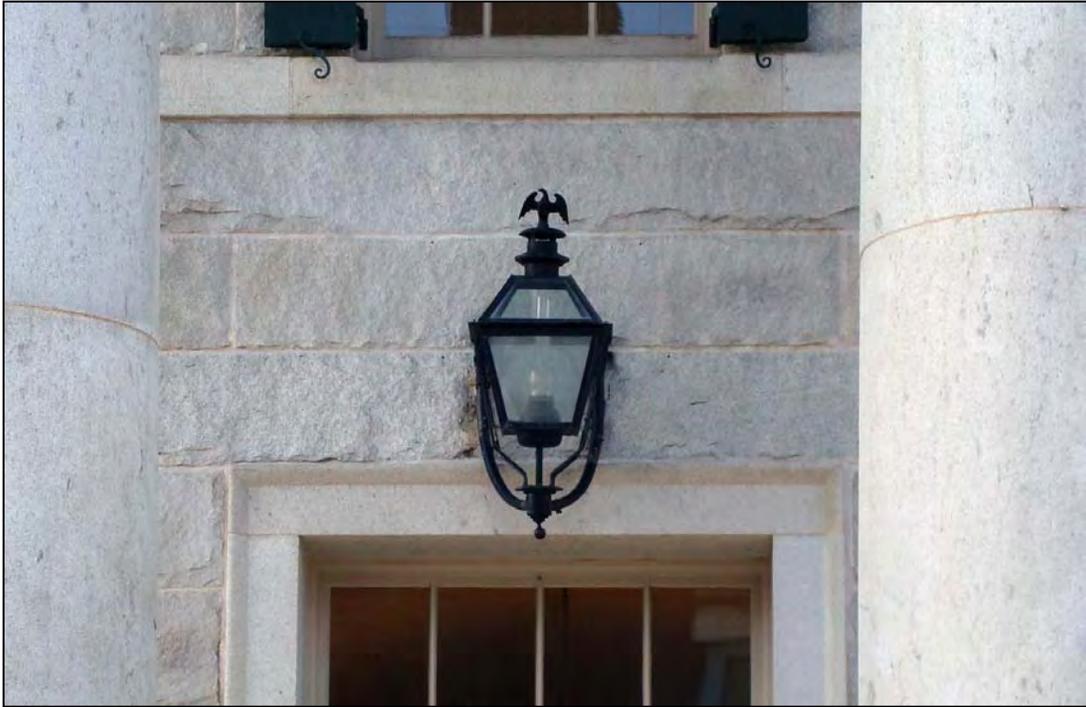
**Figure 117.** Exterior light above D101 at the front (east) façade of the U.S. Custom House (2008).

An exterior lamp is over the main (east) entrance doorway--D101 (fig. 117).

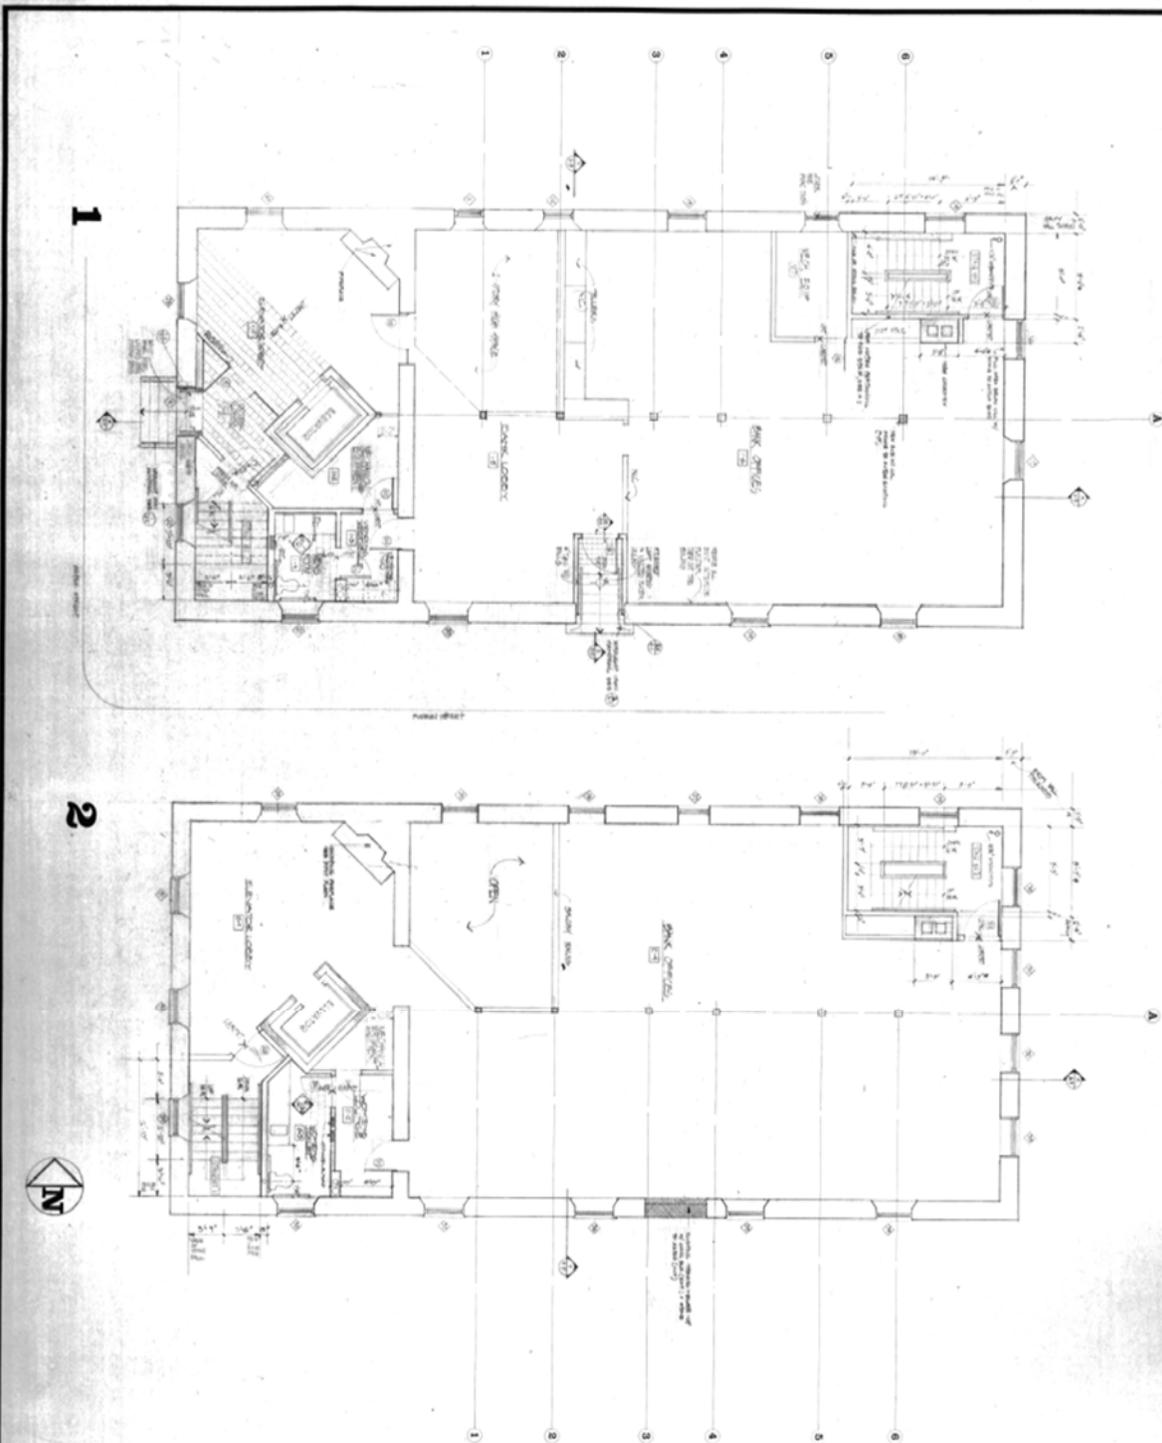
DATE	1/11/00
BY	MB
PROJECT	RODMAN CANDLE WORKS
NO.	1
DESCRIPTION	FLOOR PLANS
SCALE	1/8" = 1'-0"

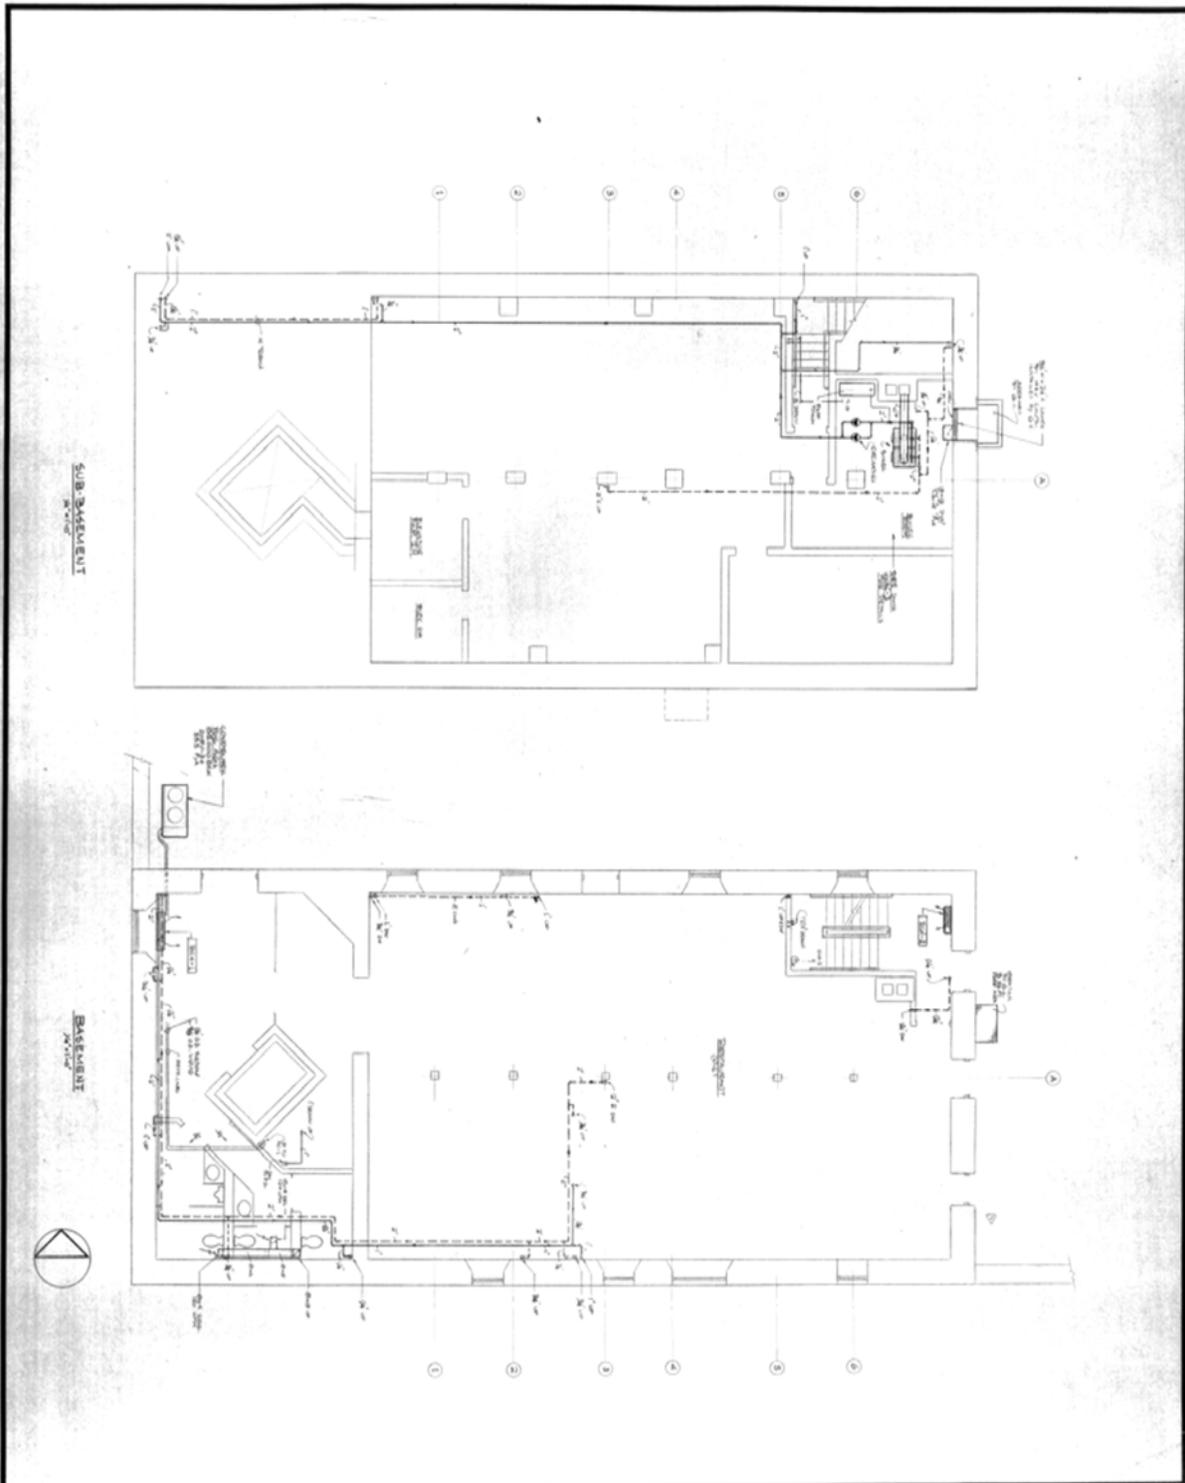
HVAC FLOOR PLANS	72 NORTH WATER STREET NEW BEDFORD, MASS.
---------------------	---
