Niota Train Depot

PRESERVATION NEEDS REPORT

December 2007

Niota Train Depot Niota, Tennessee

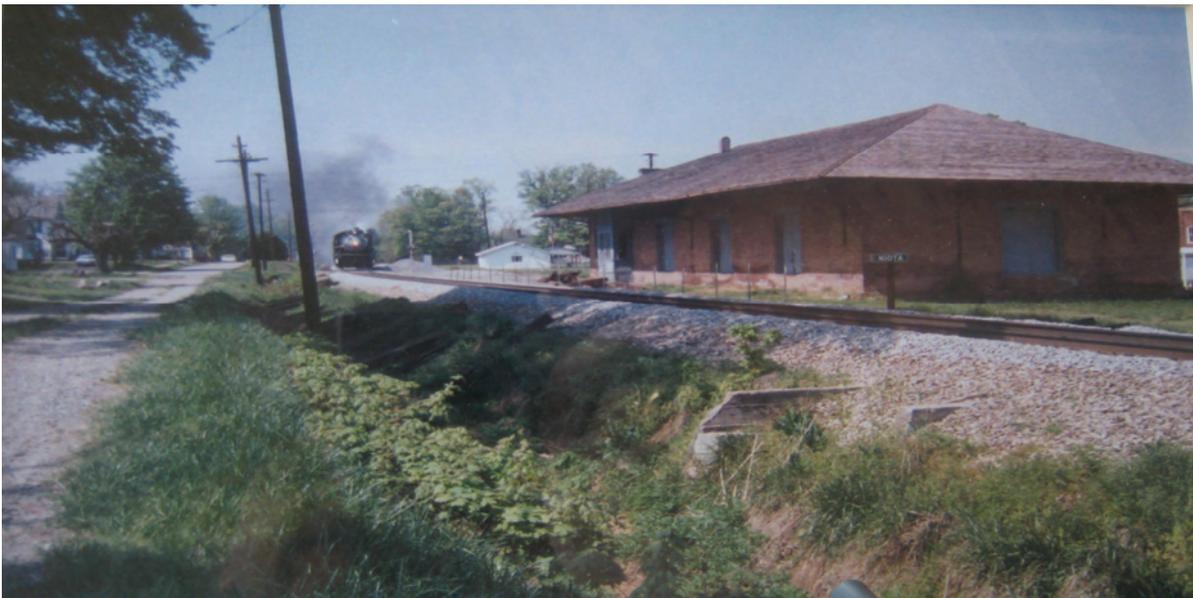
A multitude of issues caused by water damage can be alleviated by correcting drainage problems.

First and foremost, inspection of the building suggests that most of the deterioration to the Depot's exterior surfaces is the result of water damage to the brickwork. Since the Depot is the earliest brick railroad depot in Tennessee, the condition of the brick is of paramount importance. Therefore, there is no point in performing maintenance to the several areas of damaged brick until drainage problems are resolved.

- A. Purchase or fabricate new adapters for drainpipe leaders so there is a tight line and water is not leaking around foundation of building. Plastic adapters that convert from round to flat configurations (as needed for the above connection) are relatively inexpensive and readily available at most home improvement centers.

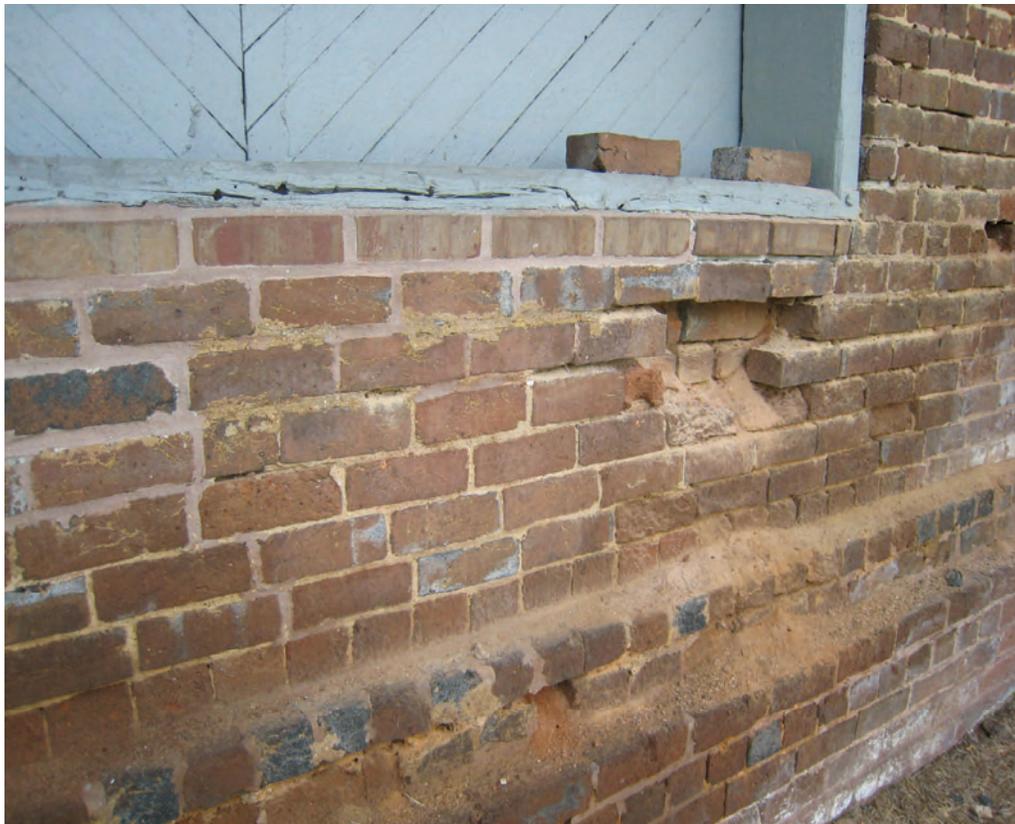
The solid surface created by inserting Portland cement into mortar joints has caused the more porous brick to crumble.

II Repair Brickwork (both interior and exterior):

A. Remove Portland cement from between bricks if brick is cracking or mortar is unsightly and repoint it with softer mortar (custom mix of sand, lime, etc.). Portland cement, which is harder and denser than brick, can cause bricks to crack or to retain water.

B. Replace missing brick and redo previous repair work where necessary. There is some old brick underneath the Depot that could be used, additional brick will need to be matched to original.

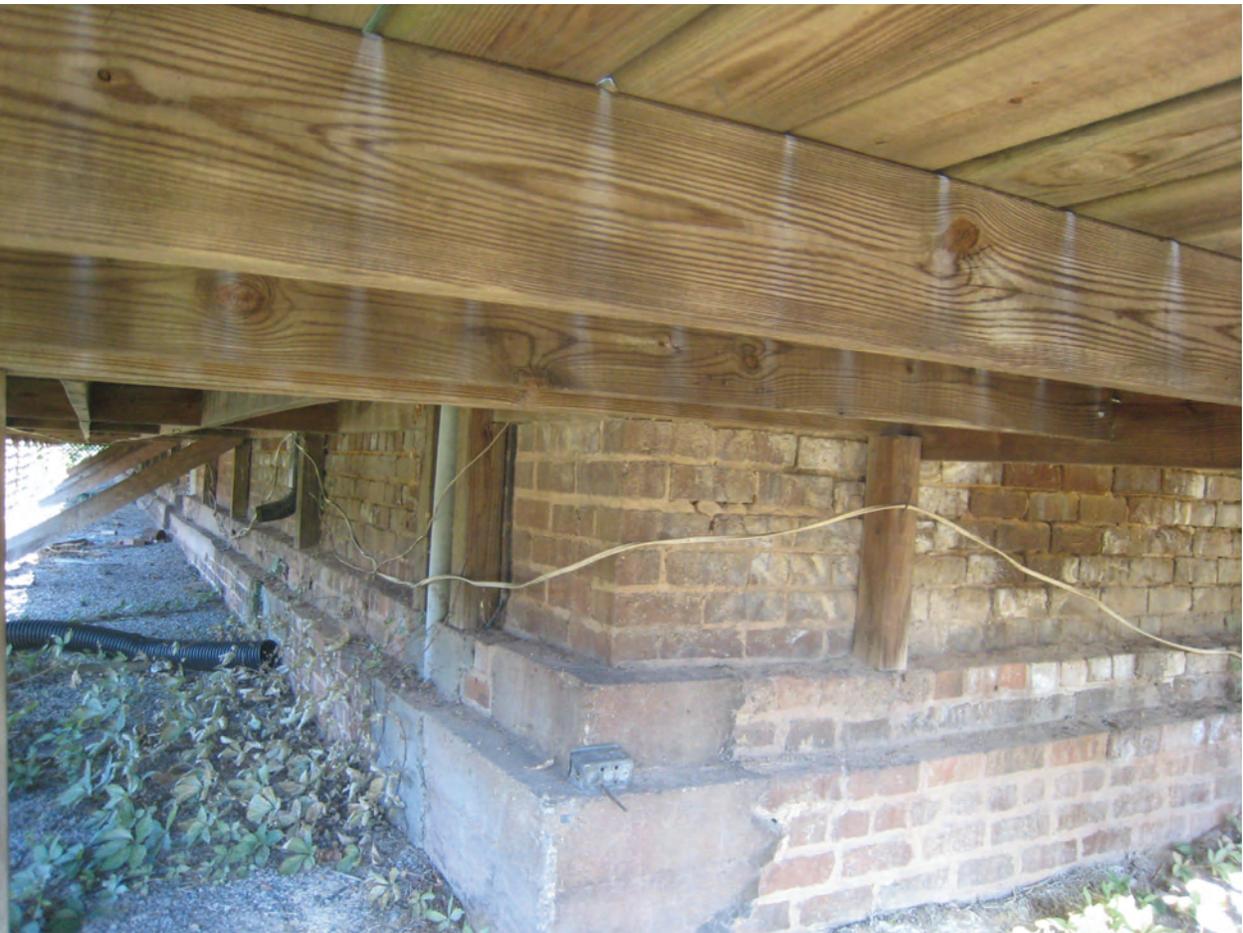
A. Pressure-treated lumber of deck appears to be bearing on the brick foundation below and may cause damage to either the foundation and/or brick itself if the present condition is not mitigated. Any deck or platform constructed for the depot in the future should be freestanding.

Note visible water damage on the wall next to support beam for deck at right. Exposed pipe at left should be inspected and possibly relocated. The adjoining corner of the foundation indicates possible previous damage to the foundation that may have been caused by drainage problems.

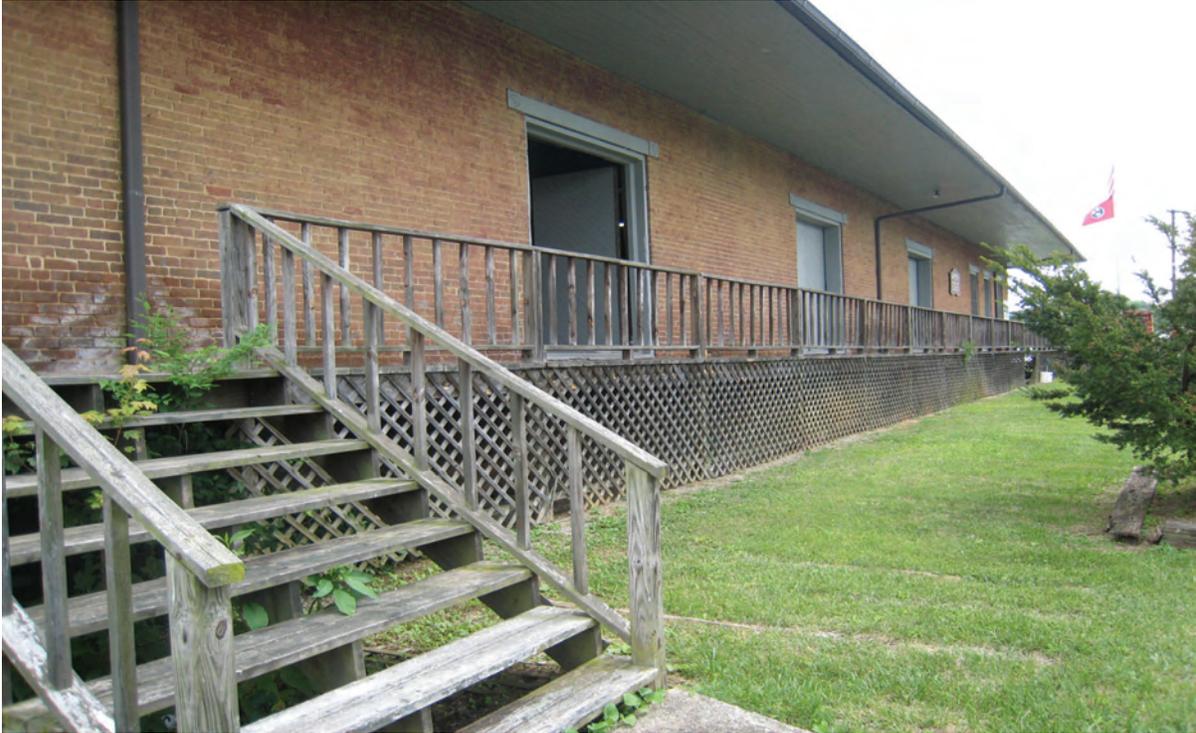
B. Latticework is not historically accurate. Consider replacement of decking with appropriate railway platform that is compatible to the wide roof overhang. Further research might reveal additional details of the historic platform. Image below indicates that there was a wooden railing along platform at one time. Ramp, platform, and railings will need to comply with Americans with Disabilities Act regulations.

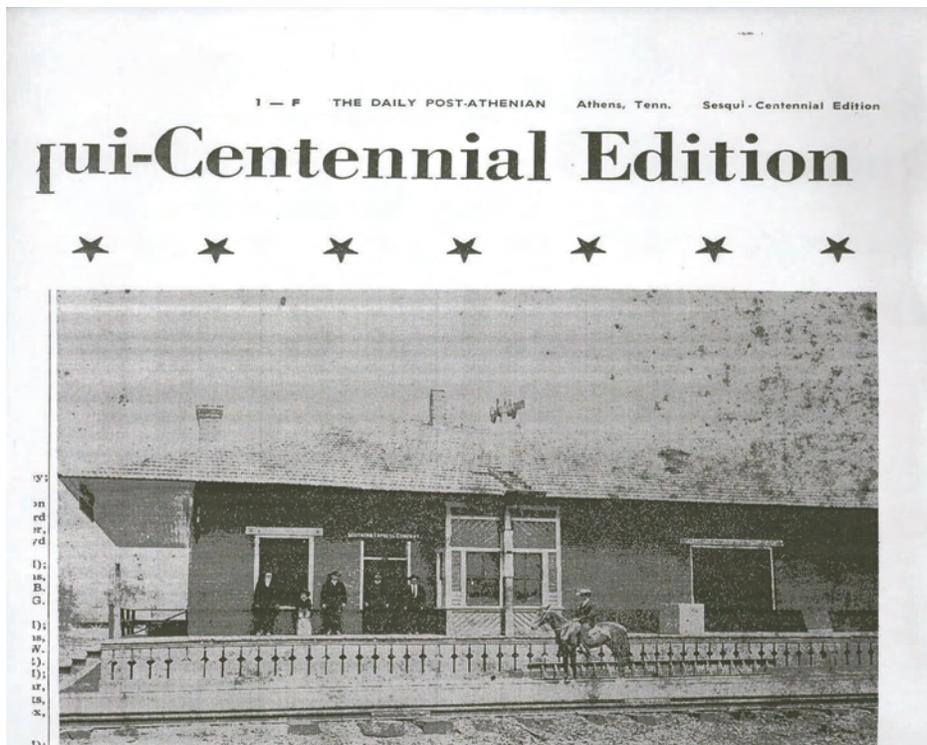
In the circa 1900 photo below, it appears that wood siding was used to hide the foundation below platform railing. Recommend restoring the platform to its historic appearance.

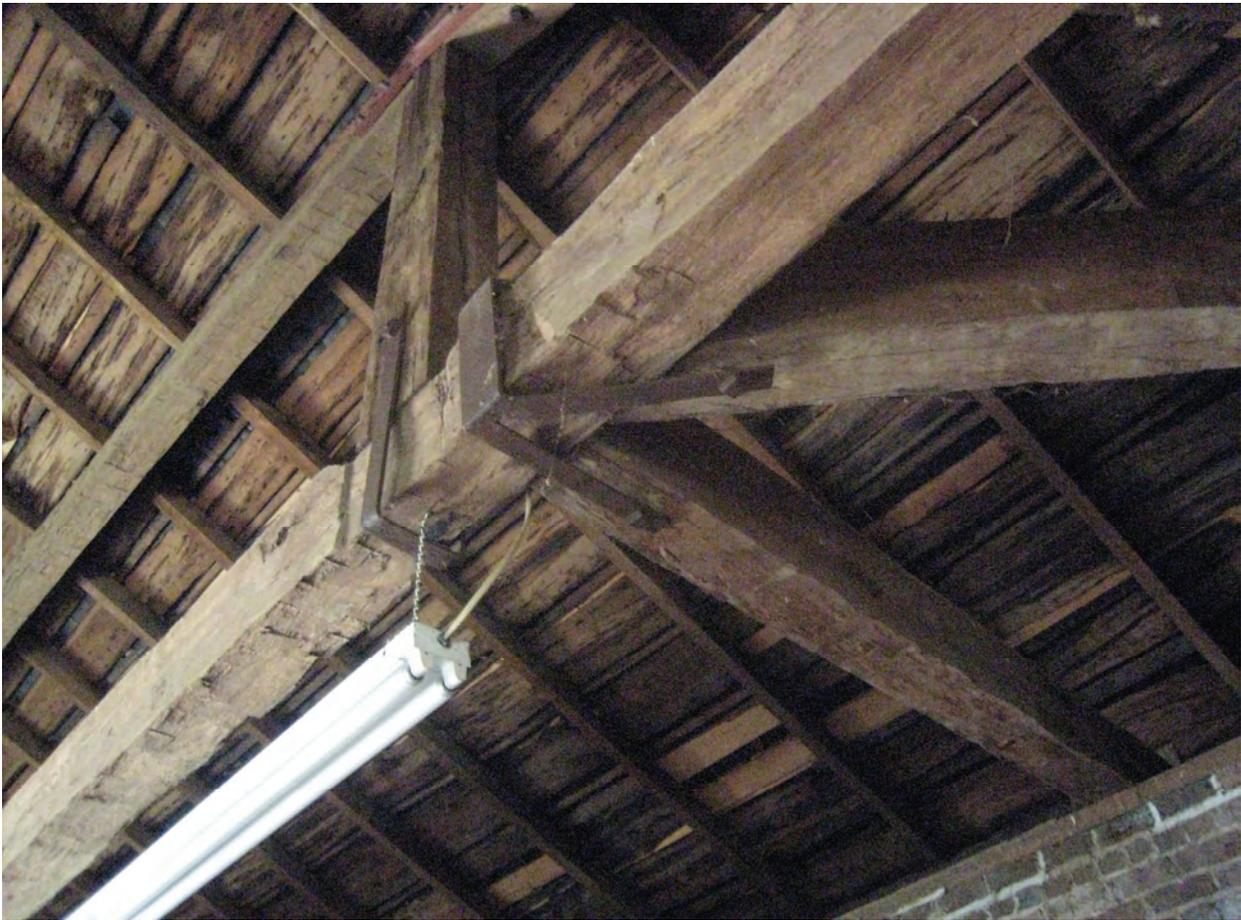
A. Structural metal rods and fasteners for beams should be inspected by a contractor who has documented experience with historic materials or by a preservation specialist. It is possible that metal elements were used to reinforce the roof structure when the terra cotta tile roof was added circa 1900. An expert in historical construction methods might be able to determine the approximate age from the workmanship, design, or materials used. Inspection recommendations for cleaning, painting, sealing, and/or other repair should be followed and a regular maintenance schedule established for interior and exterior metal fixtures. These are an important part of the historic fabric and of interest for those studying early technology in Tennessee.

Finding out when and where the metal brackets supporting and anchoring the wooden roof beams were fabricated might lead to more information about the depot and its original and replacement roofing.

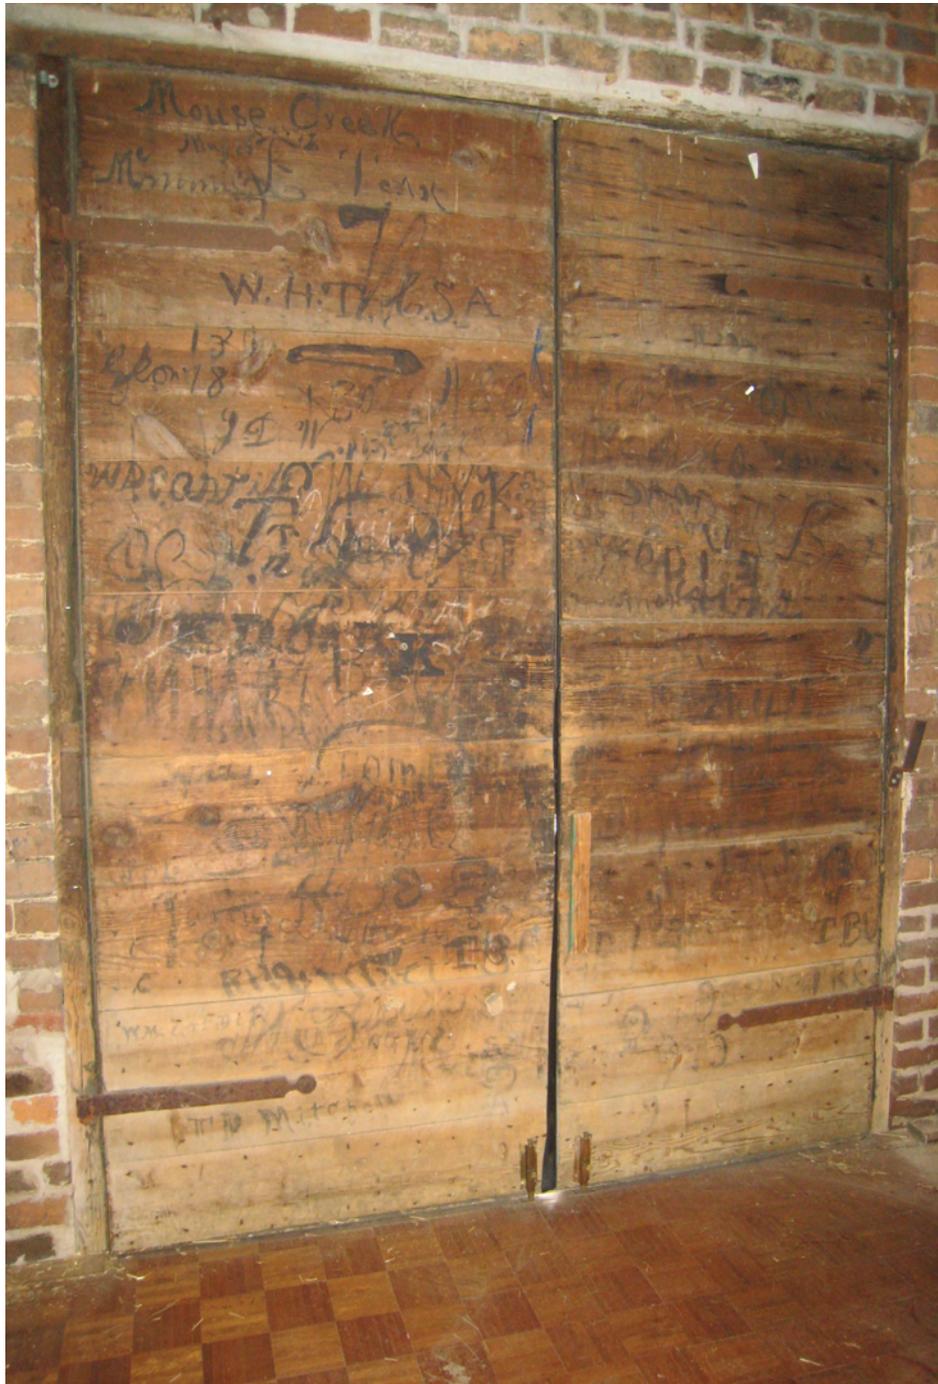
B. Baggage doors are now a combination of original and replacement material. Are they functional? Recommend that wood be refurbished and repaired (if necessary) and that facsimiles of the original hardware be obtained if possible. Graffiti on doors is historic record that might yield more information about the depot's history. Care should be taken to preserve it.

Before any sort of cleaning is attempted, a conservation inspection, including a test patch, should be done to ensure that no graffiti will be lost. Metal hardware should also be examined by a preservation specialist and treated in accordance with their recommendations.

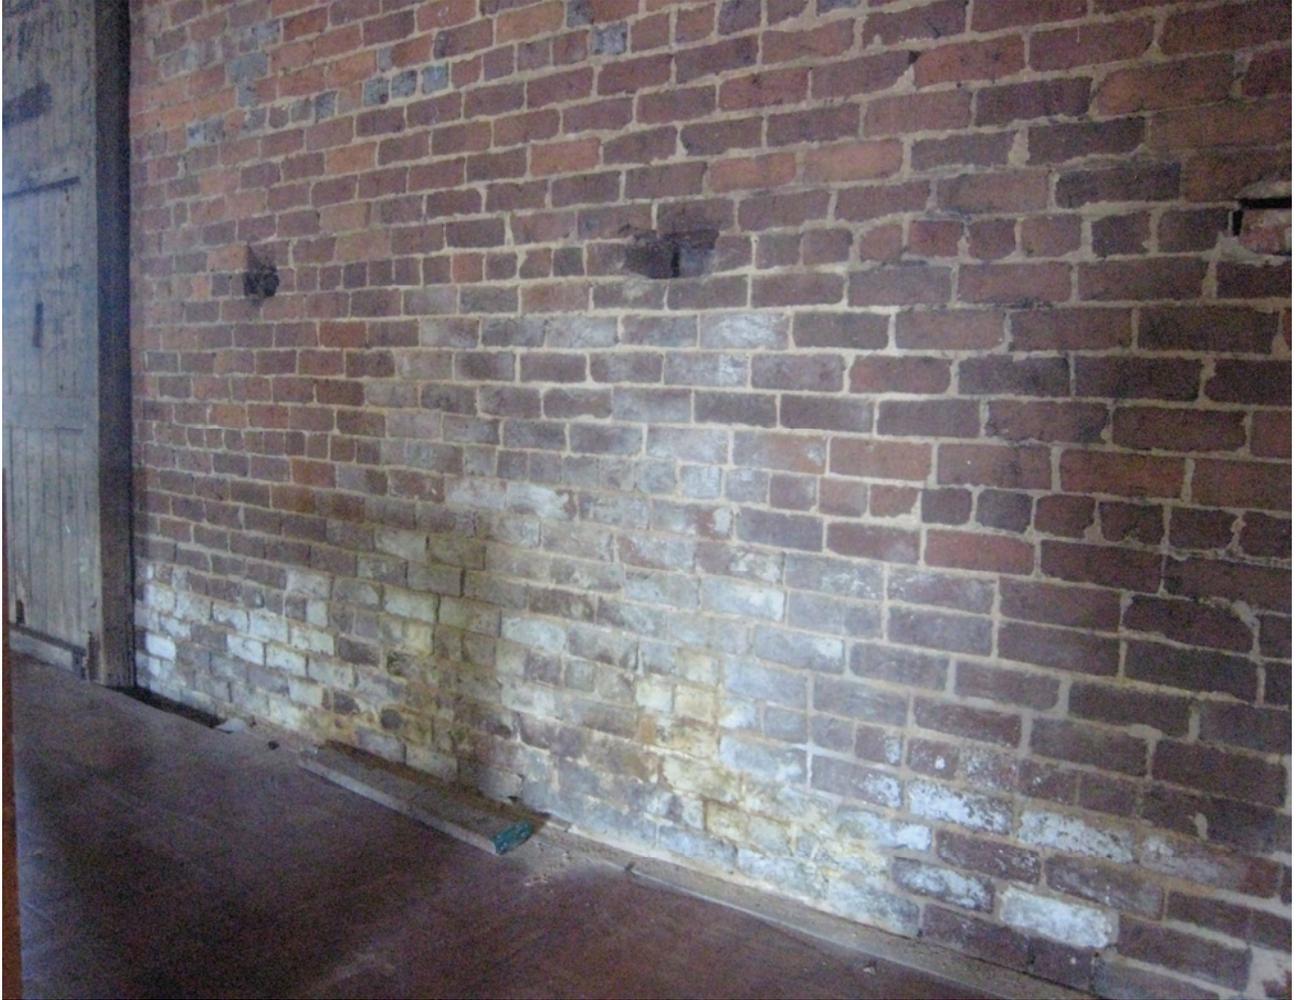
C. Clean walls and trusses to remove bird droppings, accumulated dust and grime. Clean gun-ports, but do not replugin holes because they are important to the depot's history.

The line of bricks that were punctured in order to serve as gun-ports while the depot was occupied is an important historic element in the Civil War interpretation of the depot. Care should be taken as brick below is cleaned and refurbished to preserve them.

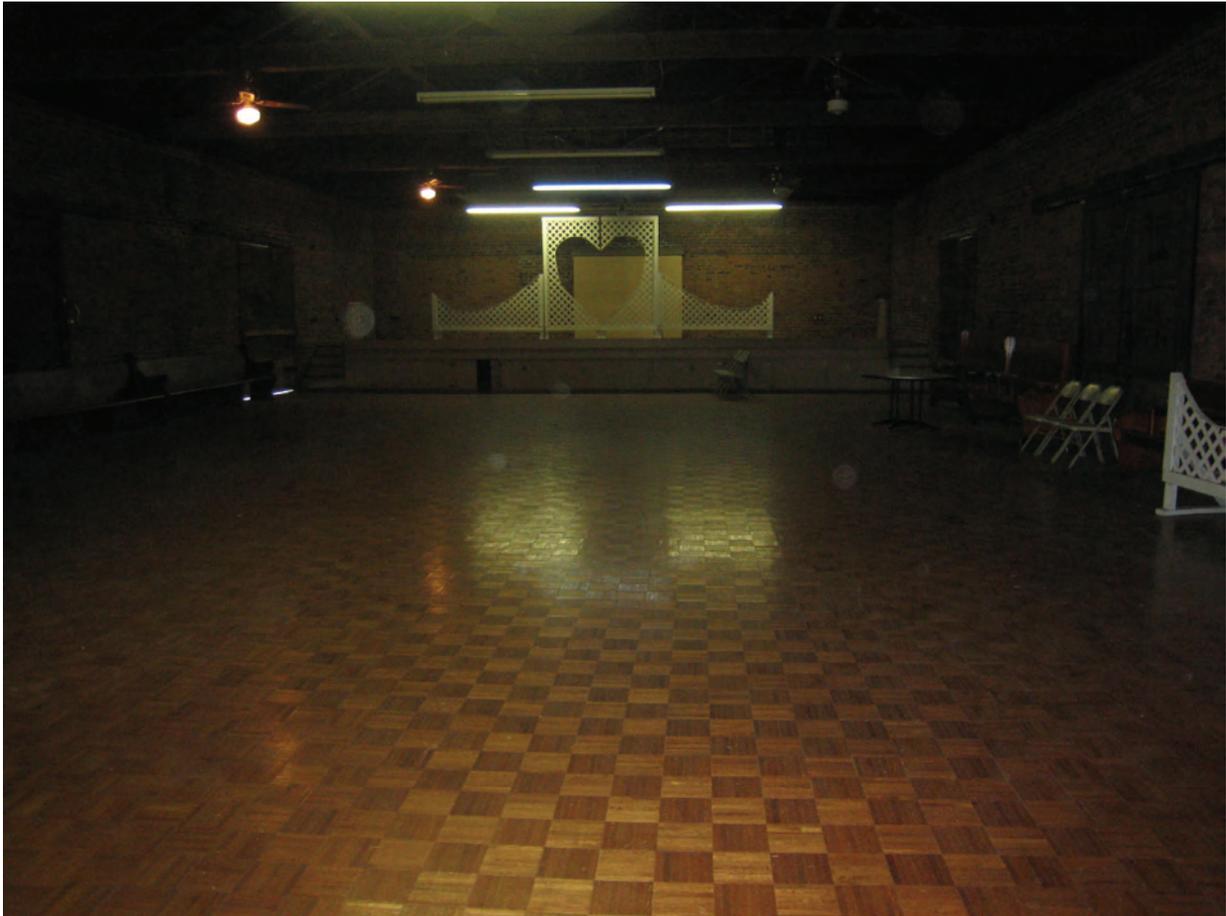
D. Parquet floor is serviceable but not historic. Recommend removal of parquet surface to reveal the historic flooring that appears to be intact underneath. Floor may need to be cleaned and refurbished.

The baggage room, when restored to its historic appearance, with the original wooden plank flooring and the removal of the elevated stage, will provide a glimpse into what was once one of the most active parts of the depot. An enhanced focus on the cargo doors, the railroad timetable blackboard, and the gun ports, plus the addition of exhibition panels illustrating the history of Niota, and the Civil War story of the depot, will provide important historical context.

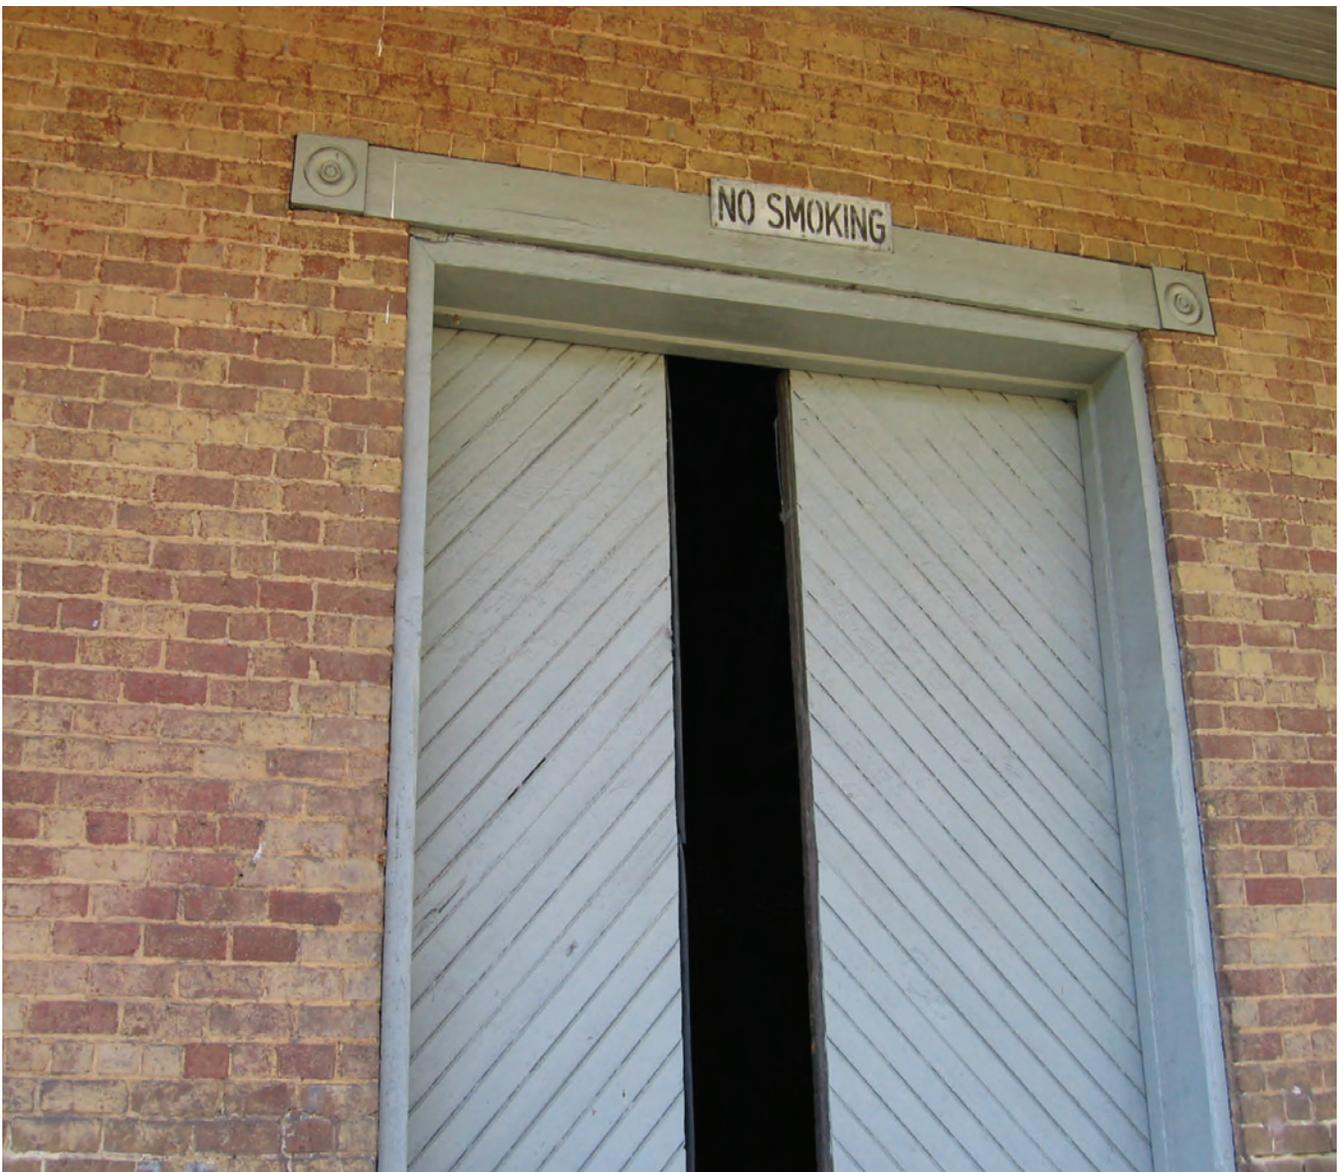
Note the bullseye moulding at the ends of the lintel above the cargo door. Such decorative elements can be important for dating architectural features.

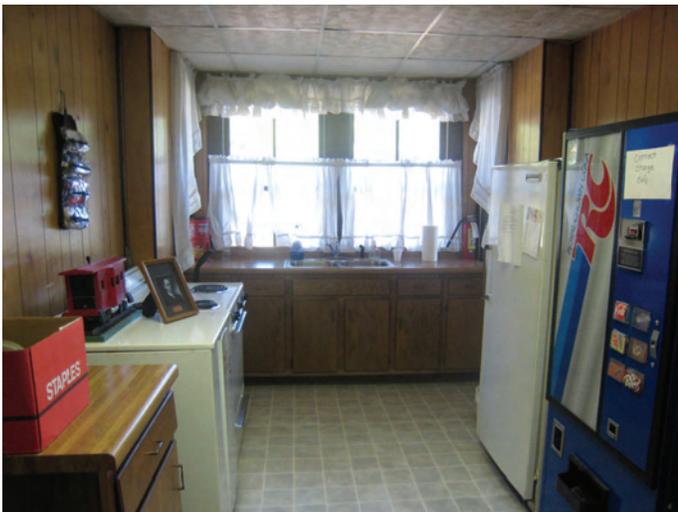
Moving the sink and converting the kitchenette window back to the original ticket office would provide an appropriate historical setting for telling the railroad history of Niota.
