National Register of Historic Places Registration Form

Historic name Oak Hill Farm
Other names/site number N/A
Name of related multiple property listing N/A
(Enter "N/A" if property is not part of a multiple property listing)

Street & Number: 1280 Keeling Road
City or town: Stanton State: TN County: Tipton & Haywood
Not For Publication: NA Vicinity: X

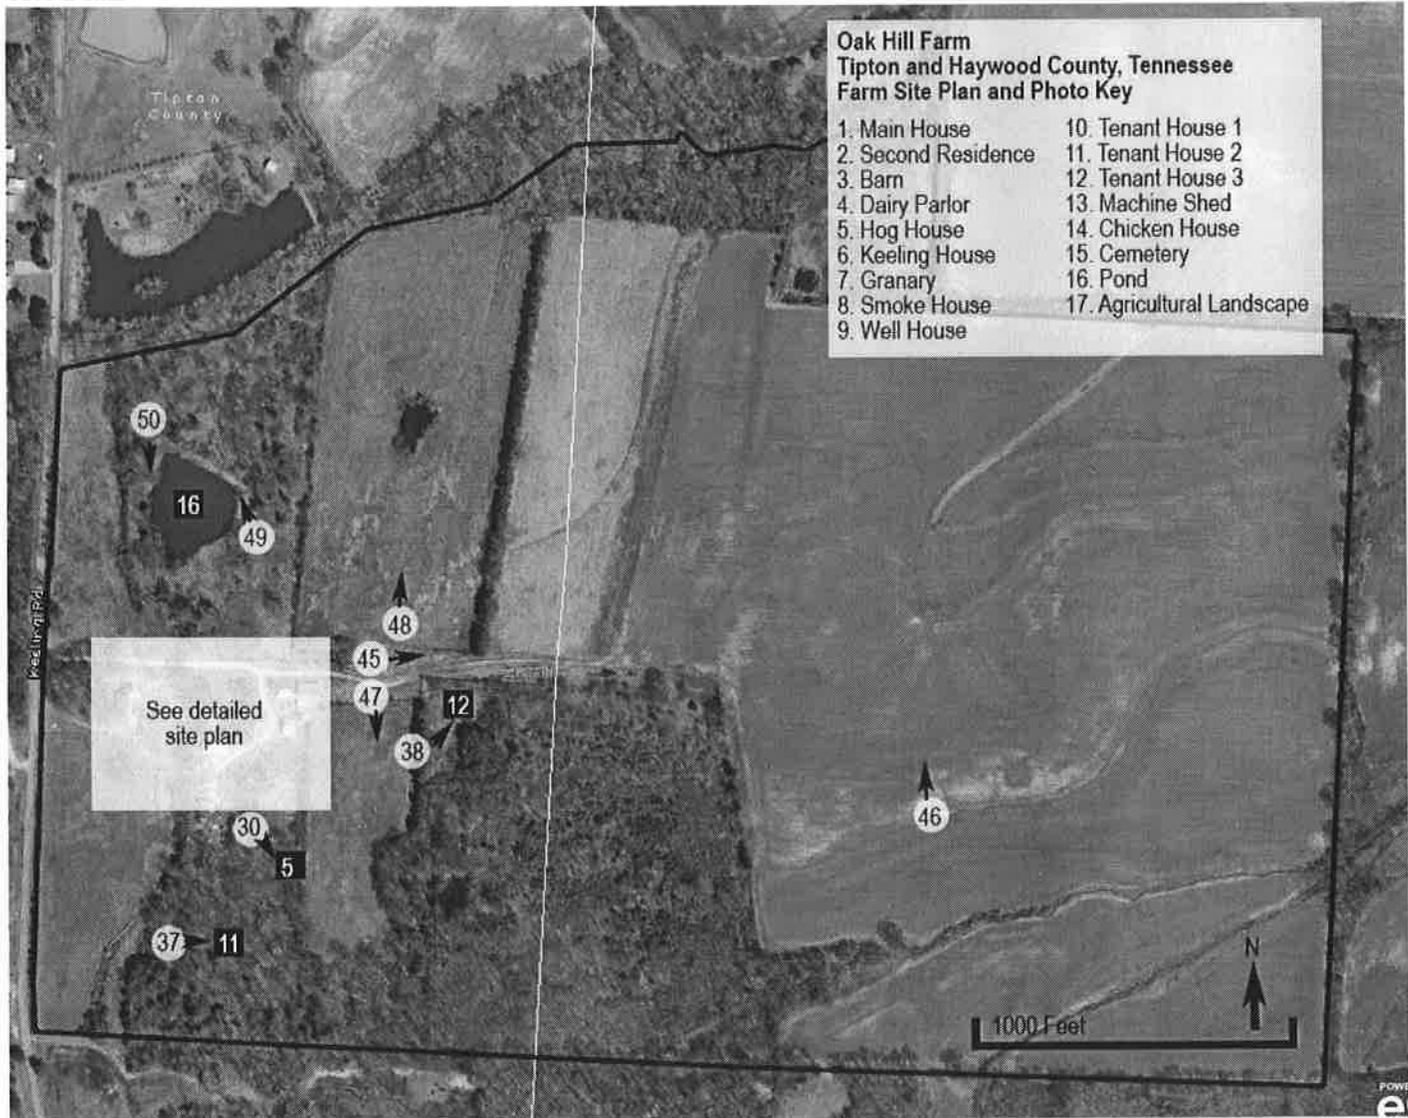
Site Plan

Oak Hill Farm includes both domestic and agricultural spaces. The built environment is concentrated at the center of the nominated acreage. The Taylor House (resource #1) anchors the property and the agricultural complex surrounds it on the east and south. Most of the supporting agriculture-related resources date to the postwar period of agricultural innovation. To the east of the house sits the barn (resource #3), the dairy parlor (resource #4), the Keeling House (resource #6), the granary (resource #7), the smoke house (resource #8), and the well house (resource #9). To the south of the house are the machine shed (resource #13) and the chicken house (resource #14). The tenant houses are situated further out from the agricultural and domestic complex. This placed tenants closer to the fields and animals they tended. Tenant House 1 (resource #10) is situated the closest to the main house of any of the tenant buildings because it was physically removed intact from the main body of the Taylor House, while the other houses (resources #11 and #12) were erected on site in wooded areas.

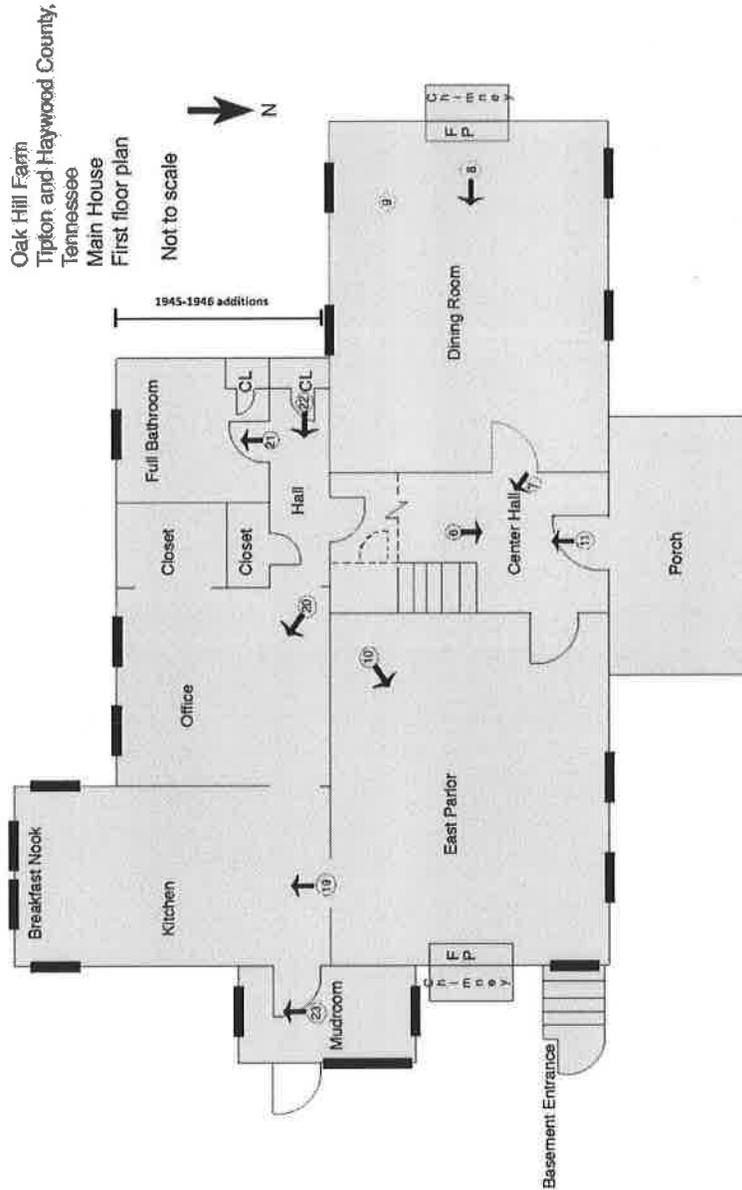
Floor Plan – Taylor House

The 1834 house follows a central hall plan featuring parlors on either side and a dog-leg staircase at the hall's south end. This plan is more or less reflected upstairs, with a central hall and two flanking bedrooms. The north end of the upstairs hall, however, is enclosed to form a small bedroom. The 1834 section of the house retains a high degree of integrity, including the majority of its historic tongue-and-groove hardwood floors, paneled wainscoting with simple molded chair rails on the lower level, eight-inch baseboards, brick fireplaces and Federal-style wood mantels, original multi-paneled wood doors with original hardware, and plaster walls. The upper and lower levels have the same molded square architrave surrounds on doors and windows, except where otherwise noted.

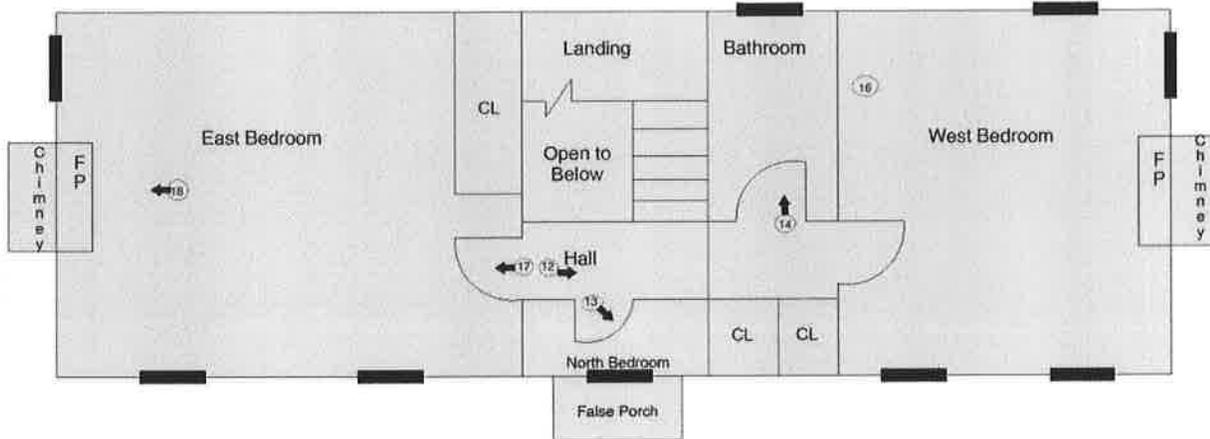
Oak Hill Farm
Tipton & Haywood County
Tennessee
Main House
Second Floor Plan

The stair from the first floor runs north along the eastern wall and reaches a landing along the northern wall of the interior. The landing has historic wood floorboards, simple square wood balusters, turned wood corner posts, and a simple wood handrail. The stair then turns south and runs along the western wall of the well to reach the second floor hall. The hall is confined to the southern end of the second floor, while a bedroom occupies the northern end of the central portion of the house on the second floor. The second floor hall retains historic tongue-and-groove wood flooring, simple baseboards, and plaster walls. Unlike the first floor hall, this hall does not include wainscoting (Photo 12). The southern end of the central hall consists of the stairs on the west and an open well on the east. The stairs and the open well retain a historic balustrade like that of the landing. A secondary, modern wood railing has been added along the western wall of the stair for additional support. Three openings are located in the second floor hall: a non-cased opening on the west wall into a modern hallway and west bedroom; a historic six-panel wood door on the north wall leading into the north bedroom; and a historic six-panel wood door on the east wall that leads to the east bedroom. The two historic doors match the other interior doors of the 1834 house and retain simple molded surrounds.

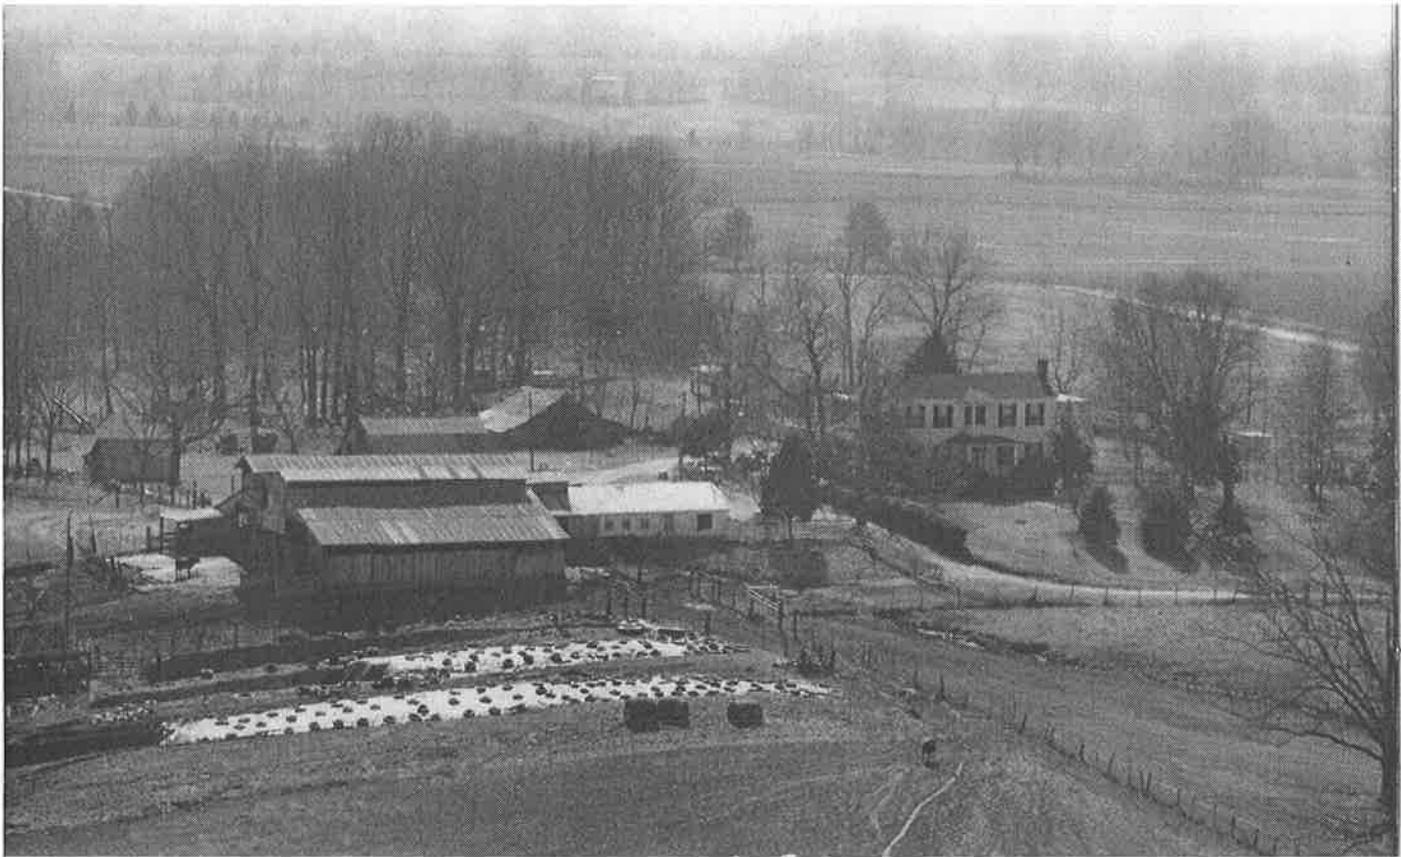
Figure 1. Aerial overview of the farm, c. 1980. Note the silage pits visible in the foreground, north of the barn.

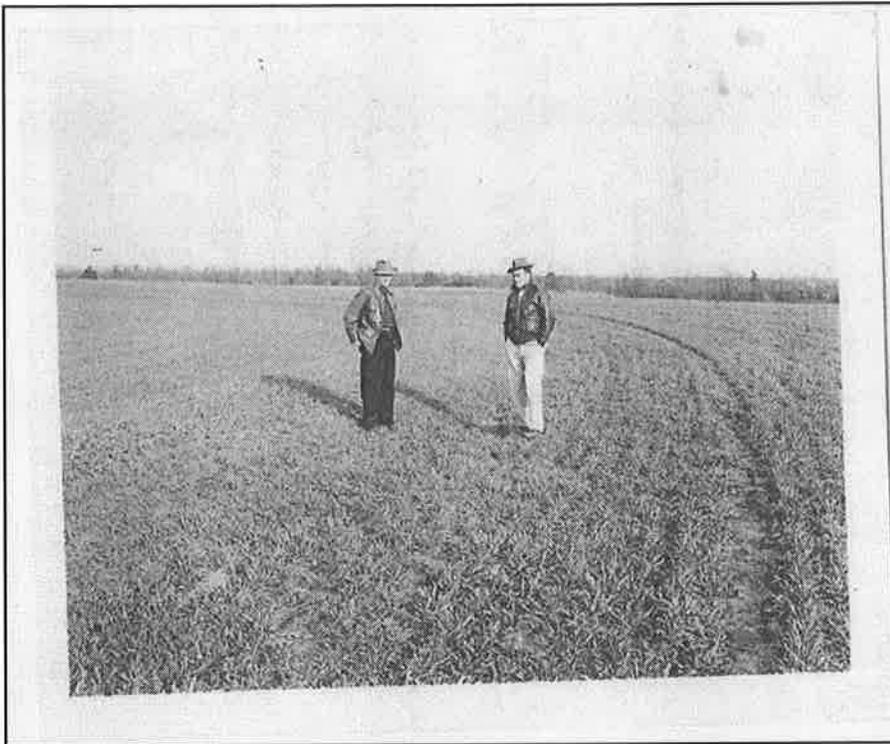
Figure 4. Caption reads: "2-2292-4
Tenn-Tipton-12-10-61 L.M. Maclin
Stanton, Tenn.

Oats on terraced land drilled on the contour.

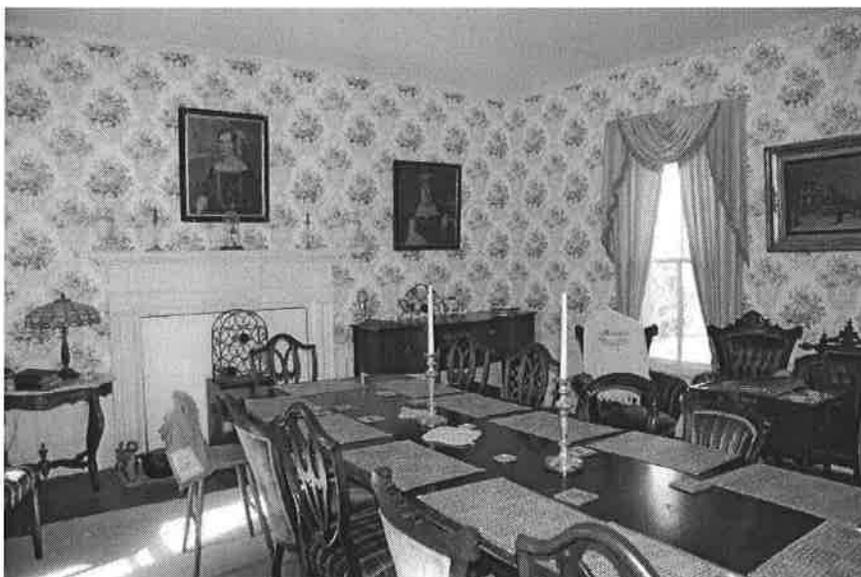
Additional Photo 1. Dining Room, Photographer Facing Northwest.

Accessible from the central hall, the dining room is a large room occupying the entire west end of the first floor (Photo 8).⁵ The walls and ceiling in this room have been replaced with drywall, but retain their historic wood-paneled wainscoting, baseboards, and crown molding. The west wall is dominated by a brick fireplace and hearth which includes what appears to be an original wood mantel and mantelshelf. The mantel is an excellent example of modest Federal-style vernacular detailing with its thin lines and formality. The sides of the mantel include pilasters with a stylized pedestal, stylized column shafts with channeling, a plain mantelpiece with central block and architrave detailing, and a molded cornice with implied capitals on which the mantelshelf rests (Photo 9).

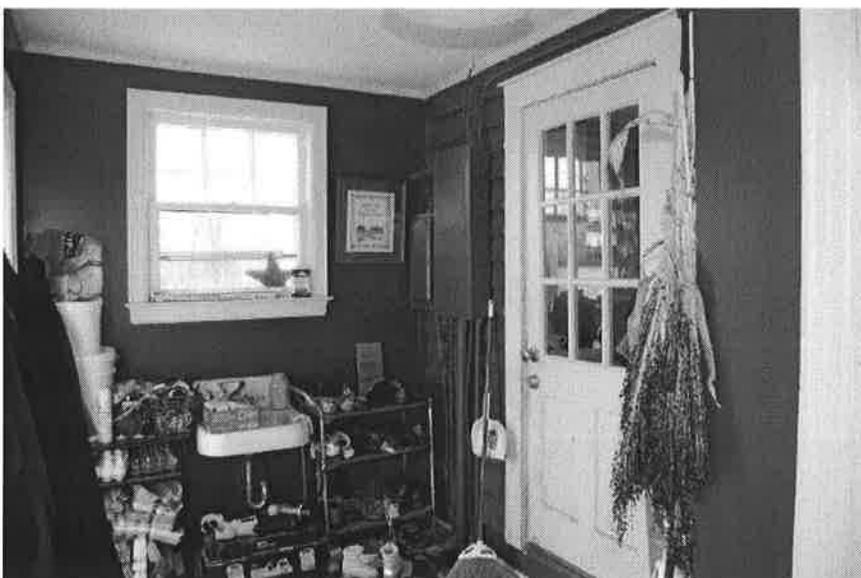
Additional Photo #2. Mudroom, Photographer Facing Southwest.

In 1945-1946, a shed roof addition was added to the south elevation of the house. A mudroom addition was made at the same time extending from the east elevation of the house and the south addition. The south elevation shed room addition introduced the first indoor plumbing to the home, and at the same time, electricity was added throughout the home. The south addition created a kitchen, an open area currently used as an office, a hallway with closets, and a full bathroom. Unless otherwise noted, these spaces have hardwood floors, drywall walls, plain four-inch baseboards, architrave trim on the window and doorframes, and crown molding.
