National Register of Historic Places Registration Form

historic name Miller, Washington, House
other names/site number Cedar Winds

street & number 1450 Frye Road N/A not for publication
city or town Columbia N/A vicinity
state Tennessee code TN county Maury code 053 zip code 38401

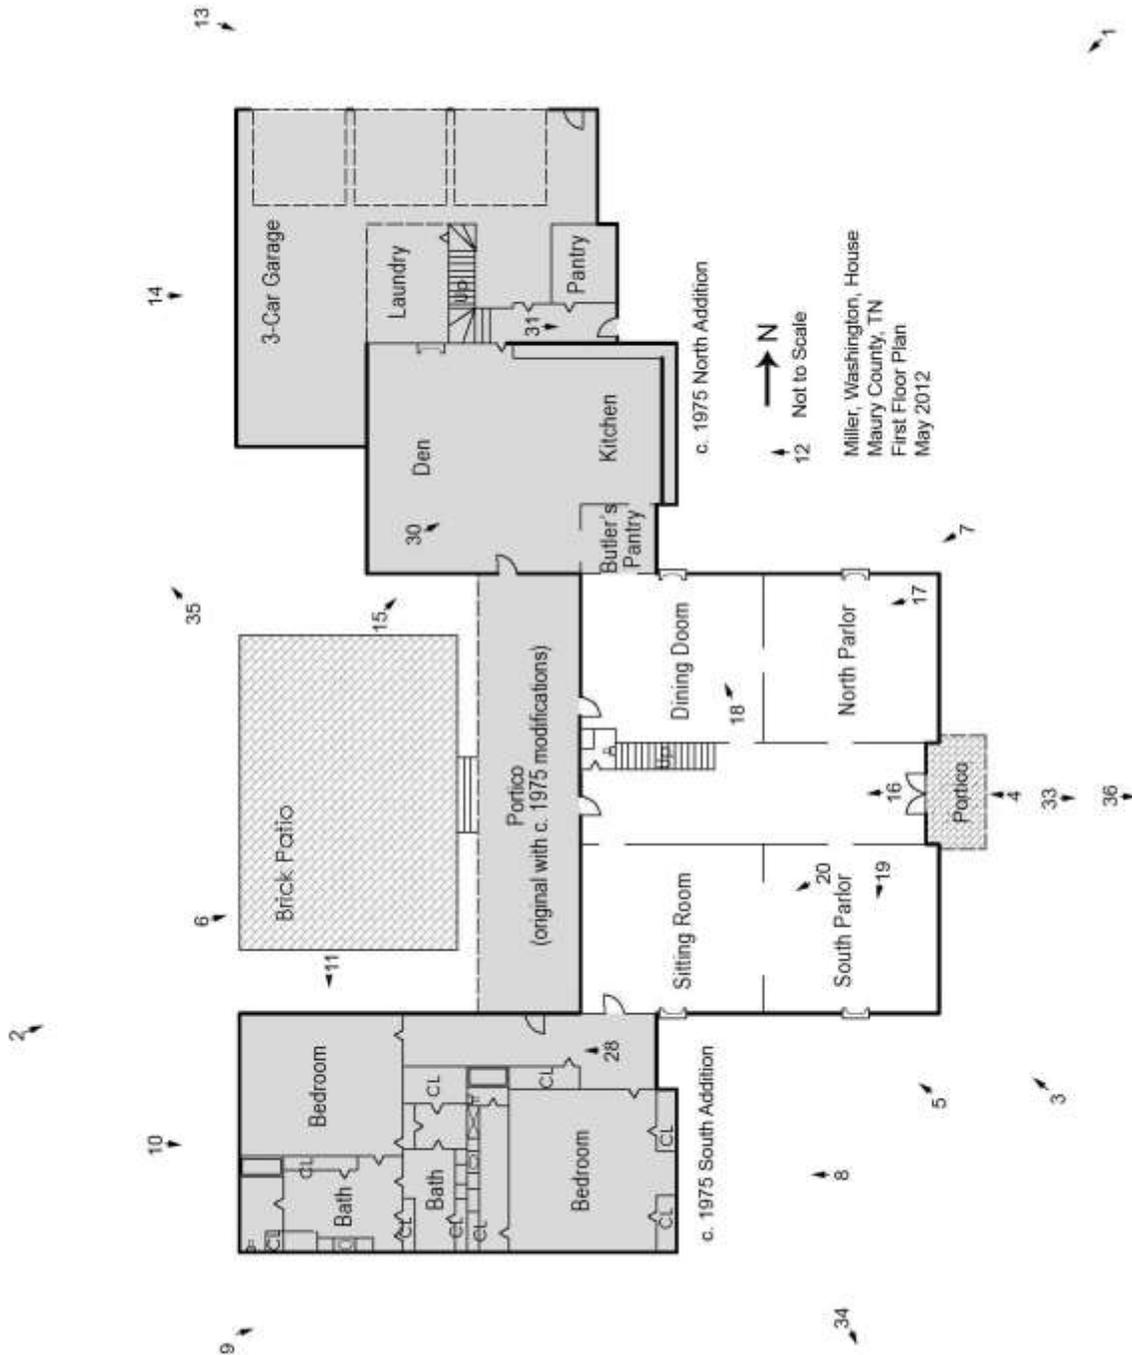
Washington Miller House. First Floor Plan and Photo Key.

The interior of the historic main block features a four-over-four, central hall plan, and unfinished attic. The original interior floor plan remains substantially intact. The front-to-back central hallway divides the first floor rooms, and corresponding spaces on the second floor are used as bedrooms (Photo #16). Rooms on the

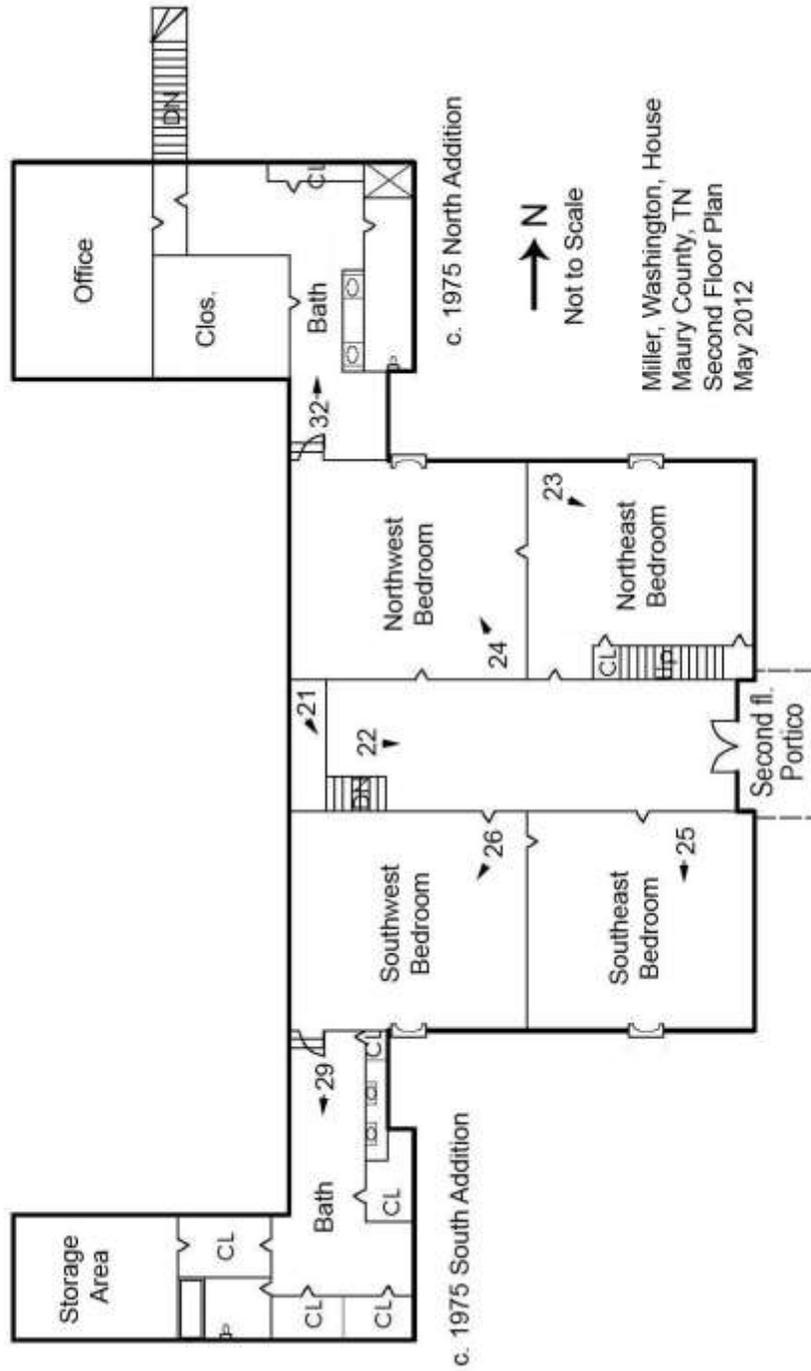
Washington Miller House. Second Floor Plan and Photo Key.

On the second floor, the stairs lead to the west end of a central hall similar to that of the first floor. A double-leaf door leading to the second floor of the front portico is centered on the east wall of the central hall (Photo #22). The door and transom reach the ceiling of the hall and occupy the majority of the west wall. The upstairs hall retains original wide molded baseboards, crown molding, and shouldered surrounds matching those seen in the downstairs hall. It also retains its original wood floors, plaster walls, and plaster ceiling. Like the downstairs hall, walls are covered with wallpaper thought to be similar to original wallpapering. Two, two-panel wood doors are located on the north and south walls providing access to the four bedrooms. A single window is centered on the west wall above the stair. The four bedrooms each retain original wide baseboards, crown molding, wood floors, plaster walls, and plaster ceiling. The

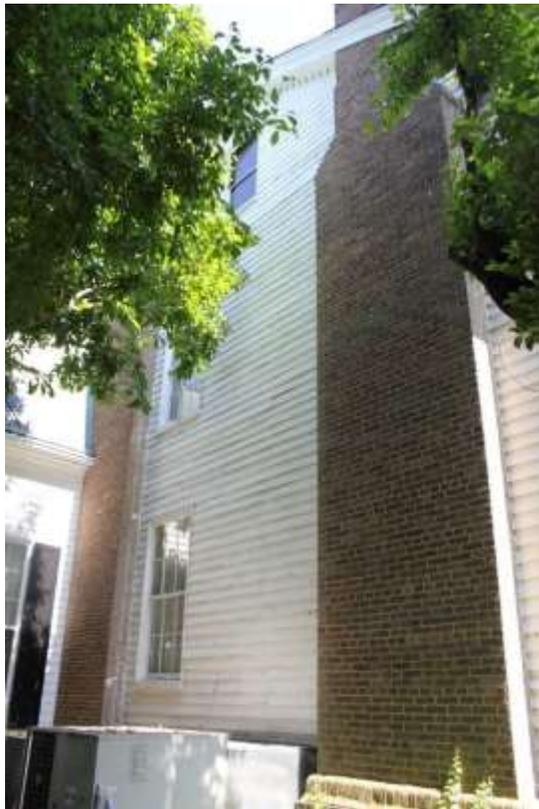
5 of 36

The south elevation of the main block is the gable end featuring two, exterior brick end chimneys (Photo #5). The chimneys are shouldered and pierce the roof of the elevation. Between the chimneys on each floor is an original, off-centered, six-over-six, double-hung wood sash window. A smaller centered six-over-six, double-hung wood sash window is located at the attic level. A raking, denticulated cornice like the horizontal cornice of the façade accentuates the roofline of this elevation.

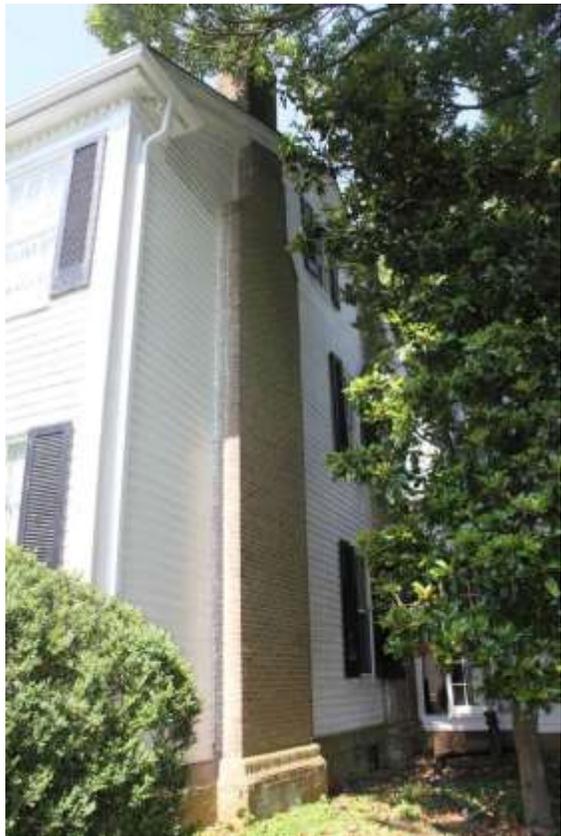
7 of 36

The north elevation of the main block is almost identical to the south elevation, with the exception that the windows on the north elevation are flanked by early-twentieth century louvered shutters (Photo #7).

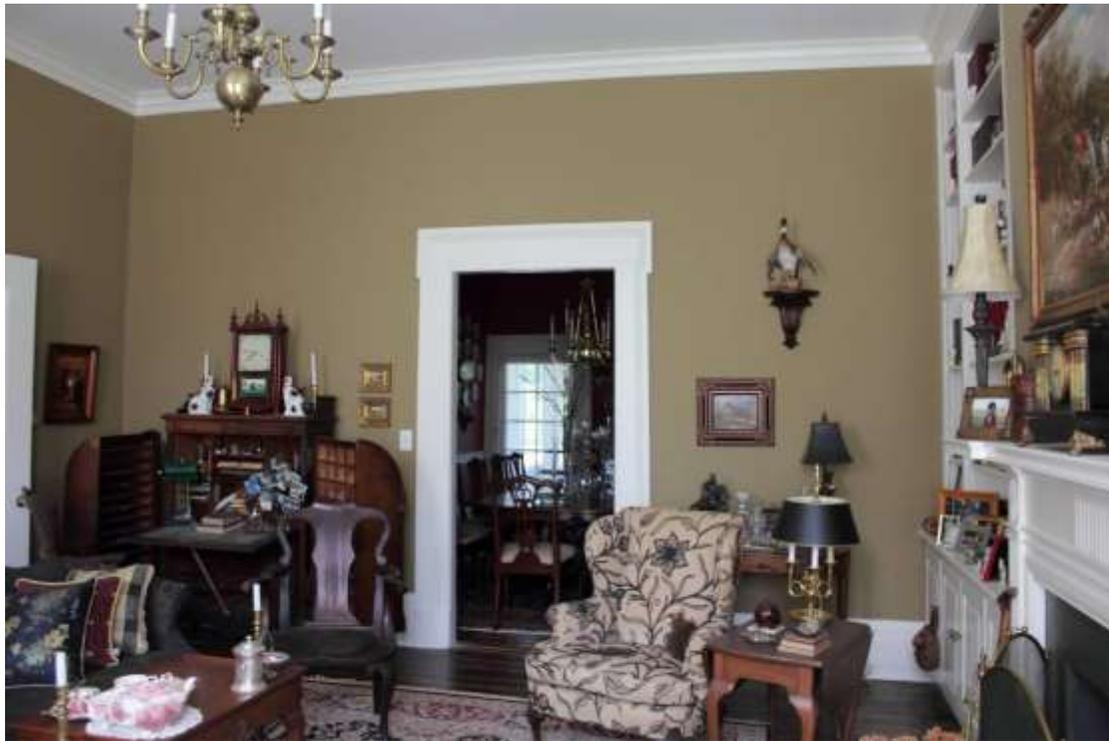
17 of 36

The north parlor, currently used as a study, is situated at the northeast corner of the main block (Photo #17). The fireplace, centered on the north wall, consists of a brick firebox with a marble surround and marble hearth. The fireplace has a modest classical wood mantel with fluted pilasters flanking either side of the firebox. The entablature consists of corner medallions and a fluted rectangular panel. The mantel shelf is slightly inset at the center leaving the appearance of column capitals at the mantel corners above the pilasters. Built-in cabinet shelves occupy the entire wall space on either side of the fireplace and were added c. 1975. The east wall of the north parlor contains two windows. The west wall has a centered opening leading into the dining room that is articulated with shouldered trim. This opening is the same width as the doorways leading to the rooms from the central hall.

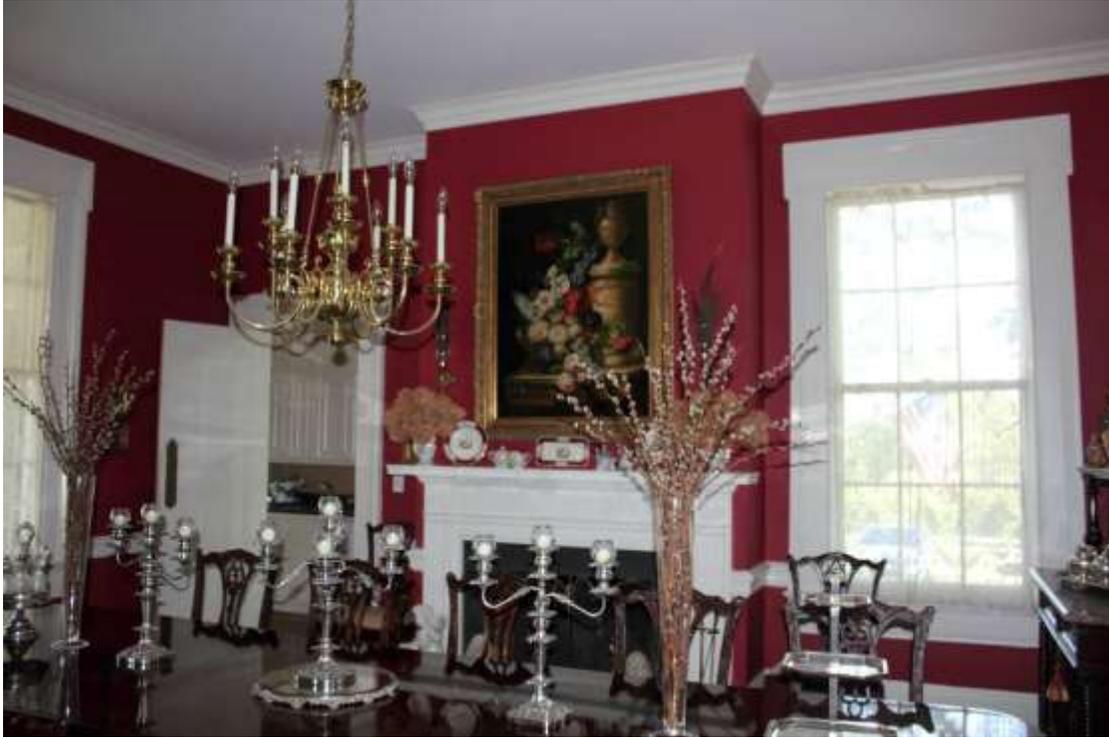
18 of 36

The dining room is located at the northwest corner of the house and contains a molded chair rail (Photo #18). On the north wall of the dining room is a centered fireplace. Flanking the fireplace is a single window on the east side, and on the west side, a swinging, two-panel wood door that leads into the kitchen of the north wing addition. On the west wall is an off-centered window and a ten-light wood door that accesses the back porch. The door opening was added c. 1975; however, the surround matches the shouldered wood surrounds found throughout the historic main block of the house. The window was likely moved offcenter to accommodate the door at that time. A small bump-out at the southwest corner of the room accommodates the half-bath installed under the stairwell and accessed through the central hall.

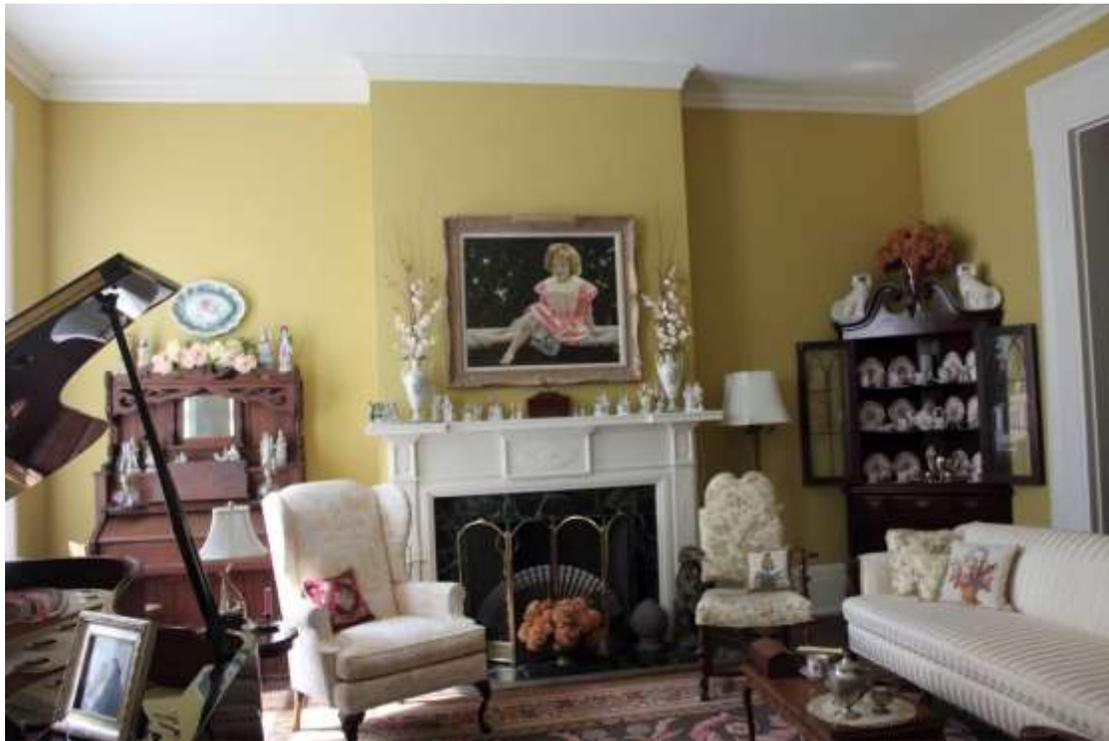
19 of 36

The south parlor, or formal living room, is situated at the southeast corner of the first floor (Photo #19). The fireplace and mantel are also identical to those in the north rooms with the exception of the sunburst panels centered under the mantel shelf. The fireplace is centered on the south wall and two windows are located on the east wall. A wide opening is located on the west wall that provides access into the sitting room. The sitting room has a central fireplace and mantel on the south wall that is identical to that in the south parlor (Photo #20). Flanking the fireplace is a single window on its east side, and on its west side, a two-panel wood door leading into the south wing addition. The west wall contains a single, centered window.

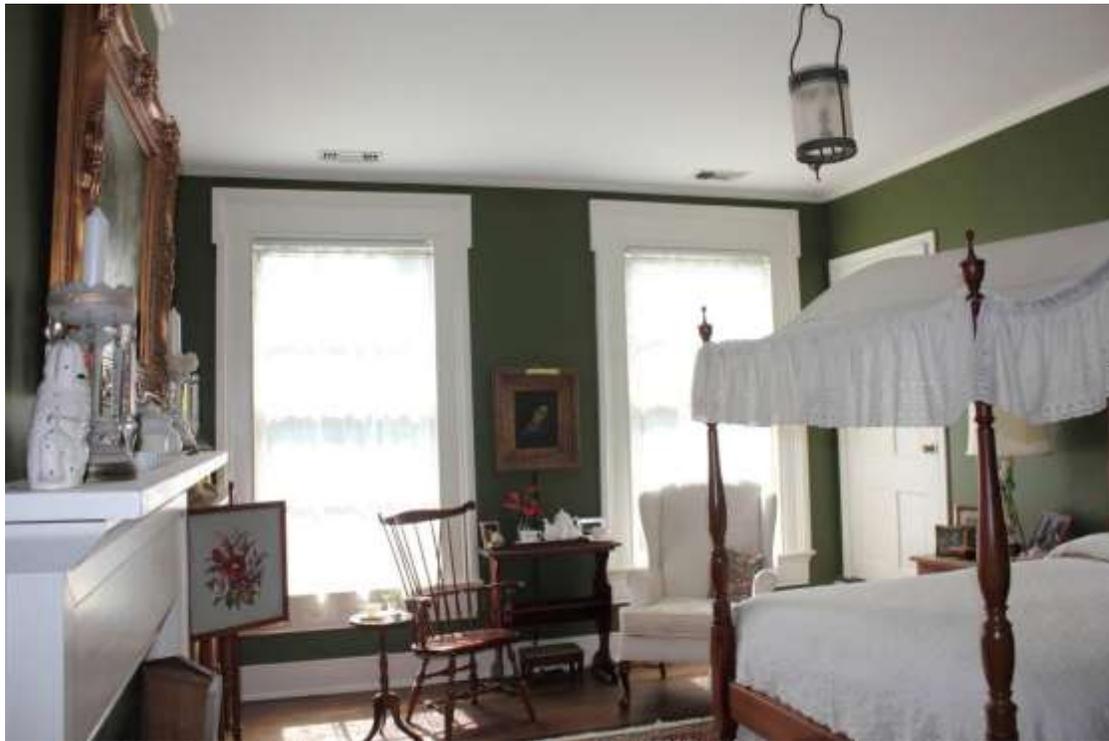
23 of 36

The northeast bedroom has a fireplace and mantel centered on the north wall (Photo #23). The fireplace is brick and has a marble hearth, and surround like those of the downstairs rooms. The mantel is simpler than those of the downstairs room and consists of a plain shouldered surround with a plain wood panel beneath the mantel shelf. Two windows are located on the east wall and a centered, two-panel wood door on the west wall leads into the northwest bedroom. Along the south wall is an enclosed stairway leading to the unfinished one-room attic. The enclosure for the stair runs almost the length of the wall, ending just before the doorway at the western end of the wall. The stair is accessed at the east end of the wall through a four-panel wood door.

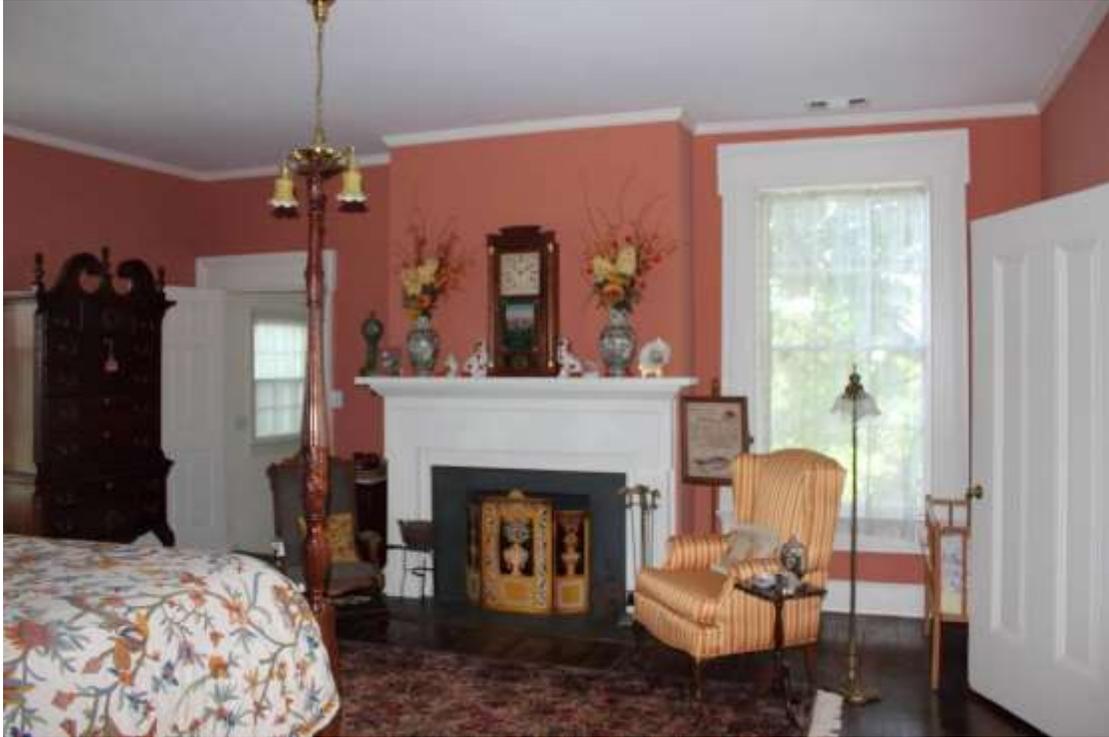
24 of 36

Centered on the north wall of the northwest bedroom is a fireplace identical to that of the northeast bedroom (Photo #24). Flanking the fireplace is a window on the east side and a six-panel wood door on the west side leading into the north addition. A single window is centered on the west wall of the bedroom.

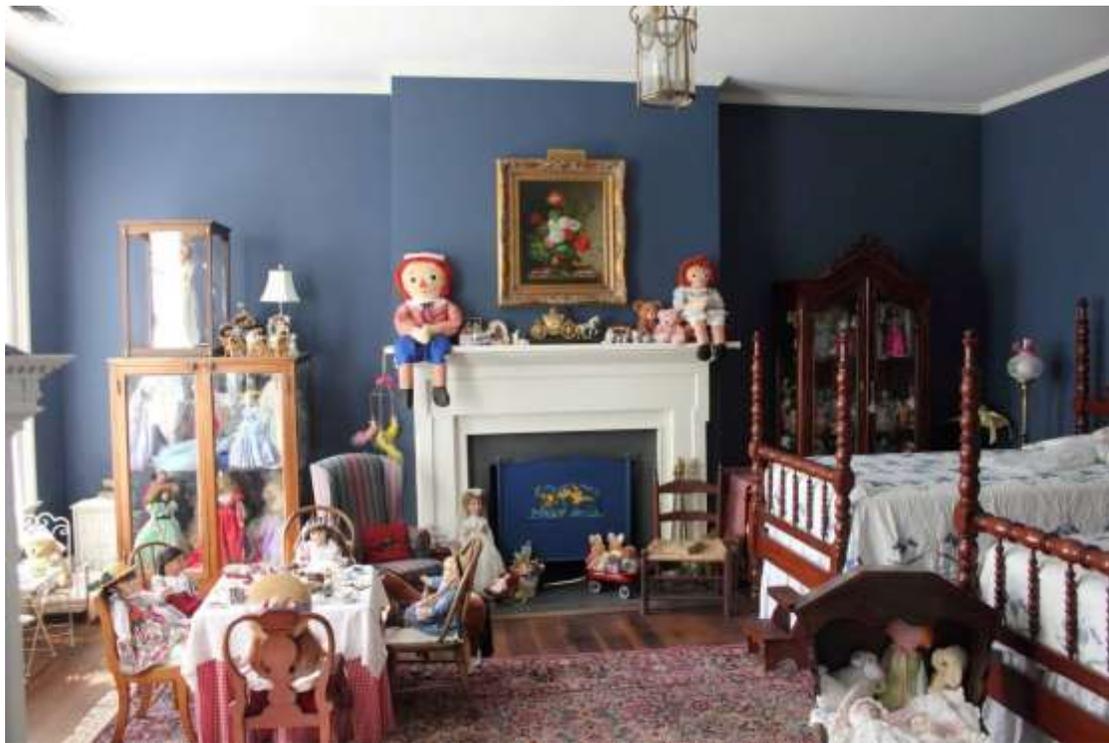
25 of 36

The southeast bedroom has a fireplace identical to those of the north bedrooms centered on the south wall (Photo #25). Two windows are located on the east wall and a six-panel wood door is on the north end of the west wall that leads into the southwest bedroom.

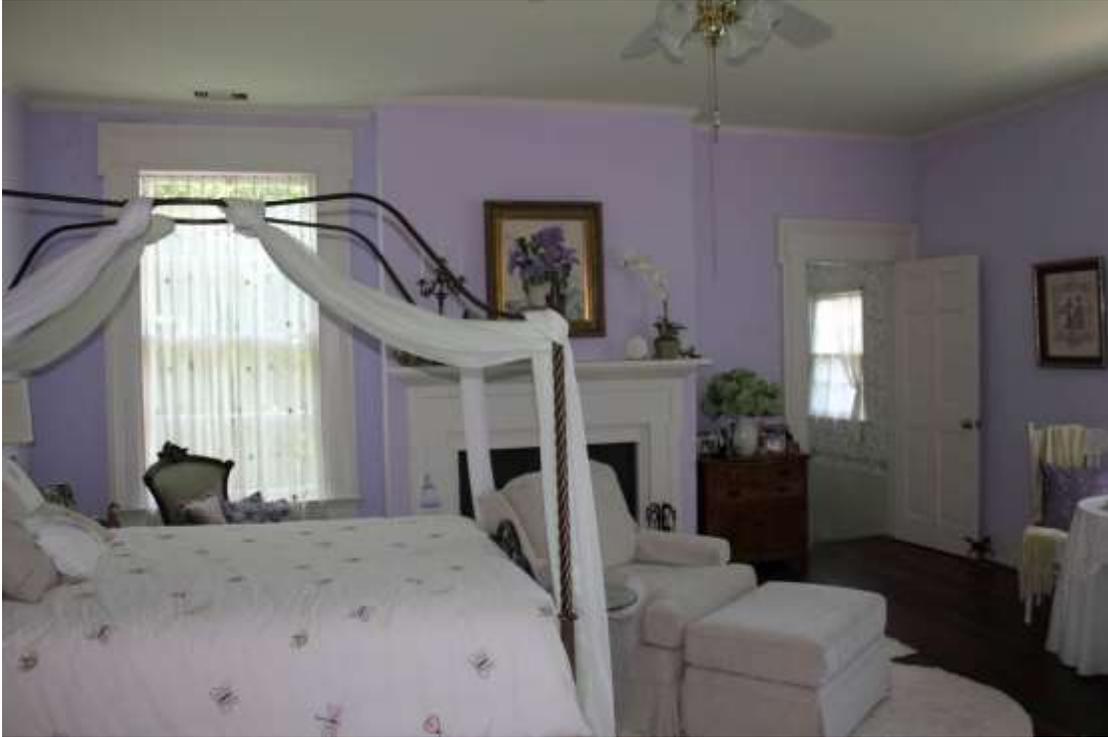
26 of 36

The southwest bedroom has a fireplace identical to those of the other three bedrooms centered on the south wall (Photo #26). Flanking the fireplace is a single window on the east side and a six-panel wood door on the west side that leads into the south wing addition. A single window is centered on the west wall of the room.

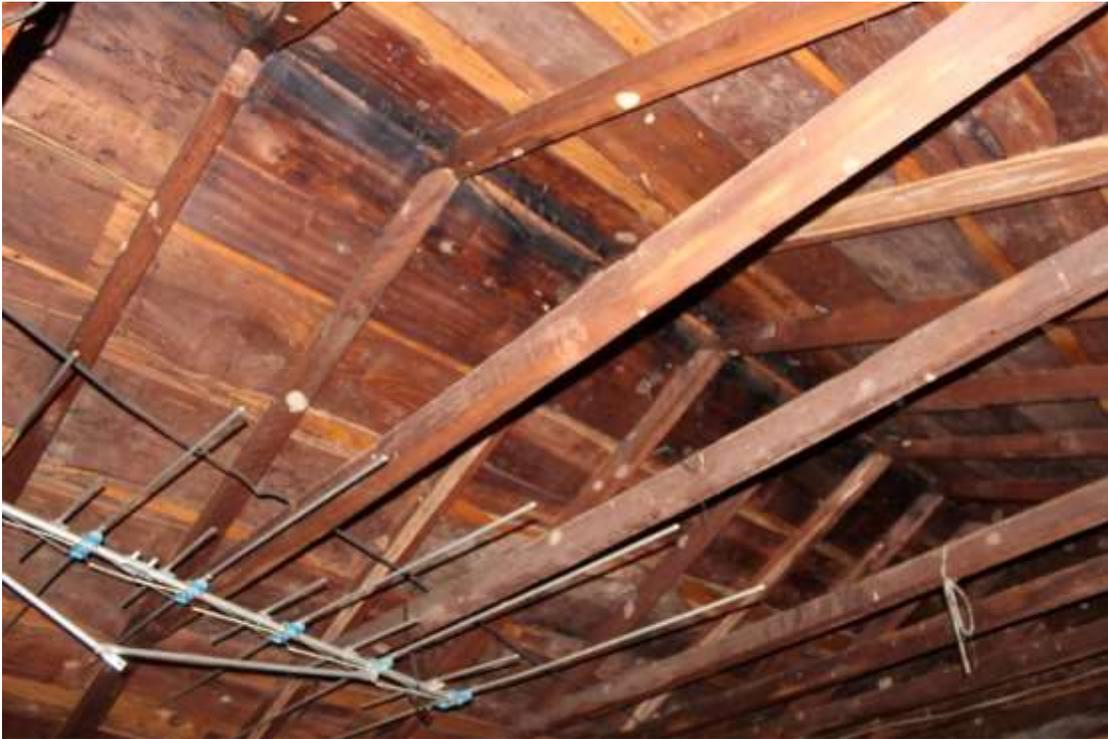
27 of 36

The attic of the original house is accessed through a set of stairs in the northeast bedroom (Photo #27). It is a large open space within the gable roofline running north-south. The roof structure of the house is exposed and consists of a common rafter system of evenly spaced rafters and tie beams. Some new support posts have been added; however, most of the roof materials are original. At either end of the attic (north and south) is a single centered window with simple unfinished wood surrounds. The end walls are covered with original unfinished wood boards.

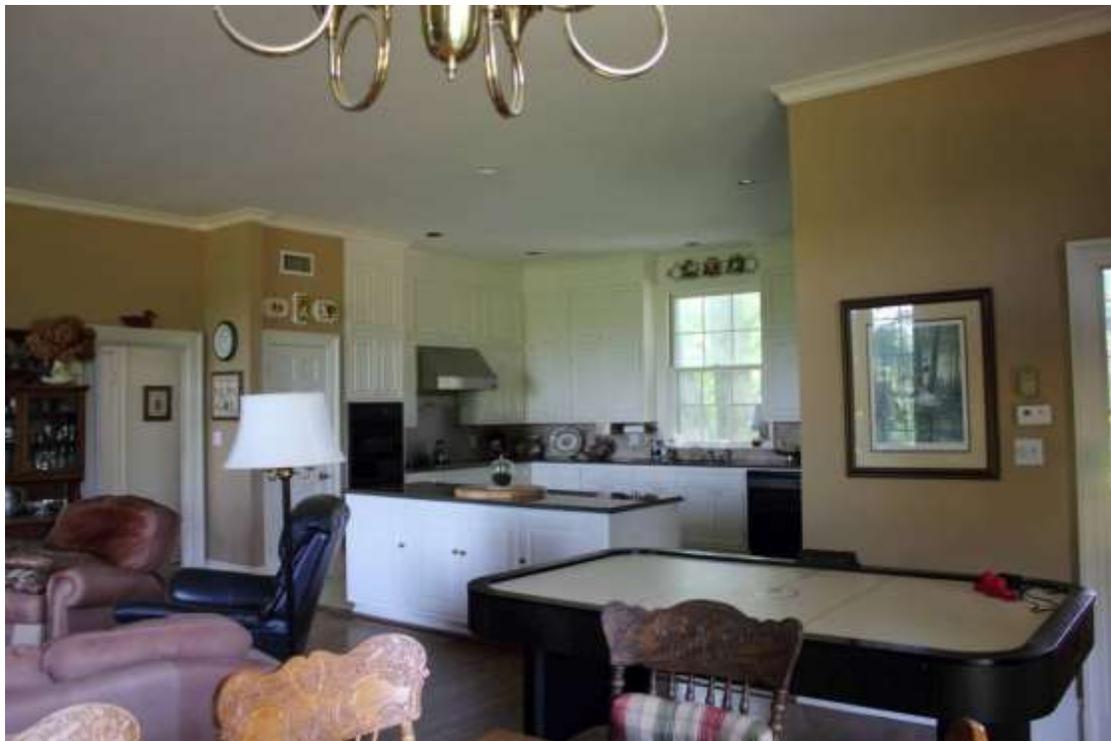
30 of 36

The first floor of the c.1975 north wing addition contains a large room with combined butler's pantry, kitchen, breakfast area, and den (Photo #30). Beyond this room is a hallway with access to the garage (Photo #31). Stairs lead from the west end of the hallway to a mid-level laundry room and a second floor bath and bonus room. The addition is accessed through a two-panel swinging wood door at the northwest corner of the dining room of the main house. Except for the kitchen, the space has wood floors, drywall walls and ceiling, wide molded baseboards, crown molding, and simple molded wood door and window surrounds. The kitchen has a tile floor and modern wood cabinetry. The secondary garage addition is accessed from the den. A hallway runs along the southern wall of the garage addition. A door on the east end of the hallway leads outside, a door on the northern wall leads into the garage, and a dogleg stairway at the western end leads upstairs. The hallway has wood floors, drywall walls and ceiling, and simple molded wood surrounds. The second floor of the north wing addition contains a bath (Photo #32), office, and several closets. It is accessed from the garage stairs and also from the northwest bedroom. Except for the bath, all spaces have carpet floors, drywall walls and ceiling, simple wood baseboards, and simple wood window and door surrounds. The bath has a tile floor rather than carpet. All doors are six-panel wood.

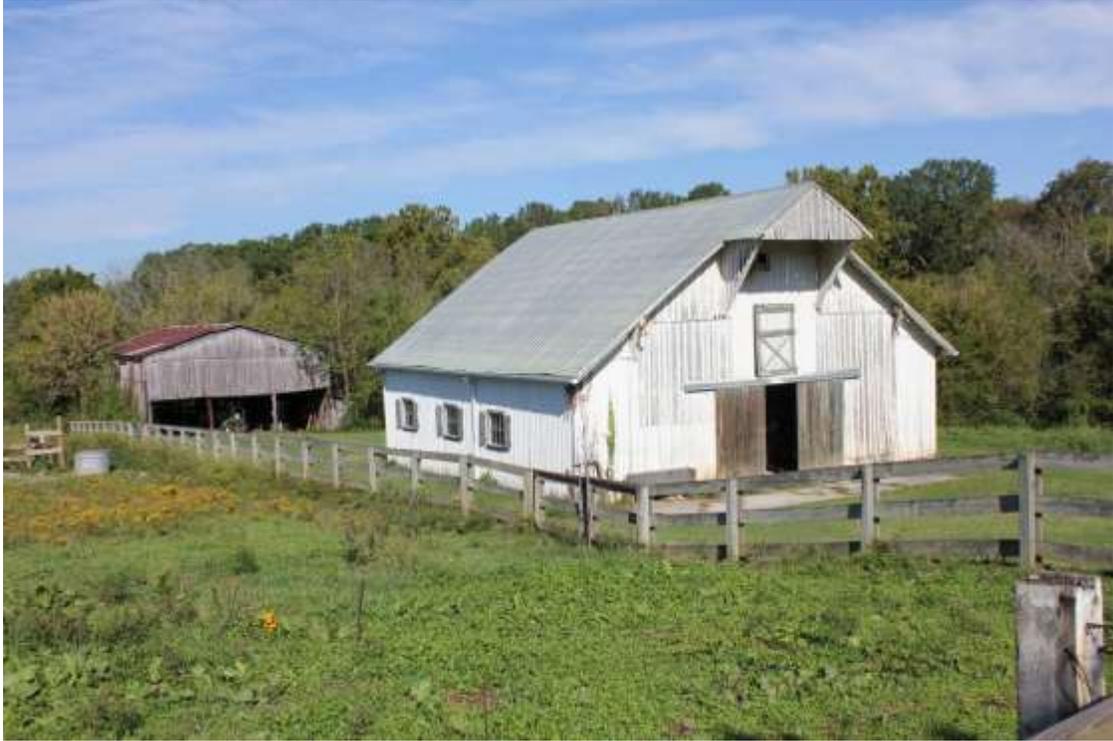
35 of 36

The front gabled horse barn measures 40 feet x 40 feet and sits on a concrete block foundation (Photo #35). The wood structure features board-and-batten siding and a steeply pitched metal roof with a cantilevered gable overhang. Wood brackets are exposed on the east and west ends. A set of double vertical board doors is centered on the eastern end of the structure. Above the double doors is a small

The one-and-one-half-story, frame tobacco barn features vertical board siding and a low-pitched 5V metal roof with exposed rafter tails (Photo #35). The structure measures 40 feet x 70 feet and is framed with supporting square wood posts and hardwood planks. The lower level is open on the façade (east) and west elevation, with three bays for lawn equipment. The three bays extend from east to west and are delineated by square wood posts. A one-story extension is situated on the north elevation and features a corrugated metal shed roof. The interior of the barn is open and sits on a dirt floor. The upper portion of the interior is open, originally used for drying tobacco, and exposes the framing system of the roof.

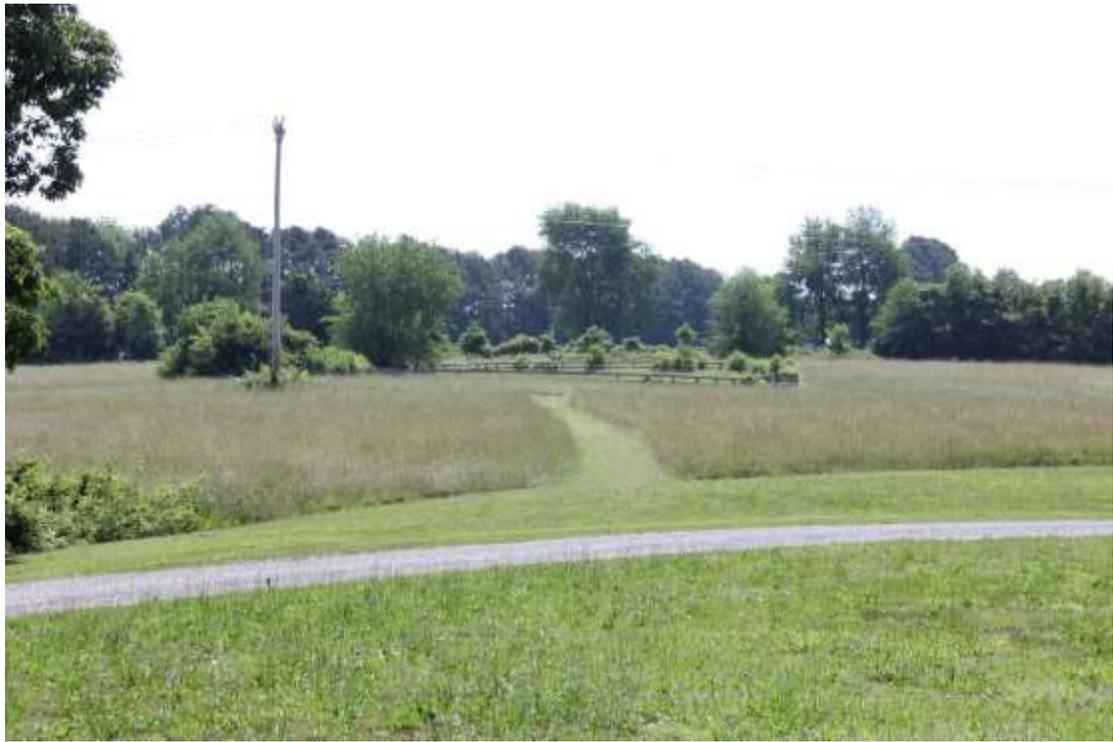
36 of 36

On the eastern end of the property is an oval-shaped horse riding ring built c.2000 (Photo #36). It is composed of a simple wood double rail fence.
