CHURCH OF THE HOLY TRINITY NASHVILLE, TENNESSEE

PRESERVATION ACTION PLAN

Michael Thomas Gavin, Preservation Specialist

**A Public Service Project of the
Tennessee Civil War National Heritage Area
Middle Tennessee State University
Murfreesboro, Tennessee 37132**

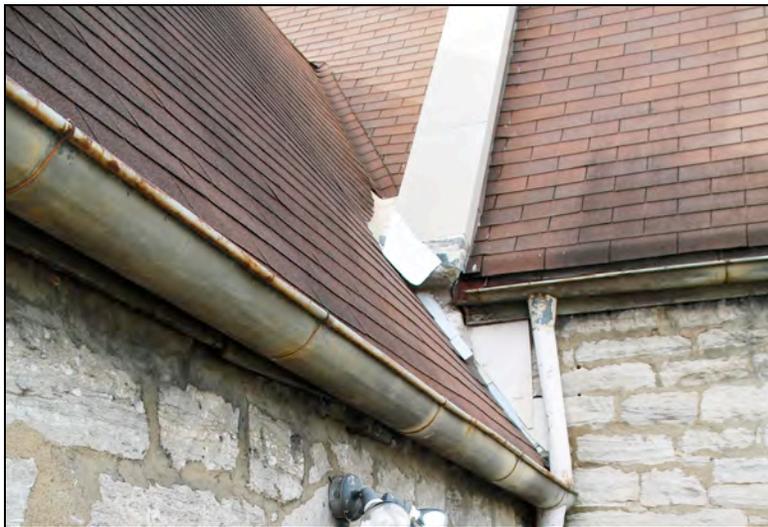
2. The most important parts of any building are its roof and the foundation. No matter what material is used, the roof must shed water at every point and must be impervious to wind-blown rain. The roof on the Church of the Holy Trinity will need replacement soon for practical and historical reasons. The present composition shingles are beginning to show wear and nails in the wood sheathing beneath them have begun to pop up. Also, it does not appear that any of the metal flashing at the roof junctions, extremities, and projections was replaced at the time the shingles were installed.

These are the very locations that need the most protection and new material should have been installed at the same time as the shingles. All flashing should be removed and replaced, preferably with sheet copper, when the next roof is installed. All chimneys and flues should have a metal cap with drip edges and a bird screen.

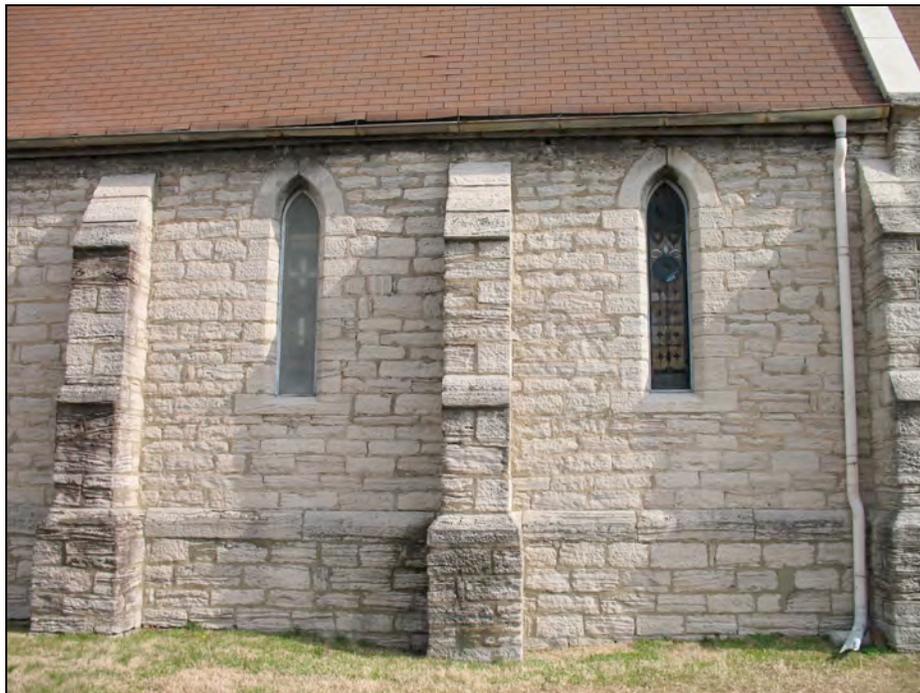
4. Closely associated with the roof are the gutters. It is important that the area around the foundation be kept dry. A damp foundation will raise the humidity level in the building, creating opportunity for mold to form. Water collected by the roof should be channeled down and away from the building with an integrated gutter, downspout, and leader system. At present, this system is not functioning properly. Some of the leaders are clogged and some of the downspouts may be. Fasteners have come loose causing some sections to sag, overflow, and not drain properly.

The ends of the leaders are crushed and inhibit proper water flow.

5. The solution to controlling the rainwater is to either install a new gutter system or refurbish the old one so that it functions properly again. As a first step in rehabilitating the present system, the gutters and other components should be scraped of rust and repainted. Care should be taken to assure that each horizontal section is pitched from a high point in the middle of the span to the low points at the head of the downspouts. A collection box should be installed in places where two roof surfaces drain into one downspout that is large enough to handle the volume of water produced. The vertical downspouts should be fixed firmly to the walls and be attached securely to the components at both ends. The bottom of the downspouts should hook up to horizontal plastic leaders installed below the surface of the ground that drain the water away from the building. All components of the gutter system must be inspected on a regular basis to prevent clogging.

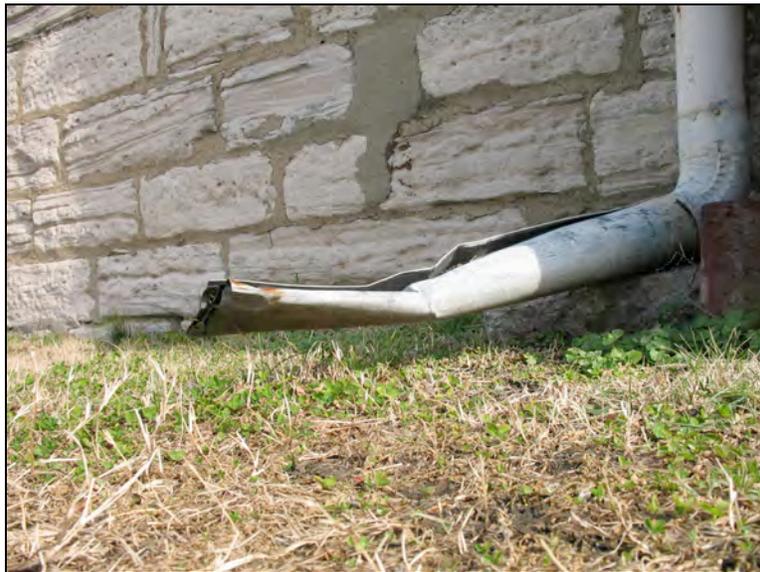
Some of the lower gutter sections have more water coming in from other roof surfaces above them. This extra volume of rainwater causes the gutters to overflow and damage the walls below.

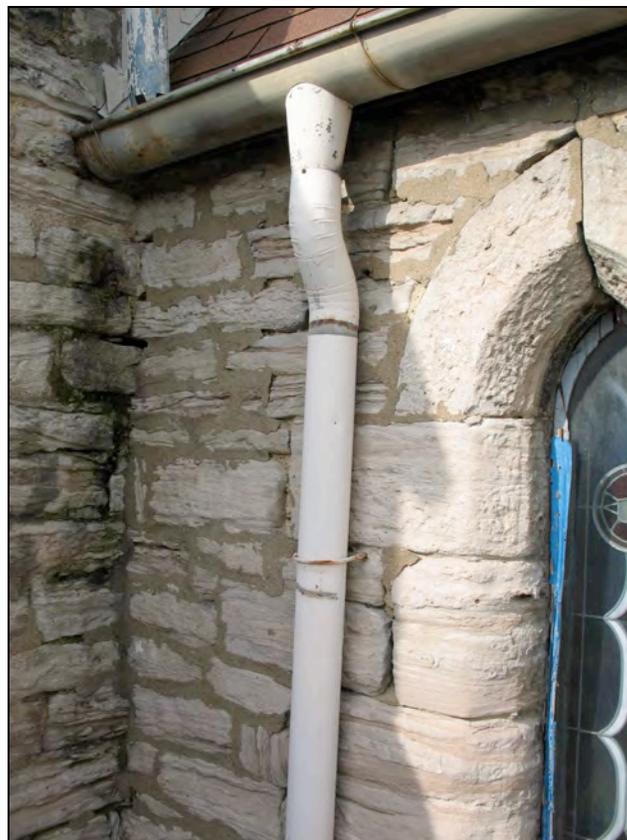
As a result, moss and mold is growing on some of the wall surfaces because of the uncontrolled runoff water.

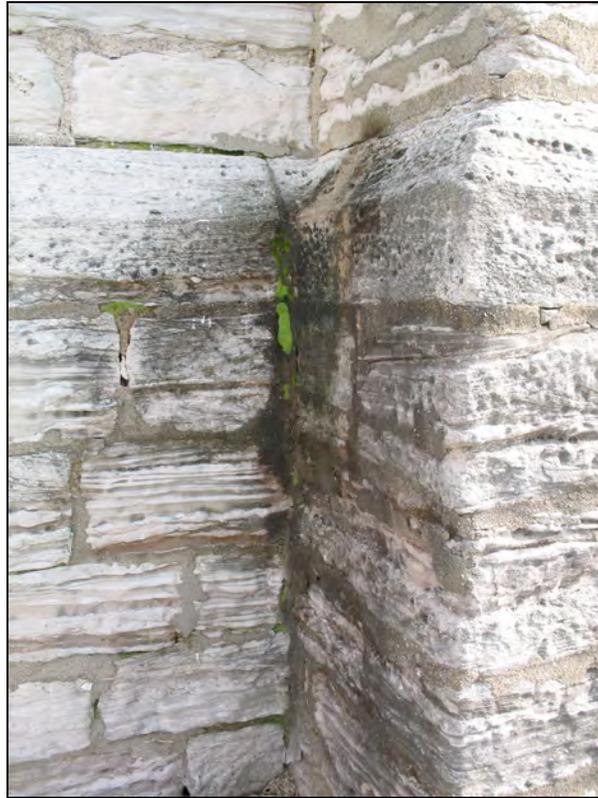
The water also spills onto the ground and splashes up onto the lower wall surfaces, causing deterioration. In addition, the splattering action displaces soil around the perimeter of the church, leaving the building in the middle of a shallow depression whenever it rains.

To correct this situation, topsoil should be brought in, spread evenly around the perimeter of the church (using hand tools close to the building), and sloped away using at least a 1:12 pitch to encourage positive drainage. The best time to do this is in the spring or fall, so that the exposed soil can be seeded and then covered with straw.

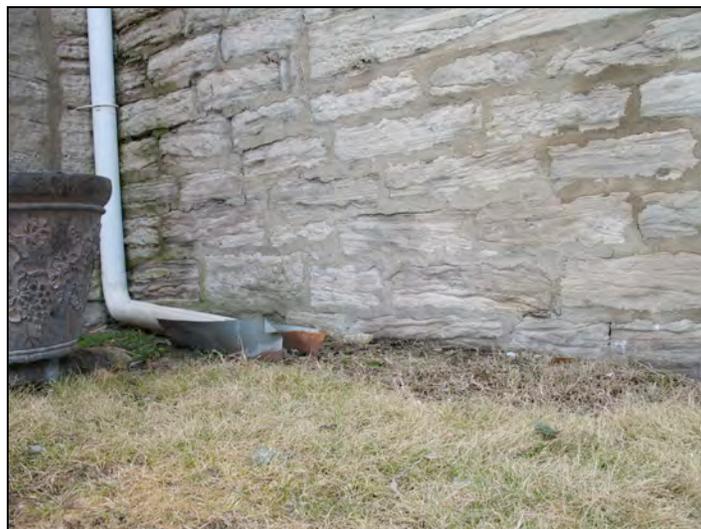
Much of this water finds its way underneath the building via voids in the mortar or through the walls themselves during periods of wet weather.
