Geologic Stability of Skagit Gorge

(Dr. J.L. Riedel, Geologist, October, 2024)

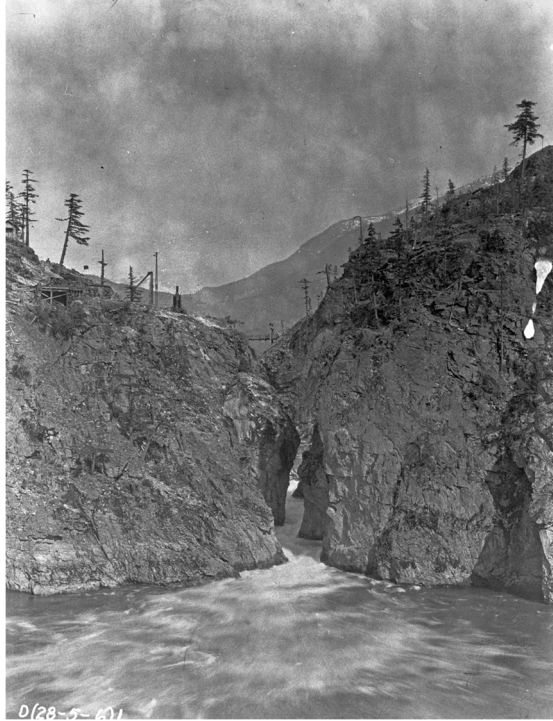
Photo 1. Skagit Gorge at the site of Diablo Dam. Note the incision of narrow (20 ft. wide) inner canyon into the broader rock valley floor above.

Skagit Gorge is one of the deepest and longest and deepest canyons in the North Cascades, a mountain range of exceptional relief and scenery that is viewed by more than a million visitors a year. The Gorge is a relatively young feature compared to the adjacent mountains and formed during initial Pleistocene continental glaciations ~2 M years ago (Simon-Labric et al. 2014). Skagit Gorge cuts across a former regional hydrologic divide breached by the spill-over of glacial lakes trapped in valleys to the north (Riedel et al. 2007). The erosion of a regional divide at Skagit Gorge joined the formerly Fraser-bound upper Skagit River with the westward flowing lower Skagit. Another important result of this process is that the upper Skagit Valley has no mountain barriers between it and the Fraser and Okanogan basins to the north. Parts of these large rivers temporarily joined Skagit River during the last ice age, providing an avenue for fish migration and further deepening Skagit Gorge, perhaps resulting in the incision of the broad shelf cut by the most recent passage of the ice sheet between 18,000 and 14,000 years ago (Photo 1).

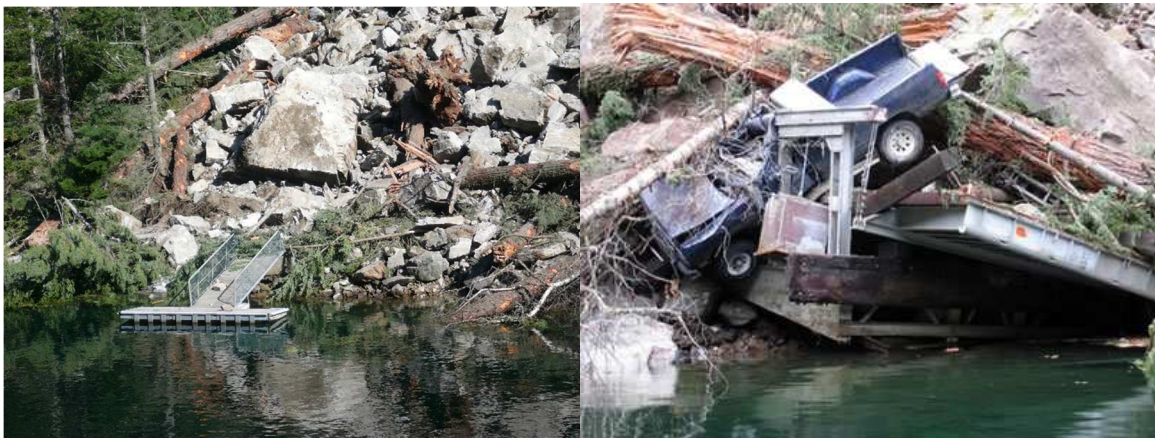
Photo 2. Debris avalanche in 2013 just below Ross Powerhouse in Skagit Gorge.

Bedrock slope instability in Skagit Gorge is illustrated by several recent landslides, including a 2013 slide near Ross Powerhouse (Map 2; Photo 2), a 2003 landslide at Afternoon Creek (Photo 3), rock falls at Diablo Powerhouse in 2006, and at numerous other sites in the Gorge (Map 1). All of these landslides were bedrock failures and involved little if any glacial or alluvial surficial deposits. Over-steepened slopes (cliffs) within the Gorge are particularly prone to mass failure by rock falls and rock avalanches.

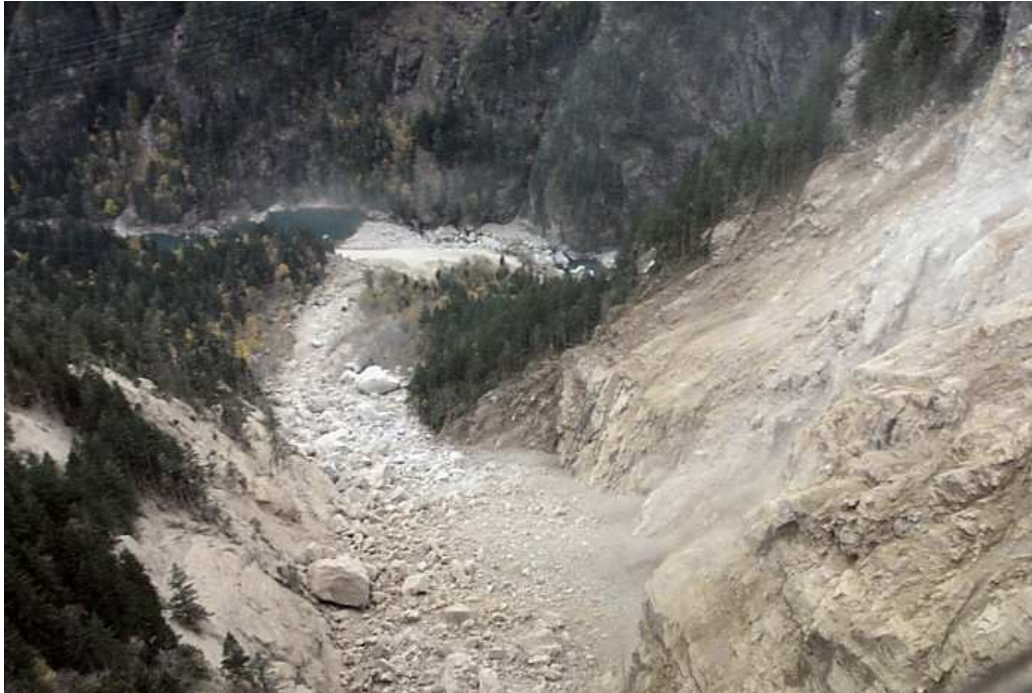
Photo 3. View into Skagit Gorge along the path of the November 9, 2003 Afternoon Creek landslide, triggered by unusually heavy rainfall (Strouth et al. 2007). This slide was active in the mid-1900s according to anecdotal evidence.
