NATIONAL HISTORIC LANDMARK NOMINATION

Historic Name: FORT CHRISTIAN

Page 4**Describe Present and Historic Physical Appearance.**

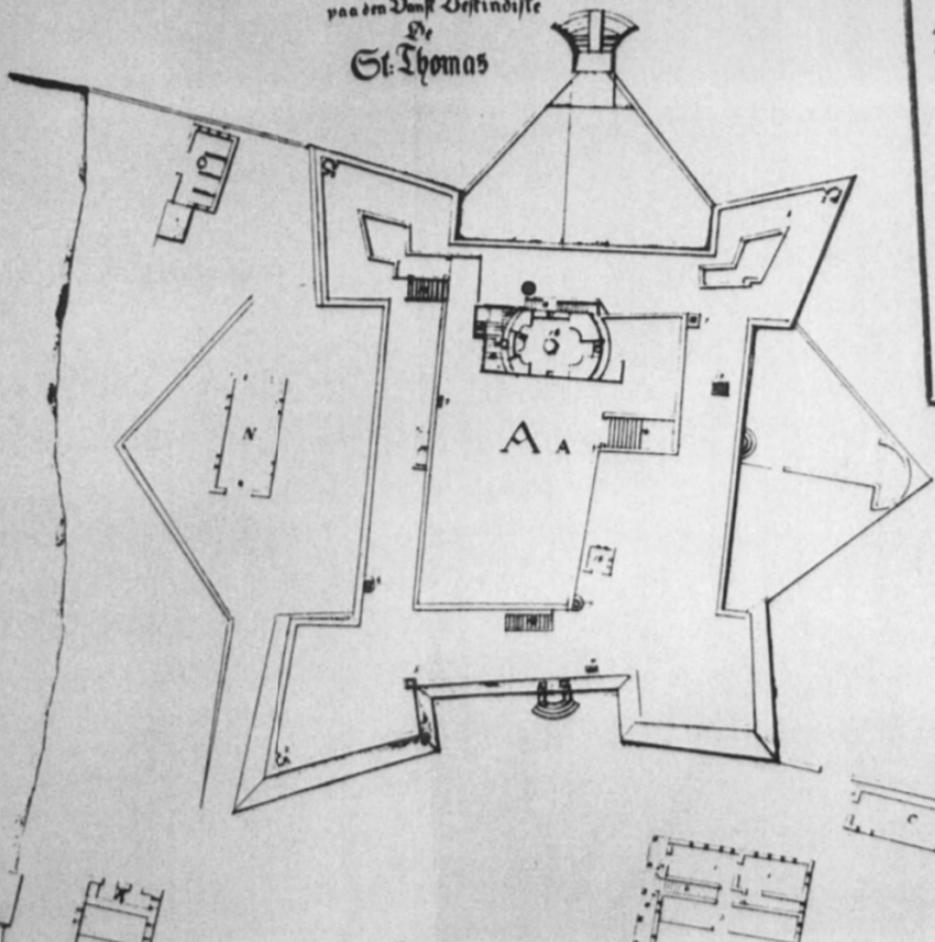
Grundelegning

Christians Fort med dets tilhørende Bygninger
paa den dansk Vestindiske
Øi
St. Thomas

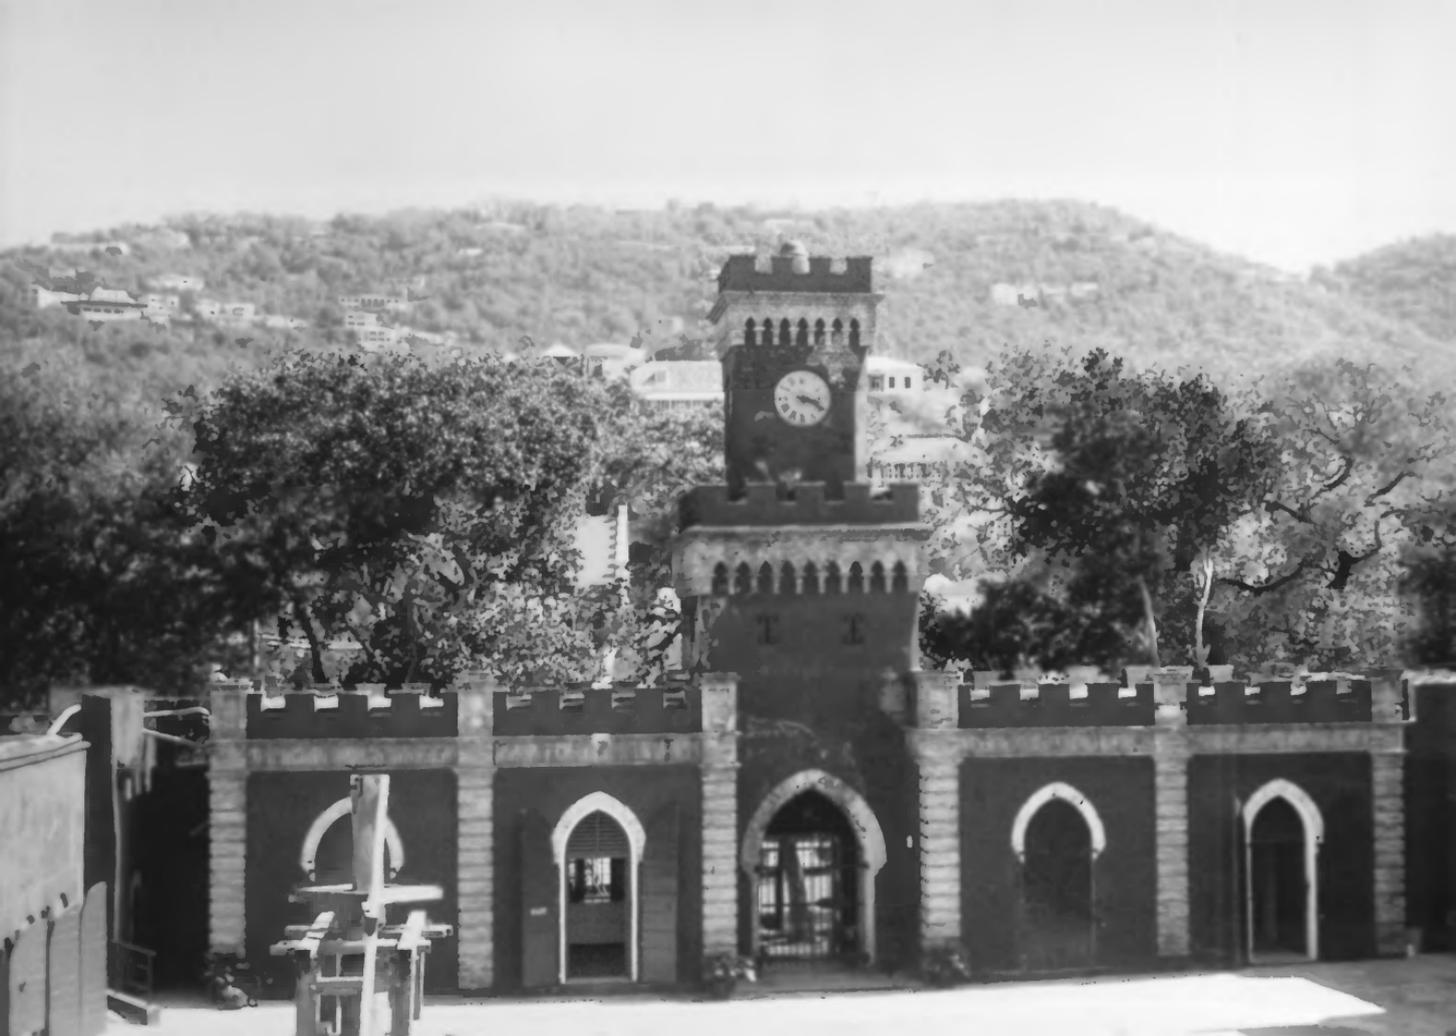
1. Fort CHRISTIAN
2. Charlotte Amalie, St. Thomas, USVI
3. M. BARNES
4. MAY 1997
5. Neg - NPS Atlanta
6. View of June 17, 1872 dated drawing of the new north curtain wall and clock tower.
7. Photo 4

In 1874, Trygborg, the northern curtain wall, and northern ravelin were torn down. That part of the fort was replaced with a Gothic Revival style building featuring a prominent clock tower (photos 4 and 5). In the mid-twentieth century, further land filling occurred along the whole northern shoreline of the harbor upon which a two lane highway (Veterans Drive) was constructed. This road ran along the south side of the fort, separating it from the water battery and barracks. The reclaimed land on the west side of the fort became Emancipation Garden, while the reclaimed land on the east side of the fort became a parking lot. The northern approach to the fort, which once contained land side defenses became two small park areas (figure 1).

In 1874 the seventeenth-century north curtain wall between the northeast and northwest bastions and the internal tower (Trygborg) were removed. A Gothic Revival style entrance and clock tower were constructed, between 1874 and 1878 (photos 4 and 5).

By 1875 the northern curtain wall had been "replaced by a new one in the then popular style of gothic revival" (photos 4, 5, and 14 and figure 2) (deJongh and Gjessing 1982:15).

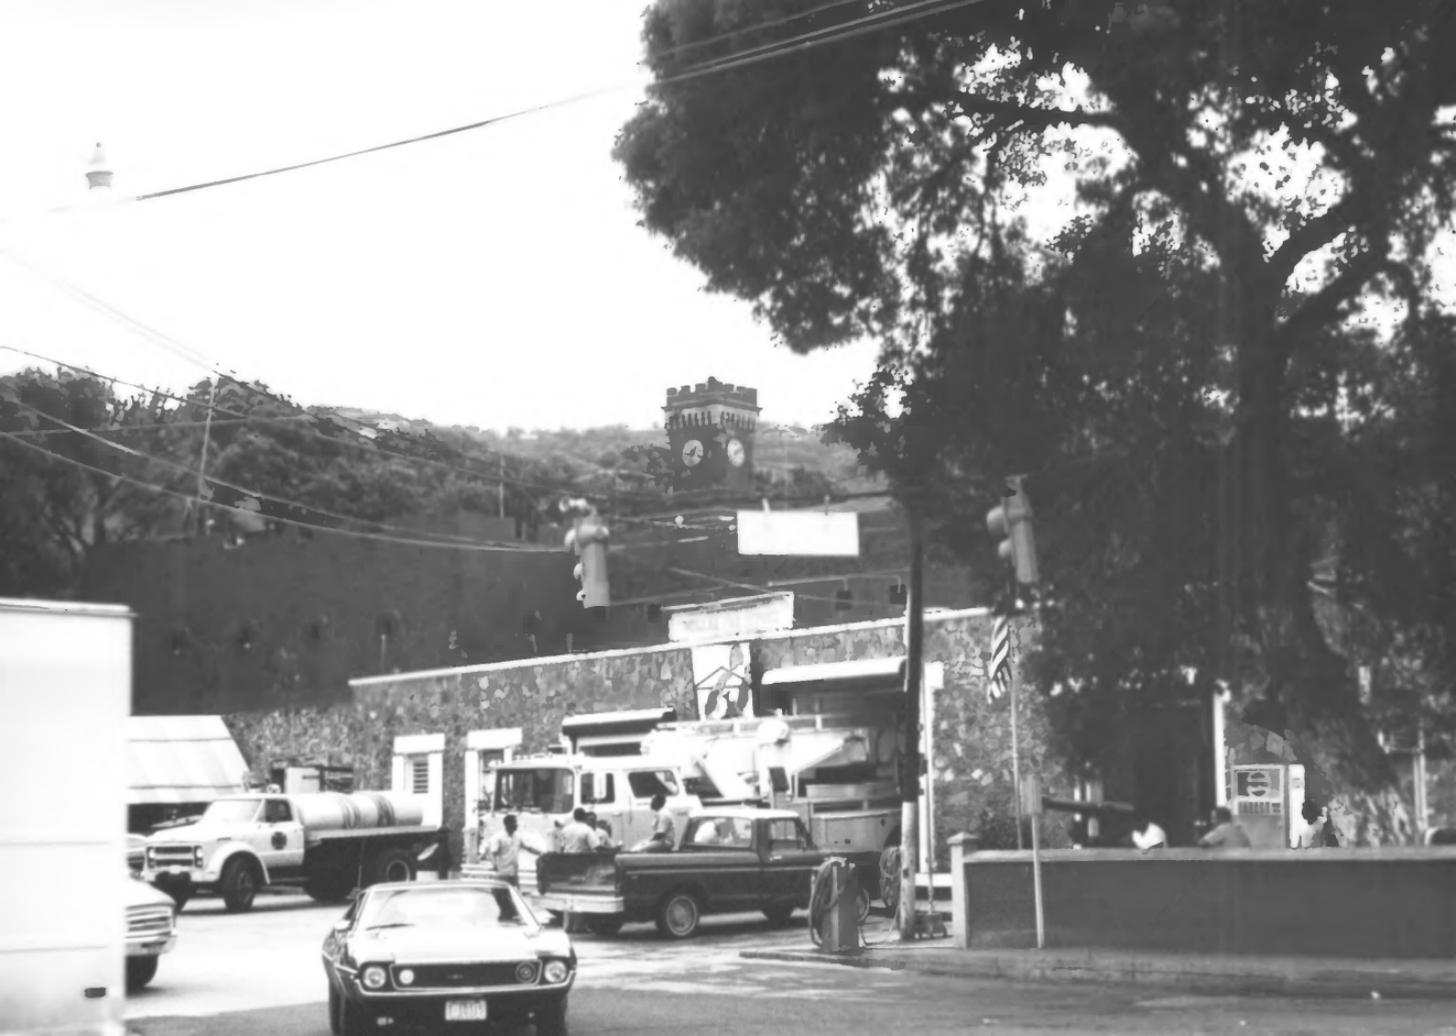
1. FORT CHRISTAIN
2. Charlotte Amale, St. Thomas, USVI
3. M. Barnes
4. April 1995
5. Neg - NP6, Atlanta
6. View of 19th century addition to fort.
View from the interior of fort looking
north.
7. Photo 5

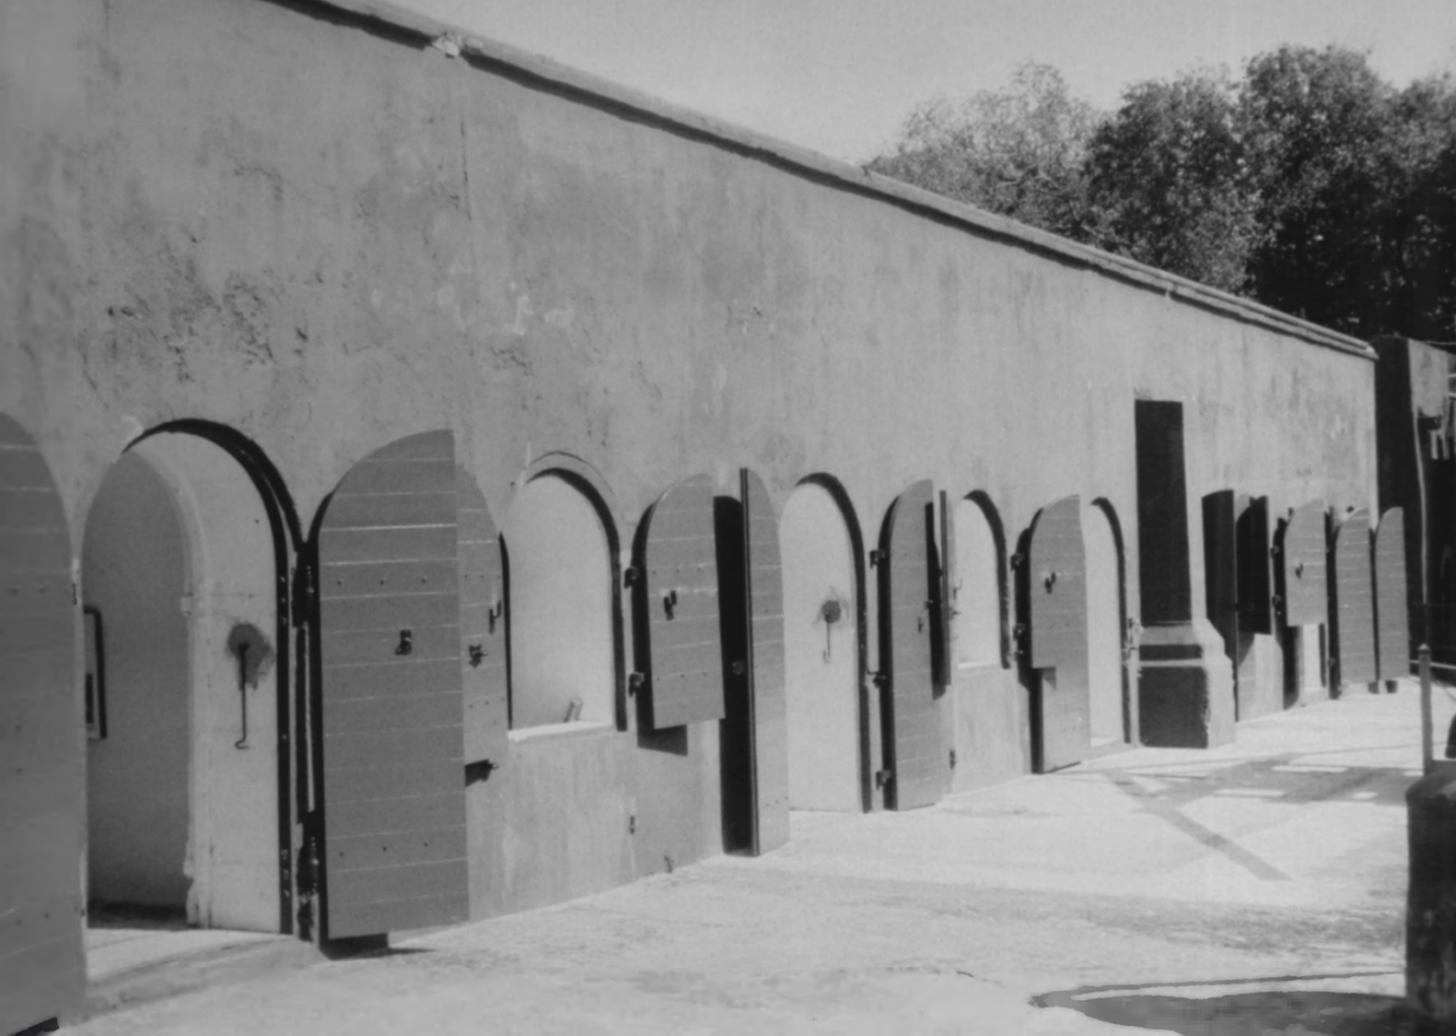
1. Fort CHRISTIAN
2. Charlotte Amalie, St. Thomas, USVI
3. M. Barnes
4. April 1995
5. Neg - NPS, Atlanta
6. Gun deck above the eastern casemates - looking south
7. Photo 7

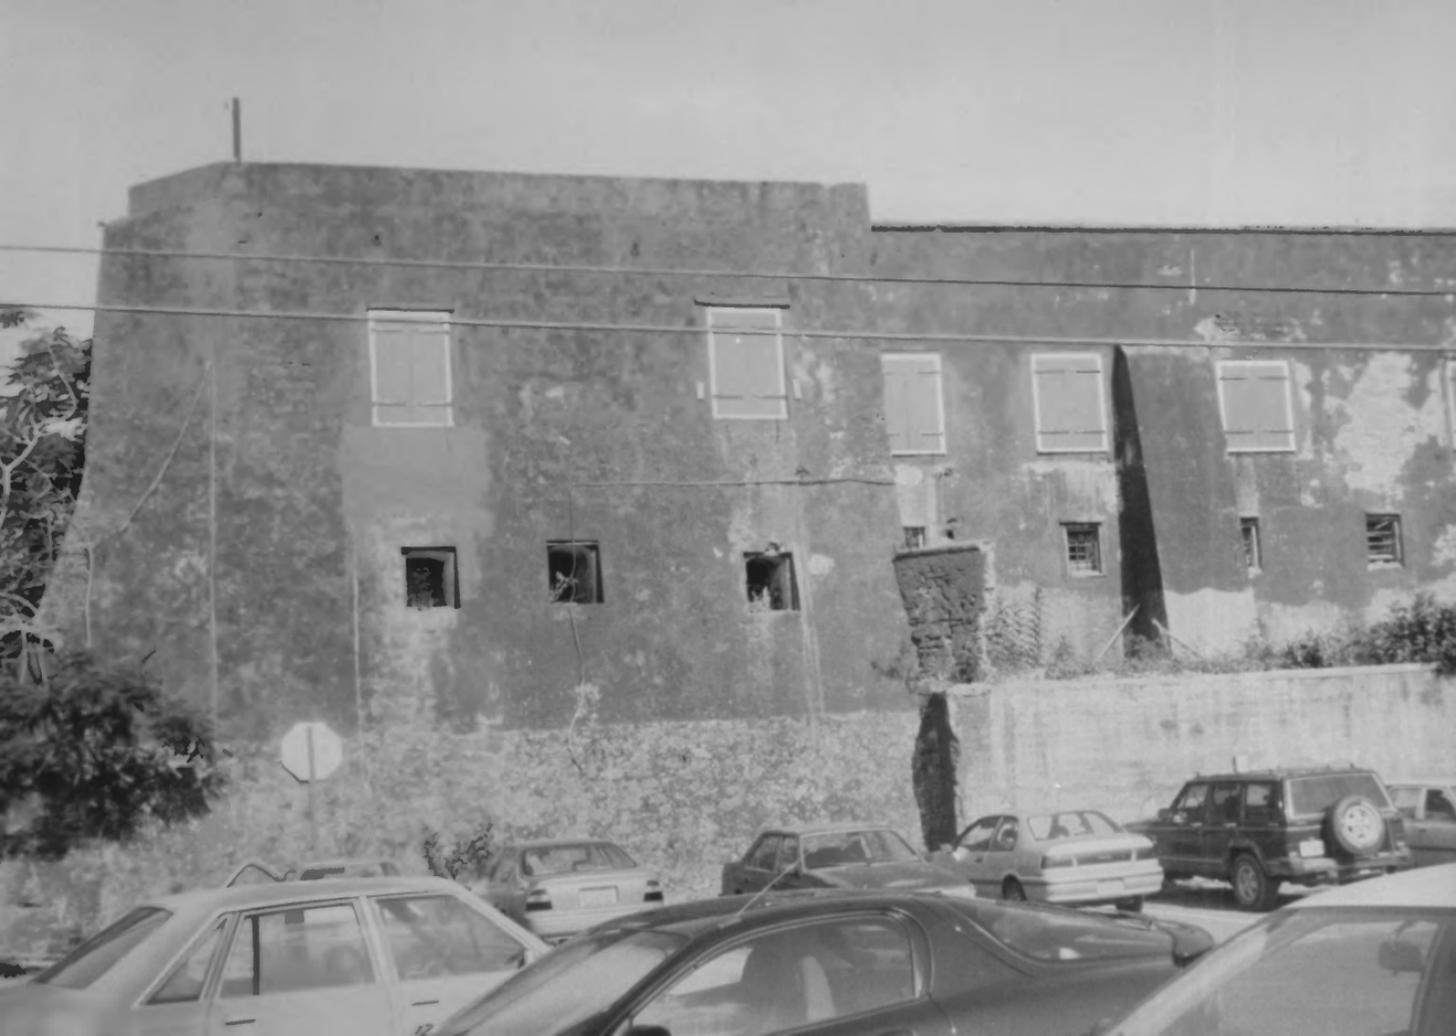
1. FORT CHRISTIAN
2. Charlotte Amalie, St. Thomas, USVI
3. M. BARNES
4. April 1995
5. Neg- NPS Atlanta
6. View of restored western casemate area - looking west.
7. Photo 8

Four small apartments [the ones built by Adolph Esmitt against the inside of the west curtain wall] (photo 8 and figure 2). In the largest there are a large window and 3 doors, the one of which is cut through horizontally halfway up. This large room is tapestried with gilt leather which commences to wear out.

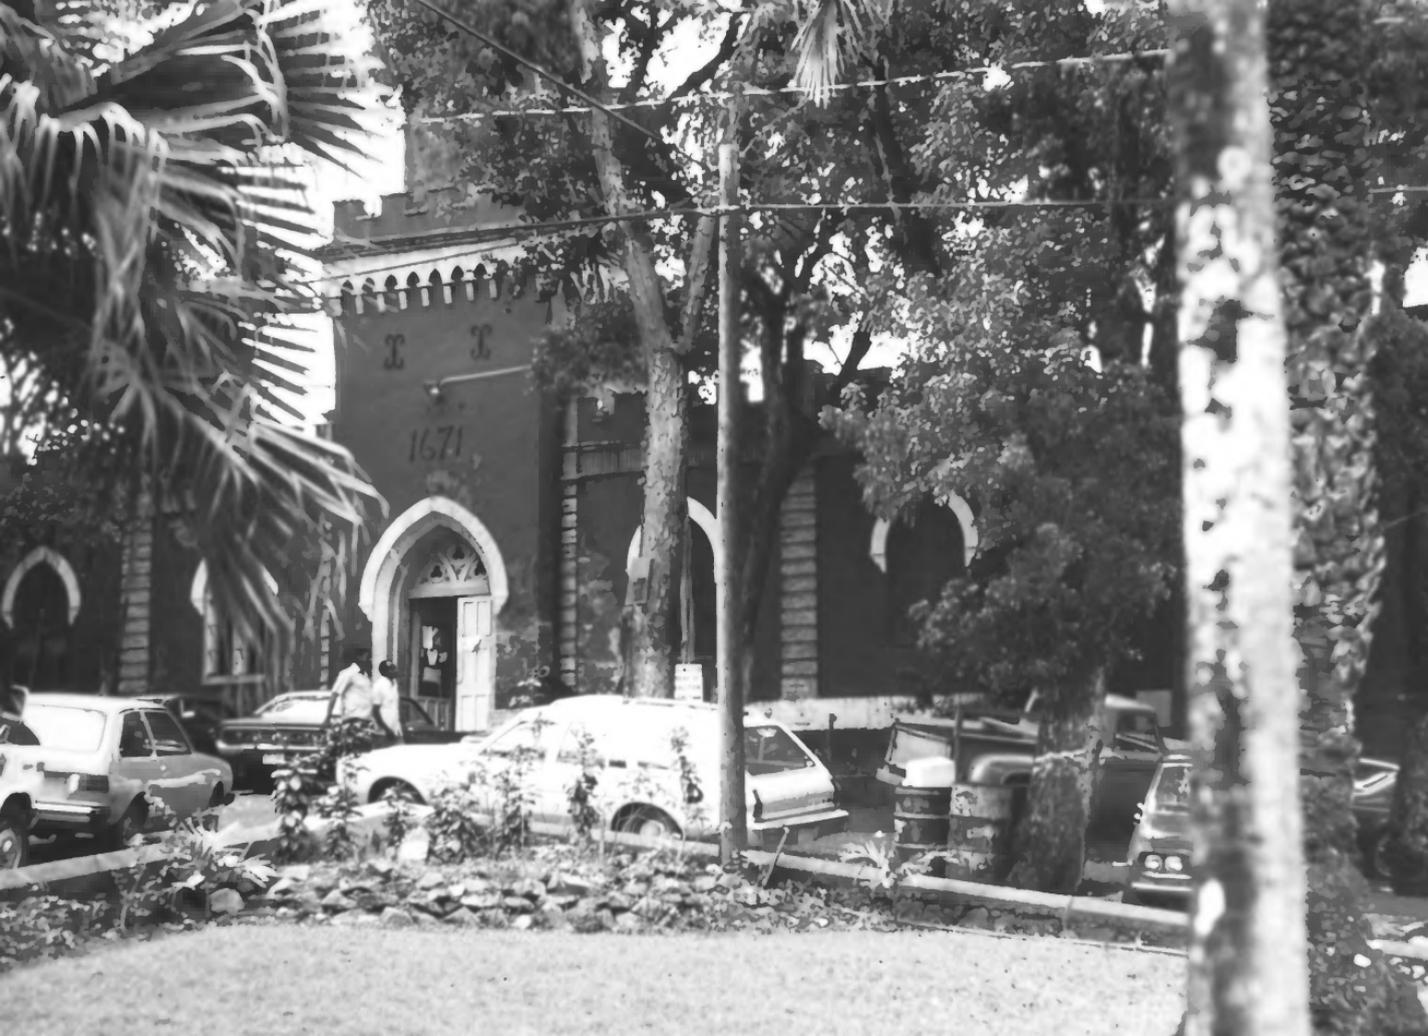
1. FORT CHRISTIAN
2. Charlotte Amalie, St. Thomas, U.S.V.I.
3. Photographer Unknown
4. May 1979
5. Neg - NPS Atlanta
6. View of east wall of fort.
7. Photo 13

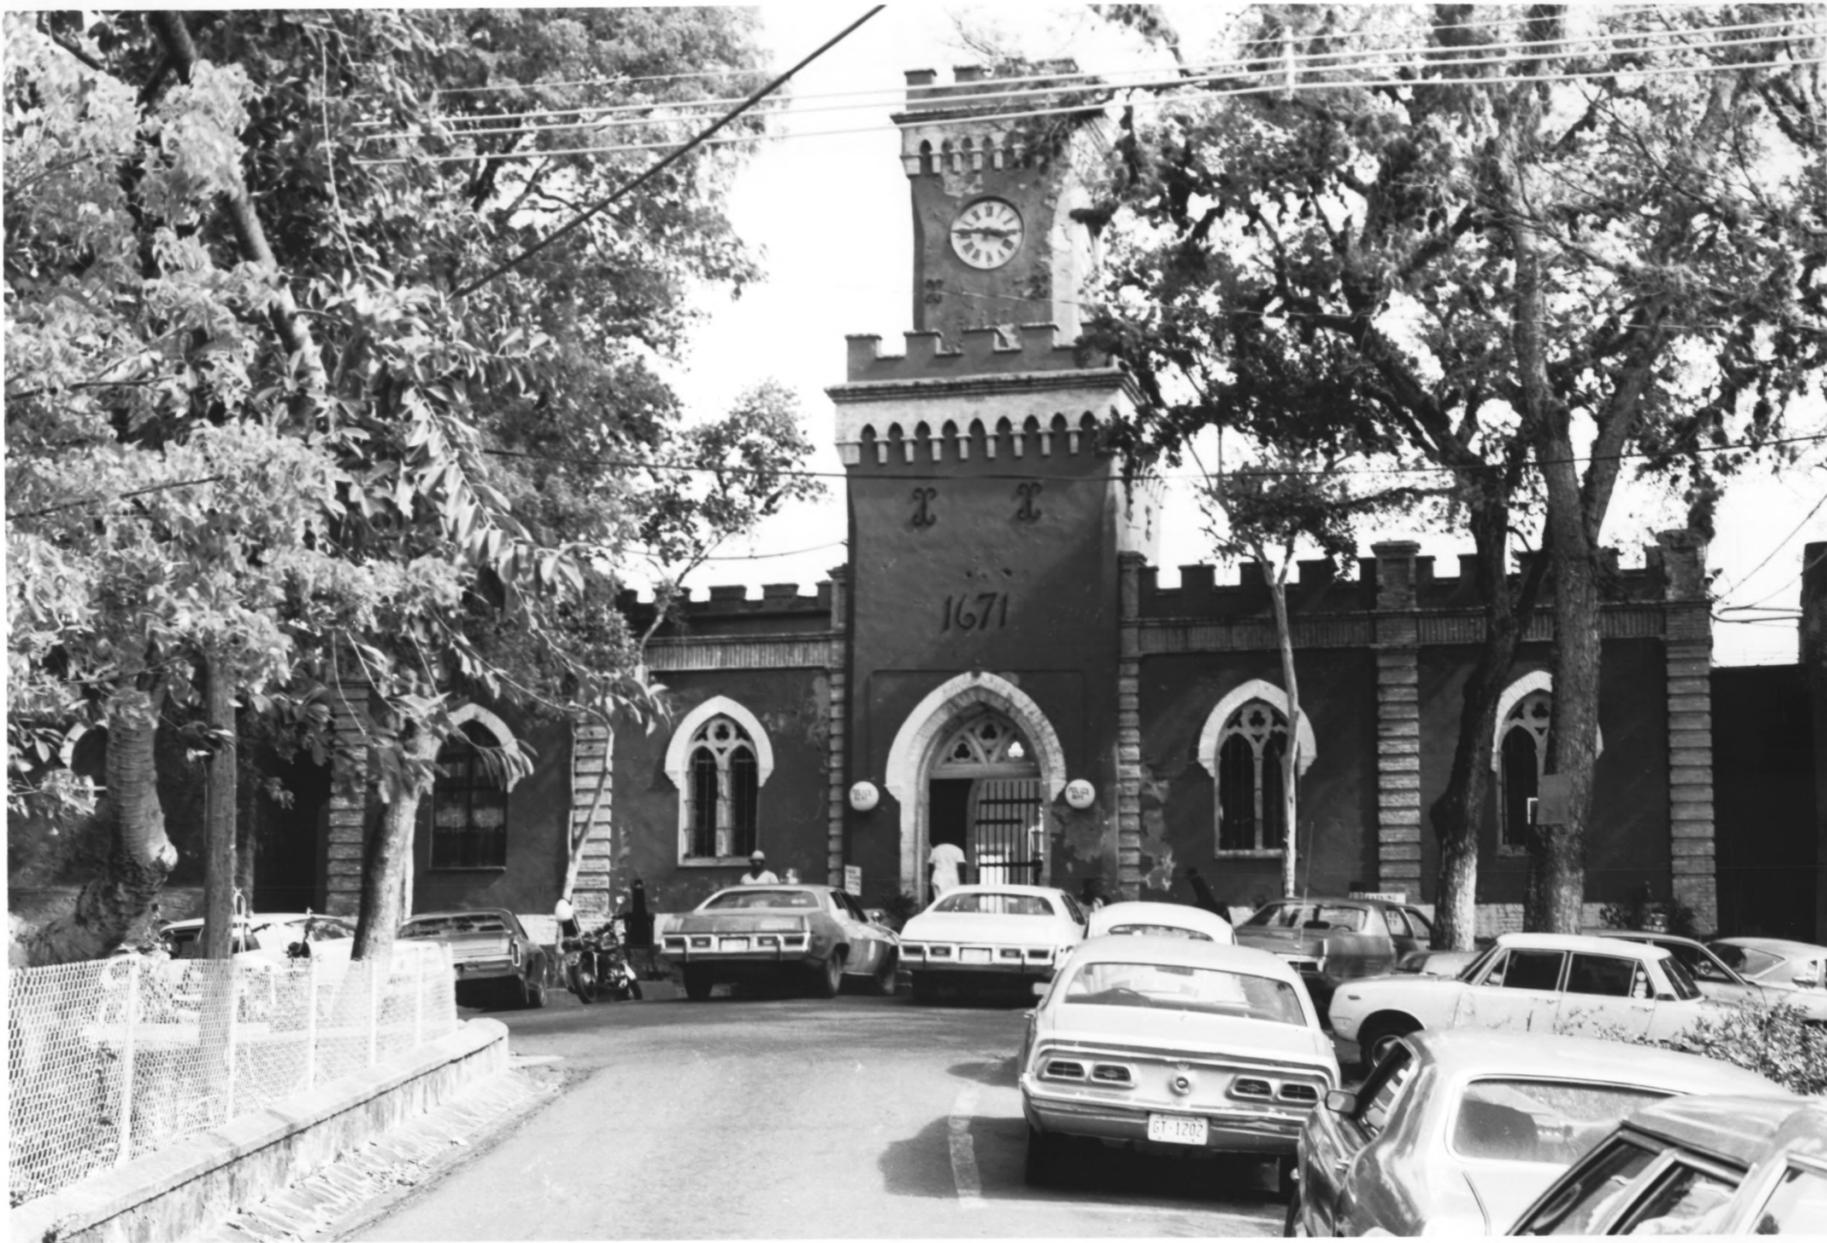
1. FORT CHRISTIAN
2. Charlotte Amalie, St. Thomas, USVI
3. Photographer Unknown
4. MAY 1979
5. Neg- NPS Atlanta
6. View of the north side of fort.
Shows 19th century entrance. Looking
south.
7. Photo 14
