HISTORIC STRUCTURES REPORT

HUMES RANCH

BUILDINGS #699-A and #699-B, CLASS CC

Elwha River Trail
Olympic National Park
Washington

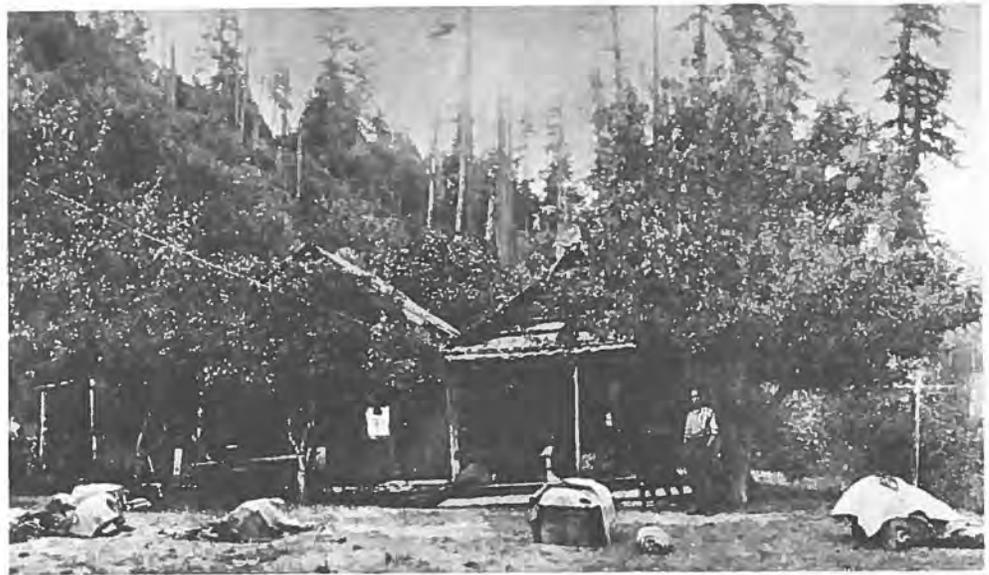
Illustration No. 1: Grant Humes standing in front of his cabin and barn, Building 699, A. and B. Date unknown. Source, Ruby El Hult, Untamed Olympics.

Untamed Olympics, Illustration No. 1. Human testimony further corroborates the indications of the buildings's historical nature.

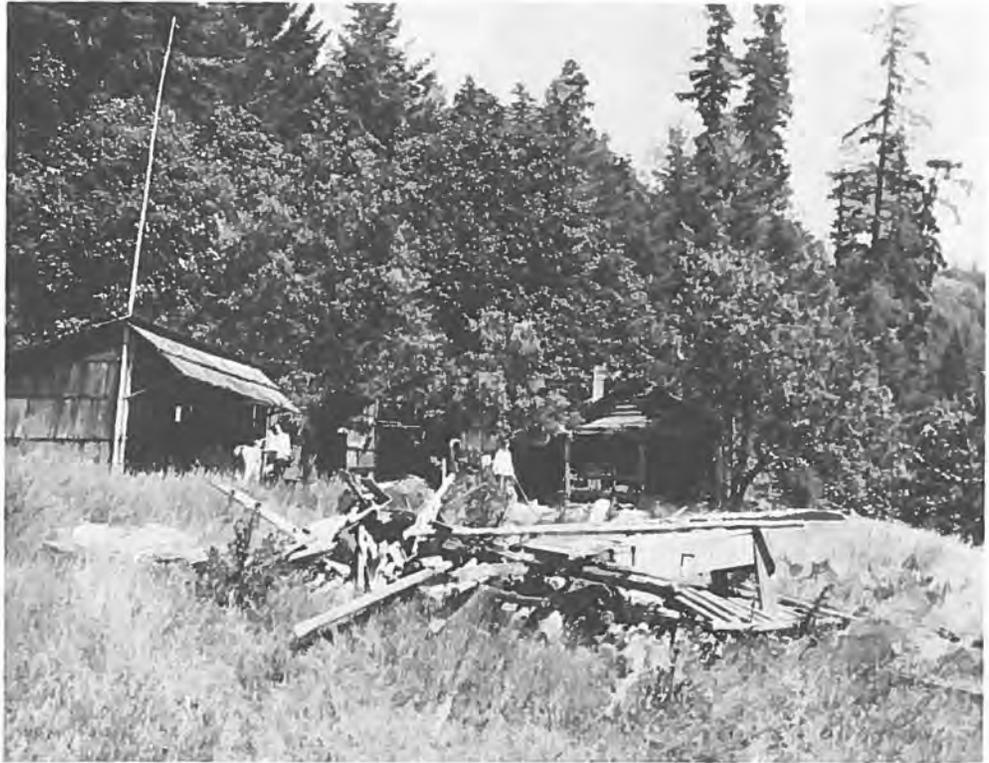
(Note: This structure which is recorded in the structure inventory and the Master Plan no longer exists (May 1968), but by description appears to be the structure once situated at the approximate spot from which the photograph, Illustration No. 5, was taken. It appears in an early photograph of the complex, Illustration No. 2.)

Illustration No. 2: Humes homestead with Building #700, Wood and Tool Shed (now destroyed), left center. Rubbish in foreground is the fencework. Date unknown. Files of Olympic National Park.

Determination for reconstruction of the Wood and Tool Shed, Building 700, and fences should be deferred for future consideration. Further investigation should determine the significance of the privy and the concrete foundation structure and their disposition. The spring and water system should be reactivated.

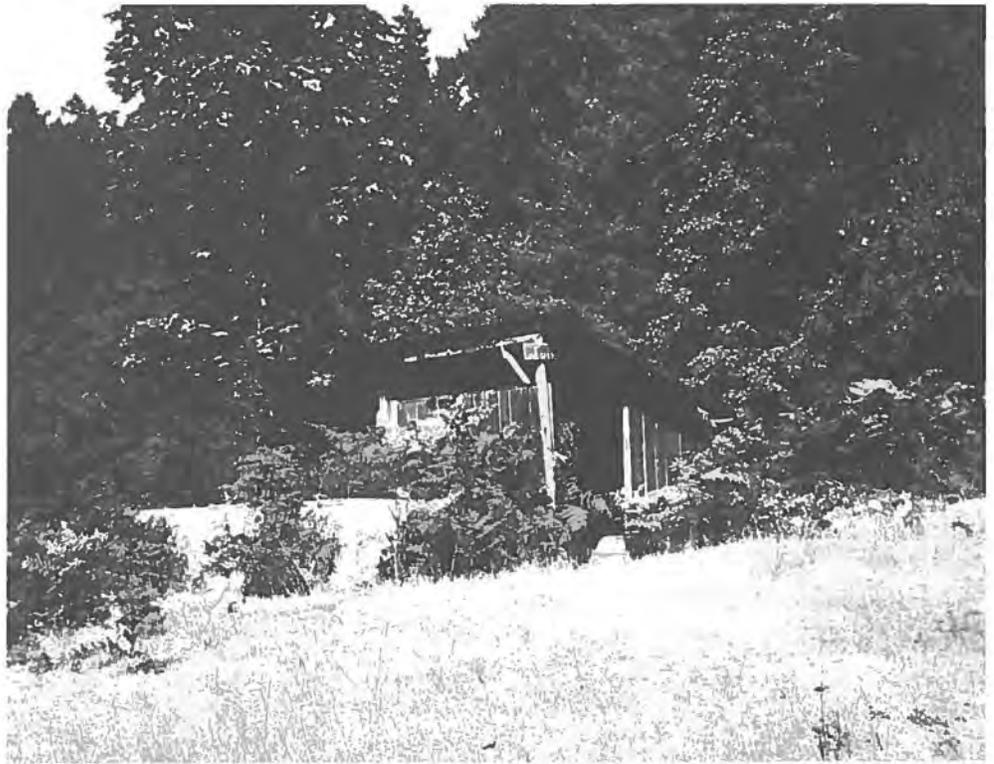
The sheds across the yard from the cabin are probably not historic. One has been made into a privy. In front of this structure is a concrete wall which suggests that this complex may have been used as a pen of some kind at one time. Illustration No. 4.

Illustration No. 4: Alleged greenhouse at the Humes homestead. At one time used as a privy. Taken 1967. Files of the Division of History.

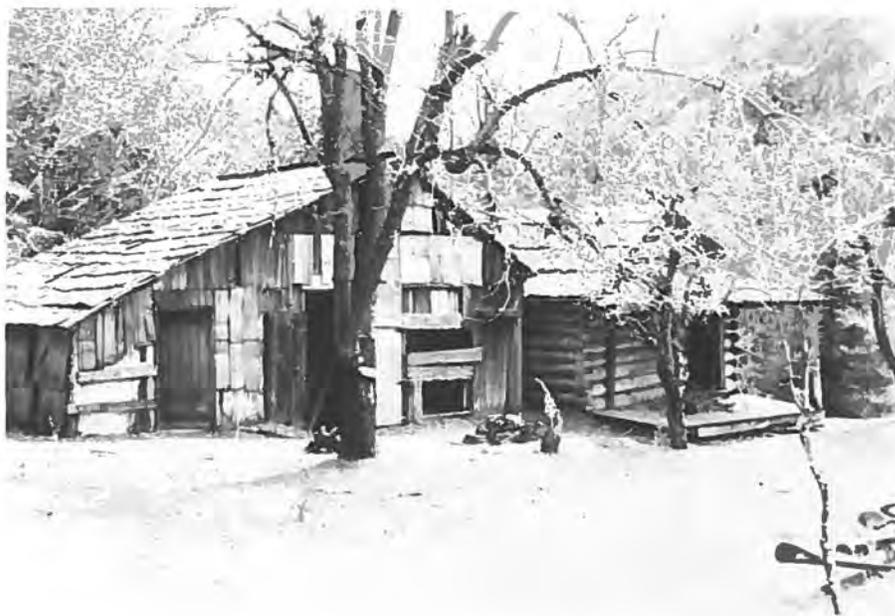
Illustration No. 5: Present view of Cabin and Barn.

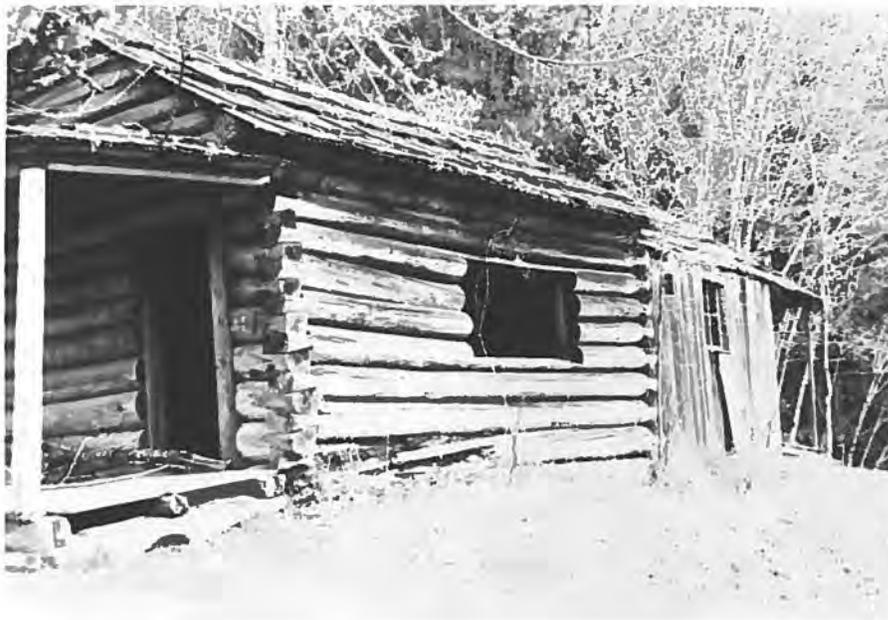
Illustration No. 6: Close-up of west side of Cabin.

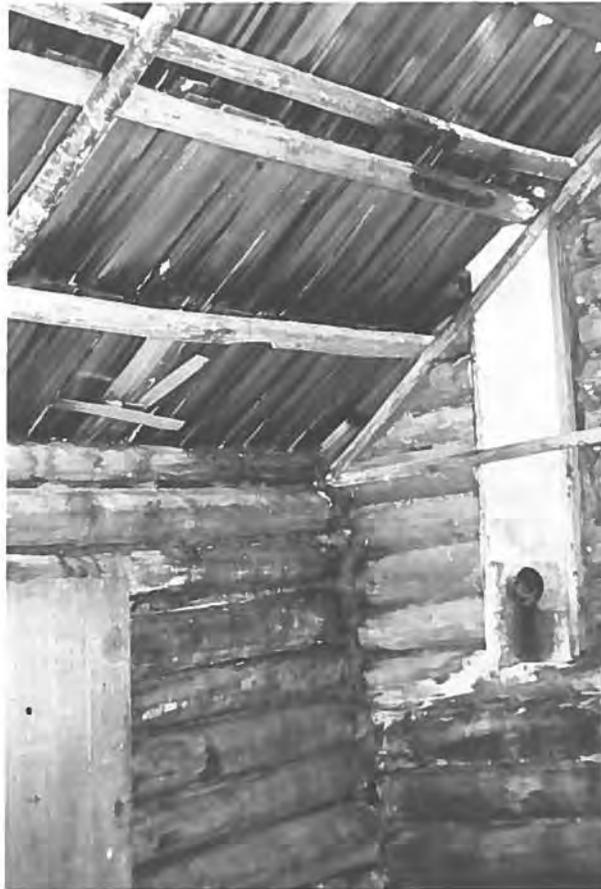
A chimney constructed of special concrete blocks 14" X 14" X 8" with a special interlocking joint layed up without mortar has been installed in the thickness of the log wall with flue openings serving the kitchen and the log cabin. Spaced roof purlins near this chimney would indicate that they once supported a metal chimney and were charred by overheating of the chimney collar. Illustration No. 7.

Illustration No. 7: Interior of Cabin. Note charred purlins that appear to have once supported a metal chimney.

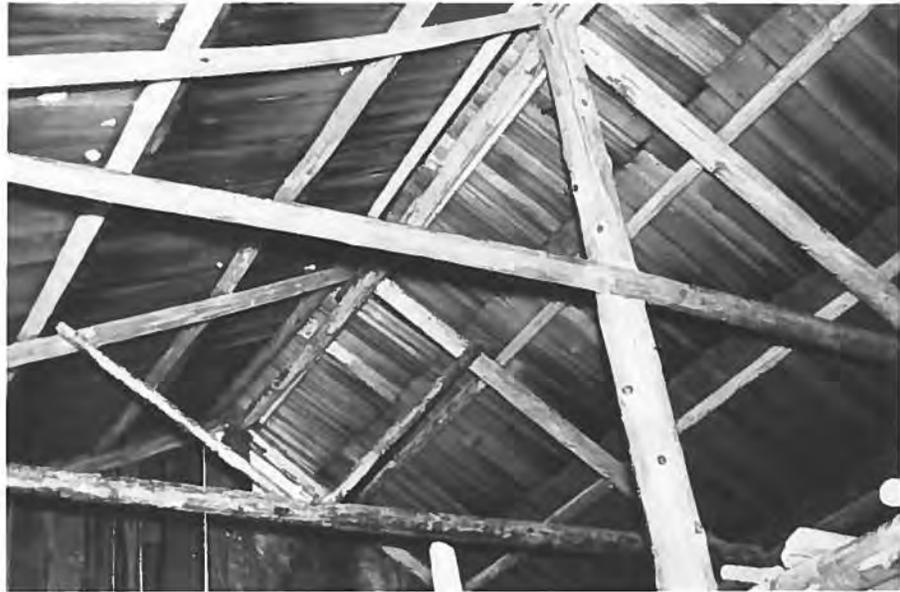
A barn approximately 28'-6" X 17'-6" adjoins the cabin, but separated from it by 16 inches. This structure is of pole and girt construction with split cedar shake roof and siding and earth floor. Illustration No. 8. Presently, the interior has been adapted with bunks constructed of saplings with plywood decks.

Illustration No. 8: Interior view showing construction of barn roof.

The barn should be made structurally sound by repairing structural members. Bottoms of posts should be spliced as necessary to eliminate decay. Shake roof and siding should be repaired. Barn should be left accessible, and bunks could remain to provide emergency shelter in the wet climate until future determination of other possible use.

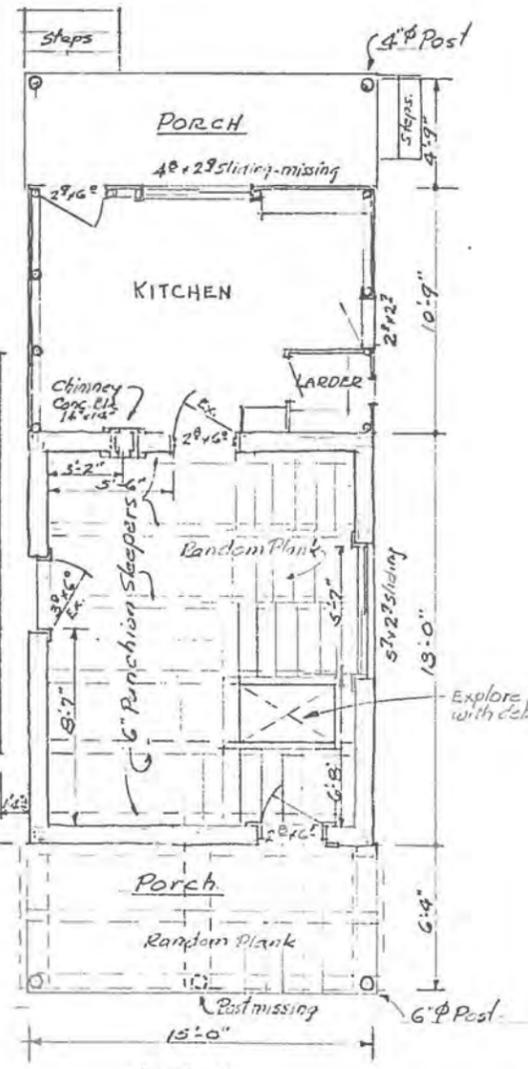
CABIN
BLOG #699

The cabin consists of one room constructed of logs approximately 15 feet wide by 18 feet long (exterior dimensions); and a kitchen to the rear the same width and approximately 10'-9" deep constructed with a sapling frame and vertical weatherboarding. The roof of the log section is constructed of split cedar shakes secured to purlins bearing on the gable end walls with the additional support of rafters at mid-section. It appears that sapling tie poles extended across the room probably supporting a ceiling of sorts. (One such pole appears in Illustration No. 7.) The gable roof over the kitchen is similar but lower than that over the log section and extends over the rear porch the width of the cabin. A porch six feet deep with a hipped roof extends the width of the cabin at front. The spring line of the roof in the log section is approximately 7'-6". The floor consists of one-inch plank of random width and length secured to six-inch puncheon sleepers resting on earth. The kitchen has a rough ceiling at height of 6'-8". A larder is built into one corner of the room. The log section has one window 5'-7" wide by 2'-7" high, originally containing bi-parting sliding wood sash. (The "ghost" of this sash is readily discernable on the window sill.) There is an entrance door 2'-8" X 6'-0", and one door 2'-8" X 6'-0" leading to the kitchen. Another door,

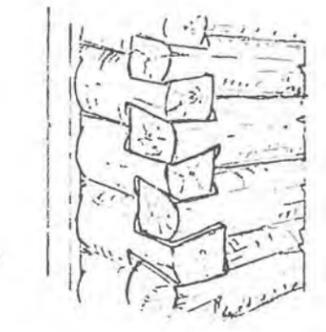
TYP. CORNER JOINT. N.S.

The log walls are assembled with dovetail joints at the corners. A hand made gutter, badly decayed, extends along the eaves of the cabin between the cabin and the barn.
