Inventory of Coastal Engineering Projects in Olympic National Park

Natural Resource Technical Report NPS/NRSS/GRD/NRTR—2013/705

March 2013

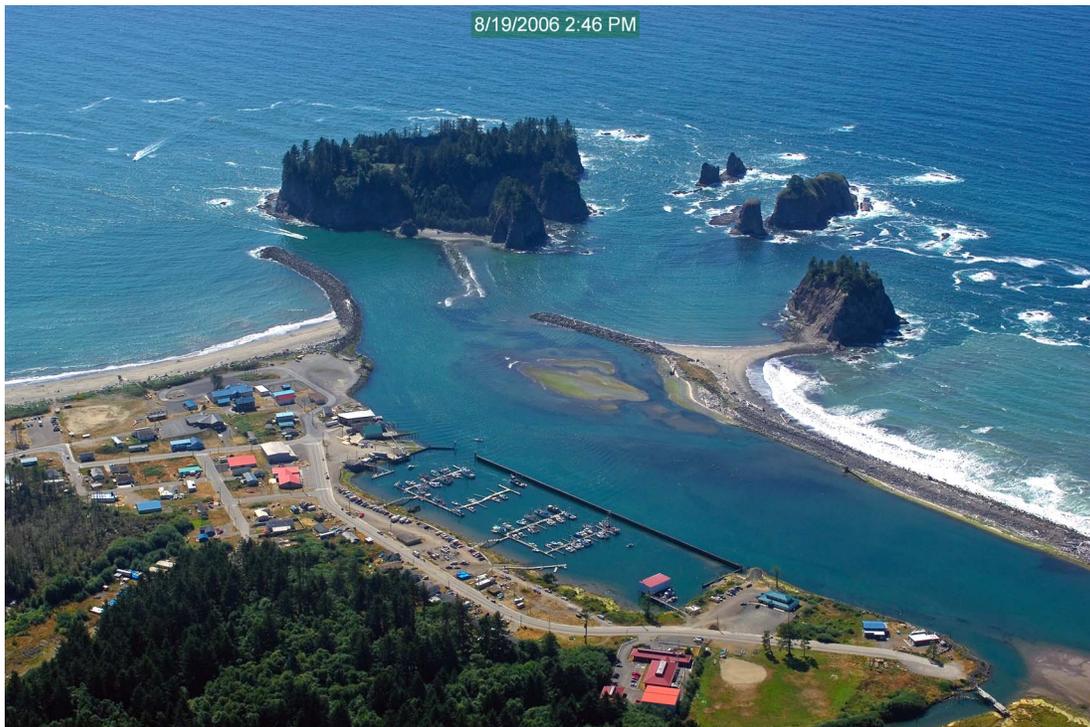
Figure 3. Coastal structures at the mouth of the Quillayute River. View is to the southwest (image from WDOE 2012).

The Quillayute River Navigation Project is located at the town of La Push, Washington. The project includes a small boat basin and navigation channel, two jetties, and maintenance of the Quillayute spit along Rialto Beach (Figures 3 & 4). The mouth of the Quillayute River has changed over time due to both natural and anthropogenic impacts. In 1882 the river mouth was approximately in its present location, but by 1889 the mouth of the river was located 2 km (1.2 mi) to the north at the northern end of the spit (McKay and Terich 1992). In 1910 a new mouth formed north of James Island (Winz 2004). Since 1916 the river has discharged east of James Island (Figure 4). Two jetties were constructed in 1931 to stabilize the mouth of the river for safe navigation (Figure 3).

The Quillayute River Navigation Project (Figures 3, 4 & 8) has continued to manipulate the landscape since its conception in the 1930s. The construction of jetties and a revetment, coupled with the use of dredging and sand placement, has altered the natural flow of sediment.

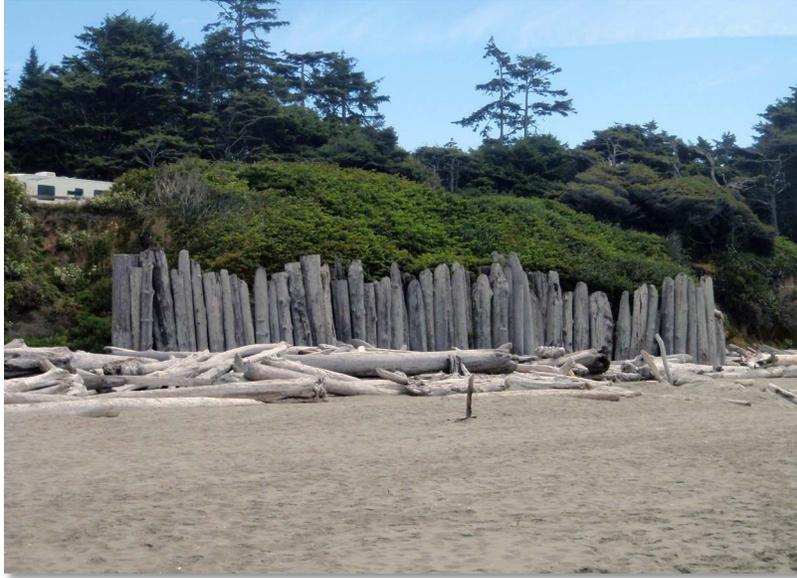
Figure 5. Driftwood bulkhead in the Kalaloch area along U.S. Highway 101 (image by Mike Berry).

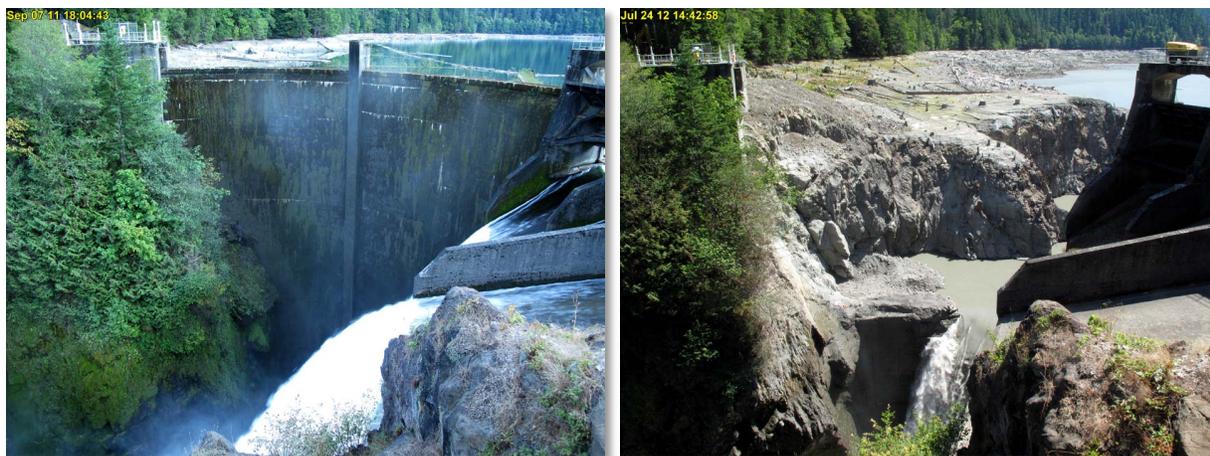
Figure 7. Glines Canyon Dam in September 2011 before dam removal (left) and in July 2012 after dam removal (right) (images from EVS 2012).

The Elwha River is home to the largest river restoration project in the United States in terms of the projected release of sediment and the size of the existing hydroelectric projects (Duda et al. 2011). The Department of the Interior removed the Elwha Dam, located outside of OLYM, and the Glines Canyon Dam (Figure 7), located within the park, in 2011–2012.

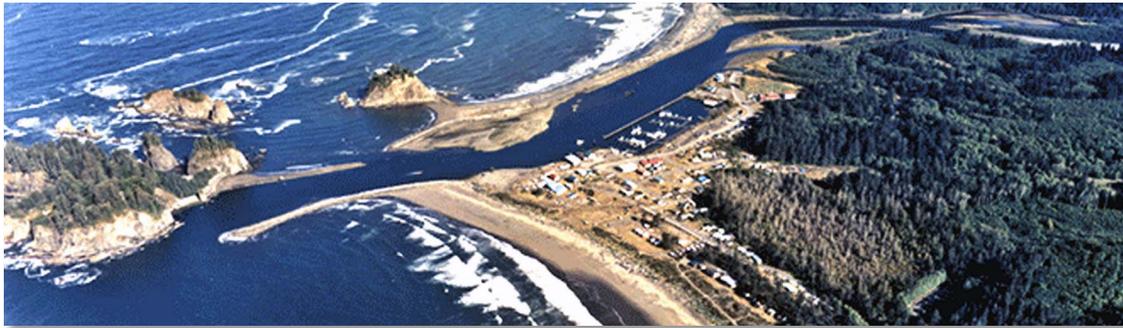
Figure 8. Quillayute River at La Push, Washington (image from USCG 2012).

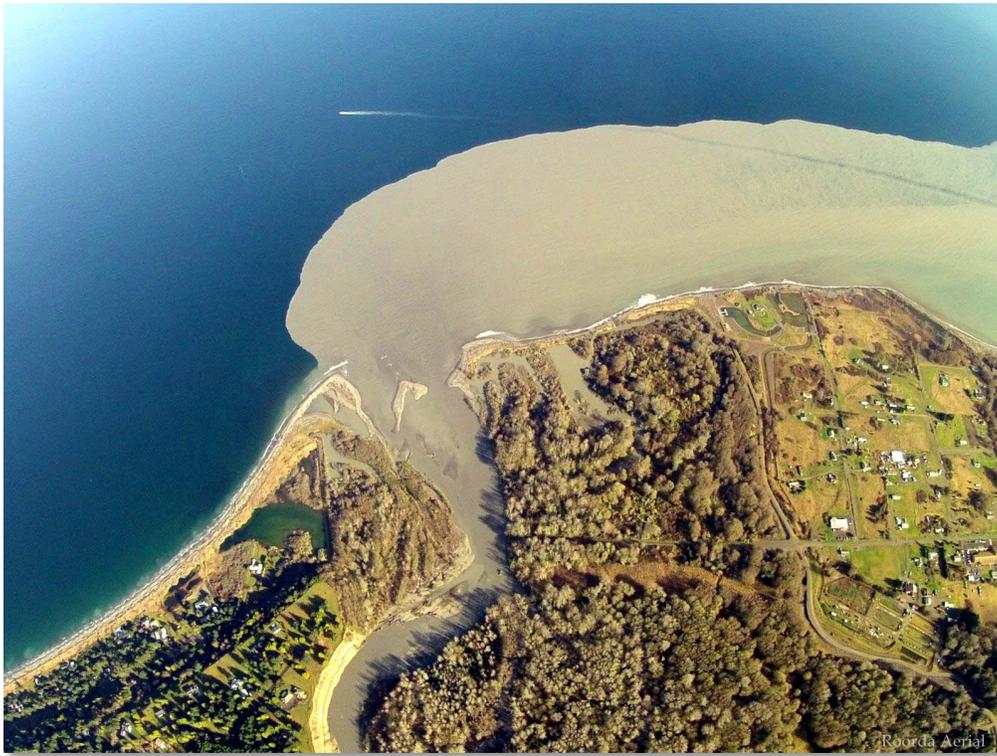
Figure 10. Elwha River sediment plume on March 30, 2012 following the Elwha Dam removal (image by Roorda Aerial, email, 9/10/2012).

Based on the region's hydrodynamics, much of the material is traveling eastward within a 1 km (0.6 mi) band offshore of the Washington coast in the Strait of Juan de Fuca (Warrick and Stevens 2011) (Figure 10). Tracer studies in the region indicate that the bulk of nearshore sediment transport is comprised of coarse grained sediment conveyed through surf zone processes (Miller et al. 2011, Miller and Warrick 2012). It is anticipated that the increased post-dam sediment load will nourish beaches and reverse local coastal erosion as well as alter the physical extent of the estuary (Figure 11) (Duda et al. 2011).

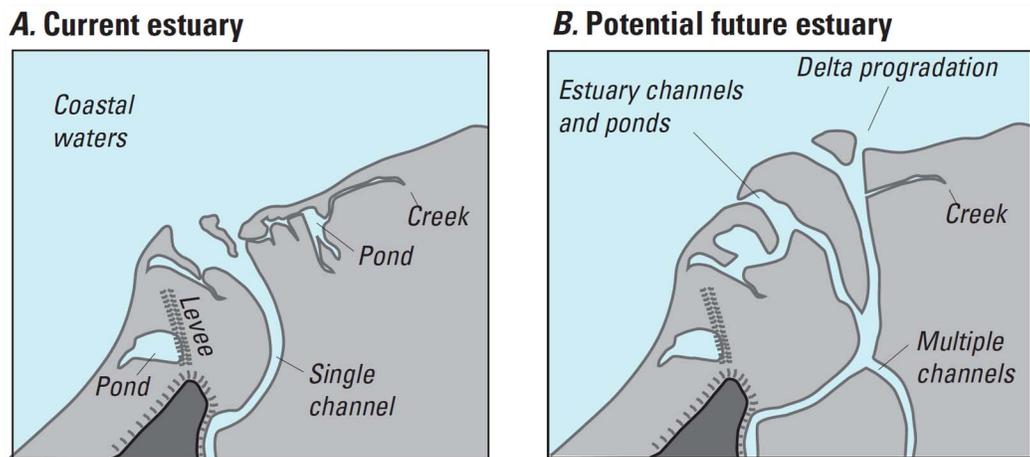
Figure 11. Potential morphologic changes to the Elwha River estuary (from Duda et al. 2011).

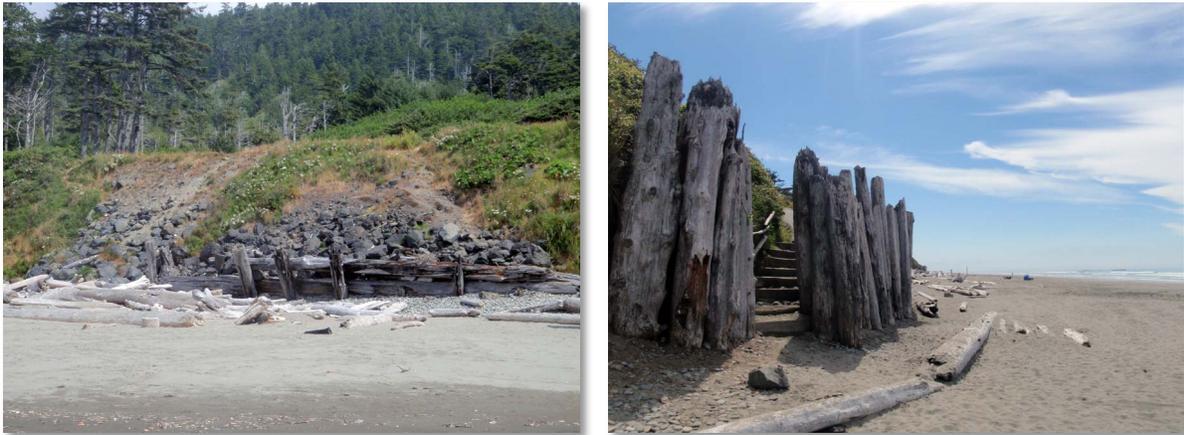
Figure 12. Driftwood bulkhead (left) and small rock placement (right) along U.S. Highway 101 near Kalaloch (images by Mike Berry).

The Kalaloch timber bulkheads and small rock revetment were installed adjacent to Highway 101 (Figures 6 & 12) in an effort to stabilize the backshore. These structures play a minor role within the local and regional sediment budget as terrestrial sediment supply is negligibly impacted given the spacing and scale (<10 m [33 ft]) of these installations. Structure failure has occurred due to local instabilities such as breakage, toe scour, or block failure associated with incident wave attack (USACE 2002).
