NATIONAL REGISTER OF HISTORIC PLACES REGISTRATION FORM

historic name Dos Lomitas Ranch

other names/site number Blankenship Well, Rattlesnake Ranch, Gray Ranch

2. Location Organ Pipe Cactus National Monument

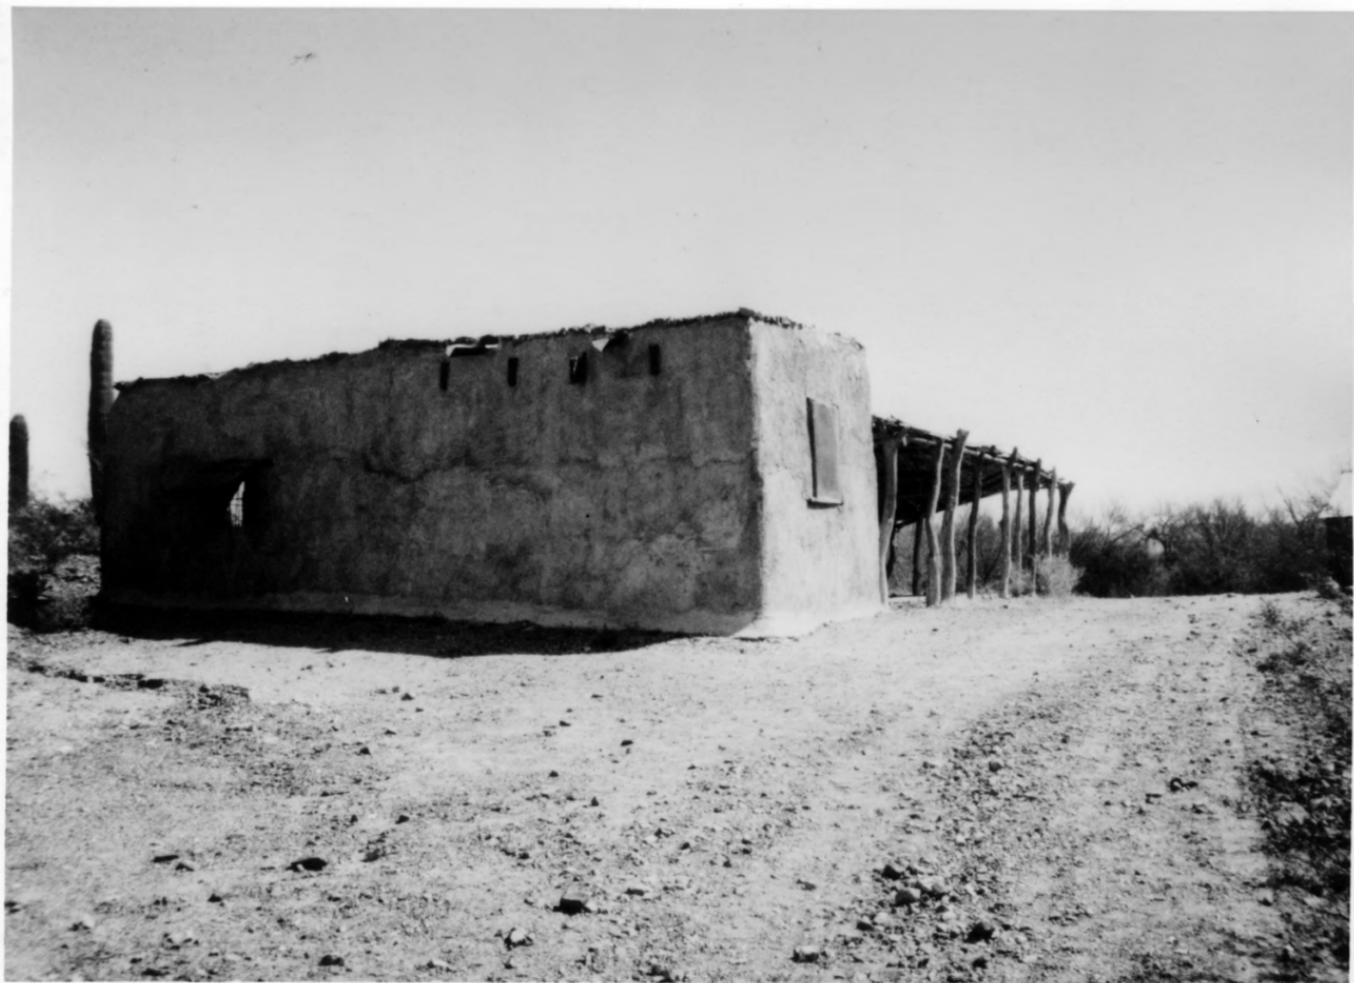
1. Dos Lomitas Ranch House, Organ Pipe Cactus National Monument
2. Pima County, Arizona
3. Lawrence F. Van Horn
4. March 8, 1989
5. Branch of Planning, Western Team, Denver Service Center, National Park Service
6. looking northeast
7. Photograph No. 1

The scene has not changed since this photograph was taken. Current conditions are reflected.

The main ranch house "is a fine example of United States-Mexican border adobe construction" (Appleman and Jones 1969:49). It contains four rooms and is a one-story, L-shaped adobe building about 40 feet long, 30 feet wide, and 10 feet high. It actually has been measured at 39 feet 6 inches in length, 29 feet 3 5/8 inches in width, and 9 feet 6 inches in height (Appleman and Jones 1969 -- "Blankenship [Dos Lomitas] Ranch House," first architectural drawing opposite Plate 27). It has an earthen floor, five windows, three doors, and one fireplace/chimney. Attached to the front is a ramada or portico, which has a flat roof made of saguaro cactus ribs and iron pipes, covered by earth and some blacktop, capped by stones, and supported by mesquite posts. The exterior of the house is covered with stucco, which helps prevent the adobe fabric from eroding.

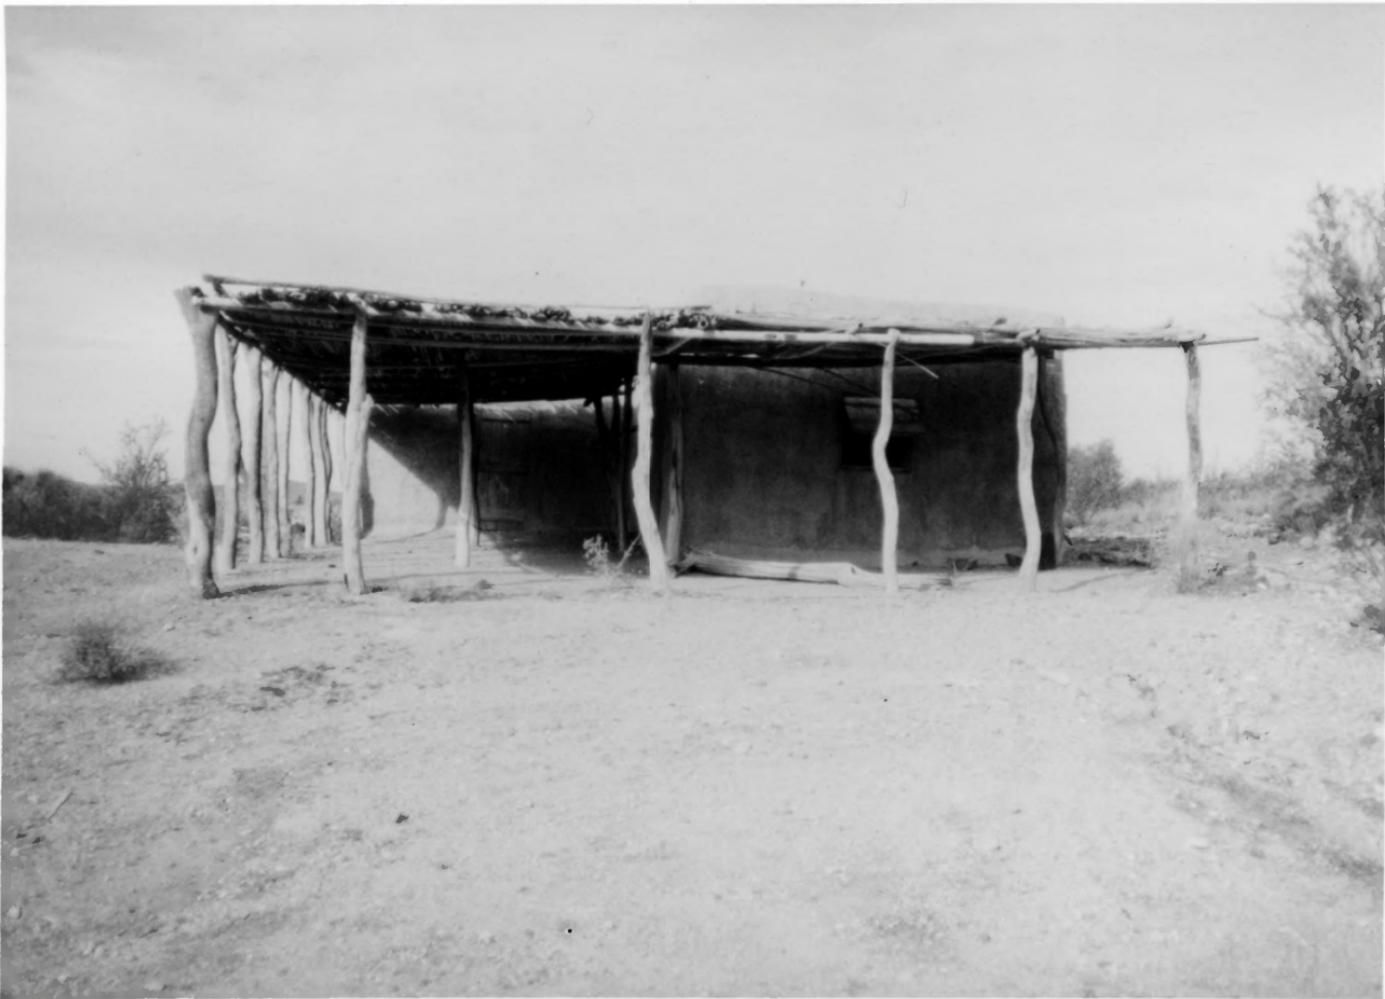
1. Dos Lomitas Ranch House, Organ Pipe Cactus National Monument
2. Pima County, Arizona
3. Lawrence F. Van Horn
4. February 1, 1989
5. Branch of Planning, Western Team, Denver Service Center,
National Park Service
6. looking west
7. Photograph No. 2

The scene has not changed since this photograph
was taken. Current conditions are reflected.
LJVH September 22, 1992

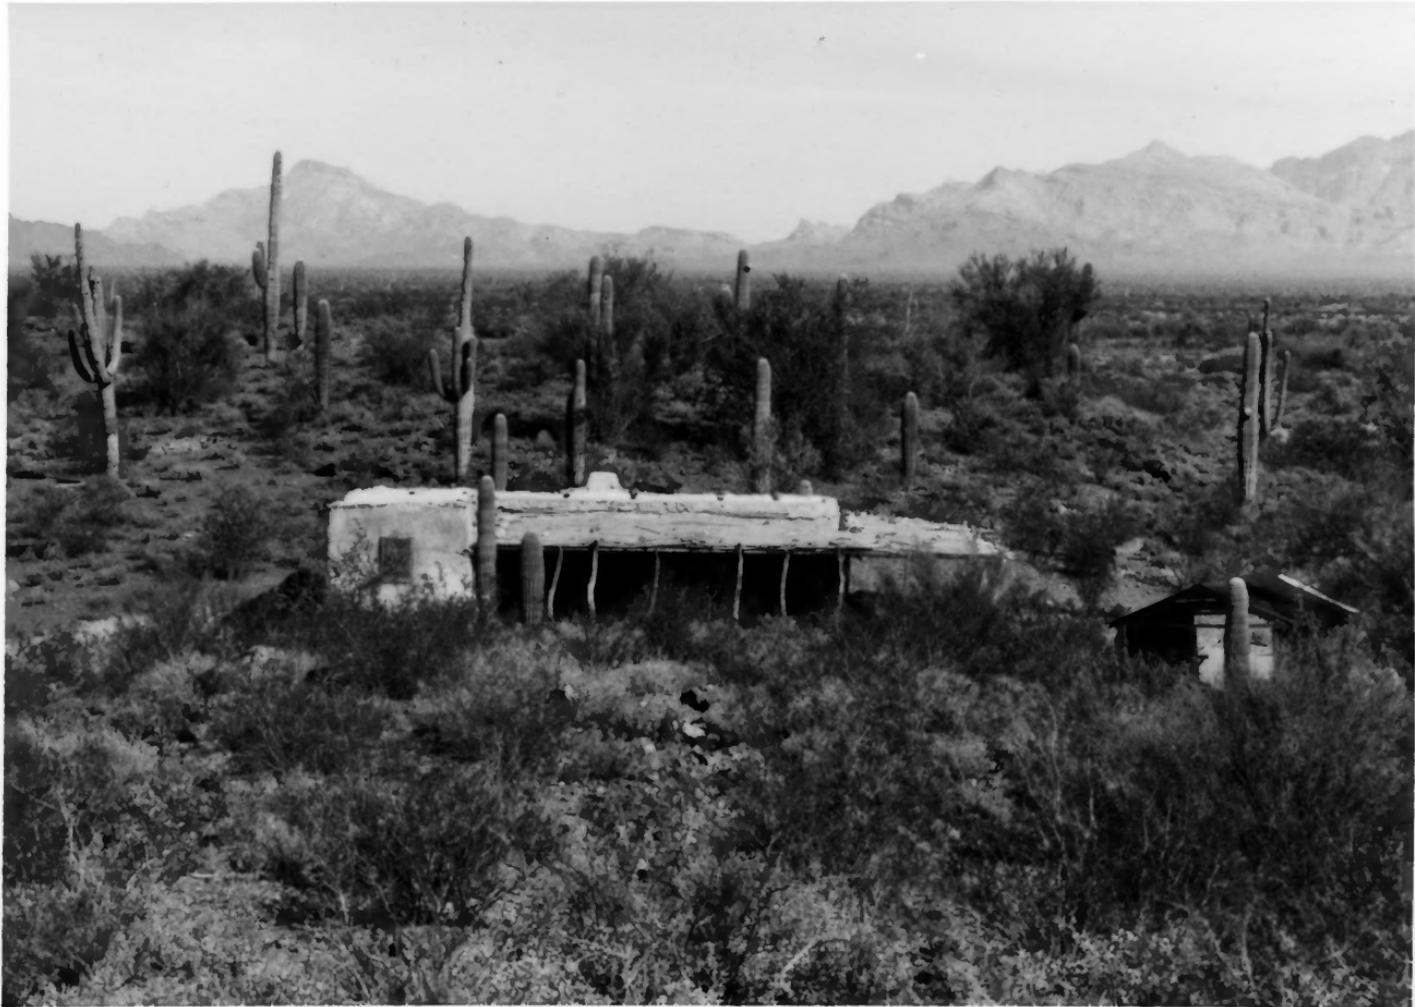
1. Dos Lomitas Ranch House, Organ Pipe Cactus National Monument
2. Pima County, Arizona
3. Lawrence F. Van Horn
4. February 1, 1989
5. Branch of Planning, Western Team, Denver Service Center,
National Park Service
6. looking north
7. Photograph No. 3

The scene has not changed since this photograph was taken. Current conditions are reflected.

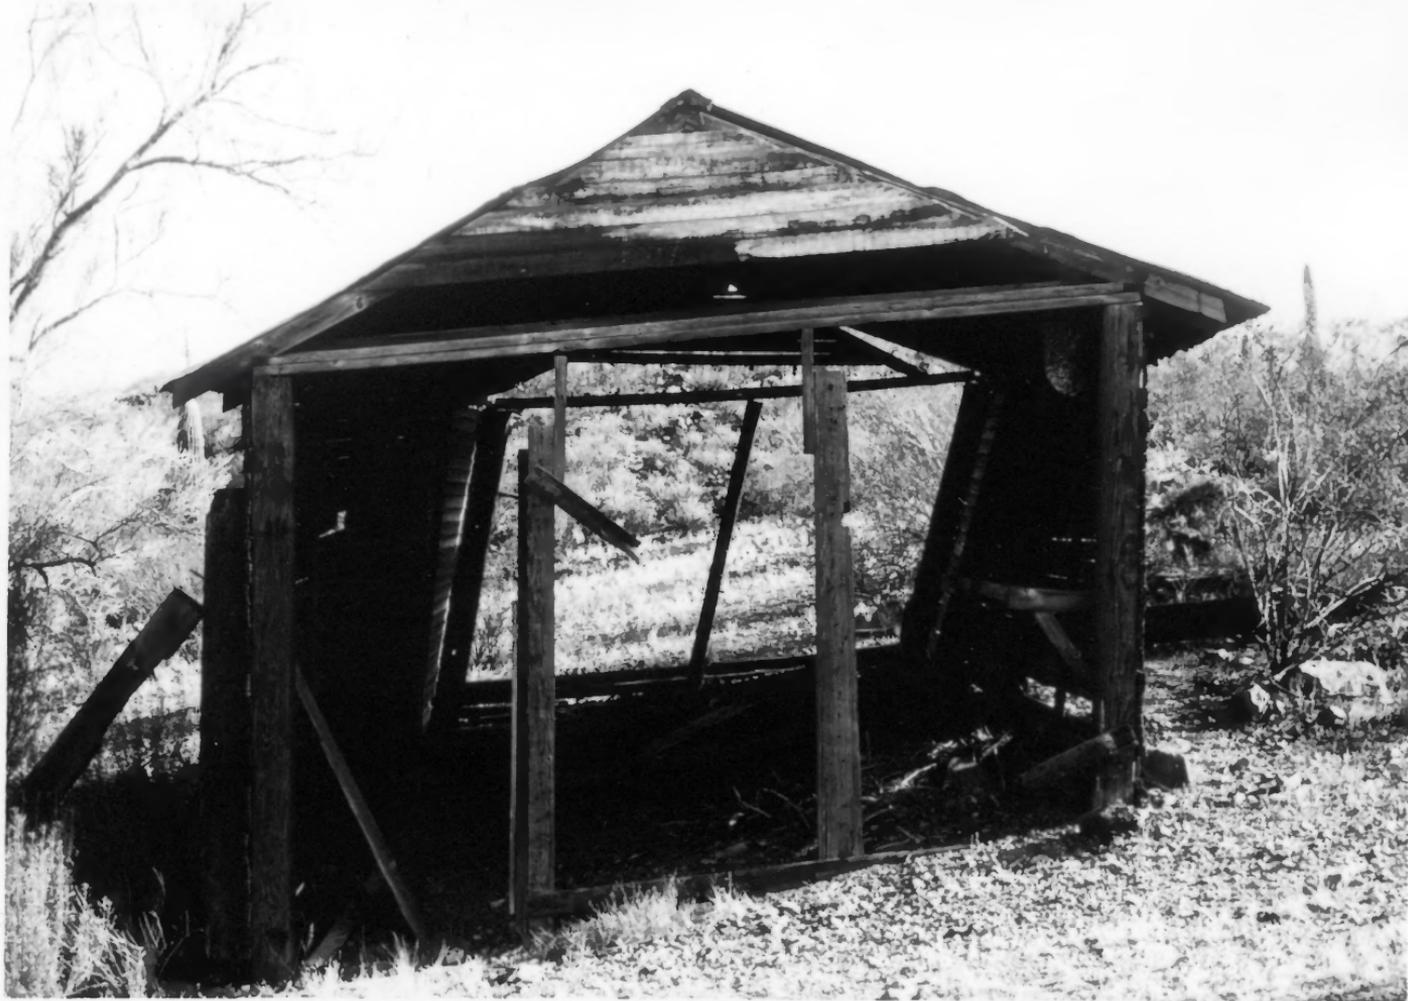
1. Saddle Shed/Tack House/Outbuilding No. 1, Dos Lomitas Ranch,
Organ Pipe Cactus National Monument
2. Pima County, Arizona
3. Lawrence F. Van Horn
4. July 16, 1992
5. Branch of Planning, Western Team, Denver Service Center,
National Park Service
6. looking south
7. Photograph No. 5

The saddle shed/tack house, which has been called Outbuilding Number 1 (Appleman and Jones 1969:50), is about 50 feet southeast of the main ranch house and is in poor condition in that the siding is missing in the front and in the rear. The building itself tends to lean out of plumb, but wooden bracing has been added to straighten and stabilize it.

The saddle shed/tack house contributes to the ambience of the Dos Lomitas property, depicting Sonoran Desert cattle ranching operations, and will continue to be stabilized. It's flume-stave siding is evidence of the adaptive nature of the frontier -- making do with what was at hand and creatively putting available materials to new uses. In other words, this building is a frontier example of "a typical structure erected by persons unskilled in the building trade, but nevertheless ingenious, using miscellaneous building materials that were available" (Appleman and Jones 1969:51). Although these words were written by historian Roy Appleman and architect Russell Jones about the railroad-tie/corrugated-metal building at Dos Lomitas that was extant at the time, they are equally true of the saddle shed/tack house with its flume-stave siding. What Appleman and Jones specifically say about the saddle shed/tack house is that it "is typical of a small building erected by ranch hands using miscellaneous materials" (1969:50).

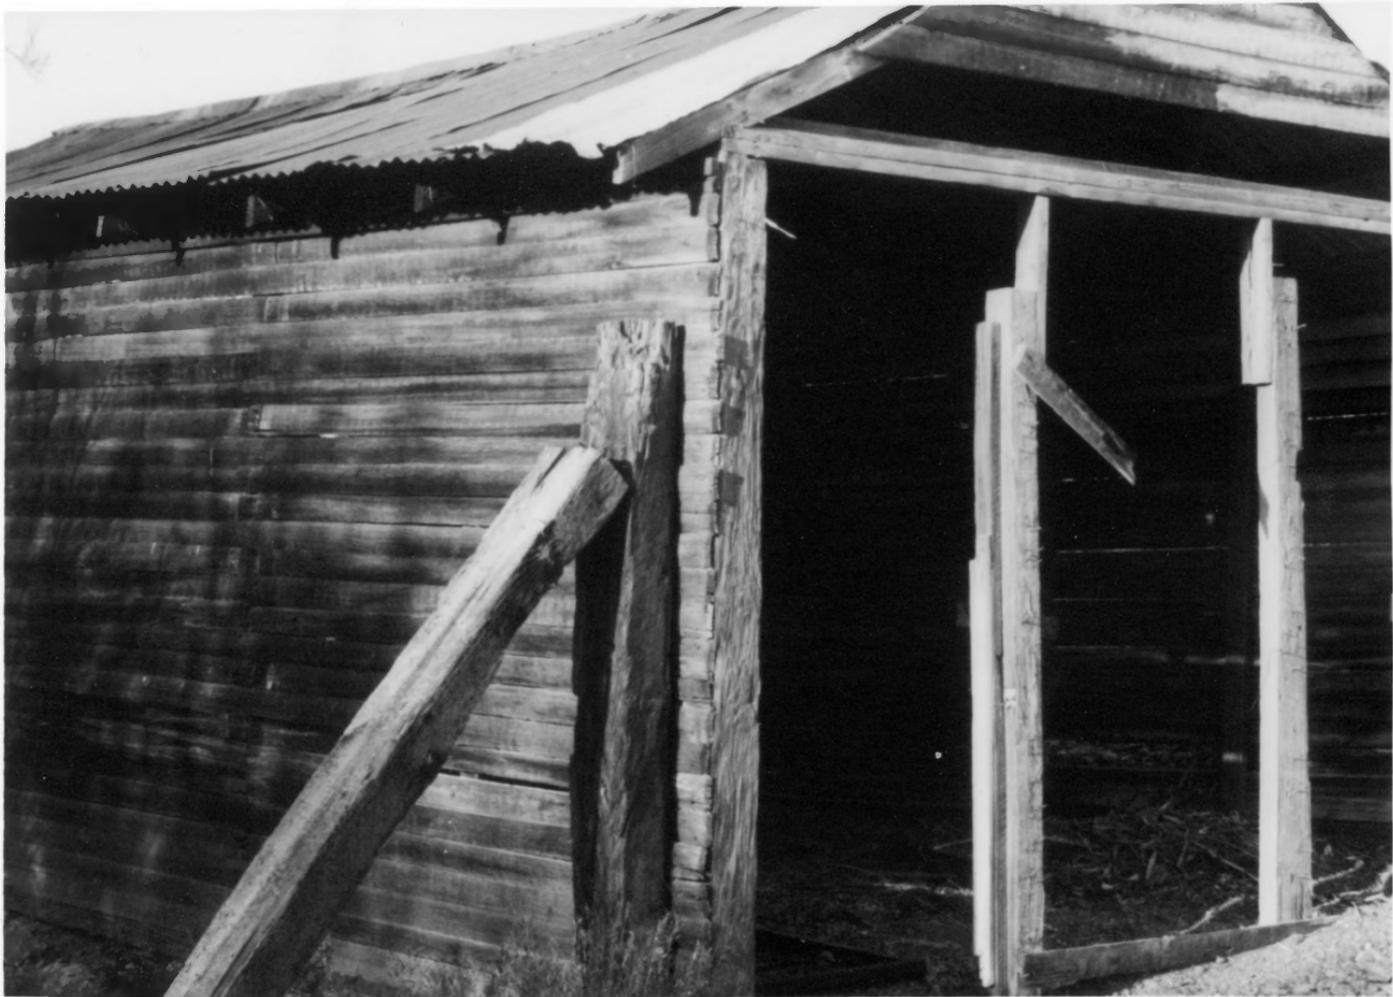
1. Saddle Shed/Tack House/Outbuilding No.1, Dos Lomitas Ranch,
Organ Pipe Cactus National Monument
2. Pima County, Arizona
3. Lawrence F. Van Horn
4. March 15, 1989
5. Branch of Planning, Western Team, Denver Service Center,
National Park Service
6. looking southwest
7. Photograph No. 6

The building leans more today.
LGHVH September 22, 1992

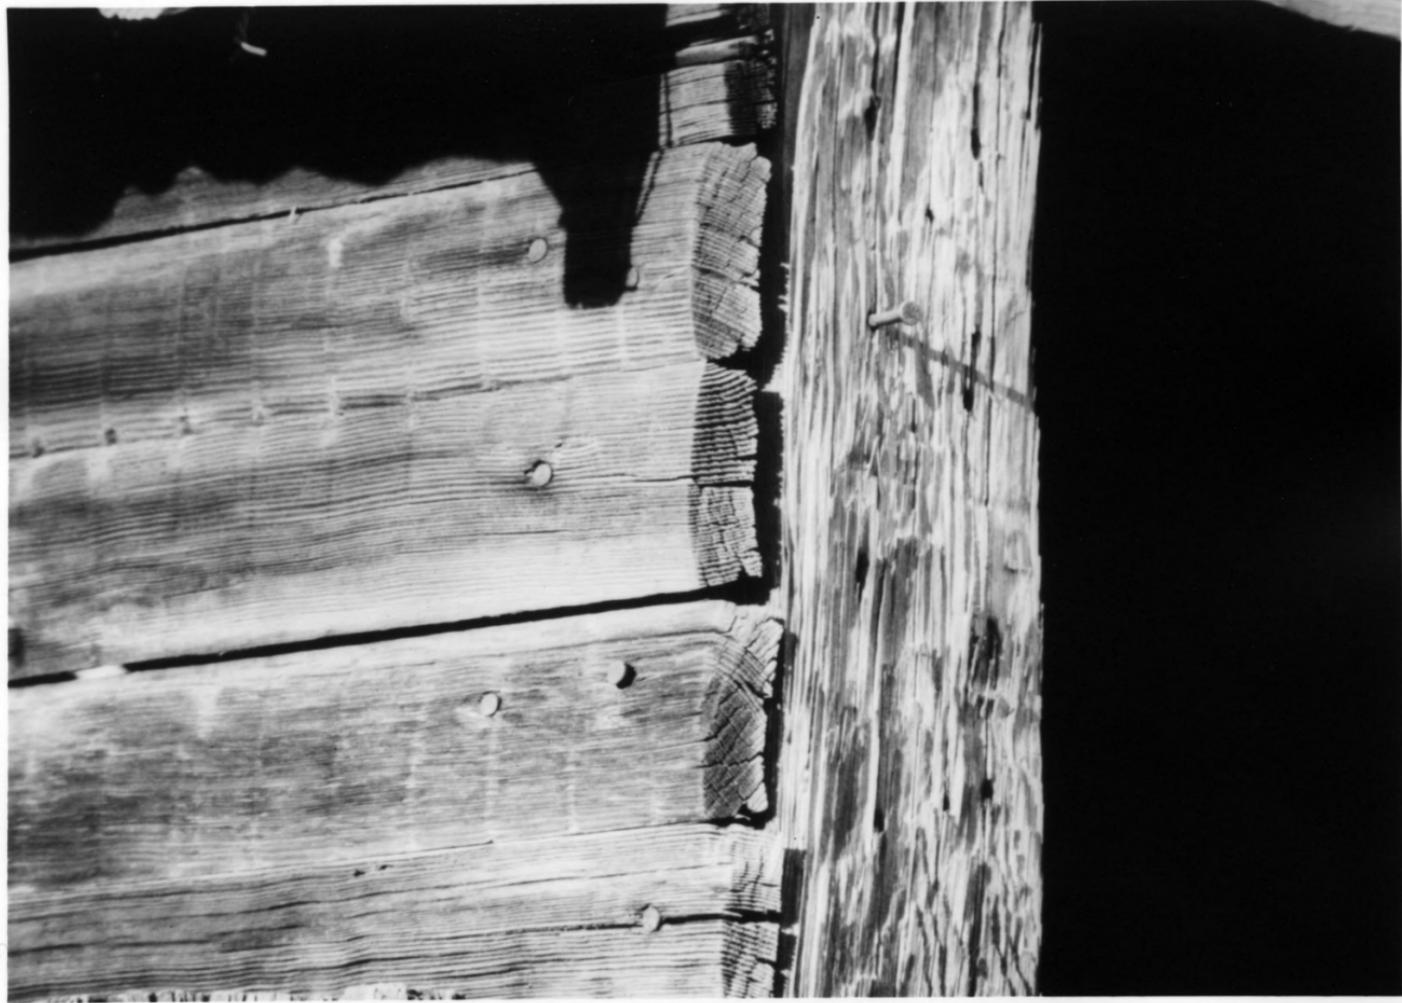
The side walls and roof of a nearby frame saddle shed or tack house still stand, showing flume-stave siding, which was apparently salvaged from somewhere in the region from a circular flume or wooden pipe to convey water (Appleman and Jones 1969:50; Garrison 1992). One estimate puts the outside diameter of the wooden pipe at 10 inches (Conrad 1992). This building is being stabilized (Smith 1994), and the distinctive feature -- flume-stave siding -- is readily visible on the east and west side walls. A corral of railroad ties and mesquite logs with a concrete watering trough is mostly extant as well as a windmill/well. The steel tower of the windmill is standing in its original place. The vane is stored in the main ranch house. The wind wheel with its sails is missing. The vane has "AERMOTOR" and "CHICAGO" stencilled on it plus its symbol, a captial "C" around a smaller captial "O" (Pennington 1994; Smith 1994).

7. Saddle Shed/Tack House/Outbuilding No. 1, Dos Lomitas Ranch; Organ Pipe Cactus National Monument, Pima County, Arizona; taken by Lawrence F. Van Horn, March 15, 1989; negative on file, Branch of Planning, Western Team, Denver (Colorado) Service Center, National Park Service; looking southwest; Photograph No. 7, Dos Lomitas, detail of curved siding. This distinctive feature of curved siding has not changed; it is still intact.

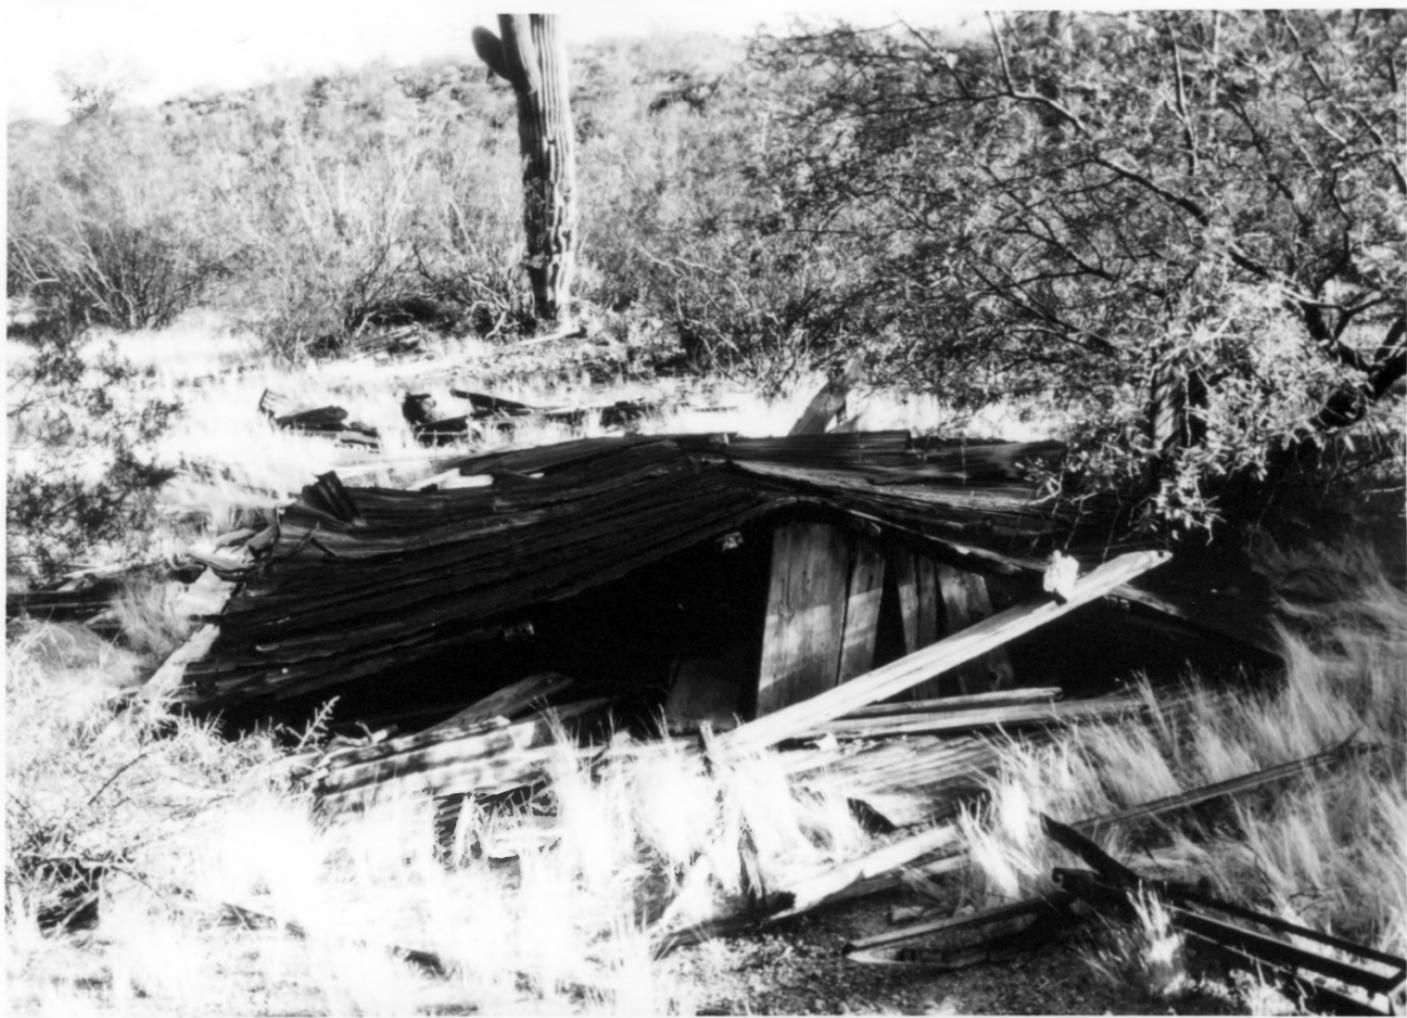
1. Ruins of Grain Shed/Outbuilding No.2, Dos Lomitas Ranch,
Organ Pipe Cactus National Monument
2. Pima County, Arizona
3. Lawrence F. Van Horn
4. July 16, 1992
5. Branch of Planning, Western Team, Denver Service Center,
National Park Service
6. looking south
7. Photograph No. 8

Outbuilding Number 2 (Appleman and Jones 1969:50) is just to the east of the saddle shed/tack house and is now in ruins. Originally built of wood planking and saguaro ribs, historian Jerome Greene (1977a:85) in his historic resources study says that it was probably used to store grain.

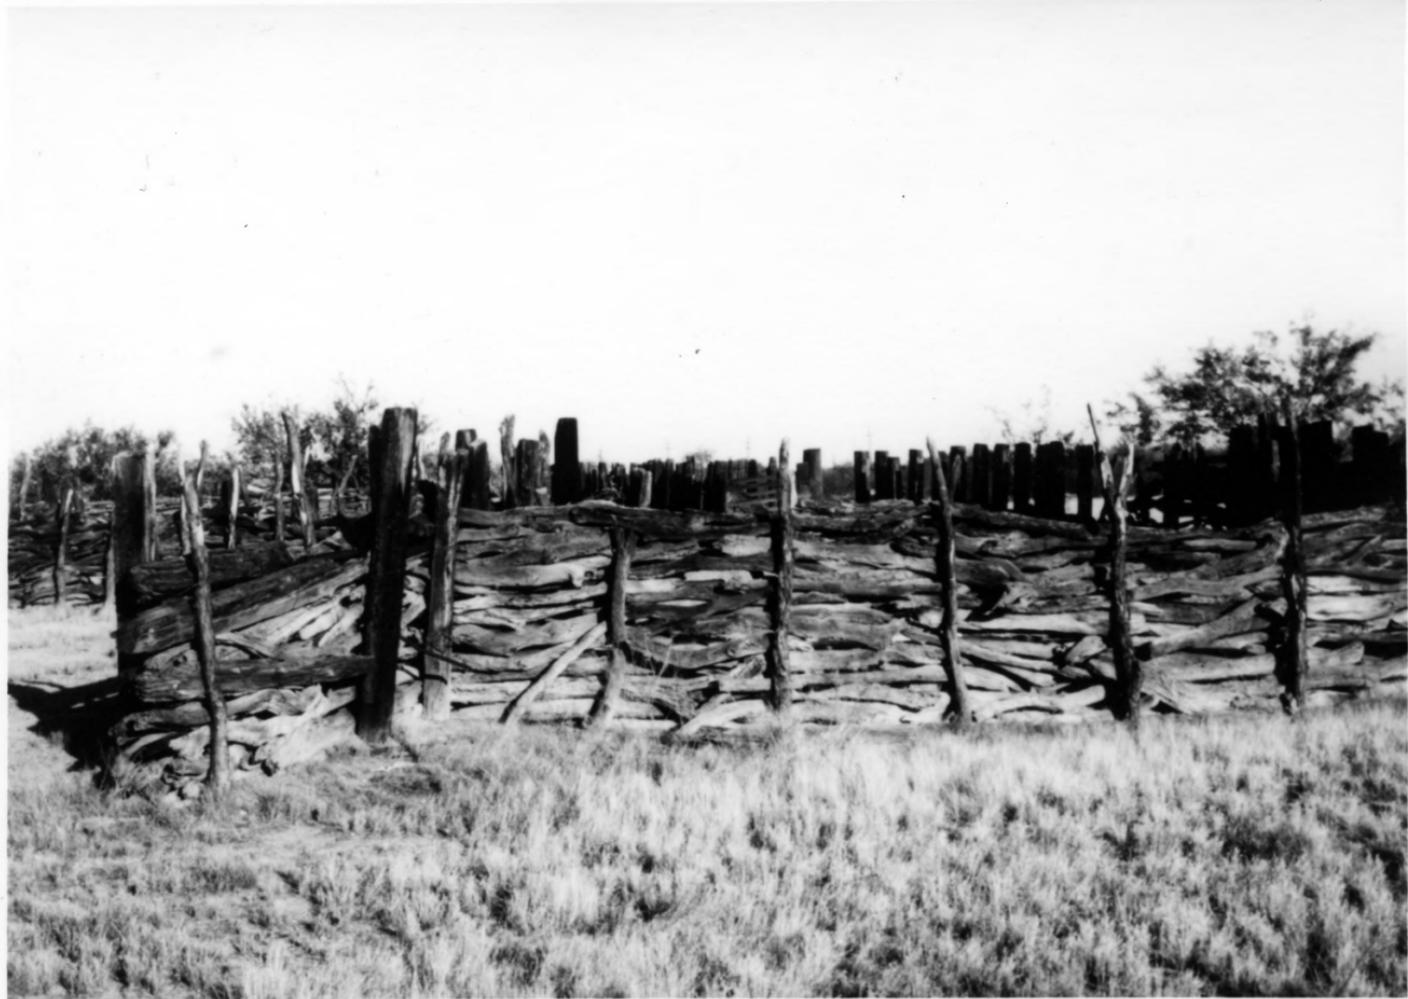
1. Corral, Dos Lunetas Ranch, Organ Pipe Cactus National Monument
2. Pima County, Arizona
3. Lawrence F. Van Horn
4. July 16, 1992
5. Branch of Planning, Western Team, Denver Service Center, National Park Service
6. looking southeast
7. Photograph No. 9.

A large, irregularly shaped corral exists on the property to the east of the main house, measuring approximately 118 feet by 97 feet (Appleman and Jones 1969:54). It has three compartments and may be said to be three corrals in one with a loading chute and ramp. It is made up partly of railroad ties and partly of mesquite poles for posts with mesquite limbs laid up between the posts to form the sturdy corral walls.

Most of the corral is in good condition. However, a few sections on the southern side are missing their mesquite walls; here the railroad-tie posts alone remain. People from south of the border have been known to take the wood and put it to uses seemingly more utilitarian in their view than historic preservation. The result is actually useful in interpreting the ranching story to visitors since various stages in corral construction may be readily visualized.

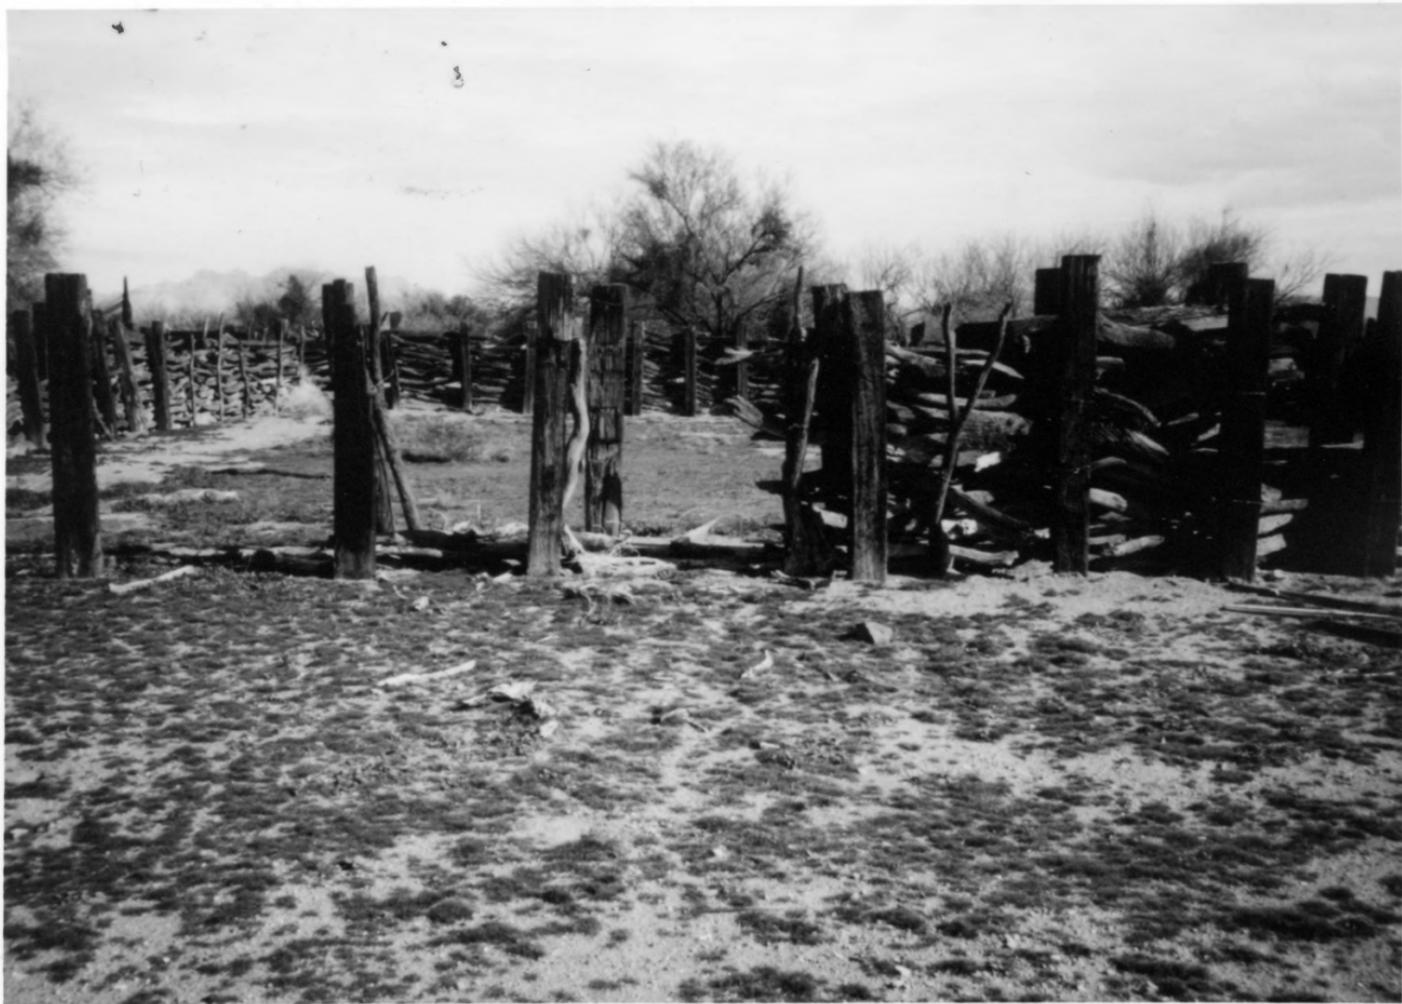
1. Corral, Dos Lomitas Ranch, Organ Pipe Cactus National Monument
2. Pima County, Arizona
3. Lawrence F. Van Horn
4. February 1, 1989
5. Branch of Planning, Western Team, Denver Service Center, National Park Service
6. looking north
7. Photograph No. 10

This photograph reflects current conditions.
LJVA September 22, 1992

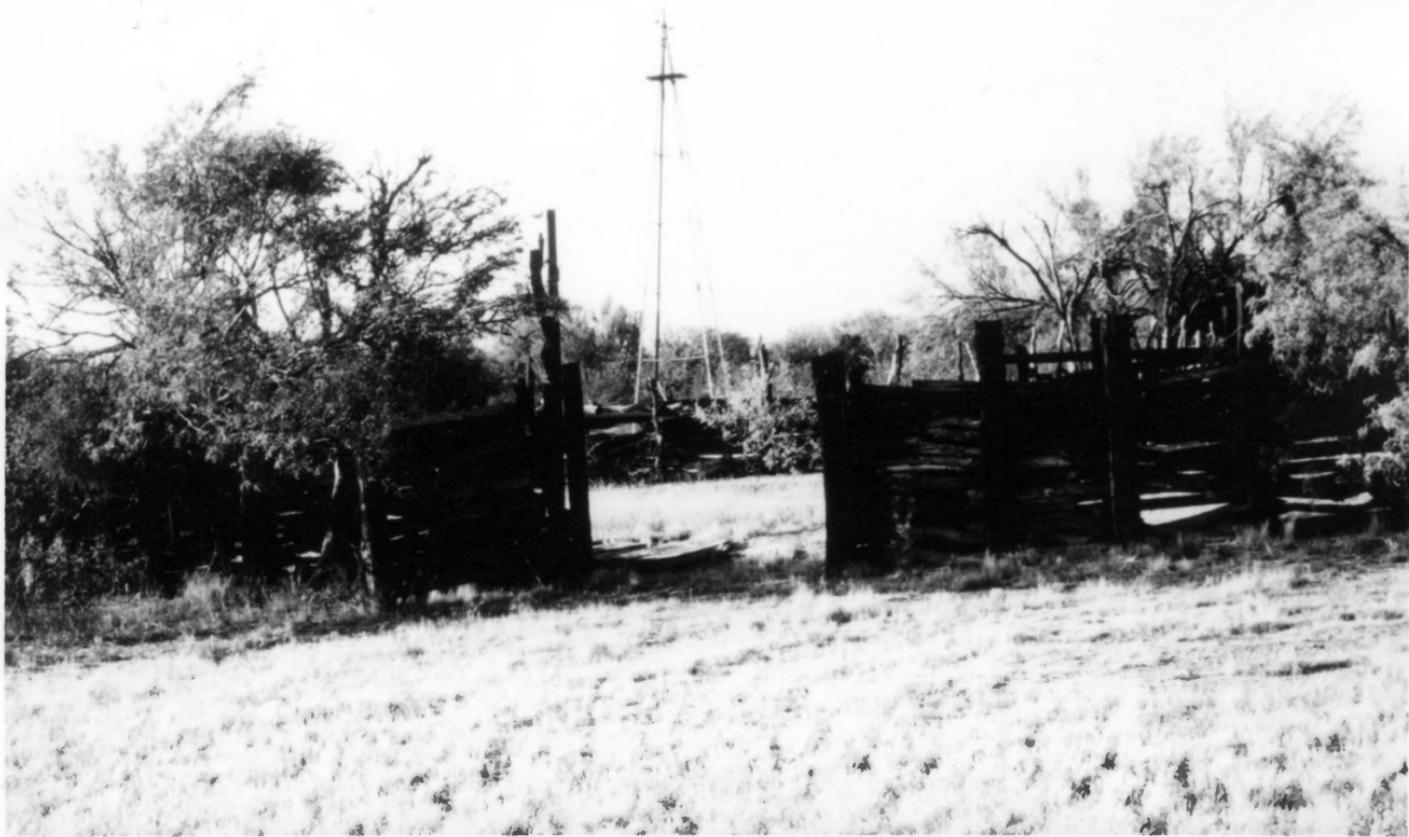
1. Corral, ^{and windmill/well of Blankenship Well,} Dos Lomitas Ranch, Organ Pipe Cactus National Monument
2. Pima County, Arizona
3. Lawrence F. Van Horn
4. July 16, 1992
5. Branch of Planning, Western Team, Denver Service Center,
National Park Service
6. looking north
7. Photograph No. 12

The well with windmill is located about twelve feet west of the northwestern corner of the corral. The chute connects to the corral at this corner on the northern side. The metal tower of the windmill is on site and intact, but, as noted above, the vane and sails are not in position. The vane is being stored in the main ranch house; the sails are missing. If restored, the story could be told better of the critical importance of water sources to human habitation in the desert at spots like Dos Lomitas.

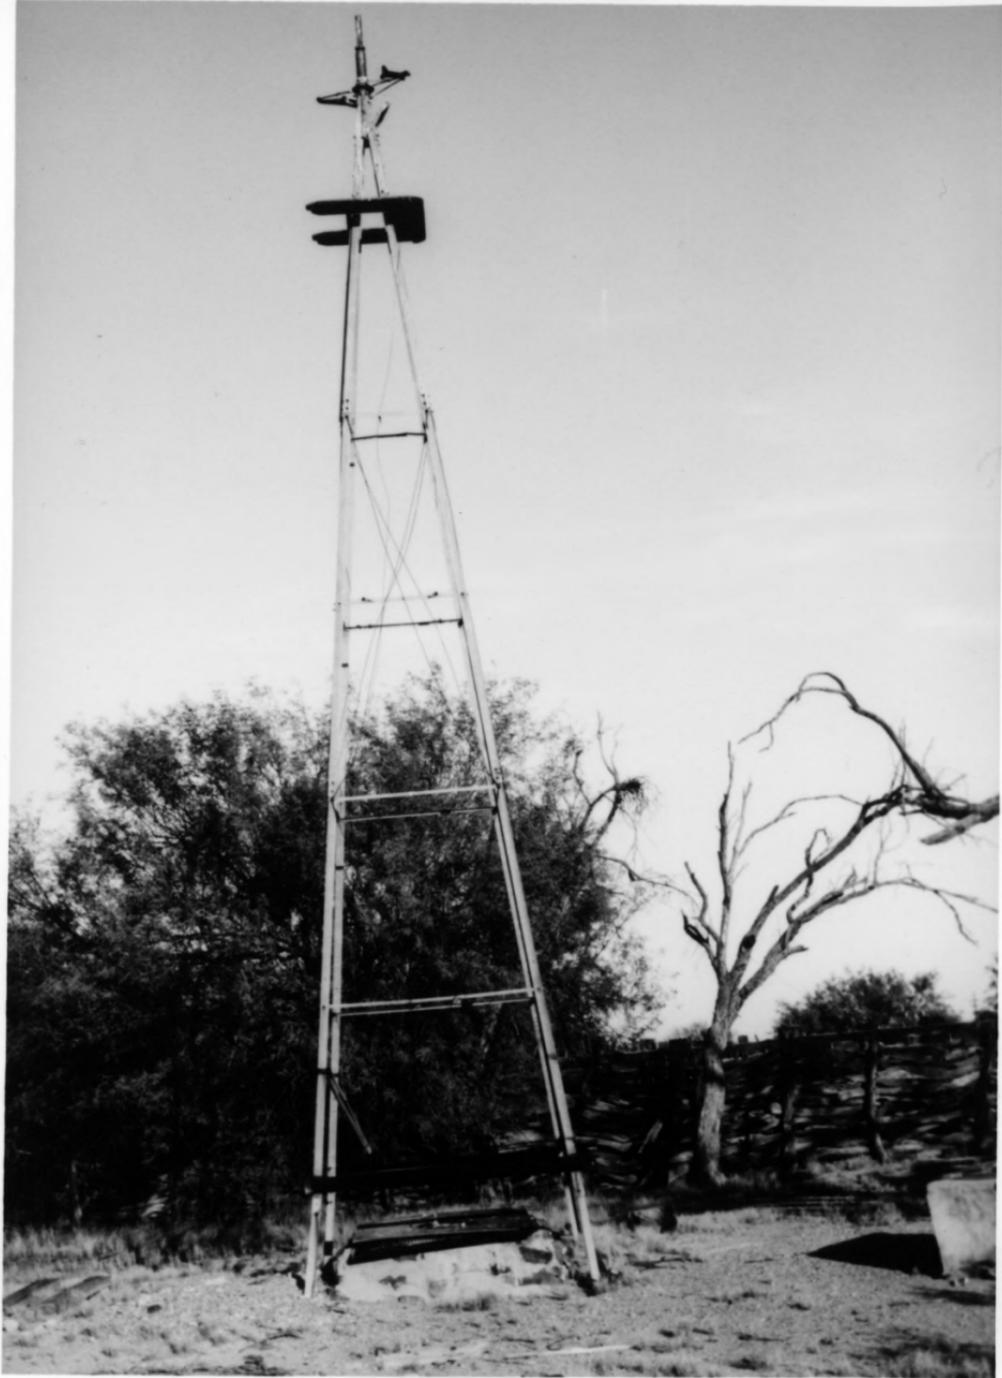
1. Windmill/well of Blankenship Well, Dos Lomitas Ranch, Organ Pipe Cactus National Monument
2. Pima County, Arizona
3. Lawrence F. Van Horn
4. July 16, 1992
5. Branch of Planning, Western Team, Denver Service Center, National Park Service
6. looking east
7. Photograph No. 13

Aermotor steel windmills have been manufactured since the 1880s (Baker 1985:383-384). Model 502 was made in 1915 only, the year that self-oiling was introduced. Model 602 was manufactured from 1916 to 1933. Model 702 was made in Chicago from 1933 to 1958 and elsewhere until 1981. Model 802 began in 1981 and is still in production (Baker 1985:116-117).
