Community Building, Buttermilk Falls State Park, New York

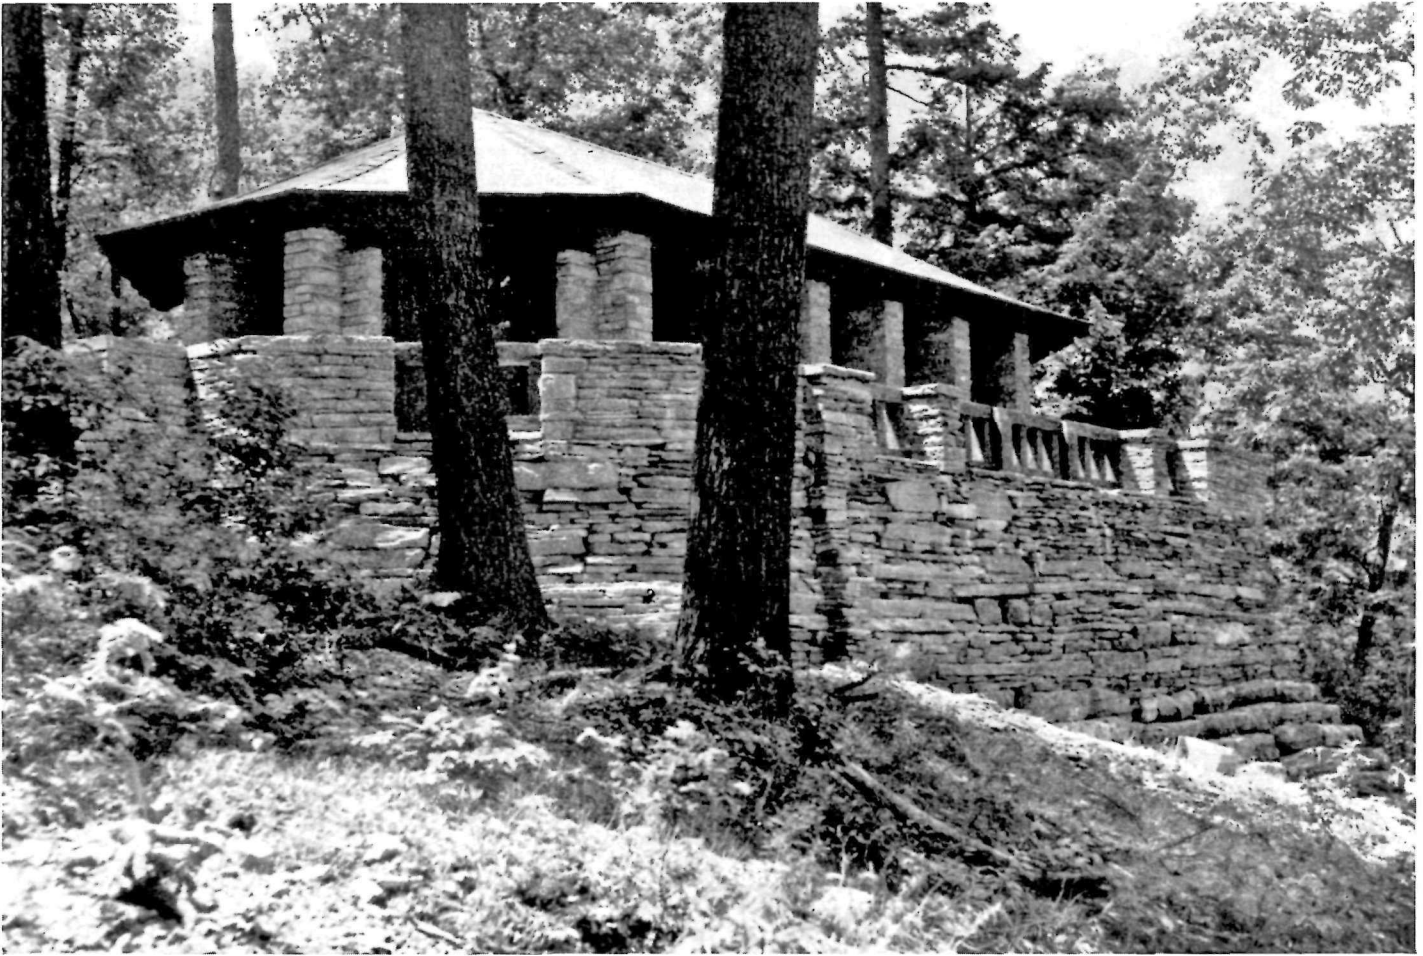
This hillside structure happily escapes the stereotyped, both in plan and exterior treatment. Abundance of doors and windows gives views in all directions. Perhaps the building is not actually

used as a community building as the term is applied herein, but being enclosed, it is more than a shelter and closely resembles the community buildings useful in cabin colonies.

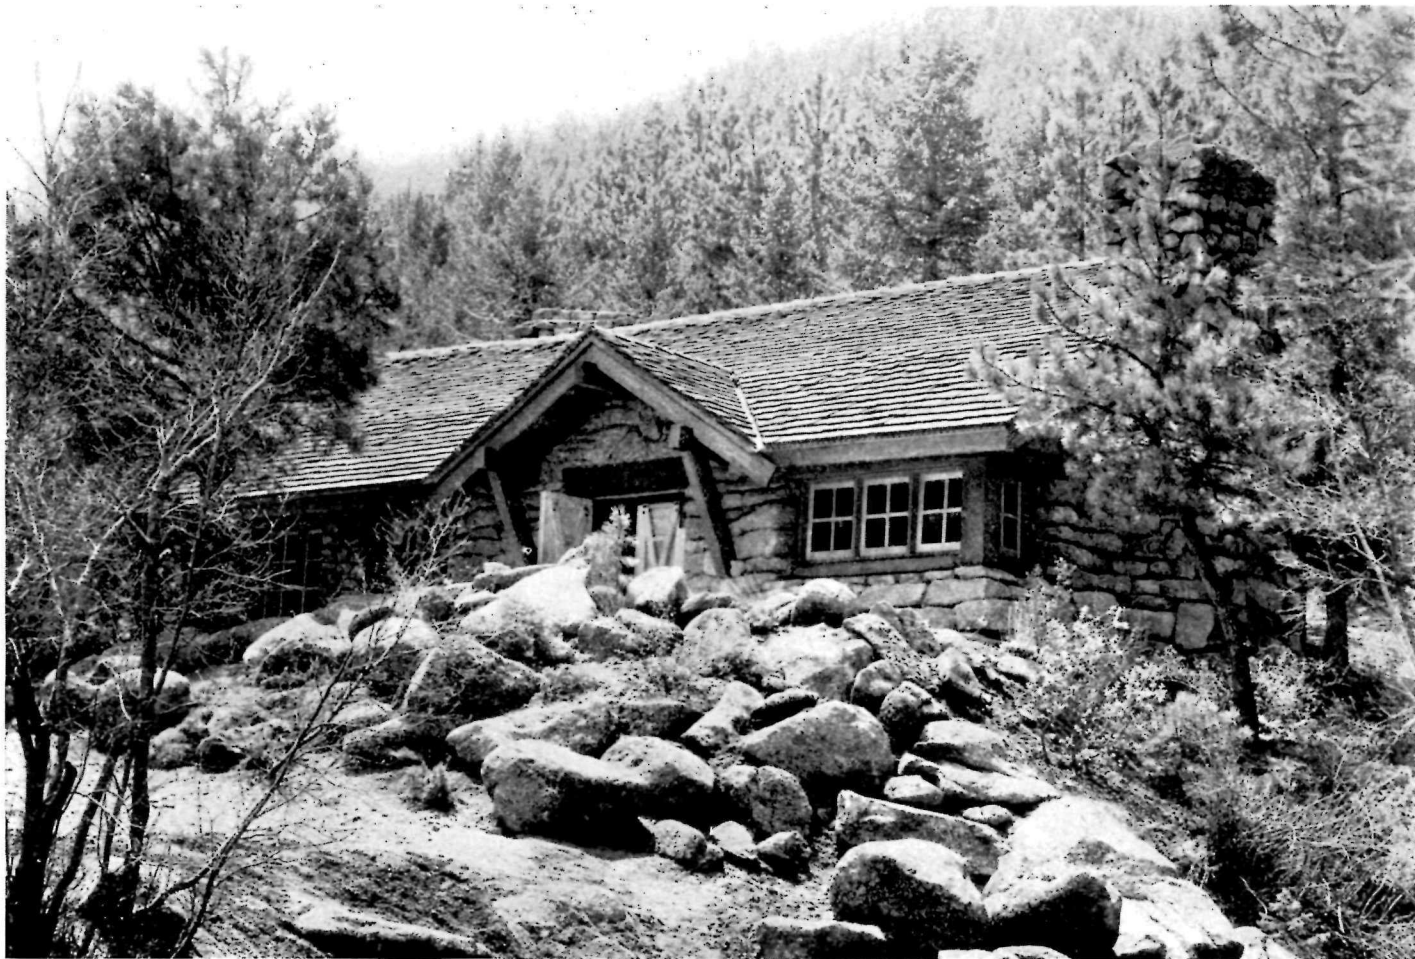
Green Mountain Community Building, Boulder Mountain Park, Colorado

FLOOR PLAN
Scale $\frac{1}{16}$ " = 1'-0"

In close harmony with the rock-strewn site, this building seems without false note unless it is the formlessness of the rocks employed to top off the chimney. Even this can claim a measure of exemption from criticism on the plea of relationship to the indigenous rocks. There are many uses for a building of this general type in a park, as a rallying point for Boy Scouts and other organizations visiting or camping in the park as groups, or as a warming shelter where winter sports are indulged in in a small way. The many windows provide good ventilation in summer, yet when these are closed and both fireplaces are lighted, comfort in cold weather is offered.

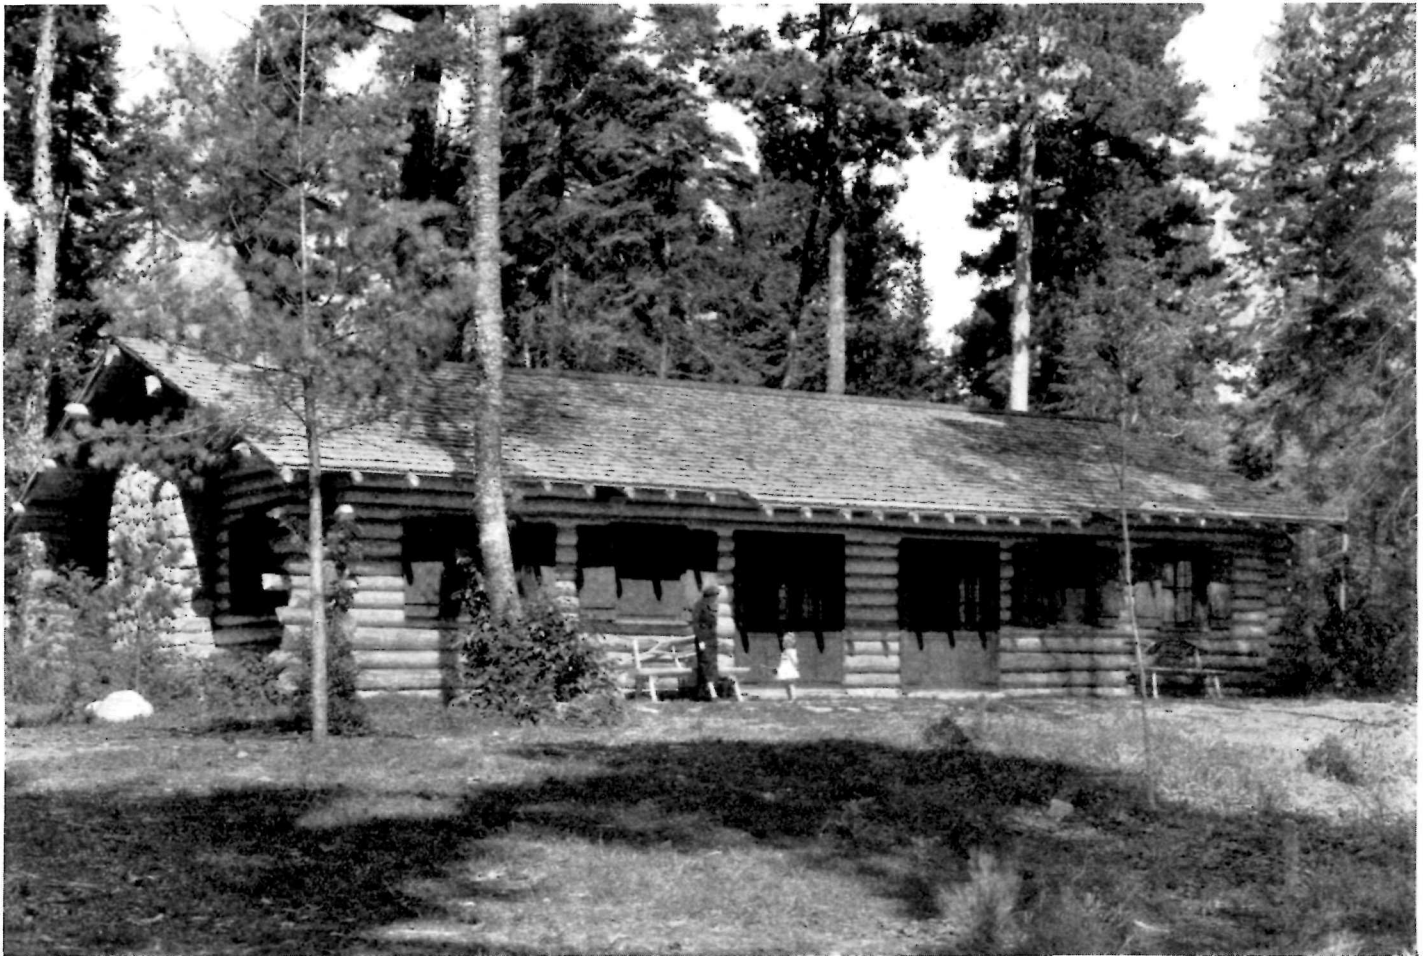
Community Building, Scenic State Park, Minnesota

In the fine character of the log construction of this example Minnesota justifies her advantage of superior native timber resources. We are almost blinded to the lesser merit of the chimney masonry, which, for all its sturdy proportions, approaches the "peanut brittle" technique. An imagined ideal park structure might call for a masonry chimney from one of several localities, but it would assuredly specify "logs and log construction by Minnesota." This building accommodates day visitors as well as the residents of a nearby group of cabins.

FLOOR-PLAN
Scale $\frac{3}{8}$ " = 1'-0"

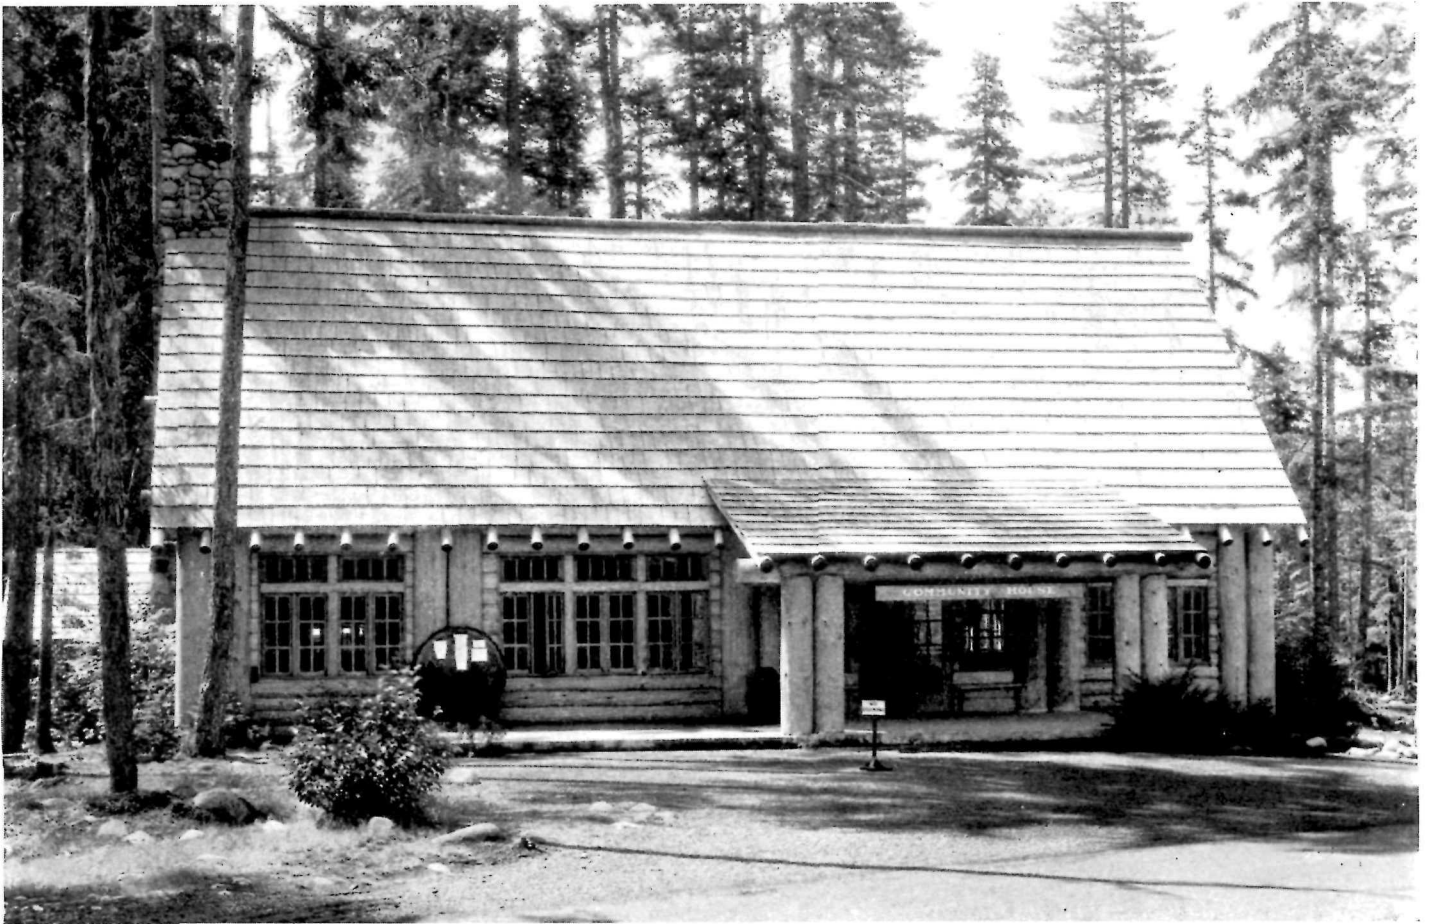
Community Building, Longmire, Mount Rainier National Park

A park structure of importance that, after pointing the way for many later buildings, has been surpassed in achievement of the subtleties of design and execution that make for true park structural character. Comparison of the almost mechanical stiffness of the rafter ends with the handcrafted quality of the “whittled” rafter ends of other subjects more recently built will indicate one such advance in structural technique. The thinness of the roof shingles and the character of the masonry of the chimneys leave something to be desired.

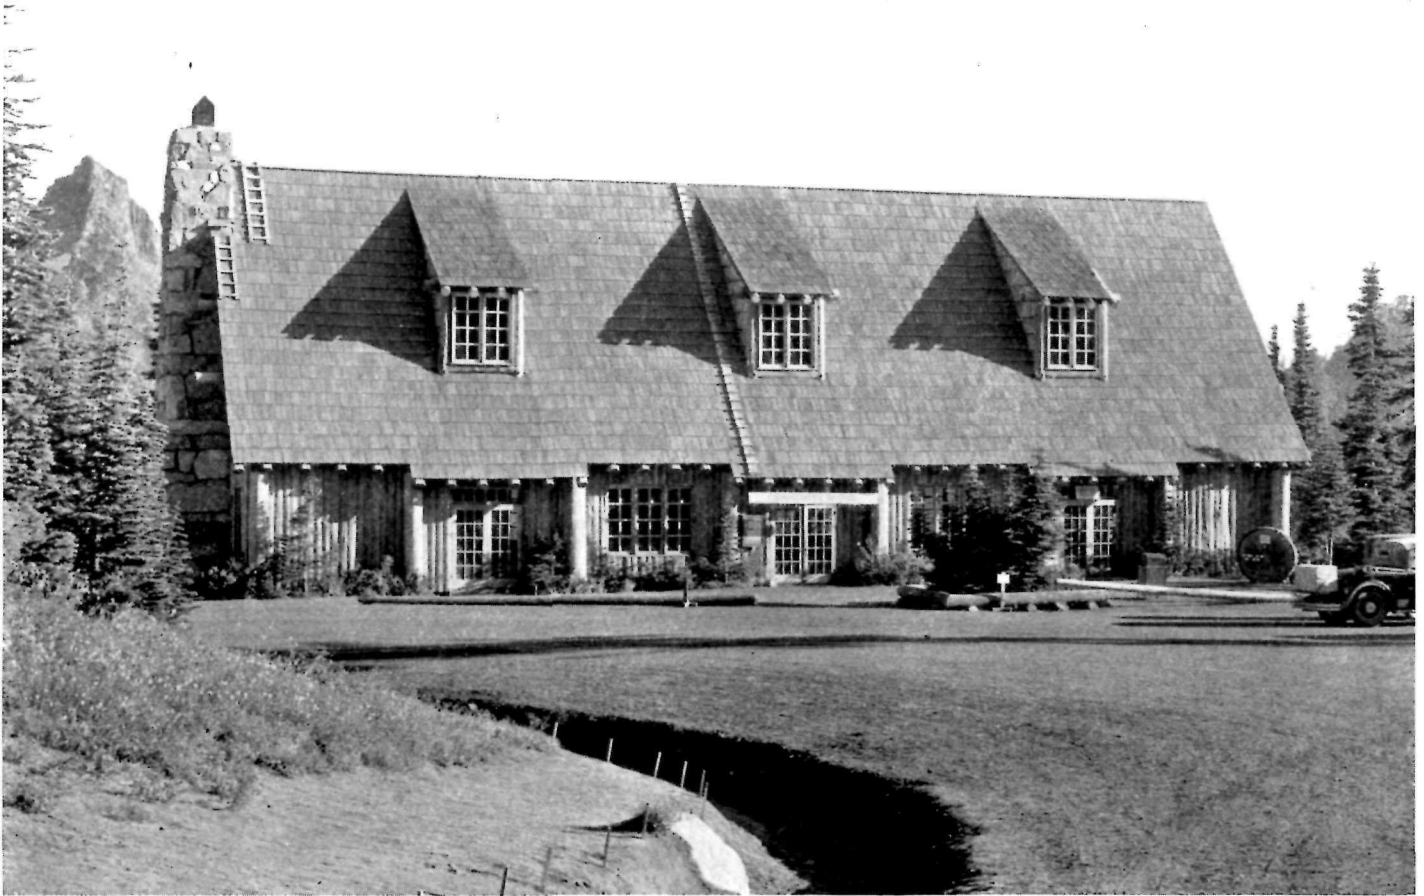
Community Building, Paradise, Mount Rainier National Park

The steepness of the roof of this building, located high up the slope of Mount Rainier, is completely justified by the heavy snowfalls. Features of the plan are the front terrace from which the snow-capped mountain summit can be viewed and the

porch with deck roof at the rear from which the lowlands far below can be seen. A balcony is built across the fireplace end of the main room, and public toilets and living quarters are provided in the lower story.

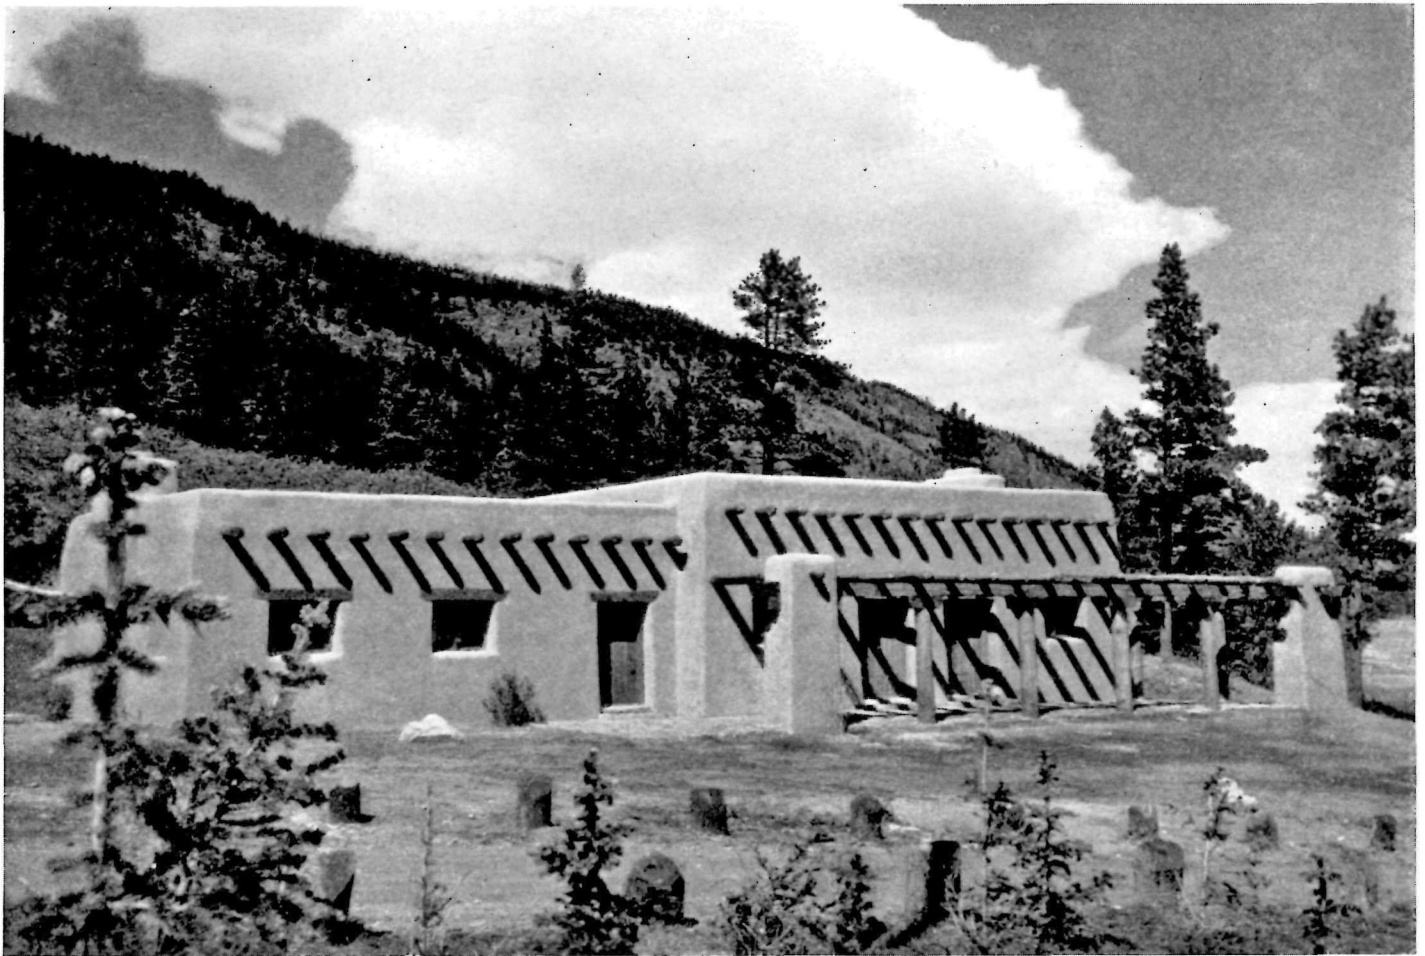
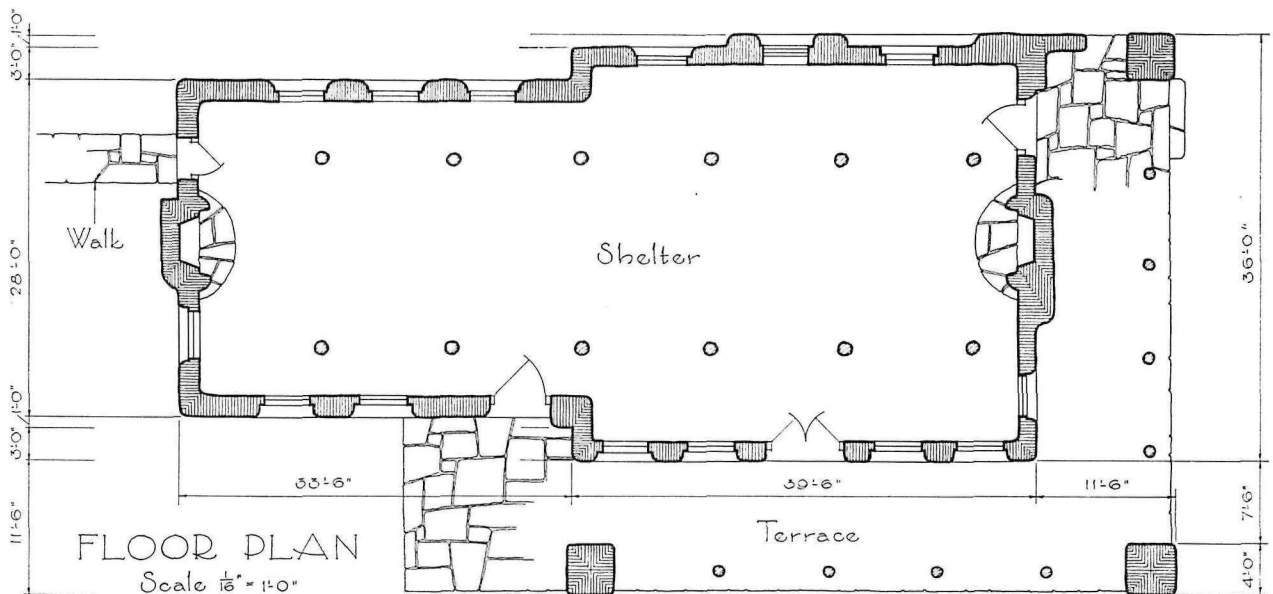
Community Building, Monument Lake Metropolitan Park, Trinidad, Colorado

Lacking any of the dependencies sometimes found in the typical community building of wide purpose, perhaps enclosed shelter is a more exact designation of this stucco-covered adobe structure in the

tradition of the Southwest. The floor plan suggests that the building can be readily remodeled in the future to qualify as a refectory building, or, if a cabin colony were developed around it, as a lodge.
