National Park Service  
Cultural Landscapes Inventory  
2008

Painted Desert Community Complex H.D.  
Petrified Forest National Park

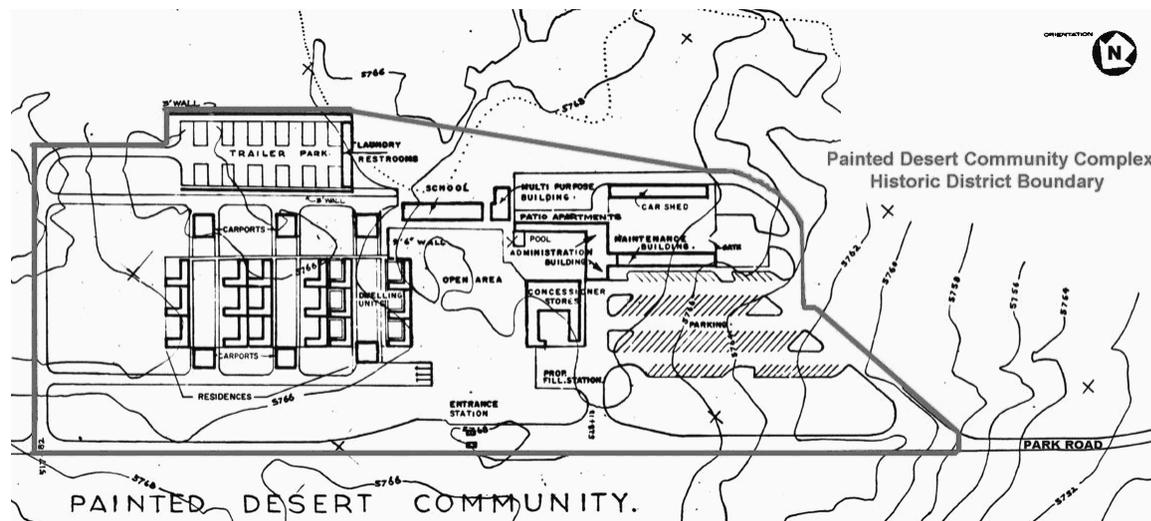
*Painted Desert Community Complex Historic District site plan. The boundary of the district was selected in order to encompass the entire Painted Desert Community Complex. Source: 1960 Master Plan, NPS.*

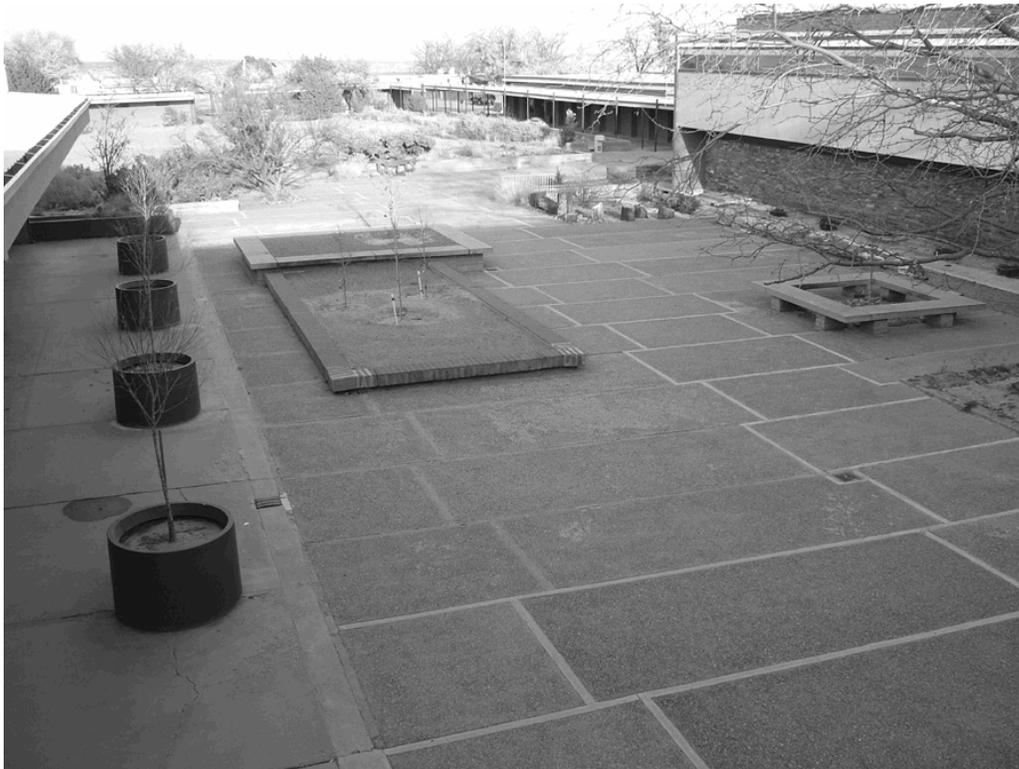
*View of the plaza from the balcony above the Visitor Center, flanked by private spaces, 2005. Source: CLR, photo number DSCF1168.*

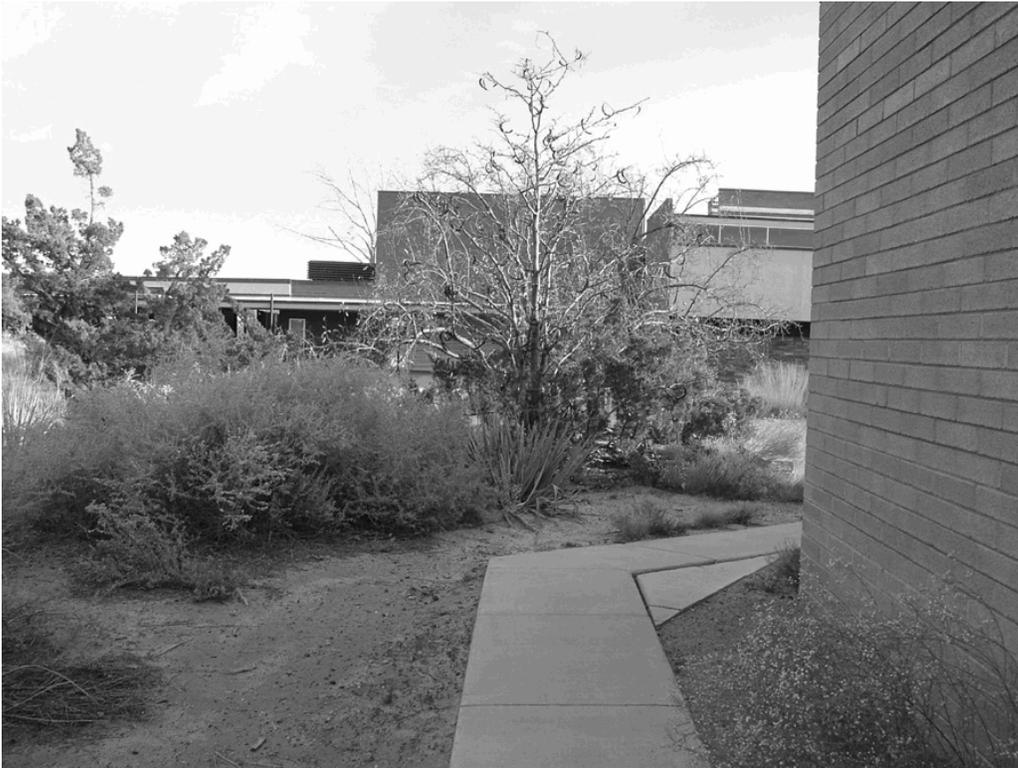
*A concrete path has been constructed, connecting the western parking area with the Concession Building, 2005. Source: CLR, photo number DSCF1149.*

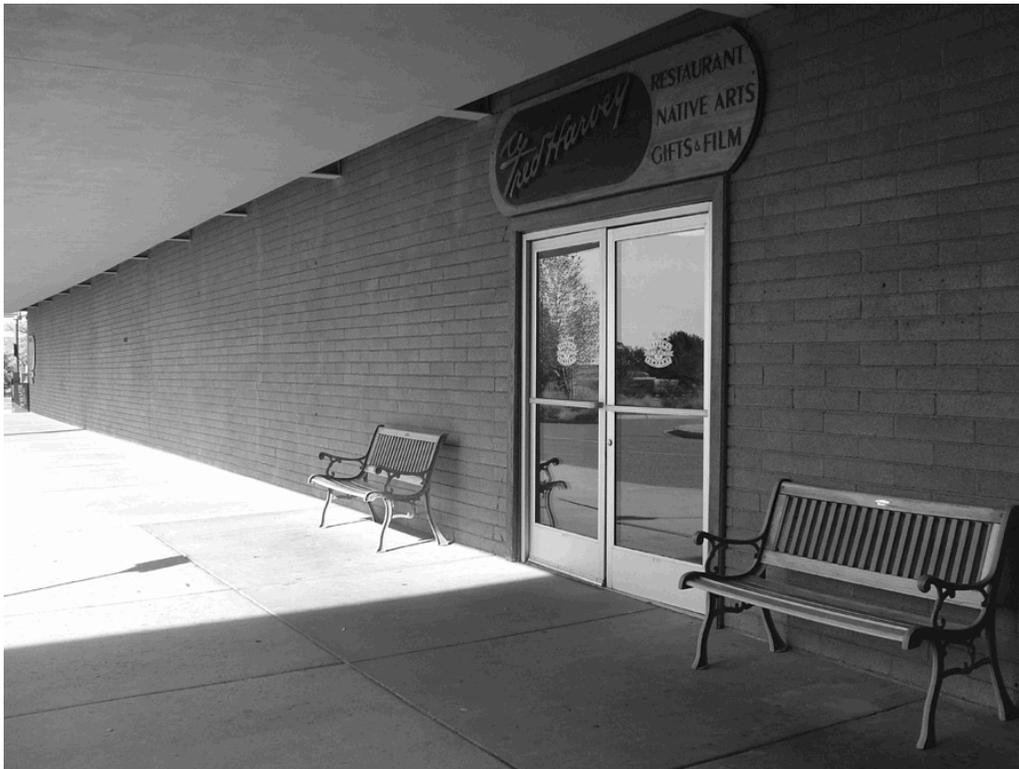
*Fred Harvey Curio Shop with added doorway to provide access from the parking area, 2005. Source: CLR, photo number DSCF1077.*

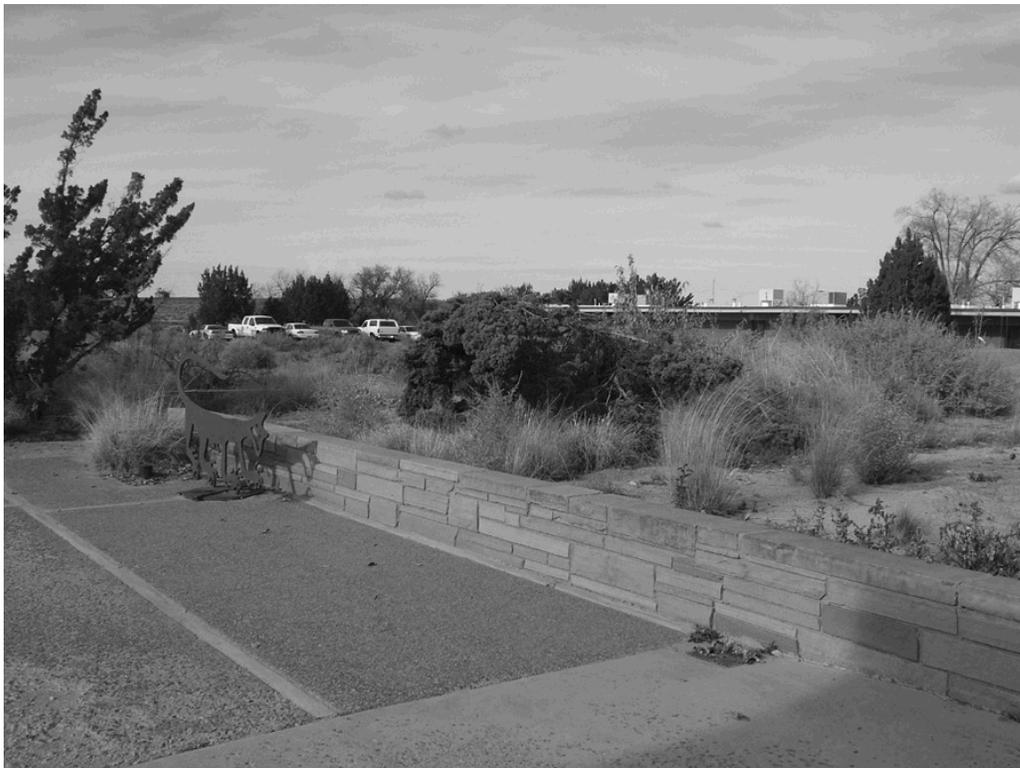
*Existing vegetation surrounding the entrance plaza, 2005. Source: CLR, photo number DSCF1111.*

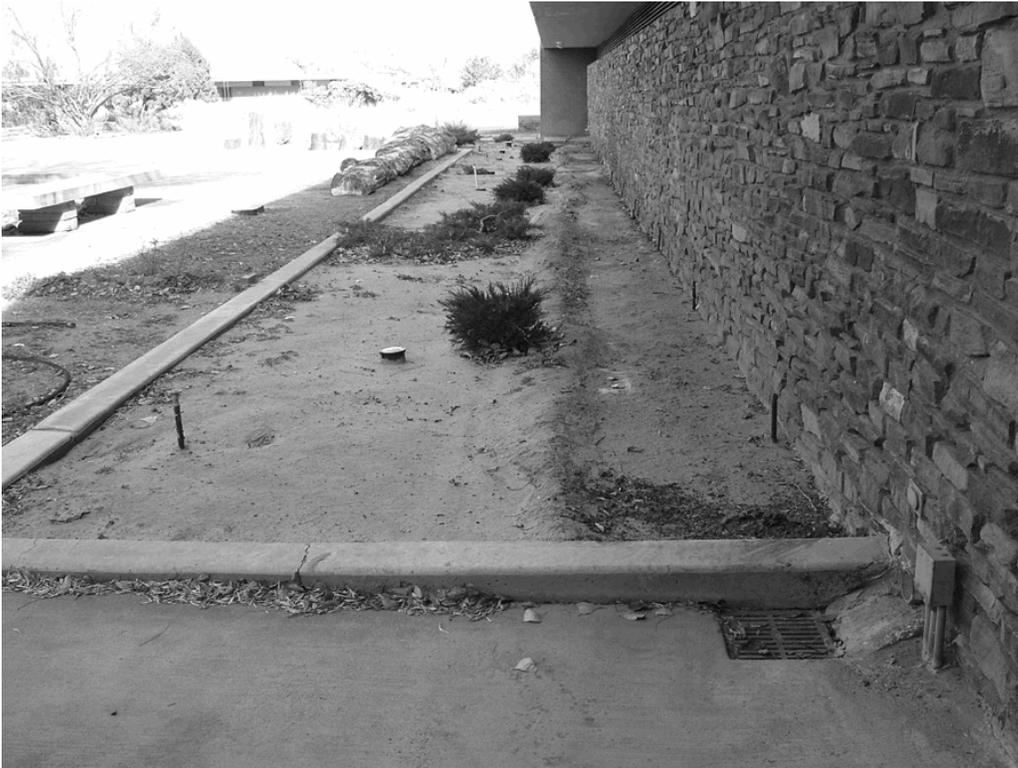
*Several small dwarf creeping junipers (*Juniperus horizontalis procumbens*) are located along the Apartment Wing Building, 2005. Source: CLR, photo number DSCF1081.*
