National Park Service  
Cultural Landscapes Inventory  
2002

Pinnacles East Entrance District  
Pinnacles National Monument

CULTURAL LANDSCAPES INVENTORY (CLI) PROGRAM  
2008 Condition Assessment Update for:

**Pinnacles East Entrance District**  
Pinnacles National Monument

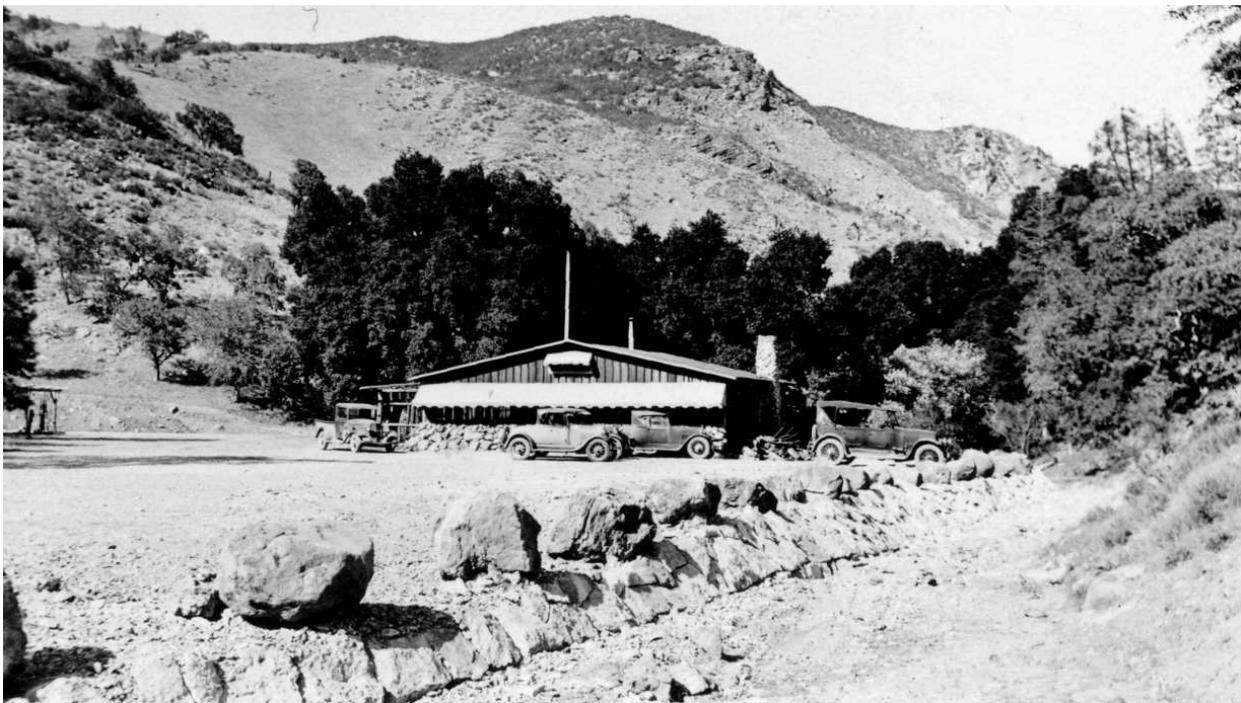
*History #1: Pinnacles Lodge with parking lot and retaining wall, looking north. (PINN archives, in Report, Bell to Vint, 1934)*

Corporation had been granted a license to operate within the monument in 1925, and began providing tent camping facilities, serving meals, and hosting Saturday night dances. The centerpiece of this concessioner development was the Pinnacles Lodge in Bear Gulch. The Pinnacles Lodge was a wood frame building with a broad gabled roof, “ingeniously constructed so that its side walls could be removed to create a large dance floor.” (Oberg, 1979: 157-161) (See photo, History #1)

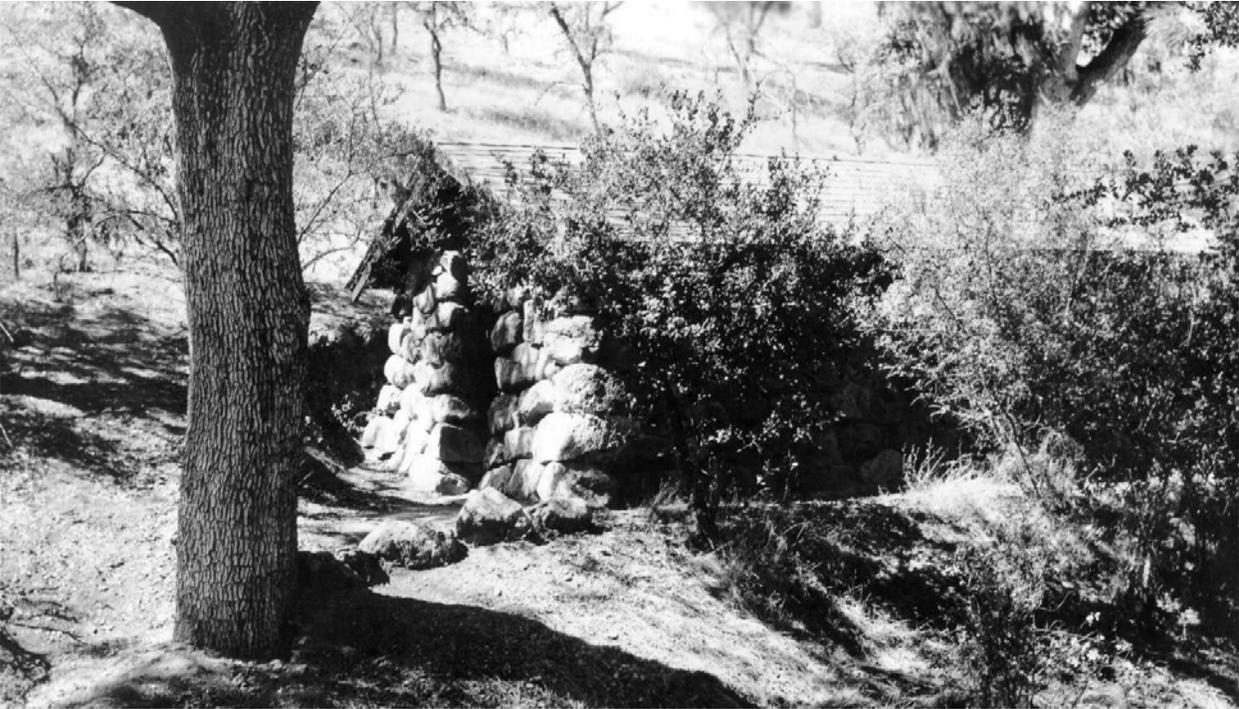
History #2: Restroom in the rustic style, blending with surrounding environment, looking north. (PINN archives, B-23, ca. 1930)

In addition to the established planning principles guiding the road's location, its design reflected classic NPS landscape development practices. Special care was taken to ensure existing landscape features were protected from damage during the road's construction. Techniques to preserve the existing landscape included constructing dry masonry rock wells around the bases of mature trees, shielding trees from blasting, and retaining rock outcroppings. The tops of slopes were rounded to present a naturalistic appearance and to minimize erosion. Stonemasonry on associated structures—culvert headwalls, guardwalls, retaining walls and bridge walls—used local materials and appropriately scaled stones to blend the structures into the surrounding terrain. (See photo, History #2)

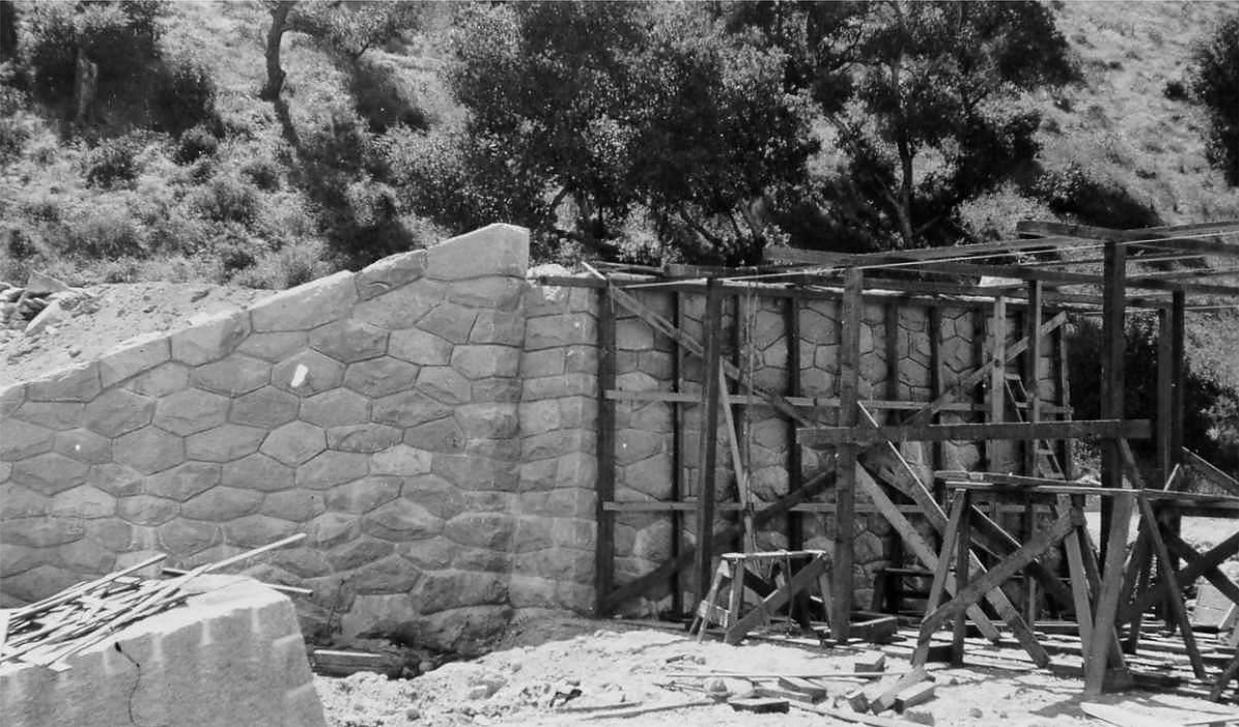
*History #5: Construction of Chalone Creek Bridge, looking north. (PINN archives, in Report, Lange to Chief Architect, 1936)*

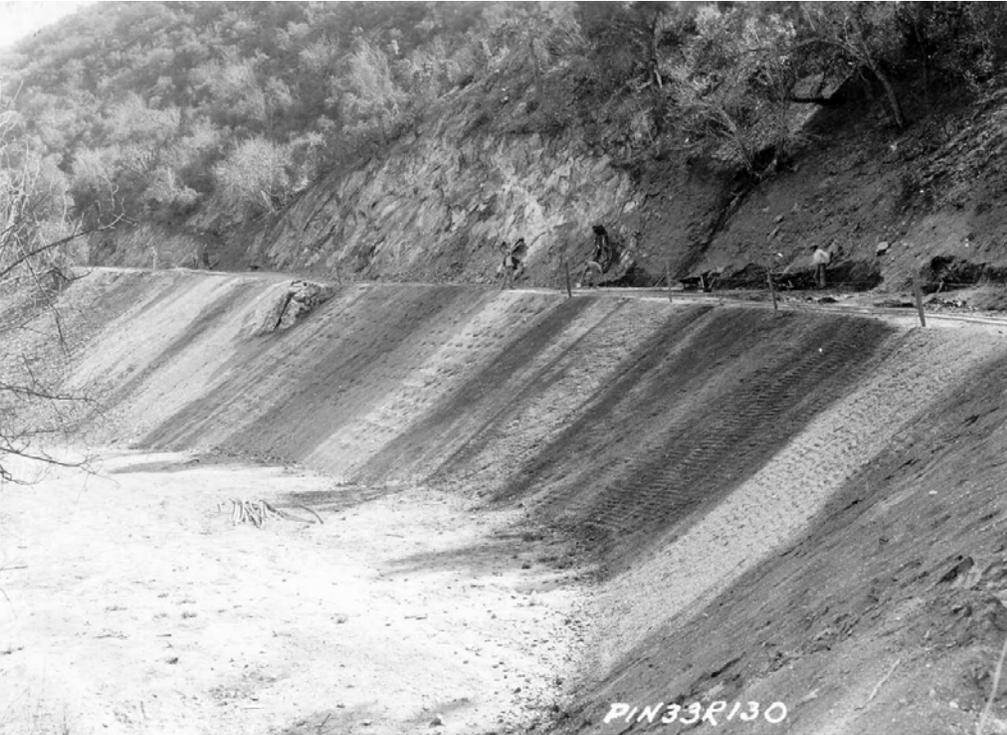
History #6: Slope of embankment just south of Chalone Creek, looking north. (PINN archives, PIN33R130 in Report, Roberts to Kittredge, 1933)

The road banks were graded on a 1:1 slope, and in cuts through solid rock, to a slope of 1:4. Cuts through loose rock were graded on a slope of 1:2. No embankment slope exceeded an incline of 1½:1. (See photo, History #6) Large rocks encountered during excavation were stockpiled for use in masonry projects: for bridge, culvert and building veneers, as well as rock fireplaces in the picnic areas. NPS project landscape architect, Thomas Carpenter, recommended that the slopes on a large fill section between where the road ascended Bear Gulch after turning past Chalone, should be planted with “readily collect(able)” native materials, including wild cherry, greasewood (chamise), elderberry and buckeye.

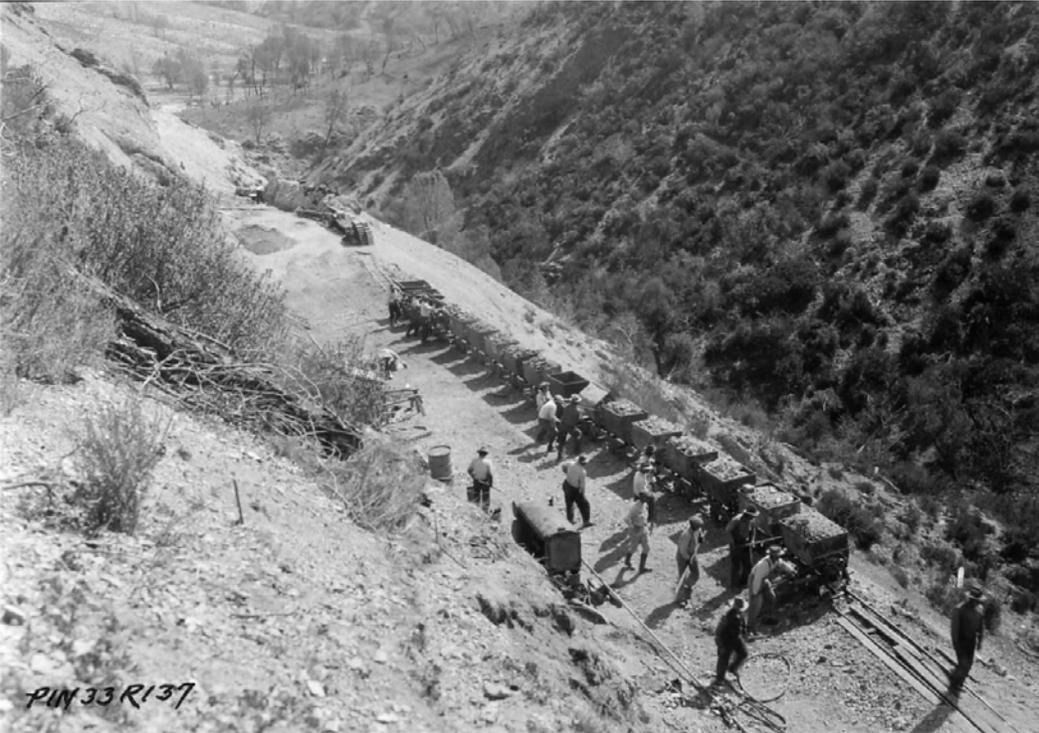
History #7: Removing rock from road section to be paved, looking east. (PINN archives, PIN33R134, 1933)

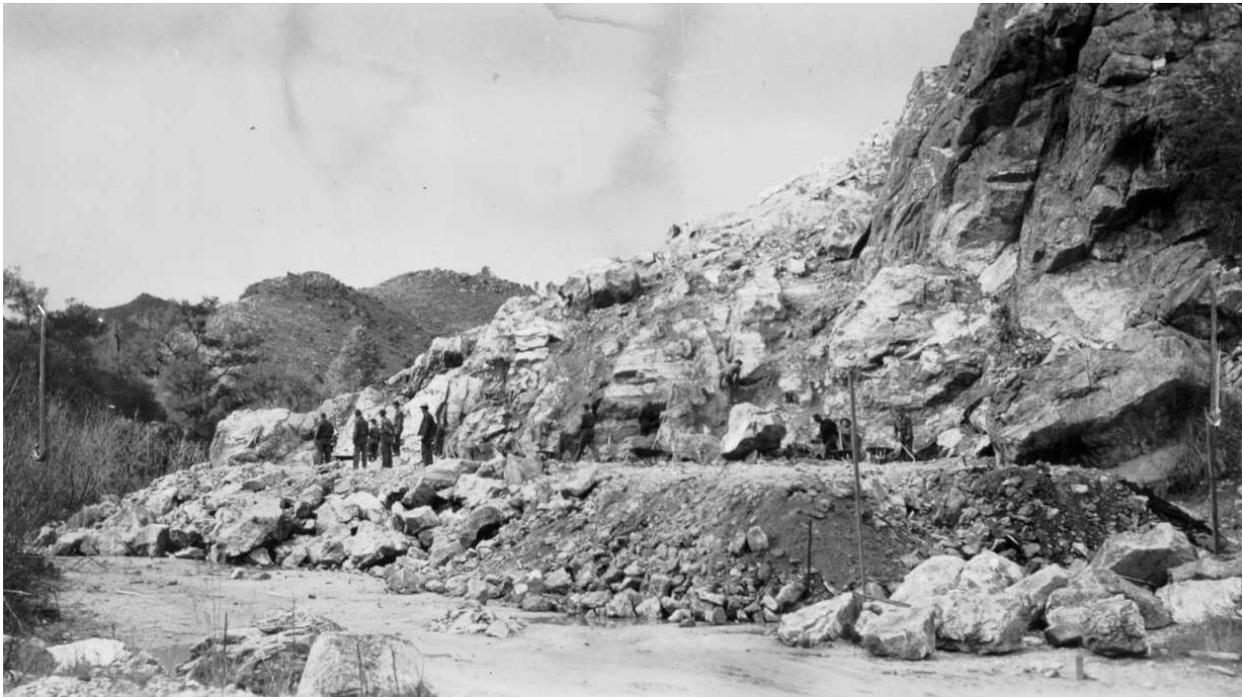
*History #8: Heavy rock cut on road to Old Pinnacles, looking north. (PINN archives, in Report, McKown, May 25, 1938)*

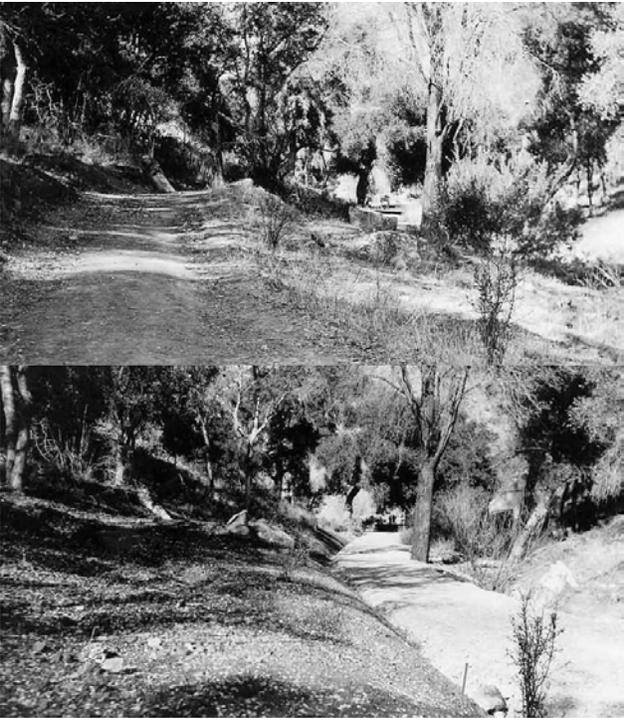
*Topography #3: Comparison of Condor Gulch Road following realignment and obliteration, looking northwest. (PINN archives, in Report, Bell to Chief Architect, May, 1934: 13)*

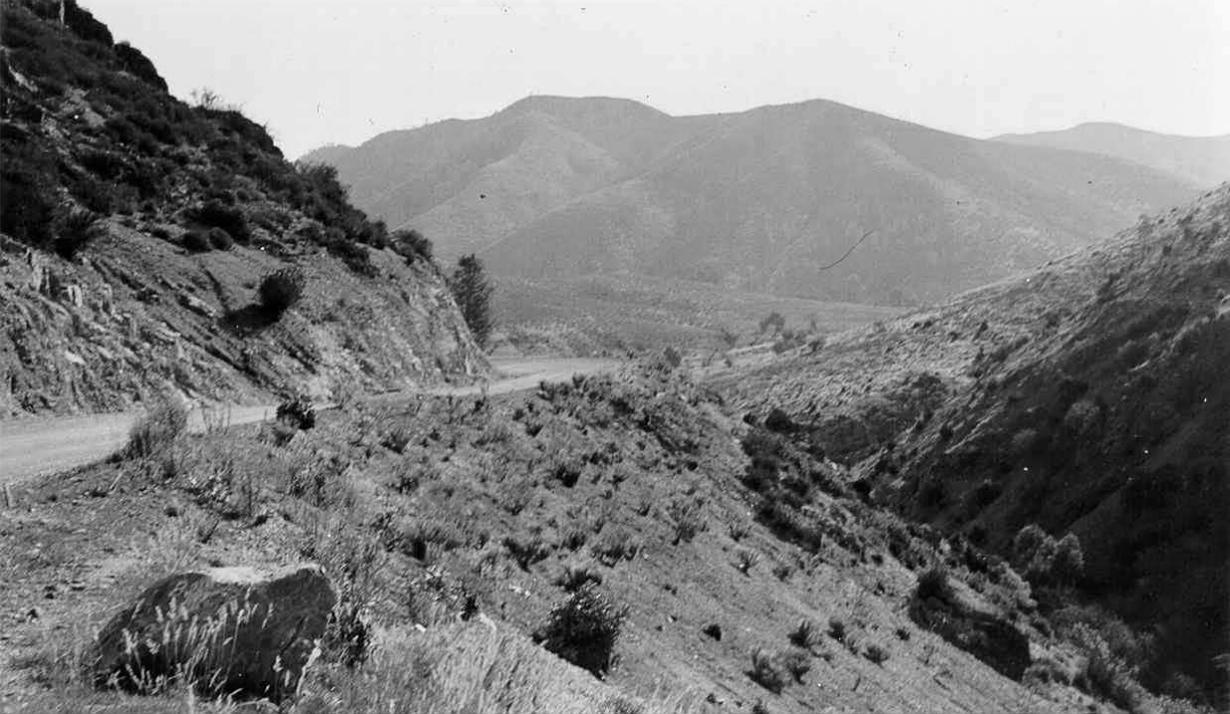
*Vegetation #1: Replanted fill slope along Bear Gulch Road, looking southeast. (PINN archives, in Report, Lange to Chief Architect, May 1936:10)*

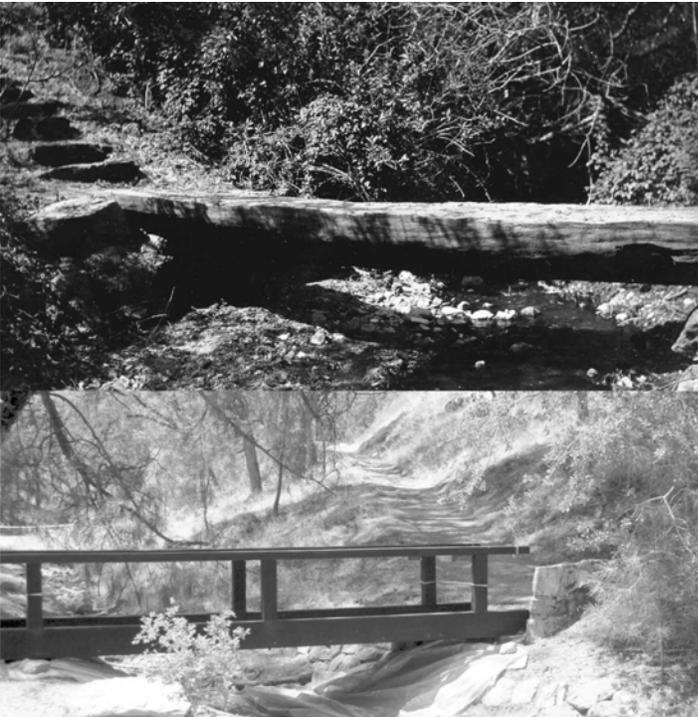
*Circulation #3: Original log footbridge and contemporary footbridge. (In report, McKown to unknown, July 1937, and PGSO, CLI, PINN-N-0006-31, 2001)*

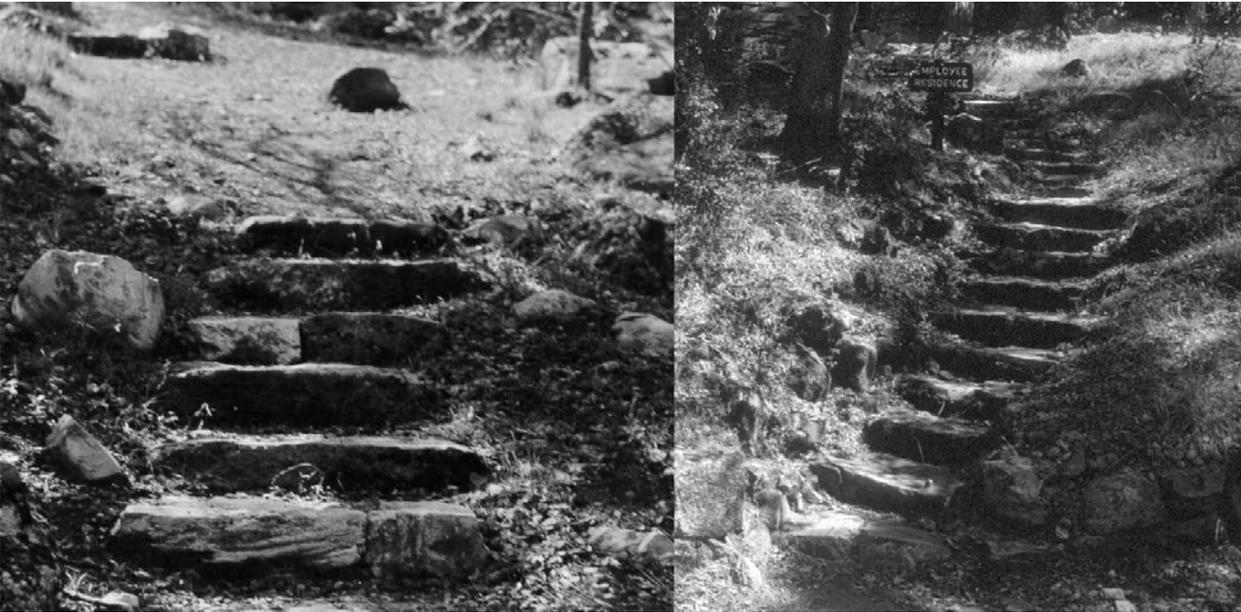
*Circulation #4: Stone stairway to Chief Ranger Residence, original and contemporary, looking south. (In Report, Lange to Kittredge, May 1935, and PGSO, CLI, PINN-S-0002-7, 2001)*

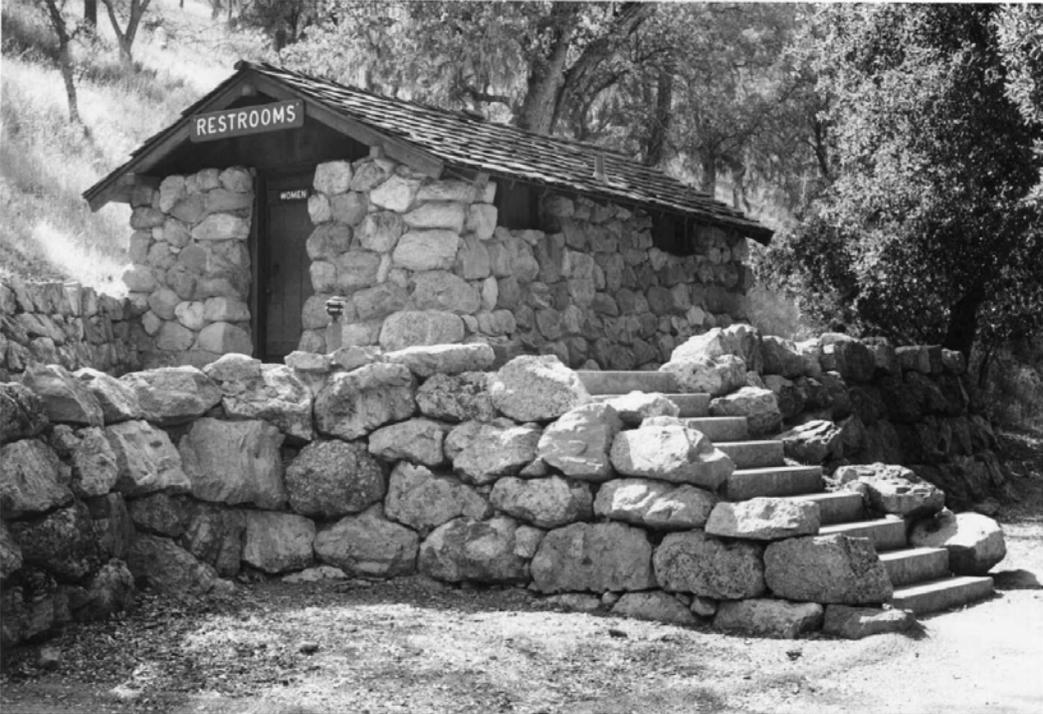
*Buildings and Structures #2: Bear Gulch Comfort Station with stair and ramp additions, looking west. (PGSO, LCS #PI-1-19, 1994)*

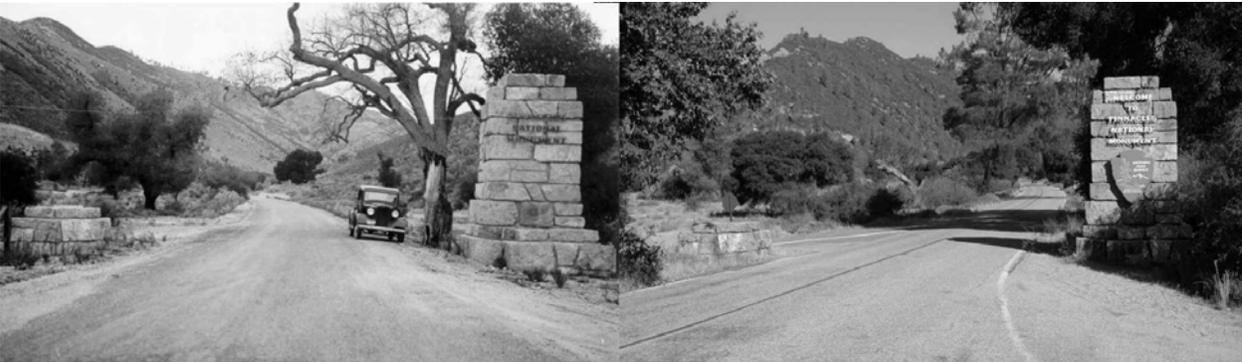
*Buildings and Structures #5: Historic and contemporary comparison of entrance pylons, looking southwest. (PINN archives, #P-4-3, 1938, and PGSO, CLI, PINN-S-0003-25, 2001)*

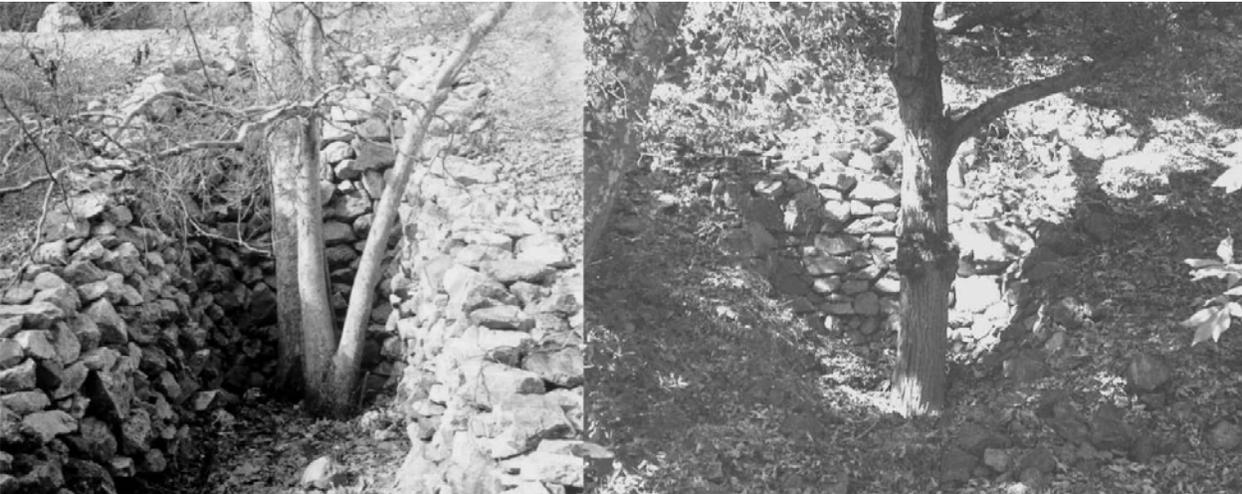
*Buildings and Structures #6: Historic and contemporary comparison of representative masonry tree wells. (PINN archives, #33R86, and PGSO, CLI, PINN-N-0005-01, 2001)*

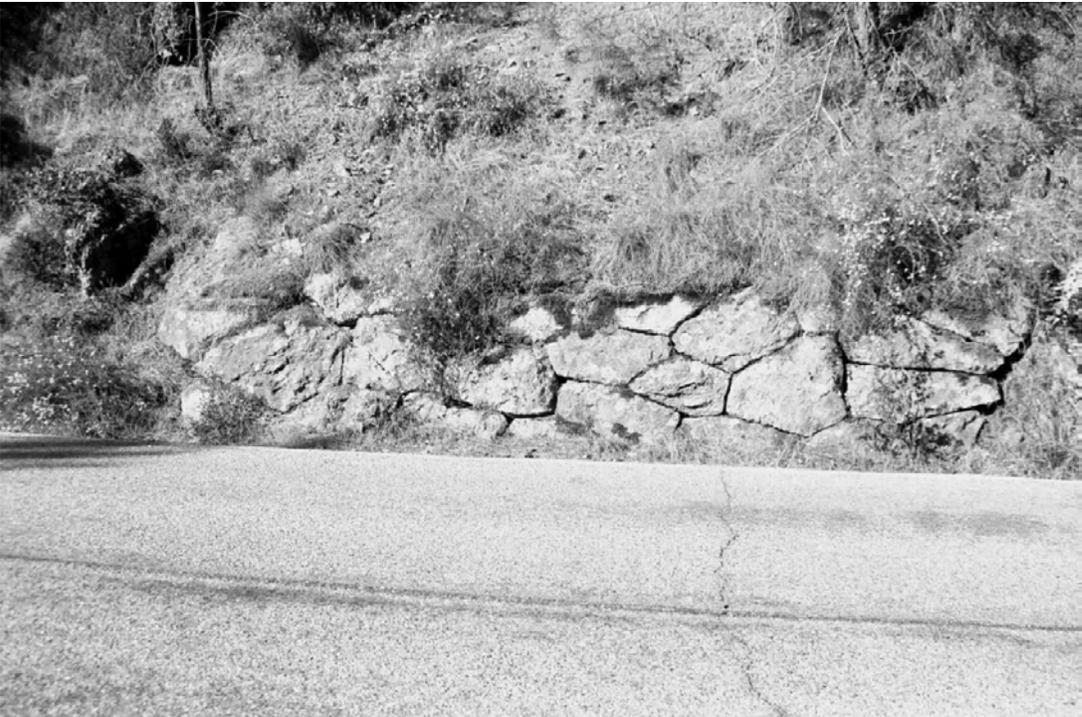
*Buildings and Structures #7: Drylaid stone masonry wall along Bear Gulch Road, looking north. (PGSO, CLI, PINN-N-0004-25, 2001)*

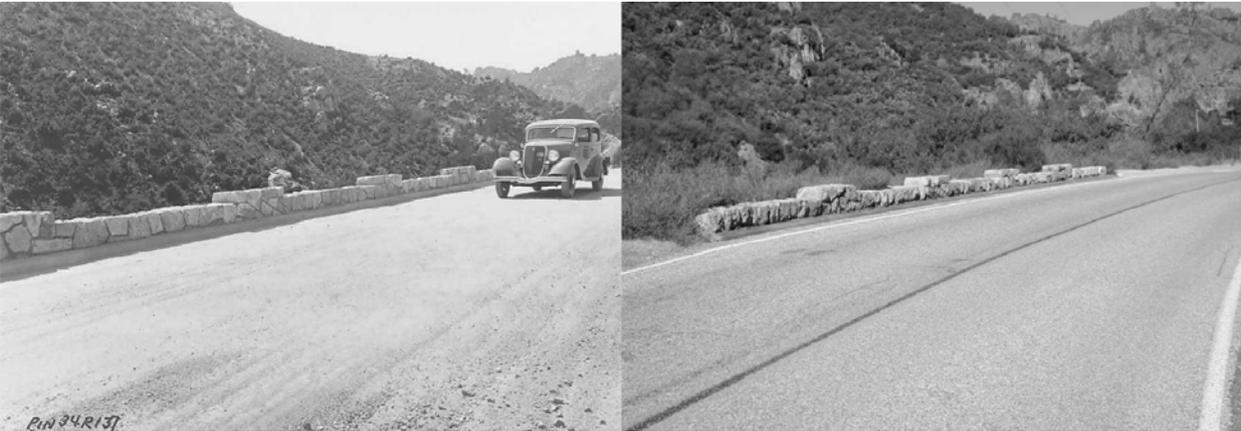
*Buildings and Structures #8: Historic and contemporary comparison of stone guardwall along Bear Gulch Road, looking west. (PINN archives, photo #34R137, 1934, and PGSO, CLI, PINN-N-0004-30, 2001)*

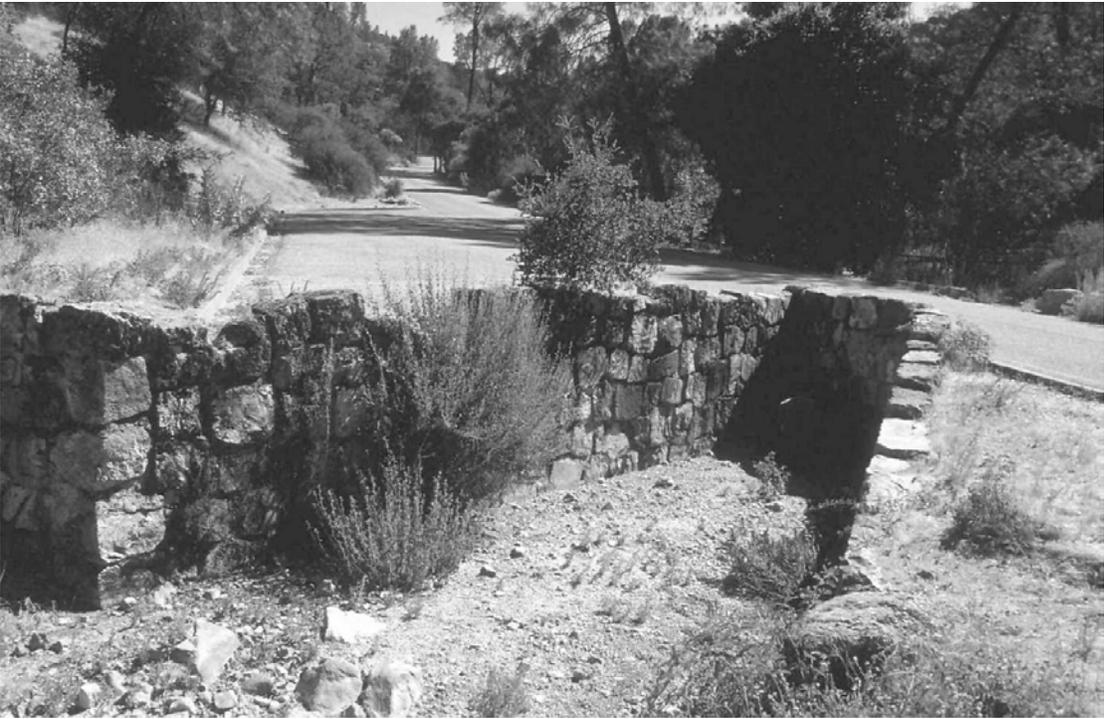
*Buildings and Structures #9: Poured concrete and stone veneered box culvert with wingwalls, under Bear Gulch Road, looking west. (PGSO, CLI, PINN-S-0002-15, 2001)*

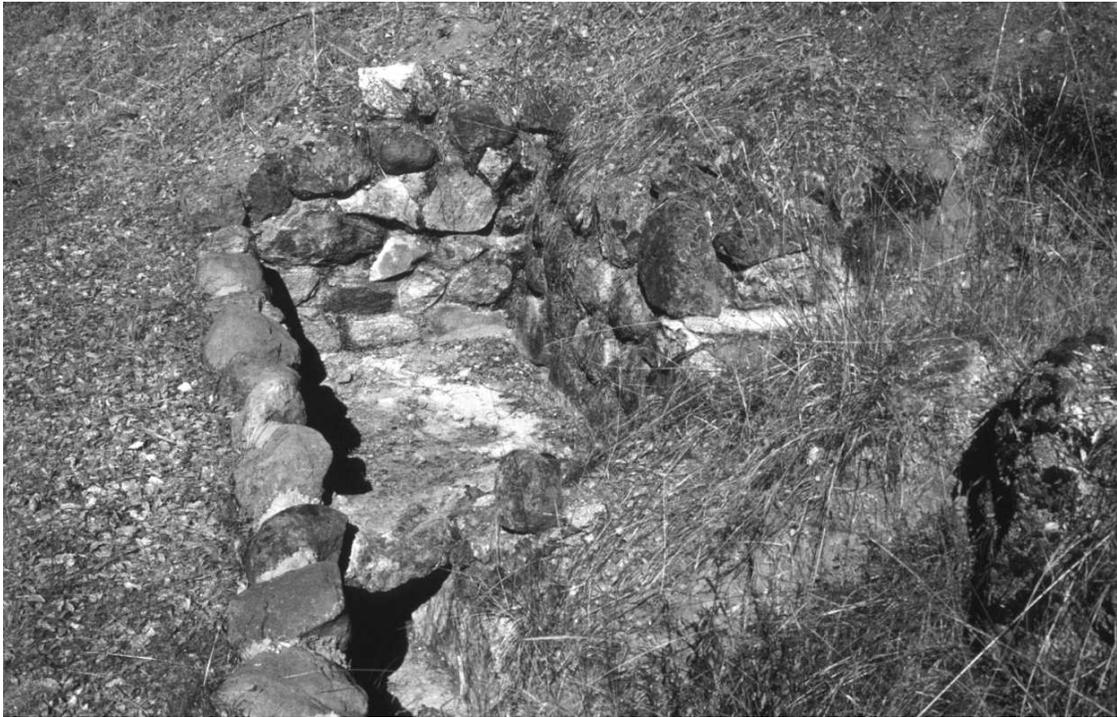
*Buildings and Structures #10: Headwall/Catchbasin on Bear Gulch Road. (PGSO, CLI, PINN-S-0002-12, 2001)*

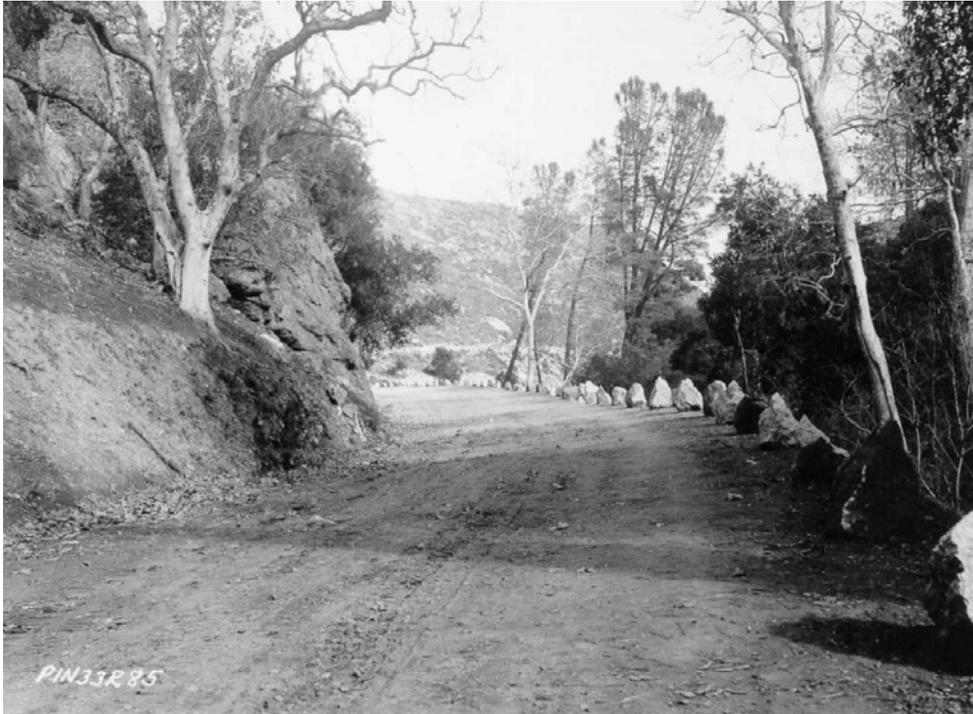
*Small Scale Features #1: Boulder barriers along Bear Gulch Road, looking northeast. (PINN archives, #33R85, 1933)*

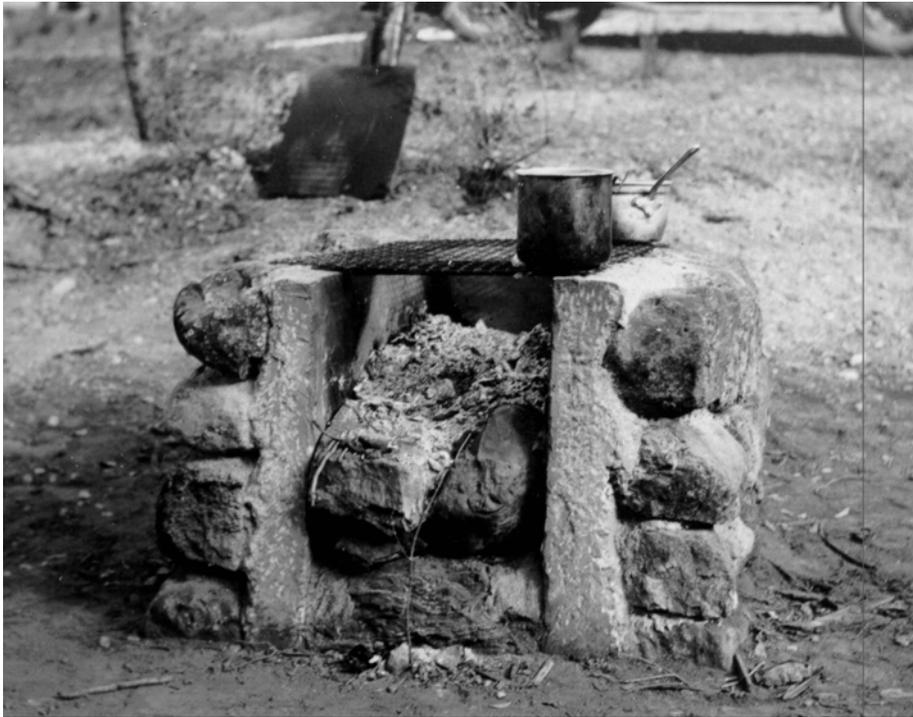
*Small Scale Features #2: Stone fireplace (barbeque). (In Report, Bell to Kittredge, May, 1934)*

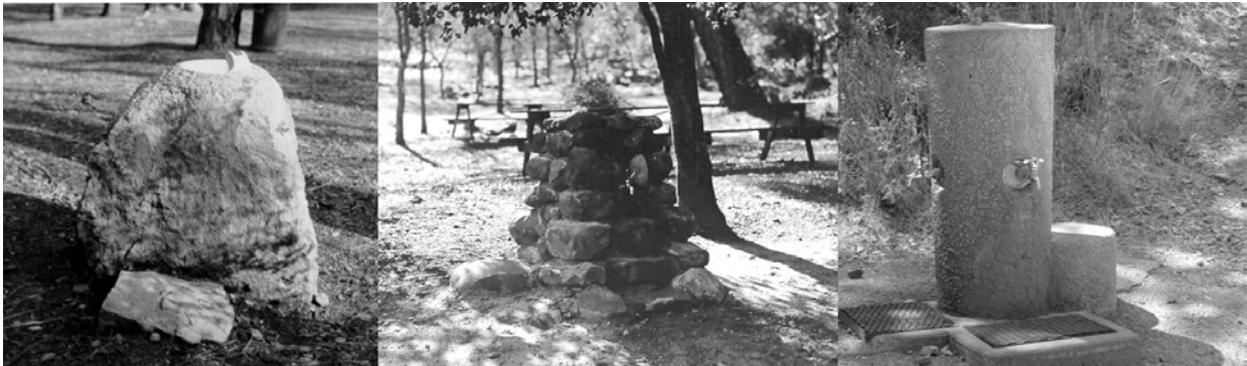
*Small Scale Features #3: Comparison of historic and contemporary drinking fountains. (In Reports, Lange to Chief Architect, May 1937 and January 1936, and PGSO, CLI, DSCN0541, 2000)*

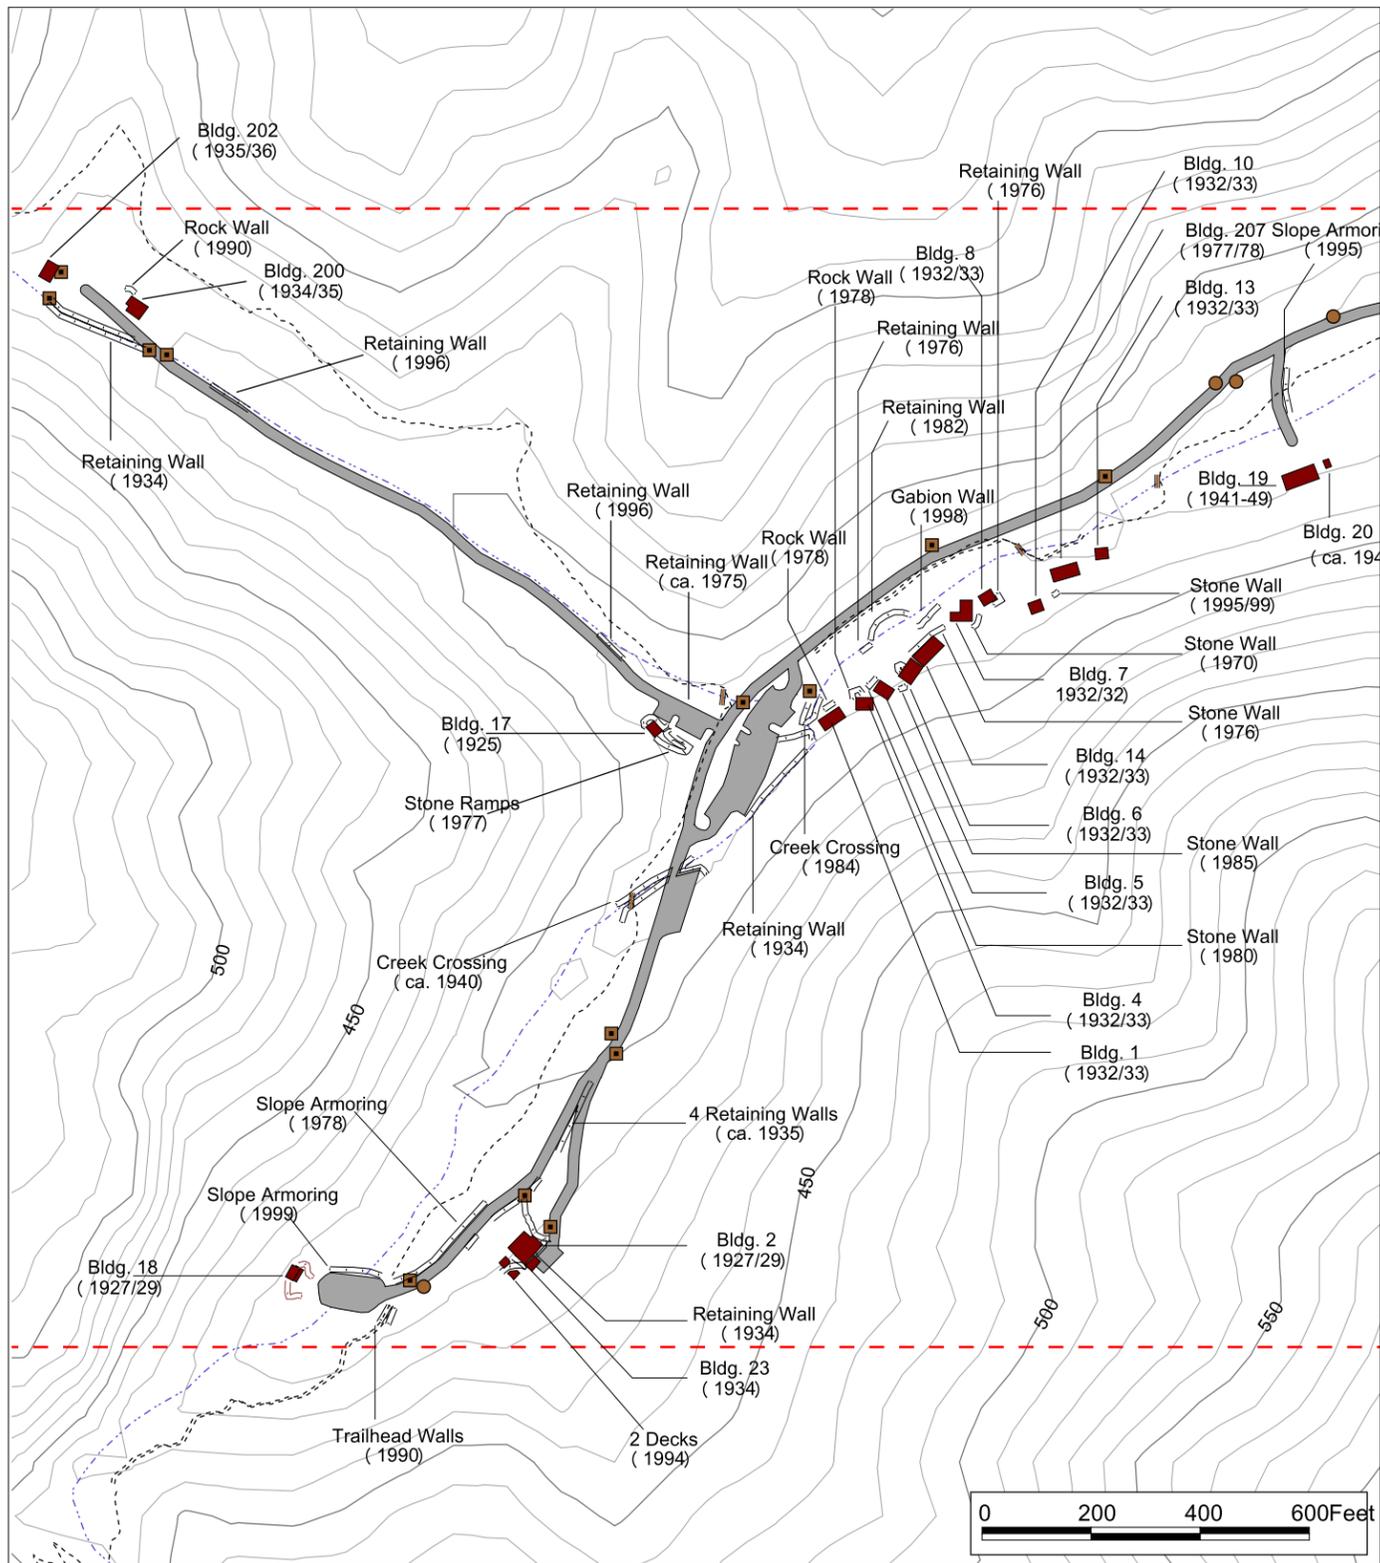
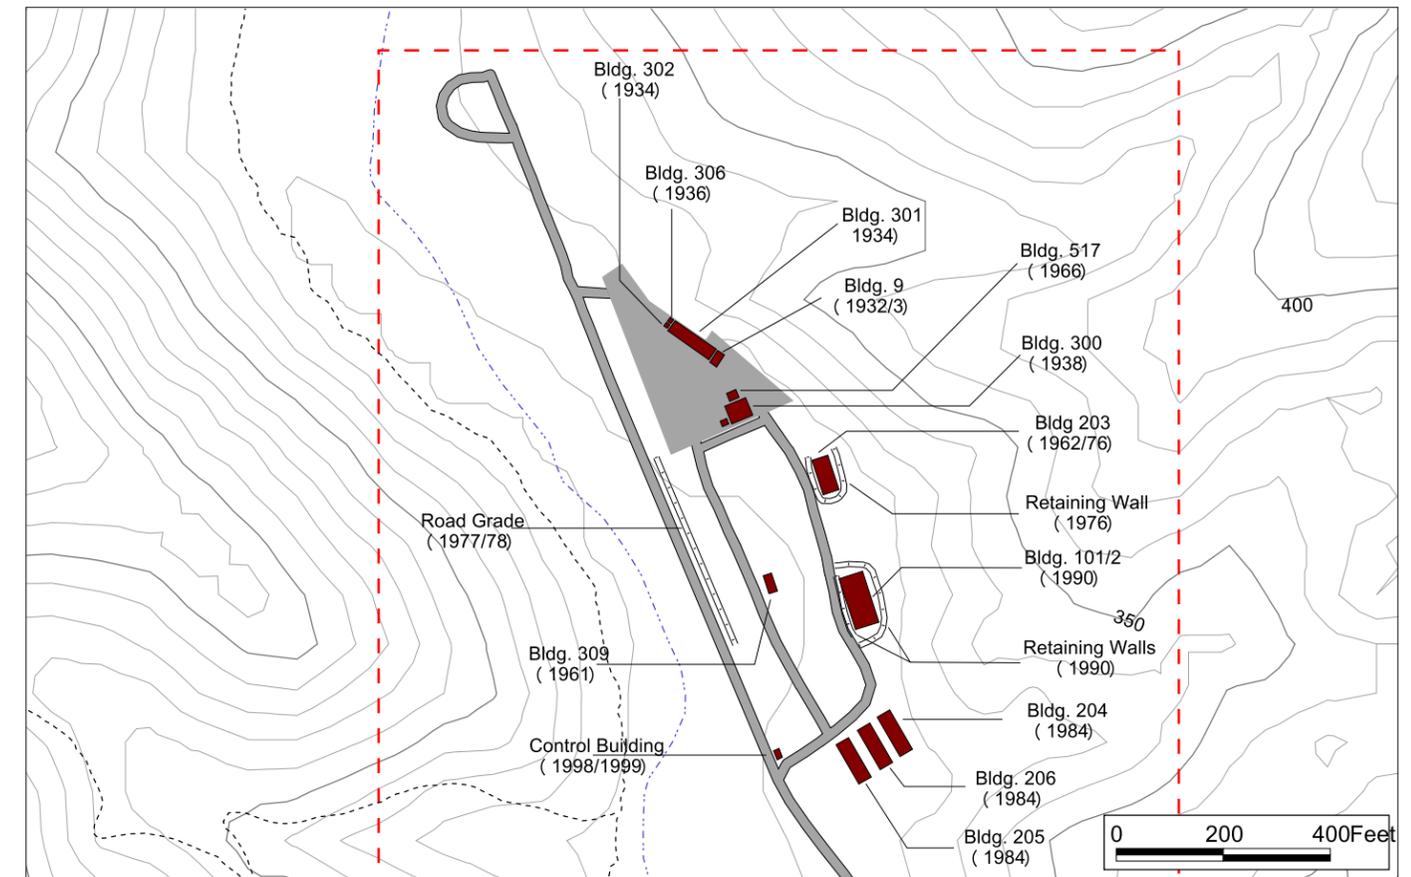
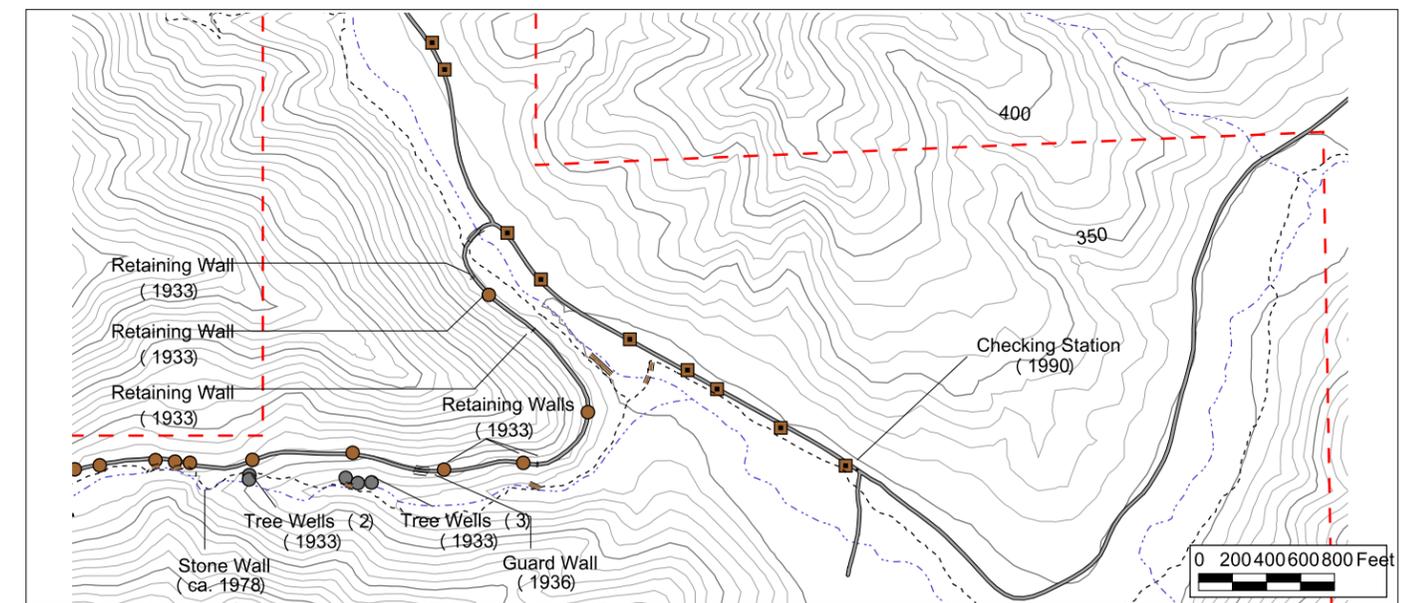
Supplemental Information #2 - Buildings and Structures Map  
 Pinnacles East Entrance Historic District  
 Cultural Landscape Inventory  
 June 2002

Note: Data obtained through a combination of GPS, field observation, and map comparison.
