National Park Service  
Cultural Landscapes Inventory  
2004

A Ranch  
Point Reyes National Seashore

# Cultural Landscape Inventory: A Ranch

**POINT REYES RANCHING DISTRICT**  
**A RANCH COMPONENT LANDSCAPE**  
POINT REYES NATIONAL SEASHORE

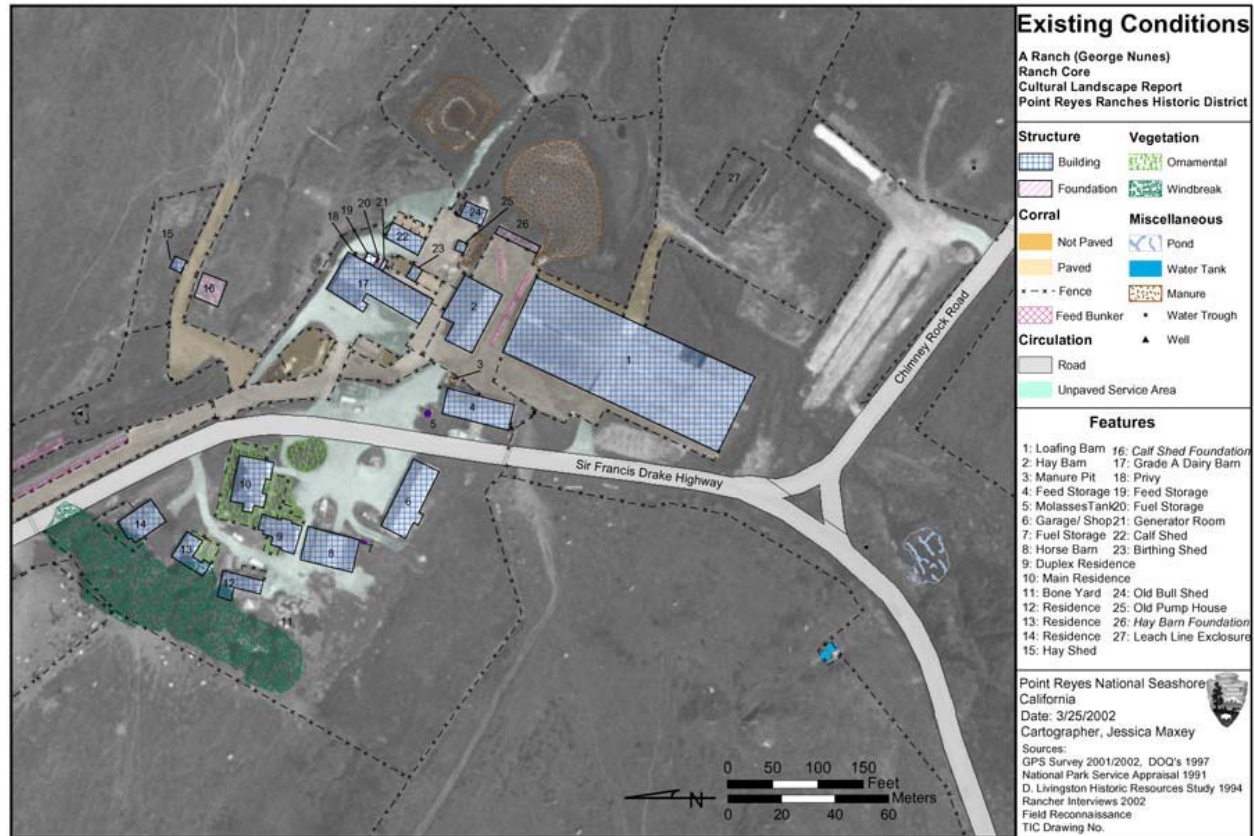
An existing conditions site map of the ranch core at A Ranch. A larger version is located in the Appendix.

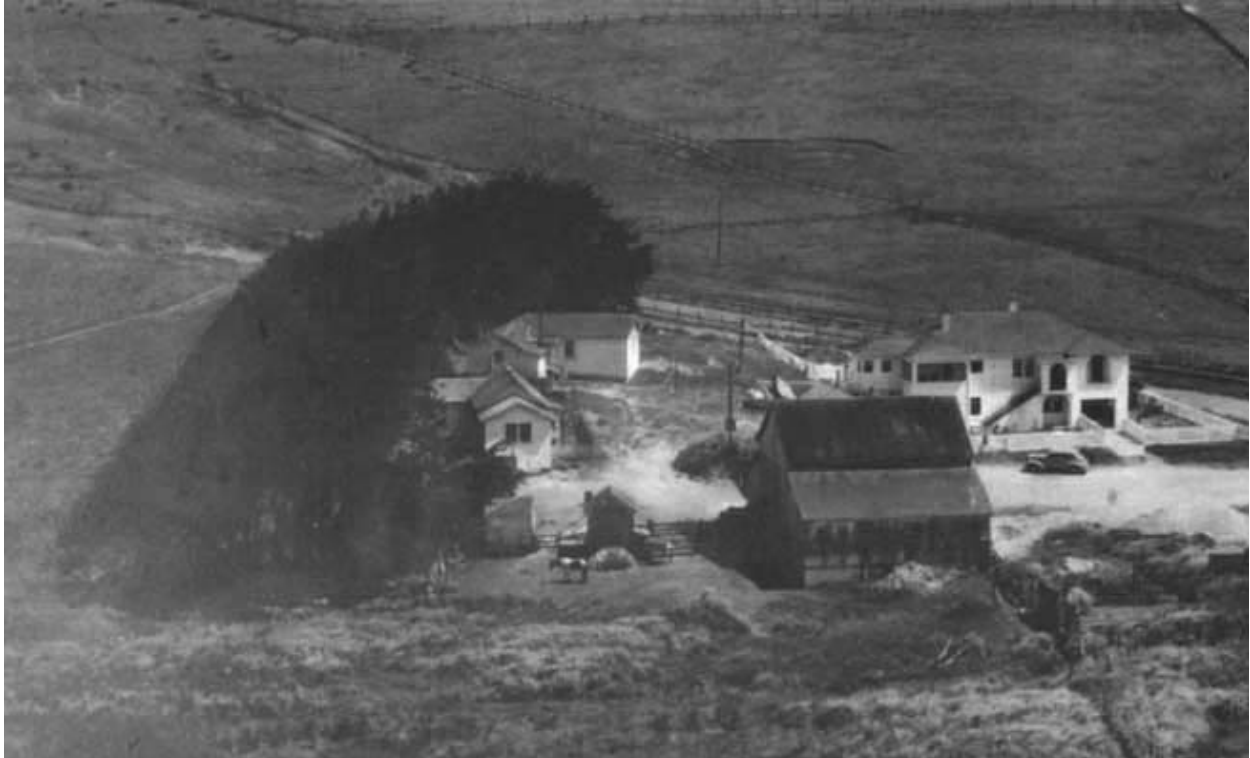
*Circa 1950 aerial photograph, showing the cluster of residential buildings within the ranch core (Nunes Family Collection).*

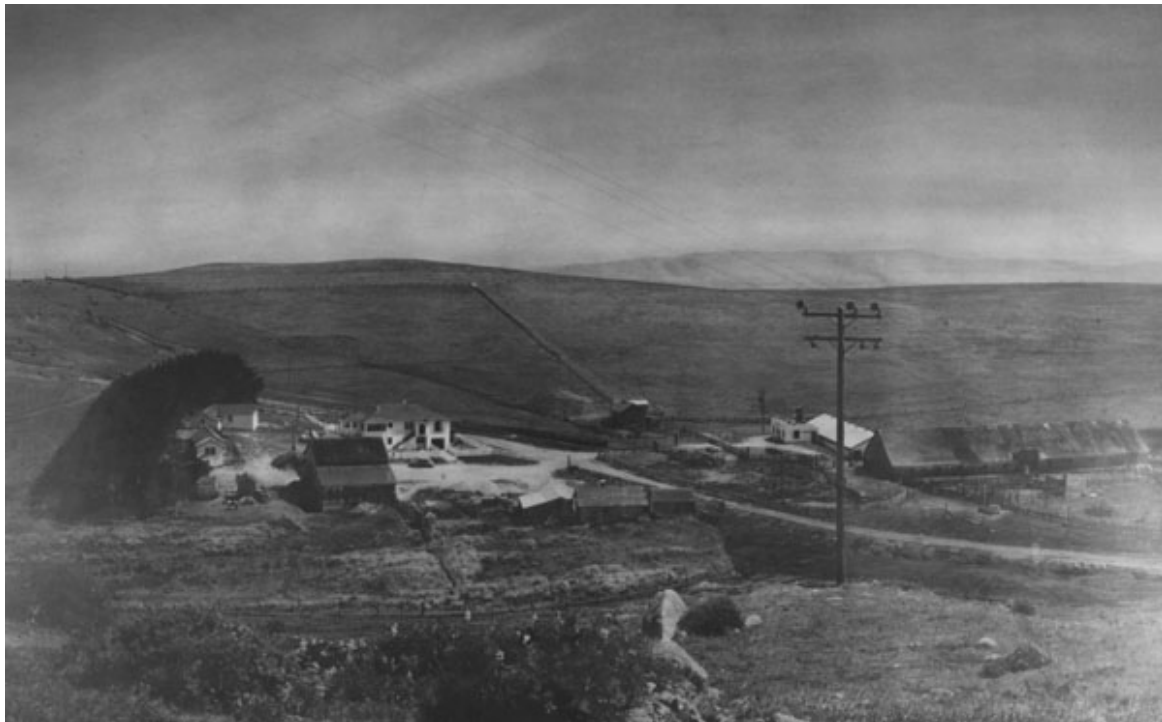
*Circa 1950 aerial photo showing the A Ranch core buildings situated within the rolling hills in the southwest end of the peninsula. (Nunes Family Collection)*

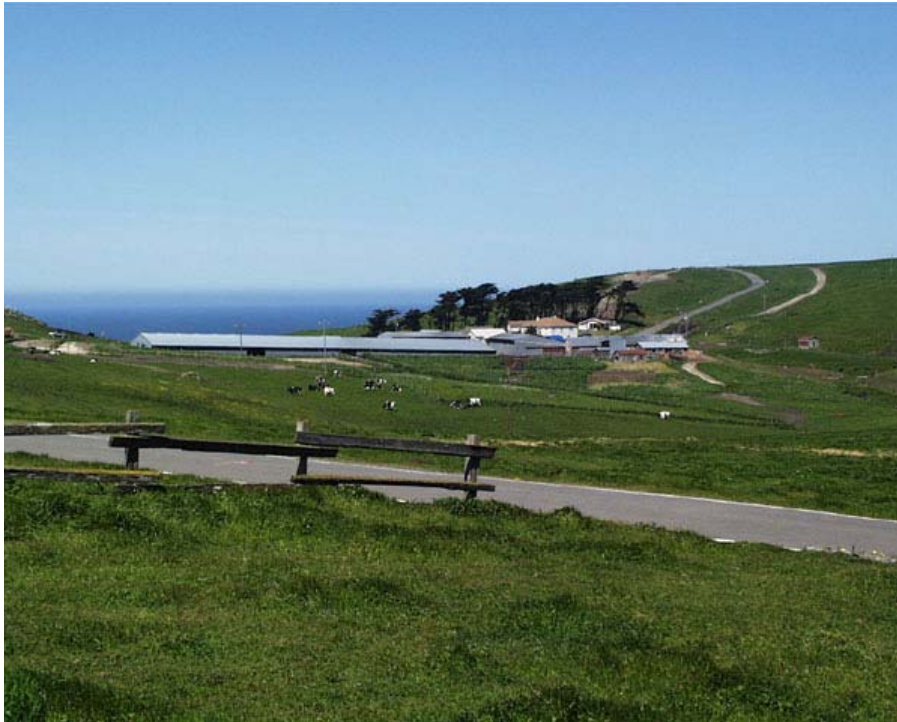
*Photo showing A Ranch buildings in relation to the landscape today. (PWRO, 2002)*

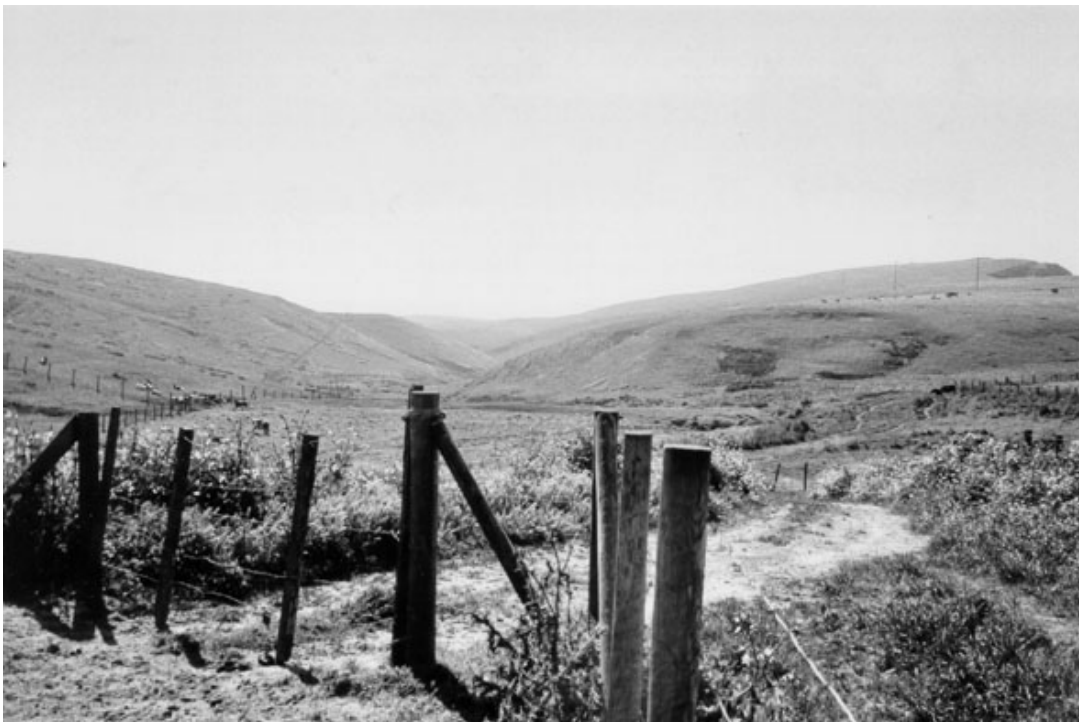
*Photo showing natural drainage patterns from the working area of the ranch to Drakes Bay in the distance. (PWRO, 2002)*

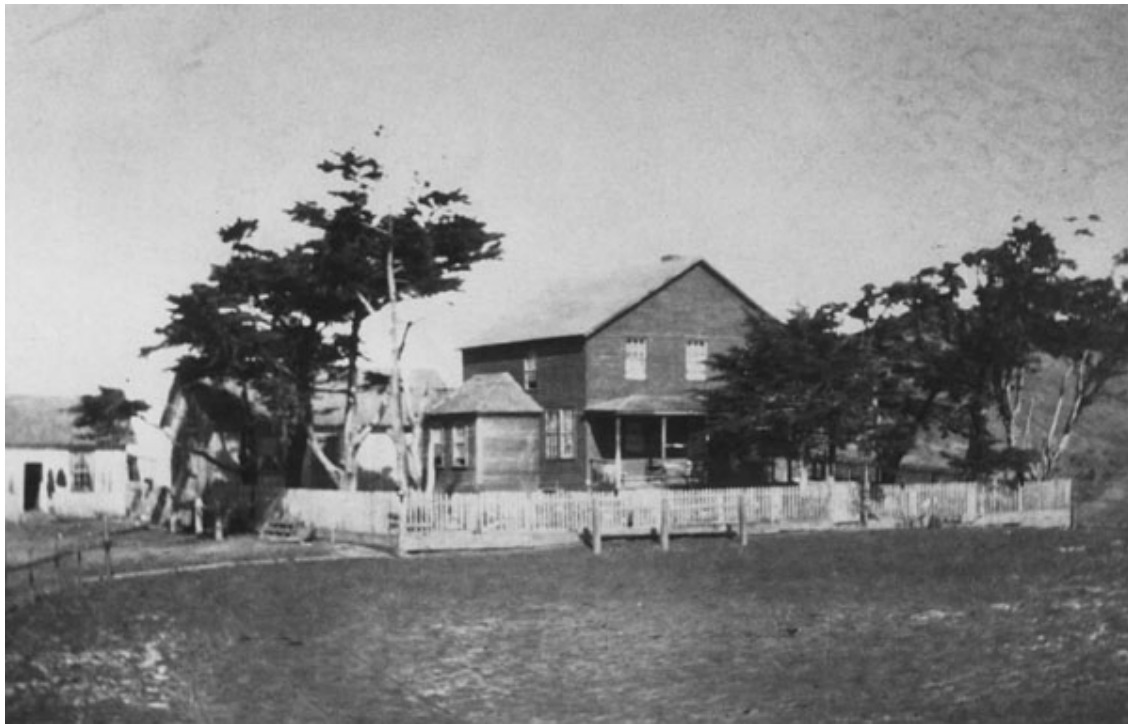
*Circa 1902 photo shows a picket fence around the initial main residence and yard. Monterey Cypress and low-growing vegetation, within the yard, distinguishes the residential area from the working area of the ranch. (Katie Bates Collection, PORE)*

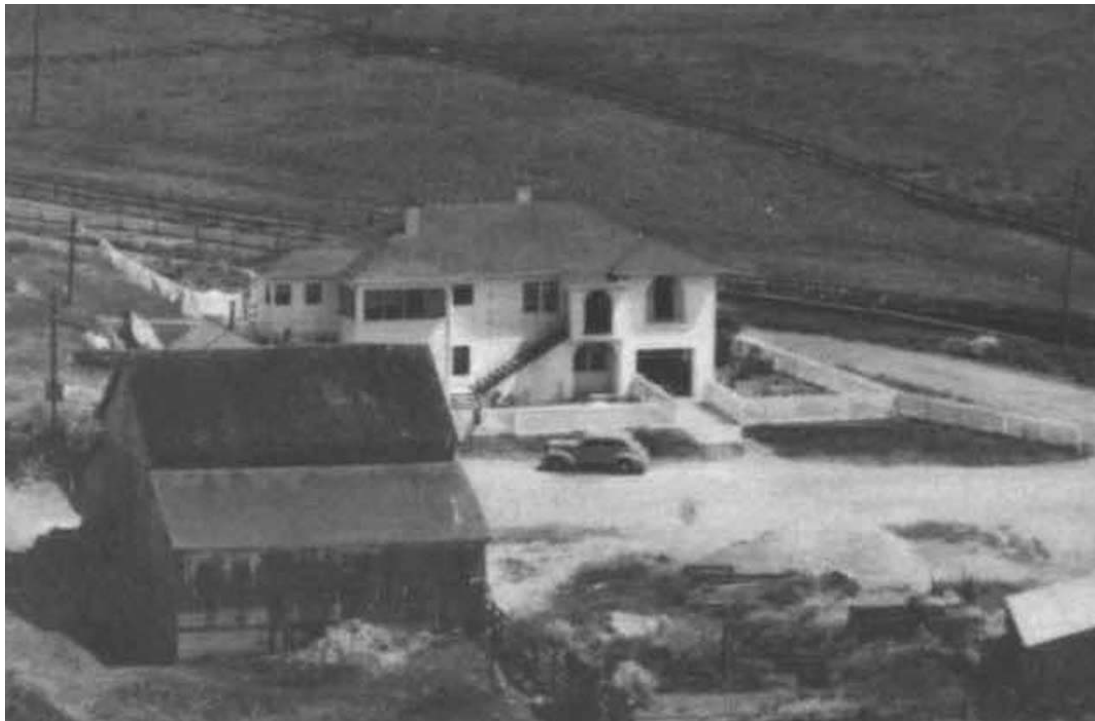
*Circa 1950 aerial photo showing a picket fence surrounding the 1945 main residence yard at the same site as the original house. In the fenced yard, lawn and perennials were planted along the fence and the foundation of the house. (Nunes Family Collection)*

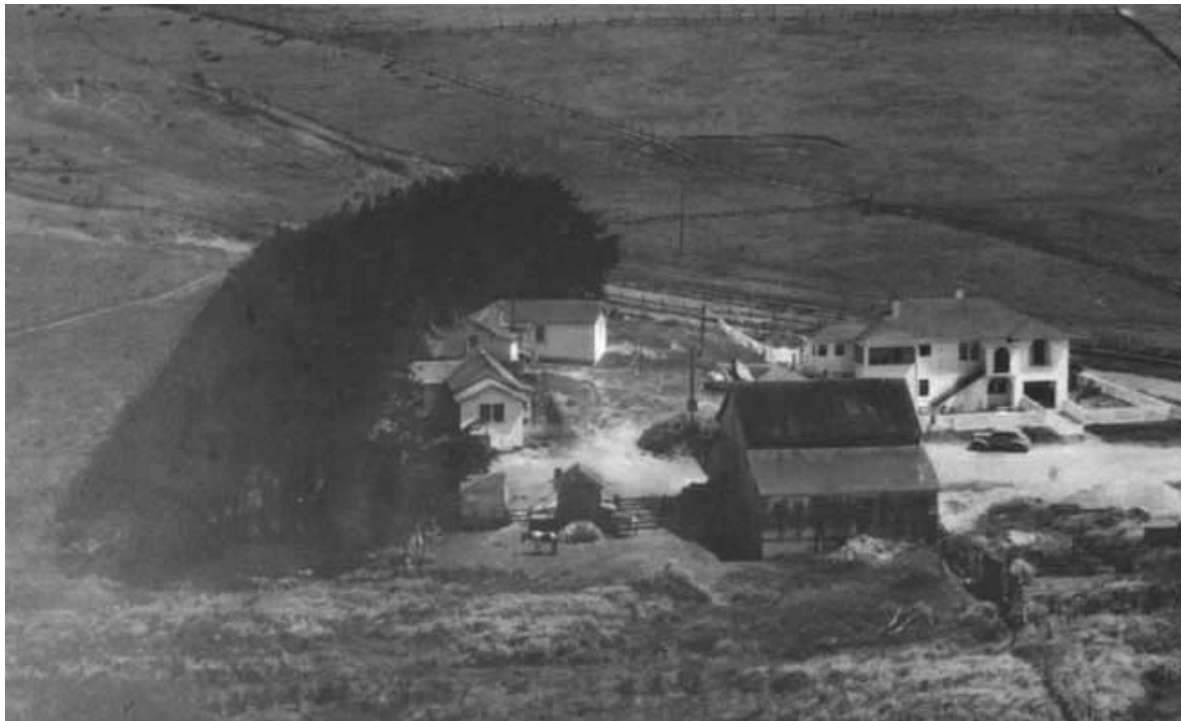
*Circa 1950 aerial photo showing the ranch core. The ranch worker residences do not appear to have fenced gardens. The mature windbreak is a prominent feature on the left side of photograph. (Nunes Family Collection)*

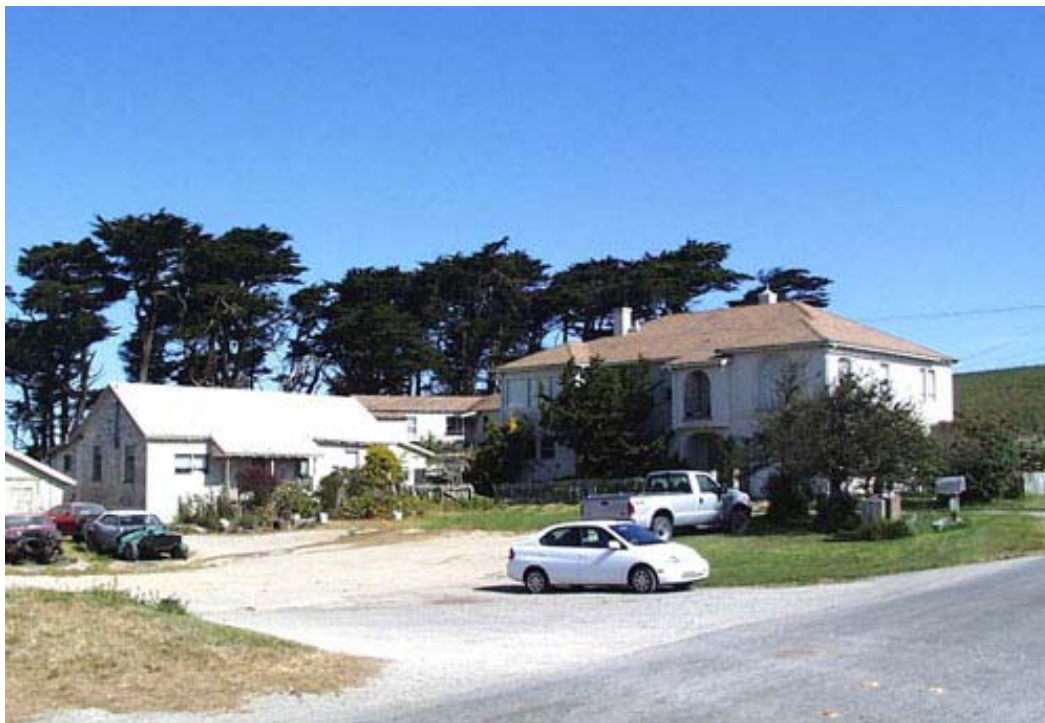
*Photo showing lawn and mature vegetation around the main residence. Note the remaining windbreak behind the house. (PWRO, 2002)*

Monterey cypress windbreaks serve to protect the ranch cores from damage and mitigate the discomfort for the ranch residents caused by high winds. The windbreaks are character defining features for the ranches. The life span for Monterey cypress can be up to 150 years and these trees were generally planted in the 1870s and 1880s. As a result, some of the trees have died or been removed from the windbreaks. The remaining trees have reached maturity and no longer have dense lower branches to provide protection. Some of the ranchers and the NPS are replanting Monterey cypress in the windbreaks.

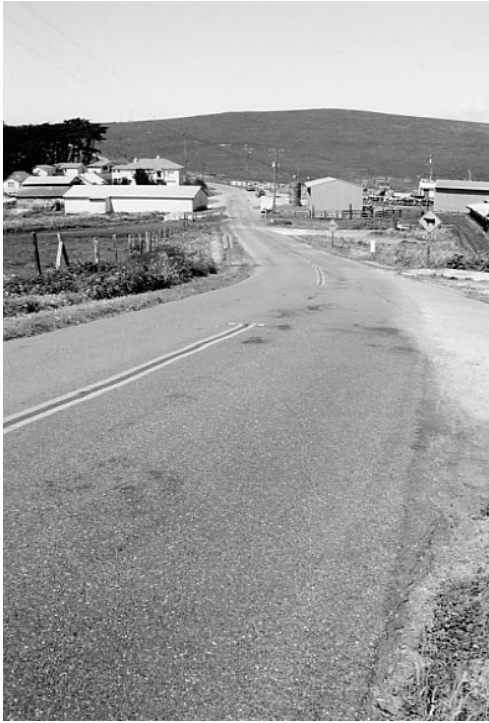
*Photo showing the Sir Francis Drake Highway through A Ranch. (PWRO, 2002)*

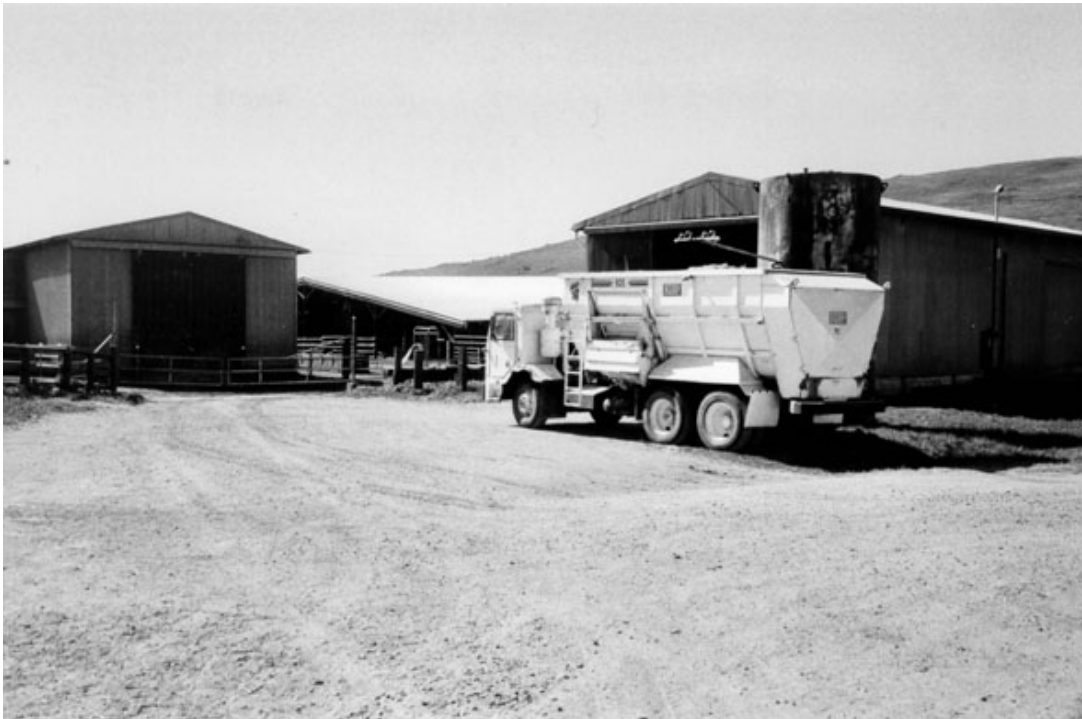
*Photo showing a turnaround/parking area in the working area of A Ranch. (PWRO, 2002)*

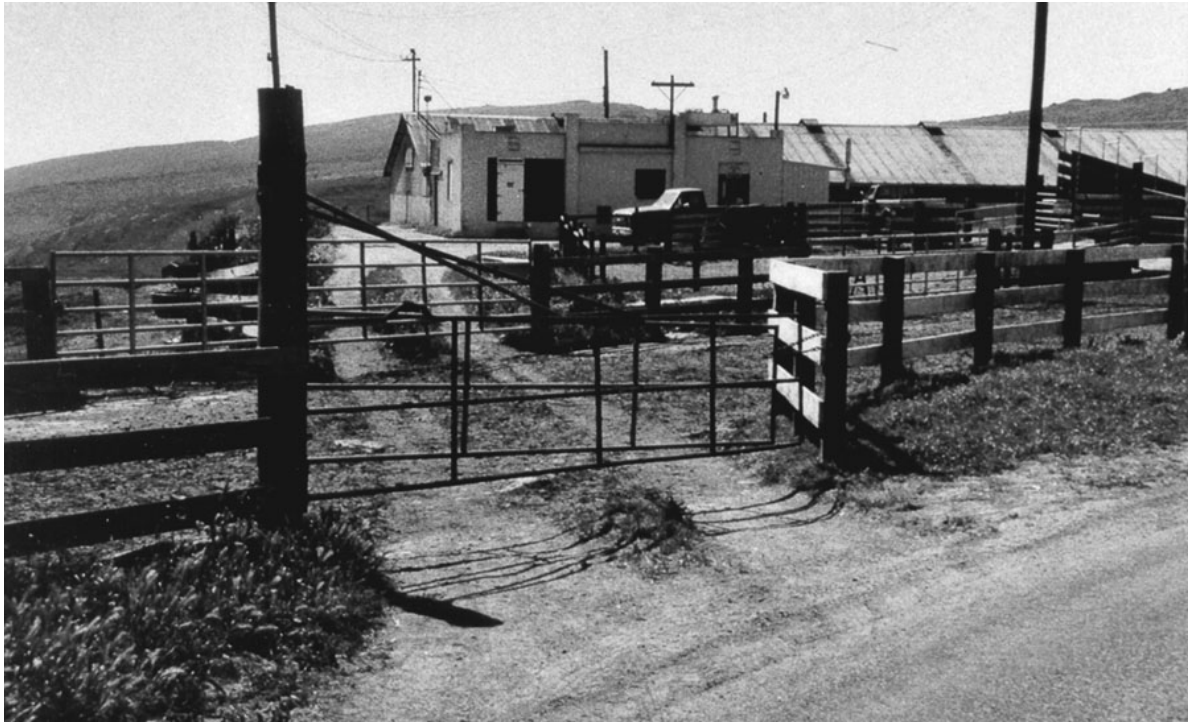
*Photo of a ranch road in the working area of A Ranch. (PWRO, 2002)*

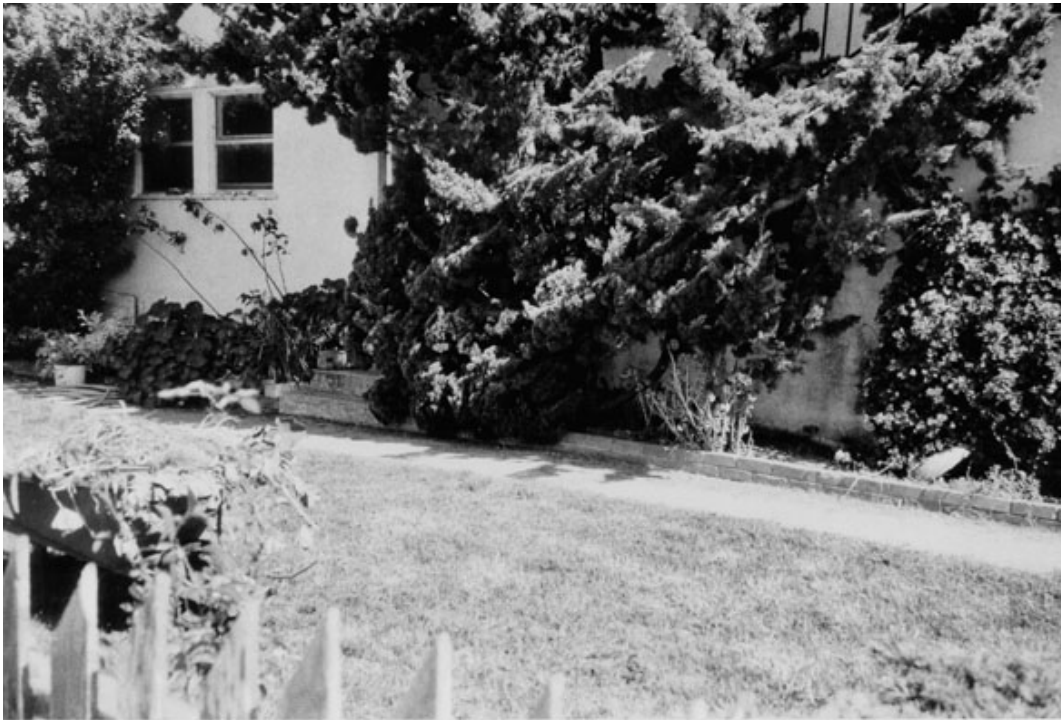
*Photo showing a concrete walkway with brick edging along the foundation planting bed in the yard of the main residence. (PWRO, 2003)*

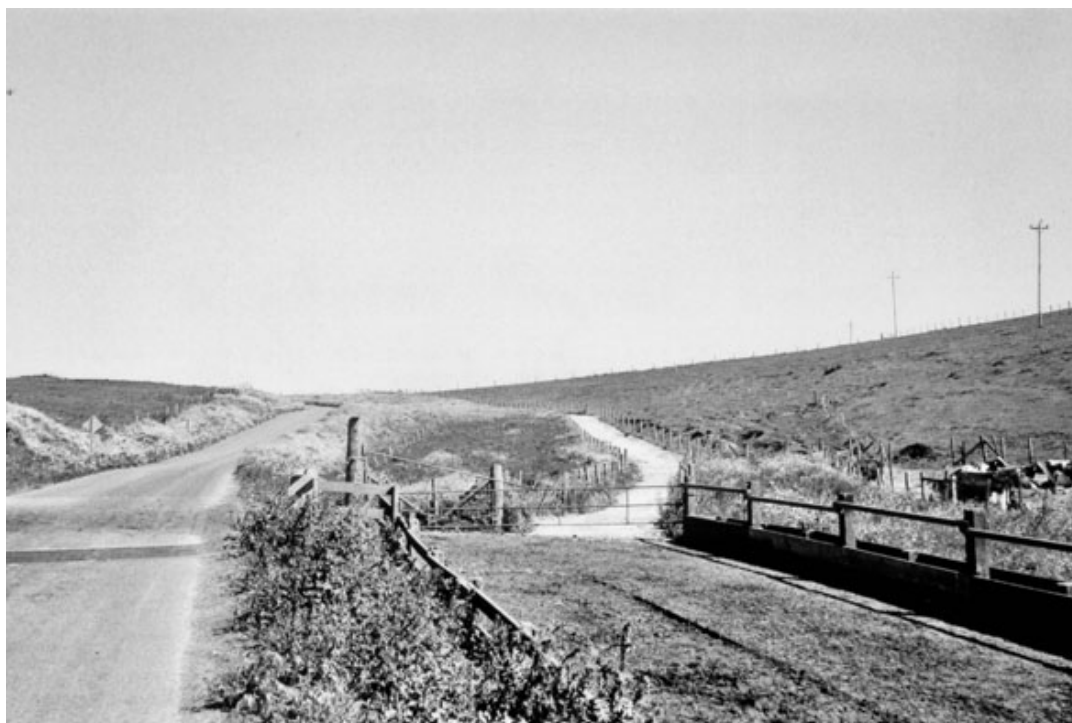
*Photo showing a livestock trail at A Ranch. (PWRO, 2002)*

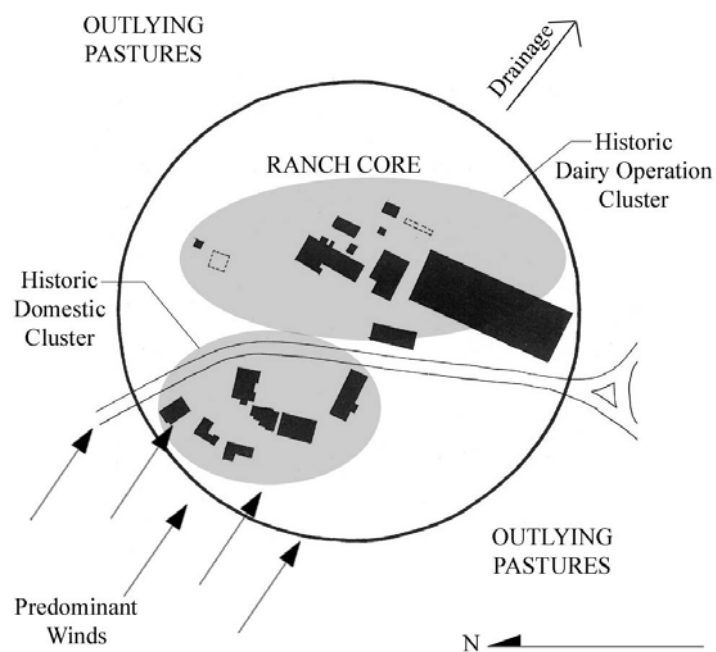
*Diagram illustrating aspects of cluster arrangement that contribute to the historic character of A Ranch. (PWRO, 2002)*
