# 22 PRESERVATION BRIEFS

## The Preservation and Repair of Historic Stucco

Anne Grimmer

U.S. Department of the Interior  
National Park Service  
Preservation Assistance Division

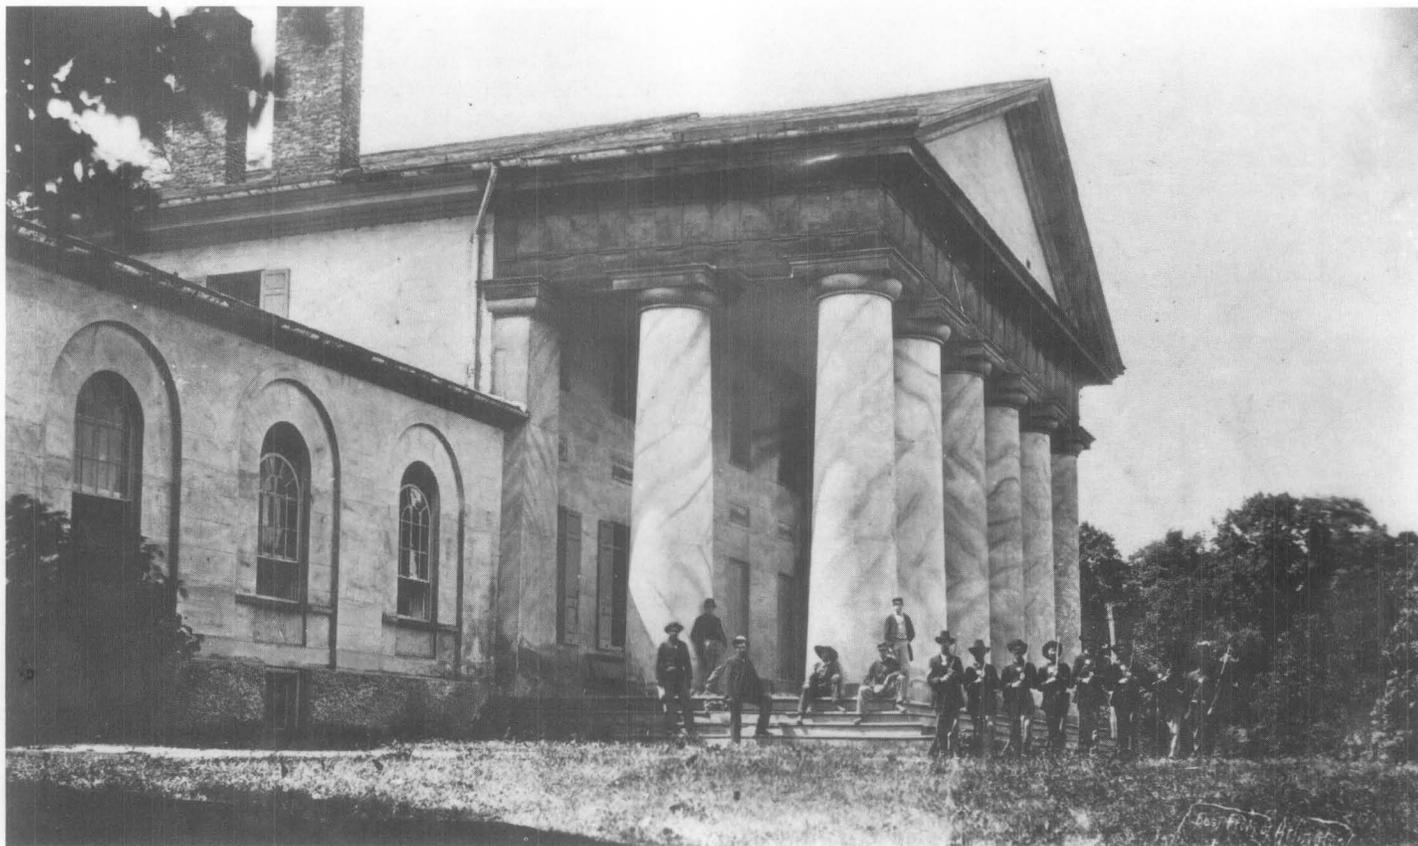
Fig. 6. Arlington House, Arlington, Virginia, was built between 1802–1818 of brick covered with stucco. It was designed by George Hadfield for George Washington Parke Custis, grandson of Martha Washington, and was later the home of Robert E. Lee. This photograph taken on June 28, 1864, by Captain Andrew J. Russell, a U.S. Signal Corps photographer, shows the stucco after it had been marbled during the 1850's. Yellow ochre and burnt umber pigments were combined to imitate Sienna marble, and the stucco, with the exception of the roughcast foundation, was scored to heighten the illusion of stone. Photo: National Archives, Arlington House Collection, National Park Service.

also marbled or marbleized—stained to look like stone by diluting oil of vitriol (sulfuric acid) with water, and mixing this with a yellow ochre, or another color (Fig. 6). As the twentieth century progressed, manufactured or synthetic pigments were added at the factory to some prepared stucco mixes.

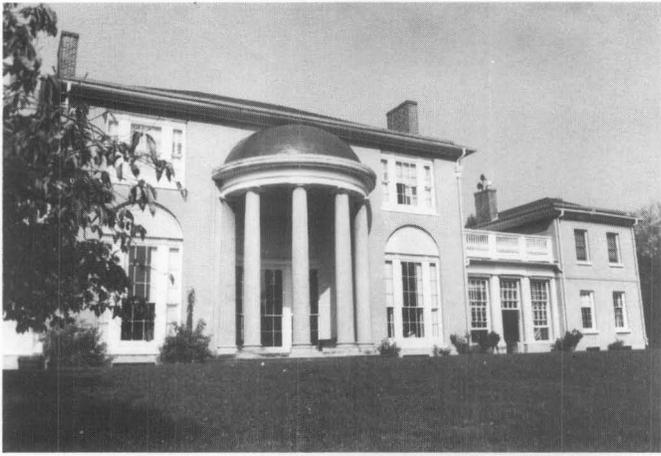
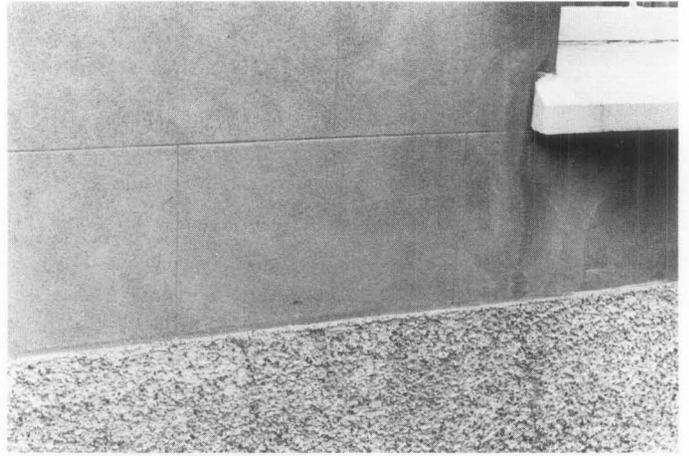
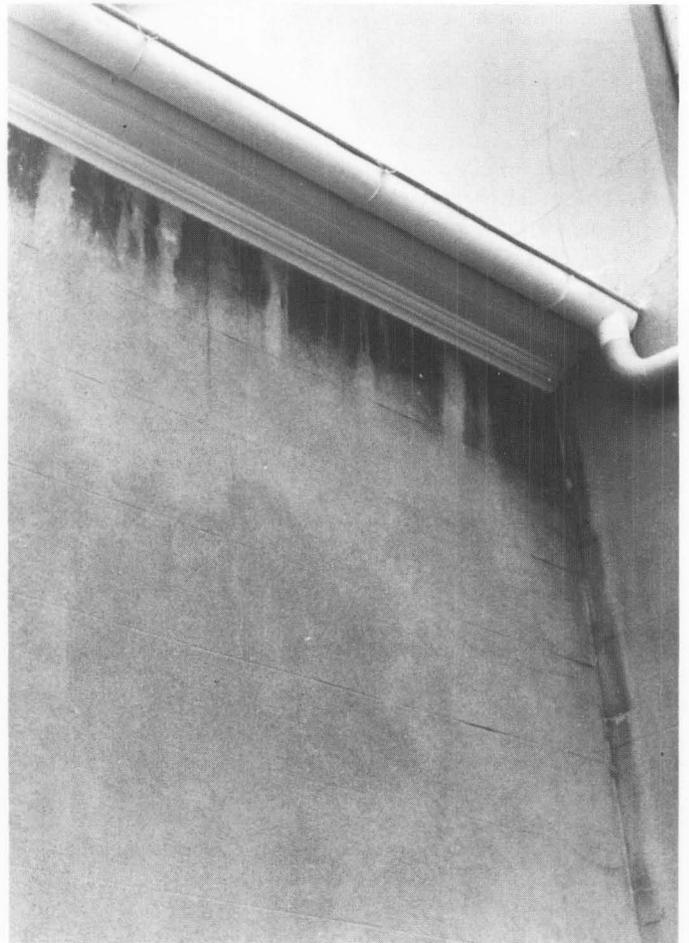
Fig. 10. (a) Tudor Place, Washington, D.C. (1805–1816), was designed by Dr. William Thornton. Like its contemporary, Arlington House, it is stuccoed and scored, with a roughcast base, but here the stucco is a monochromatic sandstone color tinted by sand and mineral pigments (b). Although the original stucco was replaced in the early-20th century with a portland cement-based stucco, the family, who retained ownership until 1984 when the house was opened to the public, left explicit instructions for future stucco repairs. The mix recommended for repairing hairline cracks (c), consists of sharp sand, cement and lime, burnt umber, burnt sienna, and a small amount of raw sienna. Preparation of numerous test samples, the size of “a thick griddle cake,” will be necessary to match the stucco color, and when the exact color has been achieved, the mixture is to be diluted to the “consistency of cream,” brushed on the wall and rubbed into the cracks with a rubber sponge or float. Note the dark color visible under the eaves intended to replicate the stronger color of the original limewashed stucco (d). Photos: Anne Grimmer.

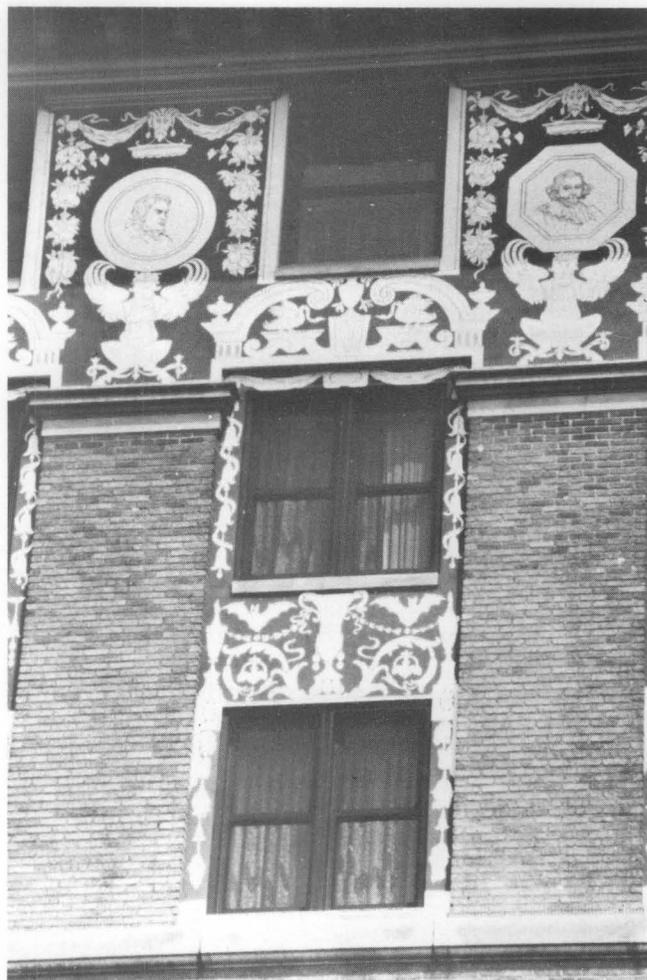
Fig. 11. The Hotel Washington, Washington, D.C. (1916–1917), is notable for its decorative *sgraffito* surfaces. Stucco panels under the cornice and around the windows feature classical designs created by artists who incised the patterns in the outer layer of red-colored stucco while still soft, thereby exposing a stucco undercoat of a contrasting color. Photo: Kaye Ellen Simonson.

Until the early-twentieth century when a variety of novelty finishes or textures were introduced, the last coat of stucco was commonly given a smooth, troweled finish, and then scored or lined in imitation of ashlar. The illusion of masonry joints was sometimes enhanced by a thin line of white lime putty, graphite, or some other pigment. Some nineteenth century buildings feature a water table or raised foundation of rough-cast stucco that differentiates it from the stucco surface above, which is smooth and scored (Fig. 10). Other novelty or textured finishes associated with the "period" or revival styles of the early-twentieth century include: the English cottage finish, adobe and Spanish, pebble-dashed or dry-dash surface, fan and sponge texture, reticulated and vermiculated, roughcast (or wet dash), and sgraffito (Fig. 11).

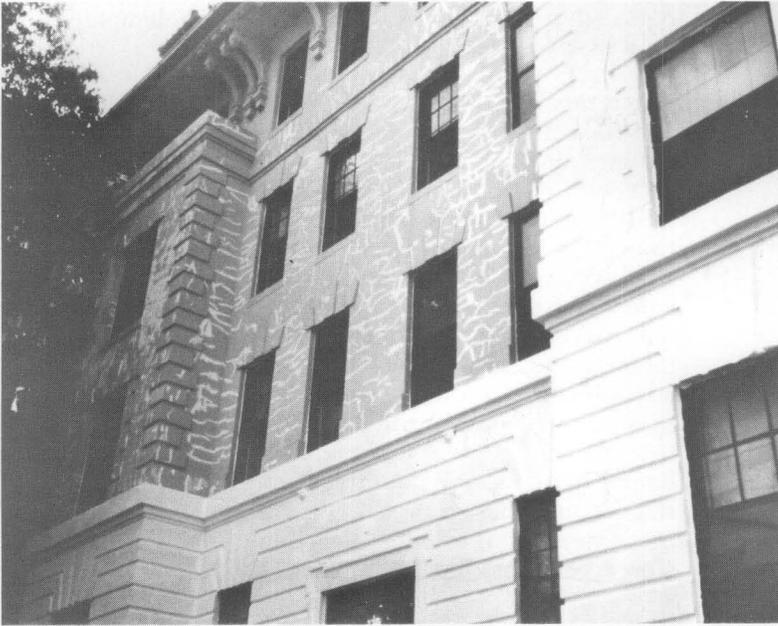
Fig. 13. (a) In preparation for repainting, hairline cracks on this Mediterranean style stucco apartment building were filled with a commercial caulking compound; (b) dirt is attracted and adheres to the texture of the caulked areas, and a year after painting, these inappropriate repairs are highly obvious. Photos: Anne Grimmer.

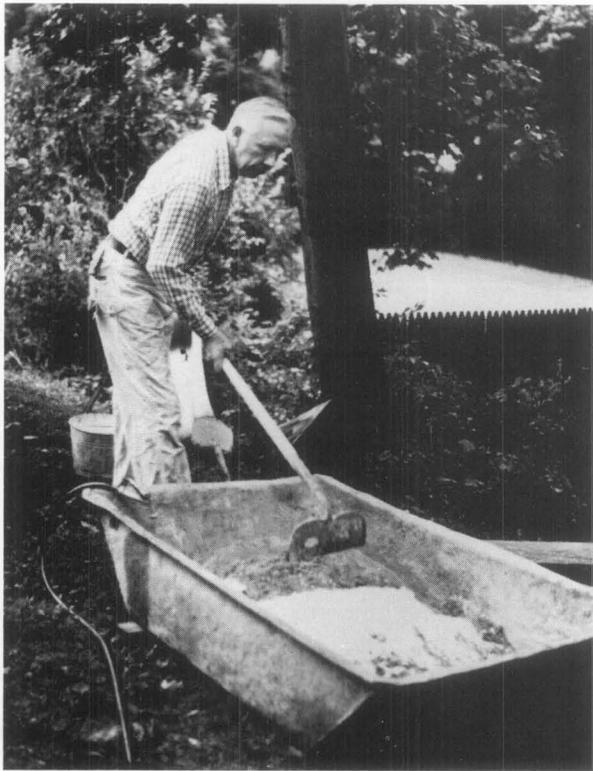
Fig. 16. (a) In preparation for stucco repair, this plasterer is mixing the dry materials in a mortar box with a mortar hoe (note the 2 holes in the blade), pulling it through the box using short choppy strokes. After the dry materials are thoroughly combined, water is added and mixed with them using the same choppy, but gradually lengthening stokes, making sure that the hoe cuts completely through the mix to the bottom of the box. (b) The deteriorated stucco has been cut away, and new metal lath has been nailed to the clapboarding in the area to be patched. (Although originally clapboarded when built in the 19th century, the house was stuccoed around the turn-of-the-century on metal lath nailed over the clapboard.) (c) The first, scratch coat and the second coat have been applied here, and await the spatterdash or rough-cast finish of the final coat (d) which was accomplished by the plasterer using a whisk broom to throw the stucco mortar against the wall surface. This well-executed patch is barely discernable, and lacks only a coat of paint to make it blend completely with the rest of the painted wall surface. Photos: Anne Grimmer.

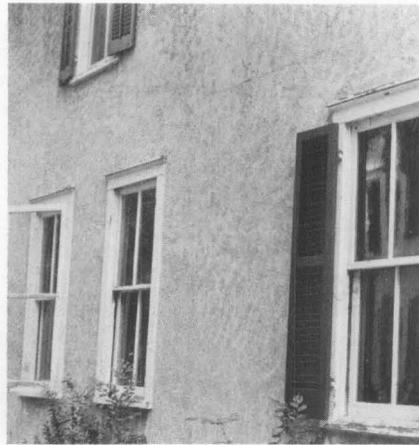
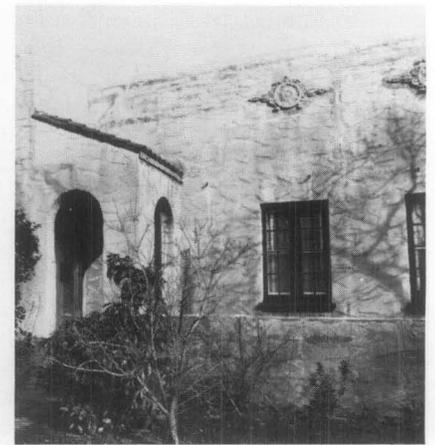
Most of the oldest stucco in the U.S. dating prior to the late-nineteenth century, will generally have a **smooth, troweled finish** (sometimes called a **sand or float finish**), possibly scored to resemble ashlar masonry units. Scoring may be incised to simulate masonry joints, the scored lines may be emphasized by black or white penciling, or the lines may simply be drawn or painted on the surface of the stucco. In some regions, at least as early as the first decades of the nineteenth century, it was not uncommon to use a **roughcast finish** on the foundation or base of an otherwise **smooth-surfaced** building (Fig. a). **Roughcast** was also used as an overall stucco finish for some outbuildings, and other less important types of structures.

A wide variety of decorative surface textures may be found on revival style stucco buildings, particularly residential architecture. These styles evolved in the late-nineteenth century and peaked in popularity in the early decades of the twentieth century. Frank Lloyd Wright favored a **smooth finish** stucco, which was imitated on much of the Prairie style architecture inspired by his work. Some of the more picturesque surface textures include: **English Cottage** or **English Cotswold finish**; **sponge finish** (Fig. b); **fan texture**; **adobe finish** (Fig. c), and **Spanish or Italian**

The most common early-twentieth century stucco finishes are often found on bungalow-style houses, and include: **spatter** or **spatterdash** (sometimes called **roughcast**, **harling**, or **wetdash**), and **pebbledash** or **drydash**. The **spatterdash** finish is applied by throwing the stucco mortar against the wall using a whisk broom or a stiff fiber brush, and it requires considerable skill on the part of the plasterer to achieve a consistently rough wall surface. The mortar used to obtain this texture is usually composed simply of a regular sand, lime, and cement mortar, although it may sometimes contain small pebbles or crushed stone aggregate, which replaces one-half the normal sand content. The **pebbledash** or **drydash finish** is accomplished manually by the plasterer throwing or "dashing" dry pebbles (about 1/8" to 1/4" in size), onto a coat of stucco freshly applied by another plasterer. The pebbles must be thrown at the wall with a scoop with sufficient force and skill that they will stick to the stuccoed wall. A more even or uniform surface can be achieved by patting the stones down with a wooden float. This finish may also be created using a texturing machine (Figs. d-f illustrate 3 versions of this finish. Photos: National Park Service Files).
