# 23 PRESERVATION BRIEFS

## Preserving Historic Ornamental Plaster

U.S. Department of the Interior  
National Park Service  
Cultural Resources  
Heritage Preservation Services

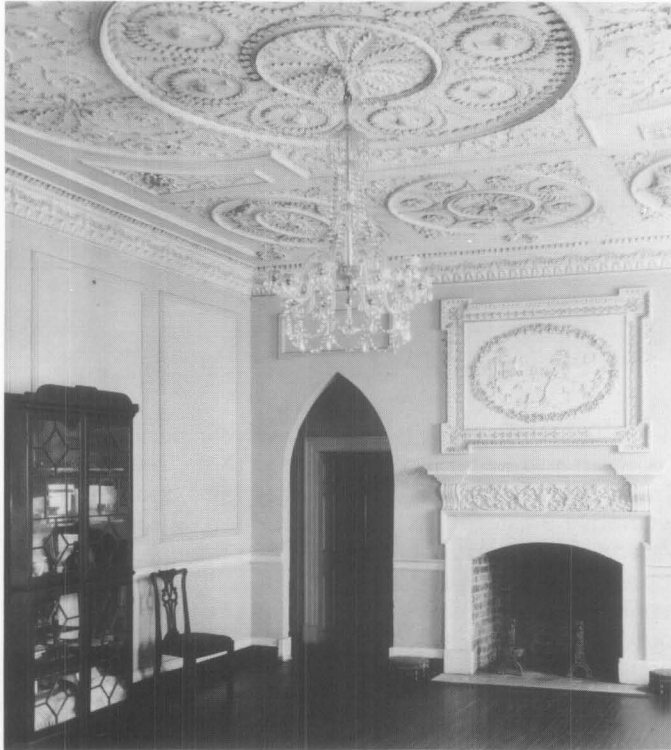
(a) Kenmore, Fredericksburg, Virginia, c. 1752. Georgian in style with ornamental ceilings based on Batty Langley's 1739 English style book, the plasterwork was executed by a Frenchman in the mid-1770s. This house was built by Col. Fielding Lewis and has the most elaborate ornamentation of any in the period. Photo: *Historic American Buildings Survey Collection*.

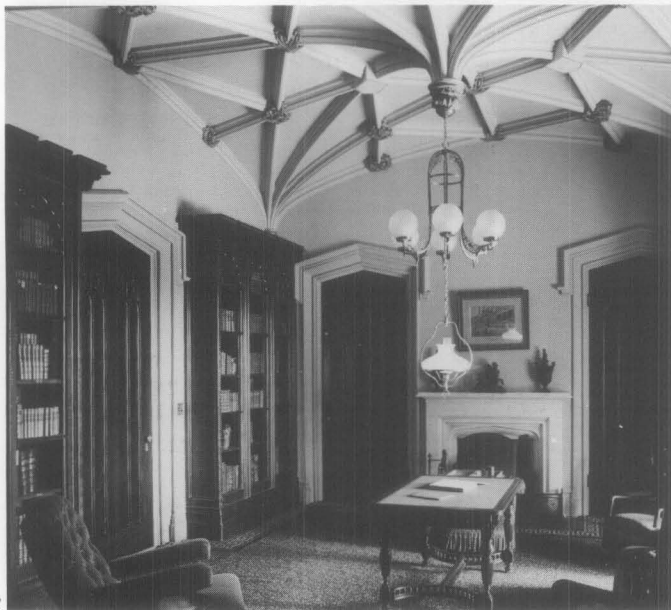
c

(c) Lyndhurst, Tarrytown, New York, c. 1838. This Gothic Revival villa on the Hudson River was built for financier Jay Gould by Alexander Jackson Davis. A versatile architect, Davis was simultaneously at work on Greek Revival buildings in New York City. Both styles called for elaborate ornamental plasterwork. Photo: *Jack E. Boucher, Historic American Buildings Survey*.

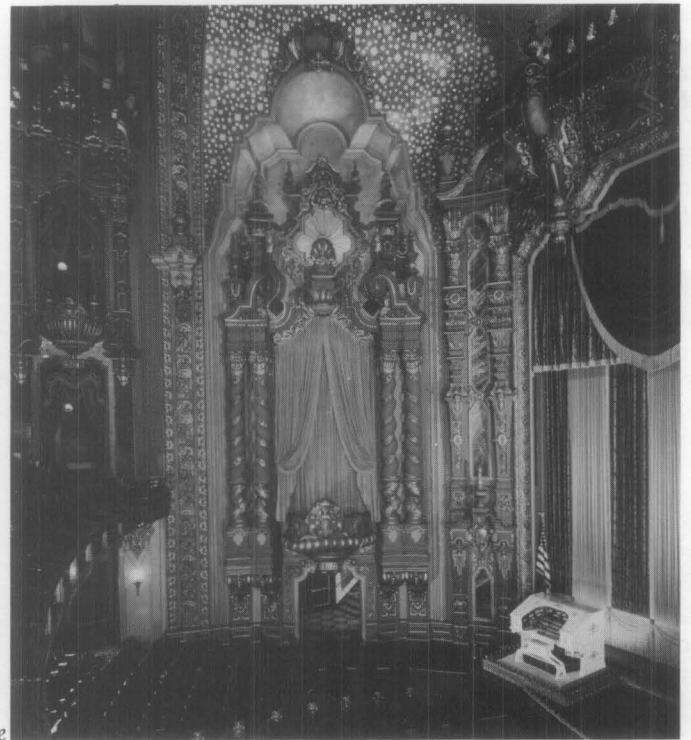
e

(e) Ohio Theater, Columbus, Ohio, c. 1928. An example of the "Golden Age" of movie palaces, Thomas Lamb's "Spanish" style interior is a typical example of the plasterwork executed just prior to the Depression years. Ornament was site cast, often on the stage, while the orchestra was scaffolded for installation. Photo: *National Park Service files*.

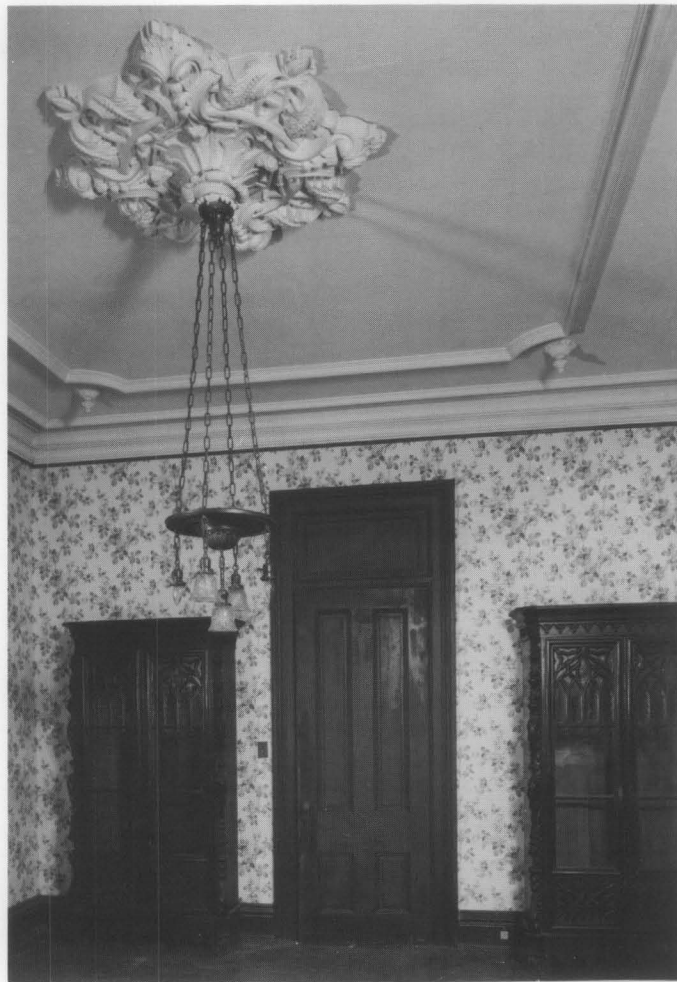
Fig. 2. This parlor medallion and pendant drops shown in a mid-19th century row house in Annapolis, Maryland were originally ordered from a catalog. A local plasterer ran the plain cornice and band ribbon, the curved corners of which were bench run, set with a plaster adhesive and pointed at the joints. Photo: M. E. Warren.

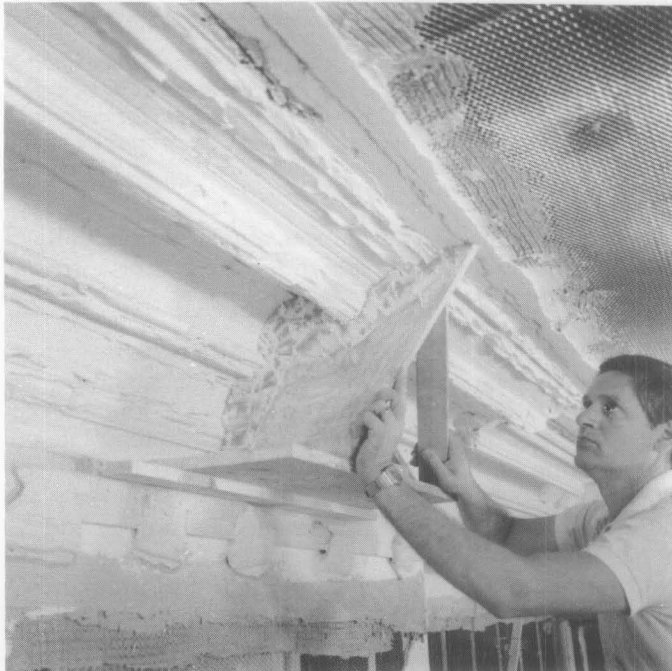
Fig. 4. Running a Cornice. The historic method of producing a cornice is unchanged today. A running mold or template is pushed along a lattice strip nailed to the wall. Base coat plaster is gypsum and sand; finishing plaster is added with small tools and stuffed wearing rubber gloves because lime burns the skin. As many as 20 passes are required to complete a smooth run; this particular cornice was formed in two stages, top and bottom, because it was so large. Cornices this size also have to be blocked and lathed to minimize the amount of applied material. Photo: Old-House Journal.

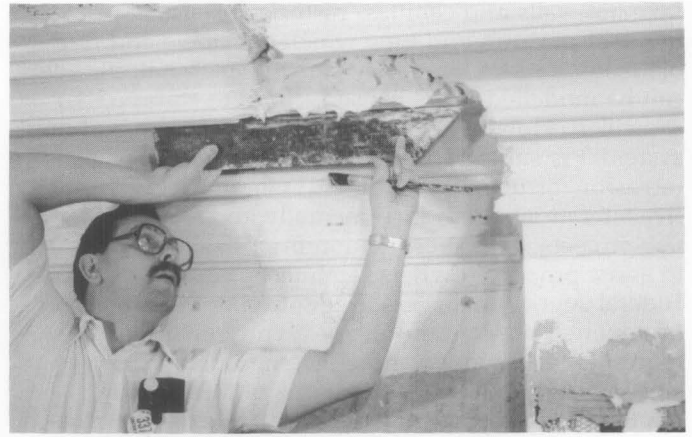
Fig. 5. Mitering a Plain-Run Cornice. Mitering requires great dexterity using the miter rod. In this case, a return at a chimney breast is tooled using an infill of gypsum and lime. Internal and external miters are required with the internal being the most difficult. Another method is to run a length of cornice (using the same blade) on a bench and set it in place, later to point the joints. Photo: Old-House Journal.

Short lengths of new cornice are best run on a bench using gypsum and lime; the reproduction molding should be somewhat longer than the required length (see Fig 18). The new footage is cut and fit in place to match the existing cornice, then securely countersunk-screwed to studs, joists and/or blocking. The resulting joints are pointed with flat mitering rods, flush with adjacent members (see Fig. 5, above).

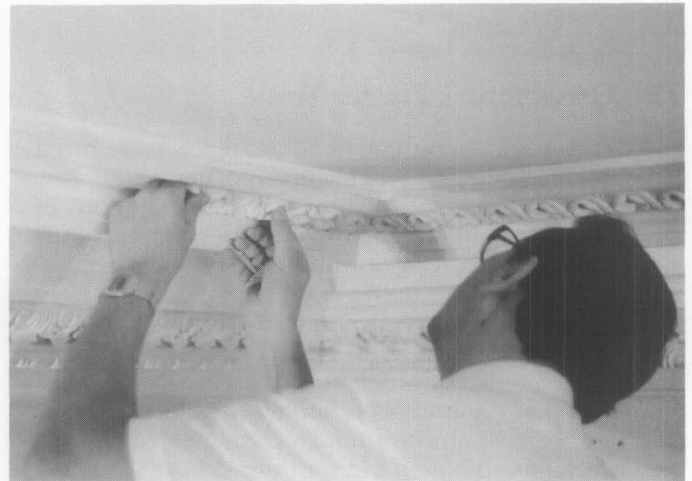
Fig. 6. Enriching a Plain-Run Cornice. After a cornice is run and mitered, cast enrichments are stuck in recessed sinkages planned to receive the casts. Ornamental models are made to engage with one another, resulting in unbroken lines or courses. A shop-cast ornament is soaked in water until saturated and pressed into its sinkage using wet plaster as an adhesive. Once the casts have been installed, they are carefully pointed at the joints and at the miters so that they appear as a continuous, repetitive design. Photo: Old-House Journal.

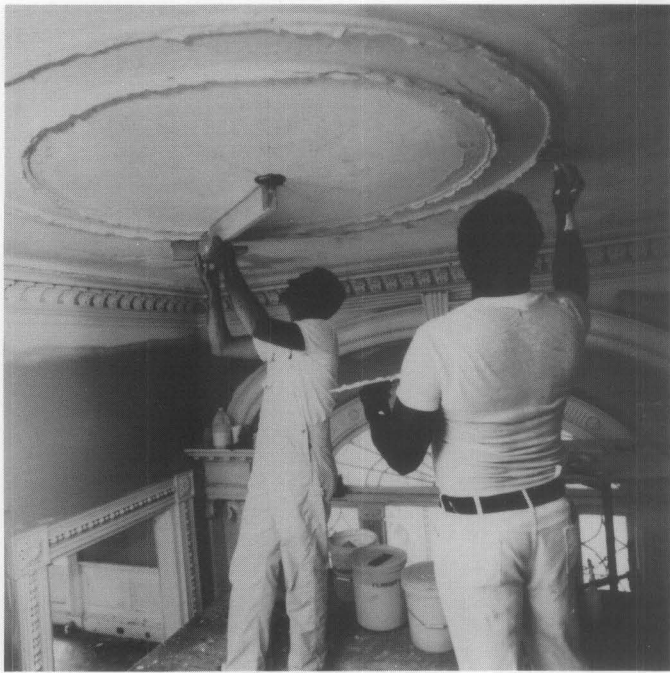
Fig. 7. Running and Enriching a Ceiling Medallion. The method of running and enriching a ceiling medallion remains the same today. (a) First, a plain-run surround is spun from a pivot point centered in the ceiling field. (b) Ornament layout is determined using plane geometric principles; segmented locations are deeply scratched to provide a rough surface for adequate bonding using plaster as an adhesive. Historically, cast enrichments could be bought from local suppliers and set individually, allowing architects to compose medallions to suit room dimensions and period motifs. Photos: Peter Sanders.

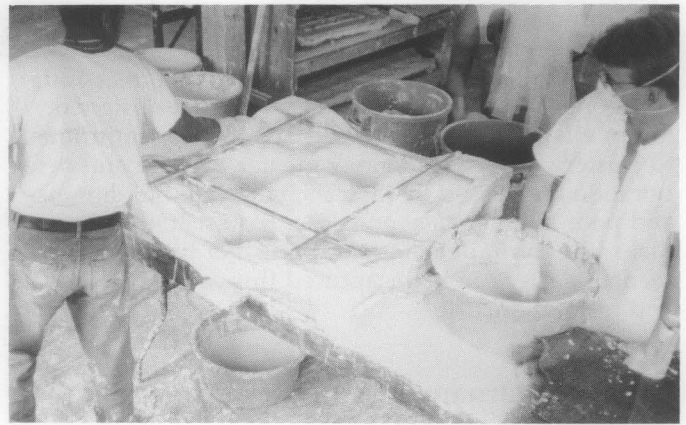
Fig. 8. Casting a Coffering Unit. Ceiling coffers are made the same way today except, historically, a hide glue mold was poured over an ornamental model whereas today urethane molding rubber is used. Now, as then, the plaster casts are made with steel channel irons embedded on the back of each panel. The coffers are hung from carrying irons fixed to the ceiling above by means of twisting wires to level each coffer to its neighbor. Afterward, the panels are fastened together and the joints pointed with plaster. Photo: David Flaharty.

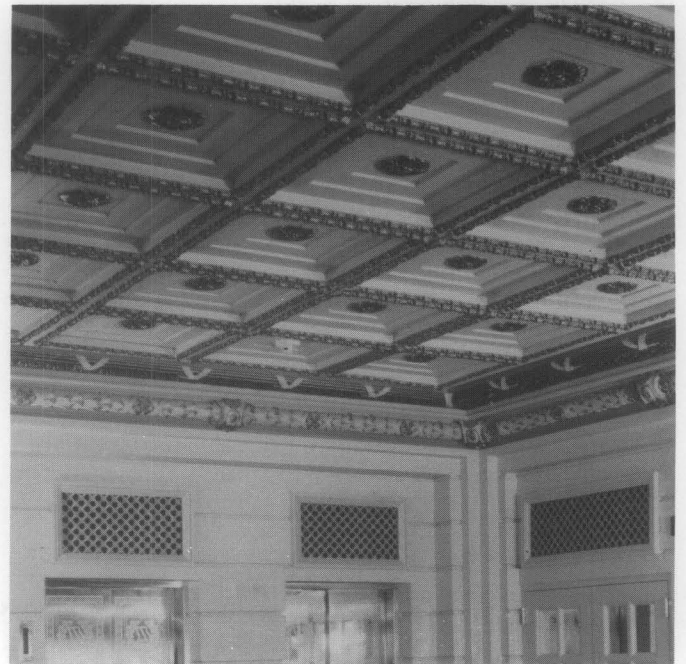
Fig. 9. The elaborate coffered ceiling was designed for the Willard Hotel in Washington, D.C. (1902-04) by Henry Janeway Hardenbergh. The coffered ceiling was restored as part of a rehabilitation project in the 1980s. Photo: Carol M. Highsmith.

identical in reflected plan; on domed or barrel ceilings, coffers differ from course to course so as to appear identical from various sight lines. The finish treatment of a coffered ceiling frequently exhibits the height of the painter's craft. Foremost examples of ceiling coffering include the United States Capitol, and Washington D. C.'s Union Station. As a popular decorative form with inherent acoustical benefits, the coffered ceiling is seen across the United States in many large public spaces such as theaters, courthouses, railroad stations, and hotels (see Fig. 9).

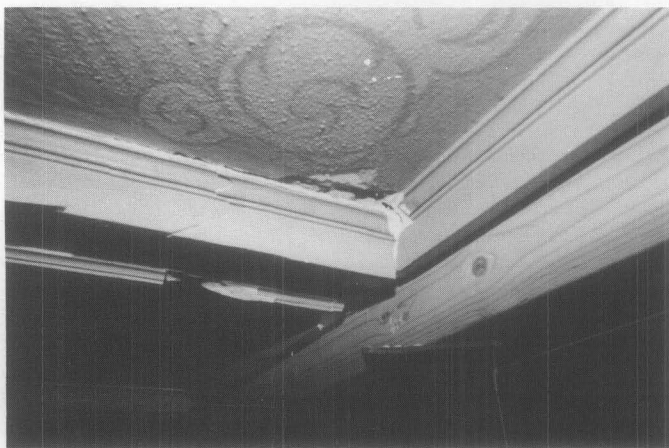
Fig. 10. Structural settling has caused this ceiling to deflect. Prior to restoring the damaged plaster and final repainting, a structural engineer experienced in historic preservation will be engaged to shore-up the ceiling from below and reattach the sagging ceiling plaster with the joists above (see also Fig. 17 under Immediate Action.) Photo: National Park Service files.

**Signs of Failure.** Failure of the substrate is more typical than failure of the plaster ornament itself. Among the reasons for deterioration, **structural movement** (see Fig. 10) and **water intrusion** (see Fig. 11) are the most deleterious. Buildings move and settle, causing deflection and delamination which result in stress cracking. These cracks often begin at the corners of windows and doors and extend upward at acute angles (see Fig. 12). Roof or plumbing leaks make finishes discolor and peel and cause efflorescence, especially on plain-run or enriched cornices. Unheated buildings with water intrusion are subject to **freeze-thaw cycles** which ultimately result in base coat and ornamental plaster failure (see Fig. 13).

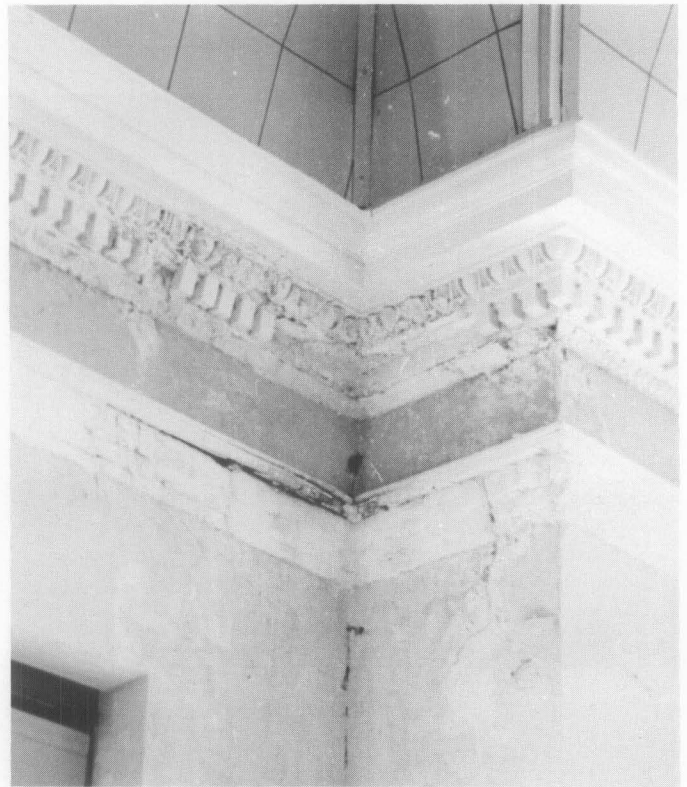
Fig. 11. The cornice of an Iowa courthouse has been severely damaged from a roof leak. In order to repair the ornamental plaster, a thixotropic rubber impression will be taken (with the paint build-up undisturbed). The efflorescence will be removed and fresh plaster casts installed so that egg and dart, dentil and leaf molding are perfectly aligned. Photo: National Park Service files.

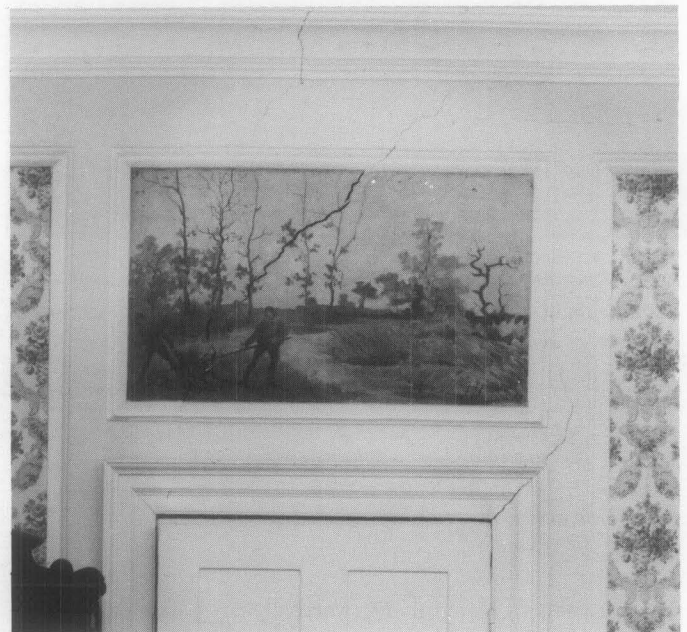
Fig. 12. Settlement caused stress cracking through both flat wall and ornamental plaster. Repairs to the cornice molding involve chamfering the stress cracks to a "V groove" and patching with a mixture of gypsum and lime. The cornice can be countersunk-screwed to its substrate to prevent further movement. Screw heads are then plastered over. The crack running through the painting will need to be filled carefully, and the painting restored by a trained conservator. Photo: Jack E. Boucher, Historic American Buildings Survey.

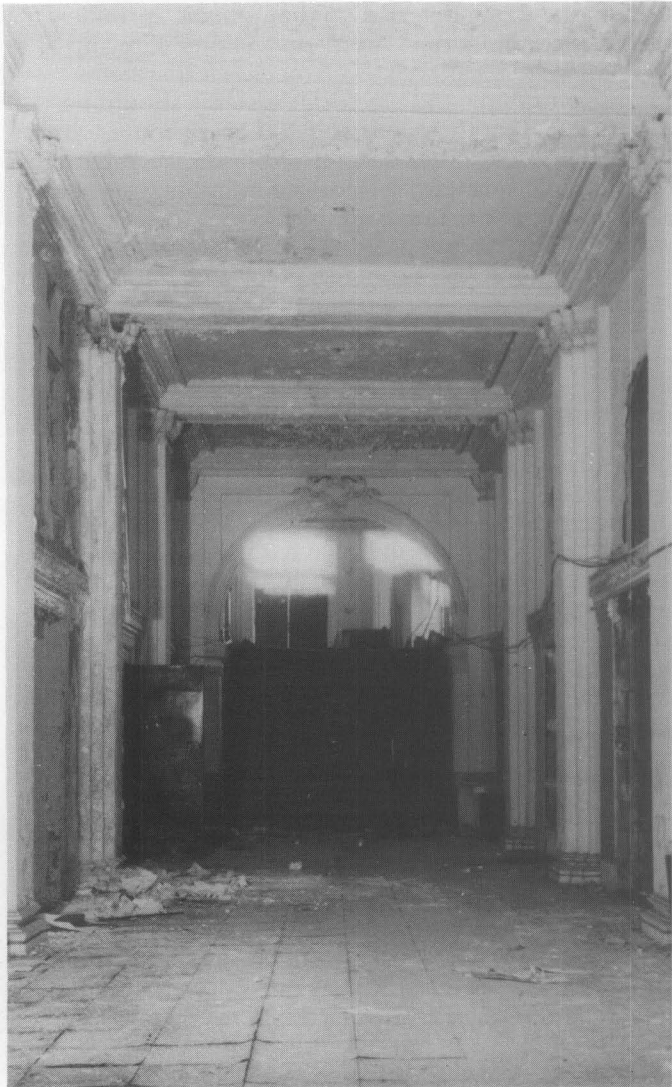
Fig. 13. Water intrusion and freeze/thaw cycles caused extensive efflorescence and ornamental plaster failure. The plaster needed almost total replacement within the rehabilitation project. Photo: Commercial Photographics.

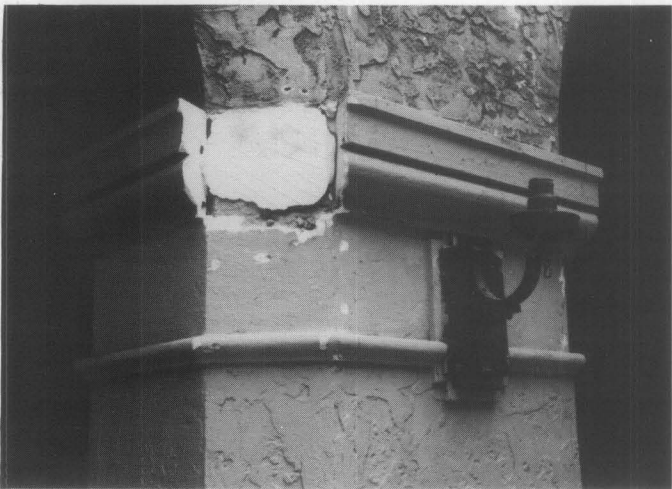
Fig. 14. A mitered portion of this impost capital abacus has fallen, revealing the plaster adhesive material. Repairs are made by obtaining a section through the abacus, making a bench-run length, cutting, fitting, and readhering the missing piece. Finally, the joints are pointed. Photo: Lee H. Nelson, FAIA.

In addition, keying and adhesive properties may be further jeopardized by **weak original mixes** (see Fig. 14) that were improperly applied. Substrate failure typically results from **faulty lathing or rusty lath nails**, causing ceilings to fall. In the 20th century, **vibration** from heavy vehicular traffic, nearby blasting, and even repeated sonic booms may contribute to damaging ornamental plaster. **Inadequate support** in an original design may also be to blame when particularly heavy units have simply broken off over time (Fig. 15). Finally, new mechanical systems, suspended ceilings and partition walls insensitively installed in adaptive use projects, show little regard for the inspired decorations of earlier periods (see Fig. 16).

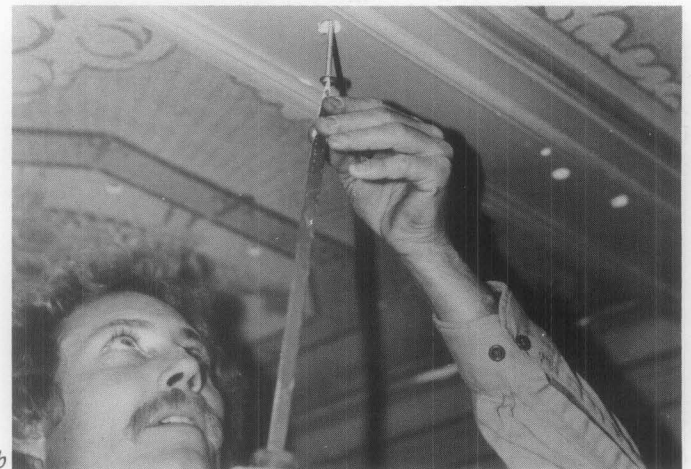
Fig. 17 (a) Where this ceiling was suffering from structural failure, the first step was to shore it up from below. (b) Toggle bolts were used to reattach the plaster molding to the ceiling joists. The ceiling was then patched with gypsum and lime, prior to restoring the significant paint finishes. Photos: National Park Service files.

First, roof or plumbing leaks must be repaired to eliminate the problem of water intrusion. General structural repairs should be undertaken to arrest building movement, which weakens the base coat plasters to which the ornamental enrichments are attached. Ornamental plaster deflection should be corrected by shoring from below followed by re-anchoring (see Fig. 17).

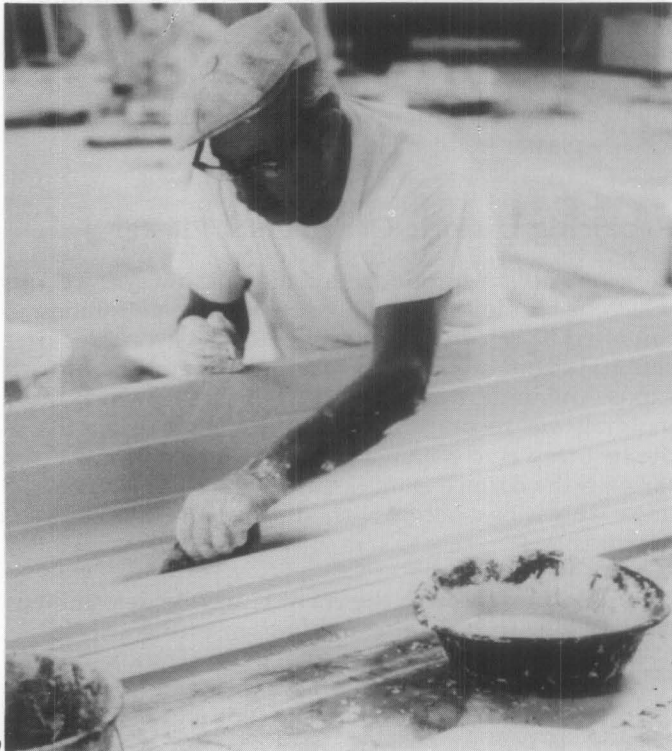
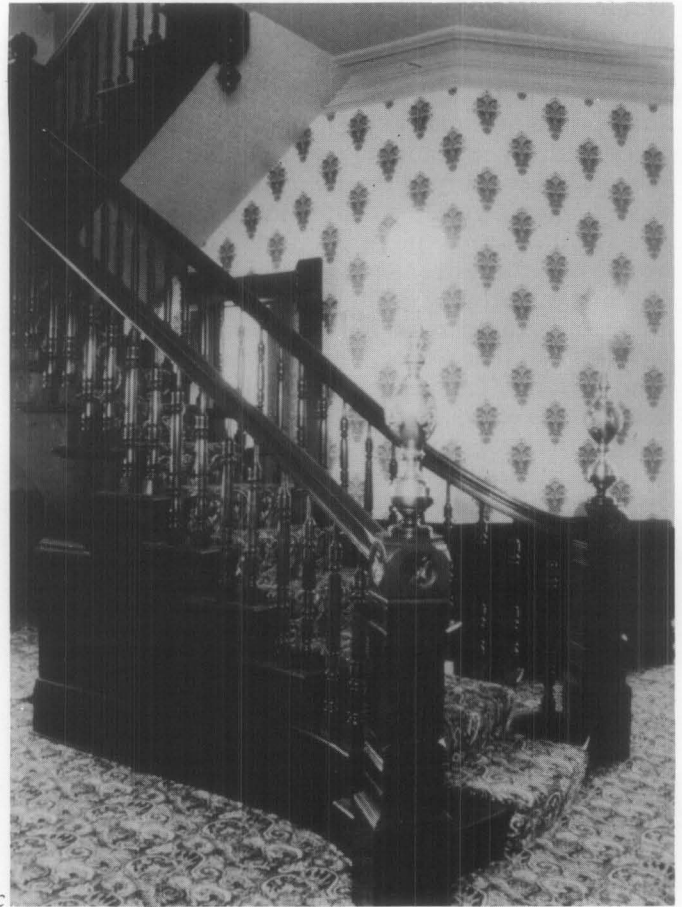
Fig. 18. Repairing a Cornice. (a) In the restoration of the Henry Hirshfeld House, a 19th century residence in Austin, Texas, removal of a tin ceiling revealed a damaged plain-run cornice. Photo: John Volz, AIA. (b) A section through the molding was taken, a template blade cut, horsed-up, and run on a bench using gypsum and lime. Photo: Charles E. Fisher. (c) The new cornice was then cut, fitted, and applied to new blocking between wall and ceiling. The external miter and returns were pointed using the miter rod. After the ceiling restoration was complete, other finishes, such as wallpaper, were applied. Photo: Candace Volz.

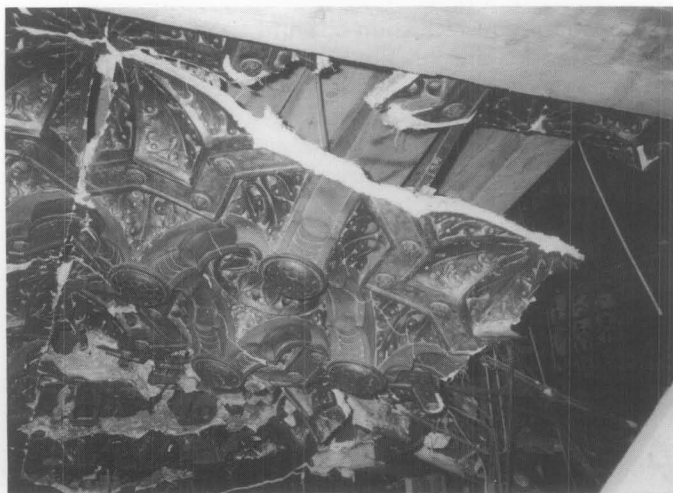
Fig. 21. The Yiddish Arts Theater, New York City, c. 1920s. The concrete roof of this building collapsed, damaging portions of the existing Moorish style coffered ceiling. The square coffer unit was easily identifiable and was removed to a casting shop for reproduction. Photo: David Flaharty.

**Coffered Ceiling.** Like cornices and medallions, coffered ceilings suffer from poor maintenance practices and structural problems; however, these individually cast ceiling units are particularly vulnerable when a building is being rehabilitated and great care is not taken in executing the work. In the most serious of cases, portions of a roof can collapse, dropping heavy debris through the hanging coffering panels, and demolishing large portions of the ornamentation (see Fig. 21).

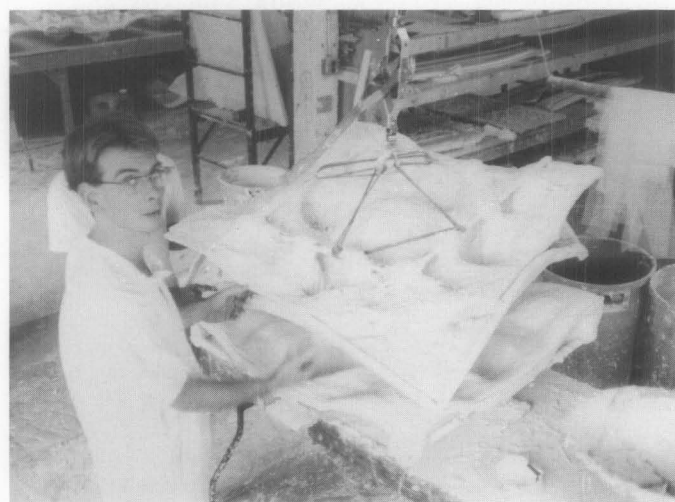
Fig. 22. Repairing a Coffered Ceiling. As part of the theater rehabilitation, the coffered ceiling panels are being reproduced in urethane rubber molds and reinforced with open weave burlap and wood fiber. Steel channel irons can be seen, attached to the backs of the casts. Later, these irons are used to hang the panels from a superstructure at the site. Photo: David Flaharty.

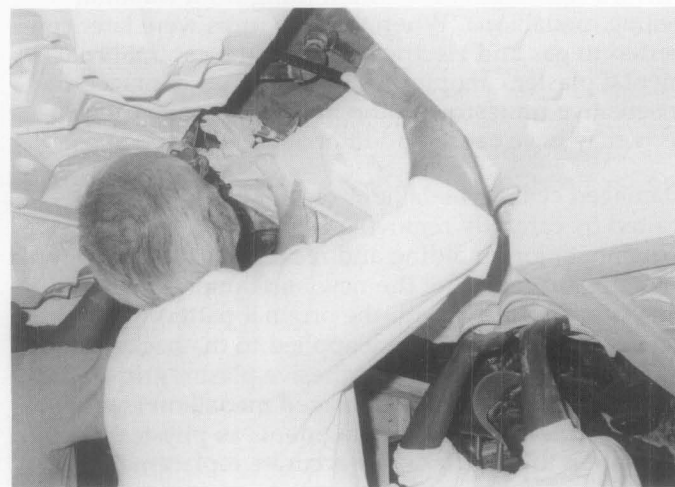
Fig. 23. A pre-cast coffer is lifted into place to abut adjacent panels. Tie wire will be fastened to the channel irons and the superstructure above, twisted to level, and finally wadded with wood fiber soaked in plaster to prevent the wire from stretching. Photo: David Flaharty.

and deflection. New channel iron is used to stabilize the existing coffers and ties reinforced, as necessary. An intact coffering unit is then identified and carefully removed to a casting shop for molding and casting (see Fig. 22). When re-hung, the units are painted to match the historic coffering (see Fig. 23).

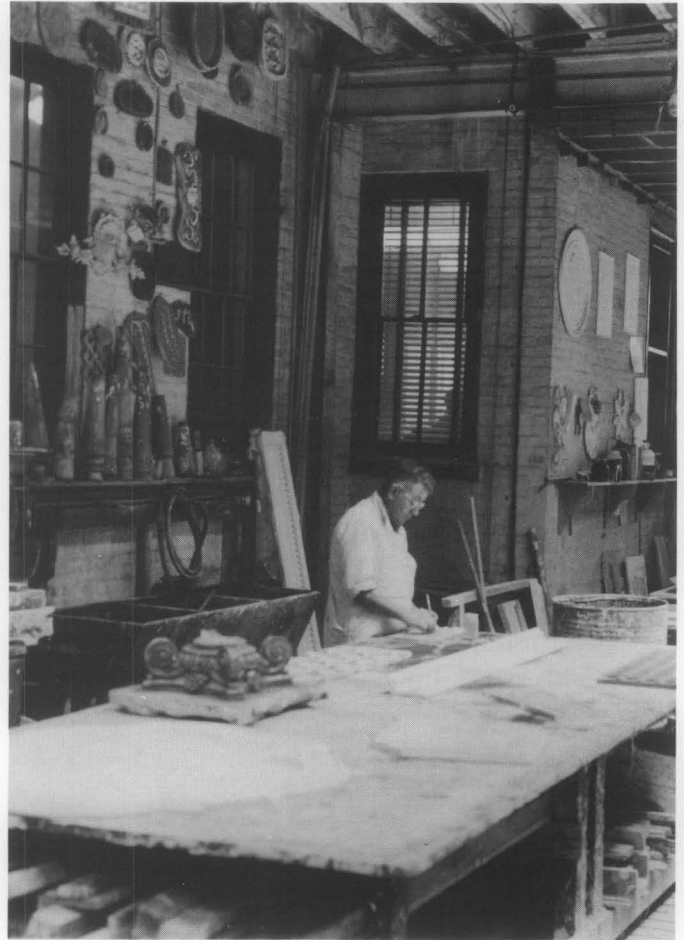
Fig. 24. This plaster studio is well organized, with ample work space. Note the plaster casts hanging neatly on the wall. Photo: Berry and Homer, Philadelphia.

or developer should secure the services of a reputable restoration contractor before proceeding further. It is clear as more and more projects are undertaken, that there is a wide disparity of skills within the trade today. This is partly due to the introduction of gypsum board as a substitute for traditional plastering. As gypsum board became popular after World War II, plasterers saw the demand for their skills decline. Plastering techniques were forgotten because they were often not passed down within shops and families. However, ornamental plaster studios have seen a resurgence in demand for their services in the last decade, particularly as more historic buildings are rehabilitated (see Fig. 24).
