26 PRESERVATION BRIEFS

The Preservation and Repair of Historic Log Buildings

Bruce D. Bomberger

U.S. Department of the Interior
National Park Service
Cultural Resources
Preservation Assistance

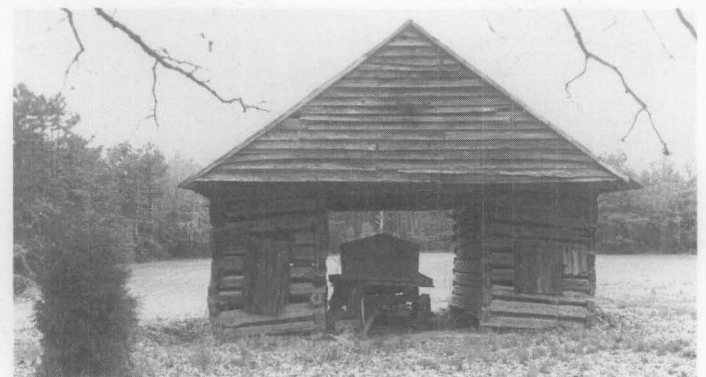
Fig. 3. This mid-19th century double-pen corncrib on the Jamison Farm in Rowan County, North Carolina, is an example of a type of log building that did not require chinking. Photo: Denise Whitley.

structed as temporary shelters by soldiers during the Revolutionary War, and across the country, Americans used logs not only to build houses, but also commercial structures, schools, churches, gristmills, barns, corncribs and a variety of outbuildings (Fig. 3).

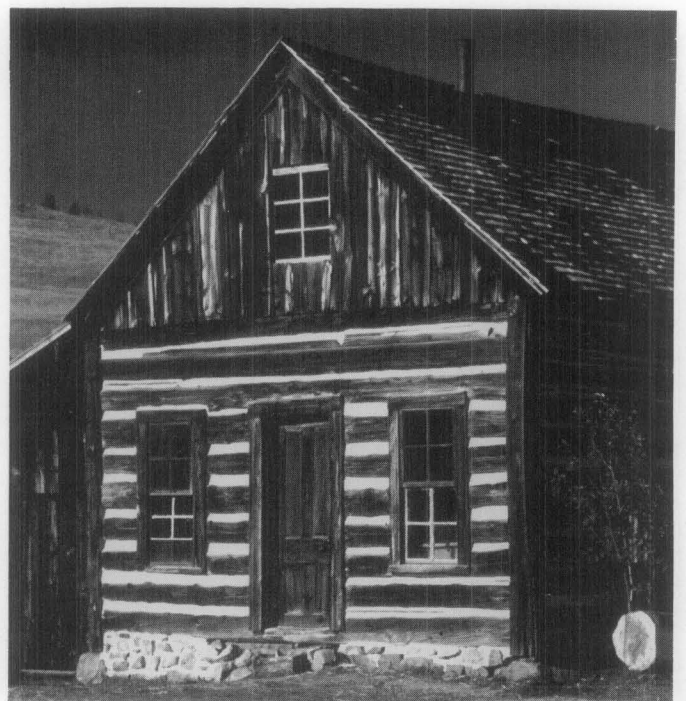
Fig. 9. This historic log building on the Walker Ranch in Boulder, Colorado is an example of the Rocky Mountain cabin form which is typified by the entrance door being located in the gable end. Photo: Bernard Weisgerber.

A somewhat different form evolved in the West around the middle of the 19th century which became especially distinctive of the Rocky Mountain cabin. While the entrance doorway to most earlier log houses was generally placed beneath the eaves, as a means of adapting to the greater snowfall in the Rockies, here the entrance was placed in the gable end, and sometimes protected from roof slides by a porch supported by two corner posts created by an extension of the roof beyond the gable wall (Fig. 9).

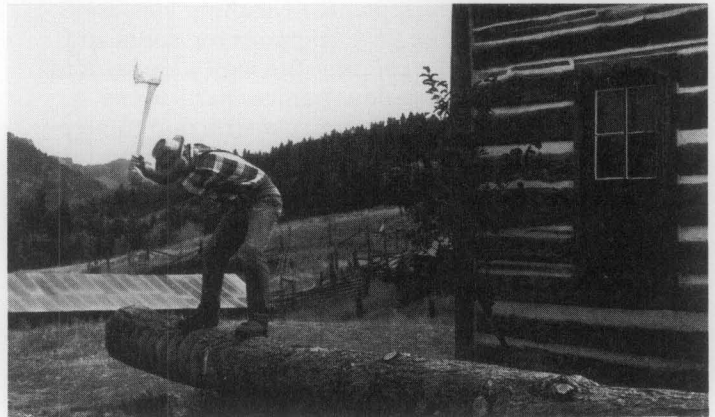
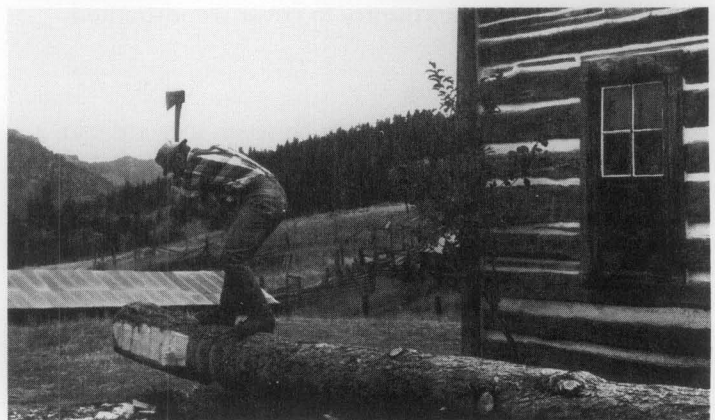
Fig. 11. Log-hewing tools and techniques: (a) scoring the log with a single-bladed felling axe, or "pole axe" in preparation for removing a uniform thickness of wood; (b) removal to depth of scoring; (c) finish hewing with a broad axe. Photos: Courtesy Bernard Weisgerber.

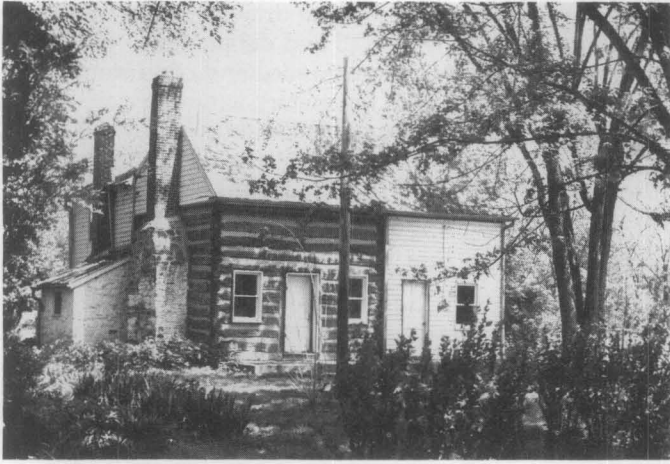
Fig. 13. Historic wood clapboard siding originally applied to conceal the fact that this house was built in two sections of different materials has been inappropriately removed from the 1793 log portion. Photo: National Park Service Files.

Sometimes log houses were sided or stuccoed later in an attempt to express a newly-achieved financial or social status. Many log houses were immediately sided and trimmed upon completion to disguise their simple construction beneath Georgian, Federal and later architectural styles. Frequently a log house was covered, or recovered, when a new addition was erected in order to harmonize the whole, especially if the original core and its addition were constructed of different materials such as log and wood frame (Fig. 13).

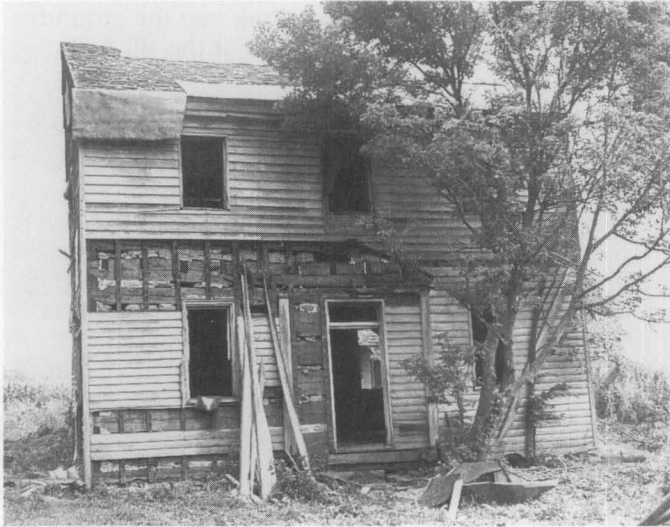
Fig. 14. Removal of the historic wood siding from the 1804 Zachariah Price DeWitt House in Butler County, Ohio, reveals that the clapboards were attached to vertical wood furring strips nailed to the logs. Photo: National Park Service Files.

Vertical wood furring strips were generally nailed to the logs prior to applying weatherboarding or stucco (Fig. 14). This ensured that the walls would be plumb, and provided a base on which to attach the clapboards, or on which to nail the wood lath for stucco.

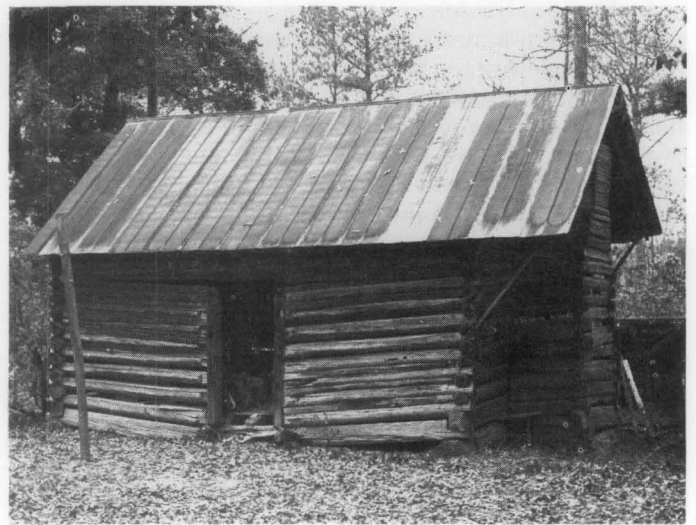
Fig. 15. The mid-19th century O'Quinn House, Moore County, North Carolina, provides a rare surviving example of a clay-lined log chimney. Although the logs of the house are saddle-notched, the chimney logs are "V" notched. The roof was extended out over the chimney to protect the daubing from the weather, and the chimney stack would have originally projected through a hole in the roof. Photo: Michael Southern.

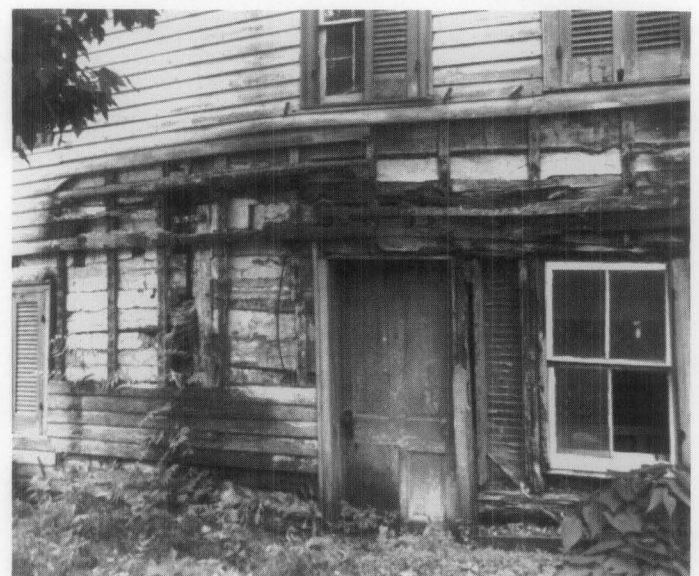
Fig. 17. Contact of this building's sill log with the ground has led to its decay, infestation by wood-destroying insects, and resulting building settlement. Photo: Anne Grimmer.

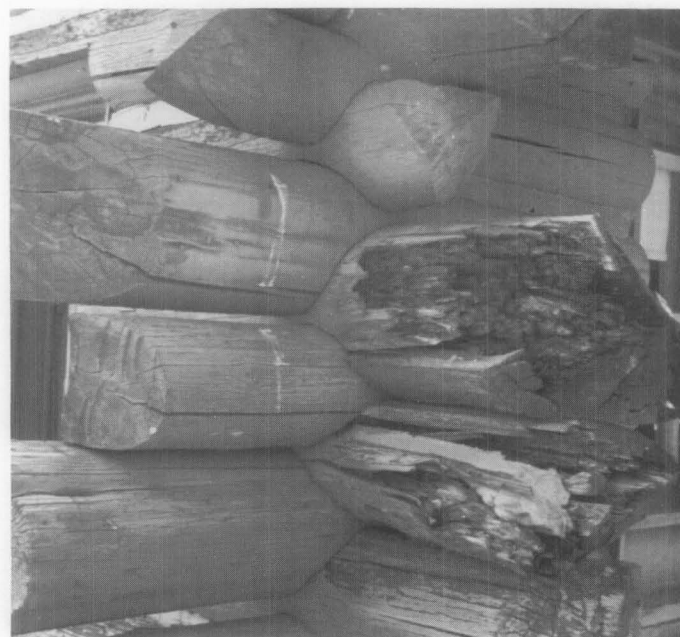
Fig. 20. (a) These deteriorated log crowns were (b) repaired with new crowns which were attached to the historic logs with reinforcing bars and epoxy. Epoxy repair of log crowns is most successful when the repaired crowns are protected from excess moisture by a roof overhang. Photos: Harrison Goodall.

The technique of treating, for an example, a decayed log crown with epoxies is begun by removing loose decayed wood, and drying the area if necessary (Fig. 20). The rot-affected cavity and surface of the log end is then saturated with liquid epoxy by repeated brushing, or by soaking it in a plastic bag filled with epoxy that is attached to the log. The porous condition of the rot-damaged wood will draw up the epoxy like a lamp wick. Once the liquid epoxy has saturated the log end and cured, the log end has been consolidated, and is ready for the application of an epoxy putty filler. The filler resin and hardener must also be mixed; pigments must be mixed with the filler epoxy to color the patch, and more importantly to protect it from ultraviolet sunlight. The filler can be applied with a putty knife, pressing it into the irregularities of the cavity. The cured patch can be worked like wood and painted with an opaque stain or a dull finish paint to help it blend with surrounding wood, although epoxy repairs can be difficult to disguise on natural, unpainted wood.

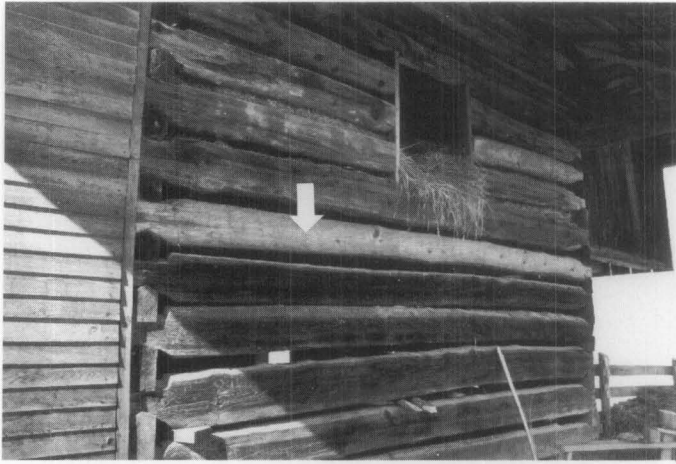
Fig. 22. The lighter-colored replacement log in this barn matches the dimensions and hewing marks of the original logs, and will darken in time to blend visually with the other logs. Photo: Bernard Weisgerber.

A replacement log should be obtained to match the wood species of the original being removed. If it is a hewn log, then the replacement must be hewn to replicate the dimensions and tool marks of the original (Fig. 22). If the same wood species cannot be obtained in the original dimensions, a substitute species may have to be used, and may even be preferable in some instances

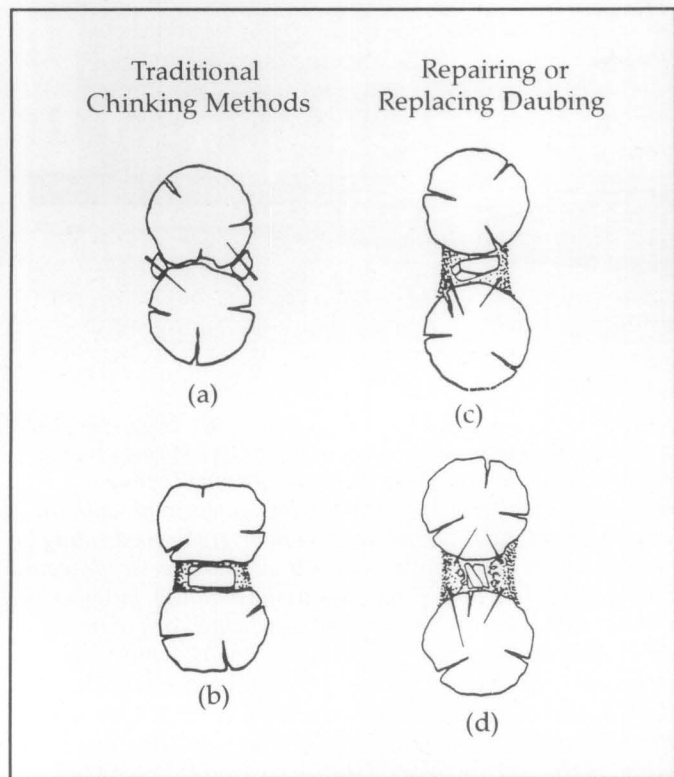
Fig. 23. Illustrated are various methods of chinking and daubing: (a) wood strips, or thin saplings nailed in place; and (b) 3-part system consisting of an inner blocking filler of stones or wood slabs, together with soft filler, such as clay, stuffed around the blocking, composes the chinking, and wet-applied daubing. Concealed aids that may improve the adherence of new daubing include (c) galvanized nails, or (d) galvanized mesh lath. Drawing: James Caufield.

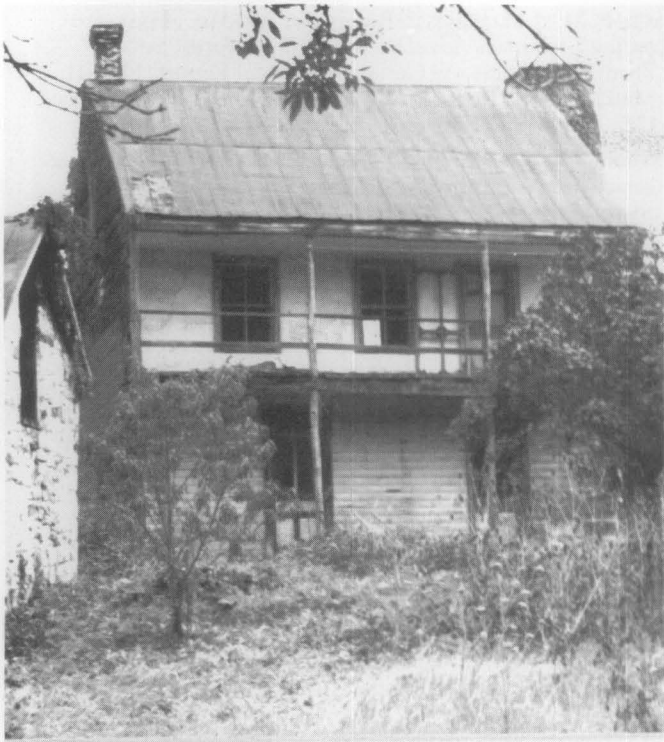
Fig. 25. (a) Prior to rehabilitation, the exterior of this late 18th century log house was sided with wood clapboard, which had been covered over by a later artificial siding, while the upper gallery of the second floor porch was stuccoed. (b) During the rehabilitation both the historic wood siding and stucco were removed to expose the logs, the gables were sided with wood shingles, and what would have originally been milled wood columns supporting the porch were replaced with rough, unmilled log posts. Collectively, these treatments diminished the building's architectural integrity, and gave it an appearance it never had. (c) The depth that the window frames extend out beyond the log surface allowing space for siding is an indication that cladding was part of the building's original construction. Photos: National Park Service Files.
