27 PRESERVATION BRIEFS

The Maintenance and Repair of Architectural Cast Iron

John G. Waite, AIA

U.S. Department of the Interior
National Park Service
Cultural Resources
Preservation Assistance

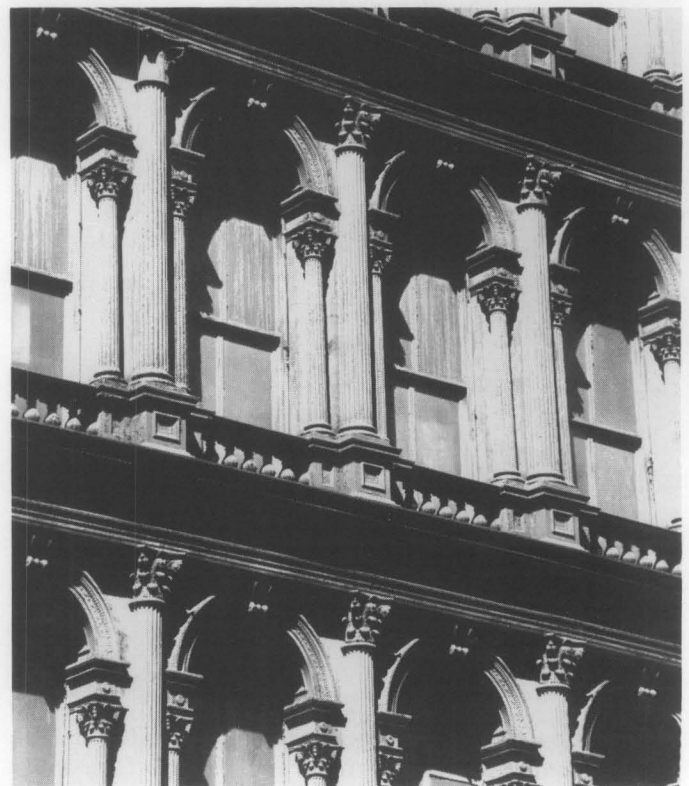
Fig. 1. The Haughwout Building in New York City is an excellent example of the quality and character of mass-produced cast-iron architecture. Once wood patterns were made, any number of elements could be cast, as was done with each of these repetitive bays. Photo: New York City Landmarks Preservation Commission.

Cast iron played a preeminent role in the industrial development of our country during the 19th century. Cast-iron machinery filled America's factories and made possible the growth of railroad transportation. Cast iron was used extensively in our cities for water systems and street lighting. As an architectural metal, it made possible bold new advances in architectural designs and building technology, while providing a richness in ornamentation (Fig. 1).

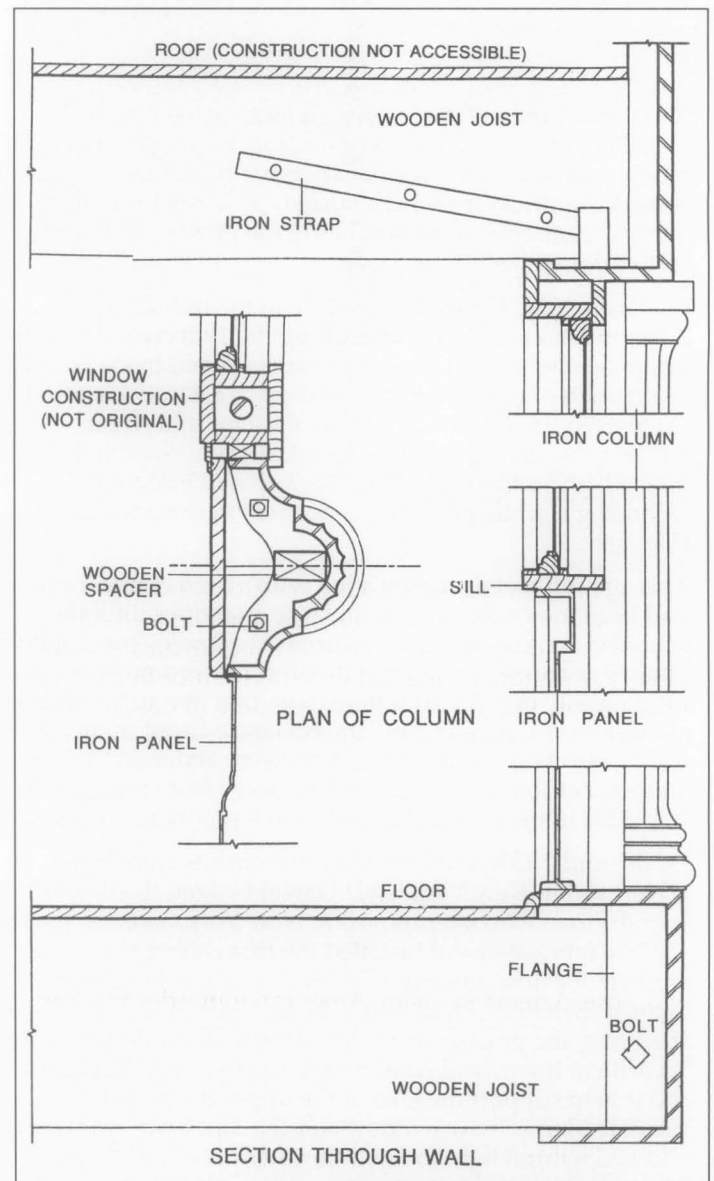
Fig. 3. Section drawing through the wall of Edgar Laing Stores showing how the cast-iron facade components were anchored to the wood floor and roof framing members. Drawing: John G. Waite, HABS Collection.

In 1849 Bogardus created something uniquely American when he erected the first structure with self-supporting, multi-storied exterior walls of iron. Known as the Edgar Laing Stores, this corner row of small four-story warehouses that looked like one building was constructed in lower Manhattan in only two months. Its rear, side, and interior bearing walls were of brick; the floor framing consisted of timber joists and girders. One of the cast-iron walls was load-bearing, supporting the wood floor joists. The innovation was its two street facades of self-supporting cast iron, consisting of multiples of only a few pieces—Doric-style engaged columns, panels, sills, and plates, along with some applied ornaments (cover photo and Fig. 2). Each component of the facades had been cast individually in a sand mold in a foundry, machined smooth, tested for fit, and finally trundled on horse-drawn drays to the building site. There they were hoisted into position, then bolted together and fastened to the conventional structure of timber and brick with iron spikes and straps (Fig. 3).

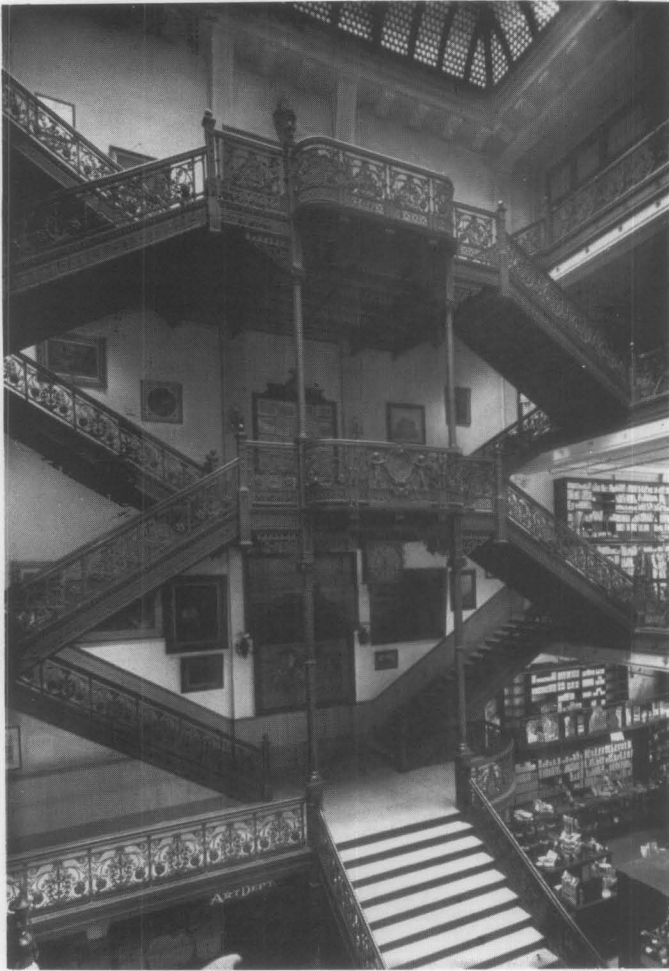
Fig. 4. The 1904 grand stairway of the former Frear's department store in Troy, N.Y. was constructed of cast iron, as was the frame of the skylight above. Some ornamental wrought iron was also employed. This use of iron was typical in major commercial buildings constructed throughout the United States. Courtesy: Rensselaer County Historical Society.

In addition to these exterior uses, many public buildings display magnificent exposed interior ironwork, at once ornamental and structural (Fig. 4). Remarkable examples have survived across the country, including the Peabody Library in Baltimore; the Old Executive Office Building in Washington, D.C.; the Bradbury Building in Los Angeles; the former Louisiana State Capitol; the former City Hall in Richmond; Tweed Courthouse in New York; and the state capitols of California, Georgia, Michigan, Tennessee, and Texas. And it is iron, of course, that forms the great dome of the United States Capitol, completed during the Civil War. Ornamental cast iron was a popular material in the landscape as well, appearing as fences, fountains with statuary, lampposts, furniture, urns, gazebos, gates, and enclosures for cemetery plots (Fig. 5). With such widespread demand, many American foundries that had been casting machine parts, bank safes, iron pipe, or cookstoves added architectural iron departments (Fig. 6). These called for patternmakers with sophisticated design capabilities, as well as knowledge of metal shrinkage and other technical aspects of casting. Major companies included the Hayward Bartlett Co. in Baltimore; James L. Jackson, Cornell Brothers, J. L. Mott, and Daniel D. Badger's Architectural Iron Works in Manhattan; Hecla Ironworks in Brooklyn; Wood & Perot of Philadelphia; Leeds & Co., the

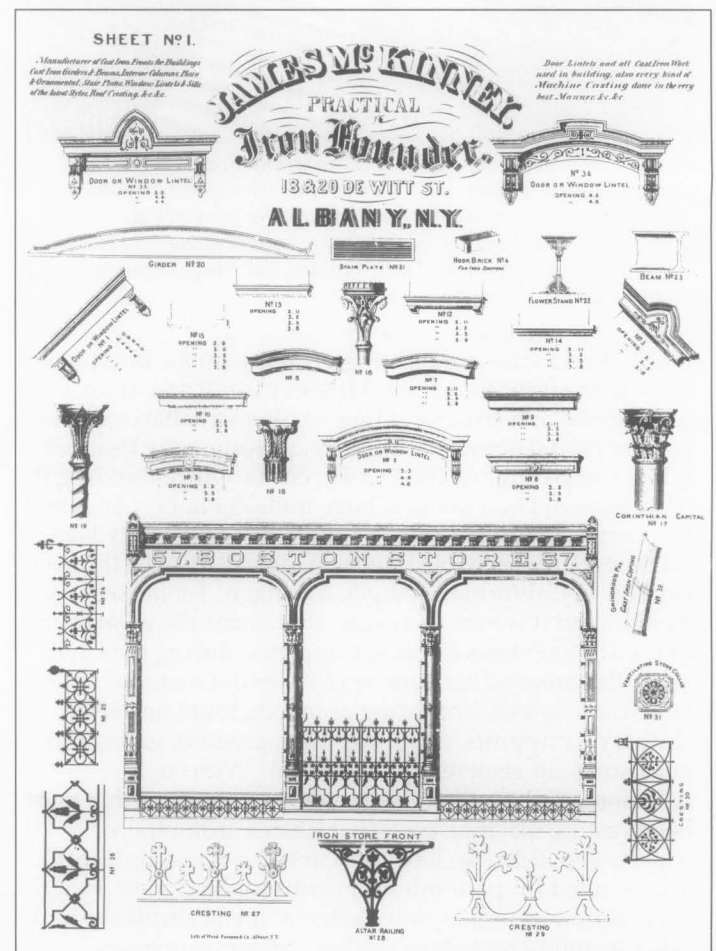
Fig. 6. Sheet from a late 19th century manufacturer's trade catalog illustrates some of the products available from foundries, such as storefronts, girders and beams, columns, stairs, window lintels and sills, and roof crestings. Courtesy: Albany Institute of History and Art.

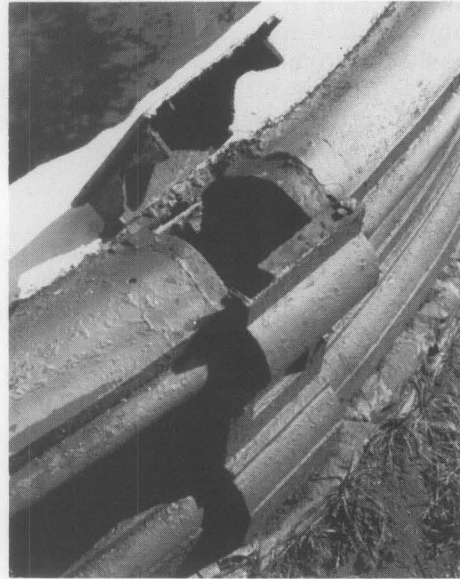
Fig. 9. Galvanic corrosion occurred where a patch of copper was installed alongside the cast-iron cap at the base of a fountain. The use of terne-coated stainless flashings with appropriate caulking would have been a more suitable repair. Photo: John G. Waite.

Galvanic corrosion is an electrochemical action that results when two dissimilar metals react together in the presence of an electrolyte, such as water containing salts or hydrogen ions (Fig. 9). The severity of the galvanic corrosion is based

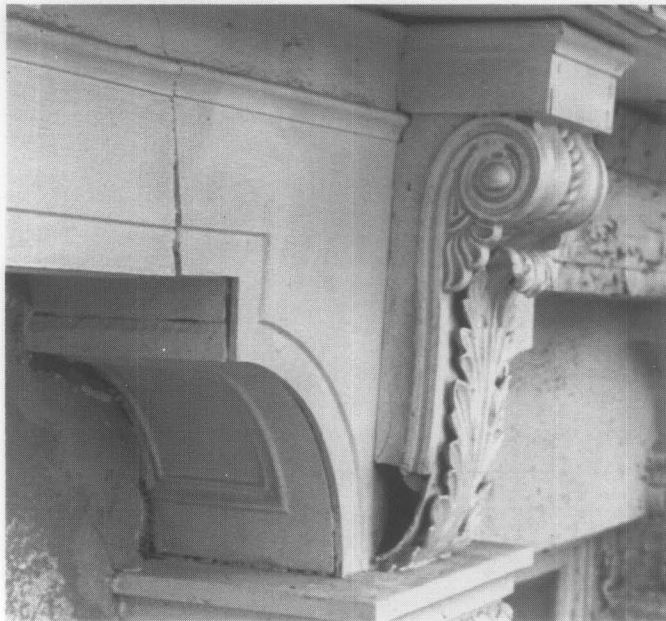
Fig. 8. Structural cracks, gaps at joints between components, and a large opening where part of the console bracket is missing are the problems evident in this cast-iron assembly. Photo: Ford, Powell & Carson.

Common problems encountered today with cast-iron construction include badly rusted or missing elements, impact damage, structural failures, broken joints, damage to connections, and loss of anchorage in masonry (Figs. 7, 8).

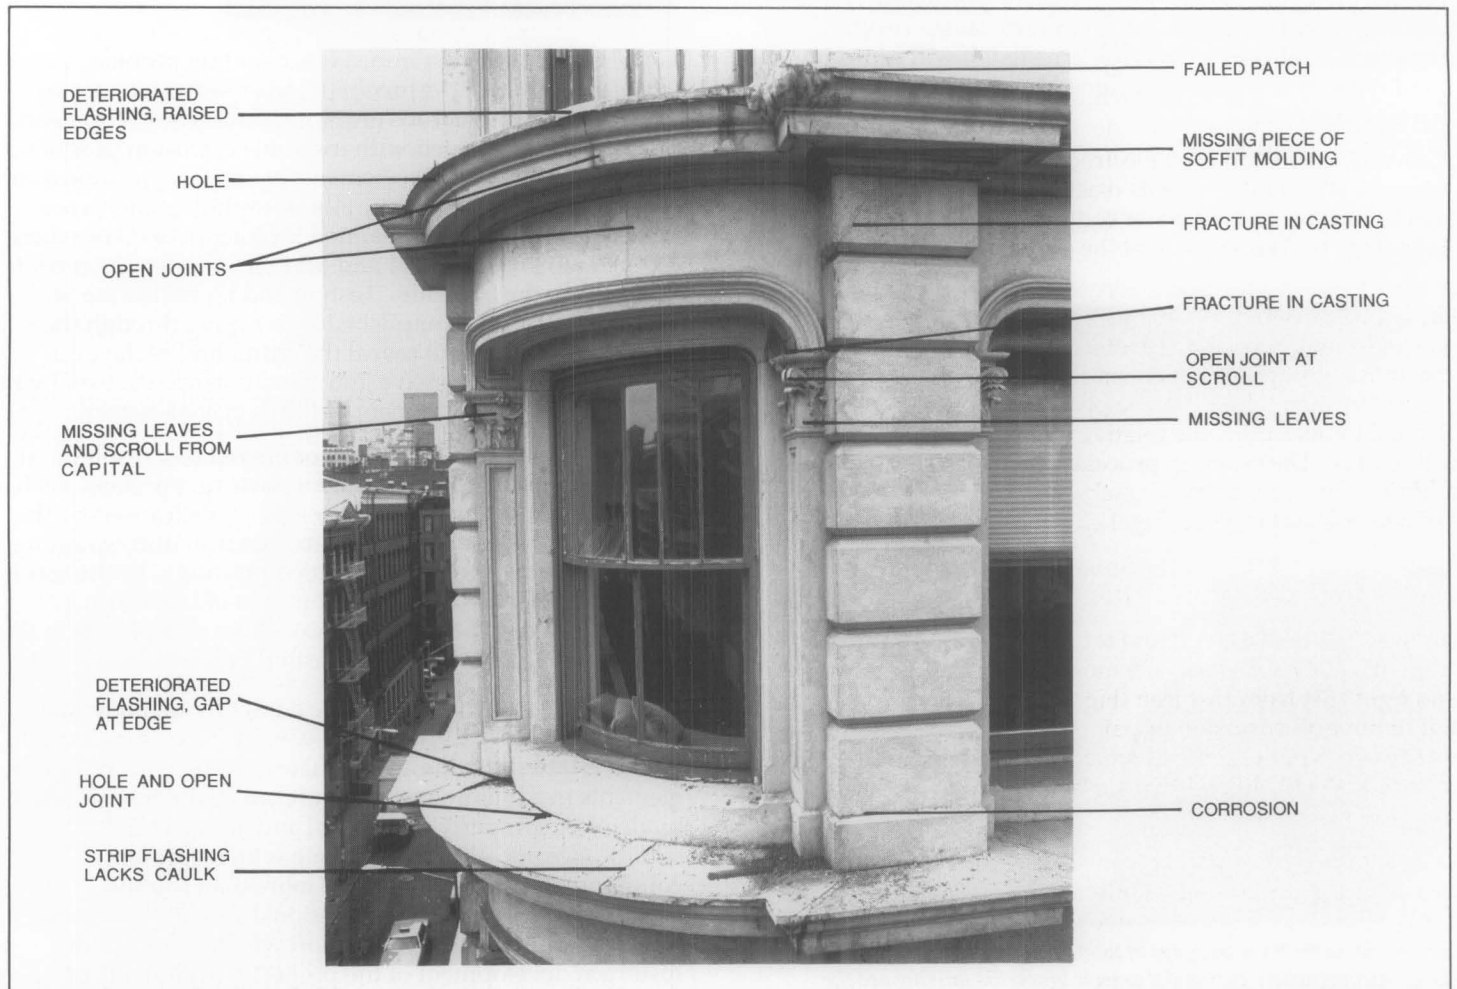
Fig. 10. During close-up inspection of the Gunther Building in New York City, photographs of each bay were taken to use in a survey of existing conditions. Photo: Willcox Dunn.

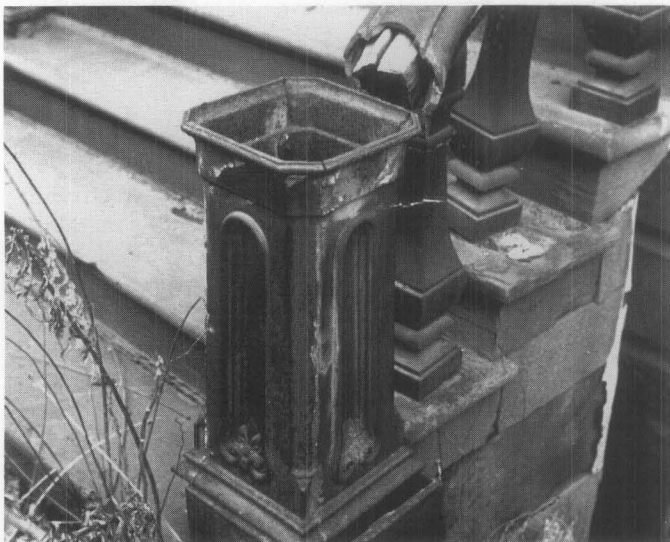
Fig. 15. In an effort to repair this stair railing, concrete was poured around the wood spacer inside the railing casting. Water penetrated the railing and reacted with the concrete to accelerate the corrosion of the iron. Photo: John G. Waite.

The internal voids of balusters, newel posts, statuary, and other elements should not be filled with concrete; it is an inappropriate treatment that causes further problems (Fig. 15). As the concrete cures, it shrinks, leaving a space between the concrete and cast iron. Water penetrating this space does not evaporate quickly, thus promoting further rusting. The corrosion of the iron is further accelerated by the alkaline nature of concrete. Where cast-iron elements have been previously filled with concrete, they need to be taken apart, the concrete and rust removed, and the interior surfaces primed and painted before the elements are reassembled.

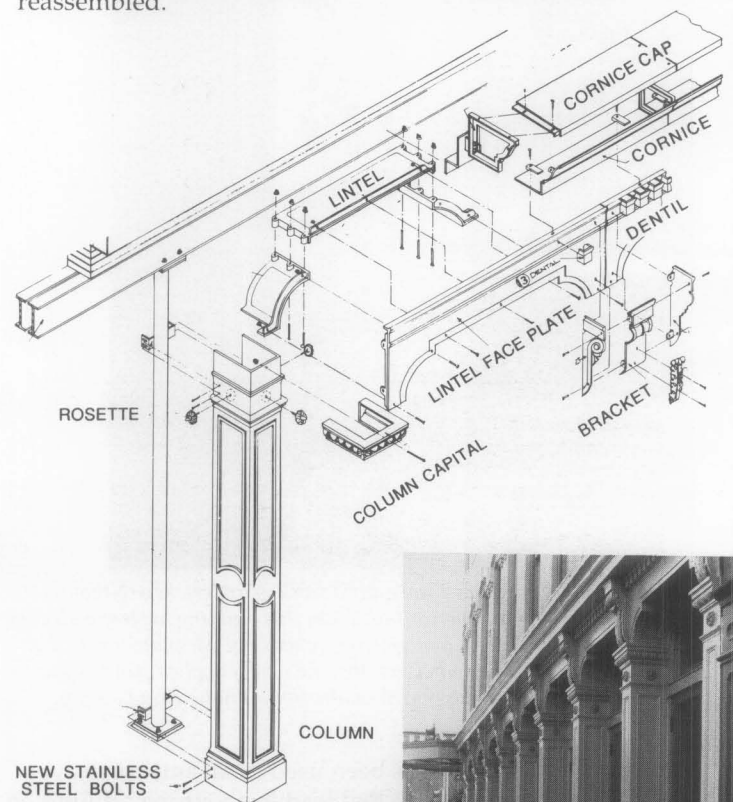
Fig. 16. Architectural cast iron is made of many small components bolted and screwed together. (a) This exploded view of a storefront illustrates the variety of elements, including brackets, fasteners, and holes for bolts. (b) The storefront was replicated in cast iron because of the extensive damage and structural failure, a detail of which is shown in Fig. 11. Drawing and photo: Historical Arts & Casting, Inc.

Most architectural cast iron is made of many small castings assembled by bolts or screws (Fig. 16a). Joints between pieces were caulked to prevent water from seeping in and causing rusting from the inside out. Historically, the seams were often caulked with white lead paste and sometimes backed with cotton or hemp rope; even the bolt and screw heads were caulked to protect them from the elements and to hide them from view. Although old caulking is sometimes found in good condition, it is typically crumbled from weathering, cracked from the structural settlement, or destroyed by mechanical cleaning. It is essential to replace deteriorated caulking to prevent water penetration. For good adhesion and performance, an architectural-grade polyurethane sealant or traditional white lead paste is preferred.

The replacement of cast-iron components is often the only practical solution when such features are missing, severely corroded, or damaged beyond repair, or where repairs would be only marginally useful in extending the functional life of an iron element (Fig. 16).

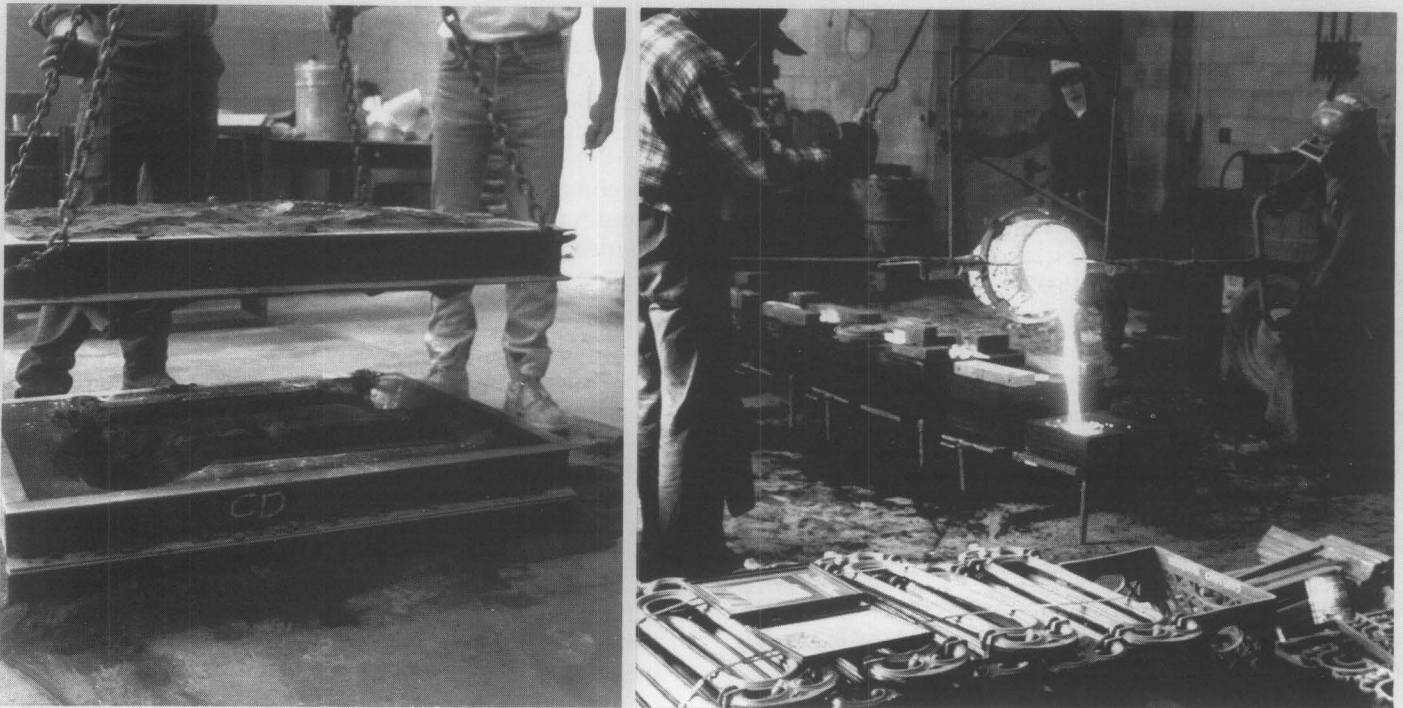
Fig. 17. (a) A two-part mold, consisting of a cope (top) and drag (bottom) for a newel post. Photo: Architectural Iron Company, Inc. (b) Molten iron being poured into a mold containing sand at a foundry. The iron casting process has changed little in the past two centuries. Photo: Karen Huebner.

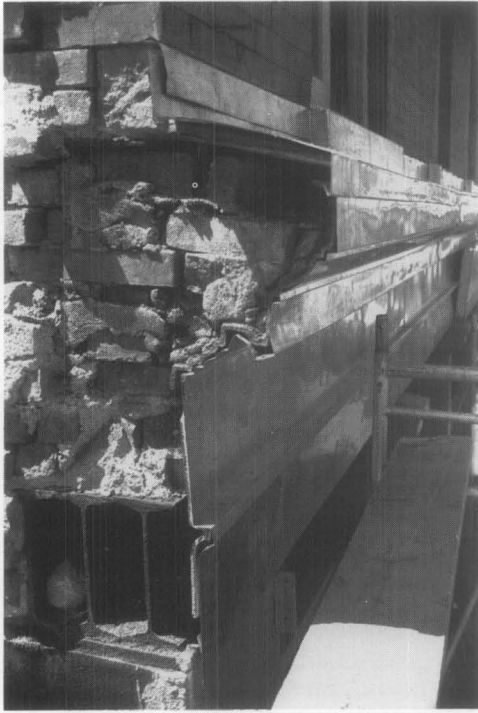
Fig. 18. This cast-iron storefront cornice was corroded beyond the point of repair, and could not be removed easily for replacement. Terne-coated stainless steel, the most durable metal for flashing cast iron, was applied to the cornice and fitted as closely as possible to the historic profile. Although painting is not necessary to protect terne-coated stainless steel, the cornice should be painted to be consistent with the historic character of the building. A primer which is compatible with the terne coating should be used. Photo: Dean Koga, Robert E. Meadows, P.C., Architects.

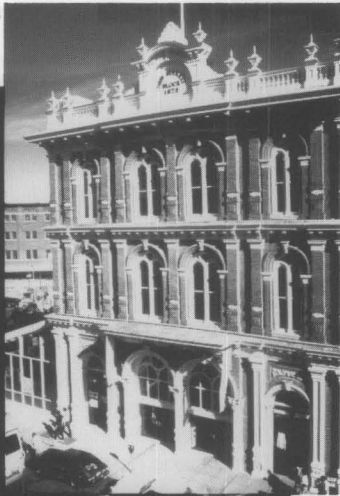
Fig. 20. The location of the feature must be taken into account if a substitute replacement material is being considered. This lightweight fiberglass column at street level sustained damage from impact within a few years of installation. The great strength of cast iron makes it ideal for storefronts and elements that must withstand heavy use. Photo: Building Conservation Associates.

corrosive, but is susceptible to ultraviolet degradation. Because of its rather flimsy nature, it cannot be used as a substitute for structural elements, cannot be assembled like cast iron and usually requires a separate anchorage system. It is unsuitable for locations where it is susceptible to damage by impact (Fig. 20), and is also flammable.
