# 32 PRESERVATION BRIEFS

## Making Historic Properties Accessible

Thomas C. Jester and Sharon C. Park, AIA

U.S. Department of the Interior  
National Park Service  
Cultural Resources  
Heritage Preservation Services

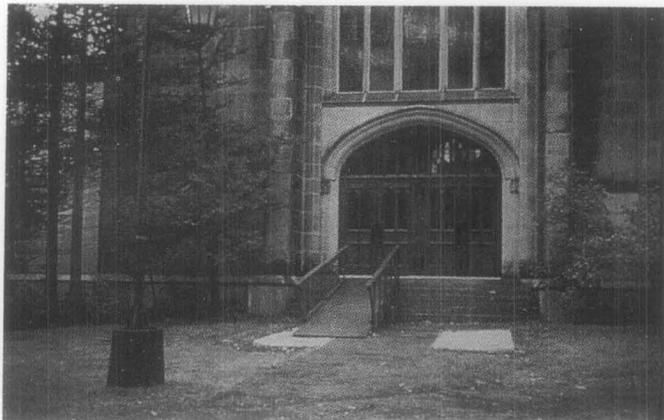
Figure 6. Entrances can be regraded to make a building accessible as long as no significant landscape features will be destroyed and as long as the building's historic character is preserved. The Houghton Chapel (a) in Wellesley, Massachusetts, was made accessible by regrading over the historic steps (b). Photos: Carol R. Johnson & Associates.

**Regrading an Entrance.** In some cases, when the entrance steps and landscape features are not highly significant, it may be possible to regrade to provide a smooth entrance into a building. If the existing steps are historic masonry, they should be buried, whenever possible, and not removed (See Figure 6).

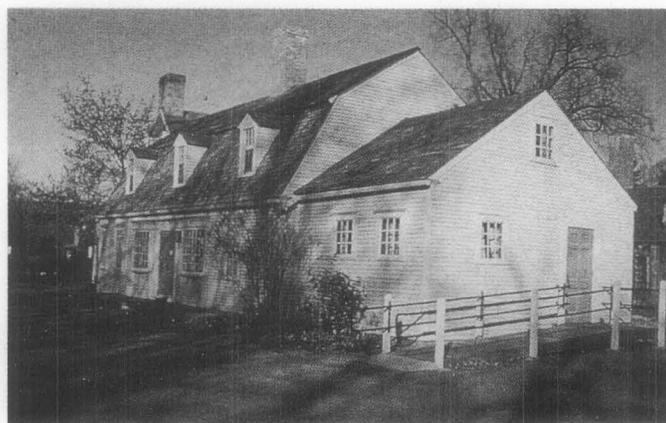
Figure 7. This ramp is convenient for visitors with disabilities and preserves the building's historic character. The design is also compatible in scale with the building. Photo: William Smith.

**Incorporating Ramps.** Permanent ramps are perhaps the most common means to make an entrance accessible. As a new feature, ramps should be carefully designed and appropriately located to preserve a property's historic character (See Figure 7). Ramps should be located at public

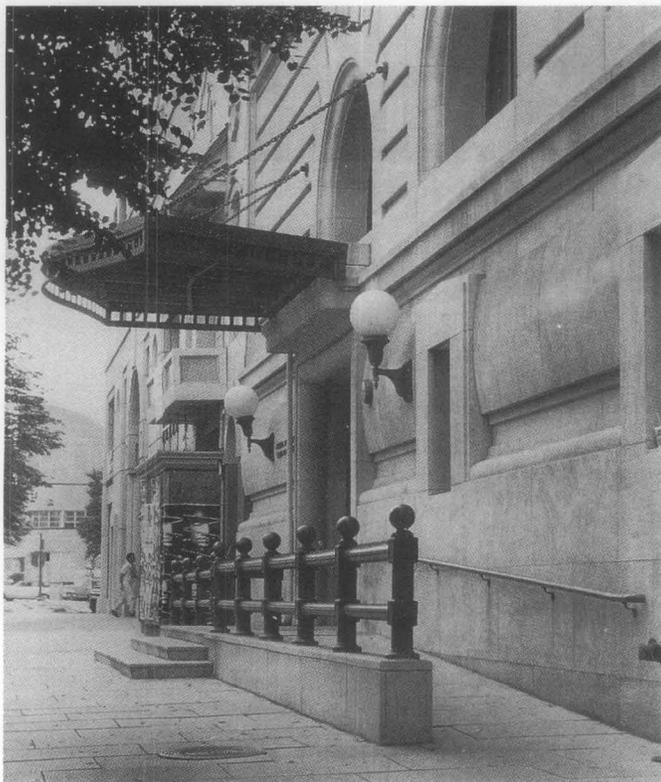
Figure 9. This ramp was created by infilling the window-well and slightly modifying the historic railing. The ramp preserves this building's historic character. Photo: Thomas Jester.

historic features, such as cheek-walls or railings, to minimize the visual effect (See Figure 9).

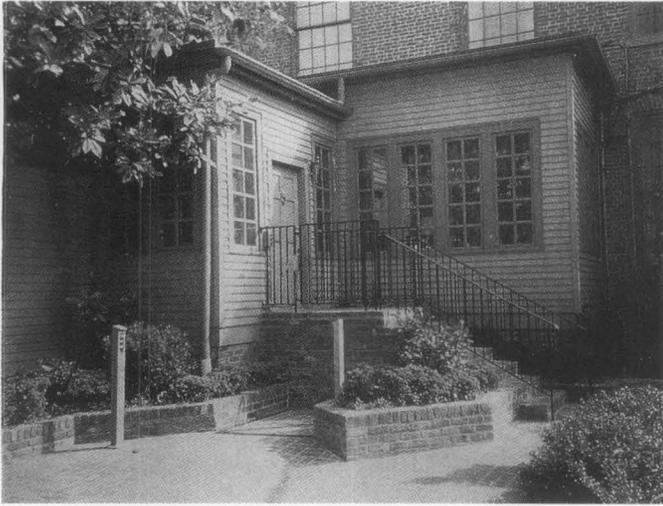
Figure 14. At the Lieutenant Governor's Mansion in Frankfort, Kentucky, a retracting lift (b) was installed to minimize the visual effect on this historic building when not in use (a). Photos: Aging Technology Incorporated.

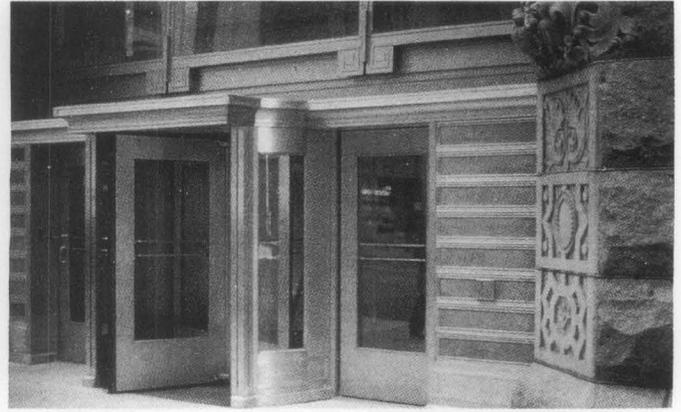
Figure 16. During the rehabilitation of the Rookery in Chicago, the original entrance was modified to create an accessible entrance. Two revolving doors were replaced with a new one flanked by new doors, one of which is operated with a push-plate door opener. Photo: Thomas Jester.

(operated by push buttons, mats, or electronic eyes) and power-assisted door openers can eliminate or reduce door pressures that are accessibility barriers, and make single or double-leaf doors fully operational (See Figure 16).

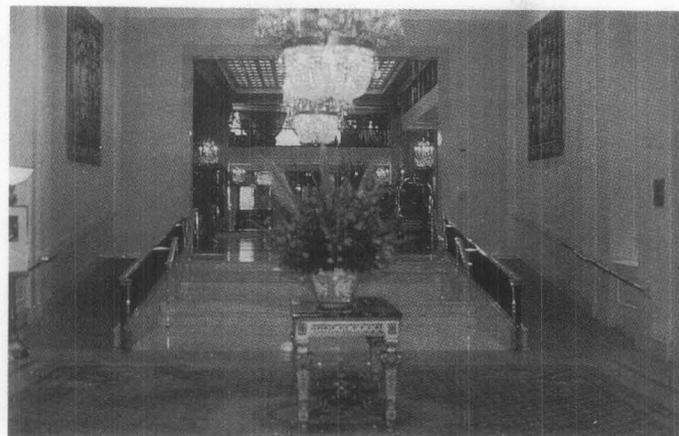
Figure 18. Symmetrical ramps at the Mayflower Hotel in Washington, D.C., provide access to the hotel's lower level. The design for the ramps respects the historic character of this landmark building. Photo: Thomas Jester.

**Installing Ramps and Wheelchair Lifts.** If space permits, ramps and wheelchair lifts can also be used to increase accessibility inside buildings (See Figures 18 & 19). However, some States and localities restrict interior uses of wheelchair lifts for life-safety reasons. Care should be taken to install these new features where they can be readily accessed. Ramps and wheelchair lifts are described in detail on pages 4-6.

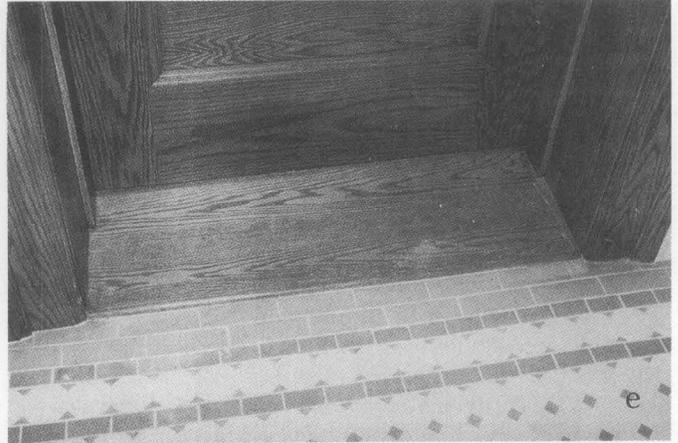
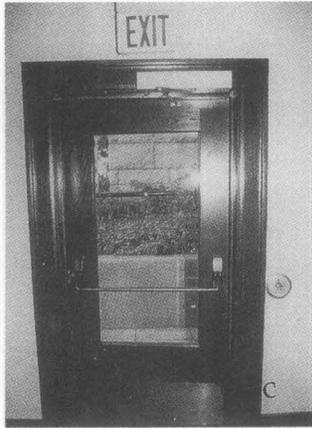
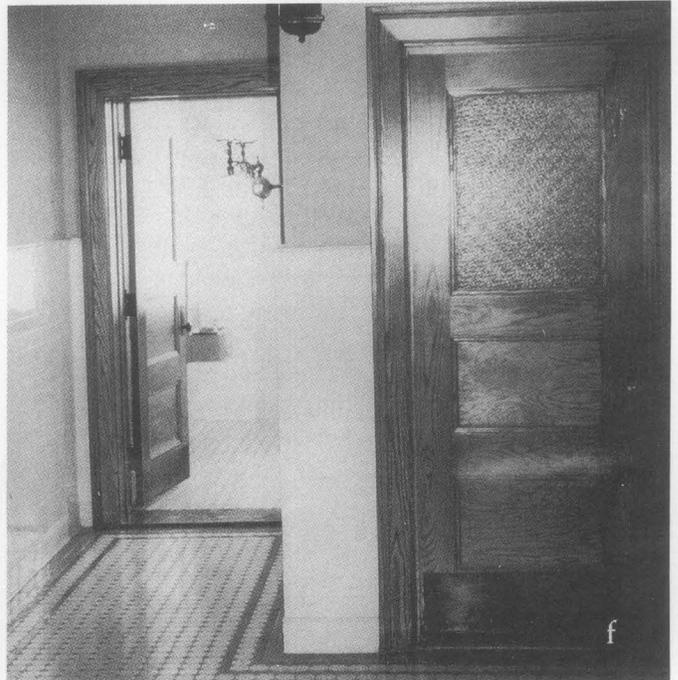
## MAKING A HISTORIC BUILDING ACCESSIBLE

The Orange County Courthouse (a), located in Santa Ana, California, was rehabilitated in the late 1980s as a county museum. As part of the rehabilitation, the architect sensitively integrated numerous modifications to increase accessibility. To preserve the building's primary elevation, a new public entrance was created on the rear elevation where parking spaces are located. A ramp (b) leads to the accessible entrance that can be opened with a push-plate automatic door-opener (c). Modifications to interior features also increased accessibility. To create an accessible path of travel, offset hinges (d) were installed on doors that were narrower than 32 inches (81.3 cm). Other doors were rethreaded to reduce the door pressure. Beveling the 1" high thresholds (e) reduced their height to approximately 1/4 inch (.64 cm). The project architect also converted a storeroom into an accessible restroom (f). The original stairway, which has open grillwork, was made more accessible by applying slip-resistant pressure tape to the marble steps (g). And the original elevator was upgraded with raised markings, alarm lights, and voice floor indicators. Photos: Milford Wayne Donaldson, FAIA.

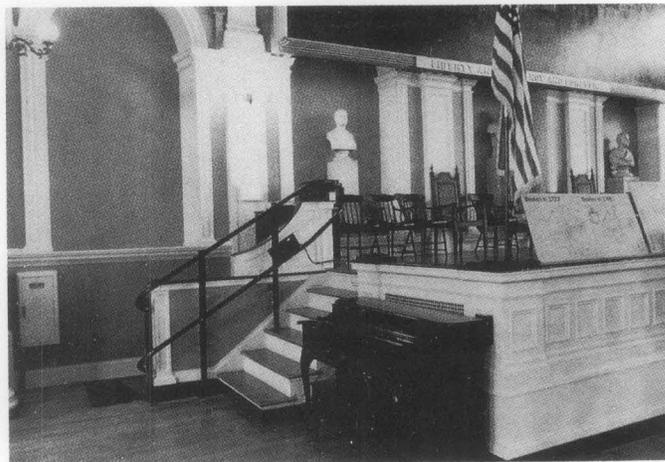
Figure 19. Inclined lifts can sometimes overcome interior changes of elevation where space is limited. This lift in Boston's Faneuil Hall created access to the floor and stage level of the State Room. Photo: Paul Holtz.

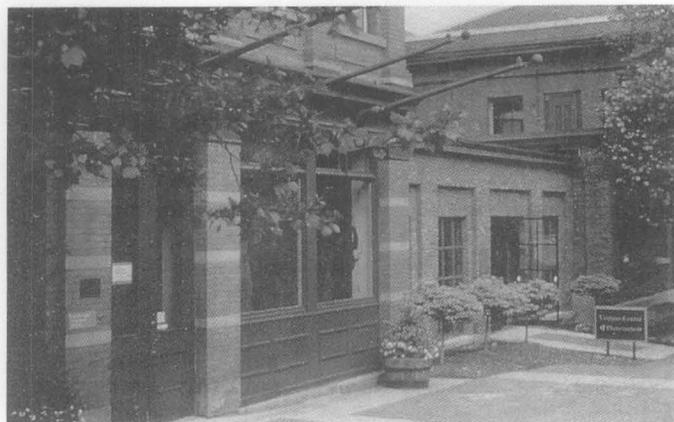
Figure 23. New additions to historic buildings can be designed to increase accessibility. A new addition links two adjacent buildings used for the Albany, New York, Visitor’s Center, and incorporates an accessible entrance, restrooms, and signage. Photo: Clare Adams.
