# 4 PRESERVATION BRIEFS

## Roofing for Historic Buildings

U.S. Department of the Interior  
National Park Service  
Cultural Resources  
Heritage Preservation Services

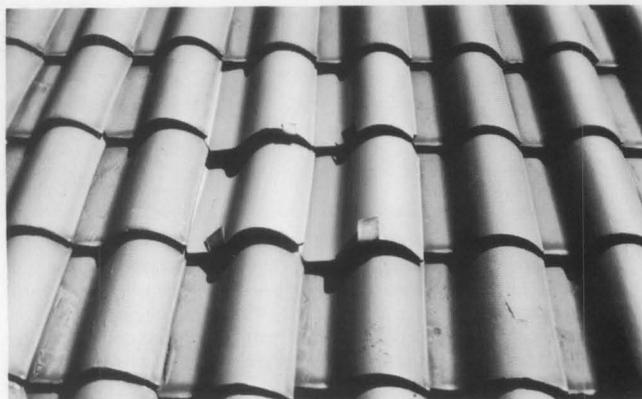
*Repairs on this pantile roof were made with new tiles held in place with metal hangers. (Main Building, Ellis Island, New York)*

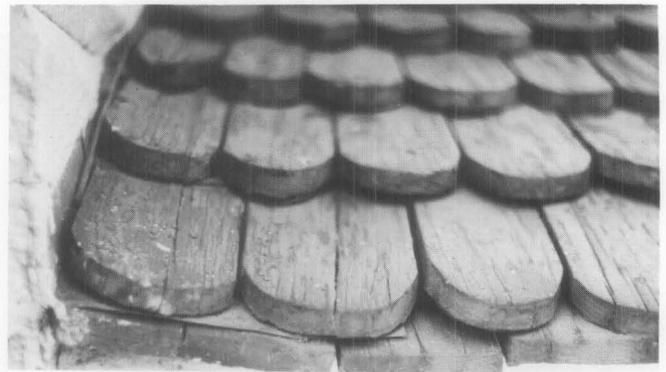
*Replacement of particular historic details is important to the individual historic character of a roof, such as the treatment at the eaves of this rounded butt wood shingle roof. Also note that the surface of the roof was carefully sloped to drain water away from the side of the dormer. In the restoration, this function was augmented with the addition of carefully concealed modern metal flashing. (Mount Vernon, Virginia)*

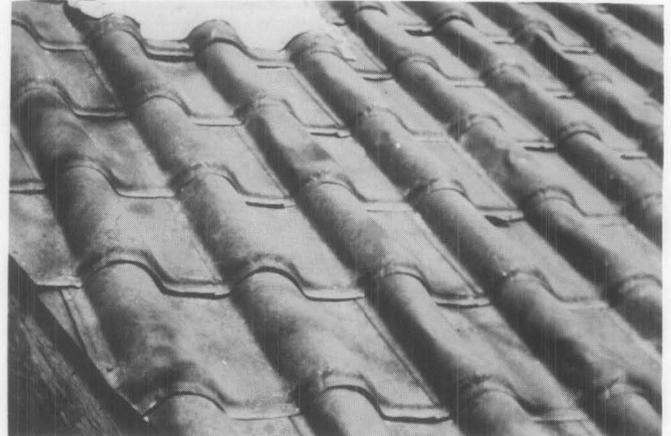
*Galvanized sheet-metal shingles imitating the appearance of pantiles remained popular from the second half of the 19th century into the 20th century. (Episcopal Church, now the Jerome Historical Society Building, Jerome, Arizona, 1927)*

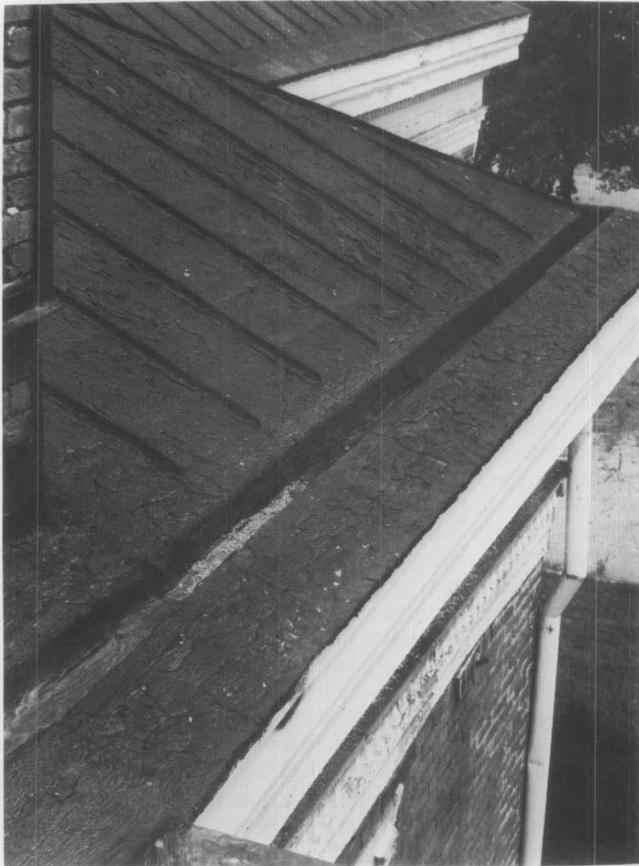
Repeated repair with asphalt, which cracks as it hardens, has created a blistered surface on this sheet-metal roof and built-in gutter, which will retain water. Repairs could be made by carefully heating and scraping the surface clean, repairing the holes in the metal with a flexible mastic compound or a metal patch, and coating the surface with a fibre paint. (Roane County Courthouse, Kingston, Tennessee, photo courtesy of Building Conservation Technology, Inc.)

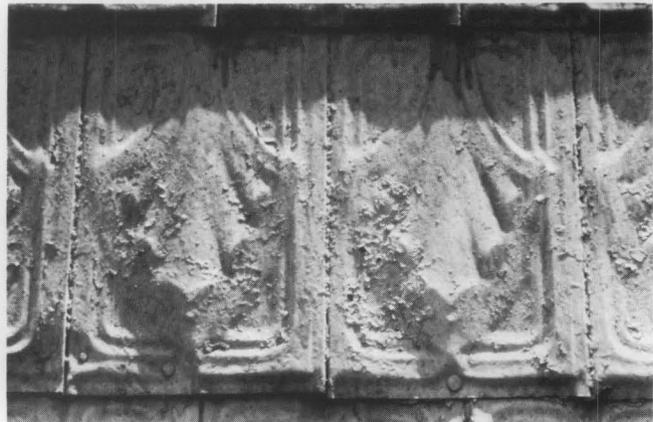
Tin shingles, commonly embossed to imitate wood or tile, or with a decorative design, were popular as an inexpensive, textured roofing material. These shingles  $8\frac{3}{8}$  inch by  $12\frac{1}{2}$  inch on the exposed surface) were designed with interlocking edges, but they have been repaired by surface nailing, which may cause future leakage. (Ballard House, Yorktown, Virginia, photo by Gordie Whittington, National Park Service)

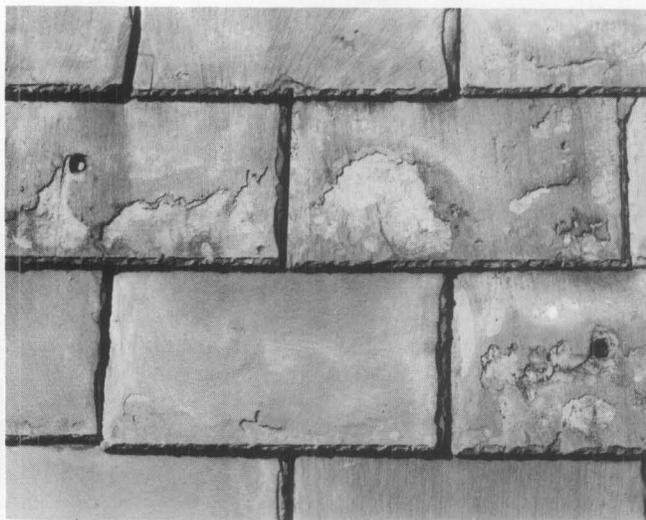
*This detail shows slate delamination caused by a combination of weathering and pollution. In addition, the slates have eroded around the repair nails, incorrectly placed in the exposed surface of the slates. (Lower Pontalba Building, New Orleans, photo courtesy of Building Conservation Technology, Inc.)*

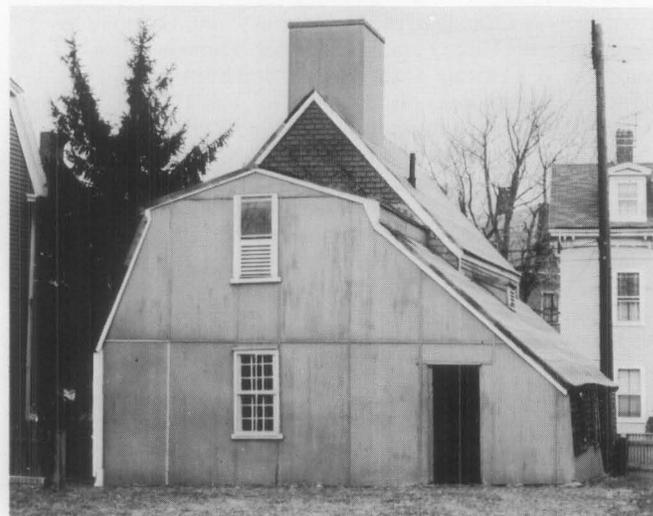
*Temporary stabilization or "mothballing" with materials such as plywood and building paper can protect the roof of a project until it can be properly repaired or replaced. (Narbonne House, Salem, Massachusetts)*

It may be necessary to carry out an immediate and temporary stabilization to prevent further deterioration until research can determine how the roof should be restored or rehabilitated, or until funding can be provided to do a proper job. A simple covering of exterior plywood or roll roofing might provide adequate protection, but any temporary covering should be applied with caution. One should be careful not to overload the roof structure, or to damage or destroy historic evidence or fabric that might be incorporated into a new roof at a later date. In this sense, repairs with caulking or bituminous patching compounds should be recognized as potentially harmful, since they are difficult to remove, and at their best, are very temporary.

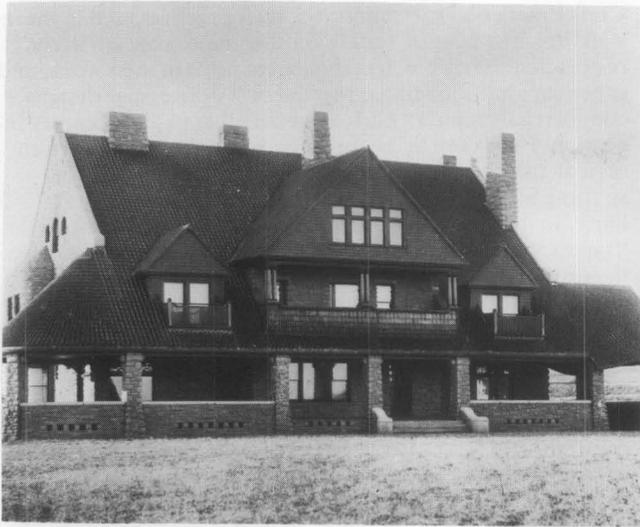
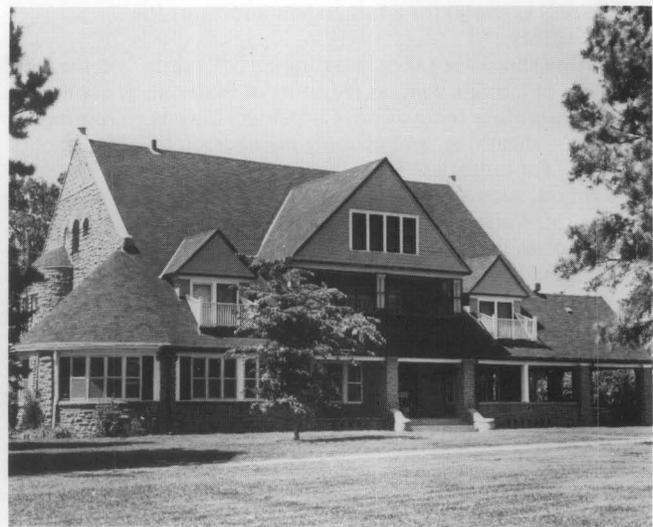
*These two views of the same house demonstrate how the use of a substitute material can drastically affect the overall character of a structure. The textural interest of the original tile roof was lost with the use of asphalt shingles. Recent preservation efforts are replacing the tile roof. (Frank House, Kearney, Nebraska, photo courtesy of the Nebraska State Historical Society, Lincoln, Nebraska)*

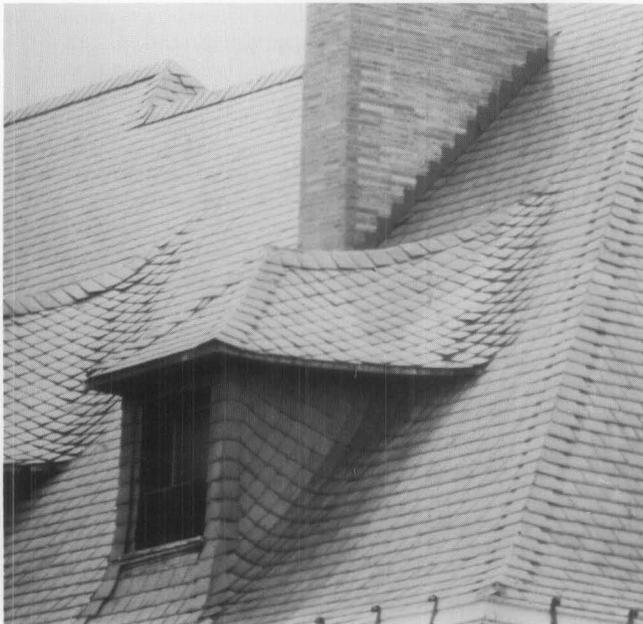
*Because of the roof's visibility, the slate detailing around the dormers is important to the character of this structure. Note how the slates swirl from a horizontal pattern on the main roof to a diamond pattern on the dormer roofs and side walls. (18th and Que Streets, NW, Washington, D.C.)*

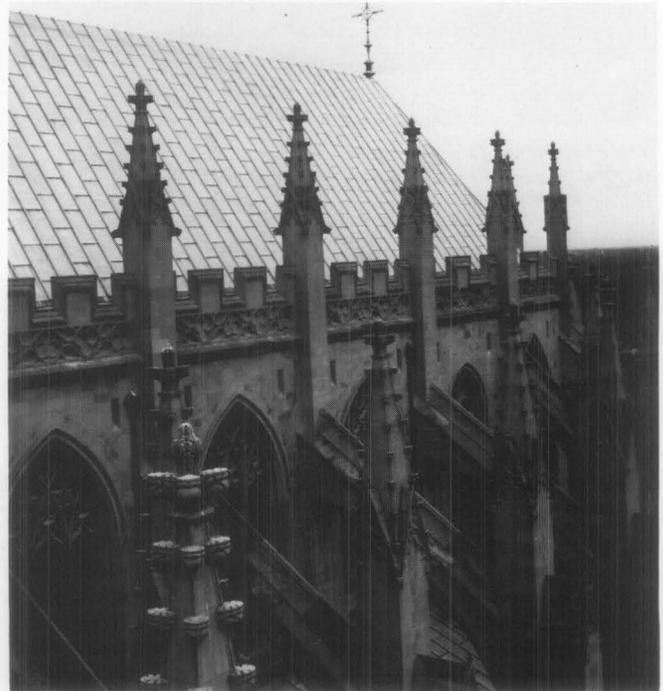
*Good design and quality materials for the roof surface, fastenings, and flashing minimize roofing failures. This is essential on roofs such as on the National Cathedral where a thorough maintenance inspection and minor repairs cannot be done easily without special scaffolding. However, the success of the roof on any structure depends on frequent cleaning and repair of the gutter system. (Washington, D.C., photo courtesy of John Burns, A.I.A.)*

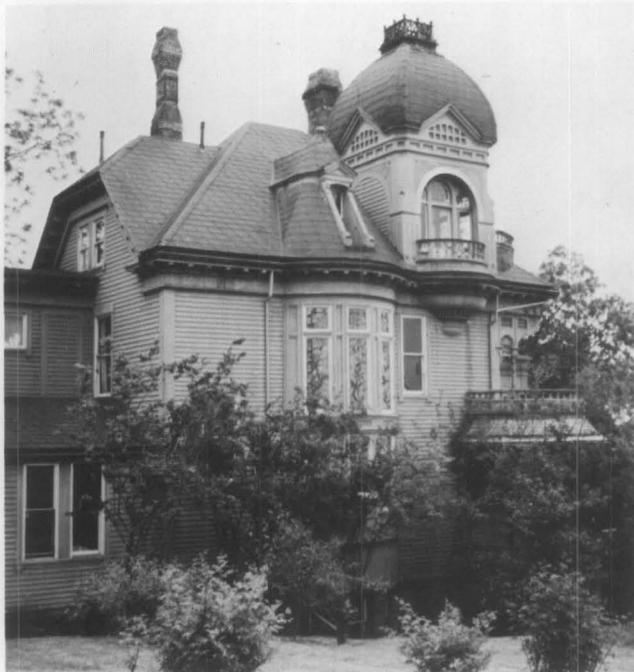
*Special problems inherent in the design of an elaborate historic roof can be controlled through the use of good materials and regular maintenance. The shape and detailing are essential elements of the building's historic character, and should not be modified, despite the use of alternative surface materials. (Gamwell House, Bellingham, Washington)*

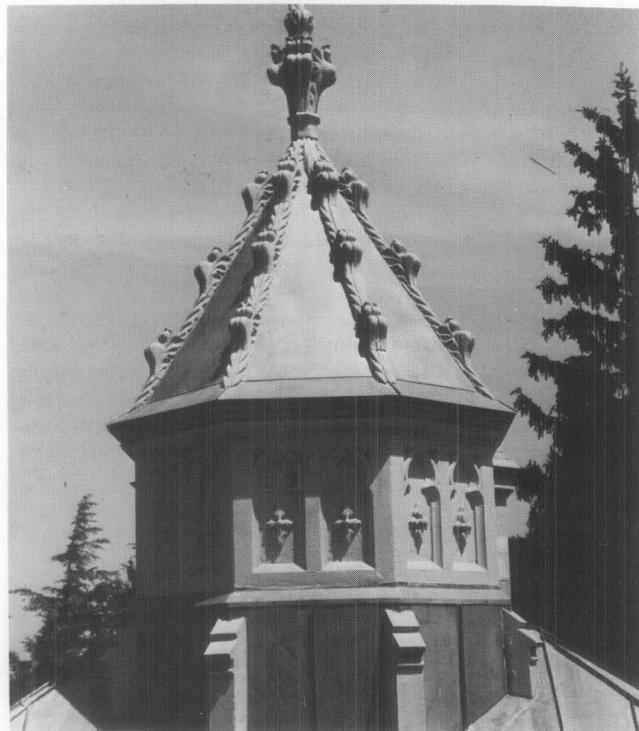
Decorative features such as cupolas require extra maintenance. The flashing is carefully detailed to promote run-off, and the wooden ribbing must be kept well-painted. This roof surface, which was originally tin plate, has been replaced with lead-coated copper for maintenance purposes. (Lyndhurst, Tarrytown, New York, photo courtesy of the National Trust for Historic Preservation)
