40 PRESERVATION BRIEFS

Preserving Historic Ceramic Tile Floors

Anne E. Grimmer and Kimberly A. Konrad

U.S. Department of the Interior
National Park Service
Cultural Resources
Heritage Preservation Services

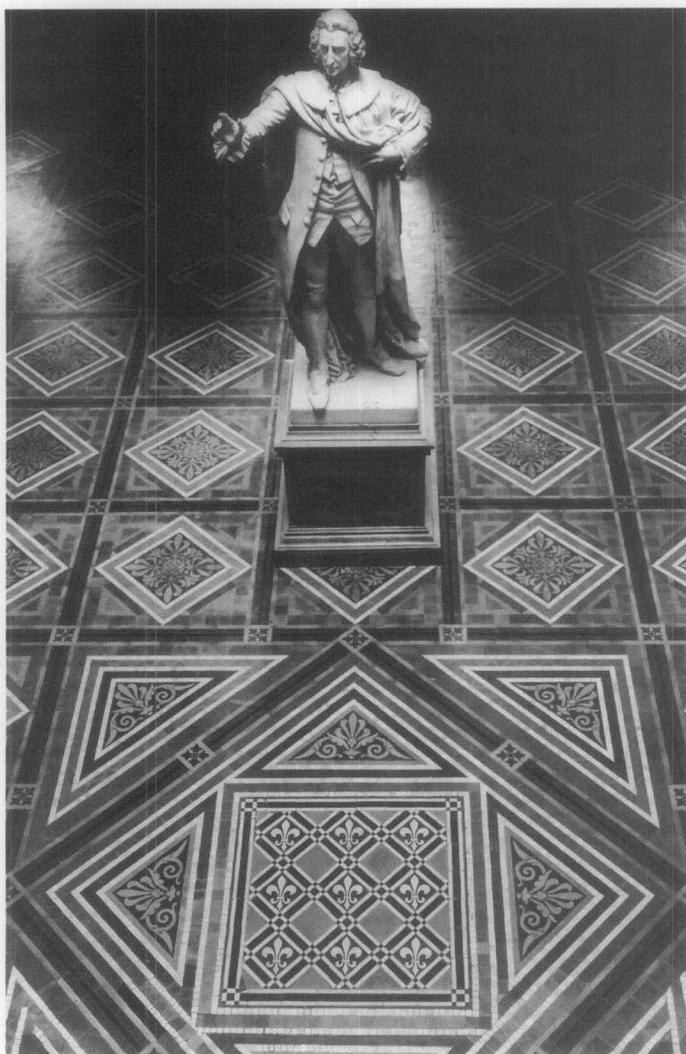
Figure 1. Minton encaustic tile floor, 3rd floor, Patent Office Building (now the National Portrait Gallery), Washington, D.C. Originally constructed between 1836-40 under the supervision of Robert Mills, the upper floors of this portion of the building were restored and redecorated in 1877 in the "Modern Renaissance style" by Cluss & Shulze, Architects, after a disastrous fire. Photo: Jack E. Boucher, HABS Collection.

With a tradition that dates to ancient civilizations, ceramic* tile flooring can be found in a variety of settings in diverse cultures and structures, including residential buildings ranging from large apartment buildings to small private houses, institutional buildings such as government offices and schools, and religious buildings such as cathedrals and mosques. Historically, its widespread use may be attributed to the fact that a readily available natural material—clay—could be converted by a relatively simple manufacturing process—baking or firing—into a very durable, long-lasting and attractive floor tile that is easy to maintain. Ceramic floor tiles exhibit a versatility of colored glazes and decoration, and they range from the plainest terra cotta tiles to highly decorated individual ceramic tiles and elaborately patterned tile floors. Their modularity, as standardized units, make them easy to fit into different sized spaces which also explains much of the popularity of ceramic floor tiles throughout history (Fig. 1).

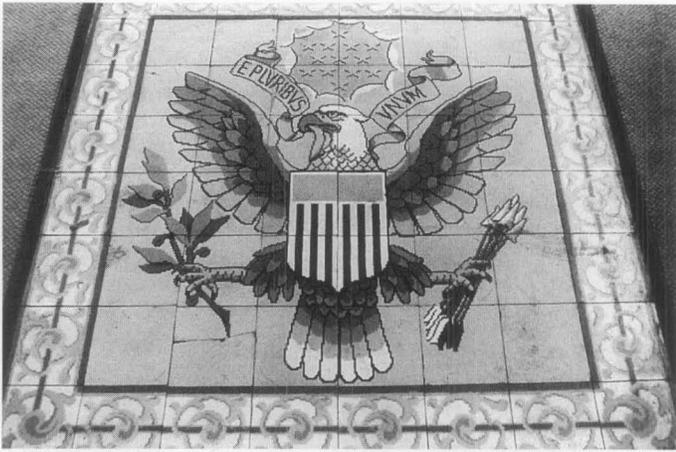
Figure 4. The tiled Presidential Seal in the courtyard of the Pension Building (now the National Building Museum), Washington, D.C., was installed in honor of President William McKinley's second inauguration in 1901. The "heavy Damask design," resembling fabric, that was used to decorate the tiles, indicates they were probably manufactured by The Mosaic Tile Company, Zanesville, Ohio, which first introduced this design. Photo: Kimberly A. Konrad.

Majolica Company; and J.B. Owens Pottery, later to become the Empire Floor and Wall Tile Company (Fig. 4). The American Encaustic Tiling Company, established in 1876, was one of the first, and most successful manufacturers in Zanesville (Fig. 5). In the early 1930s it was the largest tile company in the world, producing large quantities of floor tile, plain and ornamental wall tile, and art tile until it closed about 1935, as a result of the Depression. The United States Encaustic Tile Company, Indianapolis, Indiana; Rookwood Pottery, Cincinnati, Ohio; Cambridge Art Tile Works, Covington, Kentucky; and Pewabic Pottery, Detroit, Michigan, were some of the other well-known potteries in the Midwest.

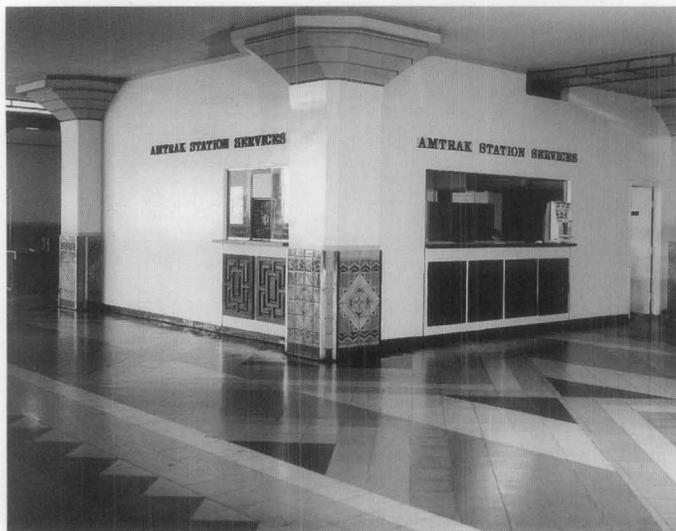
Figure 6. The Los Angeles Union Passenger Terminal features ceramic tile floors in the Art Deco-style. Photo: HABS Collection.

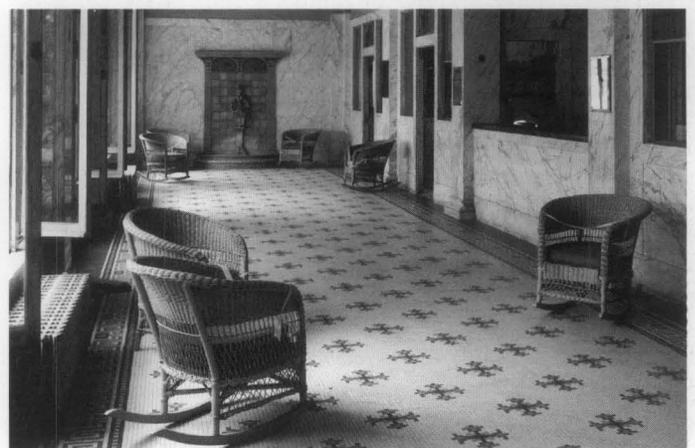
Figure 10. Ceramic mosaic tile floors were practical for structures like this Bath House, Hot Springs, Arkansas (1914-1915). Photo: Jack E. Boucher, HABS Collection.

After the turn of the century, fewer encaustic floor tiles were used, particularly in residential architecture. The introduction of ceramic mosaic floor tiles was a factor in their decline (Fig. 10). The development of rubber interlocking floor tiles in 1894, along with other, more resilient, flooring materials, was instrumental in the decreased popularity not only of encaustic tiles, but also other ceramic tile flooring. These new materials were not only cheaper, they were not as fragile; they were also lighter and thinner, and easier to install.

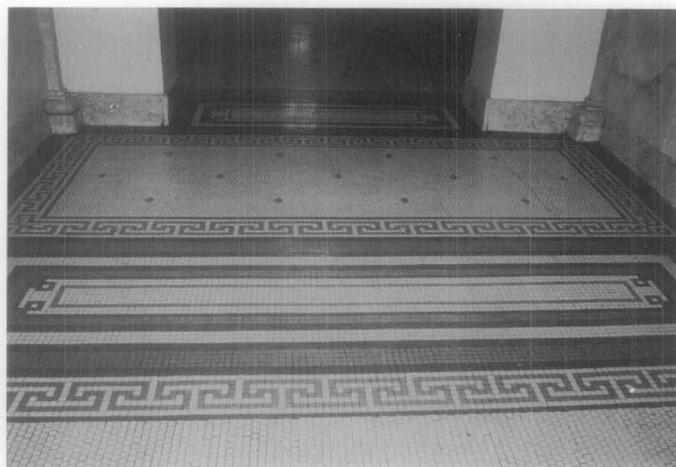
Figure 11. Ceramic mosaic tiles were used decoratively on the entrance floor of this early-20th century school building. Photo: Kimberly A. Konrad.

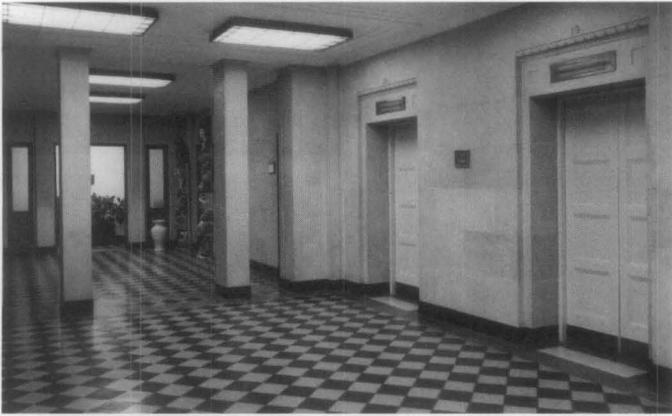
Figure 13. Quarry tiles were used in the corridors on many of the upper floors of the U.S. Department of the Interior Building (1935-1936). They were laid in a pattern identical to the more expensive marble floor tiles that were used in the public spaces. Photo: Brooks Photographers, HABS Collection.

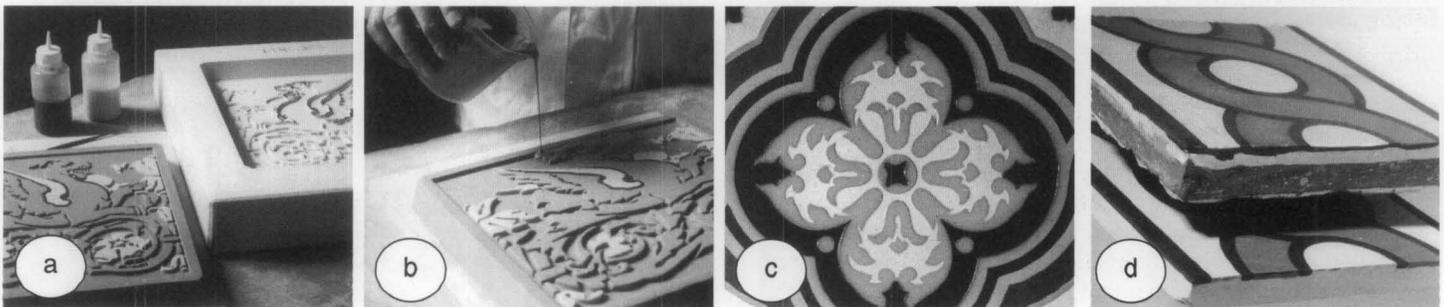
Figure 14. **Making encaustic tiles.** When finished, a reproduction encaustic tile resembles a historic tile, but the reproduction process is quite different from the traditional method. Designs for reproduction tiles are recreated by a computer from drawings of the original tile. (a) The computer image of the design is transferred to, and machine-cut into, a Plaster of Paris mold. Plastic, buff-colored clay is pressed into the mold to form the main body of the tile, and left to dry for 24 hours. (b) Colored slip, or liquid clay, is poured into the indented portions of the tile to create the pattern. (Each color of slip must dry before another color can be poured.) (c) After drying, and before firing, excess slip is scraped off, leaving the surface of the tile smooth, but the slip-filled areas still slightly recessed. (d) A side view of the 19th-century tile at the top of the photograph clearly shows the 3-layer clay "sandwich," as well as the 2 colors of slip that form the inlaid design. The new tile, below, is slightly thinner and is made from only 1 layer of clay. Photos: (a-b) H&R Johnson Tiles Ltd.; (c-d) Wayne Firth, Office of the Architect of the Capitol.

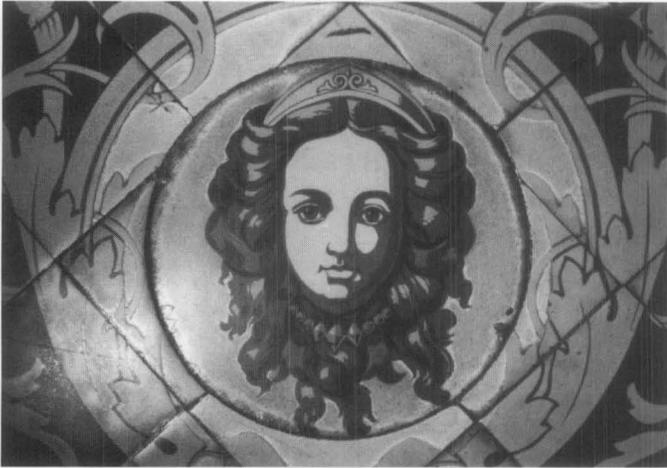
Figure 15. The detailed features of the portrait on this round tile in the U.S. Capitol were painted on the surface of the tile rather than inlaid. Photo: David W. Look, AIA.

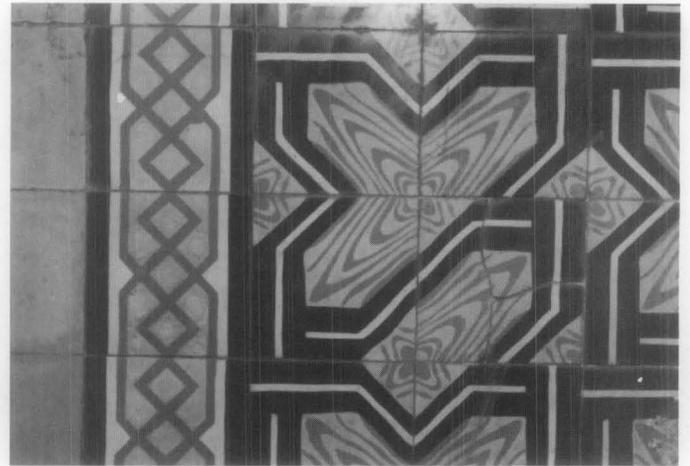
Figure 16. Historic cement floor tiles in a house at 103 Calle San Jose, Old San Juan, Puerto Rico, feature a design intended to resemble wood parquet. (Note the mismatched repair.) Photo: Jack E. Boucher, HABS Collection.

resembled those commonly found on encaustic tiles but applied as a transfer printed pattern, or using a multi-color lithographic or silkscreen process. These are still manufactured and popular in many parts of the world (Fig. 16).

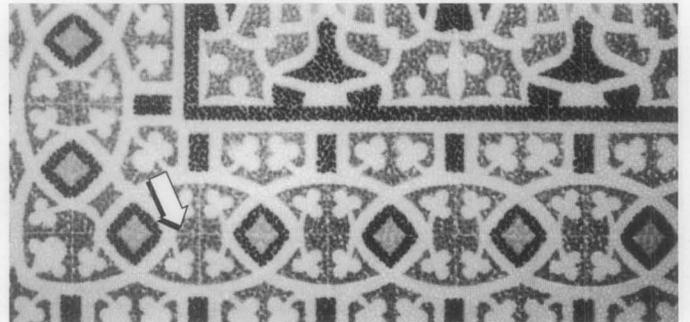
Figure 18. One-piece tiles were made with a mold that created the appearance of mortar joints and individual mosaics, as illustrated in *Decorative Tile Designs in Full Color*. Selected and arranged by Carol Belanger Grafton. NY: Dover Publications, Inc., 1992, p. 87.

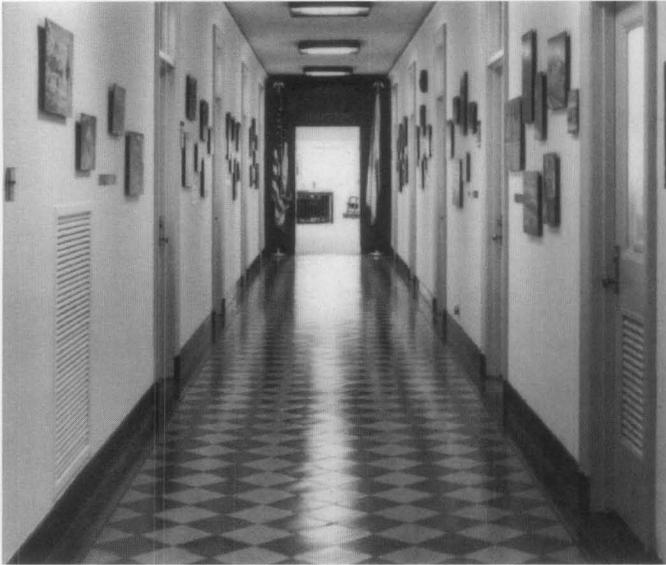
Figure 19. Regular maintenance treatments for the historic quarry tile floors in the U.S. Department of the Interior, shown here in a side corridor, include: stripping and waxing once a year; weekly spraying and buffing with a commercial "floor finish revitalizer/cleaner" that is slip resistant; and dust mopping or damp mopping 4 times a week. Photo: Brooks Photographers, HABS Collection.

Regular maintenance of a ceramic tile floor should always begin with vacuuming to remove loose dirt and grit. Then, a mild cleaning solution may be applied and left on the floor for 10-15 minutes, without letting it dry on the tiles. Heavily soiled areas may be scrubbed with a natural bristle or nylon brush to loosen dirt from the tile surface. Finally, the floor should be thoroughly rinsed with clean, clear water, preferably twice, and dried with terry cloth towels, if necessary. Any proprietary cleaning product should always be used in accordance with the manufacturer's directions (Fig. 19).

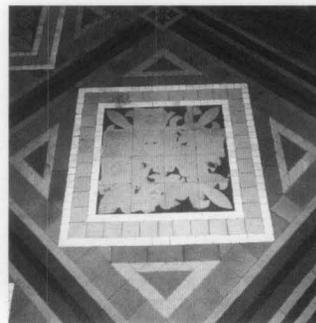
Figure 20. The surfaces of these late-19th century encaustic tiles have become worn and much of the pattern has been lost after more than 100 years of use. Photo: Anne Grimmer.

Loss of Tile Surface and Pattern. Ceramic tiles are among the most durable of historic flooring materials, but natural wear and a certain amount of deterioration or damage is inevitable. Some tiles, such as dense, close-textured quarry tiles and ceramic mosaic tiles, resist abrasion and stain absorption very well. But many others, especially patterned encaustic and geometric tiles, are extremely susceptible to abrasion. Heavy traffic can also result in uneven wear, or even cupping, in certain areas of tile floors that get more use than others, such as doorway entrances. The particular clay mix, or the dye or pigment used to color the clay, can also affect the hardness and durability of individual tiles or an entire ceramic tile floor (Fig. 20).

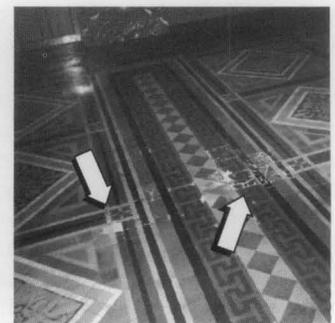
Figure 21. These cracked geometric tiles may have been damaged by the repeated passage of heavy equipment over the floor. Photo: Anne Grimmer.

Tile Breakage. Ceramic floor tiles are very susceptible to damage and breakage caused when something heavy is dropped. Repeated passage of heavy objects, or carts, over a floor can also crack and break ceramic tiles, as well as heavy vibration from outside traffic (Fig. 21).

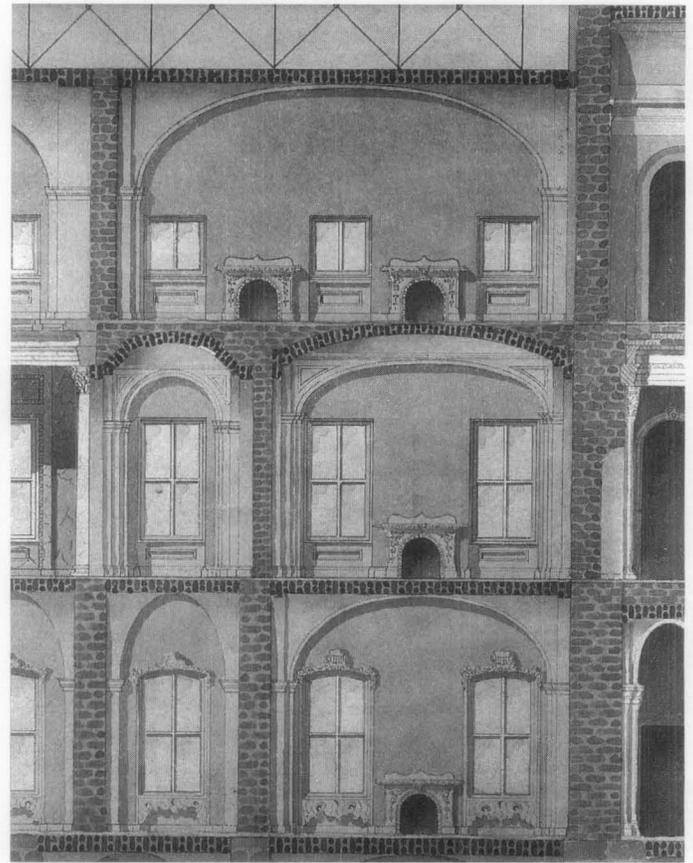
Figure 22. Original section drawing of the 2nd and 3rd floors of the House of Representatives Wing of the U.S. Capitol shows how Montgomery C. Meigs ensured the durability of the encaustic tile floors that were laid in the 1850s. He specified that the 3/4" tiles be laid on top of 1/2 to 3/4" mud (or mortar), which, in turn, was to be laid over a coal tar membrane on top of 3" of brick over an air space of 4-6". Photo: Wayne Firth, Office of the Architect of the Capitol.

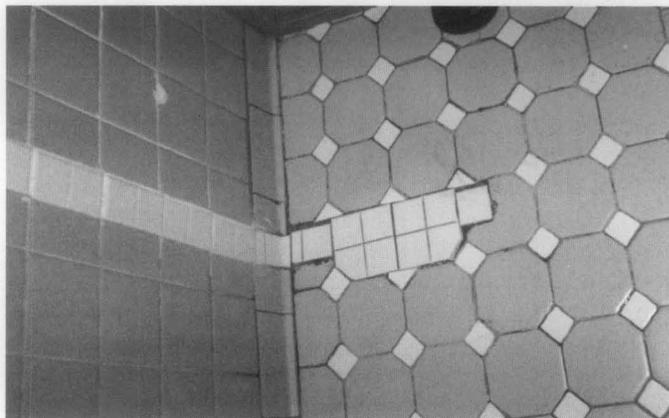
Figure 23. These non-matching tiles are inappropriate replacements for original tiles that were damaged during bathroom remodeling. Photo: Anne Grimmer.

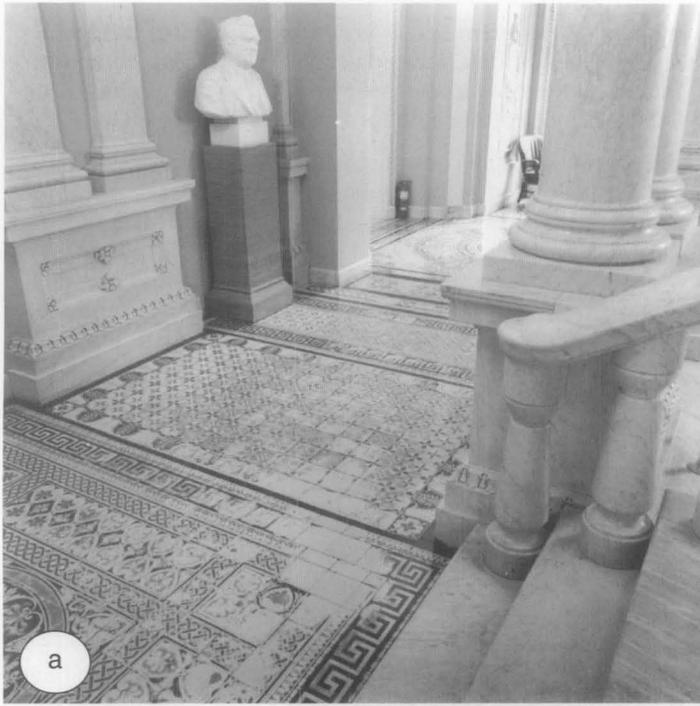
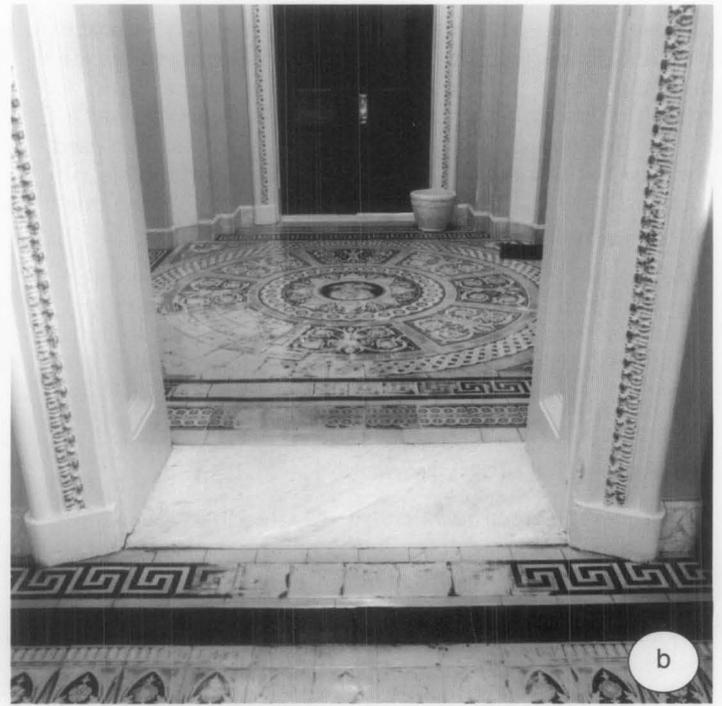
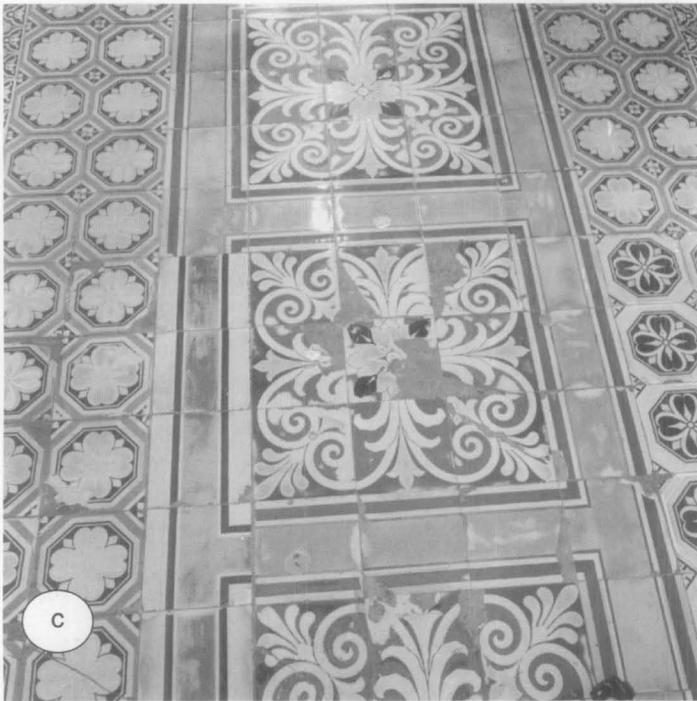
(a-b) Above: By the mid-1970s, many of the patterns in the encaustic tile floors had become faint, and some had completely worn off in the most heavily trafficked areas. (c) Below left: Damaged areas of the floor had been patched with salvaged pieces of tile that fit, but did not match. Photos: Wayne Firth, Office of the Architect of the Capitol.

Figure 24. U.S. Capitol Restoration Project. Restoration of the historic ceramic tile flooring at the U.S. Capitol is one of the most extensive ongoing undertakings of this kind in the U.S. When the Office of the Architect of the Capitol contacted H&R Johnson-Richards, the manufacturer of Minton Hollins tiles, regarding restoration of the tile floors in preparation for the American Bicentennial, the company was unaware of the extent of original Minton encaustic and geometric floor tiles in the U.S. Capitol building. Montgomery C. Meigs, Supervising Engineer, and Architect of the Capitol Extension, Thomas U. Walter, specified Minton encaustic tiles for the floors in the two wings that were added to the Capitol. The tiles were ordered from the factory in England through Miller & Coates, a Minton supplier in New York City, and installed in the 1850s.

When the project was initiated, the intent was to replace only those tiles that were severely damaged or worn. Removing and replacing selected sections of the tile floor in their entirety was determined to be a better approach because of the difficulty of removing one tile without damaging adjacent tiles in good condition, in addition to the difficulty of matching new and old tiles which are slightly different in color, pattern and thickness. This means that sometimes tiles in good condition may have to be removed, but they are salvaged and stored for future reuse.

Before ordering the reproduction tiles, each section of the Capitol floor was drawn and photo-documented. The condition of all the tiles was evaluated based on a rating of one to four (excellent, good, damaged, or, in need of replacement), and color-coded accordingly. Every tile that needed to be replaced was individually numbered and photographed with dimensional, color and grey scales.

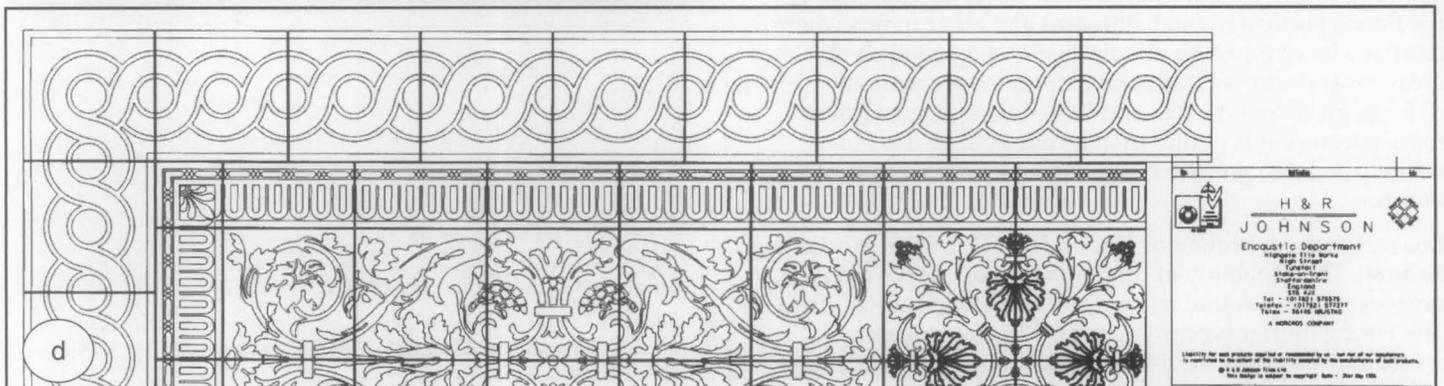
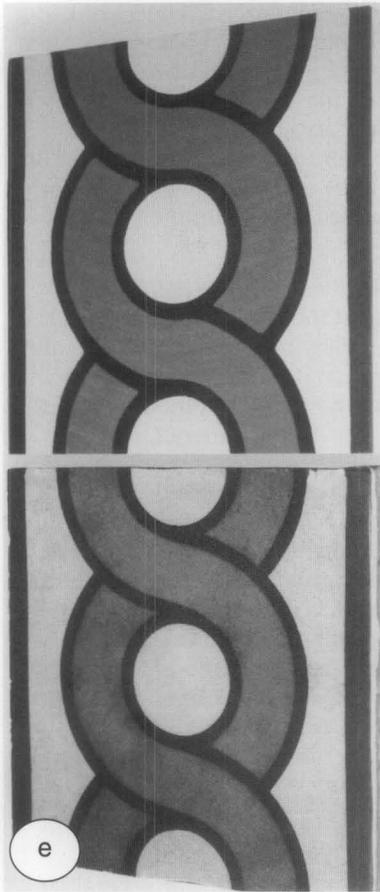
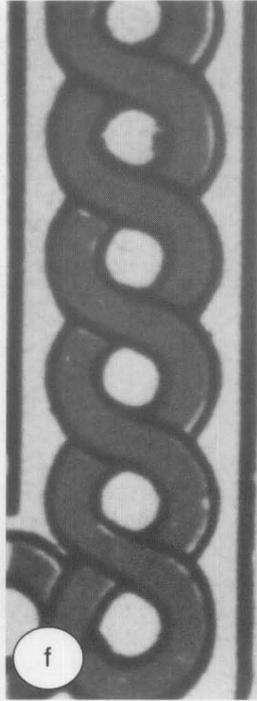
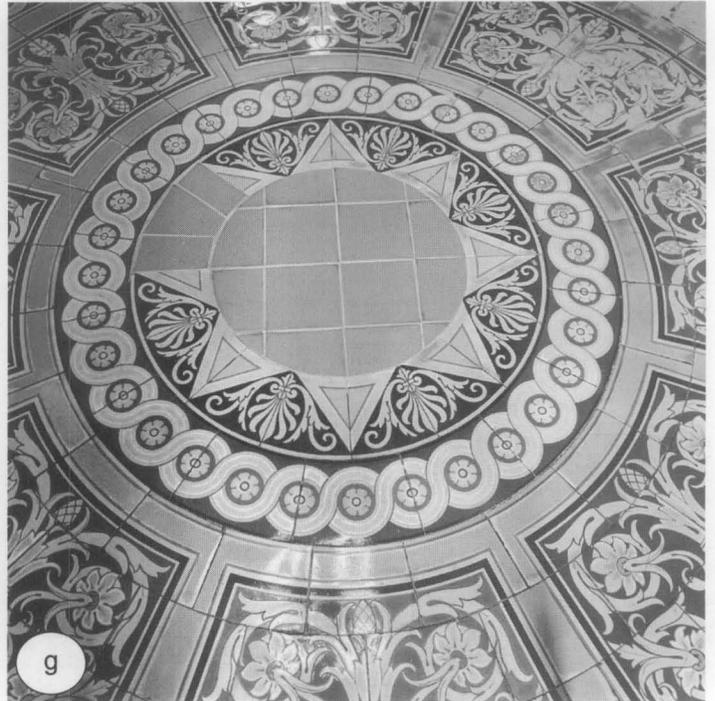
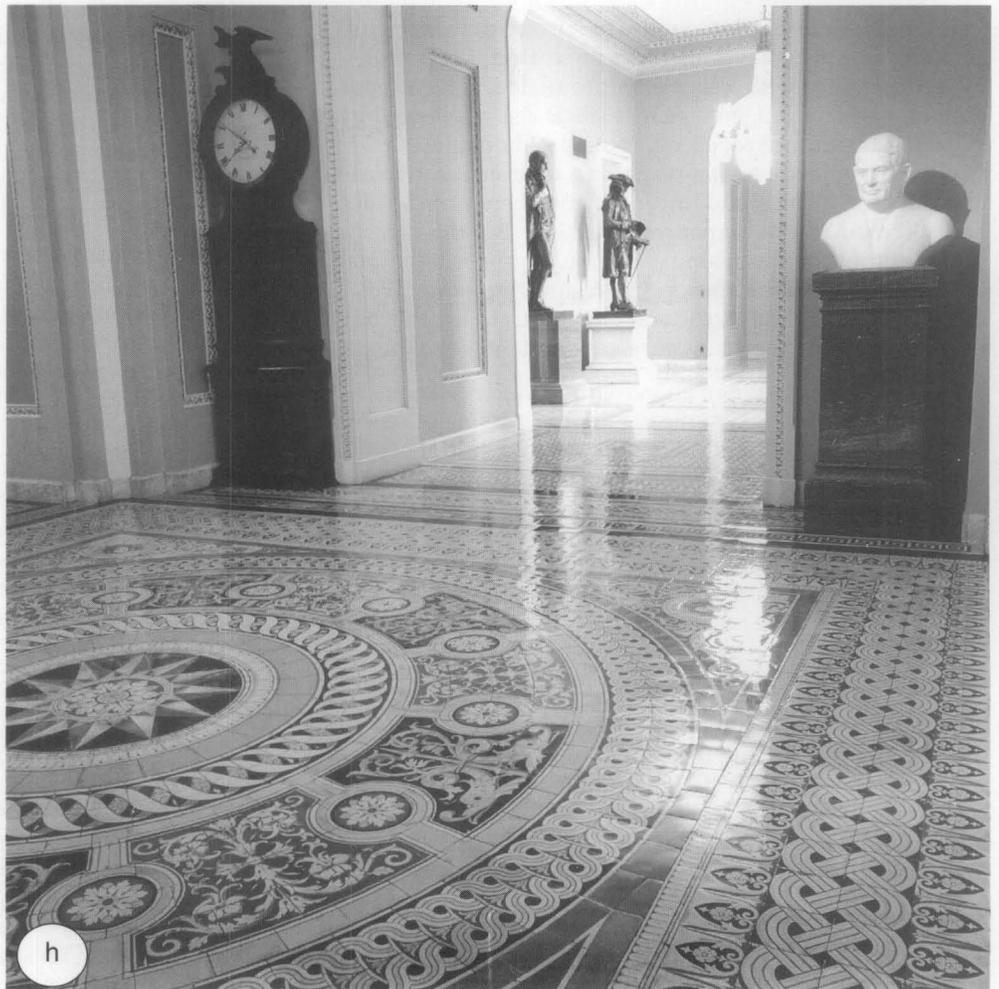
(e) The top tile is a new reproduction of the historic tile below. (f) This design is identified as No. 84 in Miller & Coates' Minton Tile Catalogue (detail Figure 2). (g) What might appear to be an inappropriate repair with non-matching modern tile in the center of the star is, in reality, a neatly executed patch to serve as temporary in-fill for the reproductions that have been ordered. (h) Shown below is a restored section of the Capitol floor. Photos: (e,g,h) Wayne Firth, Office of the Architect of the Capitol; (f) David W. Look, AIA.

(d) Since the early-20th century, making encaustic tiles had, again, become a lost art. Thus, H&R Johnson-Richards not only had to learn how encaustic tiles had been made historically, but, also, how to reproduce them. After studying old records of the early tile manufacturers, the company began reproducing tiles using modern-day computer-assisted technology (CAD/CAM). Drawing: H&R Johnson Tiles Ltd.; Photo: Wayne Firth, Office of the Architect of the Capitol.

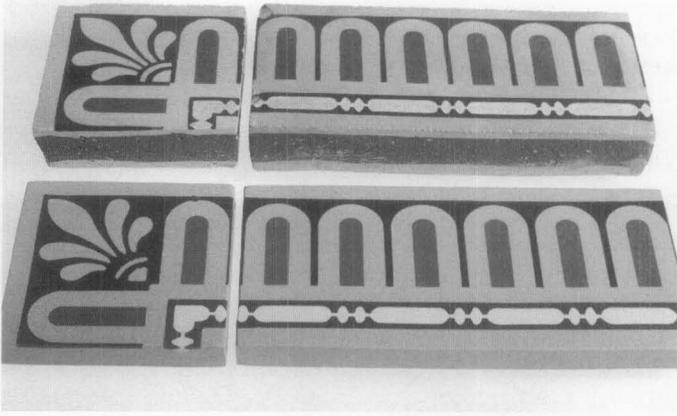
Figure 25. This comparison of an original, historic encaustic tile (top) with a reproduction encaustic tile (bottom) reveals an obvious difference in thickness, but only a slight difference in the design. Photo: Wayne Firth, Office of the Architect of the Capitol.
