41 PRESERVATION BRIEFS

The Seismic Rehabilitation of Historic Buildings

Antonio Aguilar

National Park Service
U.S. Department of the Interior
Technical Preservation Services

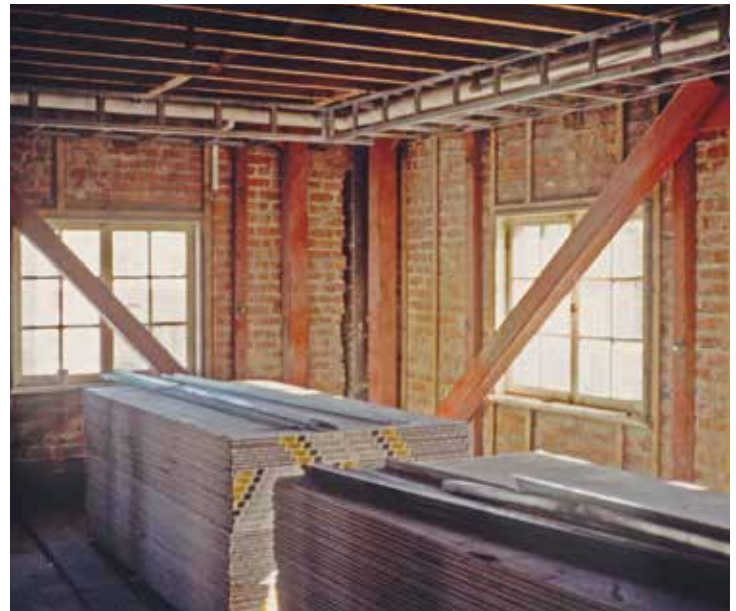
Figures 2-3. Standard approaches to seismic rehabilitation, such as adding diagonal bracing to reinforce window and storefront openings as seen in these photos, can be visually intrusive. Figure 2 (left). Figure 3 (right). Photo: Steade Craig.

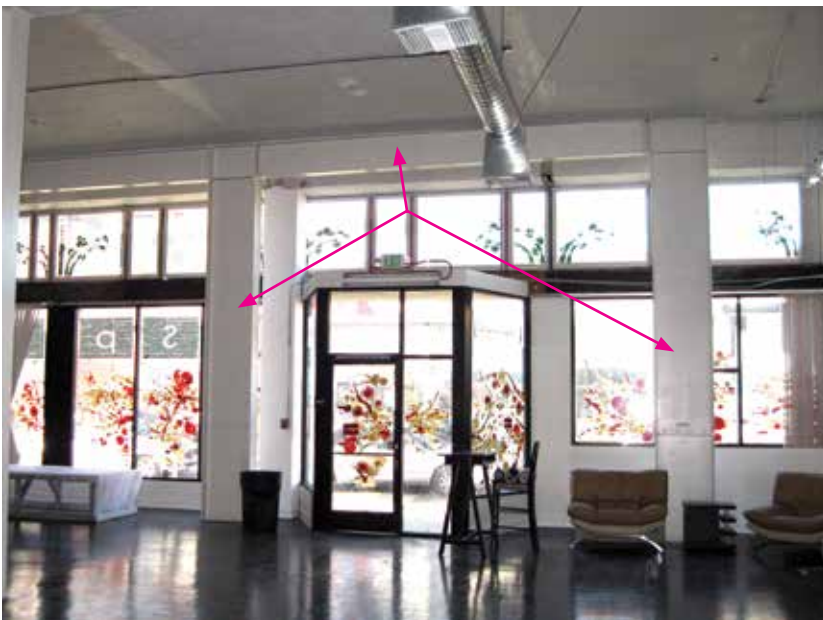
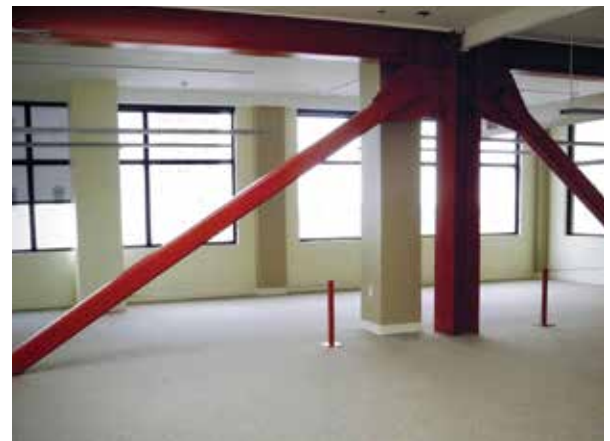
Figures 4-5. Using moment frames (horizontal and vertical steel members identified by the arrows) set back behind storefront openings as seen in Figure 4 (left), or placing brace frames (in red) away from the windows as illustrated in Figure 5 (right) are solutions that meet historic preservation goals. Figure 4. Photo: Elizabeth Hilton.

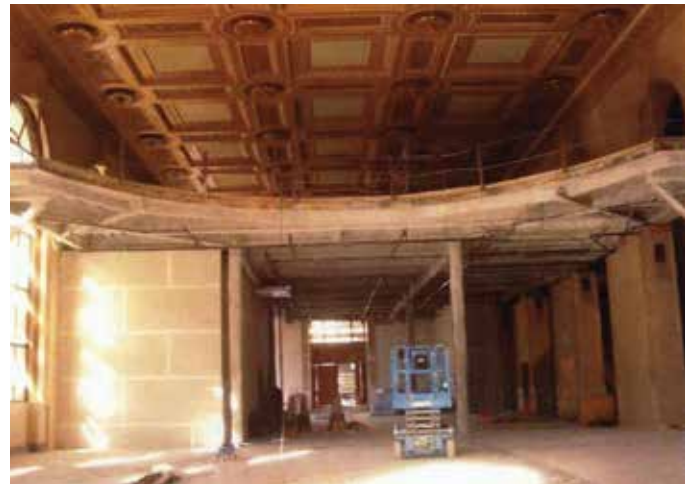
Figure 12. A mezzanine was added to the original banking hall of this 1921 former bank building as a seismic strengthening measure. Subdividing such an important character-defining space can result in a severe loss to a building's historic integrity.

Plan and elevation irregularities are too many to enumerate here. Mitigation measures for this type of deficiency can be challenging to undertake in historic buildings, as some of these irregularities may be important to the building's historic character. Some of the most problematic solutions involve adding shear walls directly behind window and door openings, particularly when they are on highly-visible elevations. Solutions that involve inserting a new floor or a large mezzanine into an architecturally significant, two-story space should be avoided.

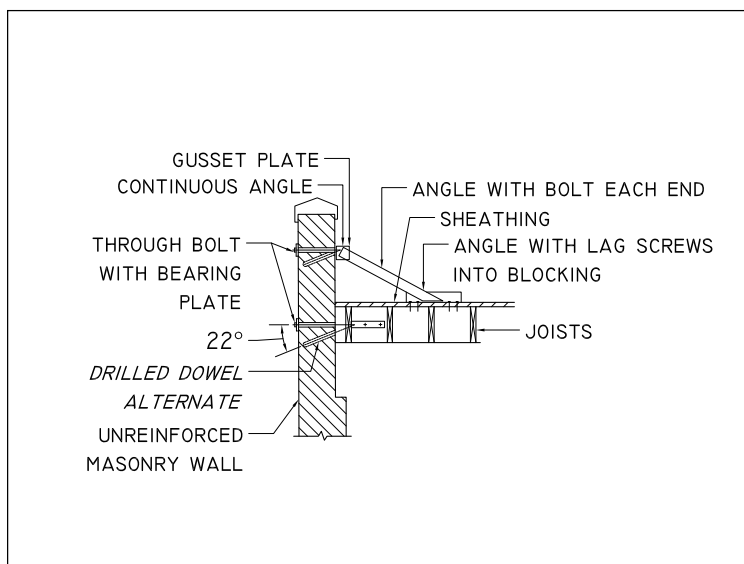
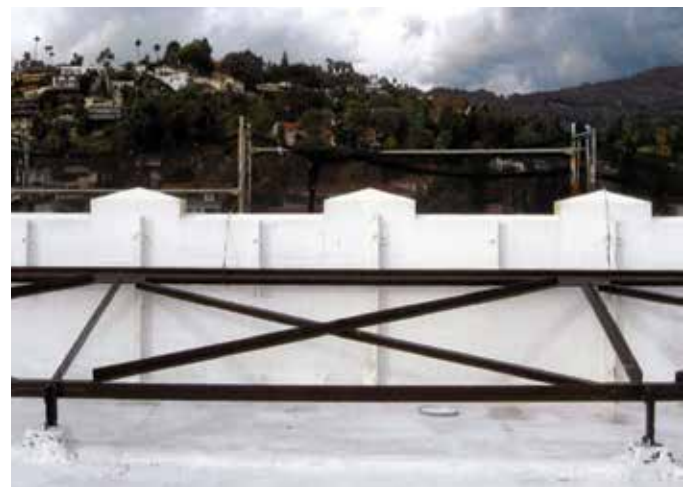
Figure 20. Bracing parapet walls, as illustrated in the typical detail drawing on the left, and as installed in the image on the right, helps avoid hazards from falling debris.

Nonstructural components are all those elements other than the columns, bearing walls, floors, beams or trusses, bracing elements, foundation, and other elements that make up a building's structure (Figures 19-20). In the past, seismic rehabilitation of existing buildings has focused on mitigating structural deficiencies. However, nonstructural components represent a substantial portion of a building's initial capital investment; and, based on post-earthquake surveys, losses from nonstructural components also represent a high percentage of losses during an earthquake (see FEMA E-74: *Reducing the Risk of Nonstructural Earthquake Damage—A Practical Guide*).

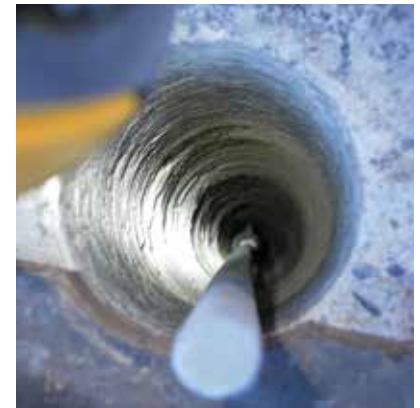
Figure 25. View of one of the center cores drilled down through the wall.

The seismic rehabilitation of this historic wine cellar building shown in Figure 23 included center coring of the exterior stone walls to add steel reinforcement, as illustrated in Figures 24 and 25. The floors were tied to the steel reinforcement in the walls using eye bolts, as seen in Figures 26 and 27, eliminating the need for exterior washers or plates. Figure 23 Photo: Architectural Resources Group. Figures 24-27 Photos: MKM & Associates.

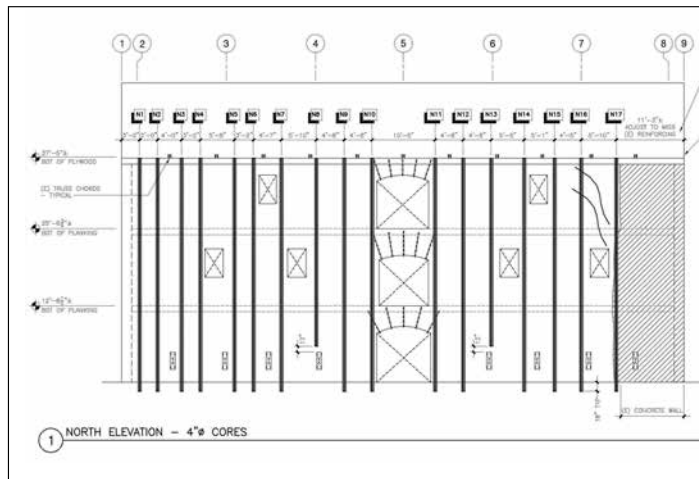
Figure 24. Drawing of the wine cellar's front wall showing the locations of the center cores for continuous steel reinforcement rods to be inserted and grouted in place.

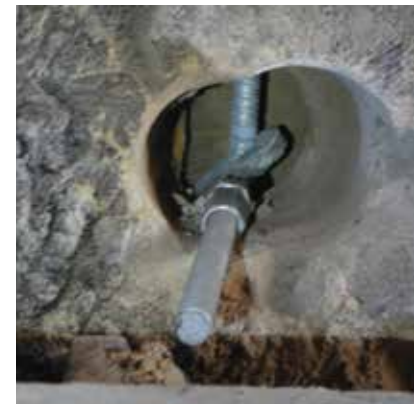
Figure 26. Eye bolts used to anchor the floor to the wall.

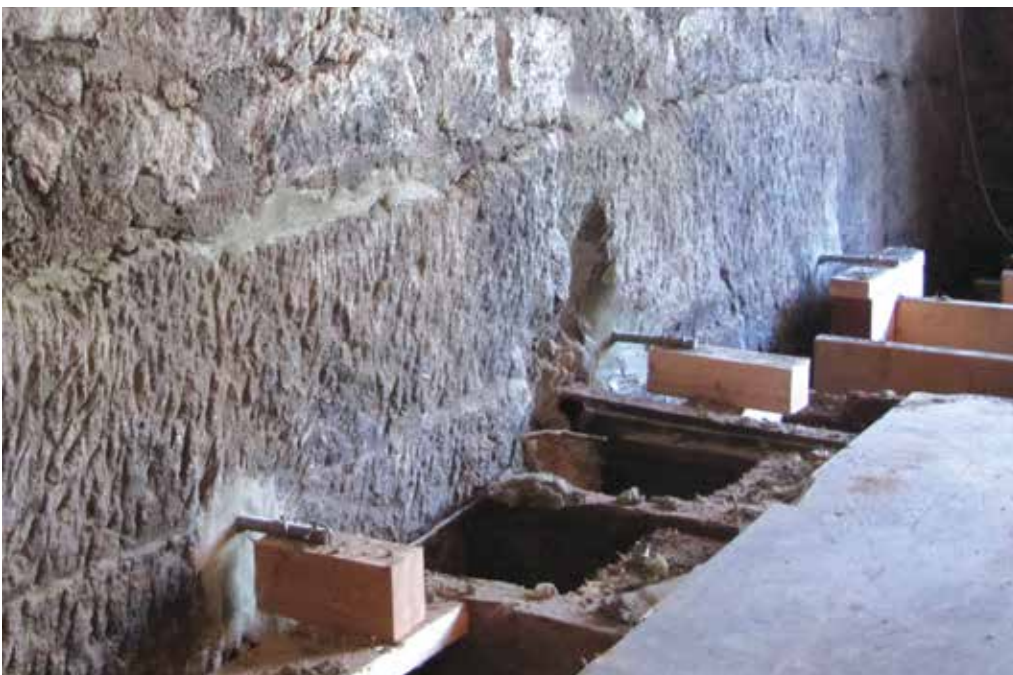
Figure 27. Location of the eye bolts after grouting

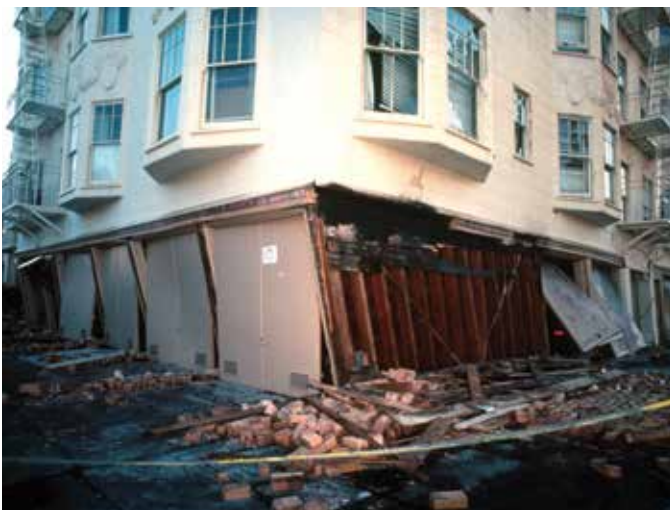
Figure 30. Large perimeter openings and a limited number of interior partitions on the ground floor can create a “weak story” condition that makes buildings particularly vulnerable to earthquake damage. Photo: USGS.

type that is also very susceptible to damage during earthquakes. The upper floors of these buildings typically have a repetitive interior layout which gives them uniform strength and stiffness. The lower floors however, because they typically have larger exterior openings and may have more varied interior configurations and large open spaces, often create a “weak story” condition (Figure 30).
