45 PRESERVATION BRIEFS

Preserving Historic Wood Porches

Aleca Sullivan and John Leeke

National Park Service
U.S. Department of the Interior
Heritage Preservation Services

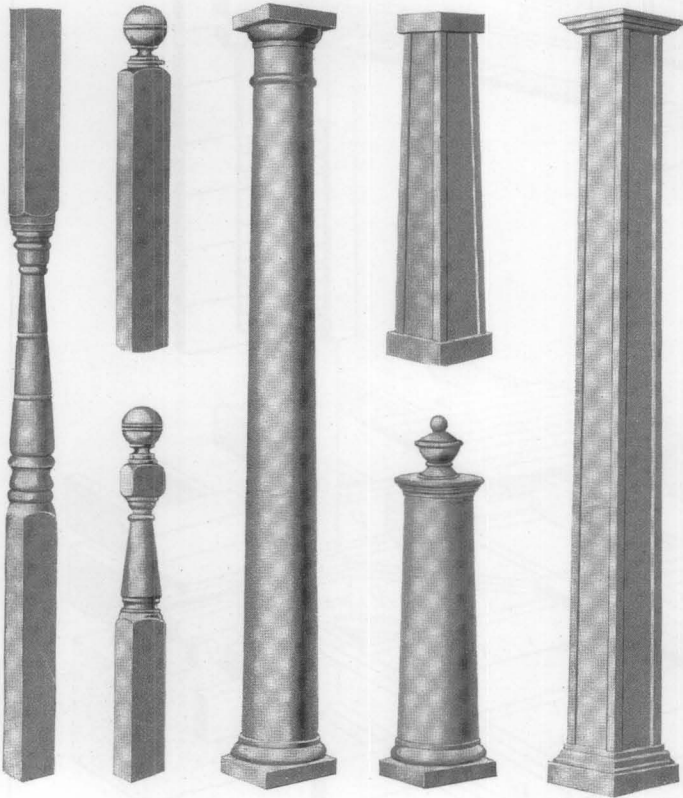
Figure 3. Throughout the late nineteenth and early twentieth centuries, millwork catalogues offered a wide variety of designs for porch parts, including columns, newels, balusters, spindles and brackets. As extolled in the Cedar Rapid Sash & Door Company's Standards Design Book, stock parts made embellishments to porches affordable both for new construction and "updating" existing homes. Courtesy of Charles Fisher.

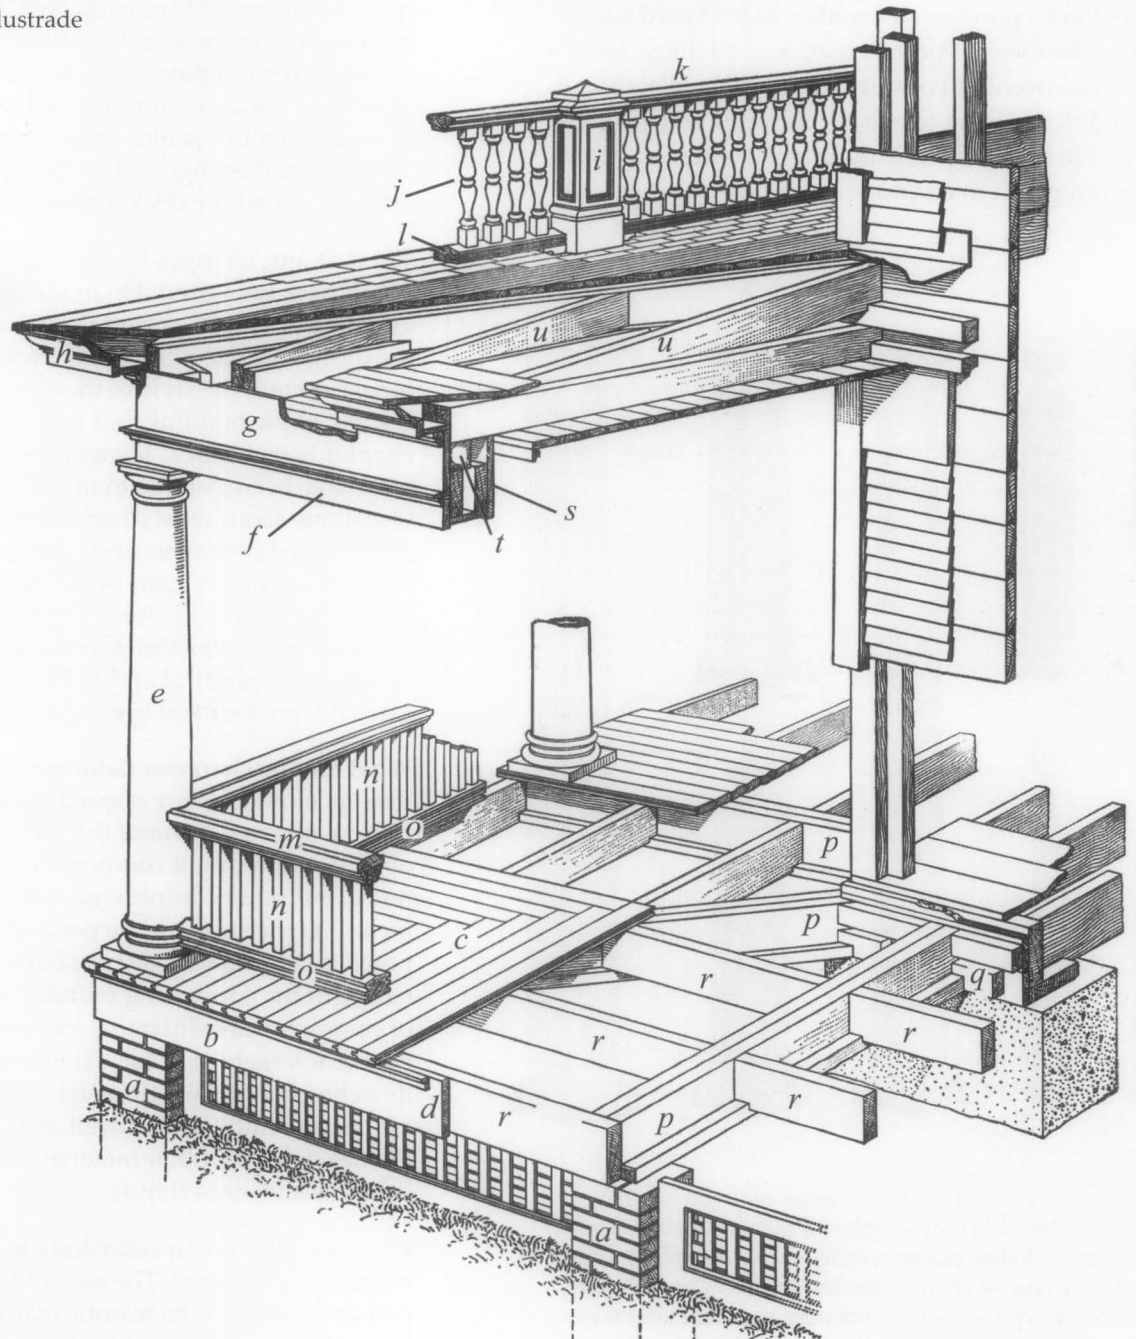
Drawing courtesy of Thomson Education Direct.

Roof Structural System (s, t, u)

- s - Beams inside the entablature span from column to column, support plate
- t - Plate of the entablature rests on beams, supports roof rafters and ceiling beams
- u - Rafter of the roof structural system

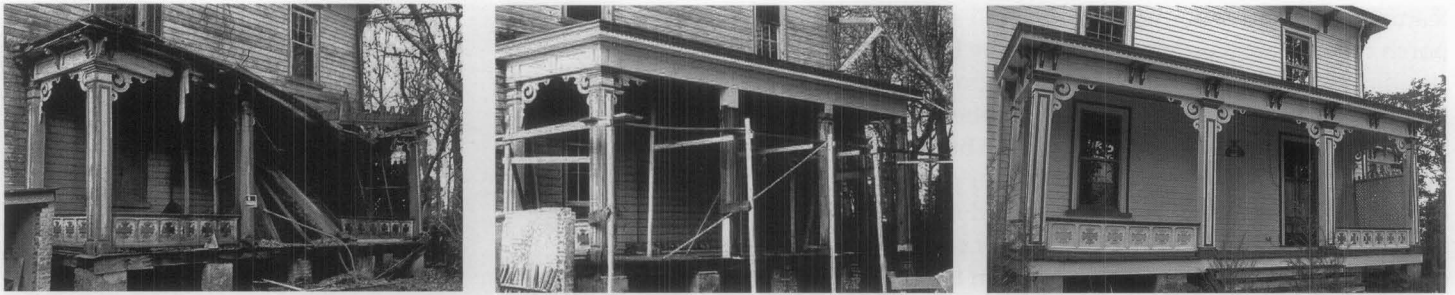
Figure 5. Even historic porches that appear to be in total disrepair may be repairable. While the roof needed replacement, much of this porch was repaired, including such features as the decorative columns, ornamental brackets, and balustrade. Photos: John Leeke.

engineer or building contractor familiar with old buildings. For an adequate assessment, it may be necessary to remove facing boards to check for potential decay in the structural sill behind (Fig 5).

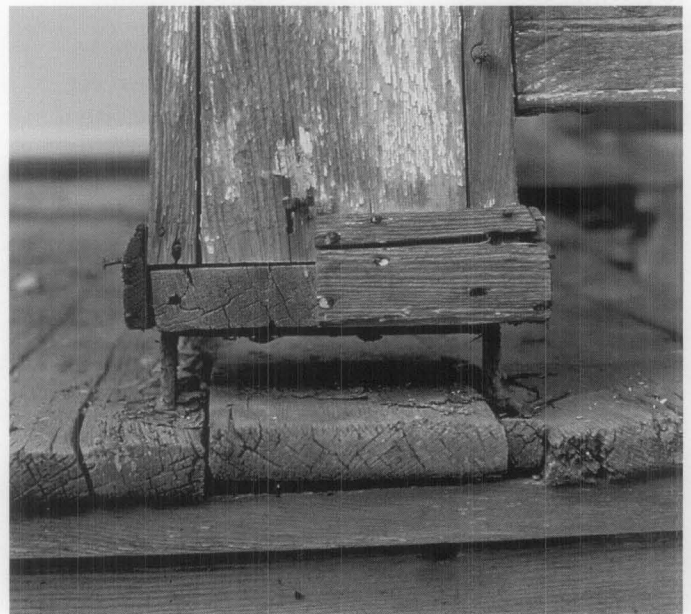
Figure 6. A traditional way to extend the life of porch posts was to place posts on metal feet, thereby providing a separation between the wood post and wood deck. This helped to prevent the wood post from rotting at the base. Early post feet were simple iron bars bent unto a stirrup shape. By the late nineteenth century manufactured cast-iron feet were common, consisting of a pair of disks separated by a short pipe. Post feet are still available today. Courtesy of Old-House Journal/Brian McNeil.

are made of and how they are constructed will aid in understanding how they function and may deteriorate over time (Fig.6). Although the posts on a wood porch are commonly made of wood, they may be of masonry or metal or a combination of materials. Large round columns usually are made of wood staves similar to the way barrels are constructed; smaller diameter columns may be solid. A sag in the deck below or a faltering foundation can impact the supporting role of a column or post above. Wood columns and posts are prone to water seeping into open joints, particularly in the base and the lower end of the shaft. It is not uncommon to find that older columns have had patches and replacement bases.

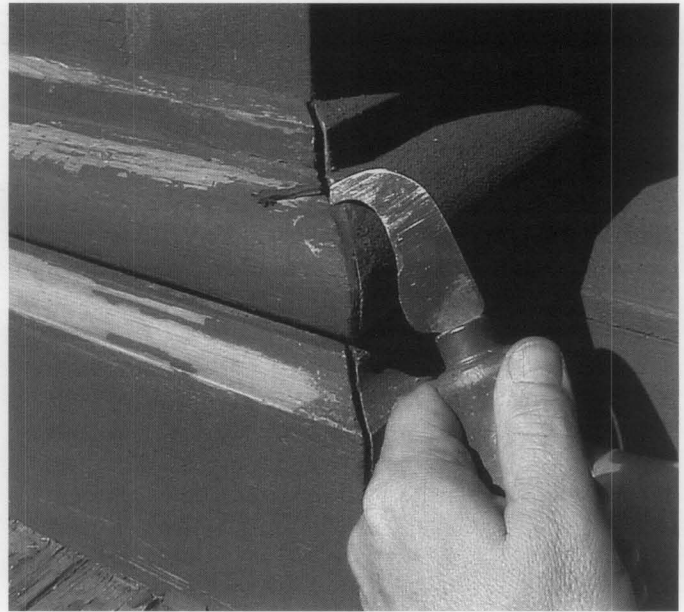
Figure 7. Common problems with porches that can contribute to serious wood decay include cracks in woodwork and joints that have opened up. Both provide an easy path for water seepage. Trapped moisture can foster peeling paint, wood decay and insect infestation. Open joints and cracks should be checked for evidence of more serious decay and marked for caulking or repair. Photo: John Leeke.

Tightly sealed connections keep water out. Where individual boards come together, cracks in woodwork and joints can eventually become a major problem (Fig.7). Cracks are primarily caused by movement and water penetration. Movement of structural members beneath the finished woodwork can shift the position of individual boards and trim, breaking open the thin coating of paint over joints. This condition is common on porches with shallow foundations that are subject either to annual winter frost heaving or where soil conditions undergo major seasonal changes in moisture content. Changes in the moisture content of the wood itself due to repeated wetting and drying or changes in seasonal humidity can also cause noticeable expansion and shrinkage across the width of a board. This provides opportunities for water to penetrate unprotected areas.

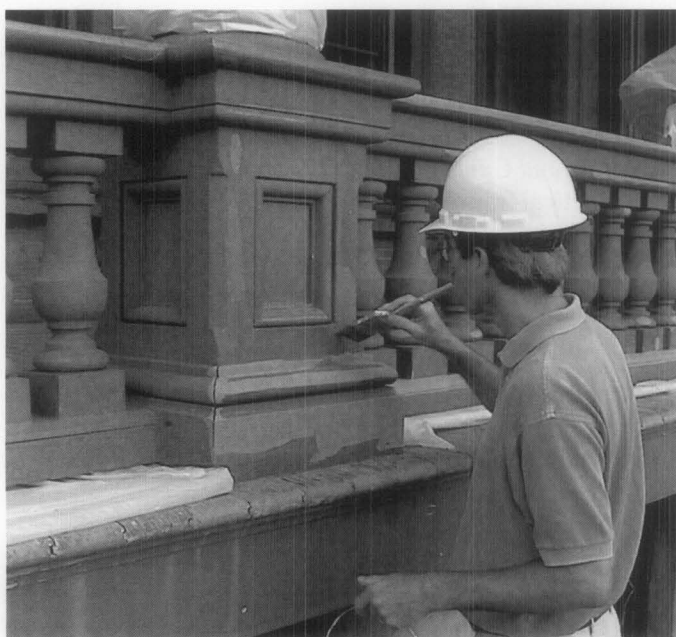
Figure 8. Decay can start when wood is left exposed to the weather or where joints open up. An inexpensive way to extend the life of the existing porch paint without jeopardizing the historic material is spot paint and caulk where needed every year or two. This cost-effective procedure is particularly effective in maintaining wood porches where the exposure to weathering is high. Photo: John Leeke.

Spot painting and resealing of open joints should be undertaken at least every other year (Fig. 8). Heavily used stair treads may require more frequent paint touchup. When peeling paint or bare wood is evident, inspect to ensure it is not signaling deeper problems, such as decay. With sound wood, scrape off the loose paint, sand, prime, and repaint the area. Where lead paint is present, appropriate lead hazard precautions and procedures apply. Only top-quality exterior primers and paints are recommended, selecting for the deck and stairs specially formulated paints. Where wood porch steps are exposed to moisture, grit added to the wet paint during application will help improve safety.

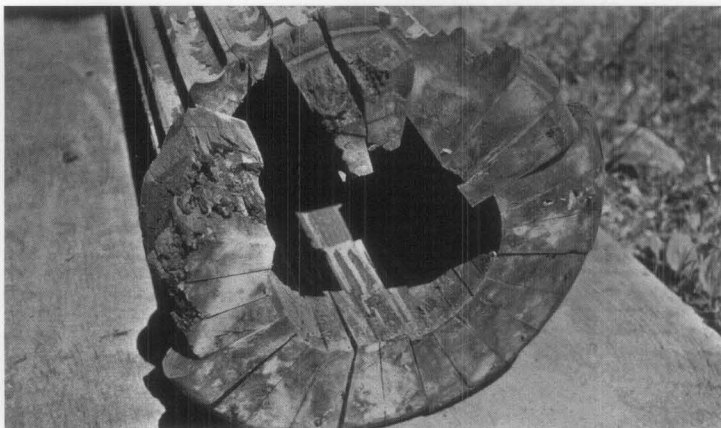
Figure 10. This nineteenth century porch column is made of wood staves, similar to the way a wood barrel is put together. After replacing the torus and making dutchman repairs to the apophyge along the base, the column and pedestal are ready to be reinstalled on the porch. Photos: NPS files.

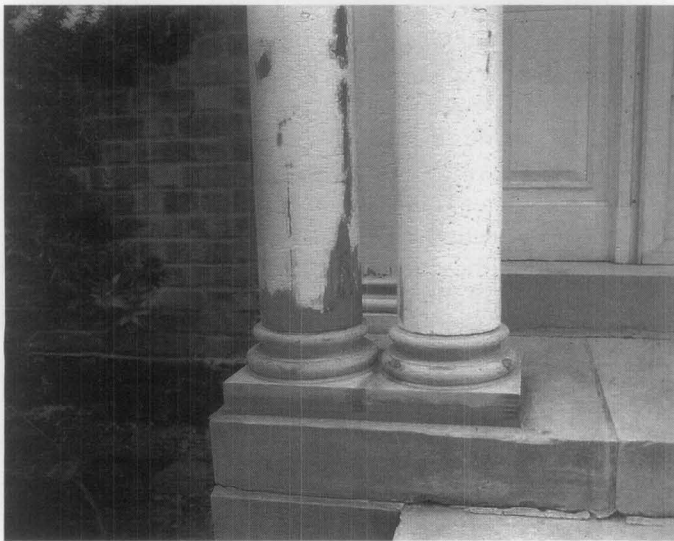
Figure 11. The lower shaft of the porch columns had decayed as water wicked up through the end grain (top). The column shafts were repaired in place by cutting out the deteriorated wood and making repairs using epoxy consolidants and fillers. (bottom). The column bases were replaced. Photos: Paul Marlowe, Marlowe Restorations.

When plinths and bases are deteriorated beyond repair, they can be replaced without replacing the column shaft, which may still be in good condition or require only minor repairs at the bottom. Such replacement will involve temporary shoring for the roof. One-story columns and shafts are often more easily removed during this work, while taller columns are sometimes supported in place. If only a few plinths or bases are deteriorated, it is often economical to have new ones made of wood to match. If numerous plinths and bases are deteriorated, replacing with bases made of rot-resistant materials can make economic sense; however, care must be taken to ensure that all the visual qualities including design, size, shape, color and texture of the historic part are matched (Fig. 11).

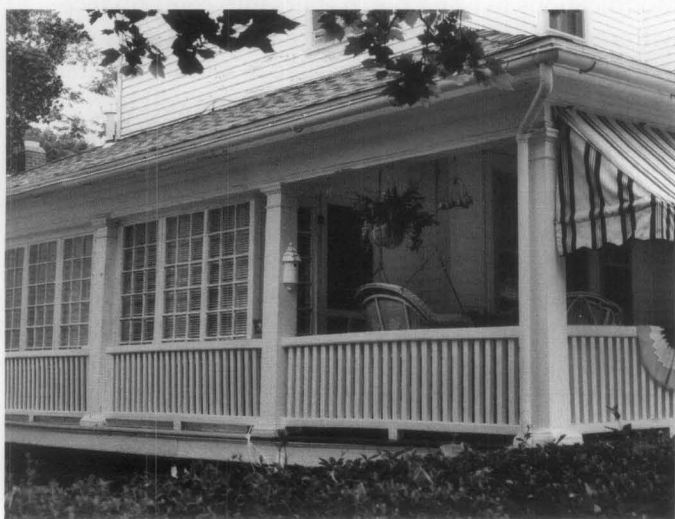
Figure 15. A traditional technique of porch enclosures still used today involves the insertion in each column bay of one or more glass enclosures set in wood frames. This enclosure is properly set back an entire porch bay from the front of the house and utilizes traditional light divisions and wood frames. The balustrade, added here for illustration purposes, shows the importance of retaining this linear feature within the enclosed bays. Photo: Charles Fisher.

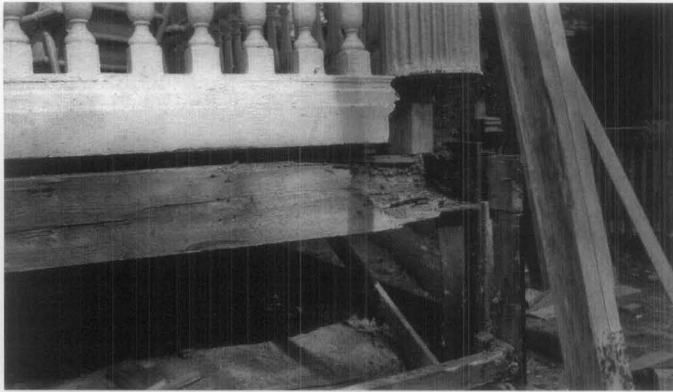
Figure 17. The porch's structural system must be capable of supporting today's loads. In this case moisture led to the deterioration of the wood girder at the corner, creating a major structural deficiency (top). A new solid timber was installed to replace the girder (middle); alternatively a built-up girder could have been used since a fascia board would conceal it. The column base was repaired and portions replaced and the balustrade and column reset and secured (bottom). Photos: Paul Marlowe, Marlowe Restorations.
