# 5 PRESERVATION BRIEFS

## Preservation of Historic Adobe Buildings

U.S. Department of the Interior  
National Park Service  
Cultural Resources  
Heritage Preservation Services

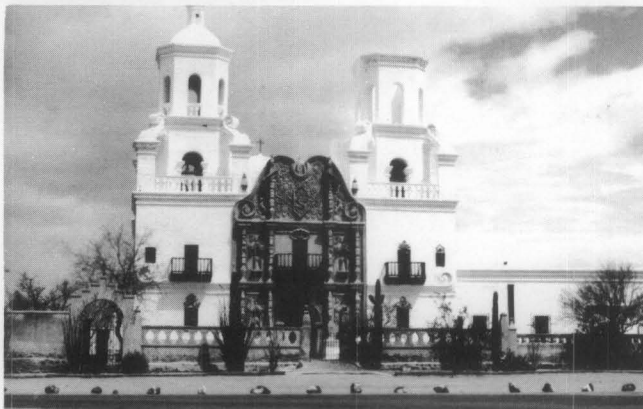
**SAN XAVIER DEL BAC, TUCSON VICINITY, ARIZONA.** Built entirely of adobe construction (1783–1797), this is one of the finest Spanish Colonial churches in the United States, having an elaborate frontispiece of molded, carved, and painted brick imitating stone. (National Park Service)

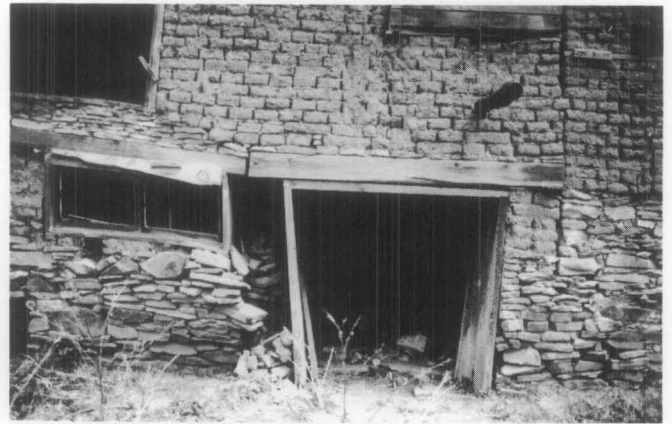
**Structural Damage and Cracking.** Sagging, bulging, and cracking of walls and roofs are signs of serious problems in the adobe building. It is always advisable to secure professional services in the repair of such problems. (National Park Service)

There are many tell-tale signs of structural problems in adobe buildings, the most common being cracks in walls, foundations, and roofs. In adobe, cracks are generally quite visible, but their causes may be difficult to diagnose. Some cracking is normal, such as the short hairline cracks that are caused as the adobe shrinks and continues to dry out. More

extensive cracking, however, usually indicates serious structural problems. In any case, cracks, like all structural problems, should be examined by a professional who can make recommendations for their repair.

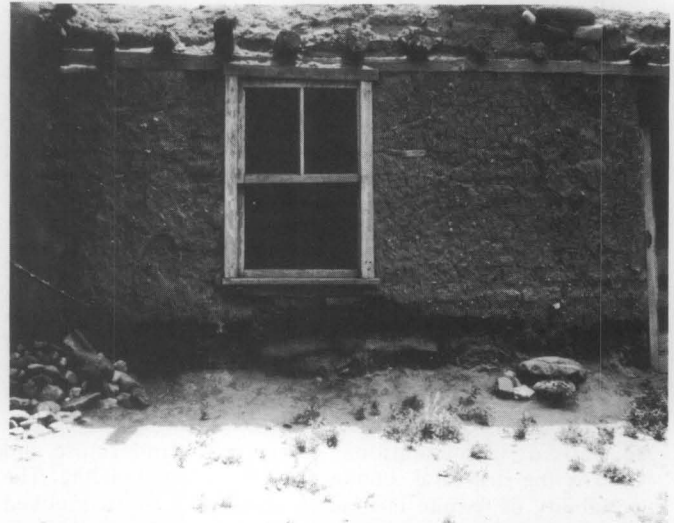
**Coving.** Salts deposited by rising ground water can evaporate and cause spalling of the adobe bricks at the base of the wall, a serious condition called "coving." Coving can also be caused and/or exacerbated by the erosion of rain splash. (National Park Service)

In repairing "coving," the damage caused by rain splash, adobe bricks stabilized with soil cement might be considered. On the other hand, concrete patches, cement stucco, and curb-like buttresses against the coving usually have a negative effect because moisture may be attracted and trapped behind the concrete.

and deterioration of the walls can be corrected by patching the area with new adobe mud and by applying traditional surface coatings. It should be remembered, however, that unless the capillary action is stopped effectively, this erosive condition will certainly continue. Most important, surface coatings and patching only repair the effects of ground water and wind erosion, they cannot cure the cause.

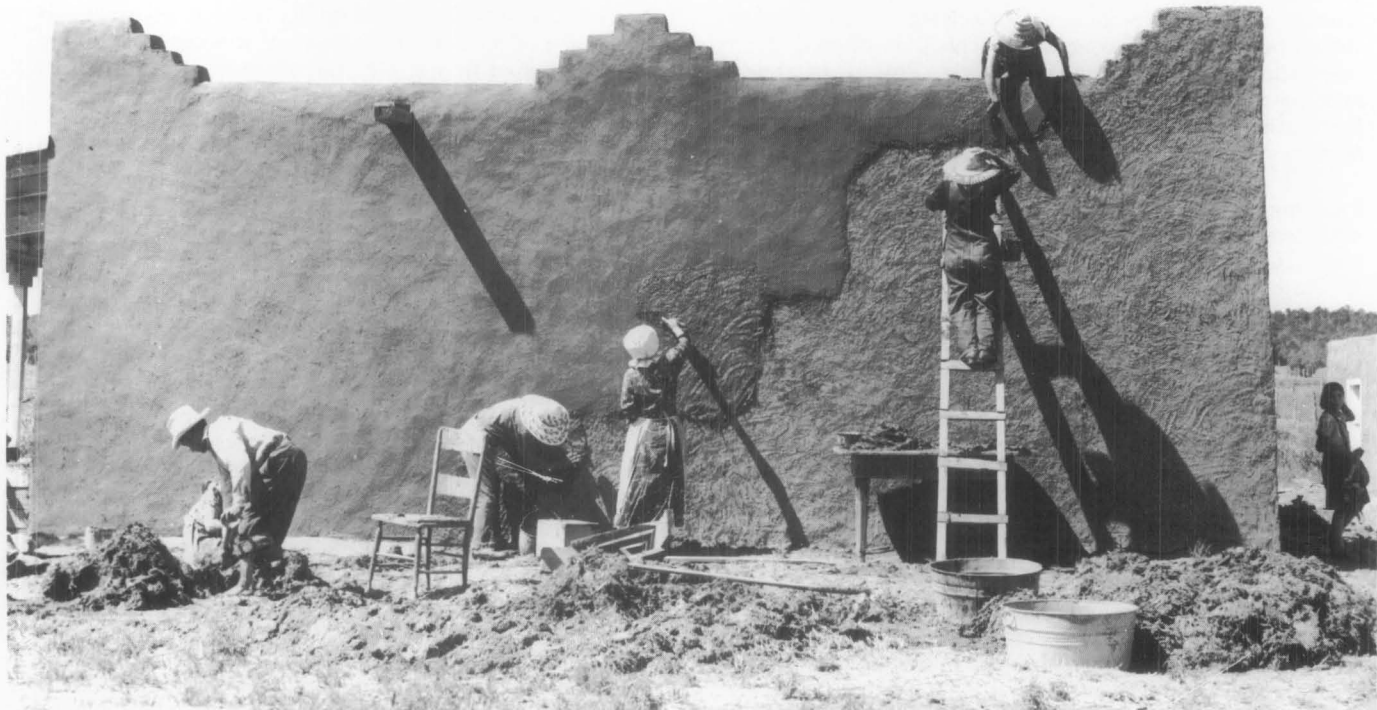
**Renewing the Surface Coating.** Traditionally, adobe surface coatings that protected the fragile adobe building fabric were renewed every few years. Recently however, high labor costs have made this a relatively expensive process. Women are seen here recoating an adobe wall with mud plaster mixed with straw at Chamisal, New Mexico. (Photo by Russell Lee, Farm Security Administration Collection, Library of Congress)
