# 50 PRESERVATION BRIEFS

## Lightning Protection for Historic Structures

Technical Preservation Services

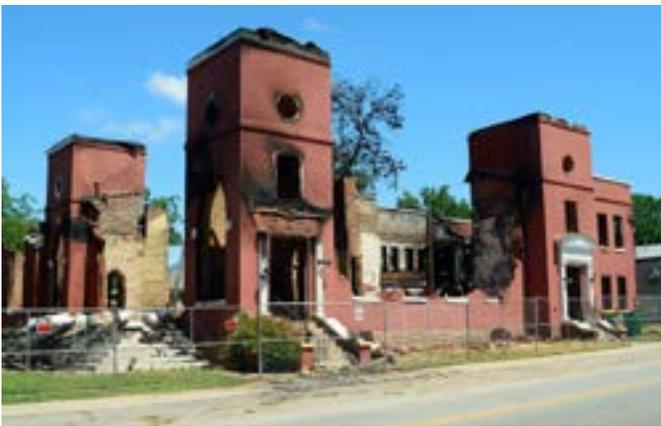
Figure 1. Saved from a wrecking ball and renovated in 1970 by a 70-person congregation, the Sanctuary of the Holy Spirit church was the oldest operating place of worship in Winder, Georgia. Just five years later, the 1904 church was destroyed by fire, having been struck by lightning during a violent thunderstorm. Photo: Paul Brennen/shutterstock.com

The insurance industry reports that 5% of all claims are lightning-related in the U.S., with annual building damage estimated as high as \$1 billion according to Underwriters Laboratories, Inc. Certain types of structures are especially susceptible to damage, particularly churches where lightning accounts for nearly one-third of all church-building fires each year (Fig.1).

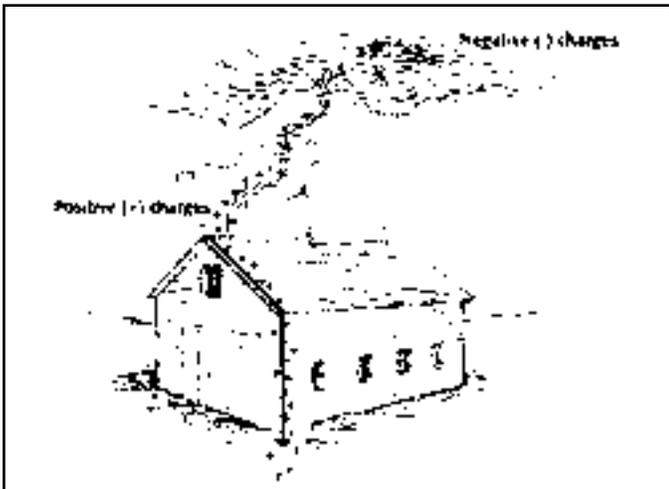
Figure 2. Positive and negative electrical charges occur naturally under certain weather conditions, causing imbalances. When a downward stream of strong negative charges in the air meets with a shorter leader of positive charges that have accumulated on, and are arising from a building, tree, or object, the resulting flash is lightning. The drawing shows a building with a lightning protection system providing a safe path for the lightning to travel to the ground rod beneath the soil. Courtesy: Cornell Agricultural Safety and Health Program, Jim Houghton, illustrator.

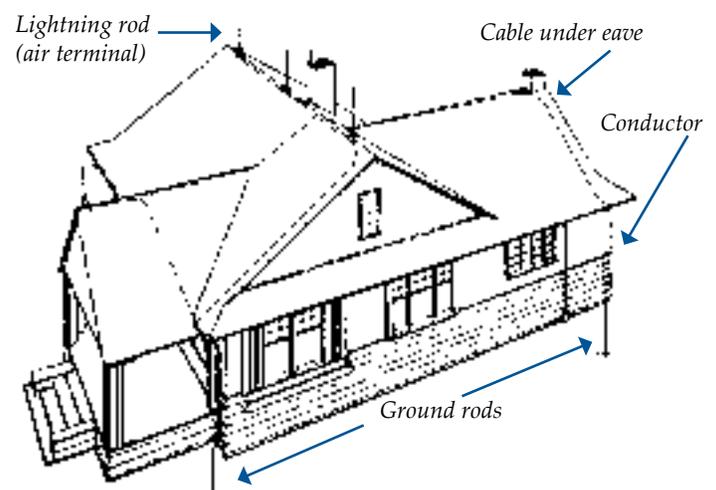
Figure 3. Conventional lightning protection systems consist of three principal components: the lightning rods, which are connected by cables to the system; two or more down conductors, which connect the lightning rods to the grounding system; and the ground rods. Adapted from a 1950 U. S. Department of Agriculture illustration.

There are three principal components of a conventional system: the *lightning rod (air terminals)*, *conductor*, and *ground* (Fig. 3). Besides these three traditional components, a system includes the *bonding* of other metal features of a building considered to be a lightning hazard and, particularly today, the use of *surge suppressors*.

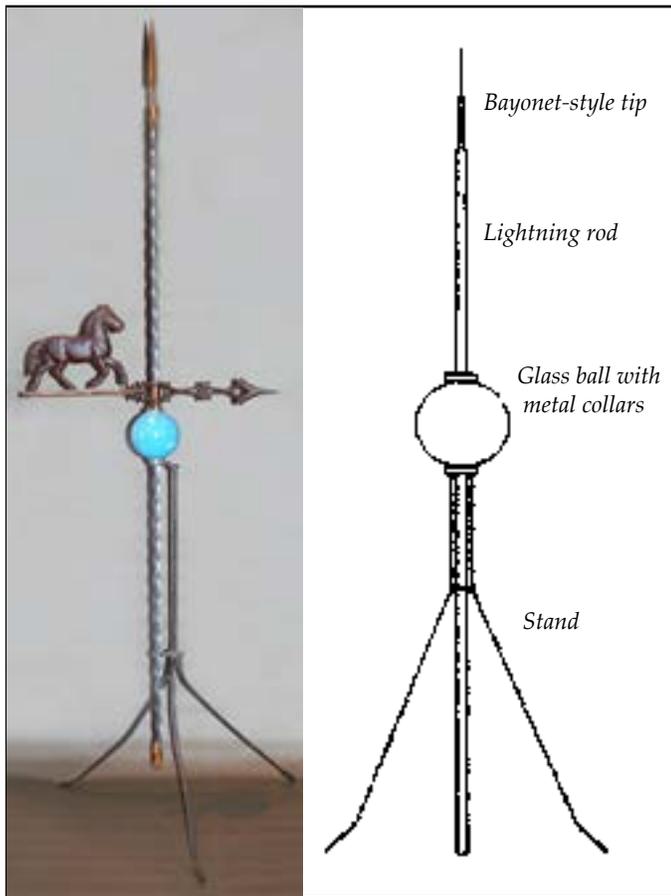
Figure 4. The most common historic lightning rods of the late 19th to early 20th century consisted of a lightning rod or air terminal, glass ball, and a stand attached to the roof. These rods tended to run four to six feet in height and were quite prominent on the roof. Courtesy: Charles Fisher Collection. Drawing: New Old Products, Inc.

its older, more traditional form could appear as an ornamental feature on a structure. In most cases, rods are used at prescribed locations and distances, joined together by connecting wires to conductors. In today's contemporary applications, the lightning rods are very simple in design, most often consisting of utilitarian air terminals measuring 10 to 12 inches in height, although certain conditions may require taller terminals. By contrast, lightning rods of the late 19th and early 20th century were usually taller, typically four to six feet in height, and often had a more decorative appearance with embellishments, such as a weather or directional vane or glass balls (Fig. 4).

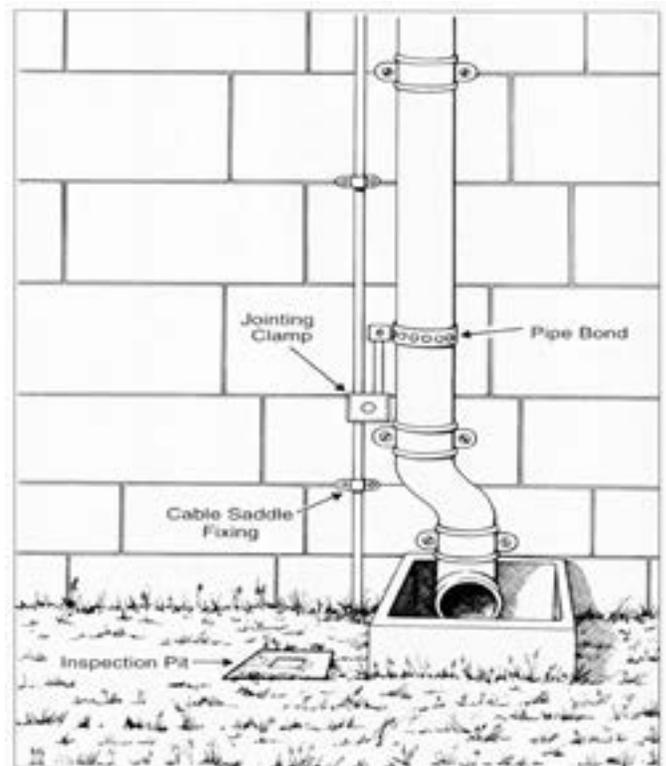
Figure 5. Bonding of conductive material on a structure to the lightning protection system is important to deter damage from side flashing. In this drawing, the metal downspout has been bonded to the down conductor. Unless bonded, metal gutters and downspouts provide a good path for an electrical discharge to side flash and cause damage to a building. Drawing: English Heritage©

is impractical to bond all metal objects, such as each steel or aluminum window on a building, only objects considered more hazardous are usually bonded to the lightning protection system (Fig. 5).

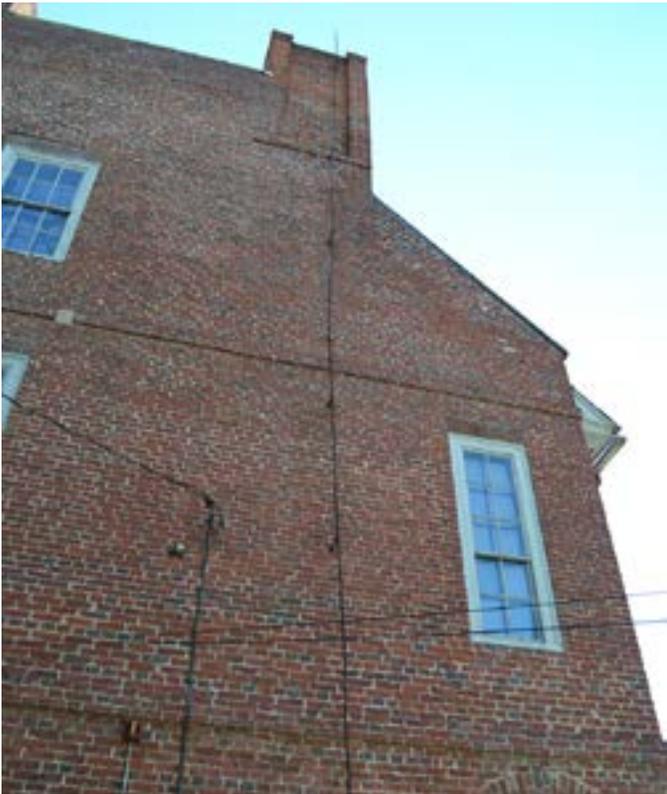
Figure 6. Lightning protection was installed on the Warner House in Portsmouth, New Hampshire, in 1767, purportedly under the personal inspection of Benjamin Franklin. An early system still survives on the building, consisting of a long forged-welded rod of wrought iron which extended up and above the chimney, comprising both the conductor and the air terminal. The conductor was joined to a separate, buried, iron ground rod by a forged hook and eye connector. Photo: Peter Michaud.

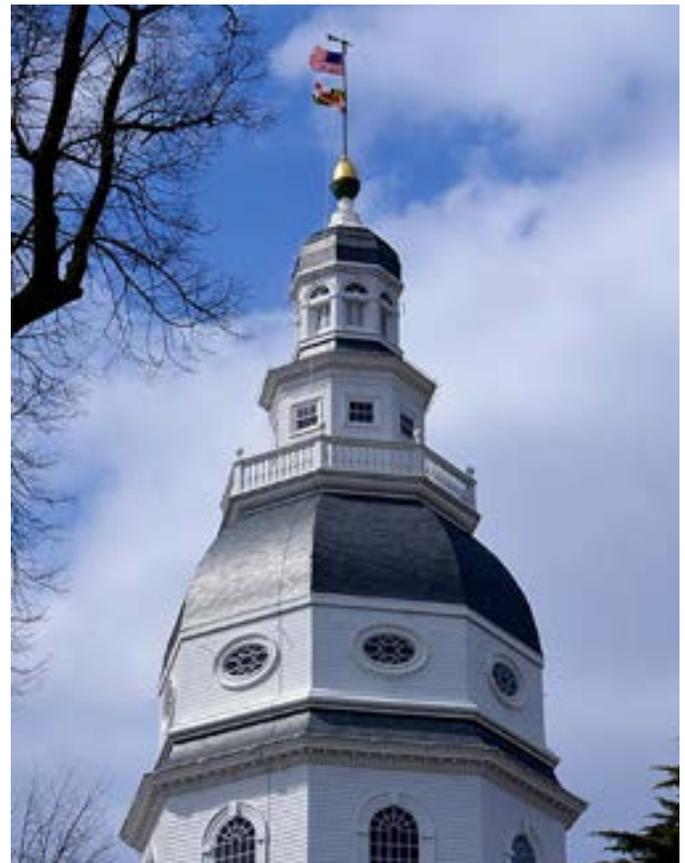
Figure 7. The c. 1788 wrought-iron lightning rod on the Maryland State House dome measures 28 feet in height, 2-1/2 inches square at its base, and is pointed at its top. The rod passes through a decorative copper-paneled wood acorn that is nearly 4 feet in diameter. The acorn helps provide stability to the rod that, in turn, is secured to the pedestal or base of the acorn. While based on the Franklin system, this rod had a decorative flare, including a weathervane and ornamental base. Prominently located in Annapolis along the Chesapeake Bay, an area of frequent summer lightning storms, the building has been struck by lightning as recently as 2016, surviving undamaged. Photo by Niagara (Own work) [CC BY-SA 3.0 (<http://creativecommons.org/licenses/by-sa/3.0/>)], via Wikimedia Commons.

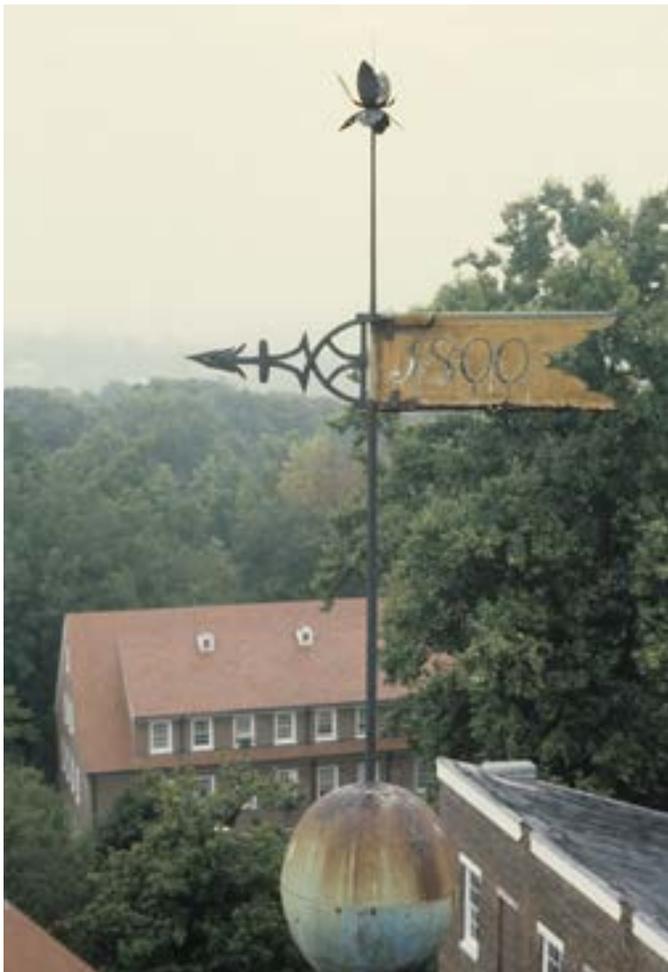
Figure 8. Church steeples, roof turrets, and chimneys were identified early on as being susceptible to lightning strikes. Finials, weathervanes, and other such ornamentation in these locations could often serve as lightning rods when connected to down conductors and grounds. The cupula on the Home Moravian Church in Winston-Salem, North Carolina, is an excellent example. Old Salem, Inc., has a number of Moravian buildings where early lightning protection systems are still in place. Photo: Sunni L. Goodson.

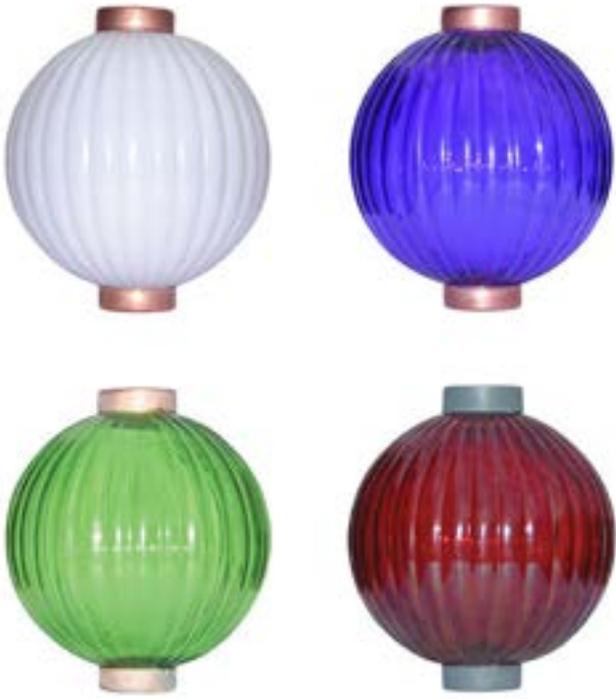
Figure 9. While plain round, 4-inch to 5-inch, color-glass lightning rod balls were most common in the late nineteenth and early twentieth centuries, balls also came in more decorative patterns and shapes such as the pleated round balls shown here in a variety of colors. Courtesy: Ferdinand Meyer Collection.

struck, thus giving notice to the building owner that the system both had worked and should be inspected for any possible damage. In fact, the glass balls were purely decorative and intended to aid sales (Fig. 9). Additional decoration could be added to a lightning rod. Multiple, color glass balls and custom-crafted metalwork were two ways to accent it. A directional weather vane attached to one of the rods could in turn be embellished with colored glass or a metal animal or sailboat, reflecting the building use or owner's interest.

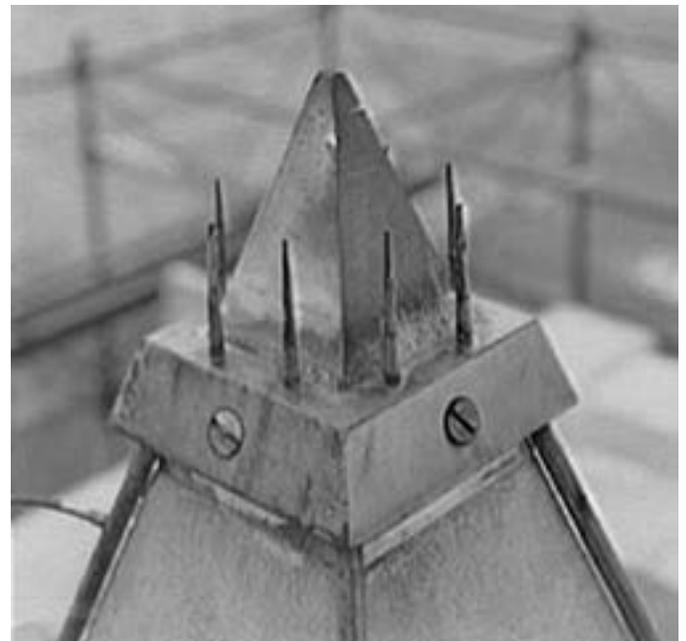
Figure 10. When the Washington Monument was completed in 1884, it was capped with a pyramid made of aluminum. Though intended to function as a lightning rod, it proved within the year to be deficient. After lightning struck, a crack appeared under the top stone. As a remedy, copper rods attached to a copper band were placed around the base of the aluminum apex. The band was directly connected to the iron elevator shaft inside the monument that was part of the otherwise functioning system. The cap is the first use of aluminum as a lightning rod in the United States. Photo: Theodor Horydczak, Library of Congress.

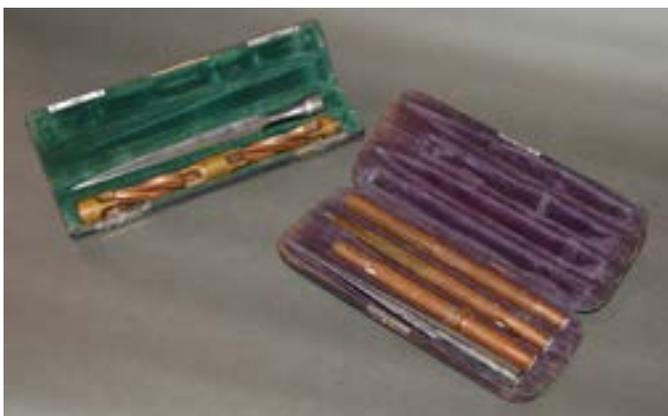
Figure 11. Two salesman kits used by F. B. Renak operating out of Racine, Wisconsin. He was a reputable agent for several companies including the Security Lightning Rod Company, which offered a reasonable 10-year guarantee upon installation at a time when some unscrupulous companies offered essentially worthless hundred-year or lifetime guarantees. The kits included sectional pieces of a twisted copper conductor and two styles of air terminals—one was a bayonet shape and the other came in a shell or bullet shape. The shell terminals were available in several materials, including copper and nickel-coated copper. Courtesy: Charles Fisher Collection.

In many communities, particularly in the Midwest, popular opinion turned against the salesman and the potential benefits of lightning protection. Ironically, this came at a time when there was general support among the scientific community as to the effectiveness of properly installed lightning protections (Fig. 11).

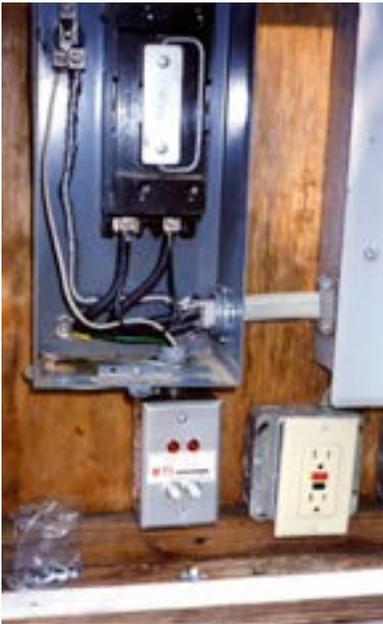
Figure 12. A surge protector covering the electrical lines in a house, barn, or other such structure is relatively inexpensive to have installed. With two or more electrical service boxes, each will need one. The surge protector includes one or more LED lights which indicate whether or not it is properly functioning. In areas of frequent thunderstorms, the unit may need to be replaced after a severe or repeated number of power surges in the line. Photo: Independent Lightning Protection Company.

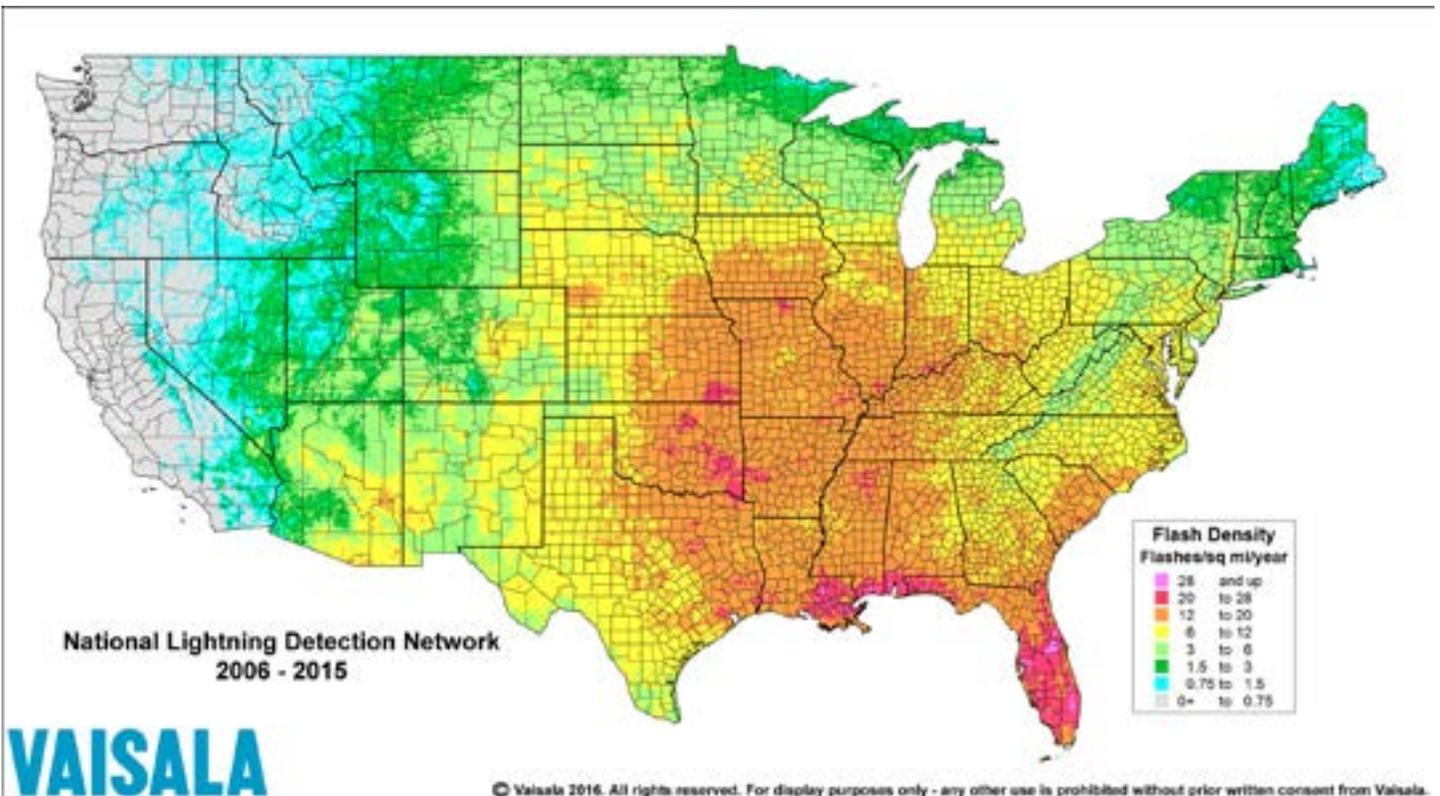
Figure 13. The frequency of lightning strikes varies considerably across the country and is tracked and reported nationwide. States with a high number of cloud-to-ground flashes in 2016 included Louisiana and Kansas with over one million each; states with a low number included Maine and New Hampshire with each around 10,000. Ben Franklin's home state of Pennsylvania had 182,071 cloud-to-ground flashes in 2016 while across the country, California had 48,958. Courtesy of Vaisala.

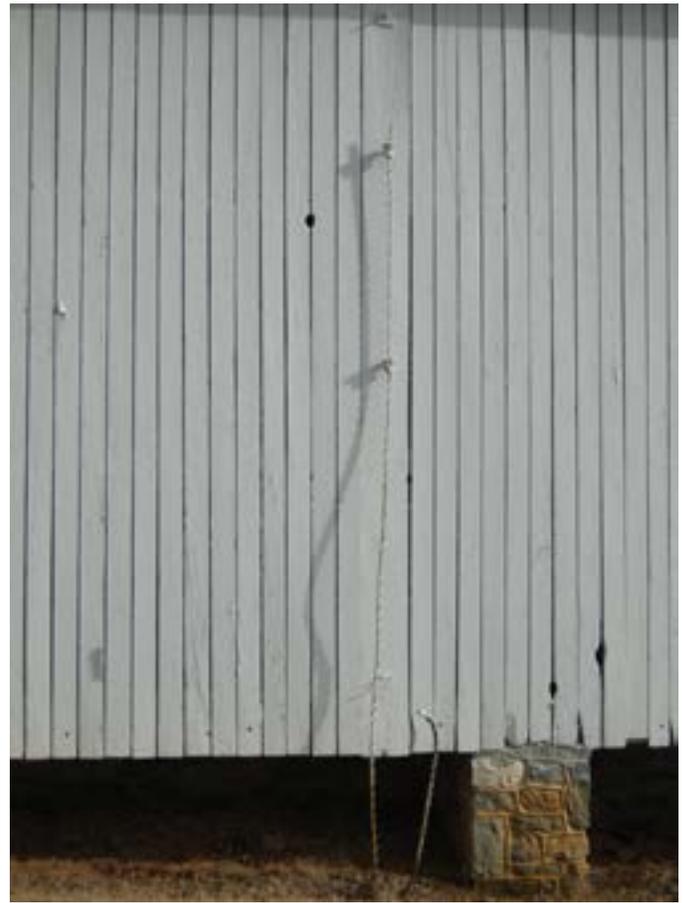
*Figure 14. Lightning protection systems should be visually inspected every year and once every five years be inspected by an experienced professional. Note the break in the down conductor at the top of the photograph and the lack of a bonded connection to the cable at the bottom, which goes to one or more grounds. The old ground rod should be bonded to the new ground. Photo by author.*

The inspection should either ensure that the system is fully functional or identify components that are broken, dislodged, or otherwise deficient (Fig. 14). Historic components needing conservation work should be identified. While today's lightning protection standards

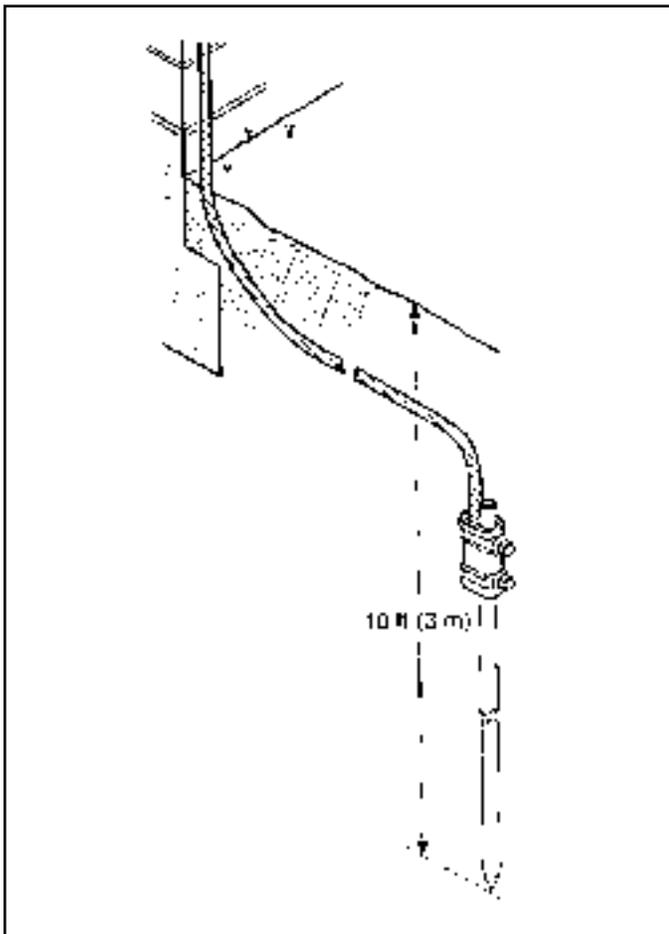
Figure 15. Ground rods decay and may need replacement within 30 years or less depending upon soil conditions. Ground rods should be copper-clad steel, solid copper, or stainless steel. They should be 8 feet long and no less than 1/2 inch in diameter. Reprinted with permission from NFPA Standard 780, 2017, *Standard for the Installation of Lightning Protection Systems*, Copyright © 2016, National Fire Protection Association, Quincy, MA. This reprinted material is not the complete and official position of the NFPA on the referenced subject, which is represented only by the standard in its entirety.

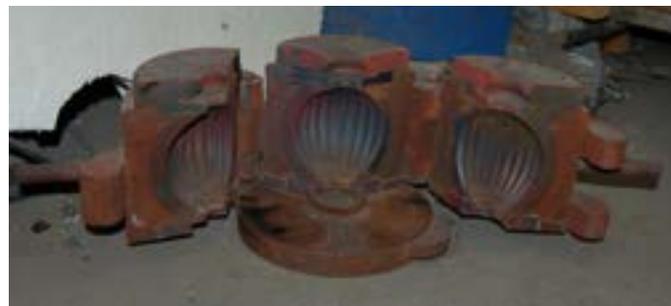
Figure 16. This three-piece vintage mold for a round pleated-glass lightning rod ball is still used to make accurate reproductions today. Photo by author.

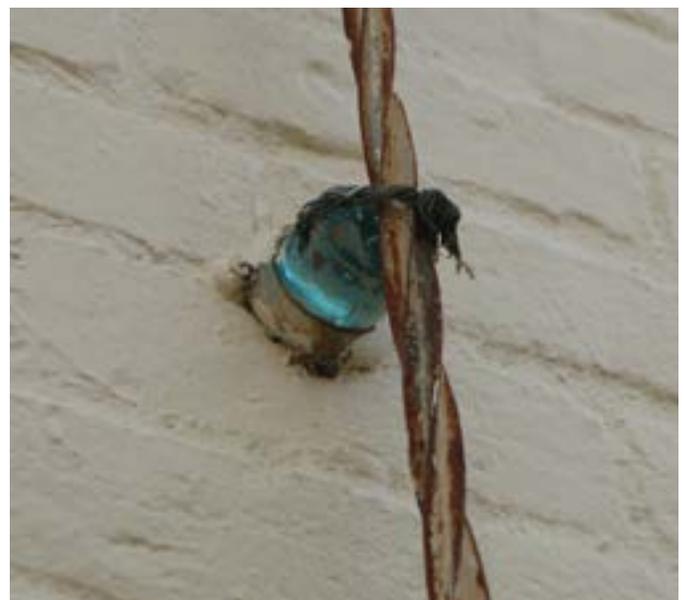
Figure 17. Glass insulators were attached to a structure in a variety of ways using metal rings, staples, wire, or similar fasteners. Where old insulators are damaged and no longer functional, they can be replaced with appropriate metal fasteners. Photo by author.

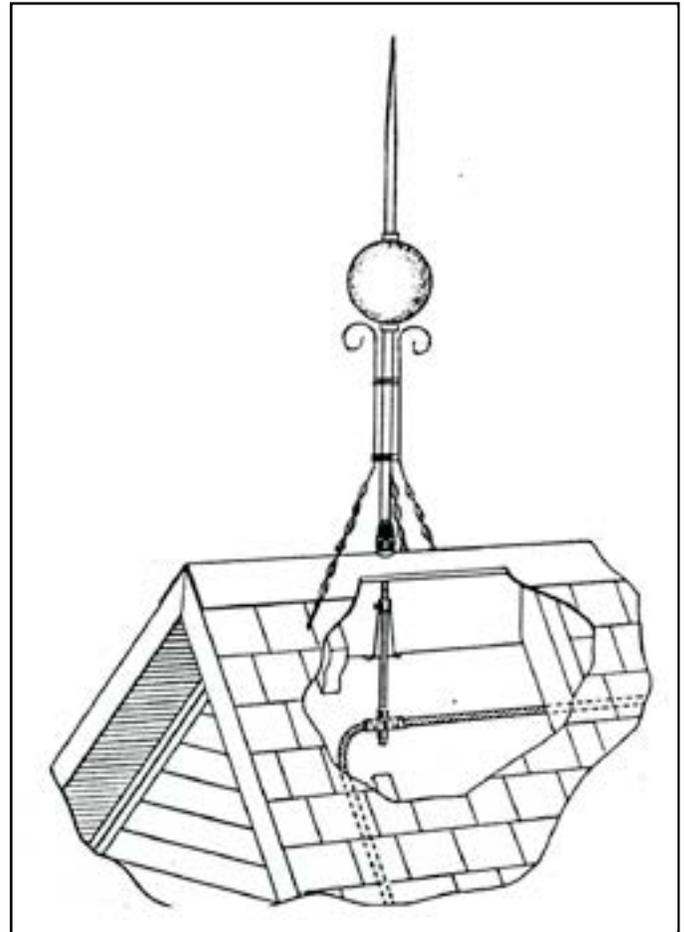
*Figure 18. With concealed lightning protection systems, cable wire connecting lightning rods and conductors are partially or totally concealed on the exterior by running most of the lines within the structure. Where the lightning rod stand is attached to the roof, as well as where the concealed cable is attached on the outside to the lightning rod, are all areas that need to be routinely inspected and repaired as needed. The roof seal at the junction of the cable through the roof will need to be replaced over time. Drawing: Courtesy of Independent Lightning Protection Company.*

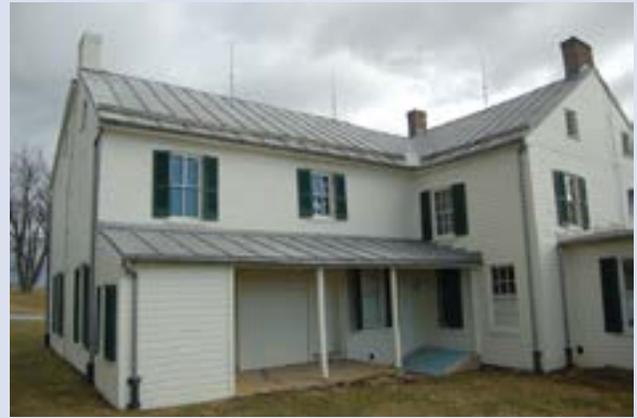
*Figure A. Rear view of the Mumma House showing three of the four tall reproduction lightning rods placed close to the same locations as the historic ones, which were too deteriorated to reuse. Running down the left side of the house below the chimney is one of the two historic down conductors, which were saved in place and bonded to the new system. Photo by author.*

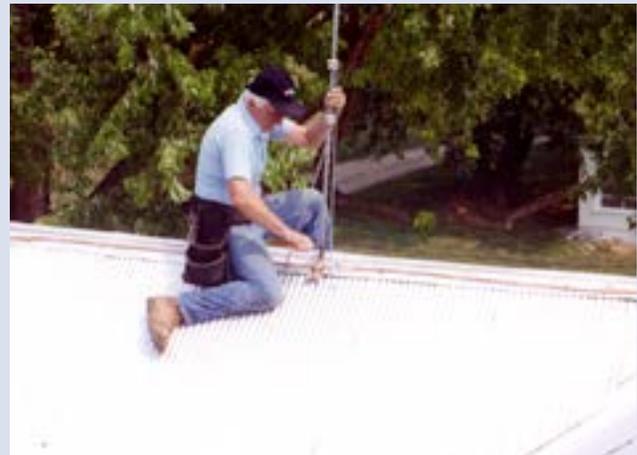
*Figure B. Photo shows one of the reproduction tall lightning rods being secured in place. New cables connected the reproduction lightning rods and the modern air terminals to the down conductors that lead to the grounds. Photo: Independent Lightning Protection Company.*

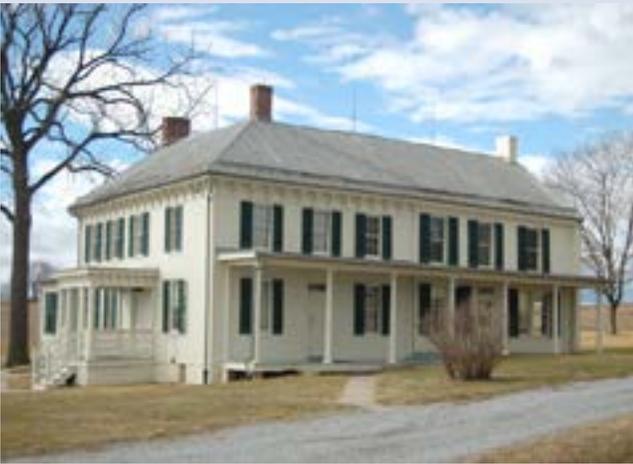
Figure D. Tall lightning rods once again stand out on the Mumma House. These reproduction rods along with retention of the historic down conductors have been incorporated into the modern lightning protection system that was installed. Much smaller, contemporary air terminals located on the roof are barely discernible from below. Photo by author.

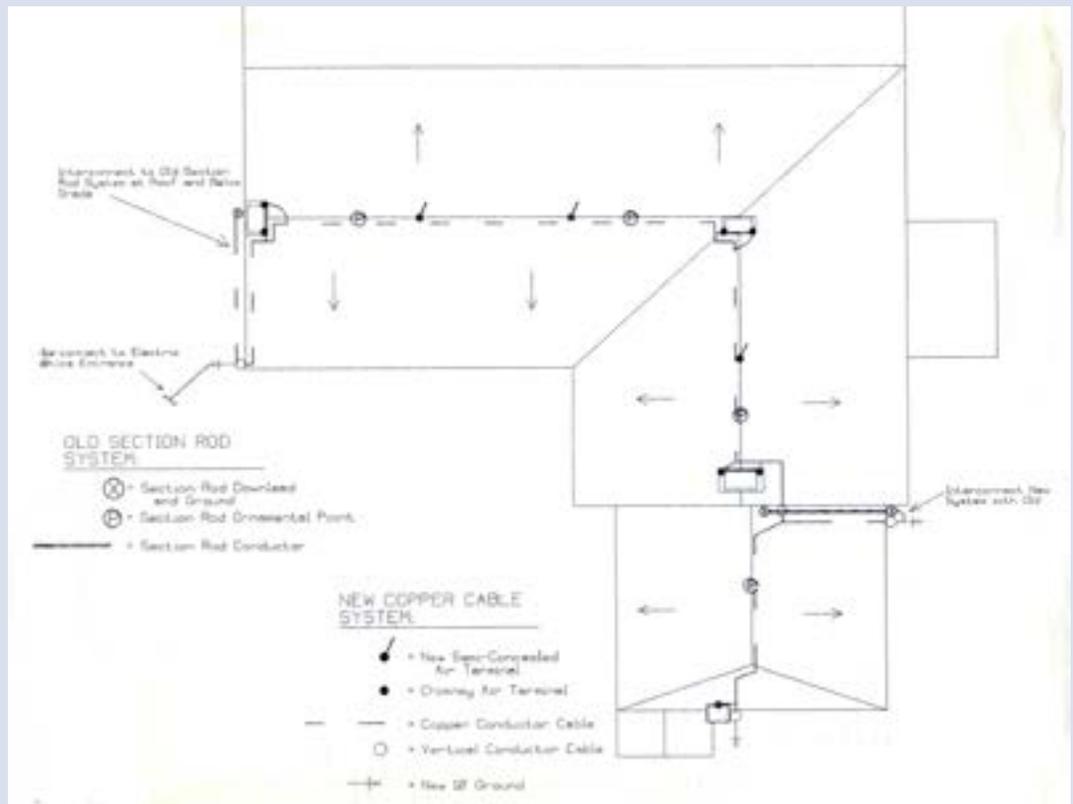
Figure E. Plan for the installation of the new system. Note that the historic systems did not include any lightning rods at the chimneys, while today's code requires two air terminals on each side of this size chimney. The required new air terminals were much smaller than the historic ones and were relatively inconspicuous along the ridge of the roof. Drawing: courtesy of the Independent Lightning Protection Company.

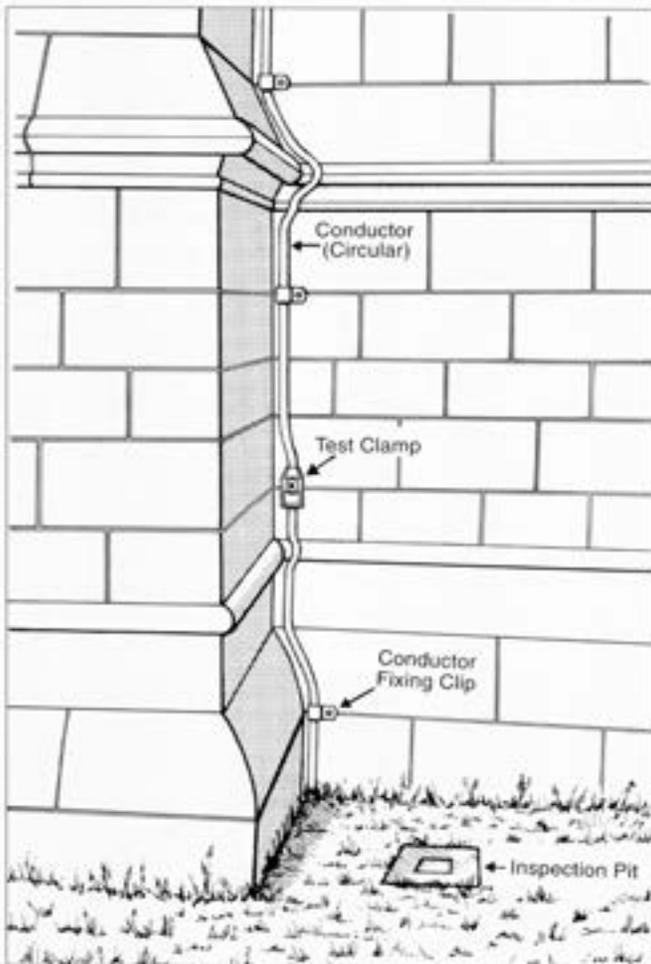
Figure 19. Placement of down conductors along inside corners or adjacent to downspouts helps minimize their visibility. This conductor has been placed on an inside corner. Other good installation practices shown in the drawing include the use of clamps to attach the conductor at mortar joints, rather than damaging the stones; the avoidance of sharp bends in the conductor; and provisions for a test clamp and an inspection pit accessing the ground connection which can be used during periodic inspections of the system. Drawing: English Heritage©.

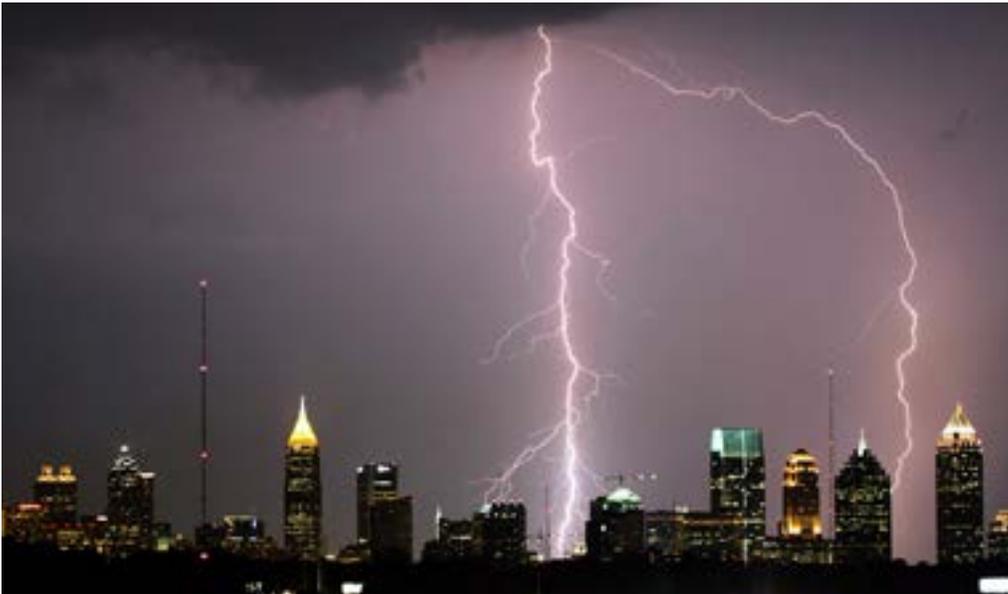
Figure 20. High-rise buildings in cities such as New York, Chicago, and Atlanta have a higher risk of being struck by lightning, and it is not uncommon for some structures to be hit multiple times during a year. Multiple strokes from a single lightning occurrence can strike more than one building at the same time as shown in this photograph of the Atlanta skyline during a thunderstorm. Photo: David Selby©.

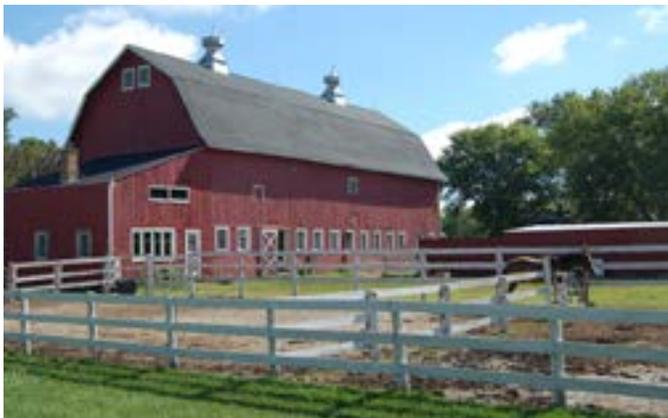
Figure 21. Small air terminals have been used in this more recent installation and have little visual impact. If a partially concealed system was desired, the cable and the mount for two of the air terminals could have been concealed within the ventilators. Photo by author.
