NATIONAL PARK SERVICE

PREHISTORIC RUINS STABILIZATION HANDBOOK
Part 2 - Field Methods

RELEASE NO. 1
May 3, 1962

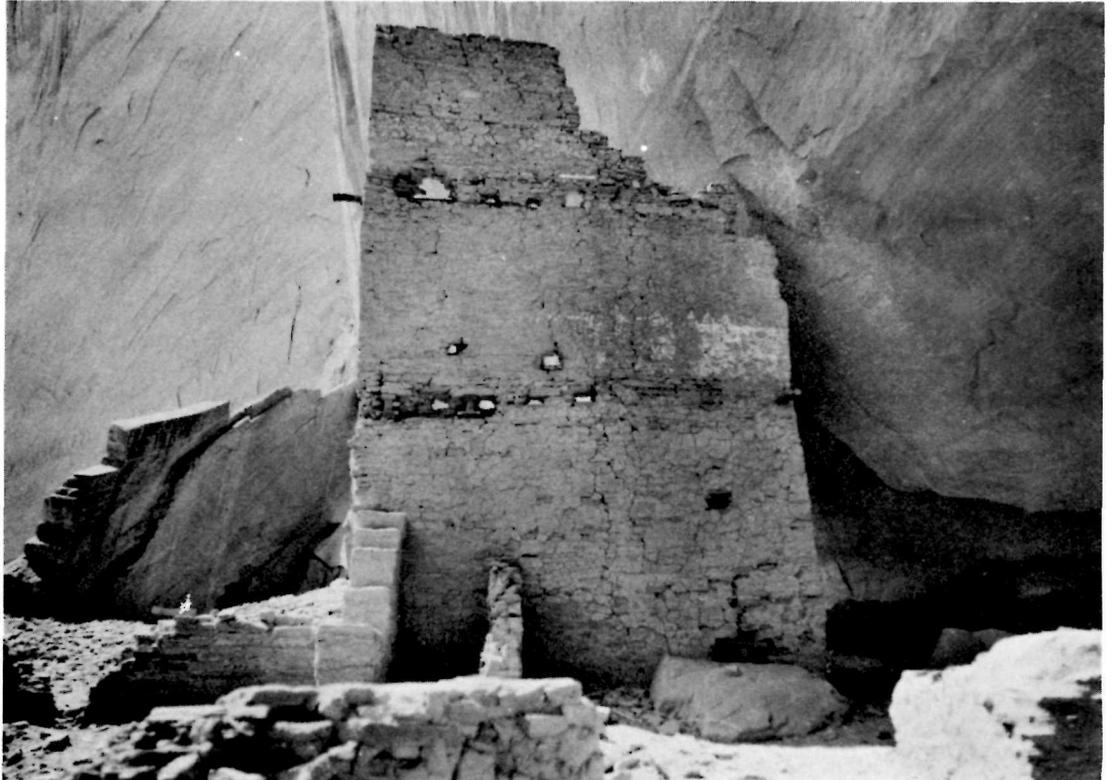
Fig. 1. Settling caused by lack of foundations and unstable fill. Bond between stone and soil mortar is poor. Holes are caused by decay or theft of wood members.

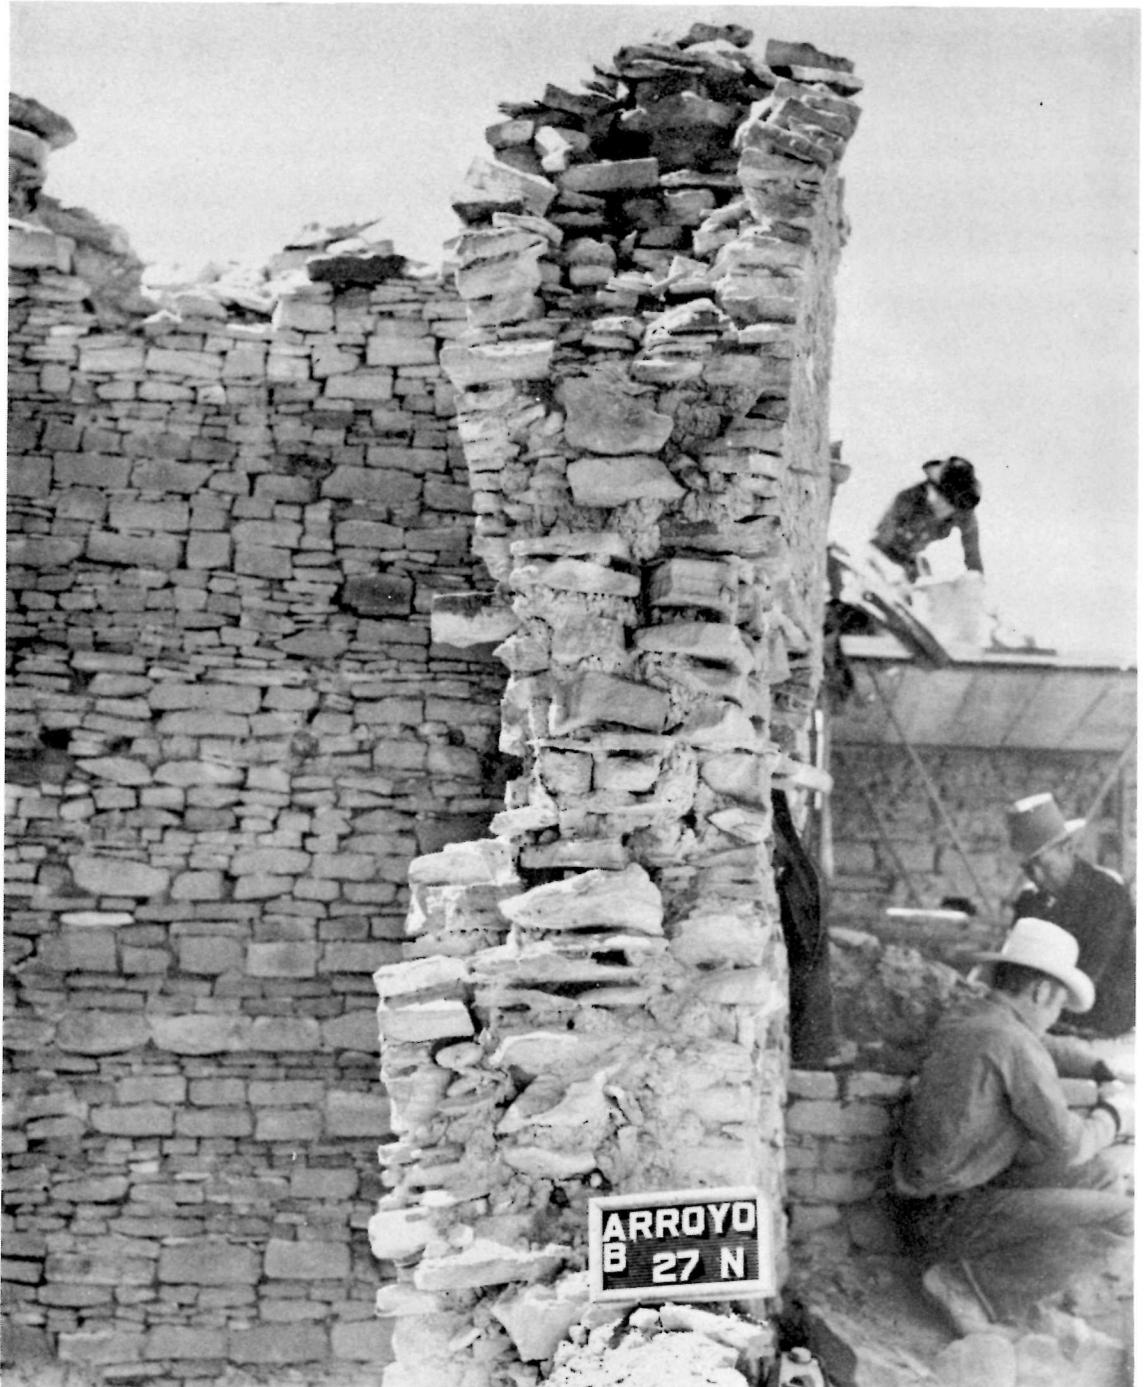
Fig. 2. Aboriginal construction often left narrow strips at ceiling line. This wall is much wider at the top than in the center.

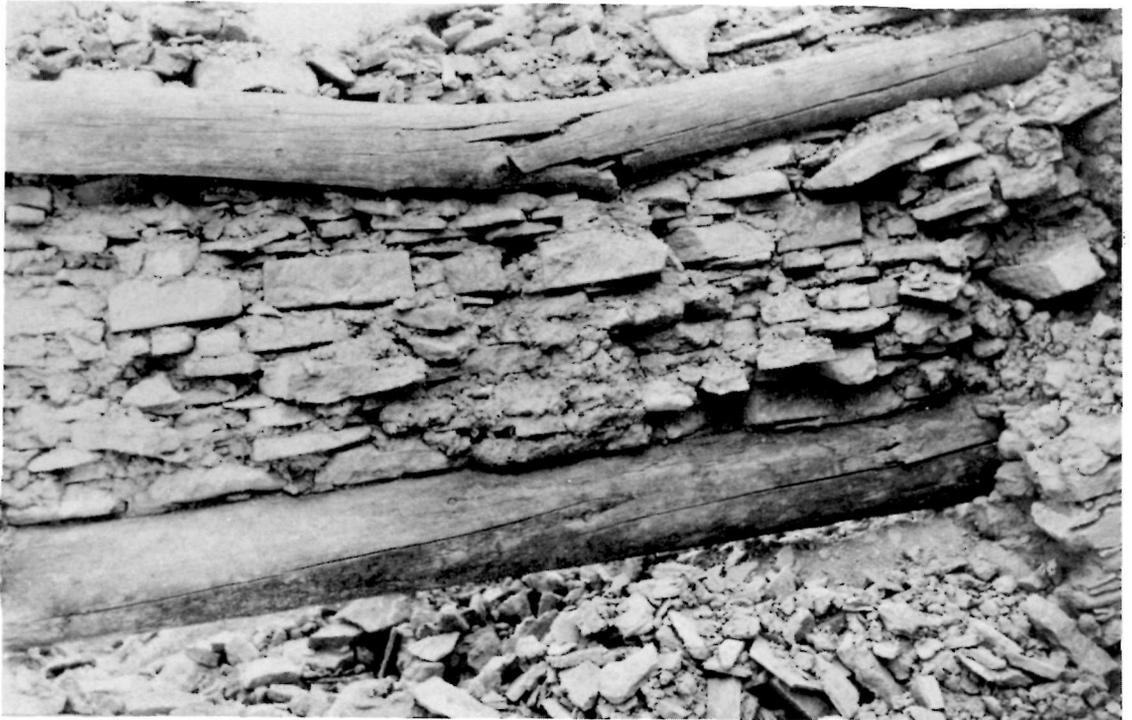
Fig. 3. The inclusion of heavy timbers within cored-type walls was a usual practice of prehistoric builders. Collapse of walls from flood damage exposed 300 logs, similar to those above, in one area of Chettro Kettle.

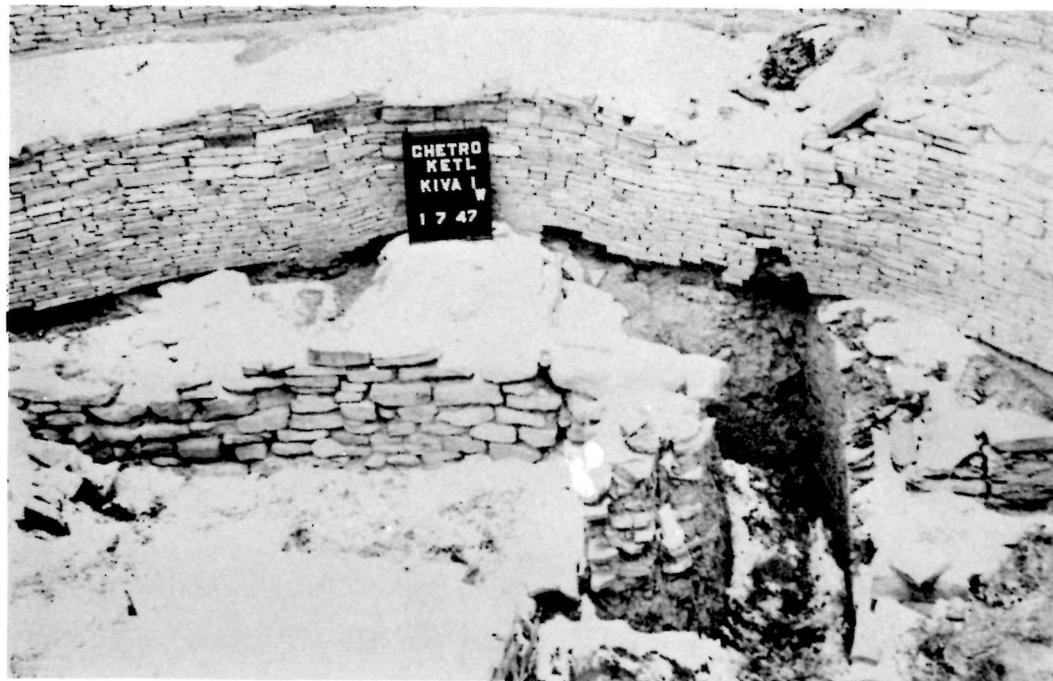
Fig. 4. Excavation neither proceeds nor ends on a single plane and often leaves walls unsupported.

The principal cause of destruction resulting from excavation is the fact that the work generally neither proceeds nor ends upon a single plane. This leaves the site partially filled at many

different levels. Water collects in an area of two or three rooms, and cuts its way to lower levels. Deeply-excavated portions are subject to the pressure of damp fill. The loose, moisture-absorbing fill in rooms transfers moisture to concealed walls and diminishes the strength of adobe mortar. In a site of any complexity, burrowing and tunneling are particularly destructive, even when backfilled, since the backfill is never compacted to the density of the removed materials.

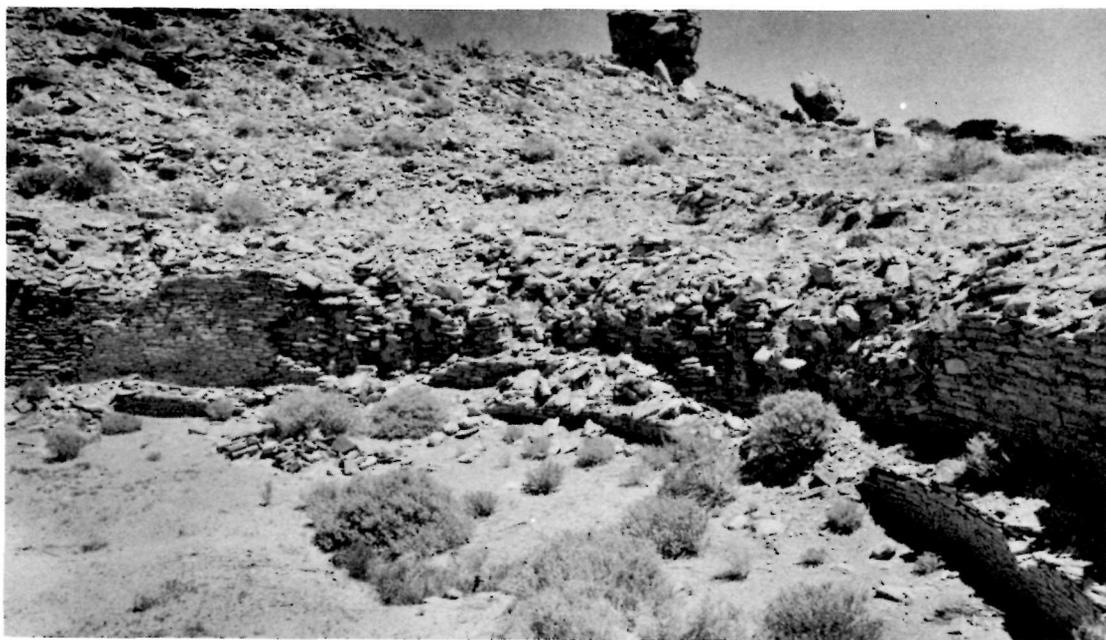
Fig. 5. Clearing of depressed areas leaves them open to surface runoff and rapid destruction.

The most well-intentioned, carefully-planned, and systematically executed archeological excavation, however scientific, is also likely to create difficult preservation problems. (Figs. 4,5.)

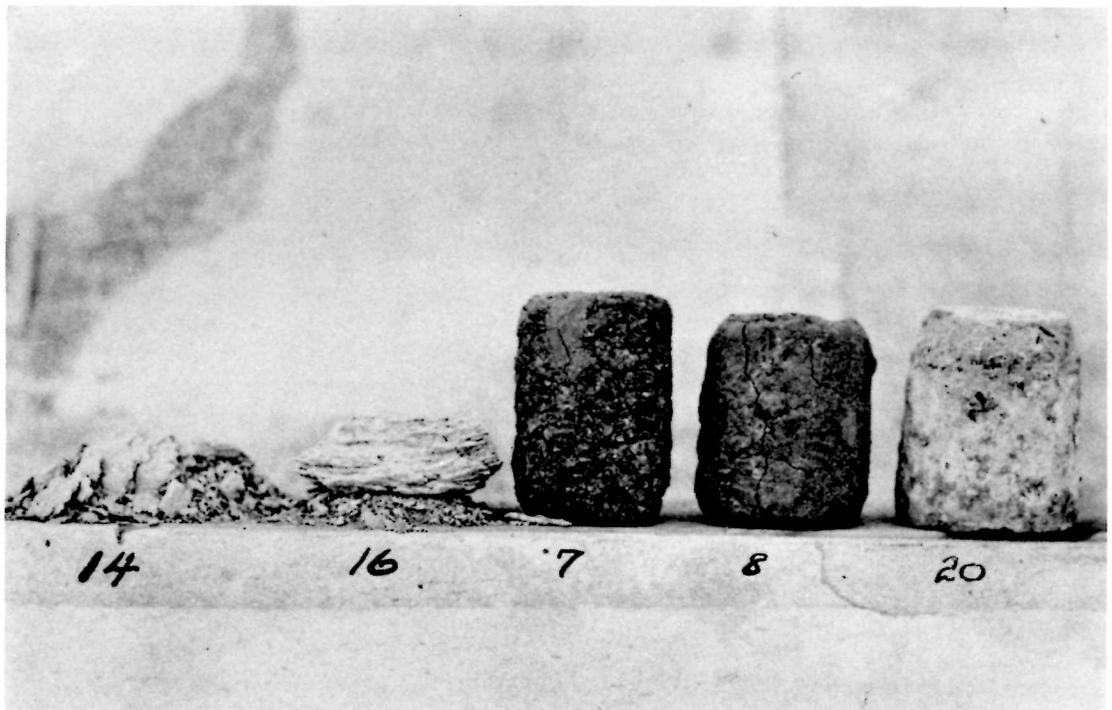
Fig. 7. Freeze-Thaw Test Results: Illustrated are cylinders used in conducting the freeze-thaw test. Cylinder No. 14, made up of equal parts of clay and silt-loam with 10% cement by volume, failed at the third cycle, as did Cylinder No. 16, which had 12% cement by volume. Cylinder No. 20, with 15% cement by volume, is shown at the twelfth cycle. Cylinders Nos. 7 and 8, consisting of three parts clay, two parts silt-loam, and emulsified bitumen were tested in conjunction with the soil-cement tests, and are shown at the fifteenth cycle.

In the freeze-thaw test the same kind of cylinders, cured the same length of time, were used. After curing, the soil-cement cylinders were placed on absorptive pads which extended into a pan of water. Thus the soil-cement had a constant supply of moisture and there was no limit to the amount available for absorption. Soil-cement, and portland cement too, will absorb large quantities of moisture (up to 20%) and it is useless to try a freeze-thaw test without making moisture available.

3. Cement contents for cylinder samples had to be at least 14% to resist the action of repeated freezing and thawing. Cylinders at cement contents less than 14% disintegrated at the third cycle. (Observation of the cylinders undergoing test indicates that no amount of cement will prevent the soil-cement from absorbing moisture either under F-T or W-D conditions. It is simply that the cement strength must be high enough to resist the force of freezing after the moisture has entered the specimen. Moisture rise in a cylinder 4" high was 2" to 3". When cylinders failed under freezing, there was not a gradual wearing away of the exterior, but rather a breaking up of the whole area that had absorbed moisture.)

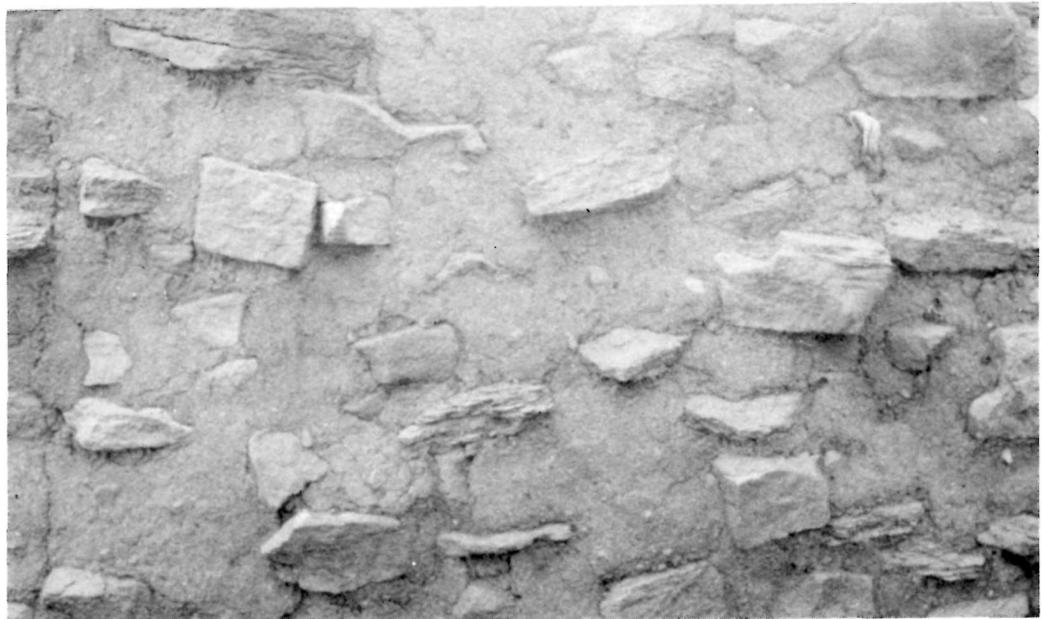
Fig. 8. Heavy grouting replacing native soil, between random stone exposed in longitudinal section after 10 years exposure.

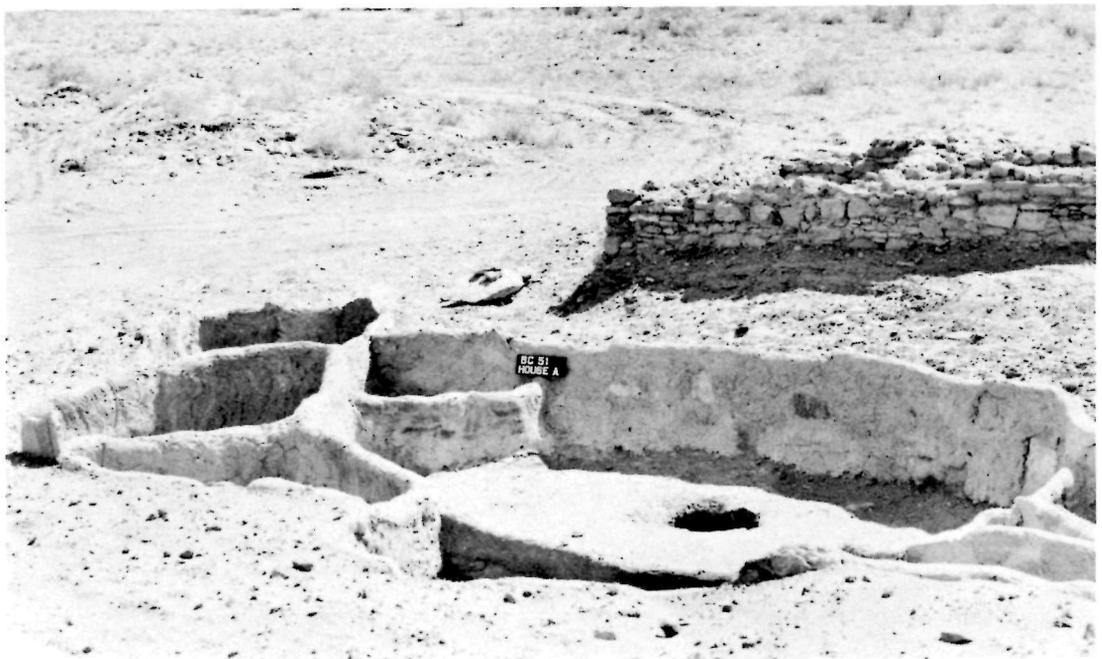
Fig. 9. Soil-cement in heavy cross section is suitable for repairs to slab-house walls.

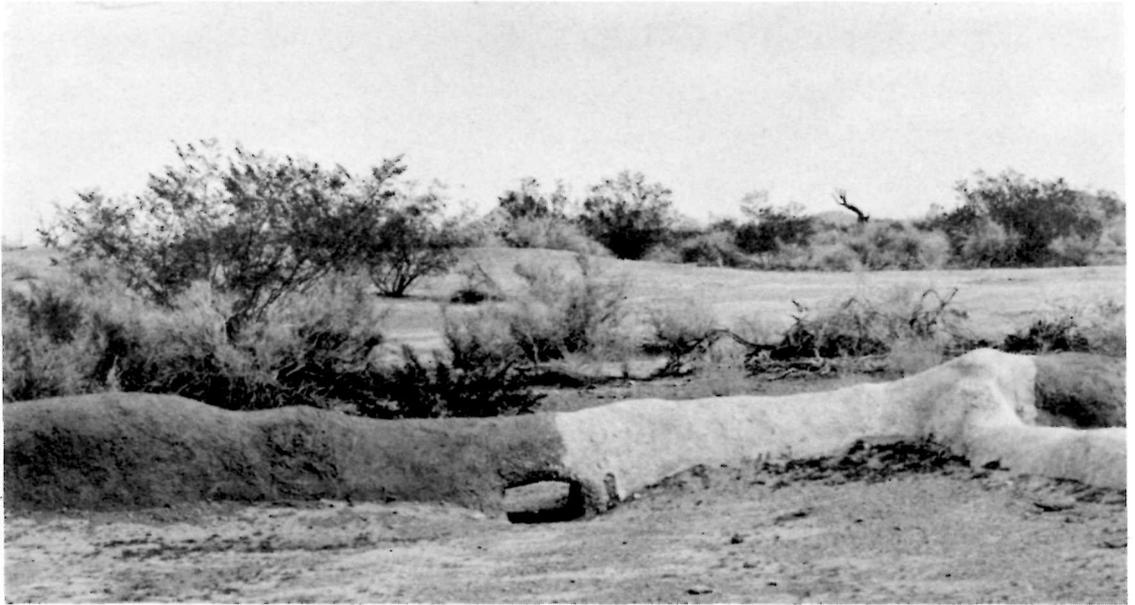
Fig. 11. Silicone waterproofing at Casa Grande immediately after a rain. The light areas were treated and repel water. The darker areas were untreated and have rapidly absorbed moisture.

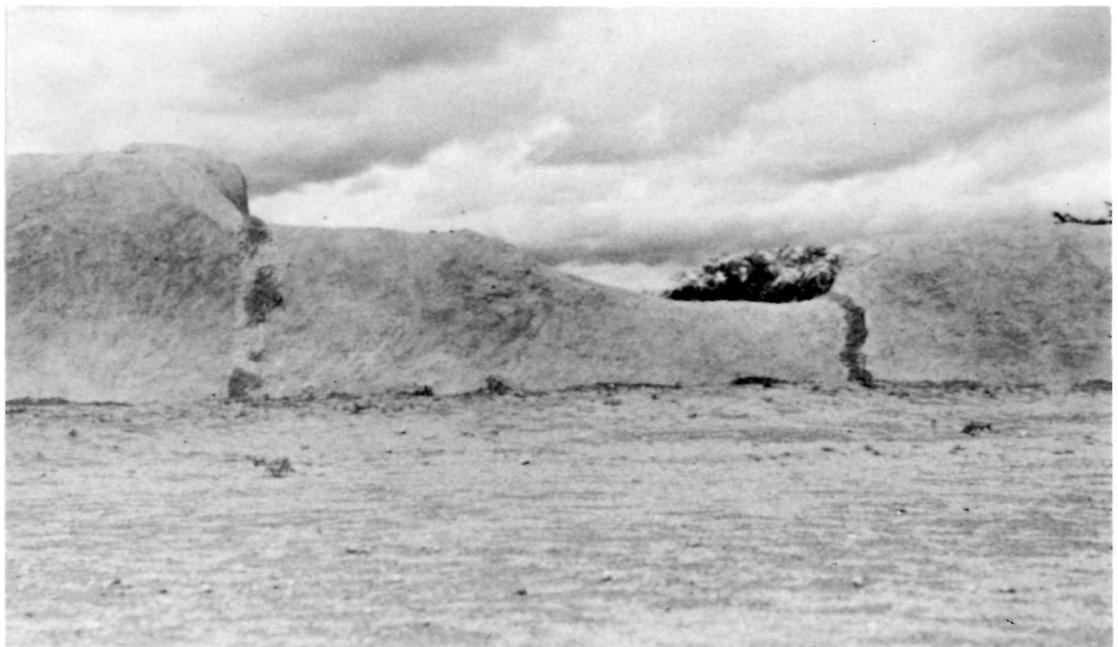
Fig. 12. A year after application of water repellent, two hairline cracks were filled. The untreated smears of plaster have absorbed moisture from the rain while the treated wall remains dry.

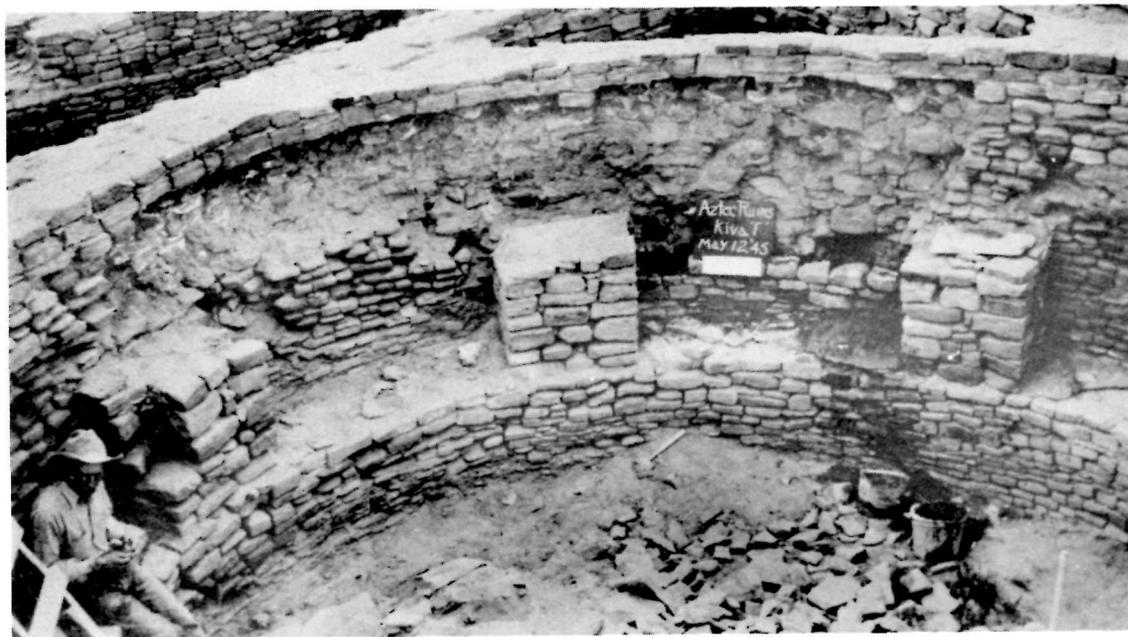
Fig. 13. Damage caused by outward movement of moisture from fill behind this kiva wall. Most severe damage is at the limit of capillary rise, just below the concrete capping.

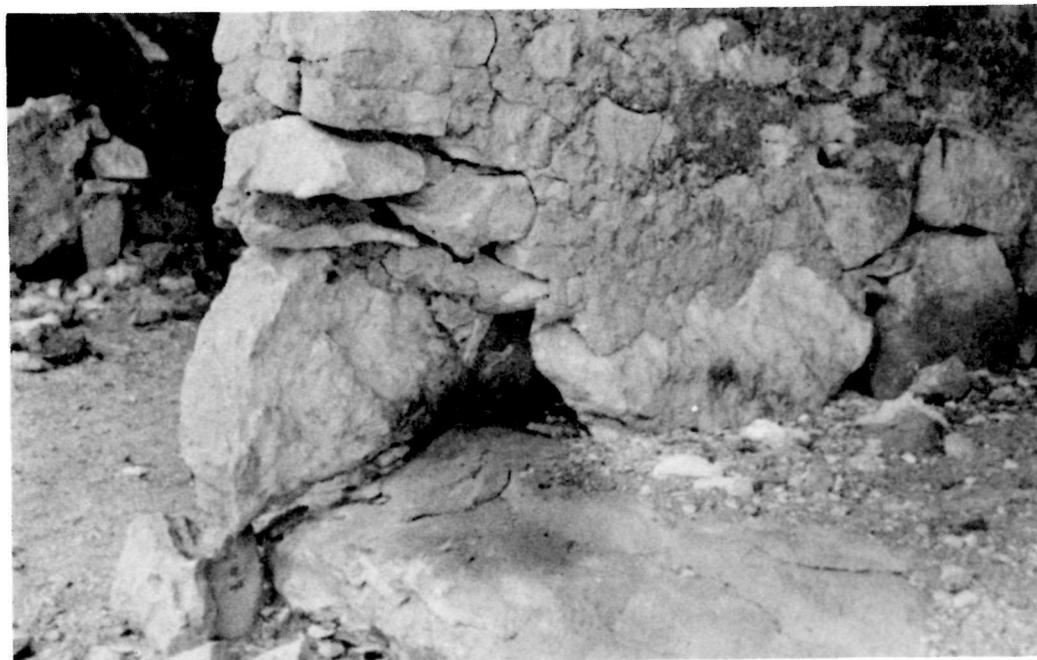
Fig. 14. Damage is caused not by general weathering but by rising moisture from melting snow. Note that decay is confined to the limit of capillary rise in the mortar column.

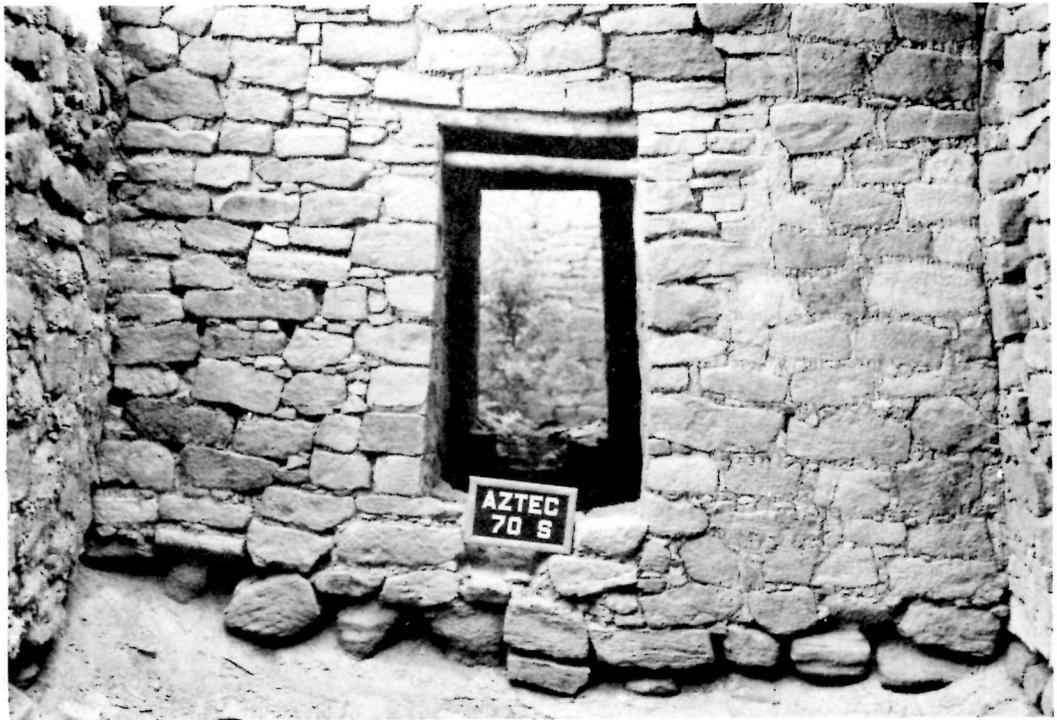
Fig. 15. Basal erosion from Capillary moisture is particularly damaging in the interiors of excavated sites where the drainage is poor.

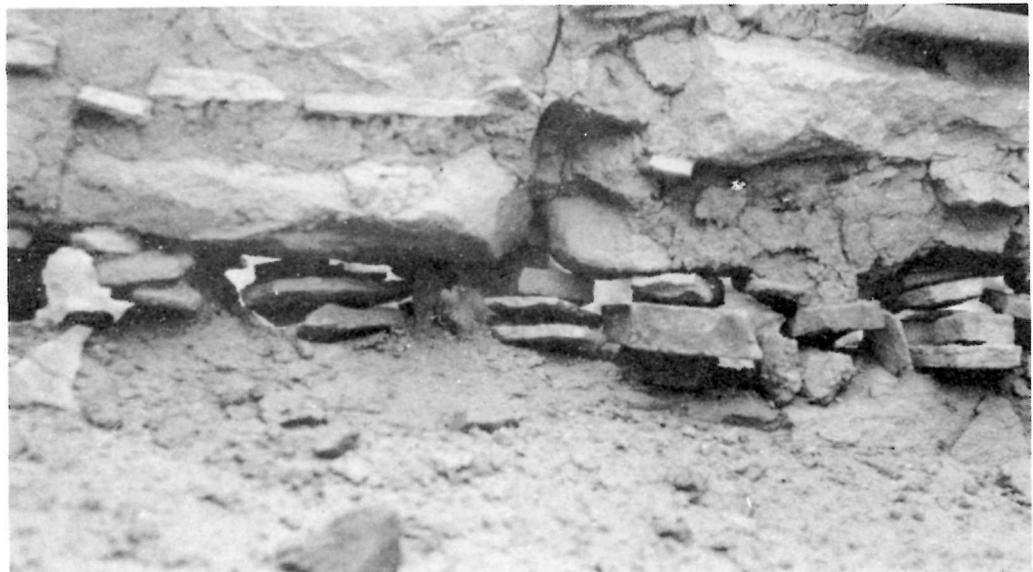
Fig. 16. It continues until the wall is almost completely undermined, a stage followed by collapse.

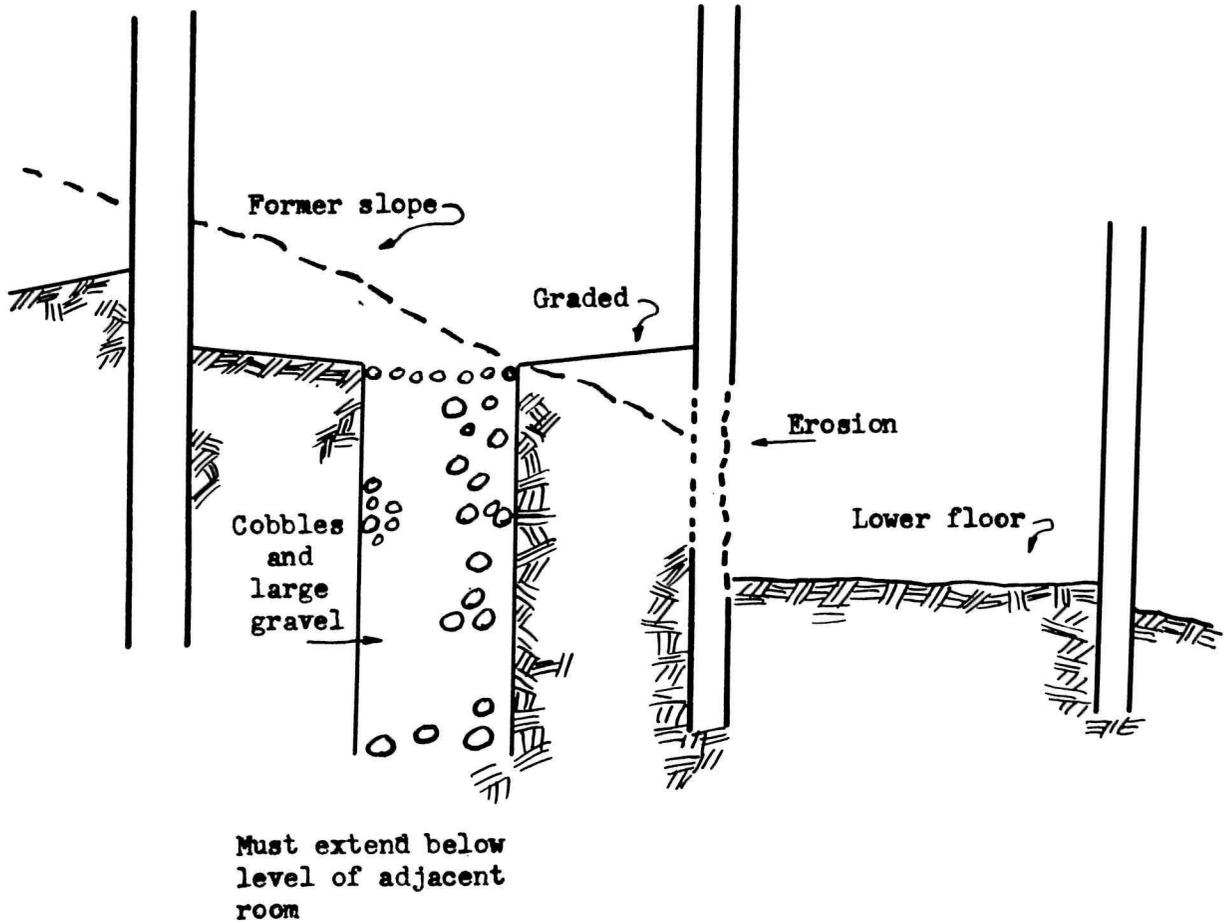
Fig. 19. Drybarreling, it should be carried well below the adjacent floor levels.

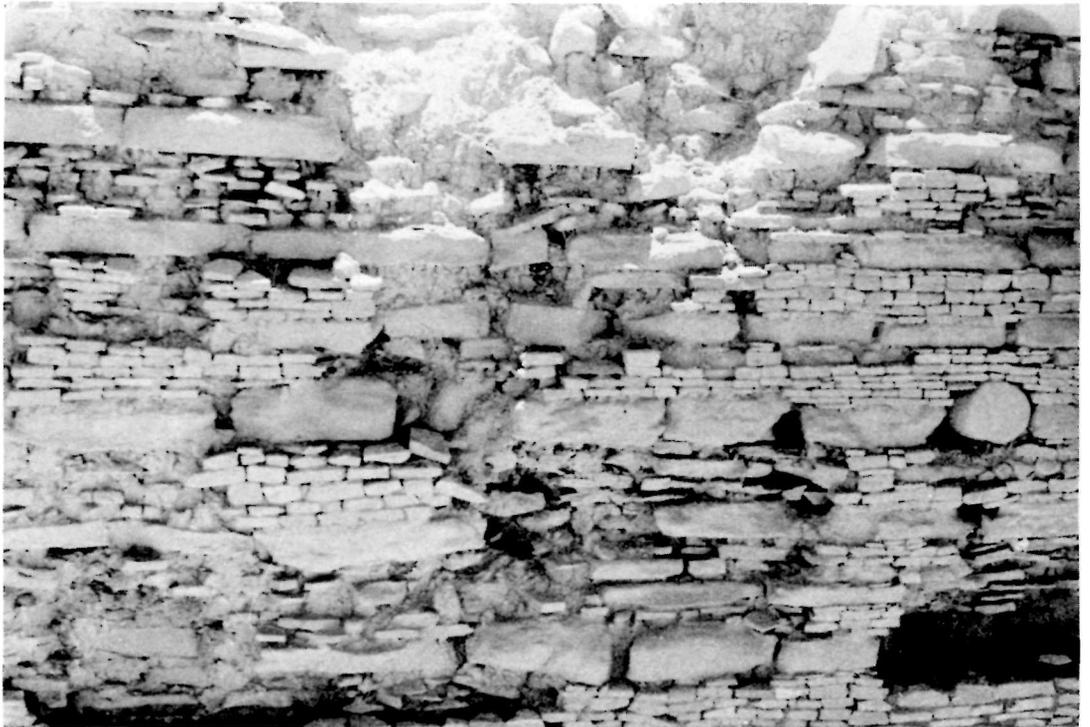
Fig. 21. Replacement of soft, pecked and dimpled stone in random areas over the surface requires extreme care if the character of the wall is not to be changed.

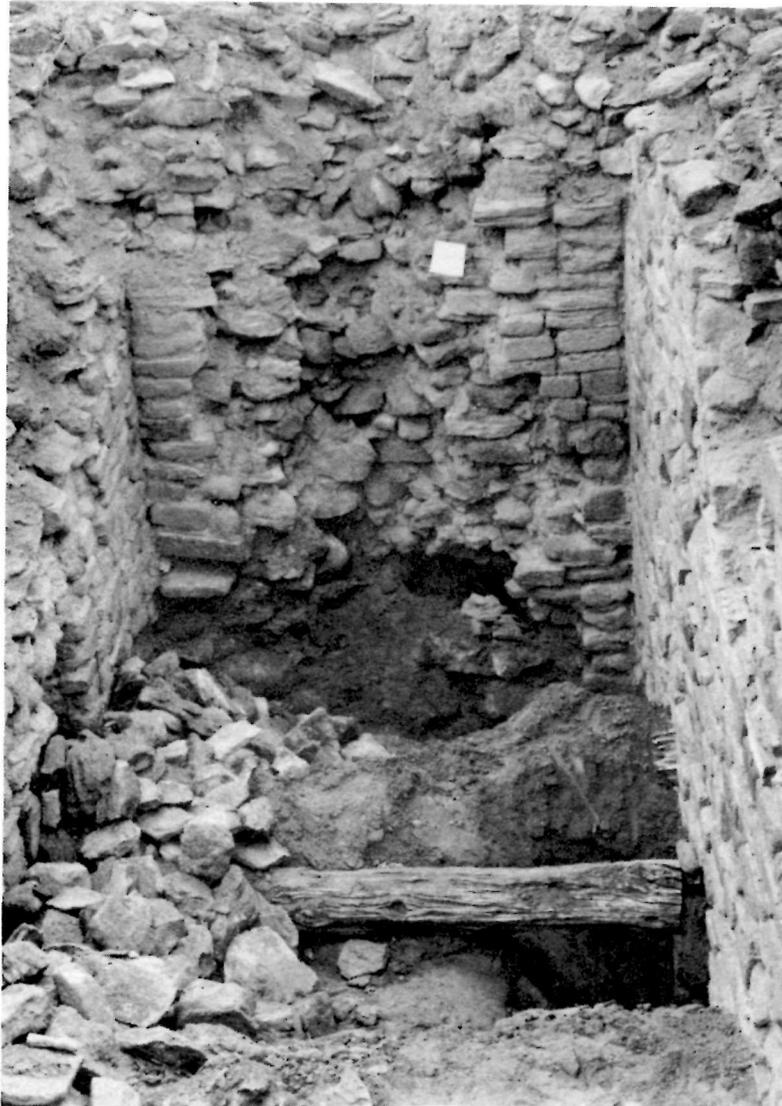
Fig. 22. Wall break in a partially excavated site. Patch must be designed to prevent further flow of water and fill at the top. Some excavation will be required to base patch on sound masonry. Patch will be subject to pressure of contained fill.

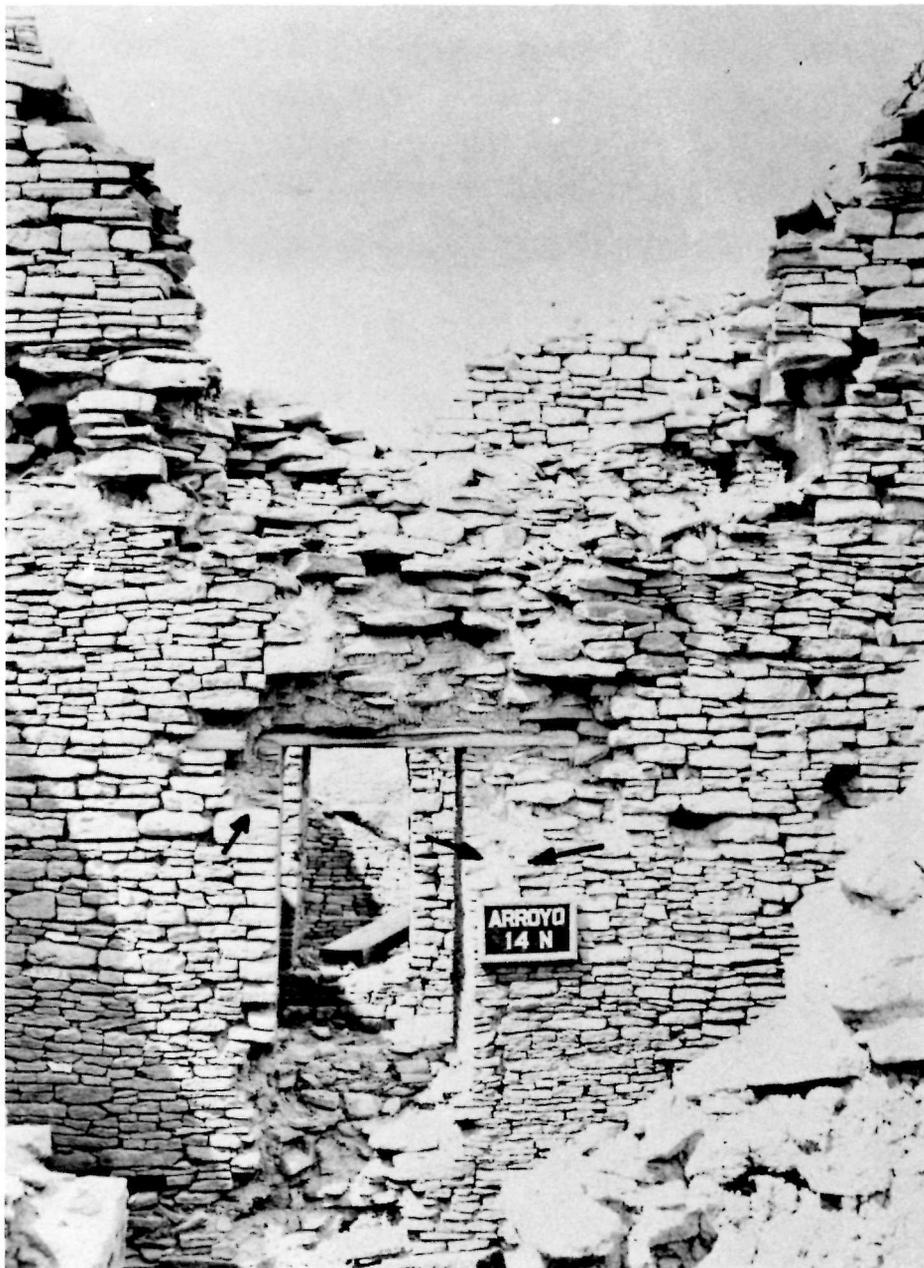
Fig. 23. Repair here will be based on a very small area in comparison with the total size of break. Every effort should be made to tie the patch securely to the existing wall.

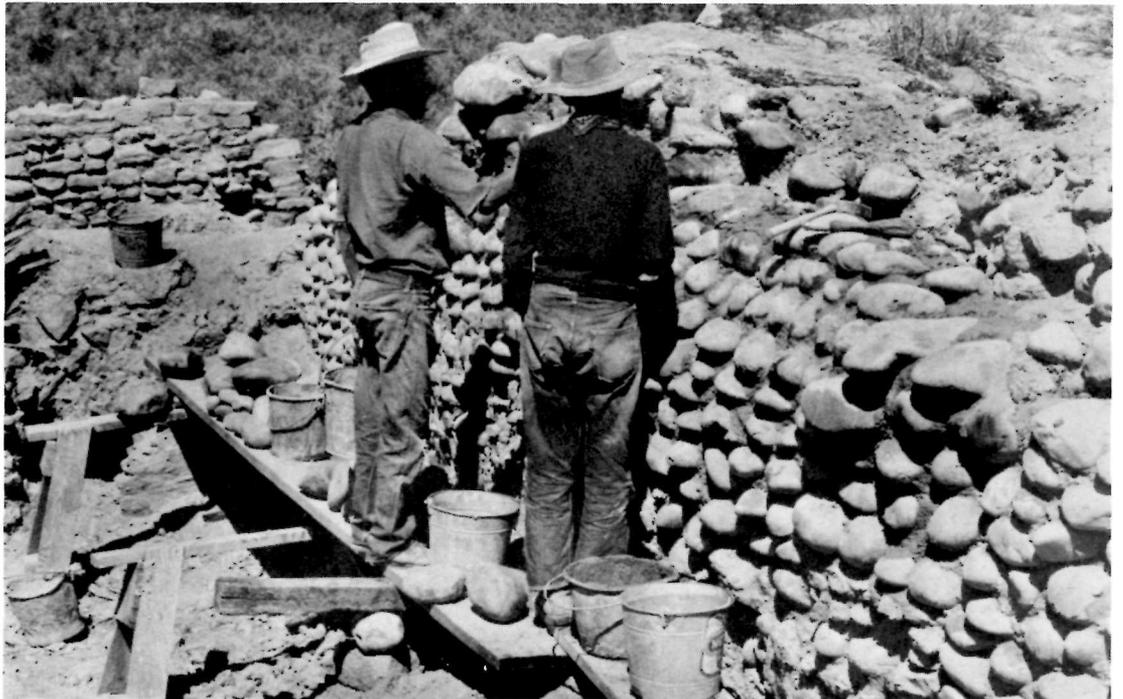
Fig. 24. Deep grouting with soil-cement on the badly weathered face of this cobblestone wall will not change its appearance but will halt the rapid rate of erosion.

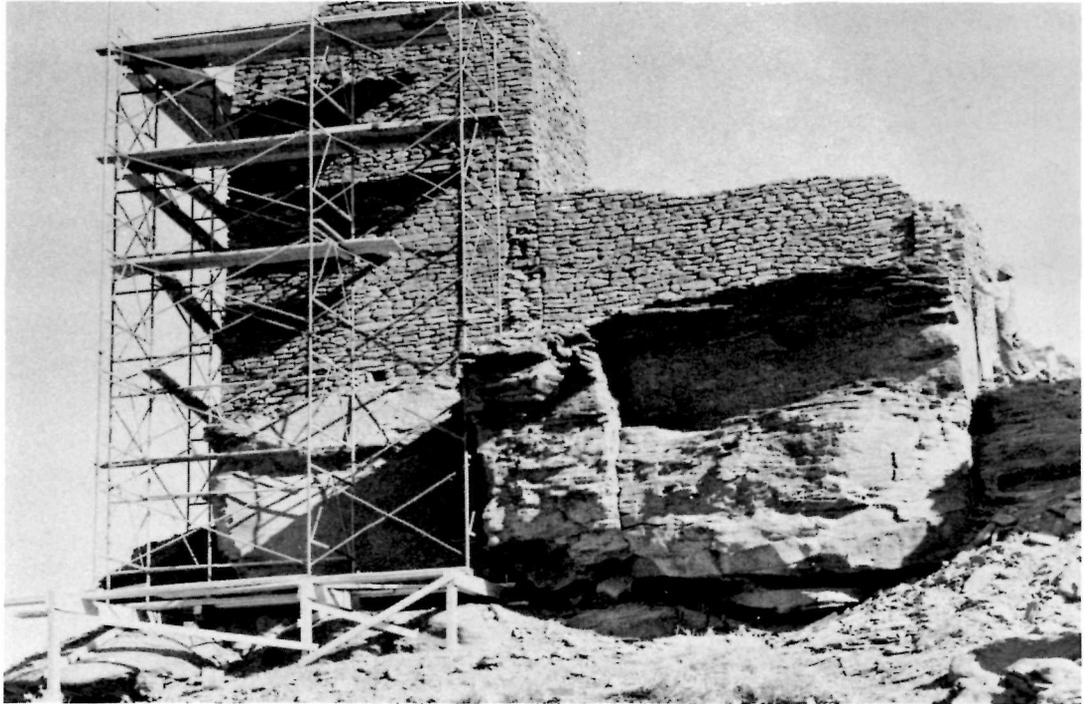
Fig. 25. Scaffolding in place at completion of respalling and grouting wall surfaces.

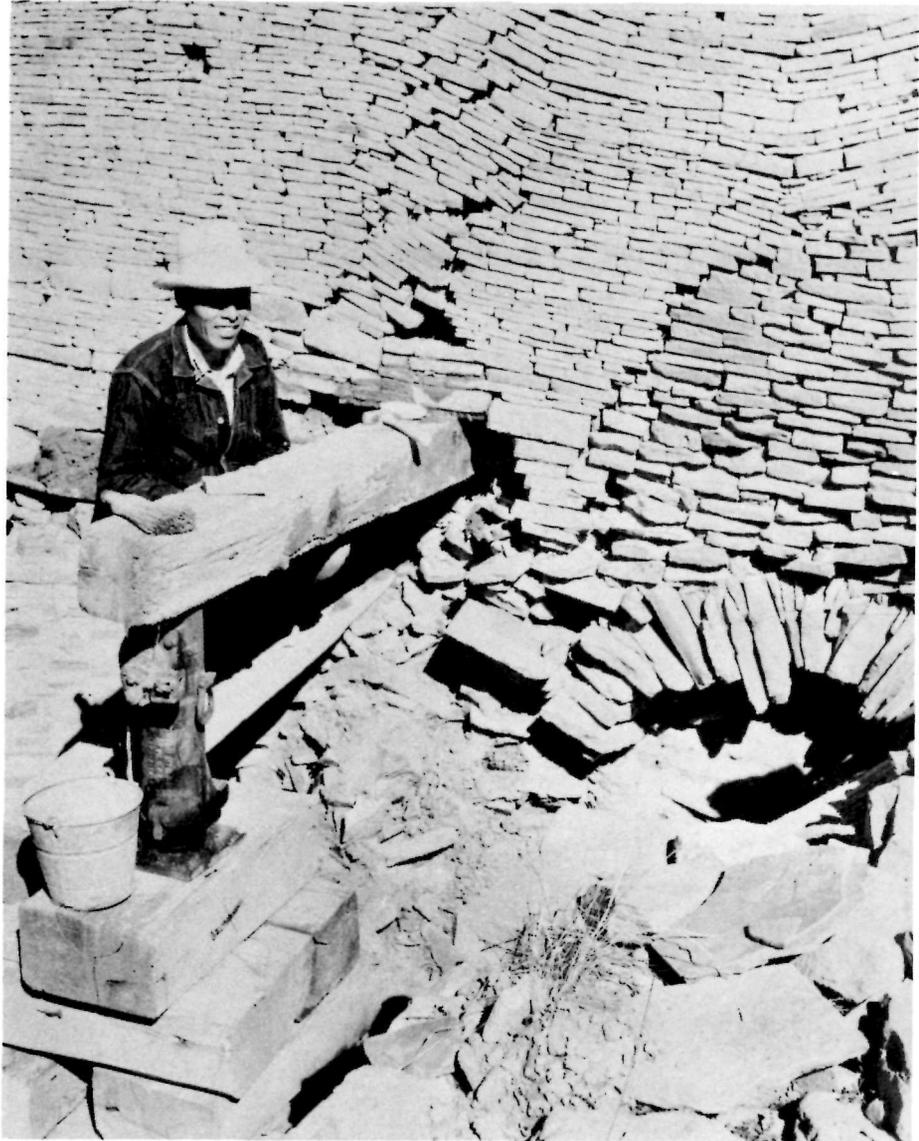
Fig. 26. Temporary support. The arch section, lower right, was a repair measure of the 1920's. The arch is being replaced to halt further settling and because of its incongruous appearance in an area where the arch did not occur. First step in supporting the wall is placement of the beam through an adjacent hole. Masonry above the beam is being repaired.

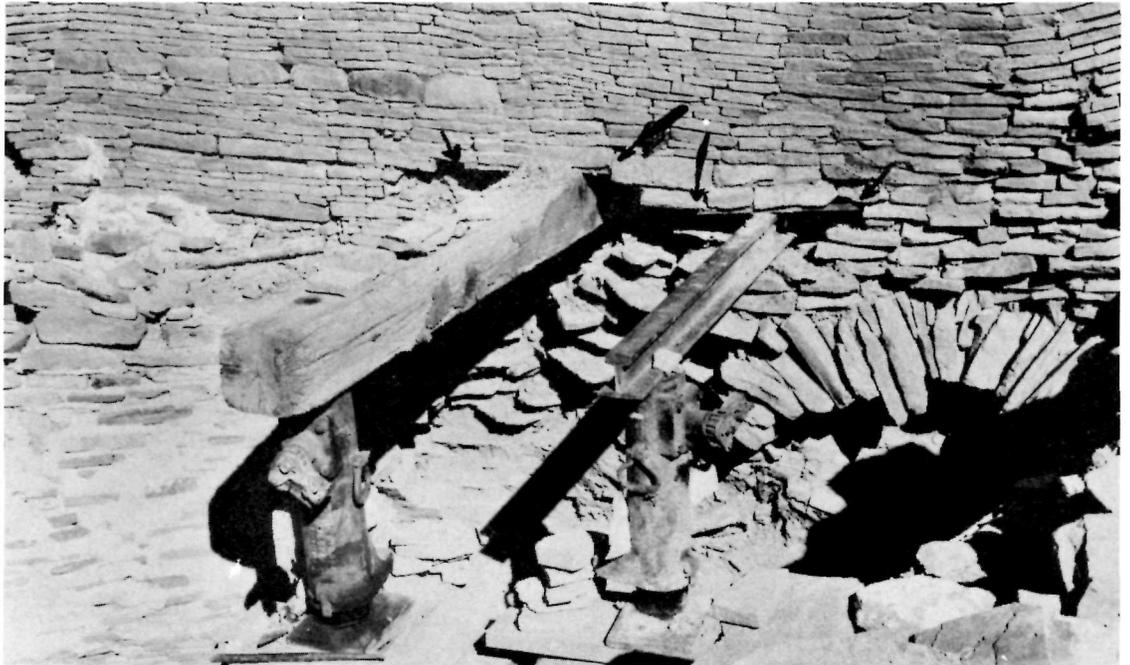
Fig. 27. A second beam resting on jacks is placed through the wall. Arrows indicate extent of steel plates above the beam. With some upward pressure the area of settling was reduced.

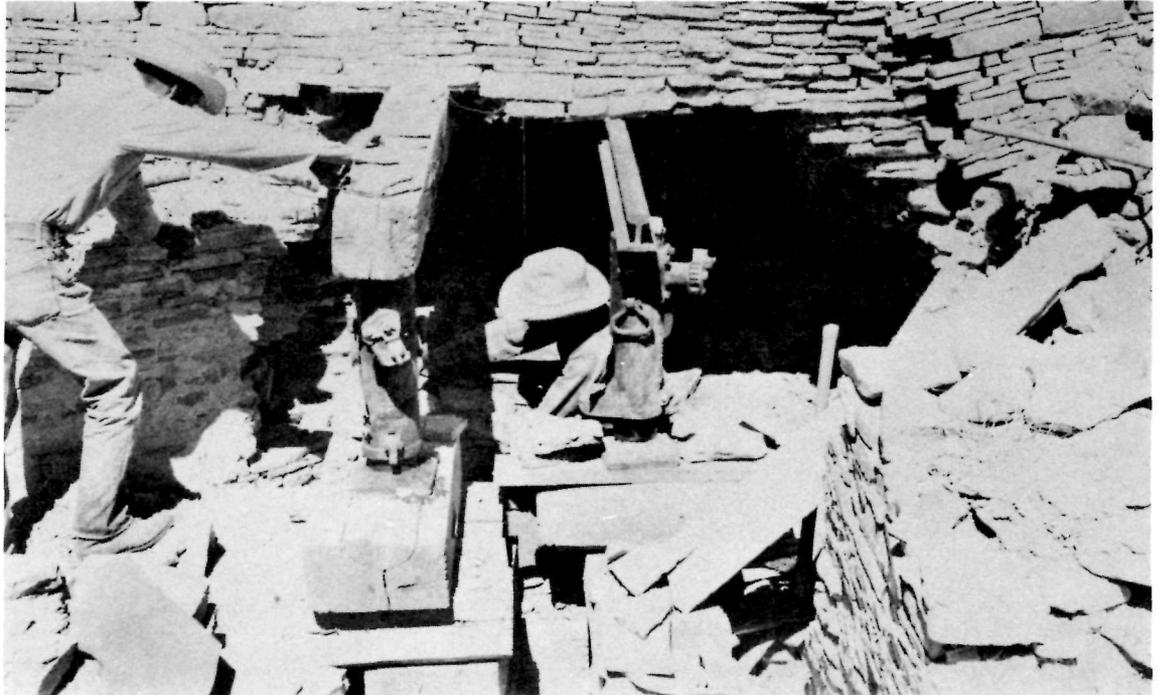
Fig. 28. Jacks and beams provide support while arch section is removed and break is filled with repair masonry. (Clearing away the rubble showed that the arch had been built over a broken doorway; this was rebuilt.)

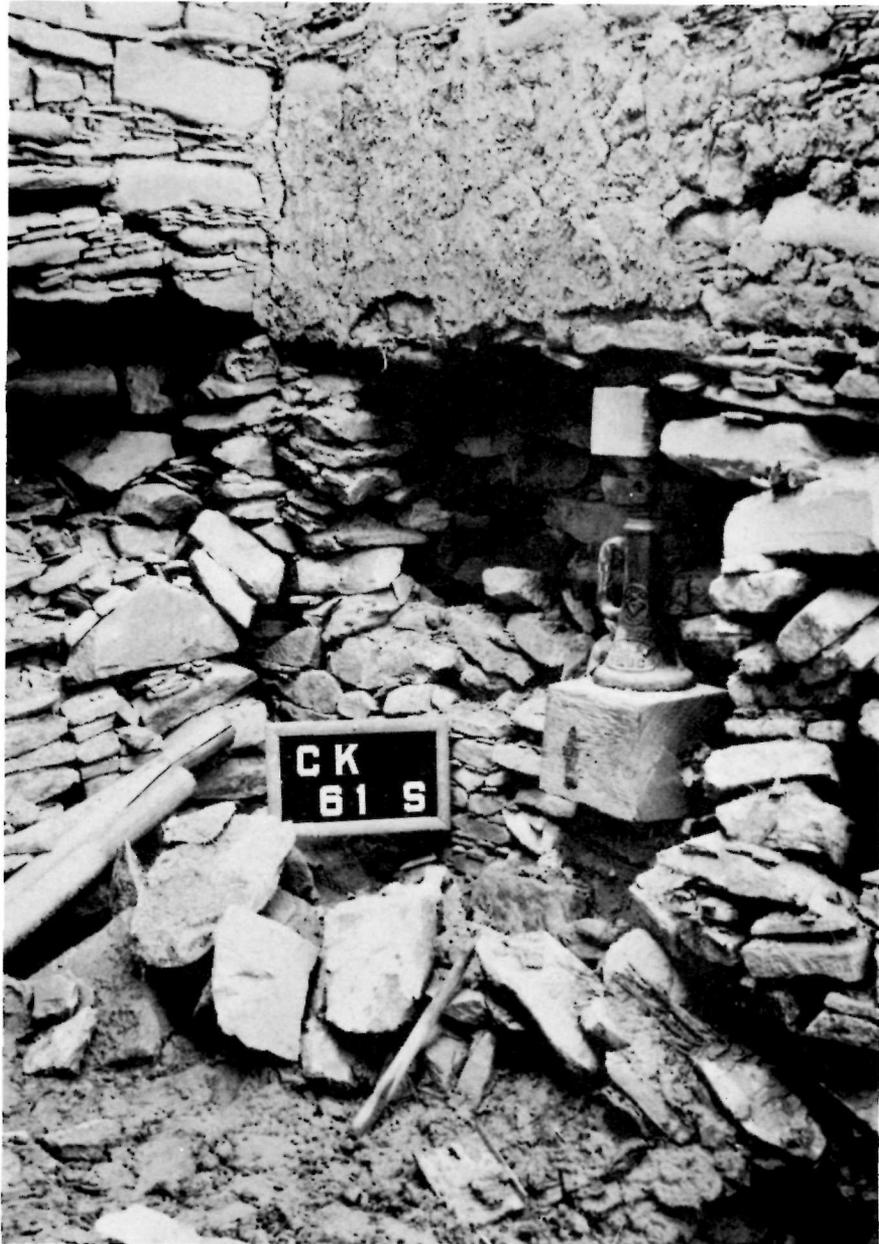
Fig. 29. Placement of jack in line with shattered facing near the bottom of a 14 foot wall. It provided support while the broken area at the right was being replaced.

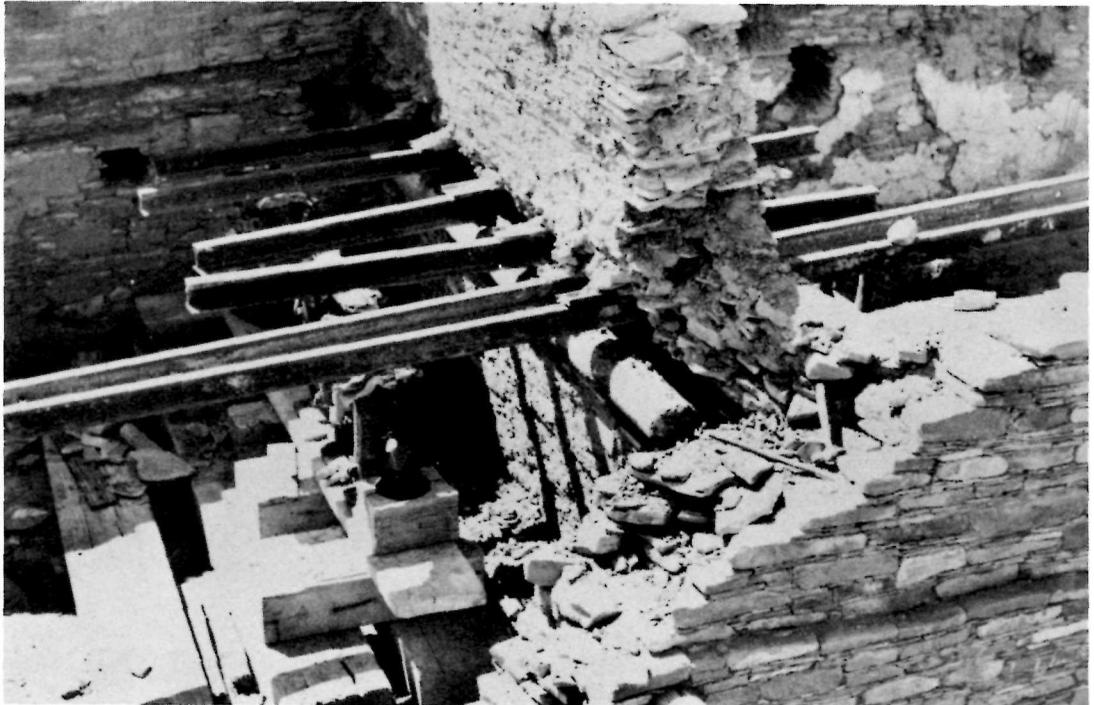
Fig. Temporary support. Six steel beams support the upper half of the wall while a decayed horizontal timber is replaced. The timber is partly removed here. With a little care, steel beams can be run through pole sockets or other natural openings without damage to the wall.
