NATIONAL PARK SERVICE

PREHISTORIC RUINS STABILIZATION HANDBOOK
Part 2 - Field Methods

RELEASE NO. 1
May 3, 1962

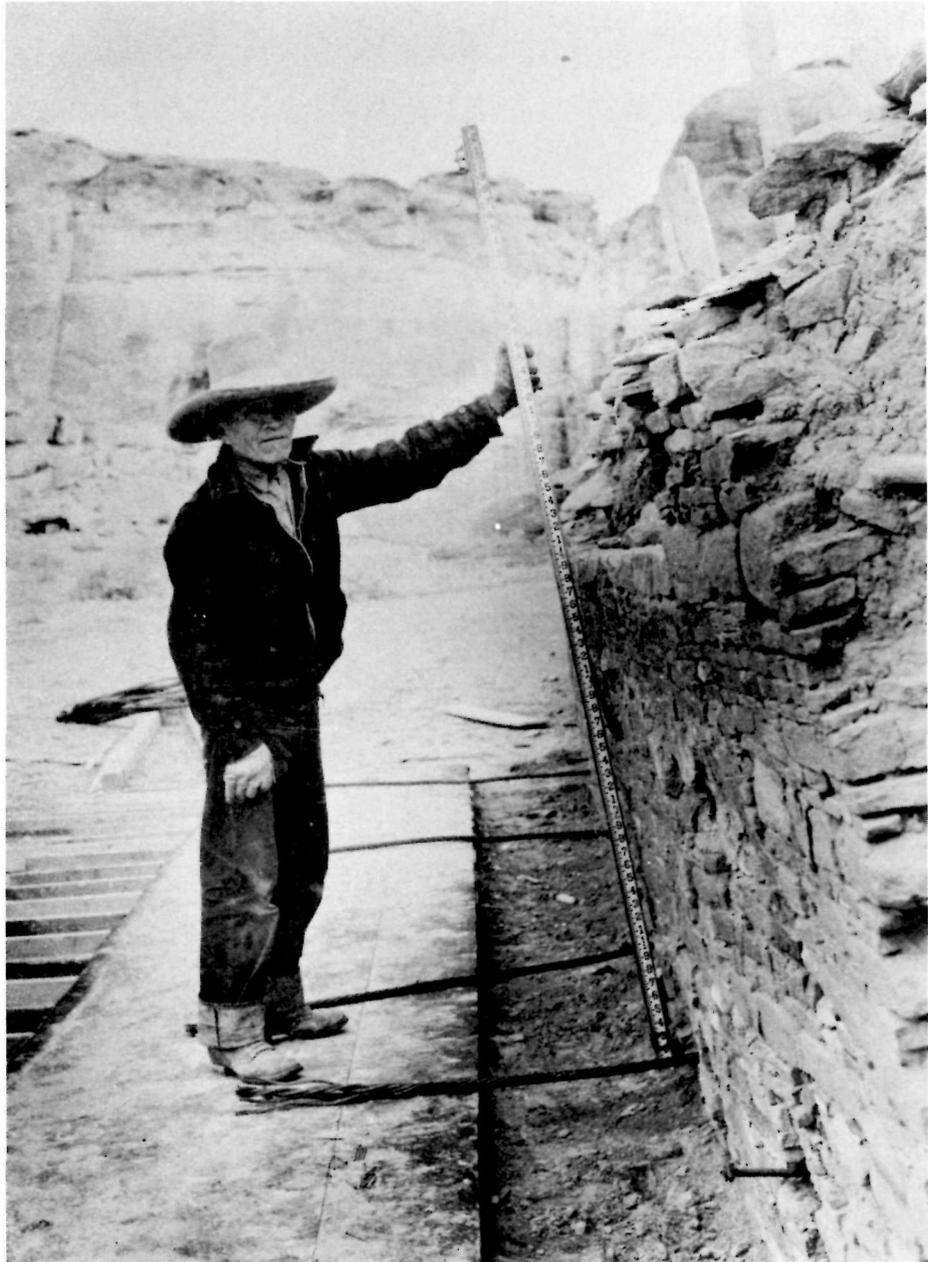
Fig. 31. Realignment. Cables have been placed through the base of the wall to be tied to the jacks. Note bolt, lower right for holding frame against wall. The framework is partially completed.

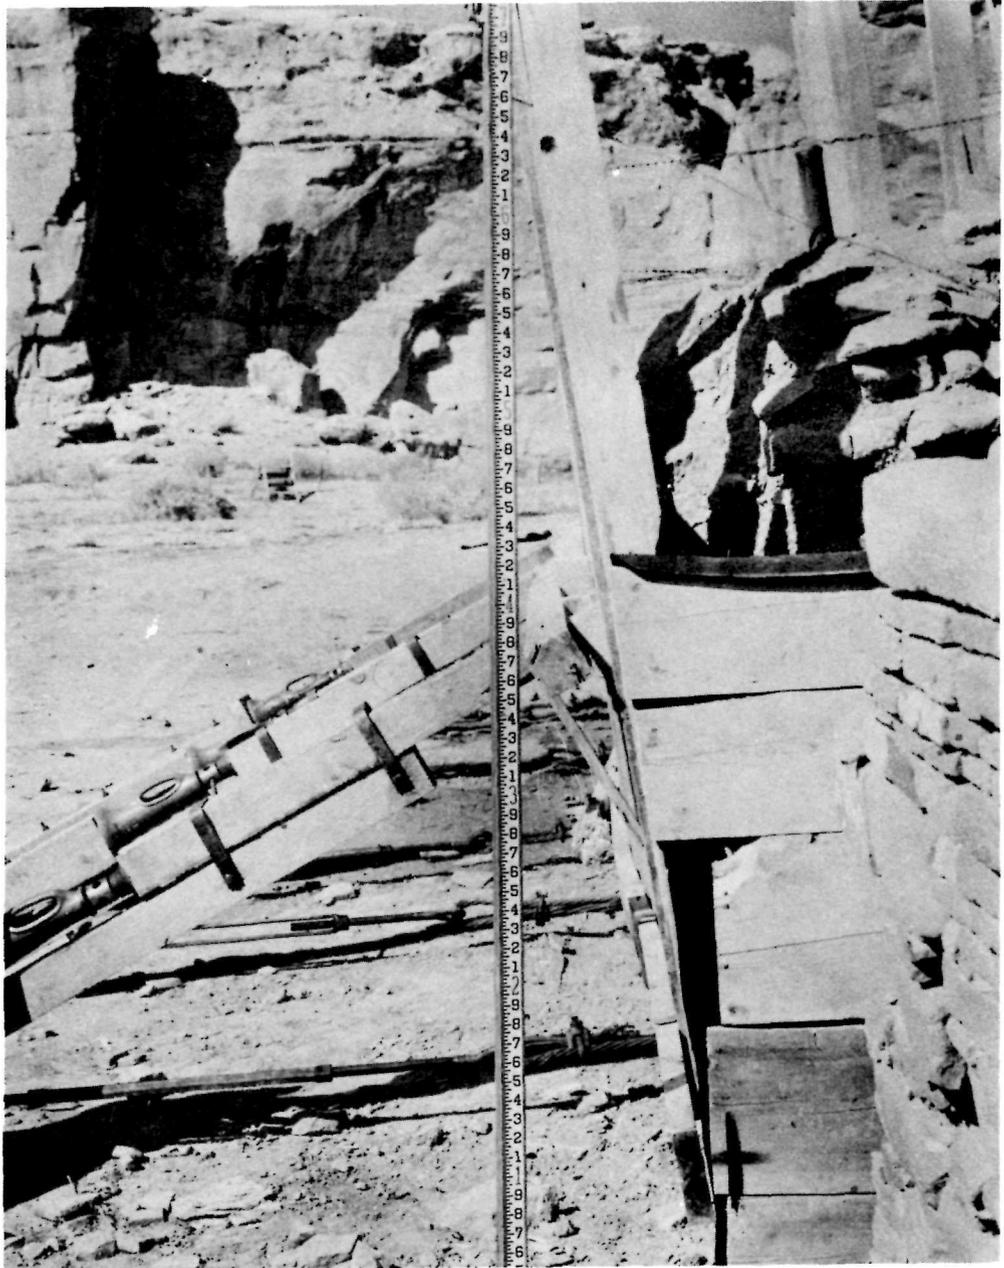
Fig. 32. Realignment. Framework in place on both sides and tied together. Frame lined with asphalt paper, space between frame and wall packed with sand. Note that the five screw jacks in sleeves bear against a 4 x 4 timber to distribute the pressure.

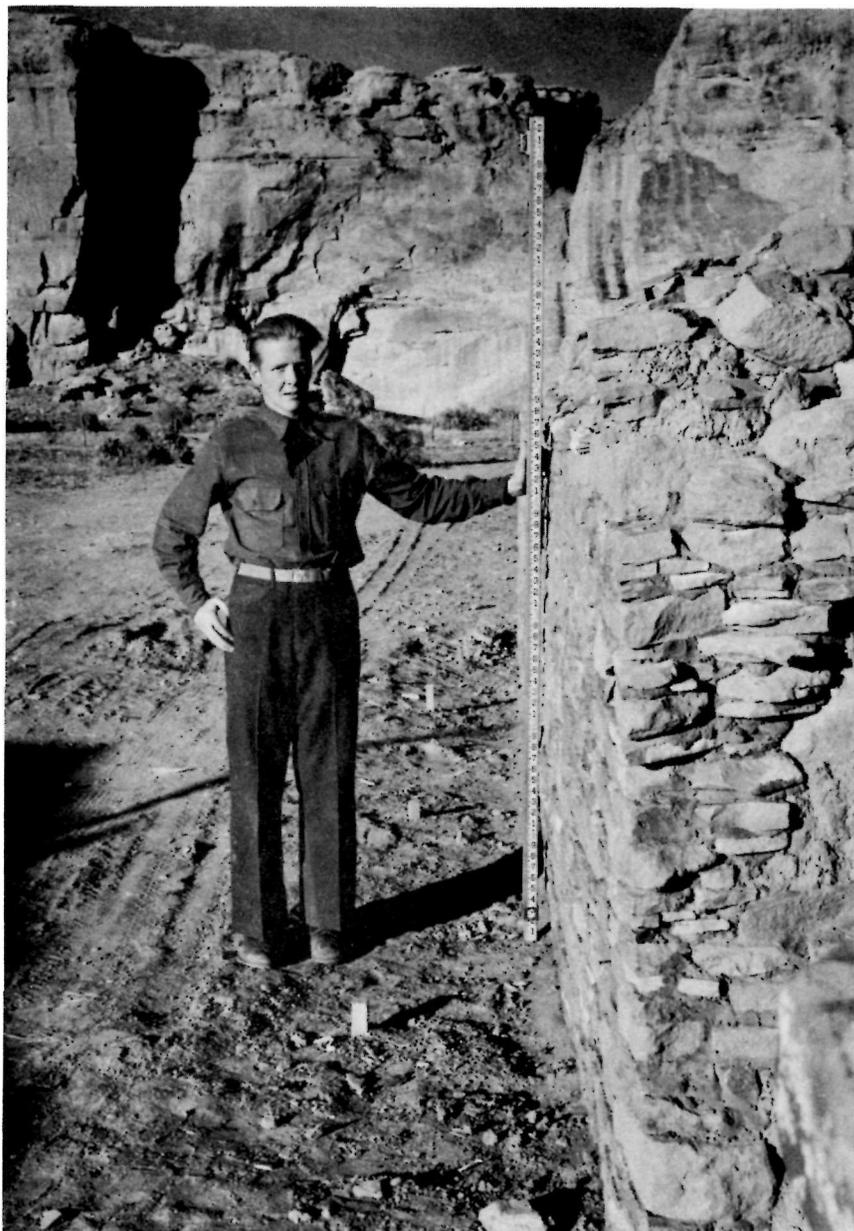
Fig. 33. The wall after pressure had been applied for three weeks by means of jacks in sleeves.

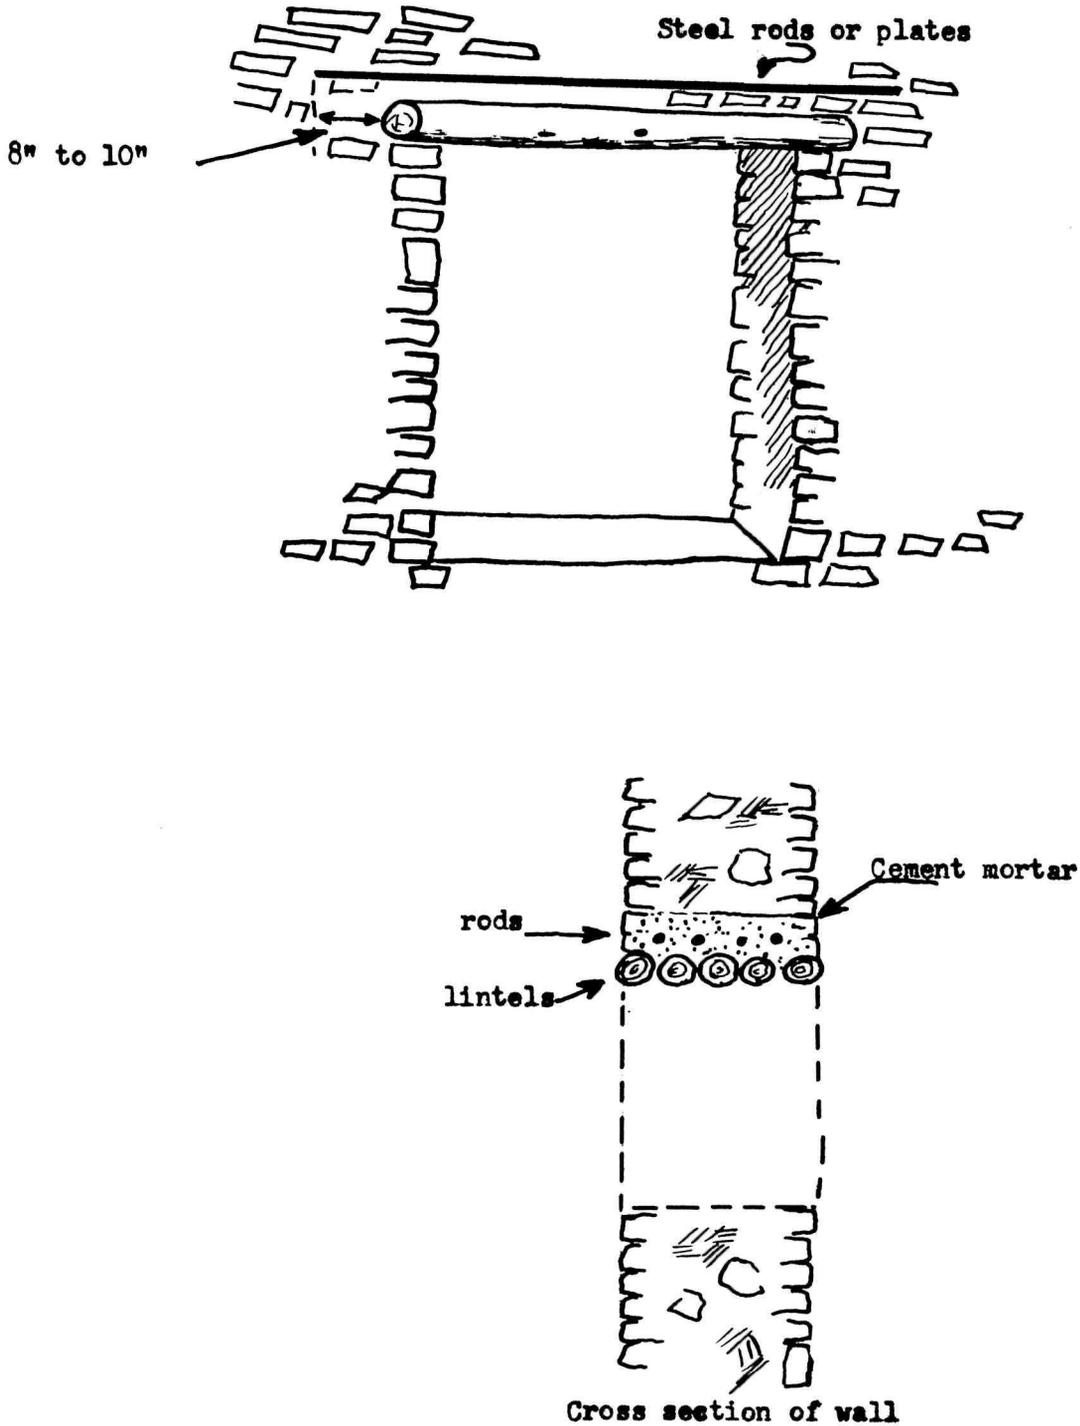
Fig. 34, placement of reinforcing in concrete mortar over pole lintels.

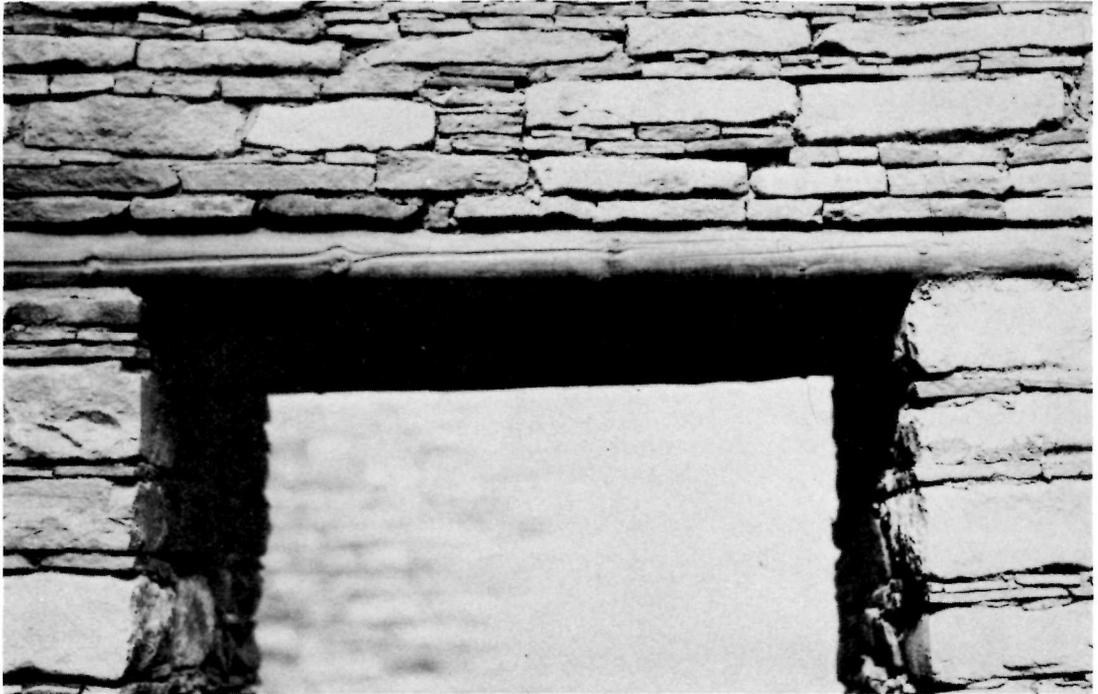
Fig. 35. Cast concrete lintels have the same appearance as the originals from which cast, are easy to install and are durable.

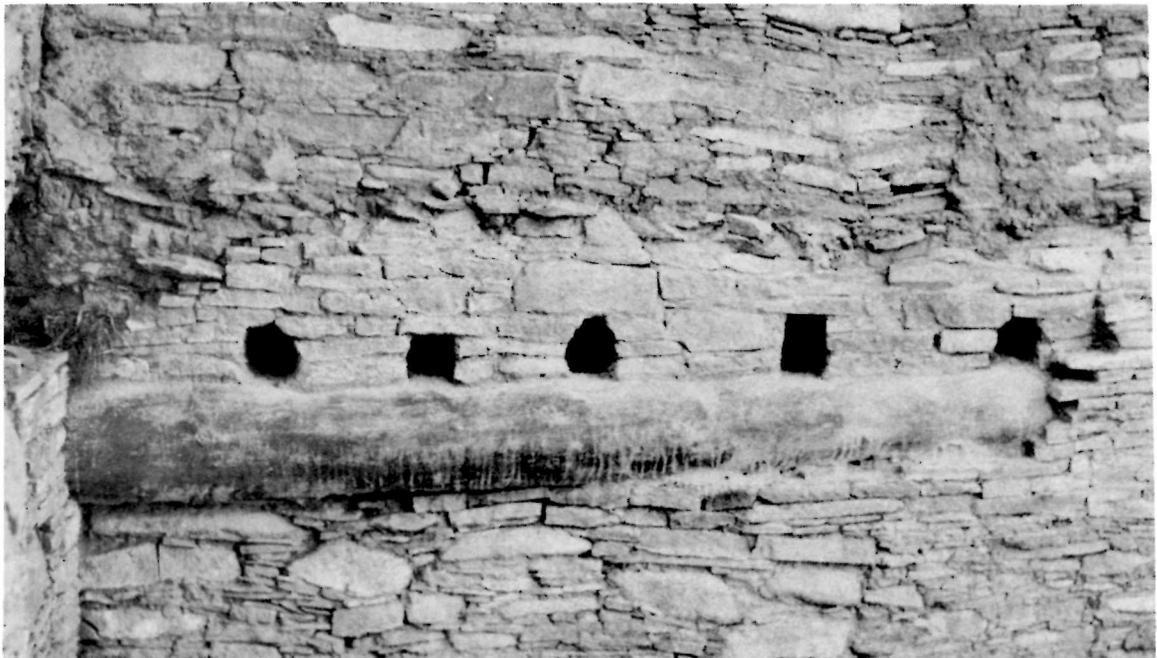
Fig. 36. A horizontal, cast log replaces the original timber which had rotted on the interior and in the embedded portions.

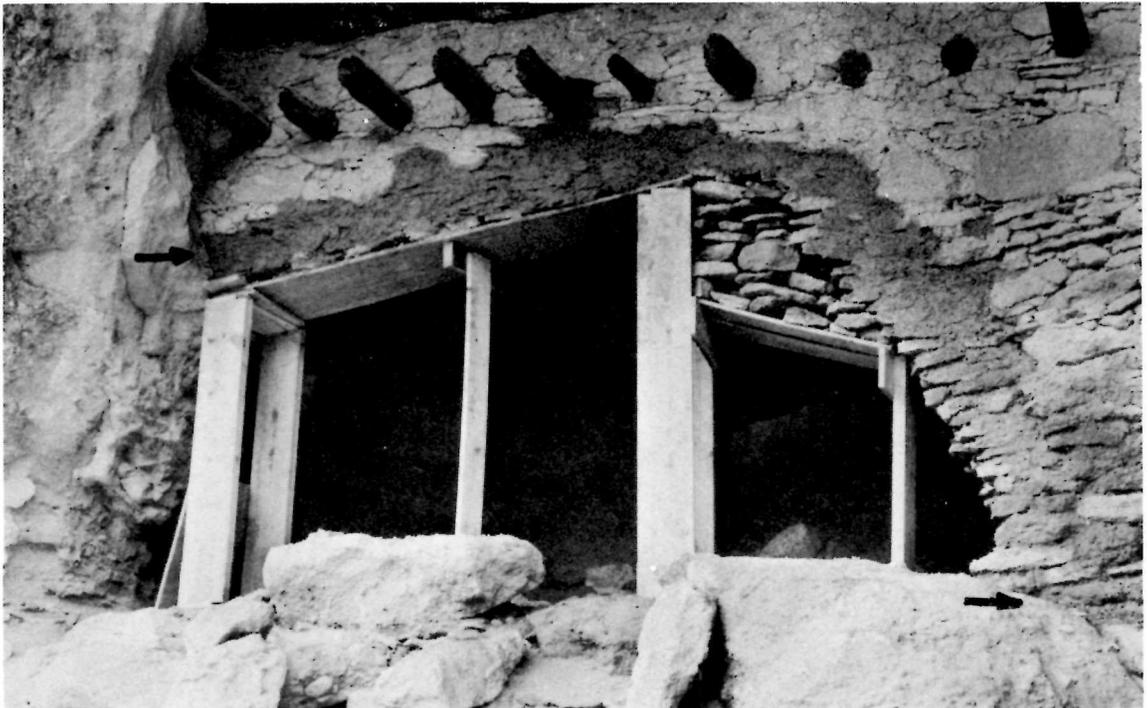
Fig. 38. Integral member, a large reinforced arch section. Here the size of the break through the wall precluded filling the center with dry masonry as support, and this timber framework was substituted. The heavily reinforced band is socketed in the cliff wall at the left side and based on bedrock at the right. The integral member has just been finished and the mortar has not yet dried. After the mortar has set the timber framework, the dry masonry at the right and that on top of the horizontal plank were taken down, leaving this large hole with its original outline, only slightly smaller and strengthened against collapse.

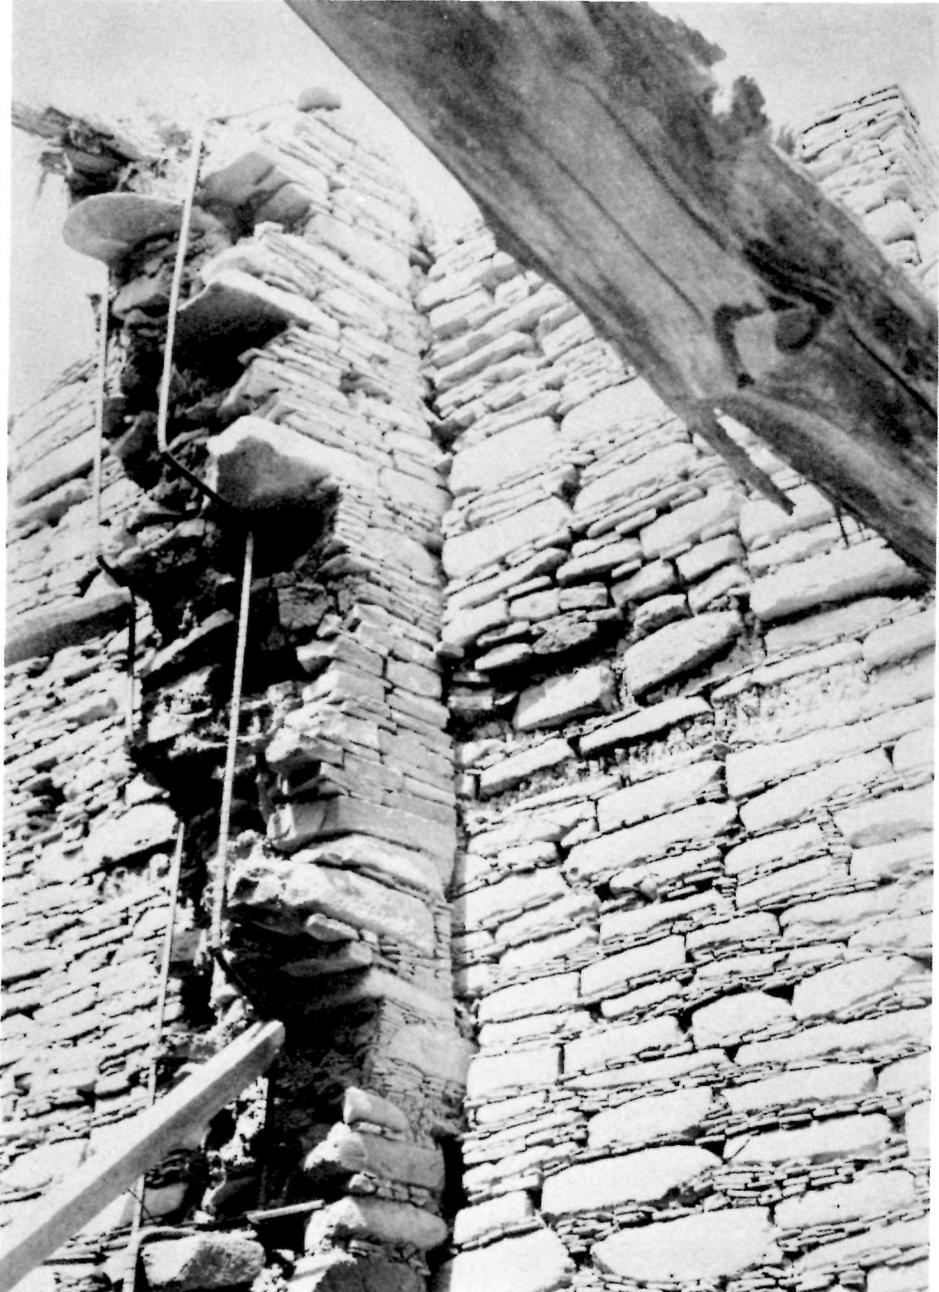
Fig. 39. Integral members. Steel in place for a narrow vertical section. The steel must be tied in securely to the cross wall at the top to provide support for the overhanging area. Some support will be required for the vertical strip of masonry as it is being laid and until the concrete mortar has set.

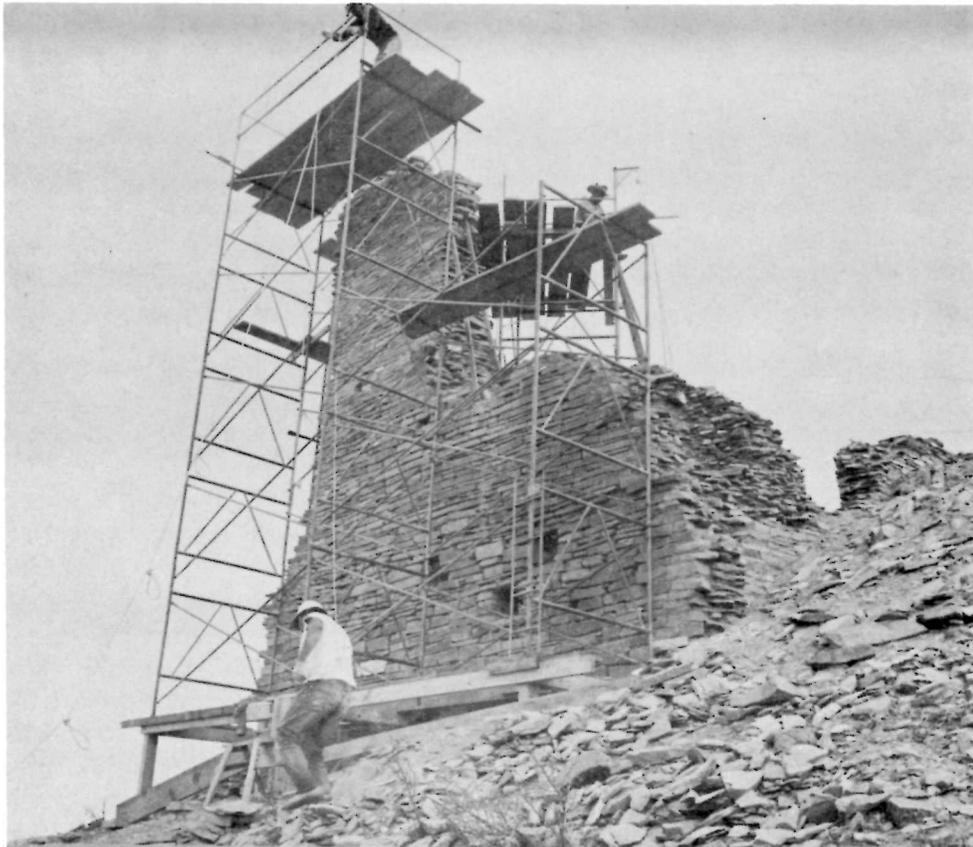
Fig. 40. Reinforced integral members are of particular value in the stabilization of tall spirelike structures such as this where considerable strength must be added without serious or objectionable alteration of the original profile. (See Fig. 41.)

Vertical and Horizontal Members. The principal application of these members is to tie together sections of separated and out-of-plumb walls, to reinforce walls against which there is pressure of retained fill, to re-lay overhanging and precarious sections, and to provide support over horizontal logs. (Figs. 39, 40, 41.)

Fig. 41. Detail. Placing reinforcing in the third story portion of the structure shown in Fig. 40. The purpose is to heavily reinforce the vertical capping which will be laid up the exposed ends of the wall to both prevent further erosion and to tie this part of the wall together. When this part was completed a short reinforced column tied into that below, was run up into the top, precarious fragment.

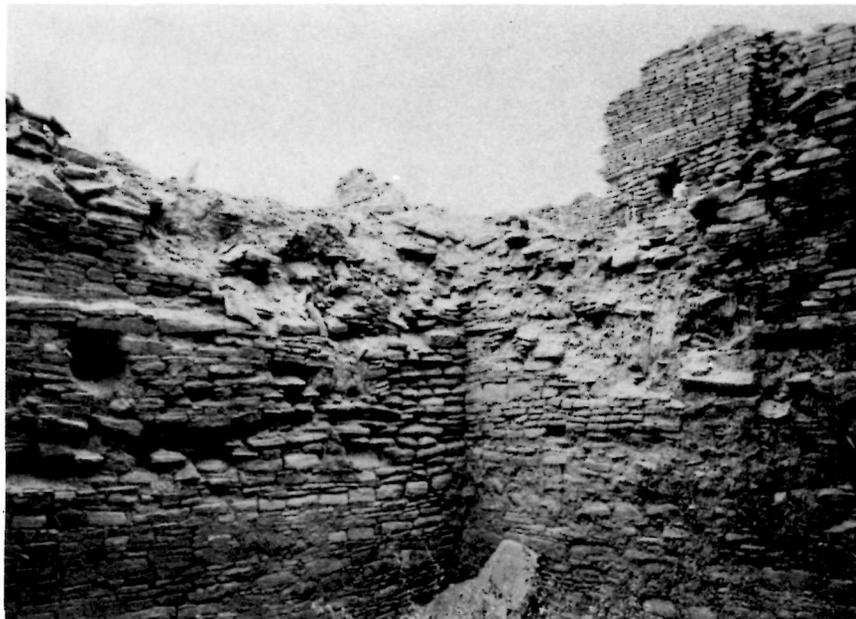
Fig. 42. In many instances it is difficult to draw a distinction between general wall repairs and capping. Here the wall will have to be carried up to the level of the outside fill to prevent further washing over the top. Whatever type of mortar is used for these wall repairs the top courses must be set in a cement mortar to provide as durable and waterproof a cap as possible.

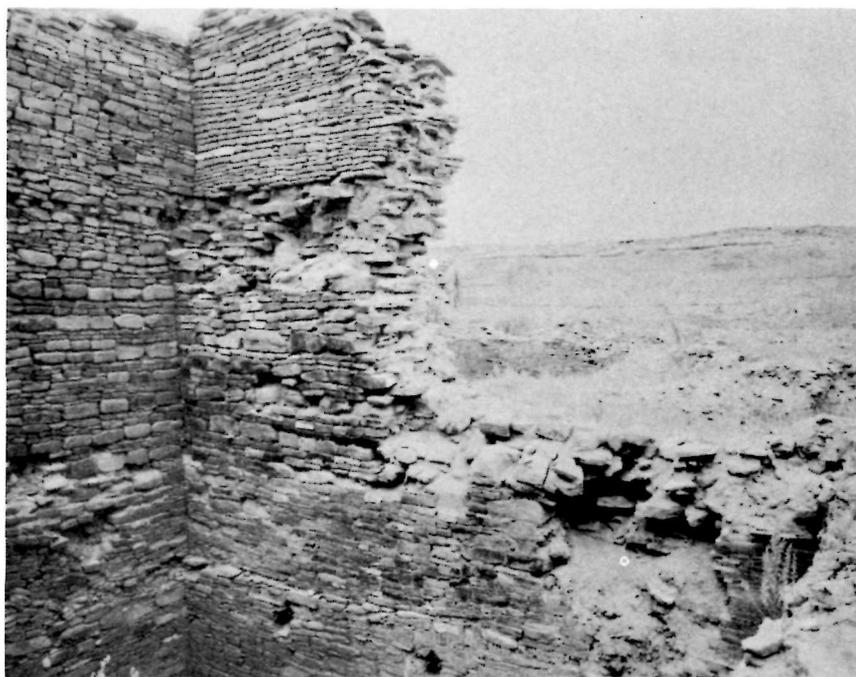
Fig. 43. Here patching of the hole will have to be combined with a short section of horizontal capping plus vertical capping or protection for the exposed and weathered vertical rise of wall.

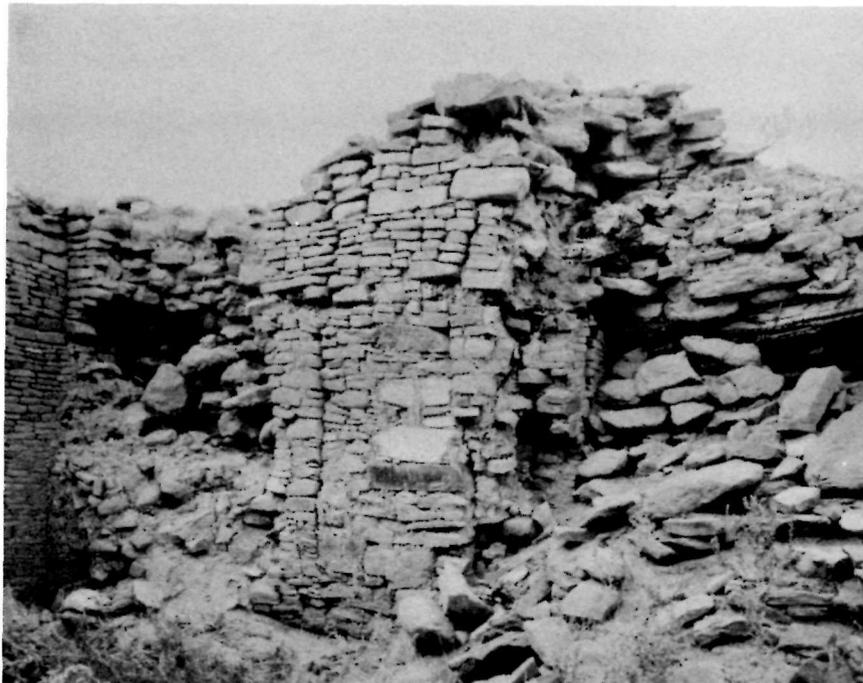
Fig. 44. In a badly deteriorated wall, such as this example, a good deal of repair masonry must be laid to fill the wall breaks and support undercut areas. Some support must also be provided for the embedded timbers. In the major part of this work it is permissible to use soil or masonry cement mortars, preferably the latter. The upper courses must, however, be laid in concrete mortar as capping to halt further washing from the top. In this example, damage was started by surface water from adjacent, unexcavated fill and every effort should be made to divert such surface water.

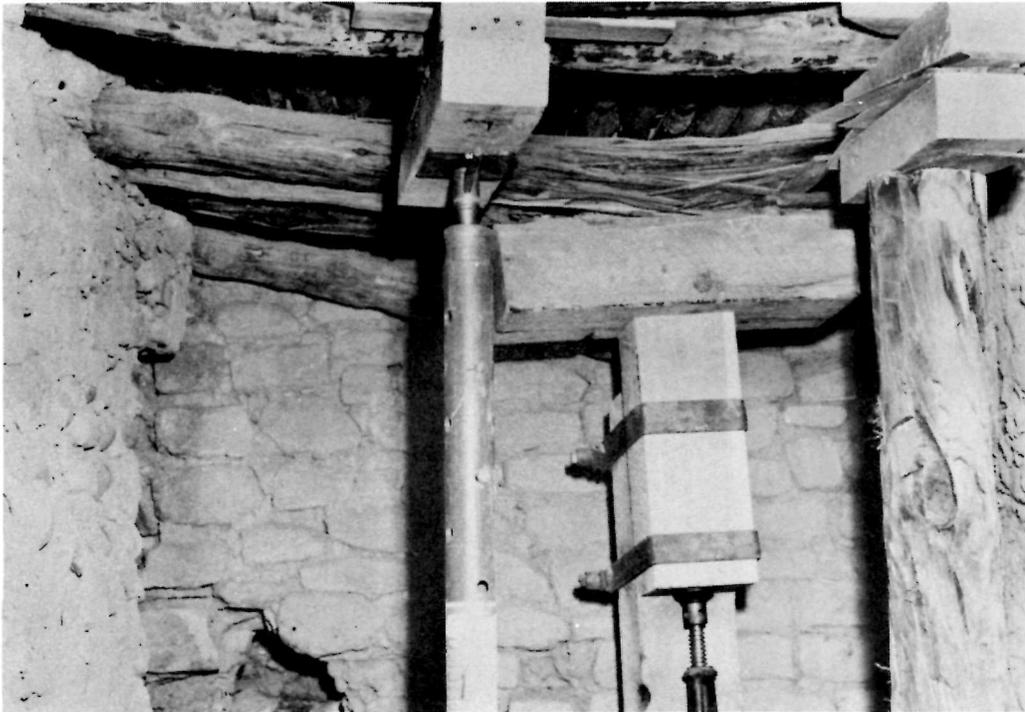
Fig. 45. Roofing, Aztec. Temporary support by means of jacks and timber props for the numerous cracked and broken beams in this ceiling. There was approximately 6' of overburden on this ceiling and the temporary supports were in place for several years before the overburden could be removed and a protective roofing constructed.

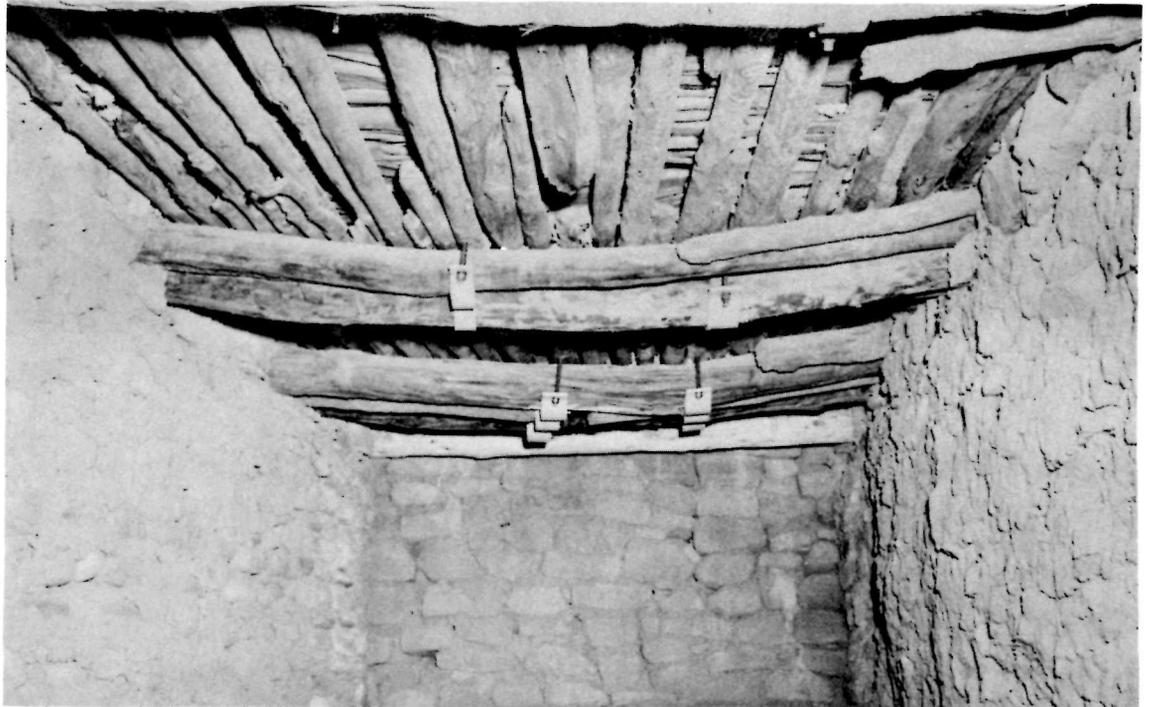
Fig. 46. Roofing, Aztec. The ceiling shown in Fig. 45 after removal of the overburden and construction of a slab roof which both protected the ceiling and permitted the support of broken beams. The bolts are fastened in the slab above and were taken up enough to transfer most of the weight from the old ceiling beams to the new roof.

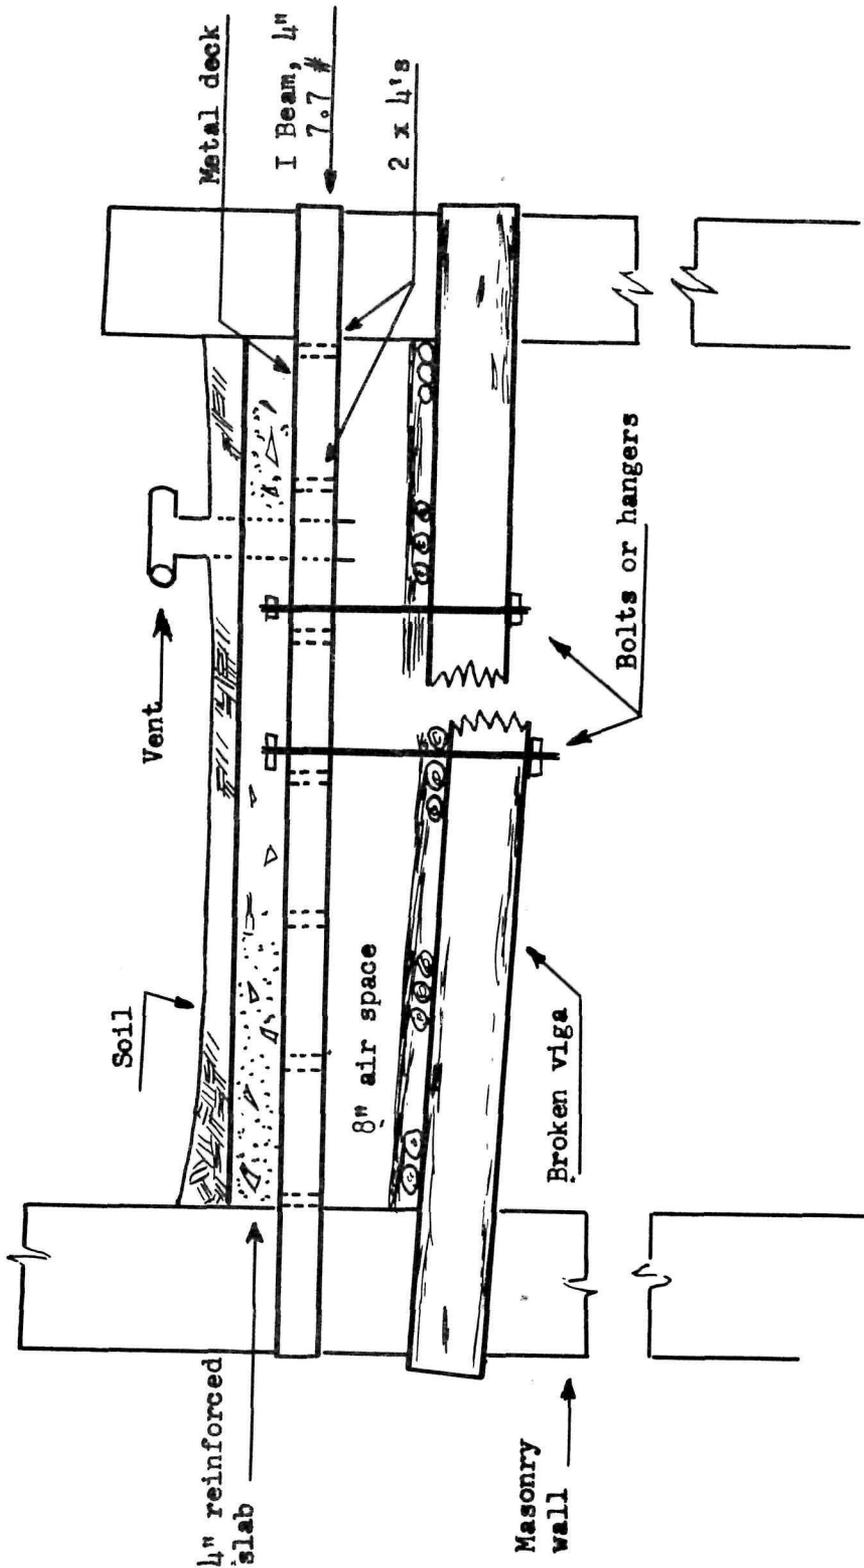
TYPICAL ROOF COVERING AND SUPPORT, AZTEC RUINS

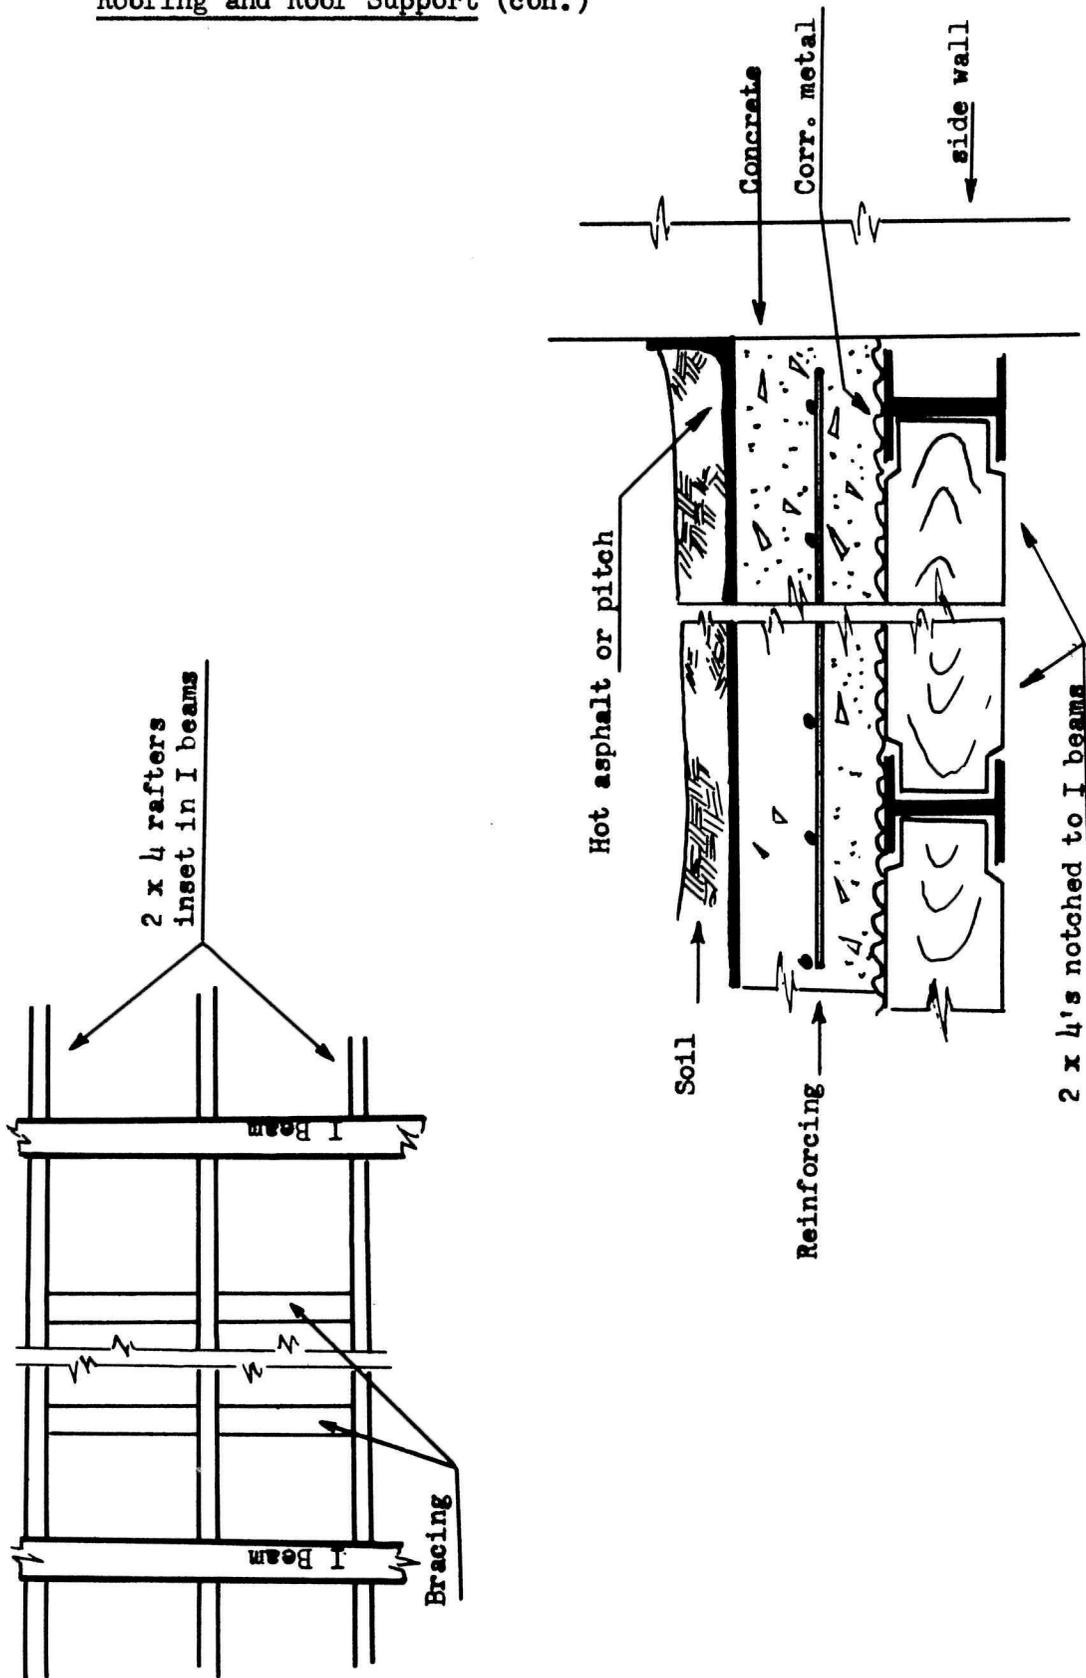
FIG. 48. DETAILS OF ROOF

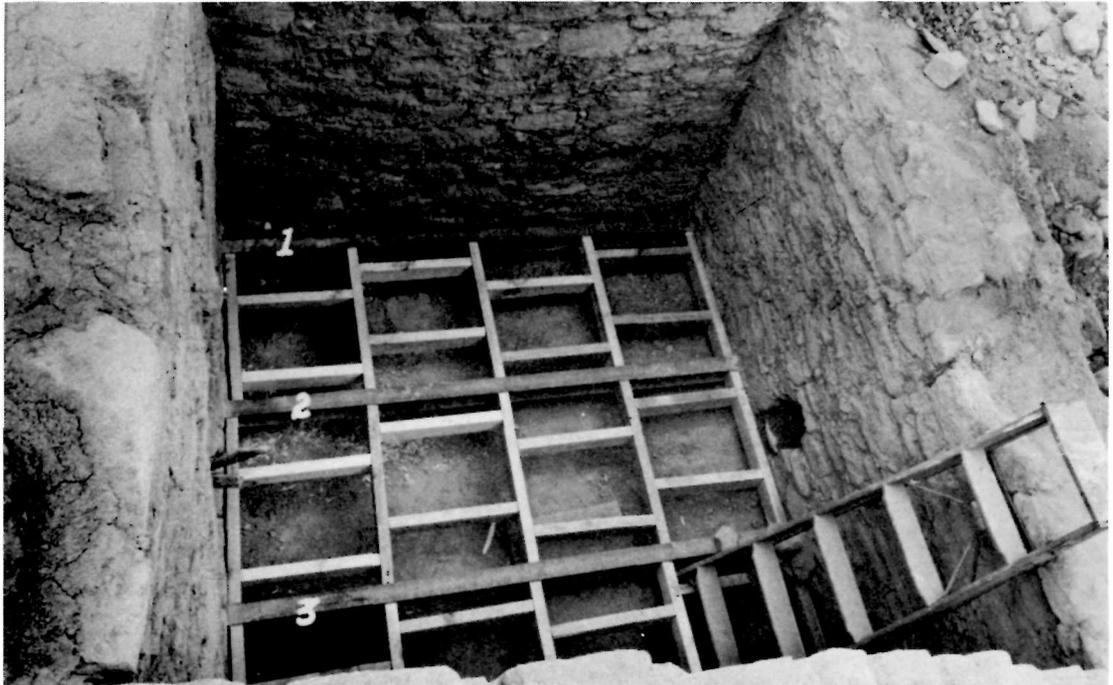
Fig. 49. During construction of a slab covering. The numbered members are I beams run through the heavy masonry walls. The longitudinal members are 2 x 4's inset in the I beams as purlins. Corrugated metal decking will be nailed to the wood as a base for a concrete slab. A covered vent will be provided through the concrete; drainage will be by tile line through the wall at the right.

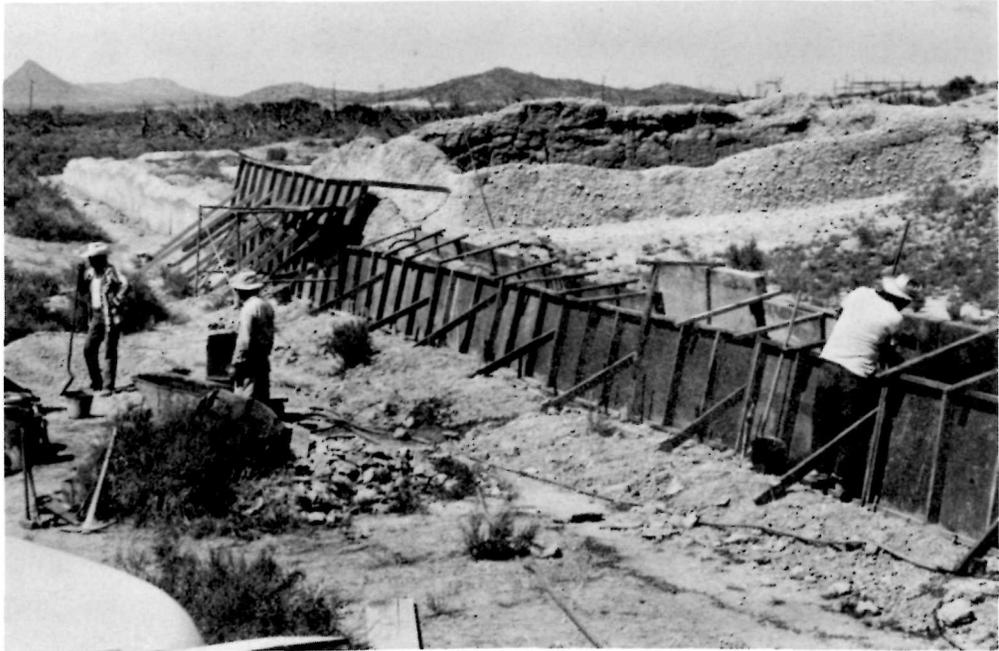
Fig. 50. Soil-cement made with caliche. Forms in place, braced and tied at the top. Upper left, the completed wall with forms removed. The form is not always filled to the top, only enough material is placed to cover the wall to a pre-determined depth.

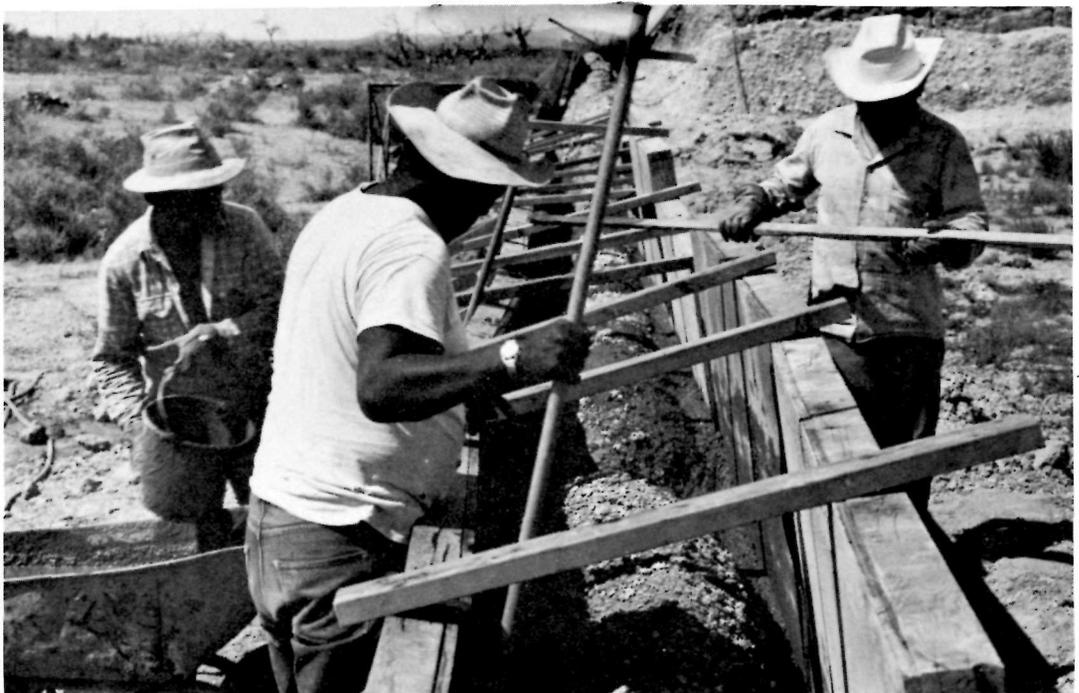
Fig. 51. The start of placing caliche-cement mix. Note that the forms follow the irregular line of the wall.

The prehistoric wall was dampened and the mix placed between it and the form (Fig. 51), well-tamped in place to fill undercut spots. It was placed to a depth to sufficiently cover the rise of the wall face and then sloped to conform to the irregular, sloping surface of the wall top. After curing, the forms were removed and when completely dry the entire surface was treated with silicone water repellent (Fig. 52). This use of heavier, self-supporting coverings of native materials parallels the already proven use of heavy sections of soil-cement in the repair of pit houses and for making facings in cuts in soft fill. (Figs. 9 and 10.)

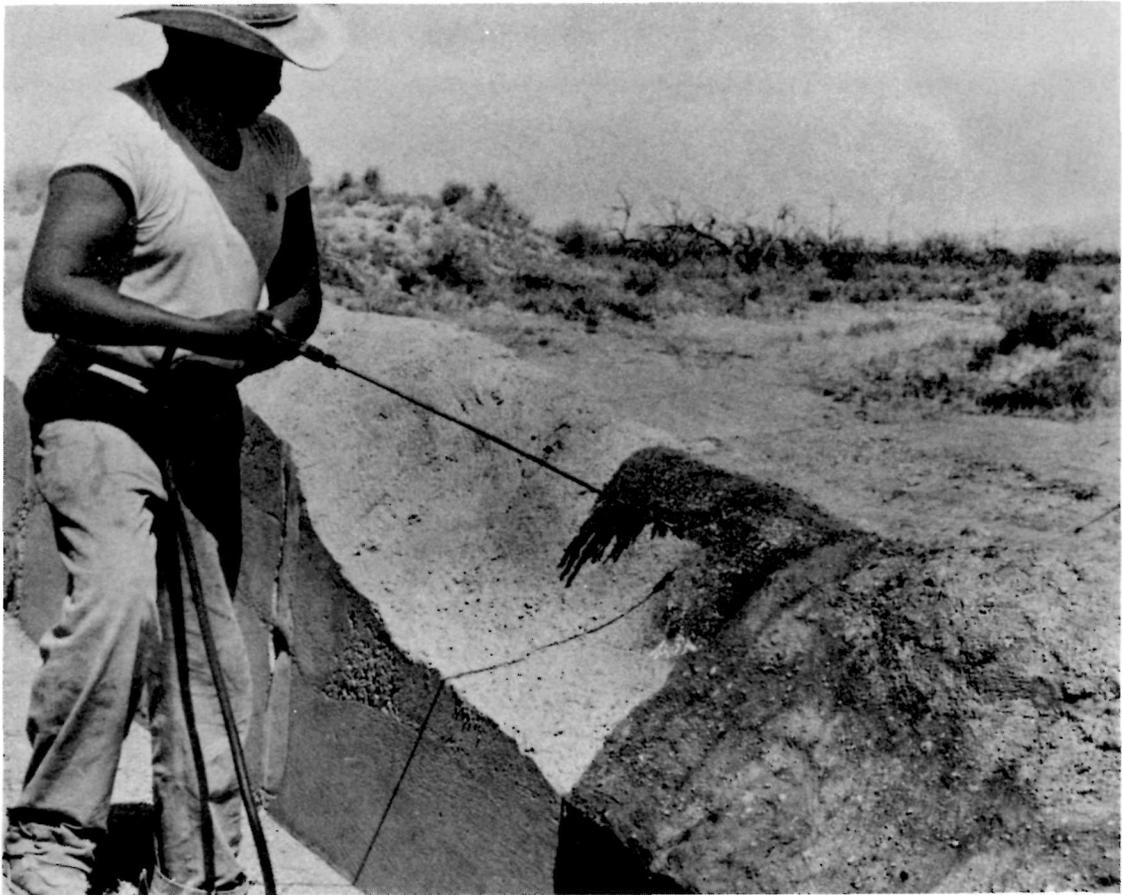
Fig. 52. John Wero applying a silicone water repellent. It is applied in a coarse stream, sufficient to produce a rundown of 6 to 8".

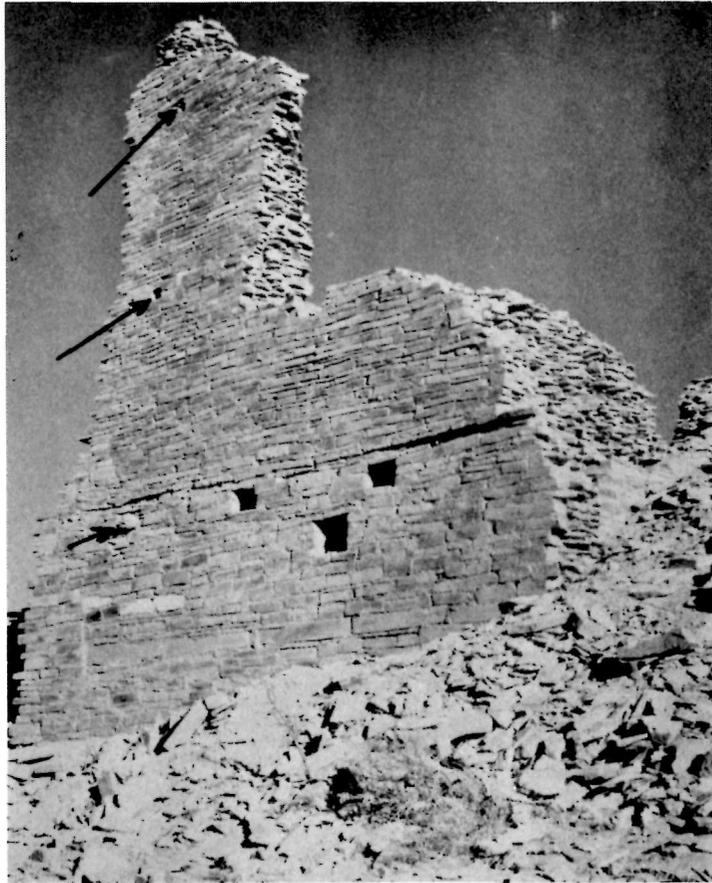
Hole at base, square openings (the two upper held beams, the lower was a ventilator) and insets repaired and wall stubs capped. Beam stub at left and two beam holes in line above (arrows) either represent reinforcing ties for kiva corner or supports for some sort of prehistoric scaffolding used in construction or a balcony.

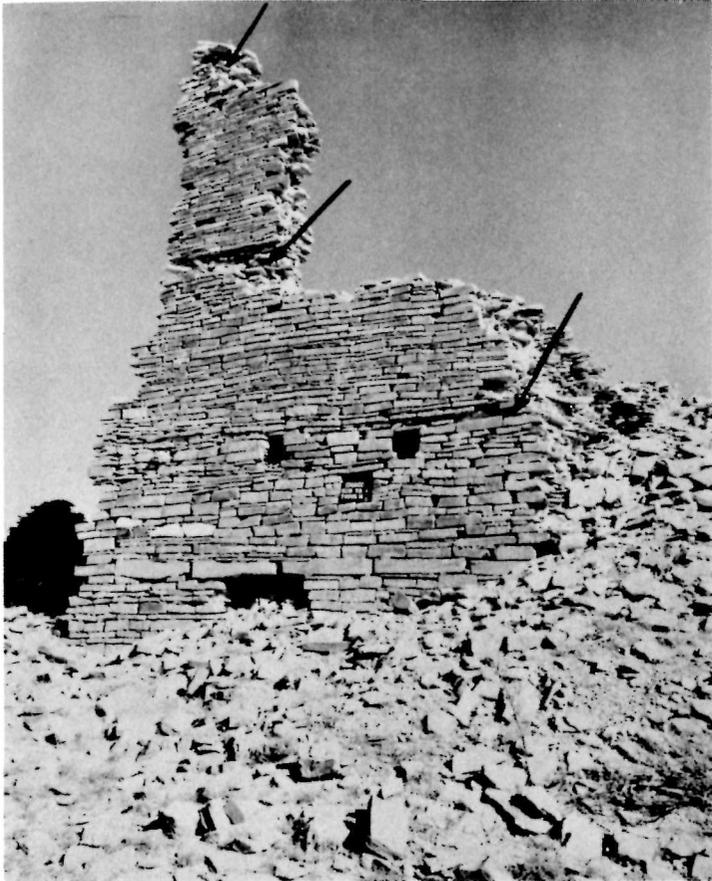
Tower Kiva, north wall exterior. Note large hole at base, and eroded insets (arrows) where second, third and fourth stories were slightly stepped back.

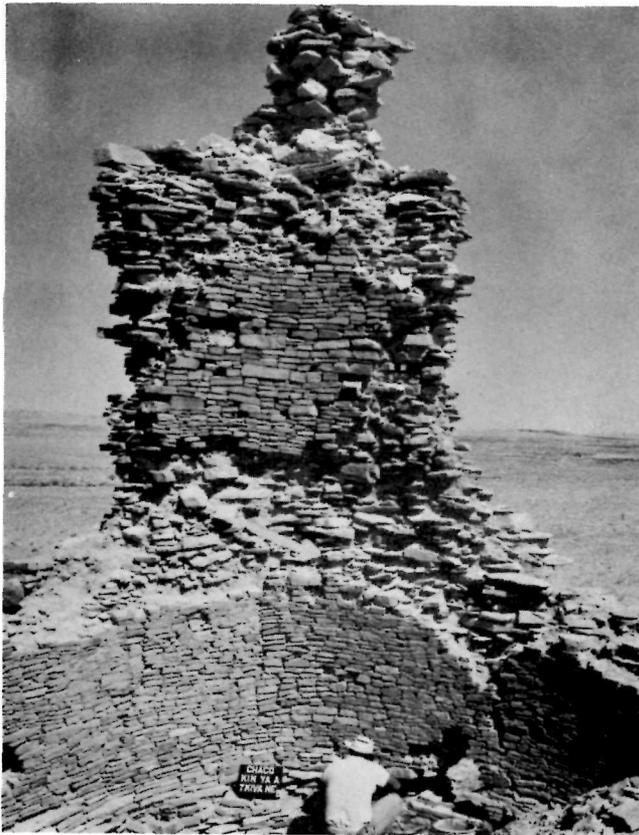
General view of northeast interior of Tower Kiva at start of project. The circular wall is stepped back or inset at two points (1) at narrow ledge or bench where Mr. John Wero is beginning repairs, and (2) where facing is gone, exposing core (arrow).
