NATIONAL PARK SERVICE

PREHISTORIC RUINS STABILIZATION HANDBOOK
Part 2 - Field Methods

RELEASE NO. 1
May 3, 1962

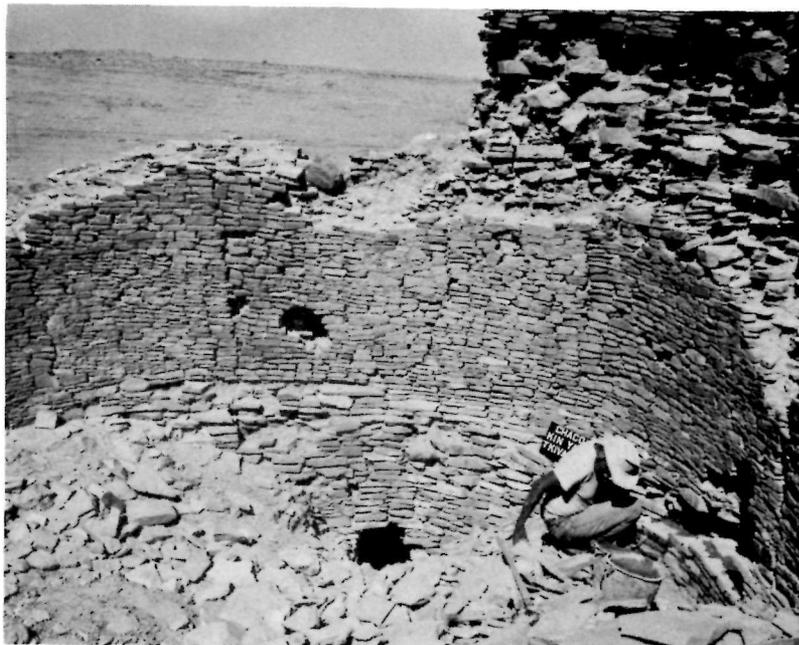
General view of northeast interior of Tower Kiva at start of project. The circular wall is stepped back or inset at two points (1) at narrow ledge or bench where Mr. John Wero is beginning repairs, and (2) where facing is gone, exposing core (arrow).

Another view (below) shows general condition of lower part of interior.

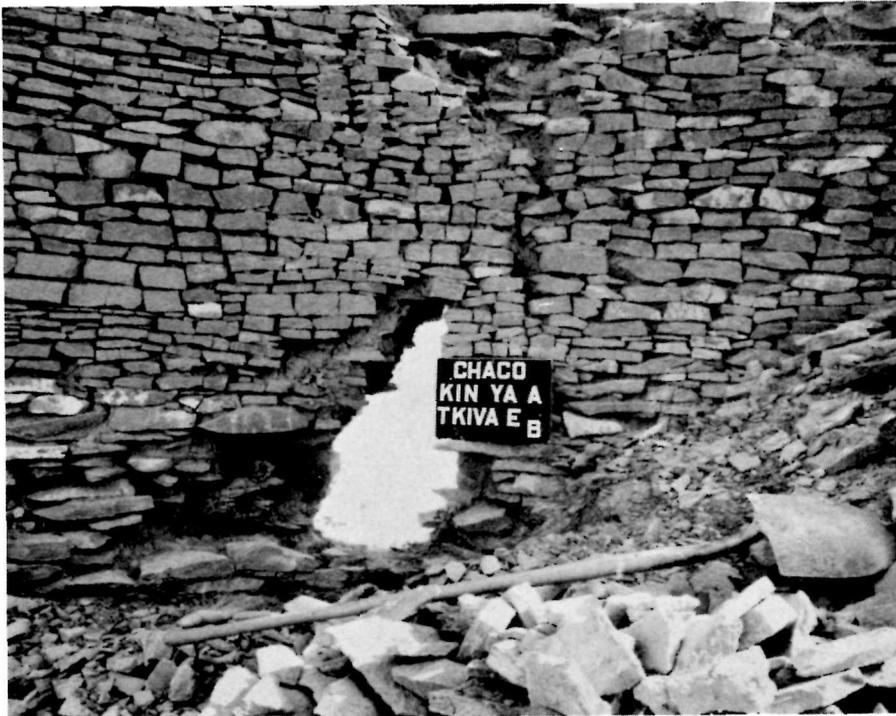
Detail of hole in Tower Kiva, east wall interior, caused by breakdown of savino sockets, the beams for which extended part way into this wall from the opposite side and originally supported the ceiling of the adjacent room.

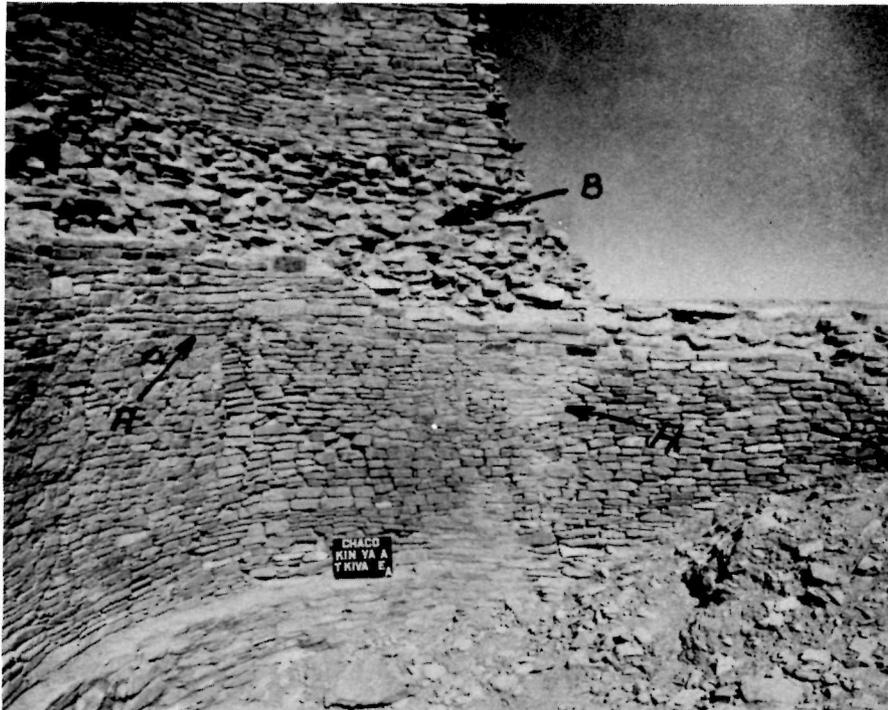
Lower portion of Tower Kiva, north and east segments, after stabilization. Offset ledges repaired, holes filled with repair masonry, facing reset (arrow A), top capped and inset core (arrow B) grouted. Compare with photos on two preceding pages.

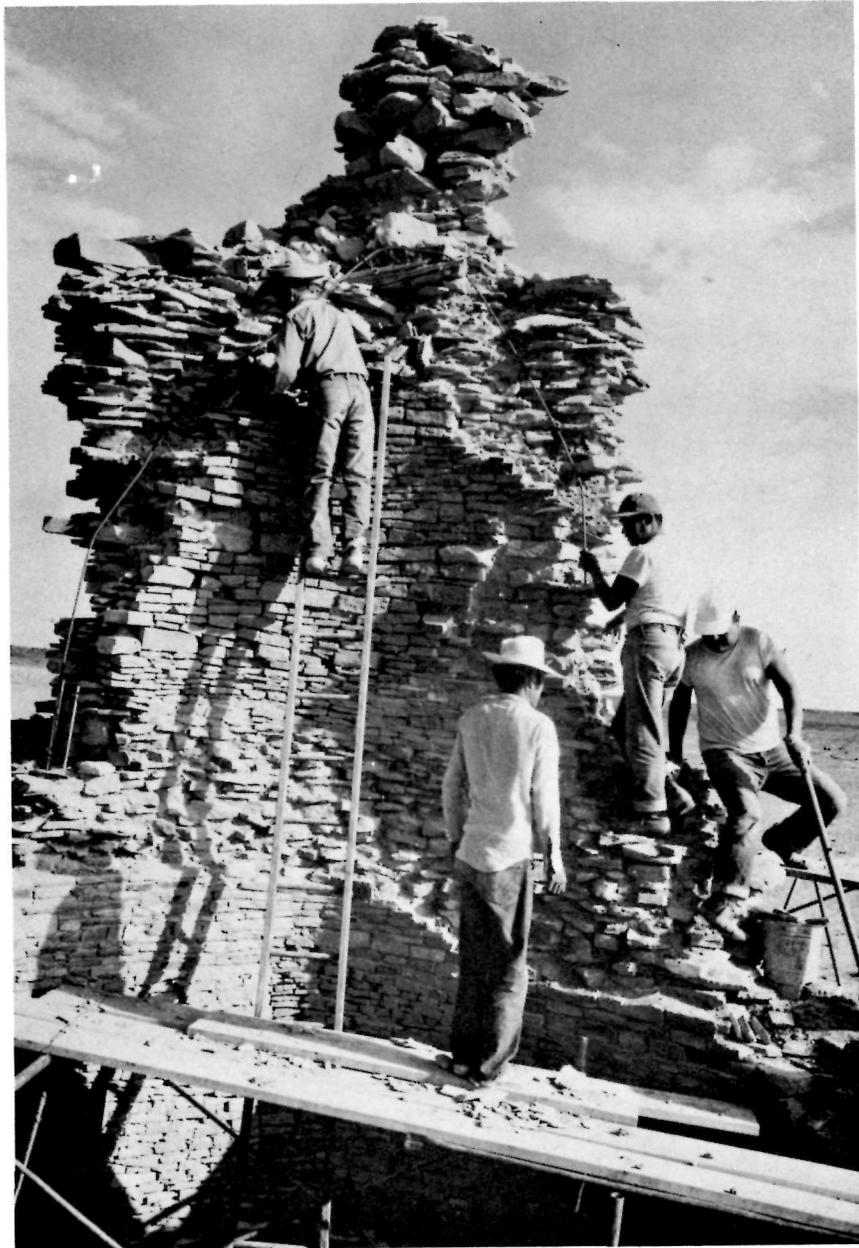
Tower Kiva, interior northeast corner, during installation of integral members to strengthen the highest wall section.

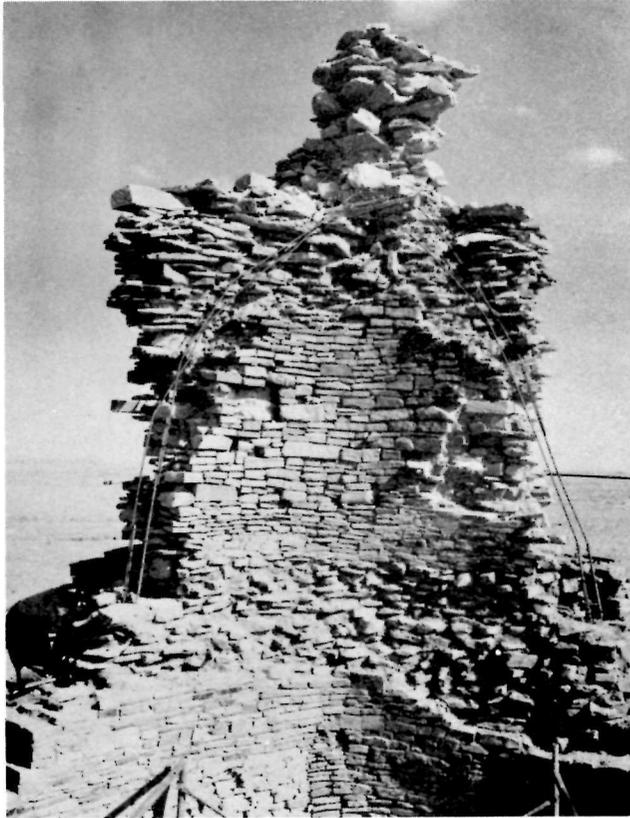
Upper portion of Tower Kiva,
northeast corner interior,
after the integral members
were anchored in masonry.

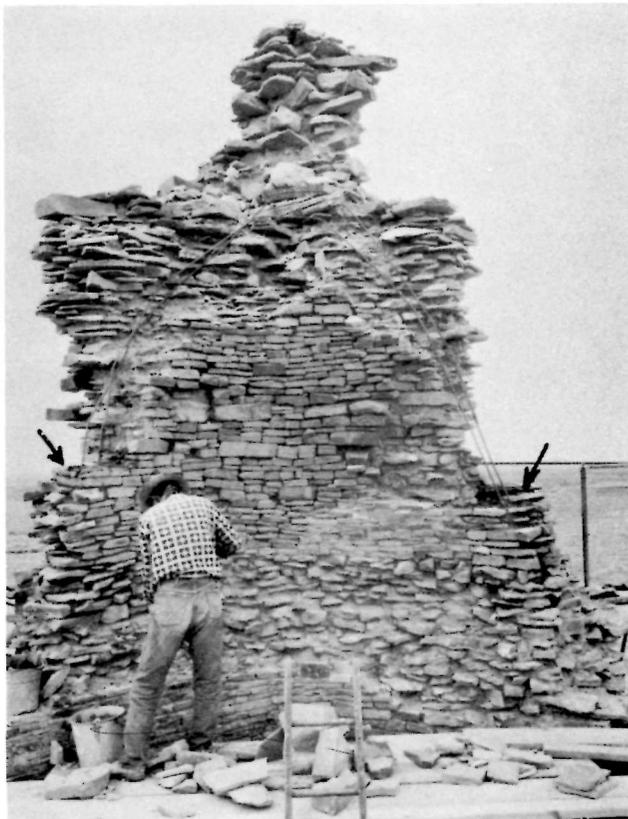
Beginning the vertical,
reinforced capping (arrows).

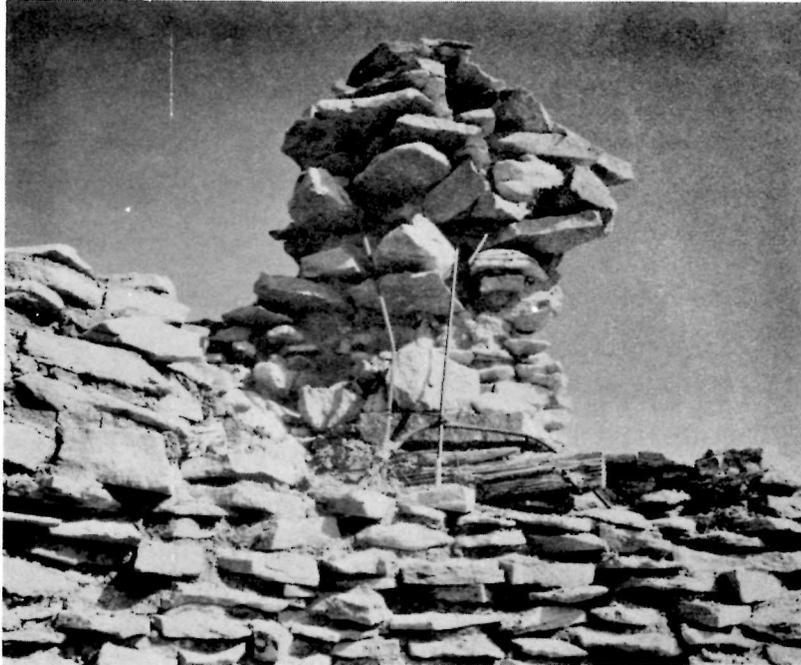
Integral members in the form of a T were installed in this top fragment of core masonry after the lower wall section had been strengthened to that point.

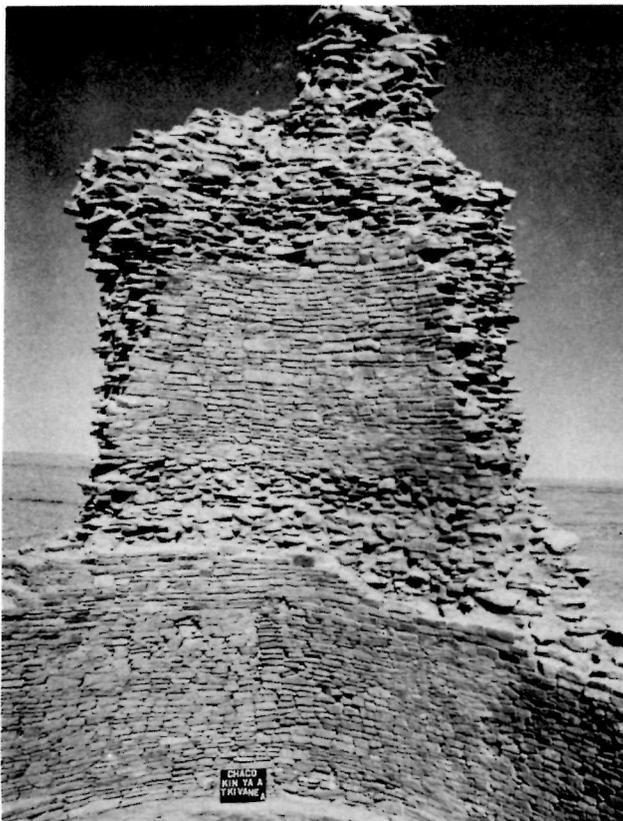
This completion picture shows a considerably strengthened and tightened wall, without serious or objectionable alteration of original profile. (Compare with preceding photos.)

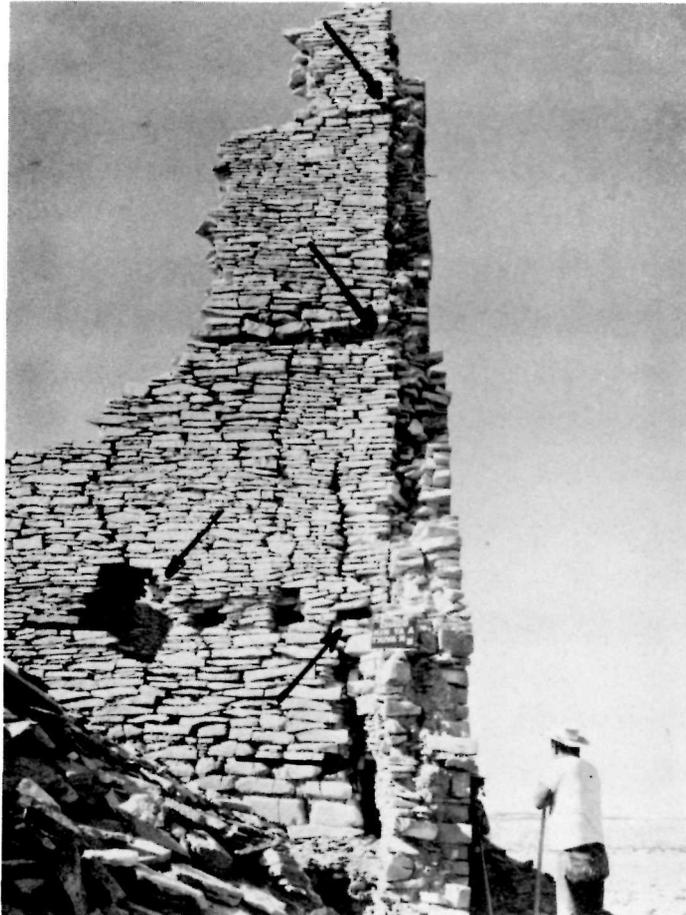
Tower Kiva, east wall exterior at juncture with north wall stub (at sign). Note the vertical cracks, eroded savino sockets (arrows) and loose, fragile spire. Portions of 4 stories are visible.

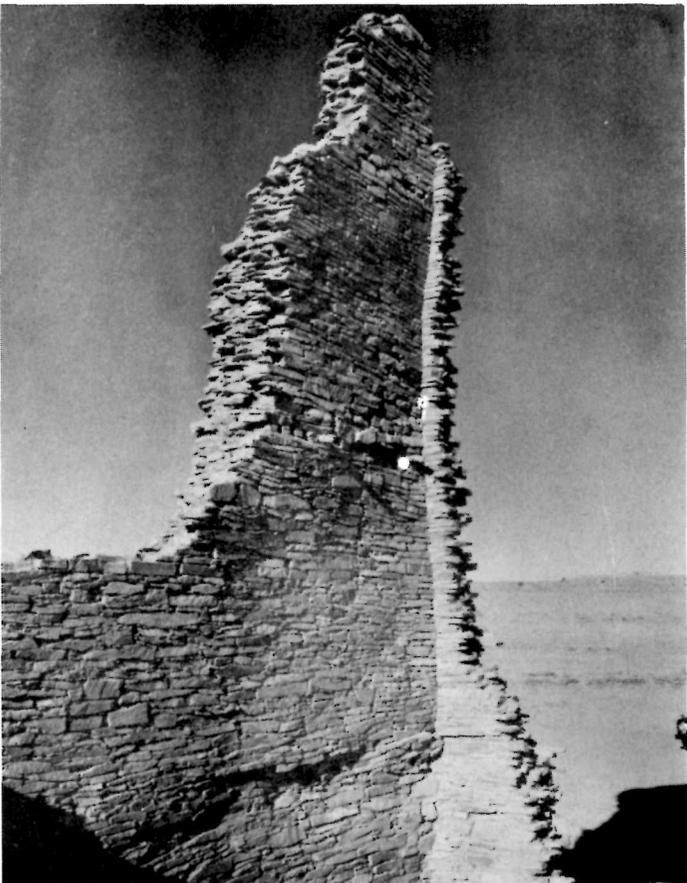
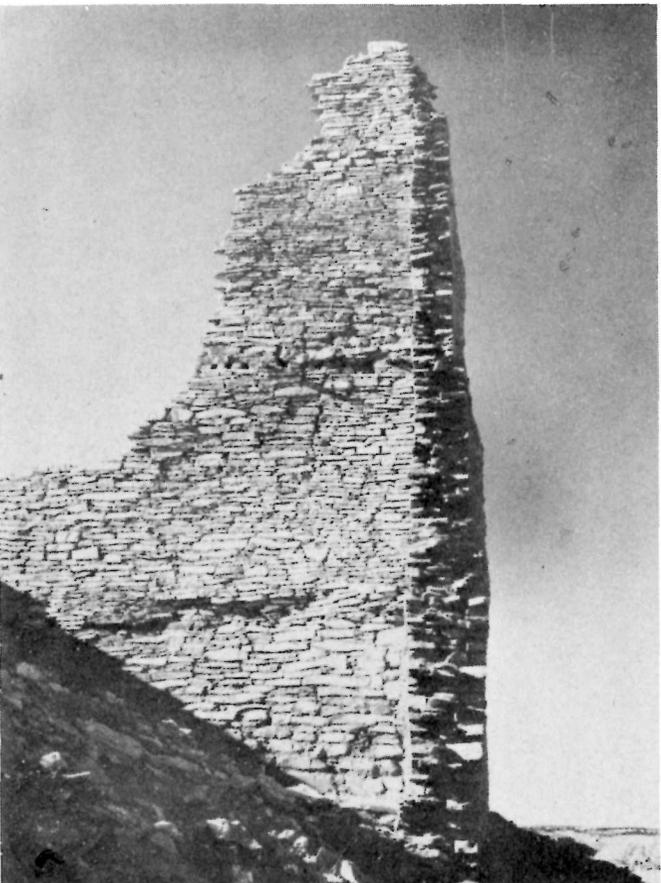
Two views of wall shown on preceding page showing vertical cap (left, north wall stub buttressed (right), vertical cracks repaired, savino sockets re-molded, and the facing grouted.

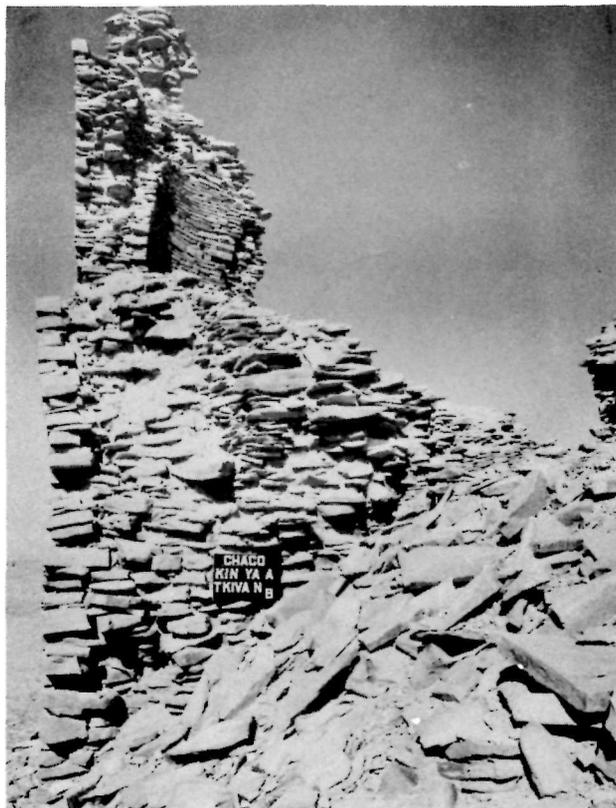
Tower Kiva, northwest corner.

The Tower Kiva, west wall. Both northwest and southwest kiva corners were cleared of surface debris, and capped. The northwest outside corner was excavated until good foundation was encountered, and then the exterior facing was reset to a depth of 18-20 courses at the north end, and to a depth of 4-5 courses at the south end. The exposed core and veneer around the U-shaped opening in the central section was reset. (See pages 18 and 19.)

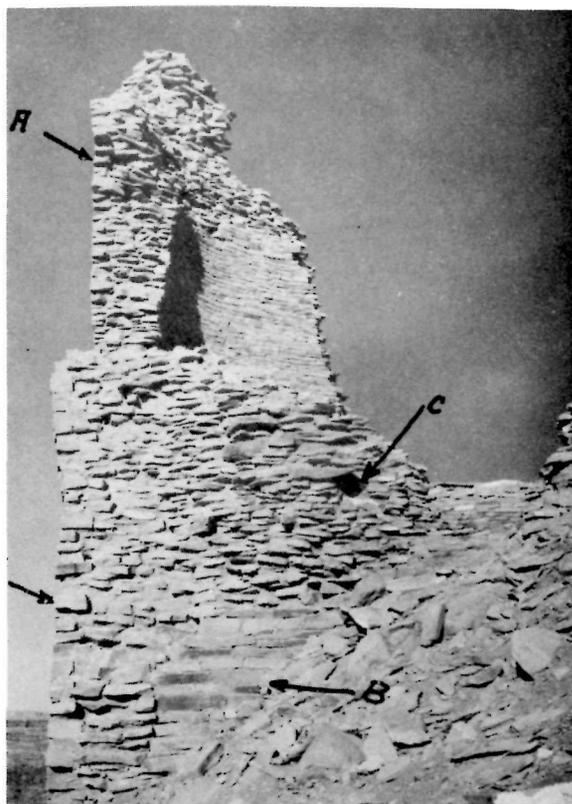
North wall stub capped (arrows A), lower portion of west wall facing reset (B), and exposed portion of thick core grouted (C).

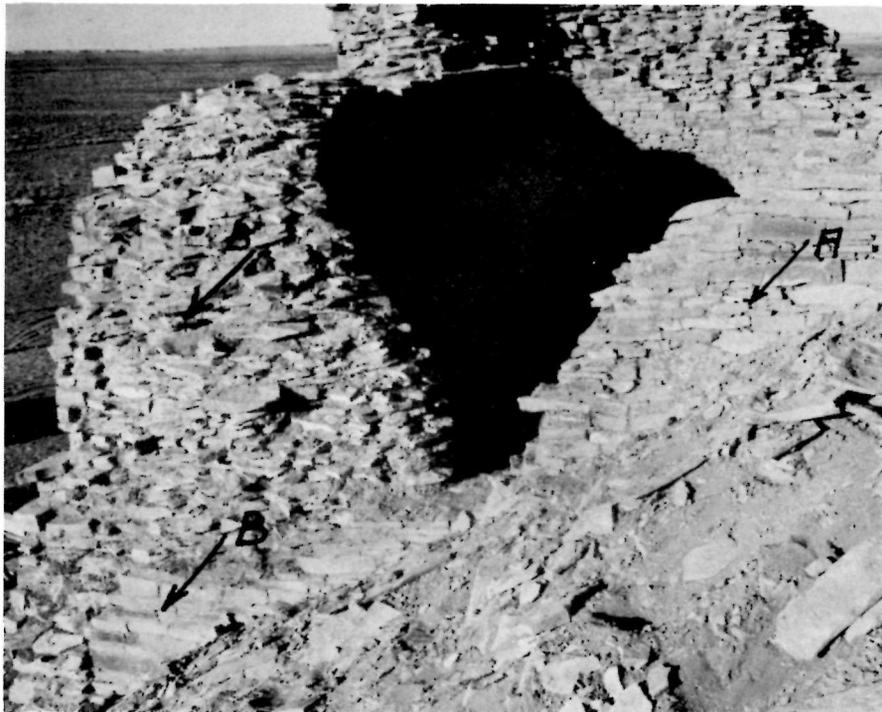
Tower Kiva, west wall. This fragmentary wall section of the square tower enclosing a round one was repaired by resetting the facing (arrows A), capping and grouting the thick core (B).

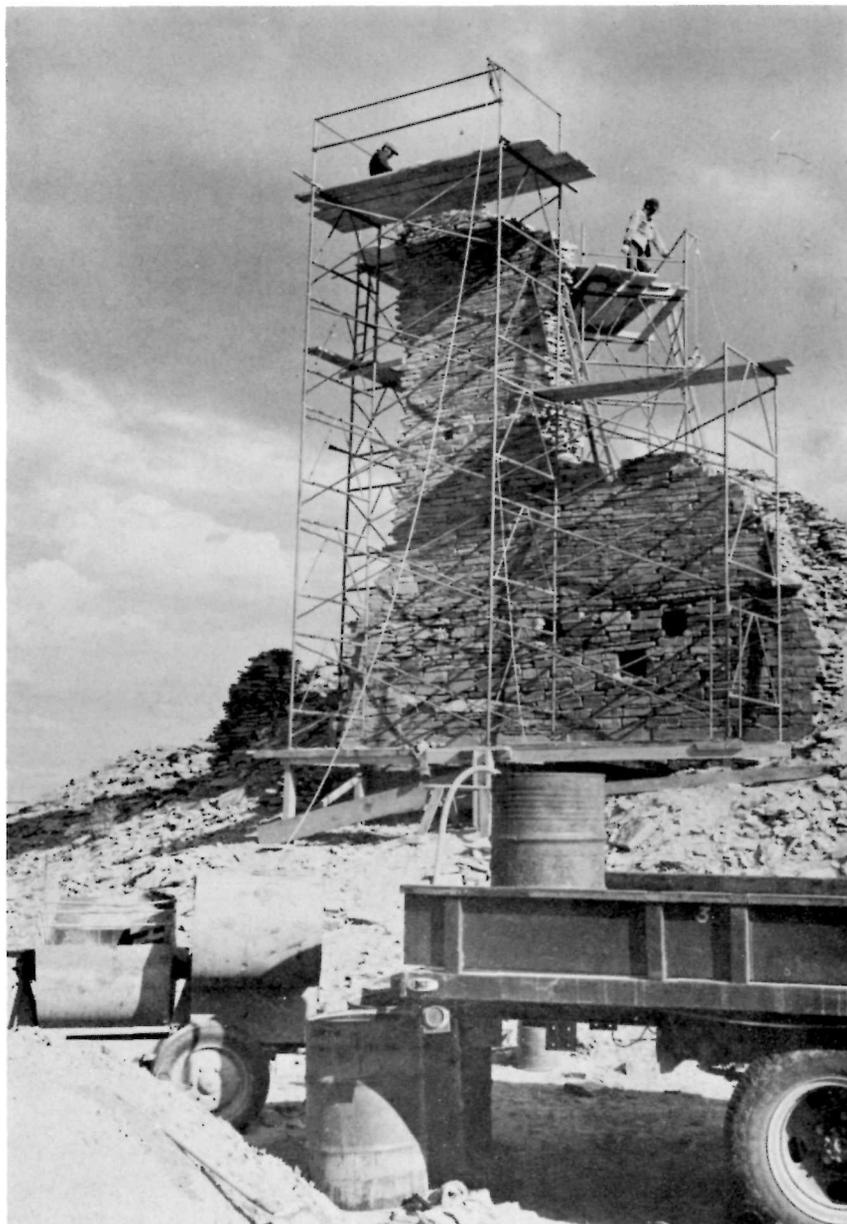
During work on the highest portion of the tower, scaffolding completely surrounded the structure. To provide maximum safety for the workmen, the three sets of scaffolding were anchored at the bases as well as across the top and through midsections, since frequent high winds increased the hazards.

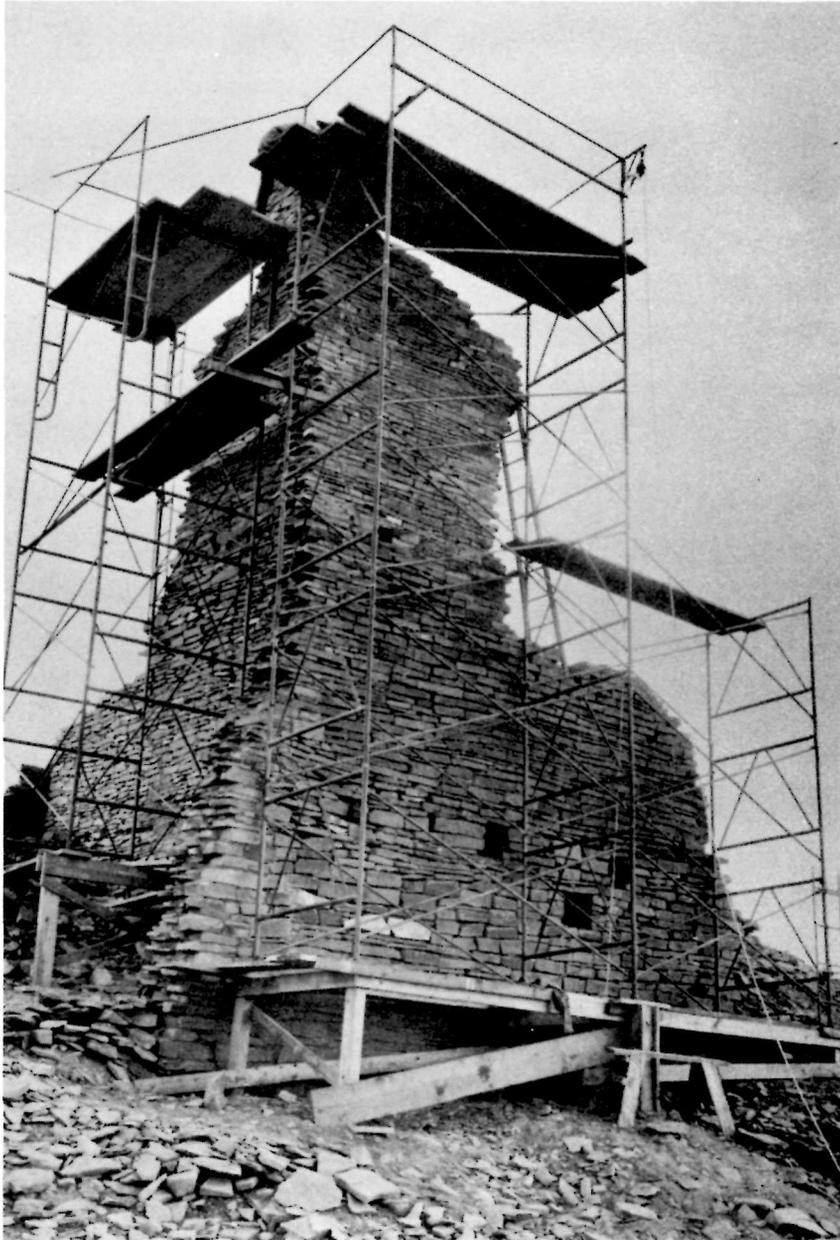
Because of the steep slope, scaffolding was anchored on firm and level bases built of heavy timbers.

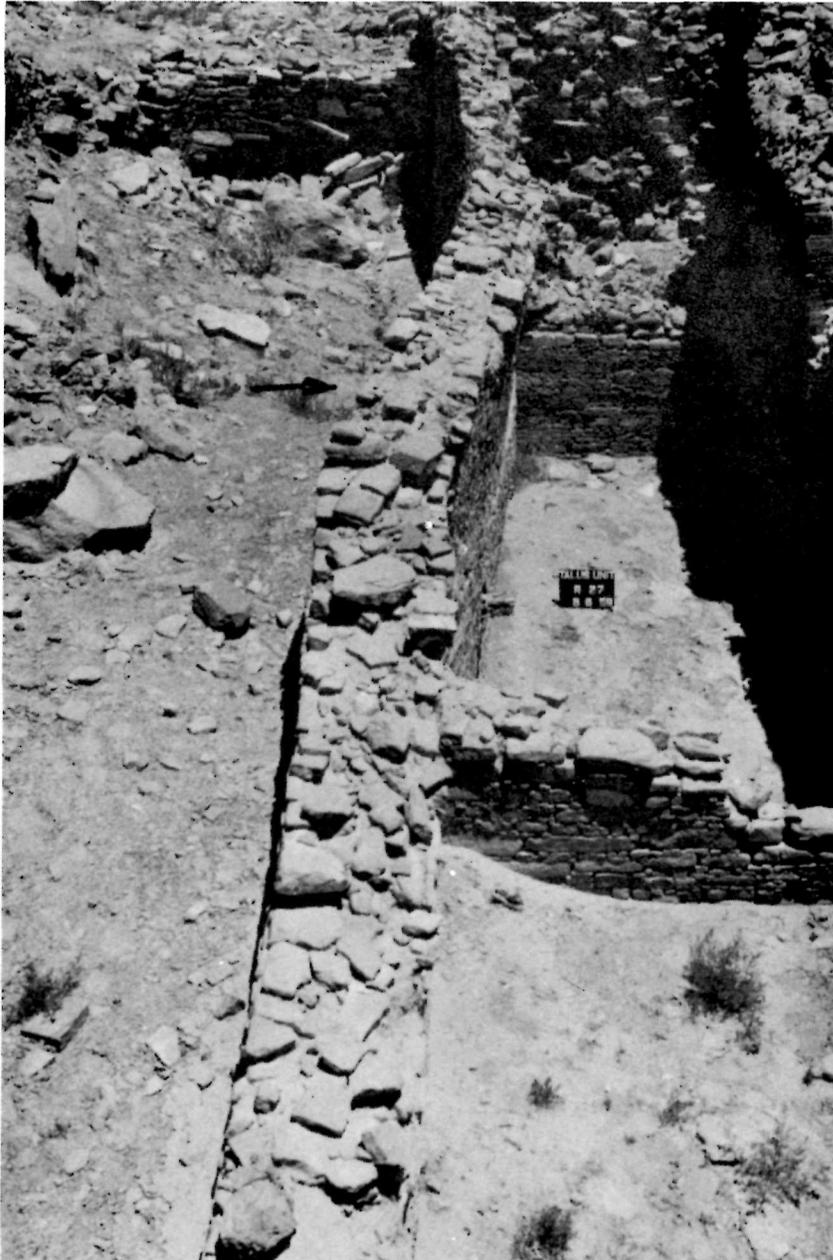
The wall between Rooms 27 and 28 was distorted and pushed out of line by pressure of fill, often damp, at the left. Arrow shows direction of force. The purpose of the stabilization, shown on the next page, was to strengthen the wall against the pressure.

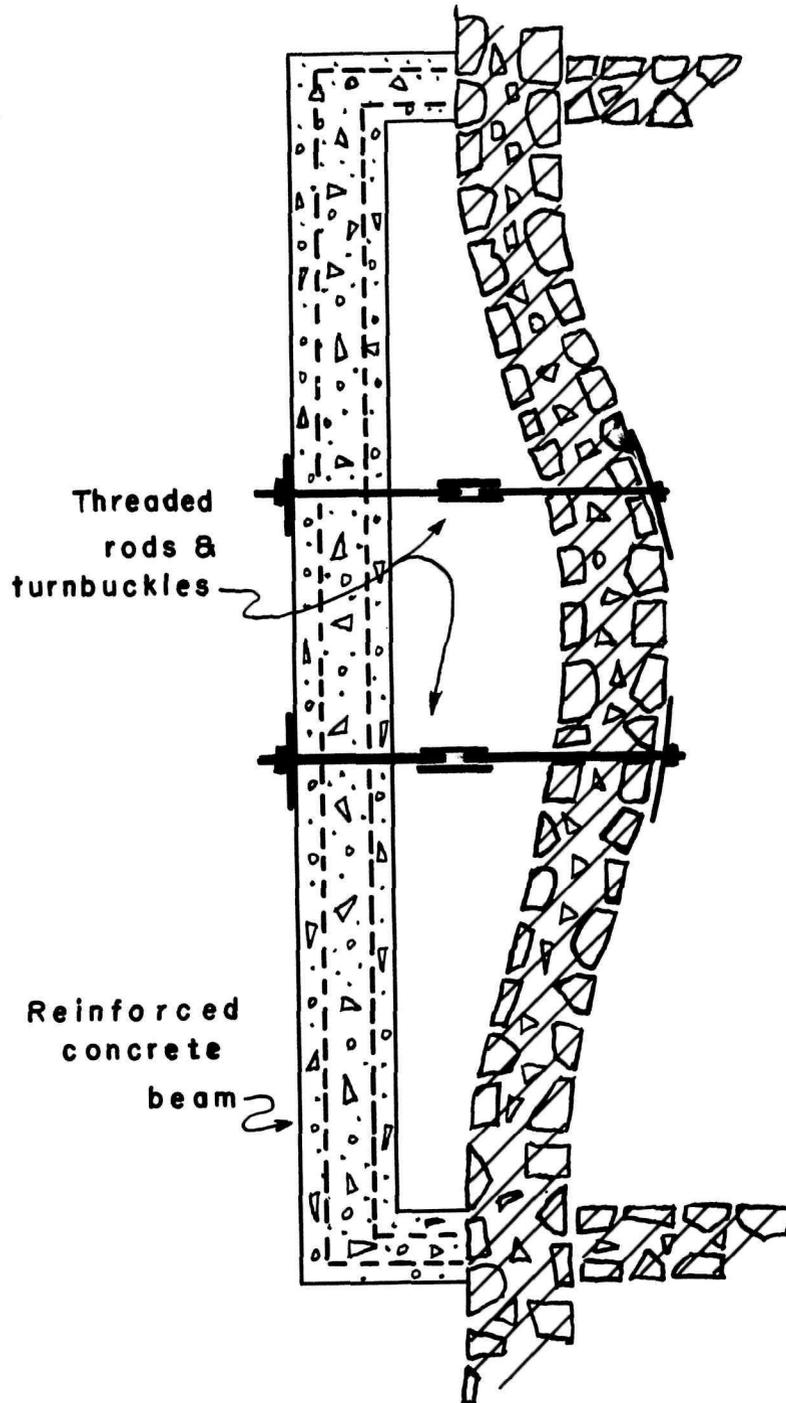
PLAN OF REINFORCED BEAM TO REALIGN AND HOLD NORTH WALL Rm. 27 Not to Scale

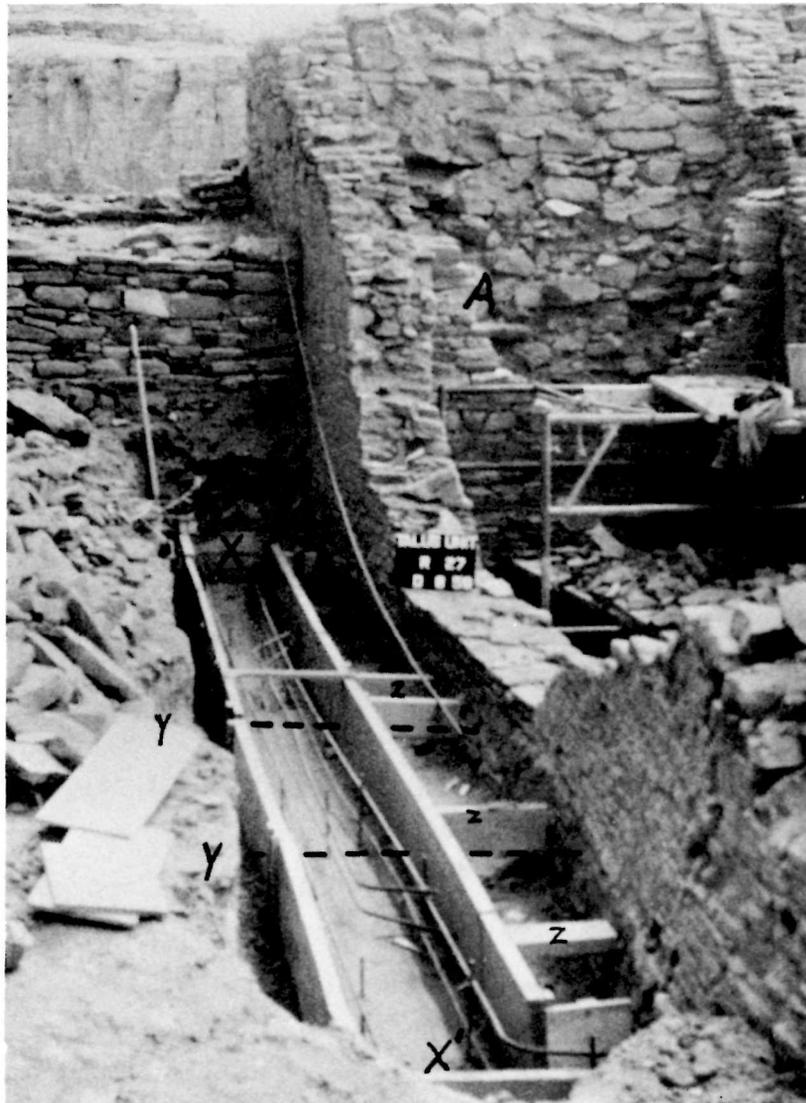
Construction of concrete beam shown in plan on preceding page, frame complete and reinforcing rods in place. X - X¹ - beam, Y - location of threaded rods and turnbuckles, Z - temporary braces. The ends of the beam bear against the wall, at each side of the bulged area at points where the wall is braced against movement by partition walls, that at the east shown as A.

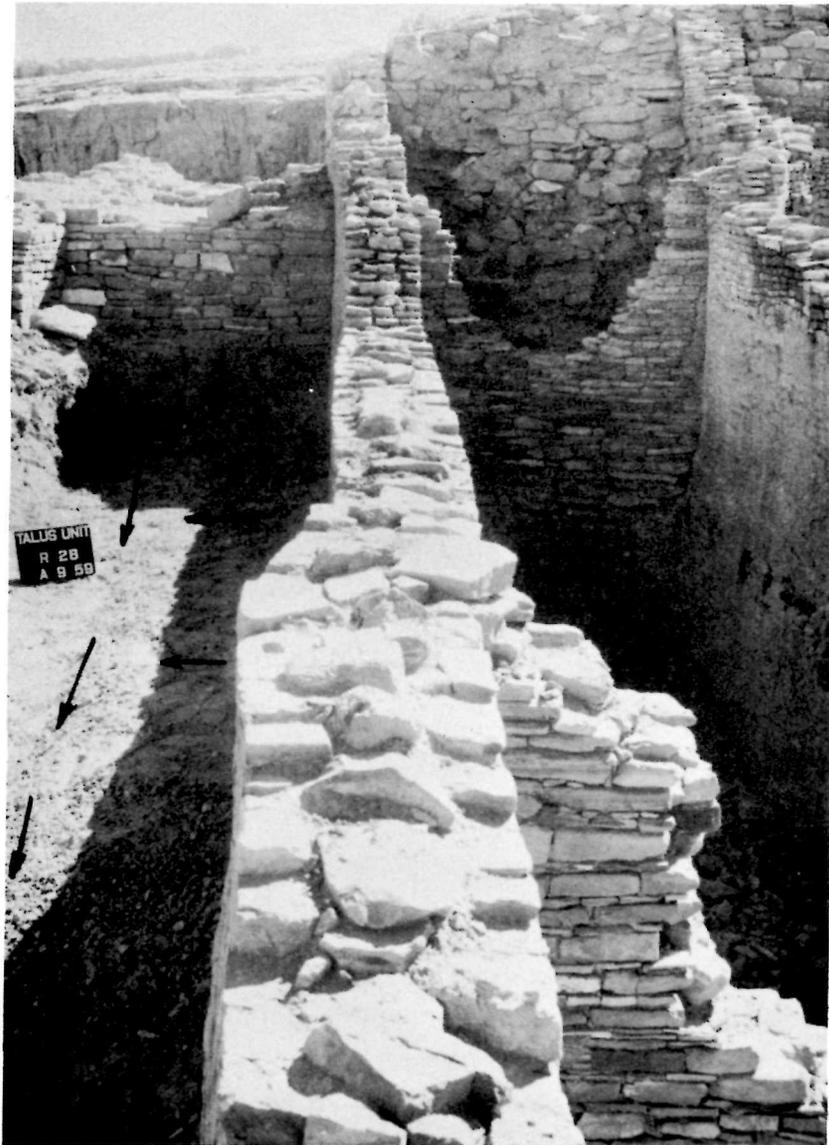
Wall has been pulled partly back into line, capping straightened up. The concrete beam dug into Room 28 is covered and the surface of this room graded, arrows, to carry surface runoff away from the damaged wall.

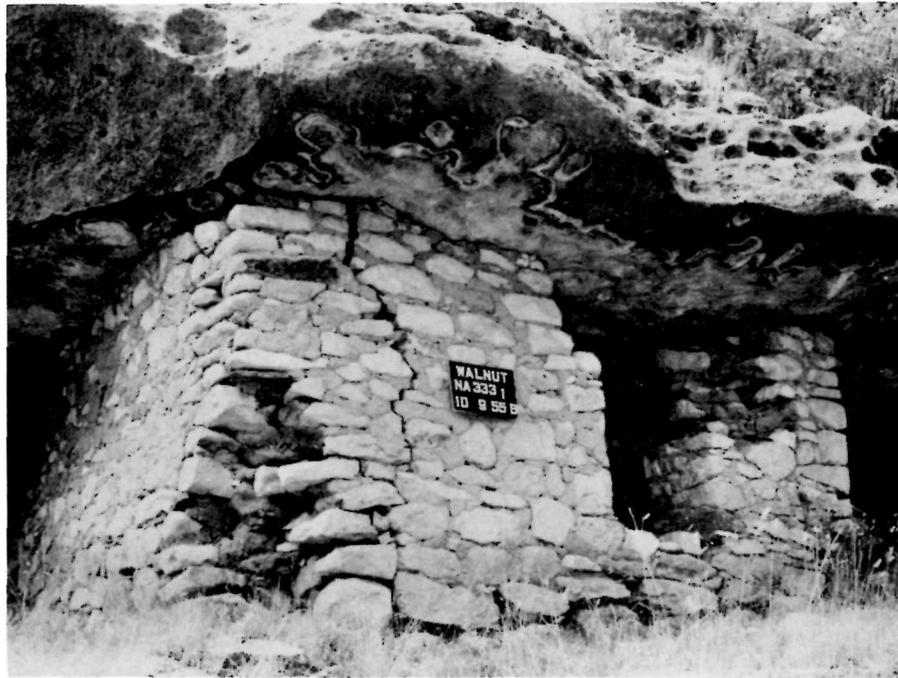
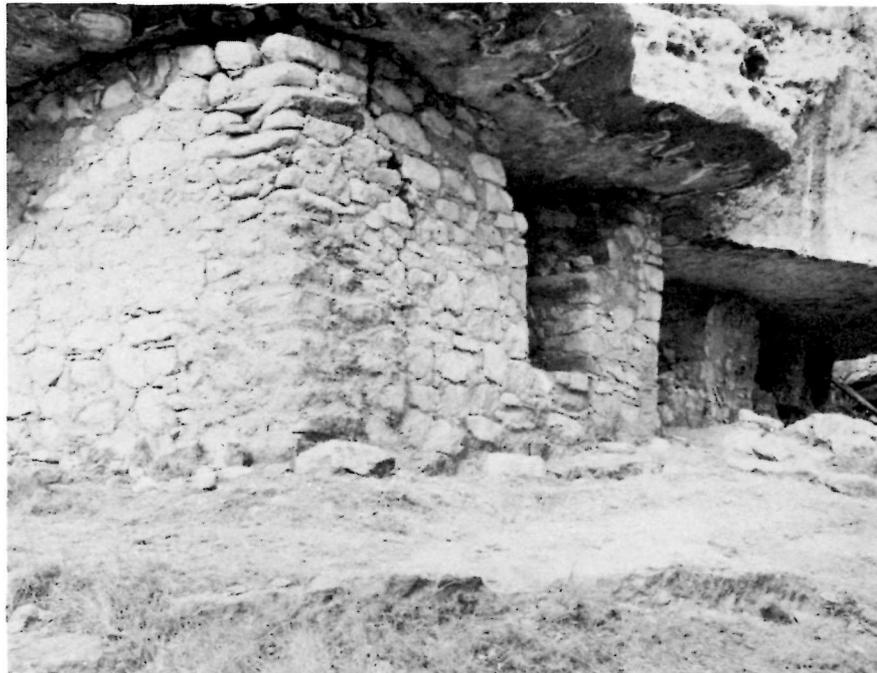
Room 1, east exposure. Before and after replacement of fallen corner, grouting of the deeply eroded wall base, and partial resetting of area above doorway. Settling crack purposely not filled to surface.
