Technical Preservation Services
National Center for Cultural Resources

The Secretary of the Interior's Standards for Rehabilitation

Subject: Adding New Openings on Secondary Elevations

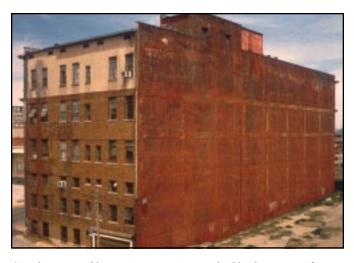
A fourth floor was added in 1934 to this building originally constructed in 1927.

Application I (Compatible treatment): Originally constructed in 1927 as a manufacturer's distribution and storage facility, this building was altered in 1934 with the addition of another story. The proposal to rehabilitate the building into apartments called for windows to be inserted into a previously unfenestrated, side elevation. Even though highly visible, because the wall was not important in defining the historic character of this building, adding windows was determined to be a compatible treatment. The new windows are set back from both ends of the building, and are simply punched out openings in the wall without sills. In further contrast to the existing, historic windows in the building which are multi-paned, the new windows have a one-over-one configuration. The completed project meet the Standards.

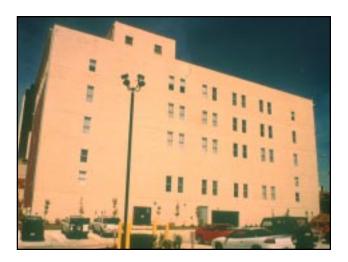
Simple, compatible openings were cut into this blank, non-significant secondary elevation when the building was rehabilitated for apartments.
