Subject: Adding New Entrances to Historic Buildings

Applicable Standards: 2. Retention of Historic Character
9. Compatible New Additions/Alterations

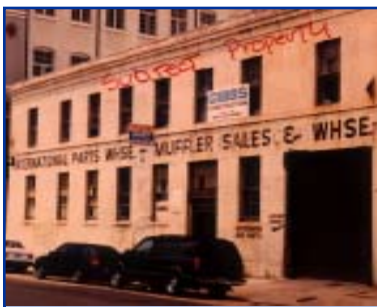
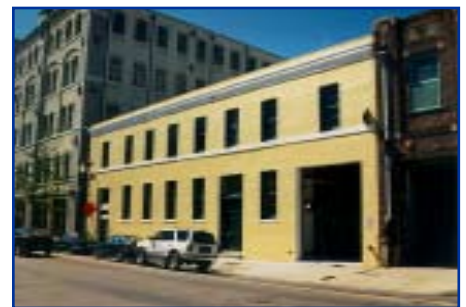
This building was constructed with a single pedestrian entrance in 1886, and a garage door was added later (left). When the building was rehabilitated for office use, an existing window was removed from the end bay and replaced with a new glazed entryway (center and right).

Application 1 (Compatible treatment): This two-story, eight-bay masonry structure was built in 1886 as an ice manufacturing plant. Originally constructed with only one entryway, a garage door had been added later when the building served as a warehouse. As part of the building's conversion into offices, a second pedestrian entrance was added to the street elevation during the rehabilitation to make it easier to get to some of the offices. The size of the new opening is the same as that of the existing historic entrance. But, the new entrance is almost entirely glazed, and consists of a simple butt-mounted glass door with sidelights, and a single-light transom. It is clearly a compatible, contemporary design that does not draw attention to itself. It cannot be confused with the historic entrance, and it does not change the character of the building. Thus, it meets the Standards.

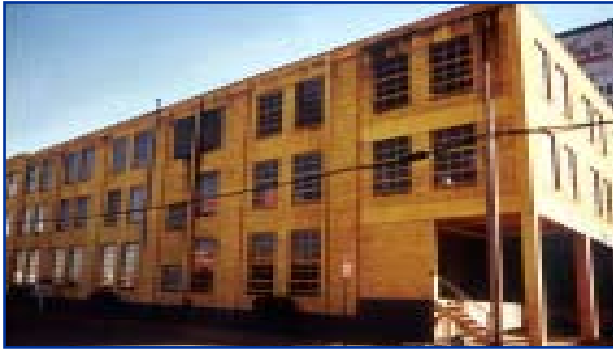
This historic warehouse had entrances on three elevations of the building prior to rehabilitation.

Application 2 (Compatible treatment): A larger, free-standing, three-story warehouse building constructed in 1922, with a 1940s addition, was to be rehabilitated into commercial and retail spaces on the first floor with residential apartments on the upper floors. The building featured a loading dock on one side and three utilitarian, non-significant entrances on various elevations. As part of the rehabilitation a new entrance was proposed to be added on a side of the building that never had an entrance. An entrance on this elevation would improve visibility and access to the new shops and businesses, and it would also help increase security for the upstairs apartments since existing entrances could be restricted for residential tenant use. Accordingly, a new glass and steel entryway which reflects the industrial character of the building and its historic metal windows was designed for this side of the building. The new entrance is compatible with the character of the historic building. It is unobtrusive and it does not noticeably impact or change the appearance of this elevation or of the warehouse building as a whole.
