ITS  
NUMBER 3

Interpreting  
The Secretary of the Interior's Standards for Rehabilitation

Subject: New Additions to Mid-size Historic Buildings

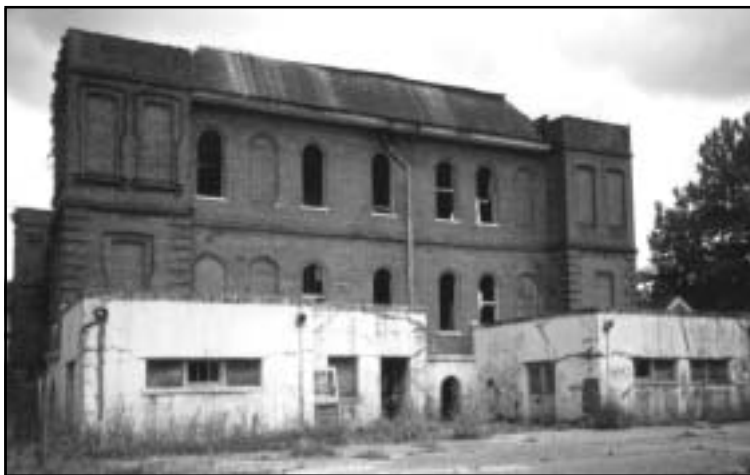
*The rear elevation of the school building before the removal of the two later, non-significant additions.*

**Application 2 (Compatible addition):** A historic three-story, 1879 brick school building, long abandoned, was rehabilitated for use as a women's and children's center. The school is a square, Italianate building with decorative towers at each corner, now flat-roofed since the loss many years ago of their Romanesque-arched open bell towers. Although the existing building was not small, it lacked sufficient space to fulfill the center's needs for private and communal living and dining areas for the residents, as well as for administration and staff offices. To provide additional space, two small non-significant additions were removed and a three-story brick addition was constructed at the rear of the school. The new brick is harmonious with the historic brick and the design of the addition is very simple. To further differentiate the addition from the historic building, the windows in the new addition have flat arches and are very plain and unadorned in contrast to the more decorative window openings and stone sills on the original schoolhouse. The new addition is compatible in size, scale, materials and location with the historic building and, thus, meets the Standards.

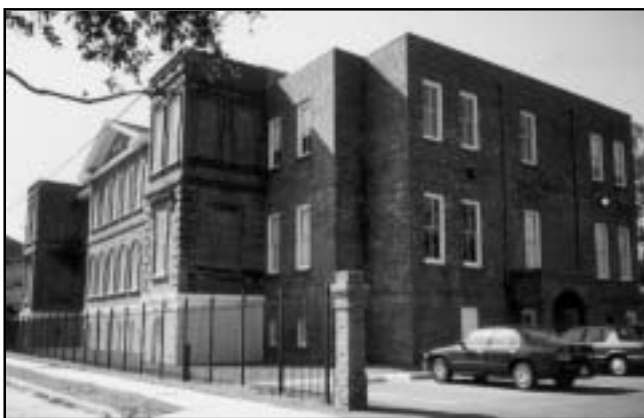
*The simple design of the new addition at the rear of the building is completely compatible with the historic character.*

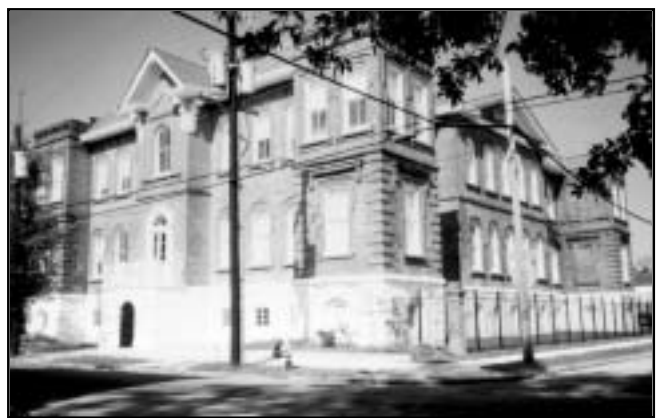
*The school, which is prominently situated on a corner, is shown after rehabilitation. The new addition at the back (right) cannot be seen from the corner.*
