## **Technical Preservation Services**

## **Interpreting**The Secretary of the Interior's Standards for Rehabilitation

Subject: Rooftop Additions on Mid-Size Historic Buildings

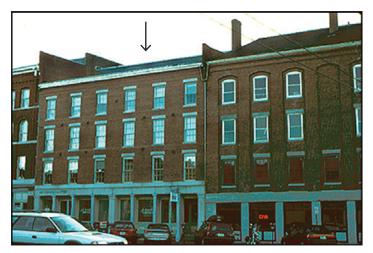
Mid-19th century commercial building with rooftop addition as it appeared after rehabilitation (center).

**Application I** (*Compatible treatment*): The rehabilitation of this mid-19th century commercial building included a rooftop addition as part of the project. Though the building is only four stories in height, this rooftop addition is compatible with its historic character. It is set back substantially—

almost halfway from the front façade and, thus, it minimally visible from public the street and within from district. the High party walls on either side also help

to reduce the impact of the addition and allow it to blend in with the adjacent rooflines. This rooftop addition does not detract from the historic character of the building and, therefore, meets the Standards.

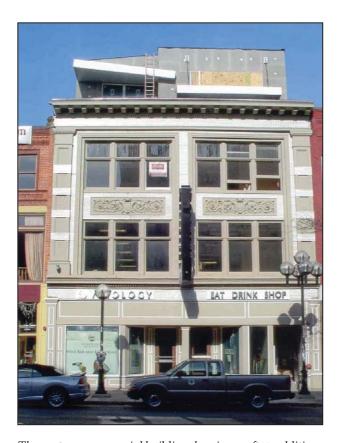
Three -story commercial building showing rooftop addition under construction.

Contrary to National Park Service guidance which states that rooftop additions should be limited to one story and are rarely acceptable for low-rise buildings, this addition rises a full story and a half above the roof. The prominent cornice, an important character-defining feature of the primary elevation of the historic building, is overwhelmed and greatly diminished by the new rooftop addition. Not only is the addition barely set back from the front of the building, its asymmetric, modernist design further detracts from the character of the building's classicallystyled façade. The rooftop addition competes for attention with the historic building and it is also out of character with the surrounding district. This rooftop addition is not compatible with the historic character of the building and, therefore, does not meet the Standards.
