Technical Preservation Services

InterpretingThe Secretary of the Interior's Standards for Rehabilitation

Subject: Reusing Special Use Structures

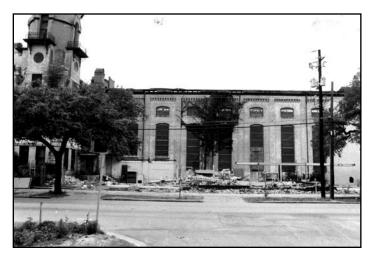
Top left: The historic jail featured a three-story warden's house (partially visible, left), and a four-story cell block.

property consisted of a warden's house and a cell block. The stark interior of the cell block reflected the building's historic use. The cells, five feet by eight feet, were separated by 18 inch load-bearing masonry walls. The internal structural system was thus independent of the exterior walls. To accommodate the insertion of apartments on all floors, the plans called for the total demolition of the historic floor plan in the largest and oldest section of the jail. The planned removal of the load-bearing cell walls also meant that the floor and roof structure resting upon them would be lost as well.

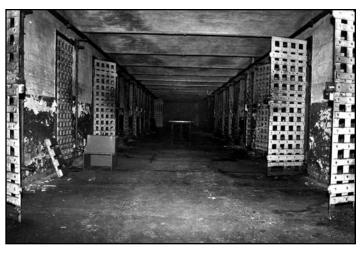
Top right: Cell block interior. Cell walls were five feet by eight, separated by 18 inch load-bearing walls.

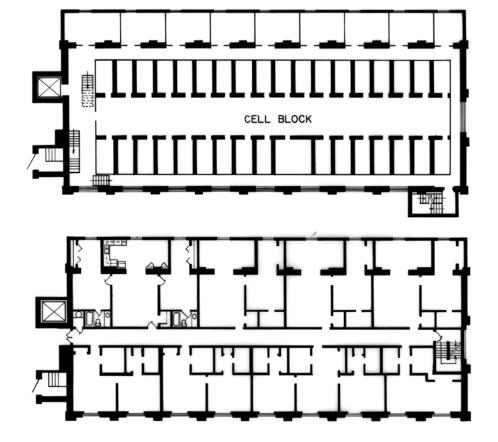
Center: Floor plan before rehabilitation. Section at top was added in the 1950s.

Bottom: Floor plan showing proposed insertion of apartments and the removal of nearly all the historic fabric.

While modifications to the interior of buildings are permitted within the scope of the Standards for Rehabilitation and the Guidelines for Rehabilitating Historic Buildings, the changes required to convert the jail to housing would have removed virtually all vestiges of the character-defining features of the historic structure.
