**Tech Notes**

**DOORS**

**NUMBER 1**

**Historic Garage and  
Carriage Doors:  
Rehabilitation Solutions**

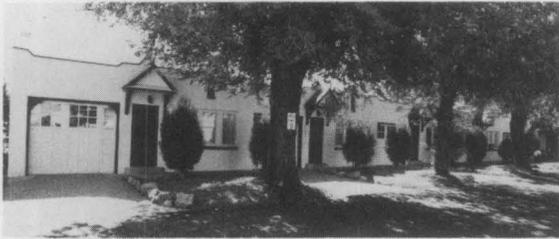
Developed between 1931 and 1939 as an auto court, the Mountain View Motel is the oldest and best-preserved motel in Ogden, Utah. The complex consists of seven buildings in the

Mission Revival Style. Two of the buildings feature individual motel units, each with its own attached one-car garage, a characteristic of many motels during this period.

Conversion of the Mountain View Motel into apartments was problematic due to the fact that bedrooms were to be located in the former garage spaces and building codes required adequate light, ventilation, and egress. The 20 existing garage doors, which operated by sliding along interior overhead tracks, were in good condition but insulation and operable windows were needed.

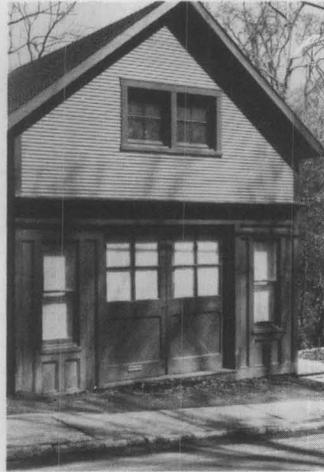
The Burgess Carriage House was built in the 1870s in conjunction with an adjacent wagon shop and was used as a paint shop for carriages and wagons. Located in the Ellicott City National Register Historic District in Maryland, it is characteristic of the numerous 19th century businesses that emerged around the town's flourishing flour trade and manufacturing enterprises.

The conversion of this 1870s carriage house to a shop necessitated creation of a customer entrance on the main level. Lacking any entrance other than through the carriage doors, a passageway needed to be created that would not alter the building's historic appearance (see figure 8). The rather formal front elevation of this utilitarian structure consisted of double-hung windows flanking the wooden carriage doors and had survived unaltered since the 19th century. The initial plan to convert one of the two windows into an entrance door would have broken the symmetrical fenestration pattern across the front and the existing doors were too large for customer use. Alternatively, locating an entrance door within one of the carriage doors would have had even a worse impact on the building's historic appearance.

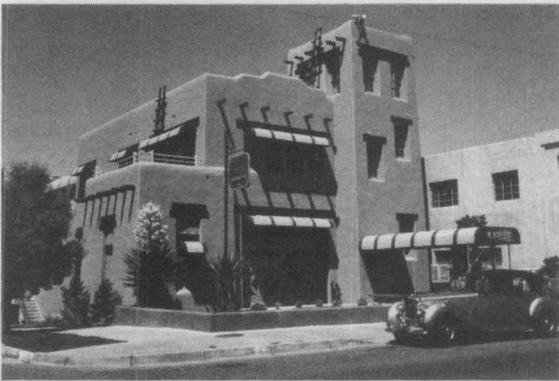
Monte Vista Fire Station

The Monte Vista Fire Station, constructed in 1936 in Albuquerque, New Mexico, is the only known Spanish/Pueblo Revival style fire station in the country. The fire station was a Workers Progress Administration (WPA) project and its style of architecture, based on Indian pueblos, typifies the WPA interest in supporting regional architecture.

of the retrofitted doors helps preserve the historic character of the exterior, although the use of glass only in the upper panels would have lessened the impact on the engine room interior, where the doors are even a more prominent feature. An inexpensive solution, it was much preferred to full glass infill or infill with a contemporary design that would have replaced the historic doors in their entirety. The chosen solution also has the advantage of being easily changed back to the original design by simply re-installing diagonal paneling, if dictated by future commercial uses.

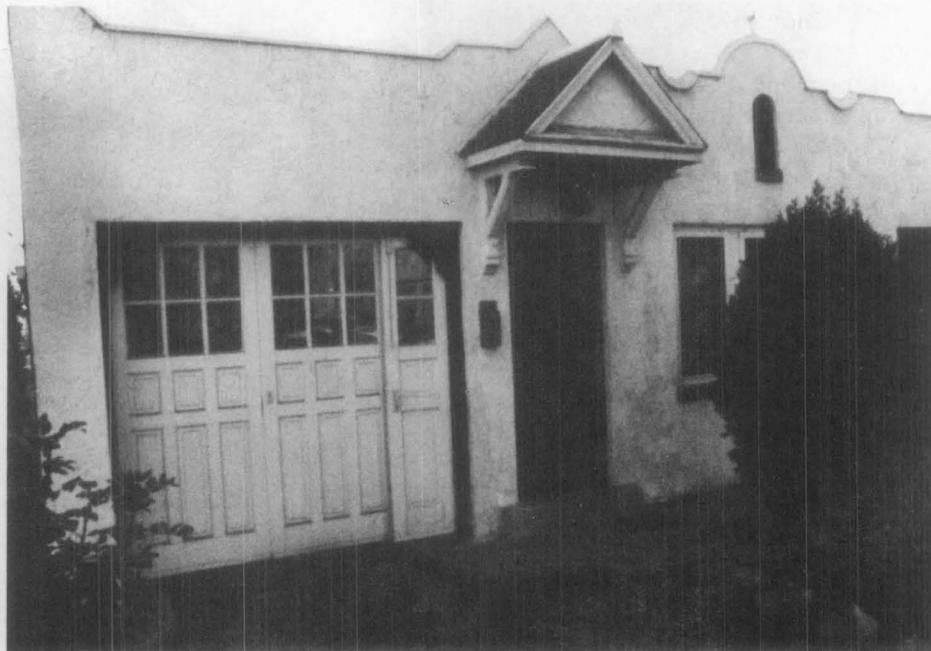
Figure 1. The attached garages were an integral part of the design of the motel, as shown in this view prior to work. Photo: Light Images

The owners of the Mountain View Motel recognized the attached garages as an important component of the historic resource and from the beginning examined ways of retaining the existing doors (see figure 1). The final design called for re-installing the doors in their historic position within the garage opening and constructing a new stud wall on the interior. This provides needed insulation for the bedrooms while preserving the doors on the exterior.

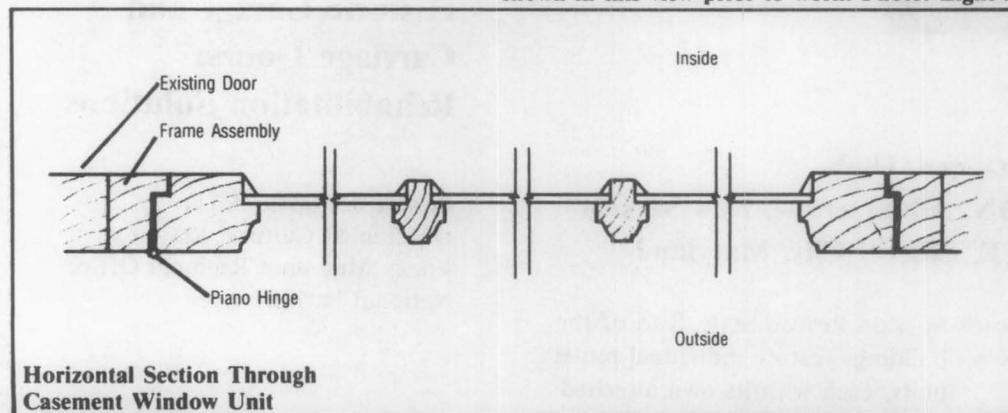
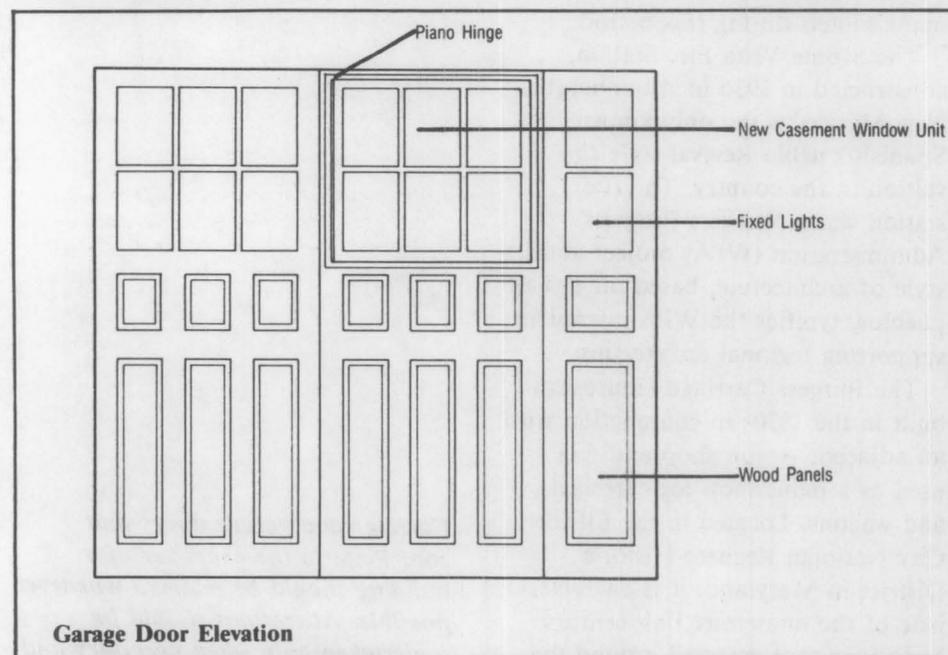
Figure 2. The existing doors were retrofitted by removing one window and installing an operable casement window. Drawings: Bonnie J. Halda, A.I.A.

The interior wall was built with an opening the same size and location as the window opening in the door. To provide ventilation and emergency egress, one section of multipaned windows in each set of doors was cut out. A millwork company fashioned a custom window unit to match the

configuration of the removed window, and the new unit was installed flush with the plane of the surrounding garage door (see figure 2). A piano hinge allows the custom window unit to operate as an out-swinging casement (see figure 3). The piano hinge is only slightly visible from the exterior and all other hardware is interior mounted. When closed, the new operable window appears as part of the garage door. The owner elected to leave the track hardware from the doors in place on the interior as evidence of the former garage converted to a bedroom (see figure 4).

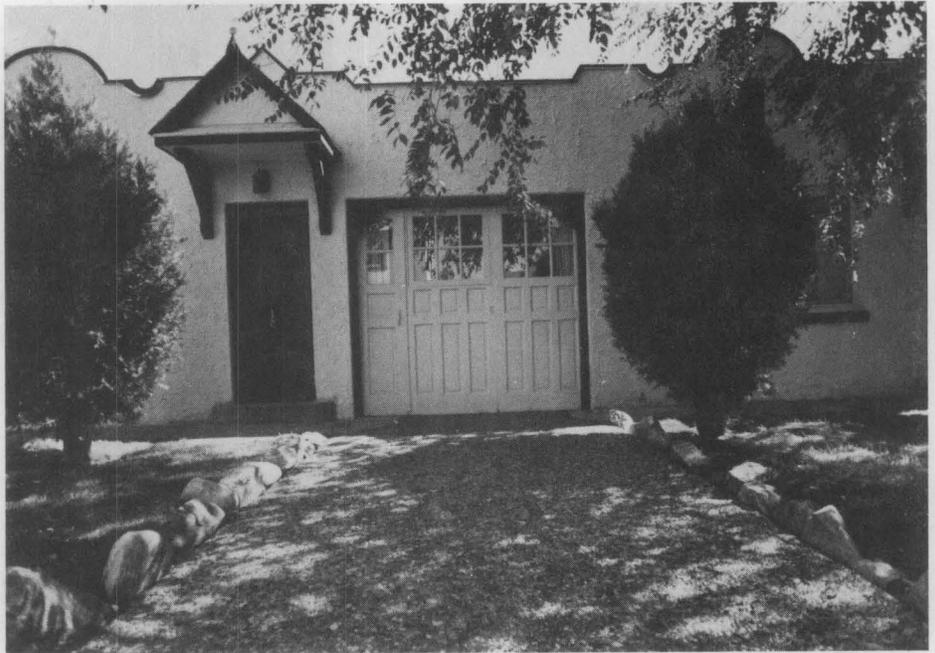
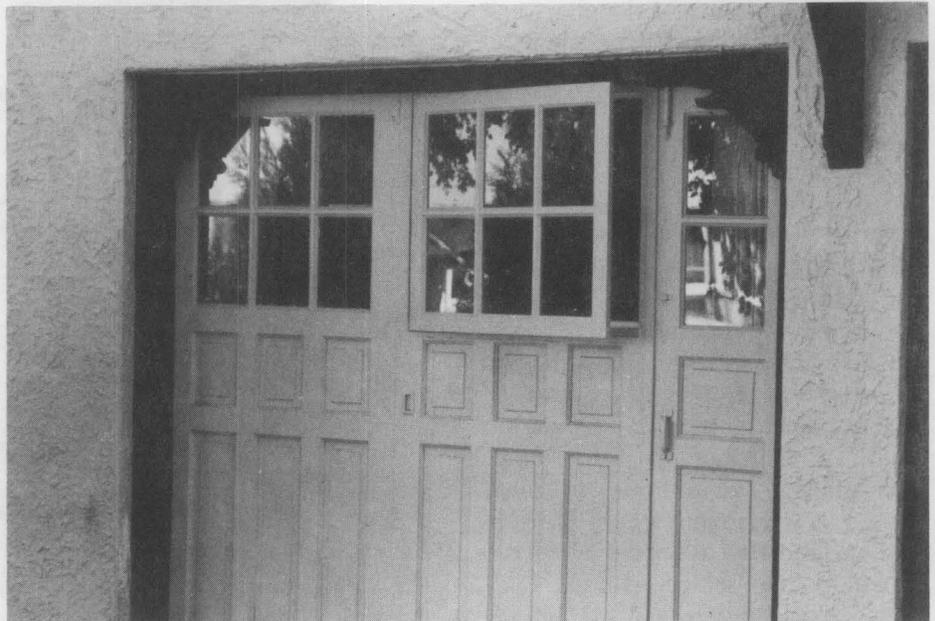
**Figure 3.** The new casement windows in the garage doors are visible only when the windows are open. Photos: Light Images

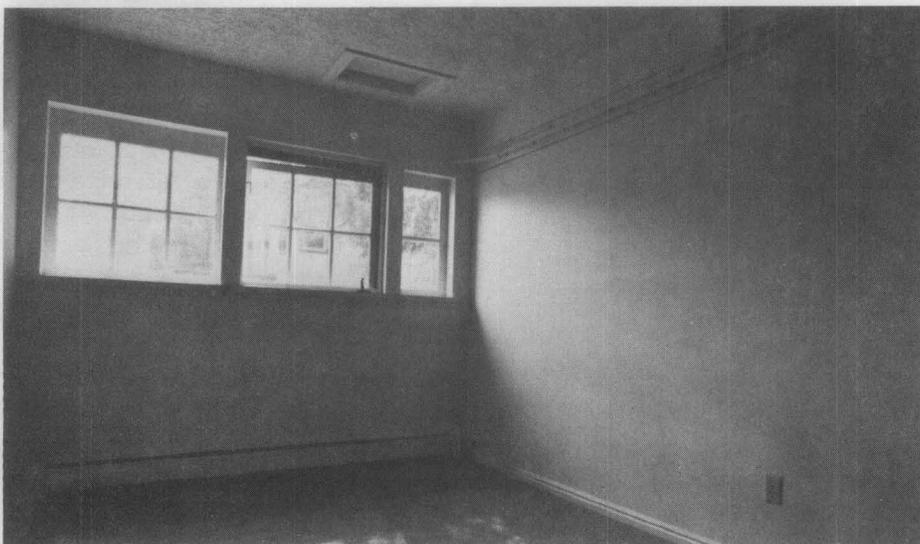
**Figure 4.** The original garage door hardware was retained on the interior. Photo: Light Images

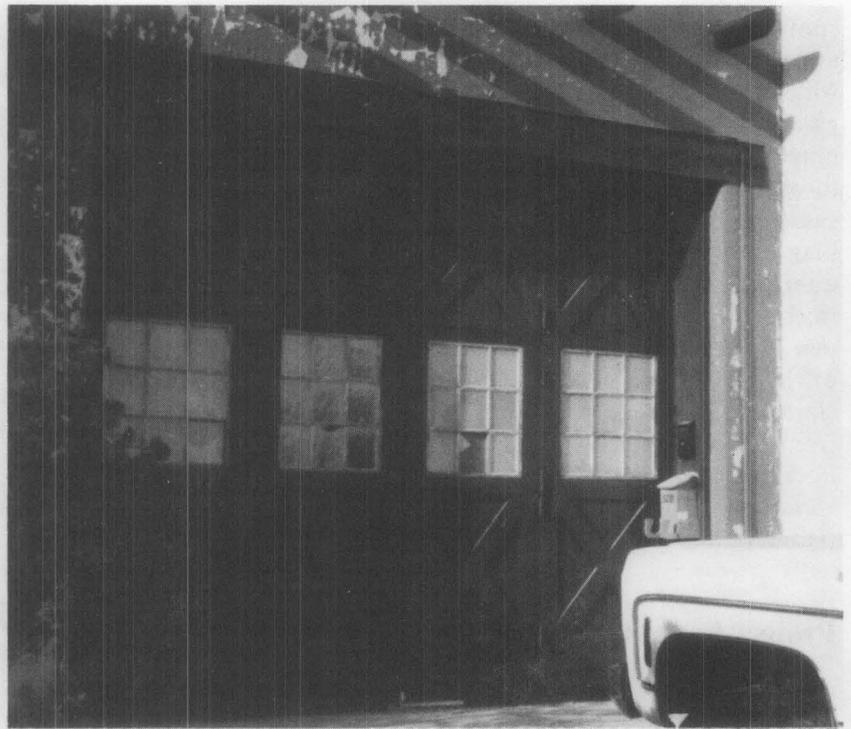
**Figure 5. The historic fire truck doors, which featured wood cross-bracing and multipaned windows, played an important role in defining the historic character of the building. Photo: Chip Kaufman**

The plan of the new restaurant proposed for the Monte Vista Fire Station called for the dining room to be located in the former truck bay. The dining room needed both light and views; however, the existing historic doors in the truck bay did not meet this requirement. The 14-foot-high doors featured wood cross-bracing over tongue-and-groove boards in the upper and lower third sections, and multipaned glass lights in the central third sections (see figure 5). Overhead operating hardware allowed the doors to fold open quickly in the event of an alarm. One portion of the doors had been modified to accommodate a pedestrian door, but were in otherwise good condition. The doors were recognized as significant features of the building, but their small amount of glass did not provide adequate light or views and the poor fit of the doors within the opening allowed air infiltration.

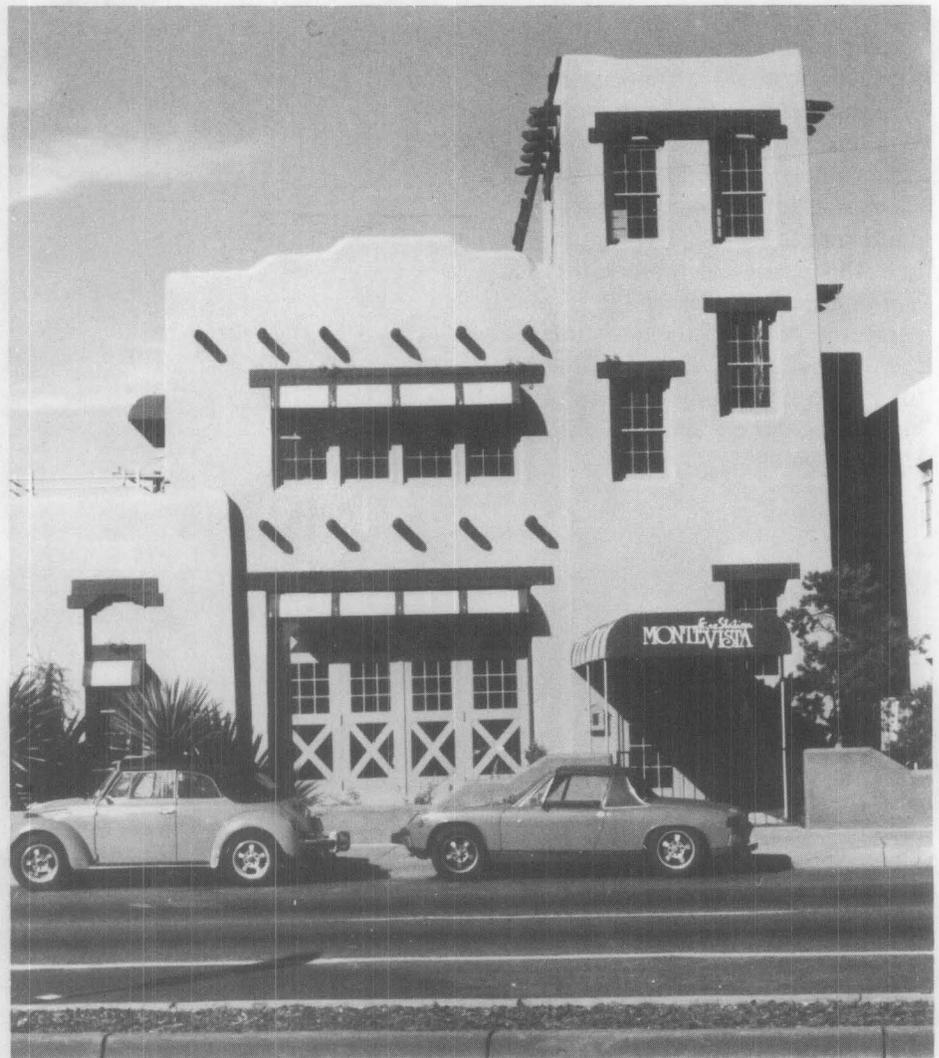
**Figure 6. The historic doors were repaired and fixed in place, with the installation of glass behind the cross-bracing. Photo: Chip Kaufman**

The decision was made to repair, weatherstrip, and fix in place the existing garage doors. The tongue-and-groove boards behind the cross-bracing in the upper and lower portions of the doors were removed and insulating glass was installed (see figure 6). The actual work on the doors was simple, requiring only a half of a day of labor to remove the boards and install the glass. The new glass lights, together with the glass in the central section of the doors, allows light into the interior and

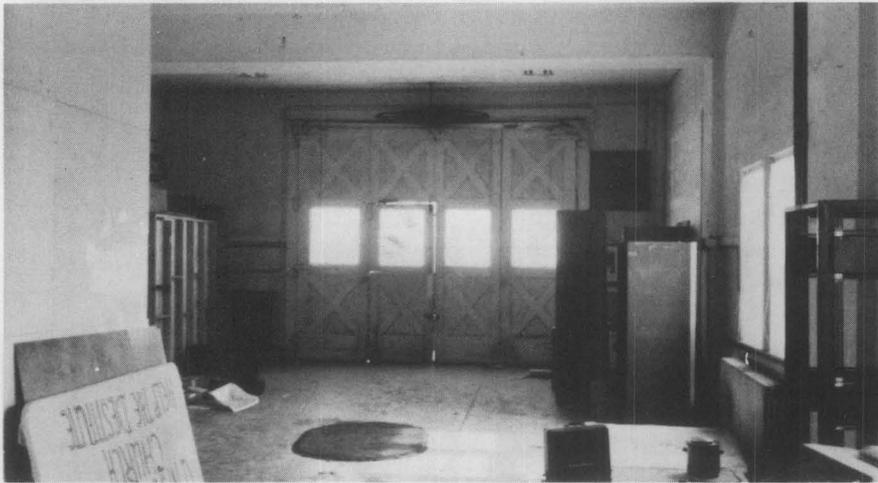
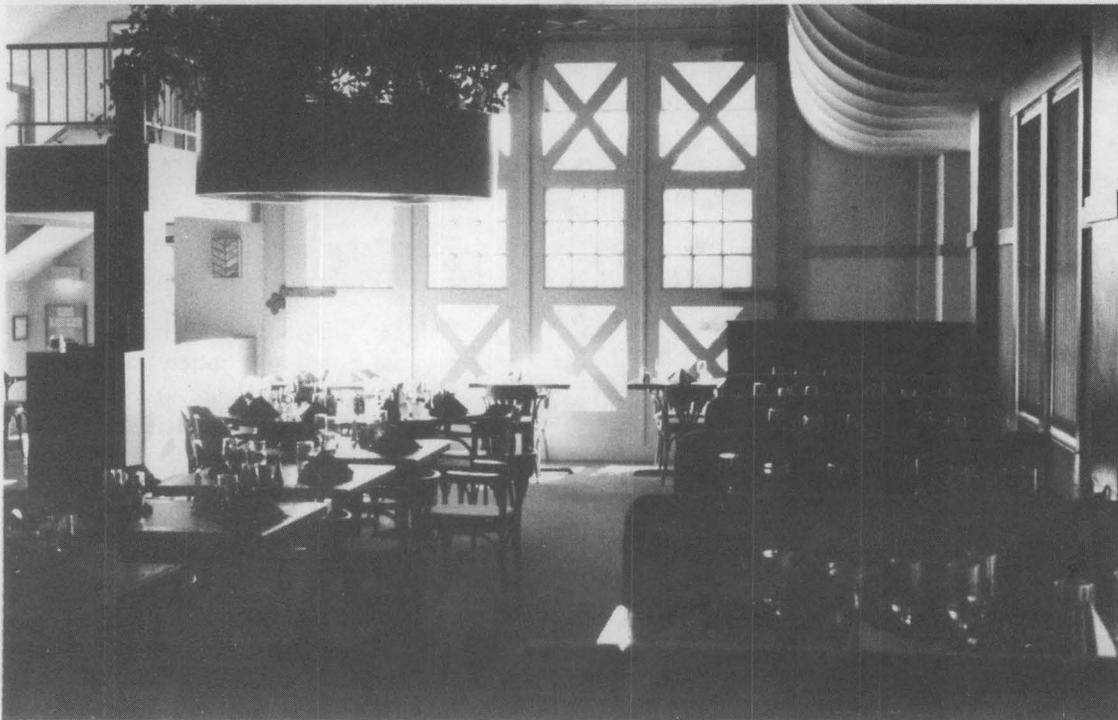
**Figure 7. Replacing the tongue-and-groove boards with glass opened up the former fire truck bay while retaining the character of the doors.**

The customers using the new dining room are able to take advantage of the New Mexican sunshine as well as having pleasant views to the exterior (see figure 7). The innovative design

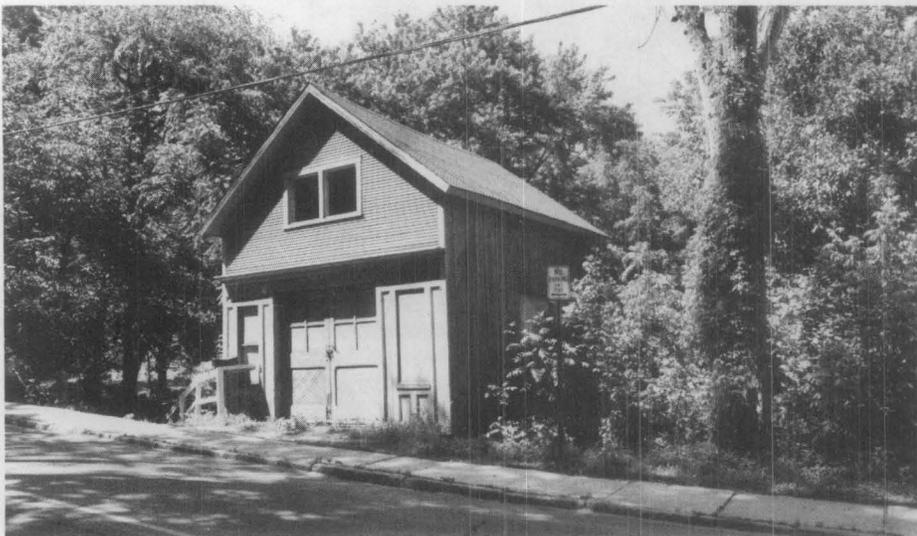
Figure 8. This 1870s carriage and wagon painters shop never had a customers' entrance other than through the carriage doors. Photo: Charles Fisher

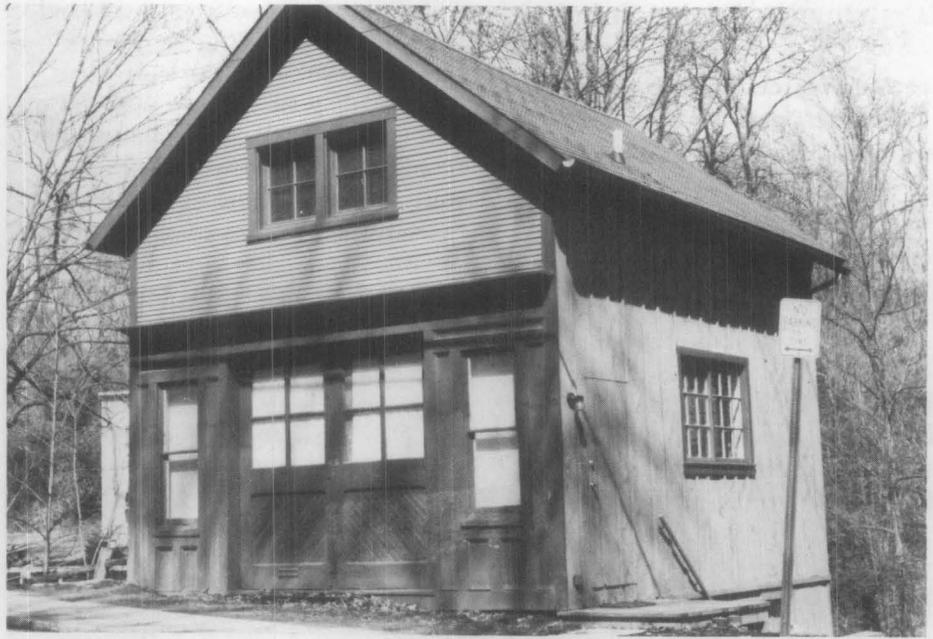
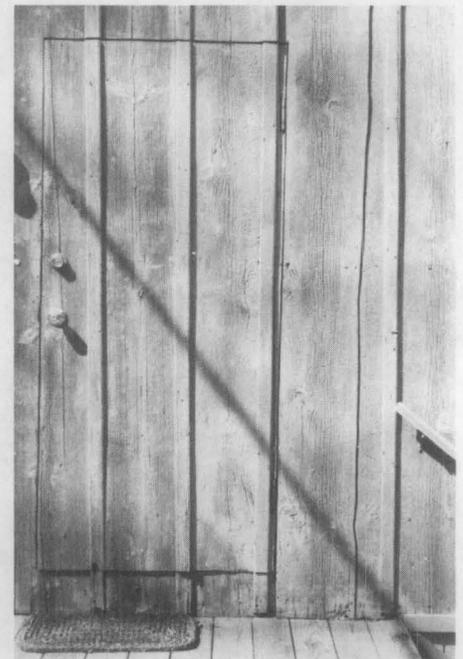
Figure 9. A new customer entrance was created through construction of a door along the side. The concealed nature of the door minimized its impact on the building's historic appearance. Photos: Charles Fisher

“hidden” entrance, utilizing the original board and batten as facing for the door (see figure 9). Since the door would be immediately adjacent to the front, there was no need to have the door serve as a highly visible entrance. The plentiful glass openings across the front and a new unobtrusive sign board were considered sufficient for successful retail use. For a second means of egress, a new stair to the basement would provide passage to the outside off the back of the building.

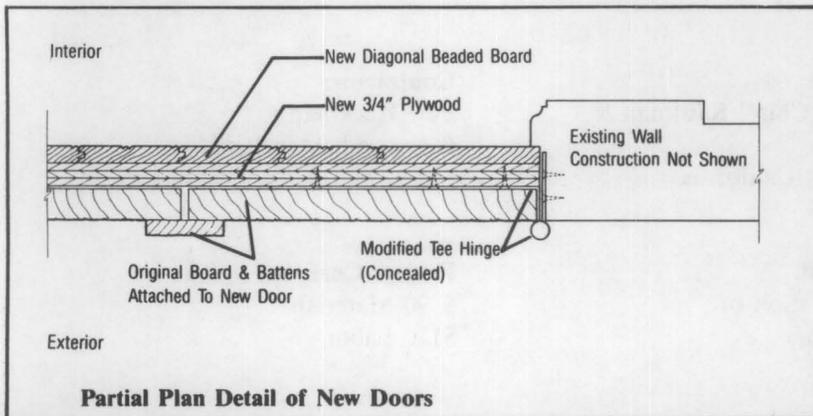
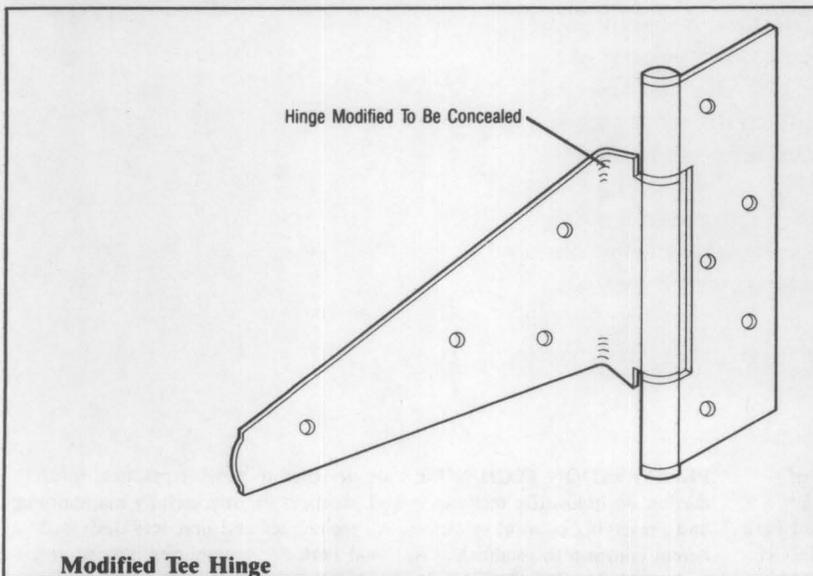
Figure 10. Drawing of the new entrance door. Drawings: Camille M. Martone

The door was designed to consist of 3 layers (see figure 10). The center portion consisted of a sheet of 3/4" exterior grade plywood. On the inside, 1" x 5" clear pine was used along the perimeter face and 1" x 5" beaded pine was installed diagonally within. This detailing was similar to that found in other utilitarian entrances within the community, including the carriage doors on the building (see figure 11). For the outside face of the door, the original

board and battens were reattached in their same position so as to align with the boards above the door.

As part of the plan to downplay the entrance, exterior casing was not used around the new door frame. In fact, the door frame was set back behind the board and batten. Normal door framing and trim would have called unnecessary attention to the entrance. Heavy-duty strap and plate combination hinges were used to hang the door, with the plate against the jamb and the strap secured to the door prior to affixing the board and batten.

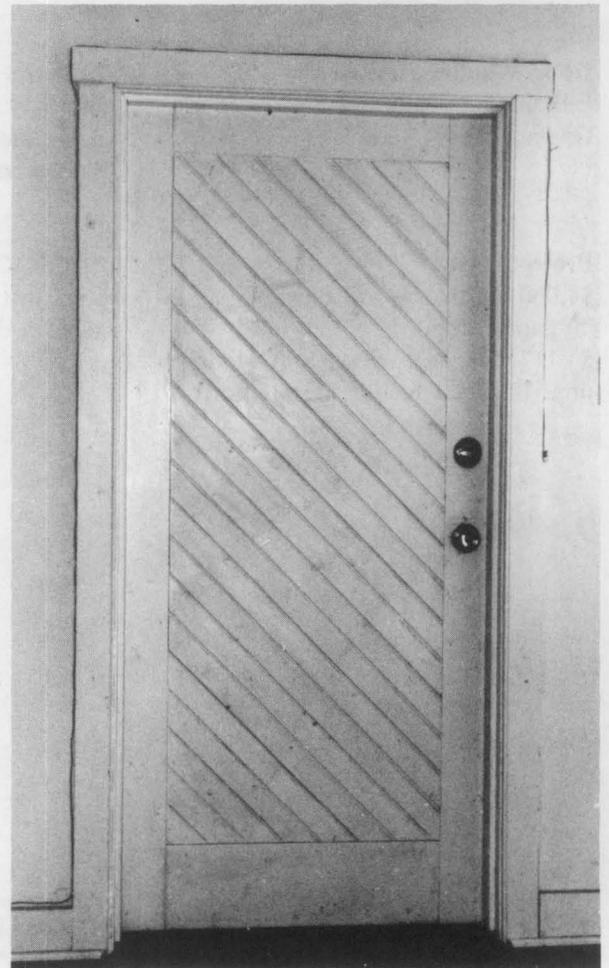
Figure 11. Diagonal boards used on the interior side of the door are in keeping with the utilitarian character of the building. Photo: Charles Fisher
