Tech Notes

EXTERIOR WOODWORK

NUMBER 4

Protecting Woodwork Against Decay Using Borate Preservatives

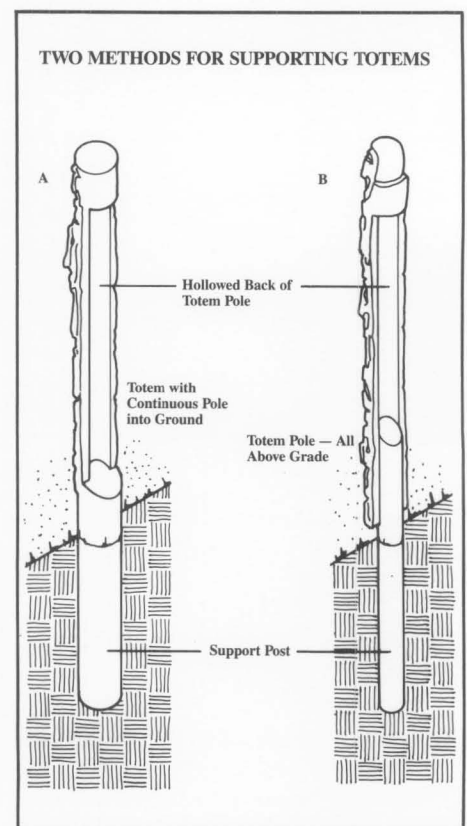
Figure 2. Two methods existed for securing the totems in place. Each of the 3 totems replicated by the Civilian Conservation Corps consisted of one continuous pole which extended into the ground (A). The other 4 totems did not extend into the ground but, rather, were attached to a separate supporting post (B). Due to the deteriorated wood below grade, all 7 totems are being re-erected using separate support posts (B). Drawing: Timothy Buehner.

to deterioration. All 7 poles were hollowed out on the back side at varying lengths above ground. Four poles (Waasgo Legend, Lakich'inei, Yaadaas Crest and Raven/Shark) were mounted with steel bolts onto separate supporting posts that were set into the ground (see figure 2). The Mosquito Legend, Trader Legend and Frog Raven replicas, carved by the Civilian Conservation Corps, have concave backs (above ground only), with the full butt section of the carved poles extending into the ground — the original method for erecting totems.

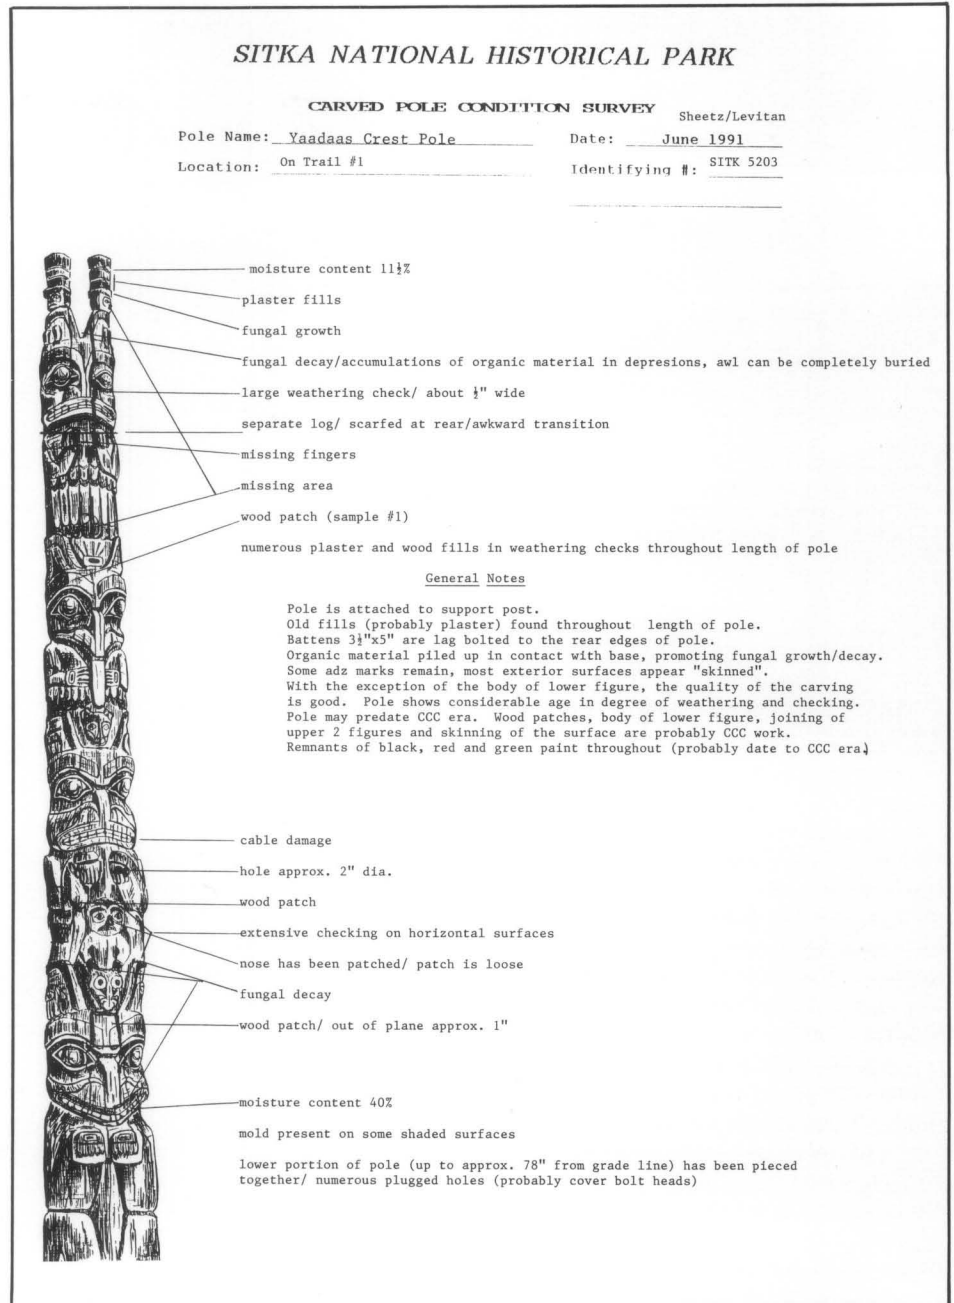
Figure 3. A condition survey of each of the 7 totem poles identified a variety of problems, including fungal decay, cracks and splits, and high moisture levels.

In 1991, a 3-day Totem Preservation Conference was held in Sitka to evaluate preservation approaches and a condition survey made of the collection. The survey included 30 carved poles and carved house poles at the park; some were on display and others were in storage (see figure 3).

The 7 poles determined to be in the most advanced state of decay shared several characteristics. They were all displayed outside and, in consequence, their bases were decayed. In several cases, the moisture content of the wood to 6" above ground was as high as 47% and fungal decay on the surface was clearly evident. Damage to the bases had occurred directly above ground and below grade to a depth of 18".

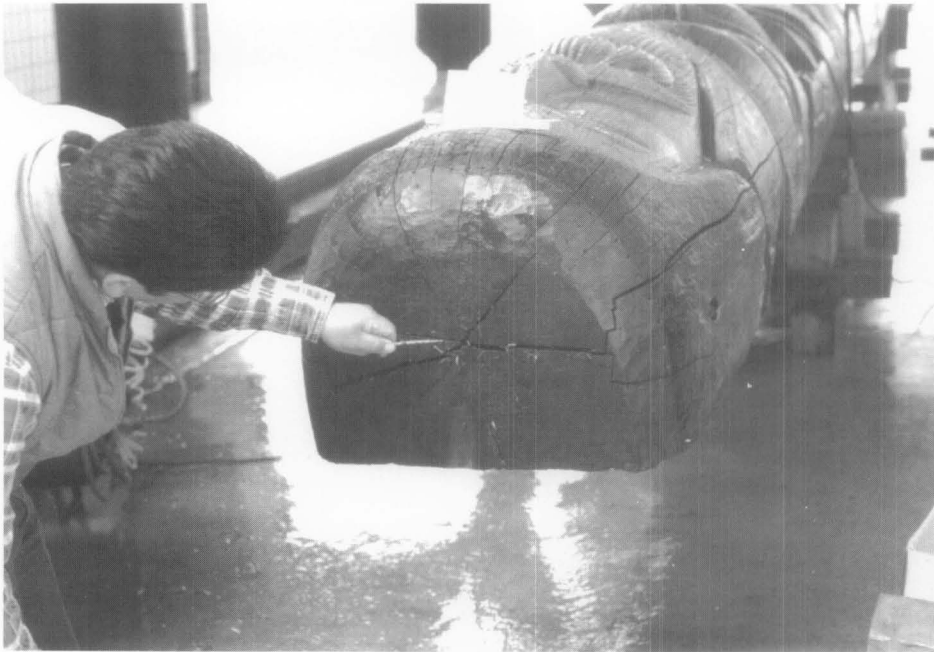
Figure 4. Organic debris had collected in the splits and cracks, contributing to moisture retention and fungal growth.

Although less serious than the damage to the bases, fungal decay also had occurred at other locations. At the top of the poles, the open end grain and cracks in the wood created perfect conditions for water retention (see figure 4). Some of the poles were flat at the top, permitting water ponding. Fungal decay also was evident on the horizontal surfaces of the carvings throughout the length of the poles, in crevices created by carvings, and in the cracks and splits in the wood where organic debris tended to accumulate and retain moisture. One pole had an 8 foot-long vertical split at the base. Finally, decay was evident in the concave backs of the poles that abutted supporting posts (see figure 5).

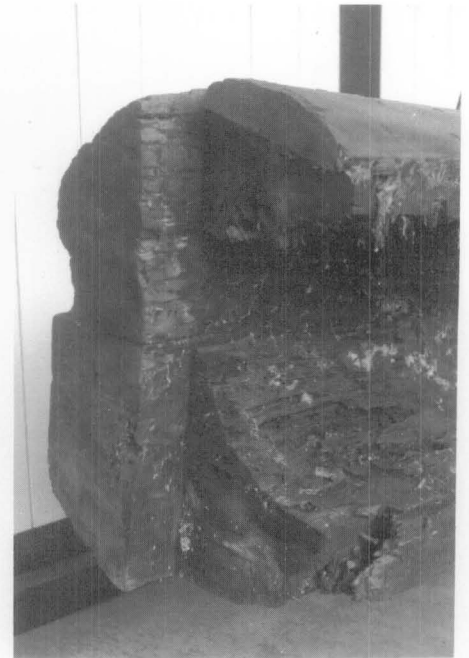
Figure 5. Deterioration occurred between the support post and the hollowed back of the totem. Coal tar had been applied in the past to the hollowed back of this totem to deter fungal decay.

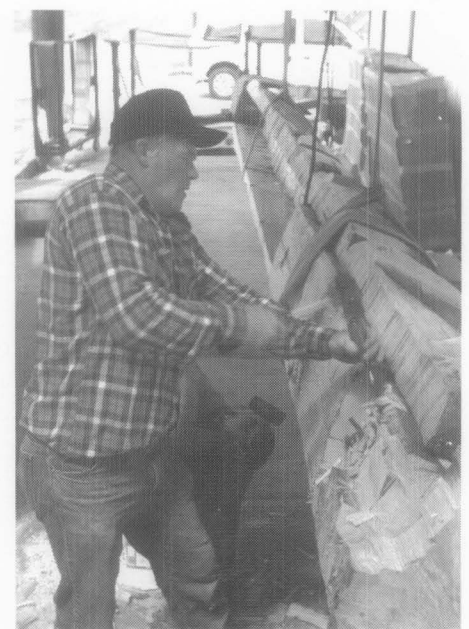
Figure 6. Three of the 7 totems had support posts. The steel bolts connecting the support posts to the totem had rusted and often needed to be chiseled out of the support post. Note the hollowed back of the totem which extended nearly the entire length while the support post extended only about half way.

base. Support posts were detached by removing the 1/2" all-thread steel rods that had connected the posts to the carved poles (see figure 6). The totem poles then were cleaned with water using natural bristle brushes and a garden hose with a spray attachment. Since the red cedar poles had

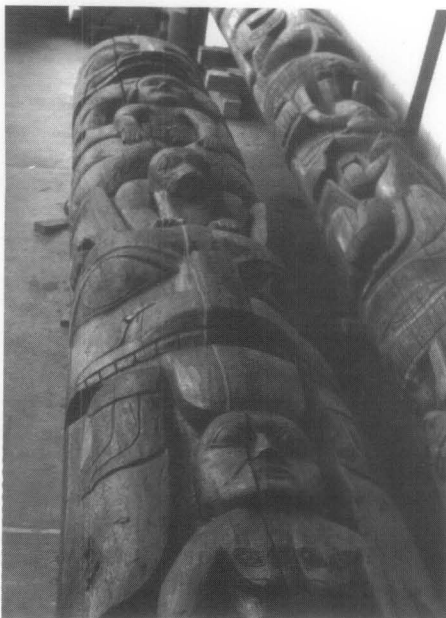
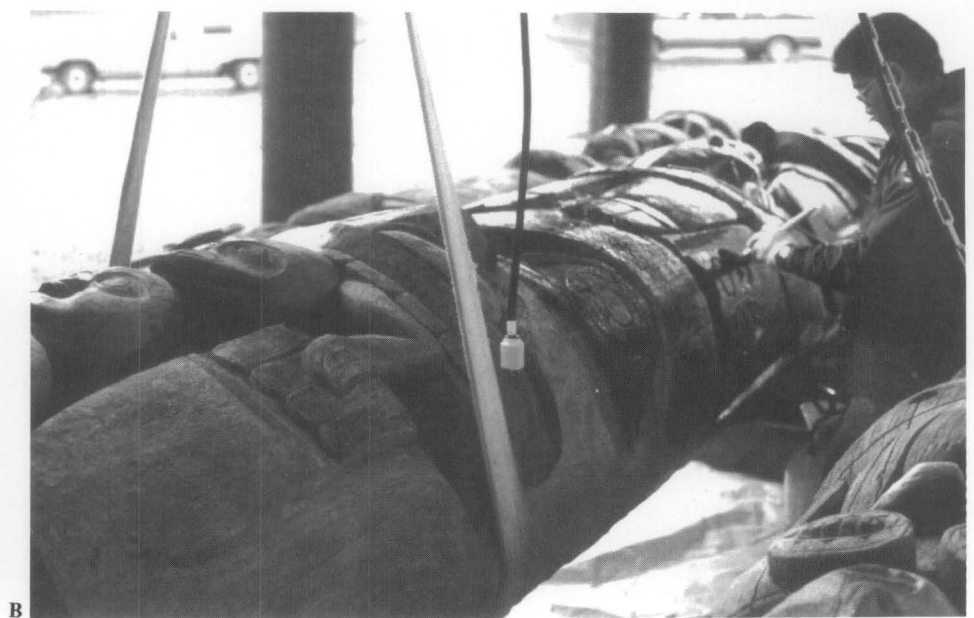
Figure 7. Borates were applied to the totem using a garden sprayer and brushes. This was followed by an application of a water repellent with mildewcide. Photo A is during application and photo B shows totems while drying.

Following repairs, the poles were first treated with a commercially available borate preservative. It was purchased as a concentrate and diluted with warm water in a 1:1 mixture in accordance with label instructions. With the pole on its back, supported by cribbing and padding, the ends were treated with a brush application of the preservative as well as with any end grain exposed by carvings. The preservative was then sprayed onto the rest of the pole using a 2-gallon garden sprayer (see figure 7). This was followed by a second coat, spraying slowly to ensure all cracks and crevices received ample coverage. The poles were sprayed until thoroughly wet and rotated with a chain hoist as needed. Near the surface, where wood was oversaturated with the preservatives, boron salts fluoresced on the surface after the glycol and water evaporated. The fluorescence was removed by wiping with a wet brush. After waiting several days for the surface to dry from the application of the wood preservative, the water repellent and mildewcide mix then was sprayed onto the pole, again using a garden sprayer to apply the mix and a brush to spread it.

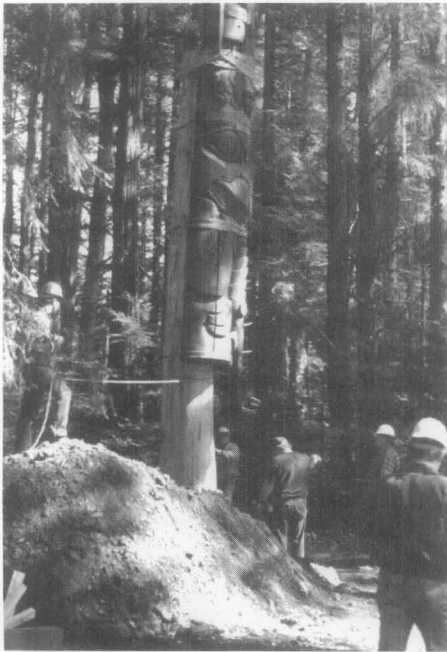
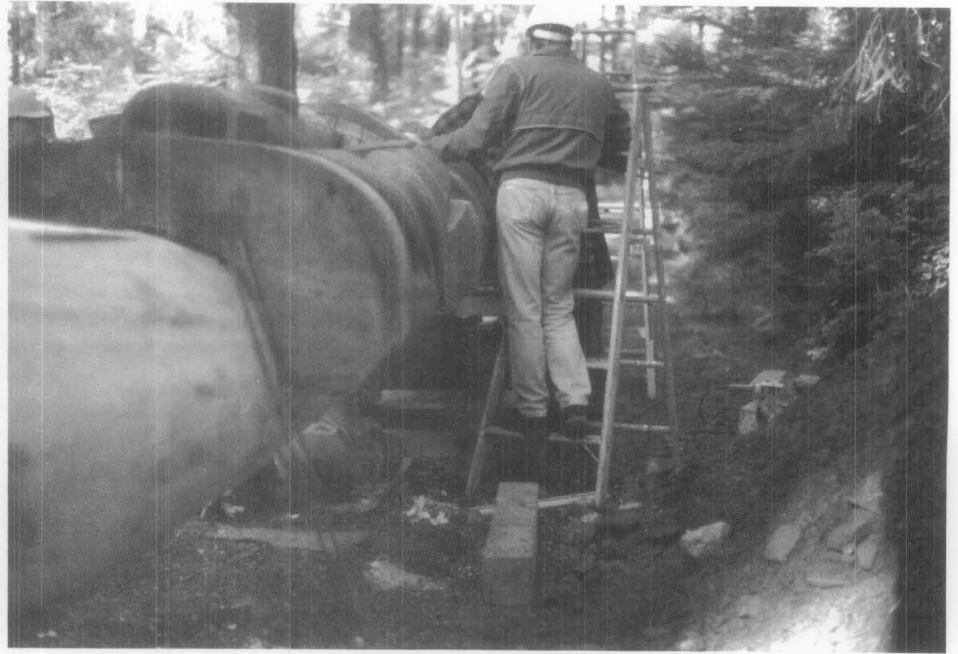
Figure 8. Due to the heavy weight of the totems, they were usually attached to their fitted support post and re-erected at the site.

Upon securing the support post to the totem, the entire unit was re-erected (see figure 8). The prepared bandage was fastened to the support post before the last 20" of fill dirt was added (see figure 9).

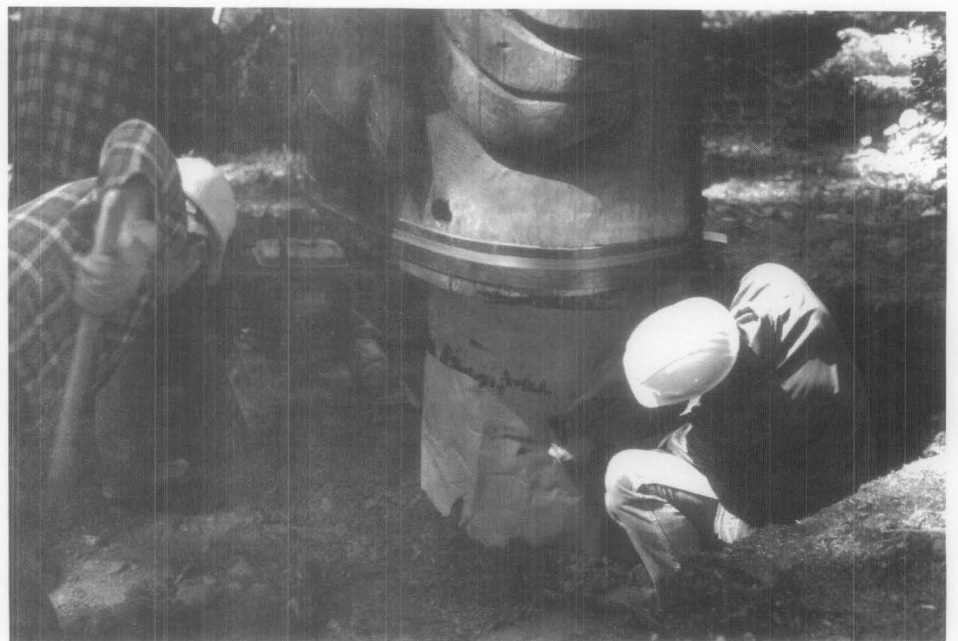
Figure 9. After securing the support post in the ground, a wood preservative in a "bandage" form was attached to the support post before dirt was filled to grade level.

mold and mildew. The utilization of a wrap or bandage was considered the most effective application method and, in addition, it would retard the borate from leaching out of the wood. It is anticipated that the wraps will be inspected in 10 years to assess their condition and possible replacement. (This would only require removal of the dirt around the bases to a depth of approximately 20" so that a new wrap could be applied, if needed.)

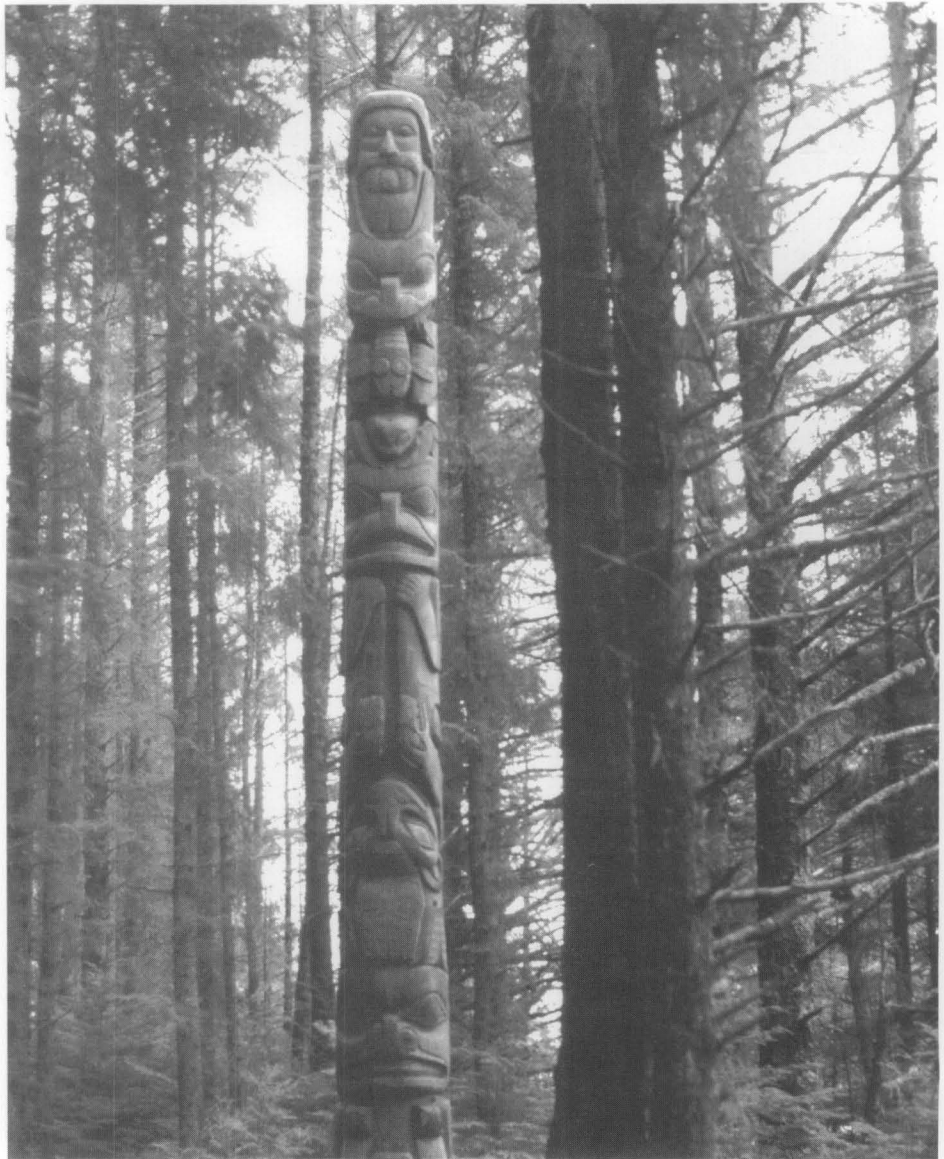
Figure 10. Application of a water repellent to the totems will probably be needed approximately every 3 years. This can easily be done in place. The support post's "bandage" wrap located just below grade, will need to be inspected in about 10 years.

Selected for use on various totem poles at Sitka because of its purported effectiveness and relative safety, borate treatment has potentially broad applications to wooden structures and outdoor artifacts. Log buildings, window sills, and above-ground outdoor wooden objects subject to decay or insect damage are just some of the potential applications. There are commercially available borate preservatives designed for topical applications to seasoned or partially seasoned wood such as that which was applied to the poles at Sitka. Careful monitoring of the carvings on the poles along with the test log will help document the long-term value of borate preservatives when applied to unpainted wood in this moist environment. Successful results will depend in part on regular maintenance of the poles, particularly in removing collected organic debris and in periodically reapplying a water repellent coating (see figure 10).
