HISTORIC INTERIOR SPACES

NUMBER 3

Preserving Historic Corridor Doors and Glazing in High-Rise Buildings

Chad Randl
Technical Preservation Services
National Park Service

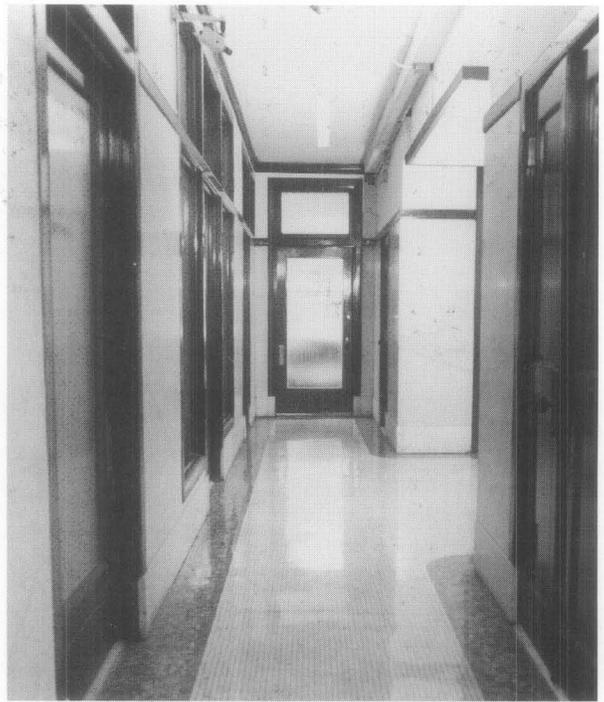
Figure 1. Historic corridor features such as doors, transoms and sidelights often do not meet current fire resistance regulations. Photo: Fisher Building, Frank Merrill Photography.

building undergoes a major rehabilitation or change in occupancy classification, the owner is usually required to bring the structure into compliance with modern codes written primarily for new construction. Among other provisions, current building codes often require that assemblies and materials provide a specified level of fire resistance. Historic doors, transoms and sidelights are common corridor features that are unlikely to meet such resistance ratings (*see figure 1*).

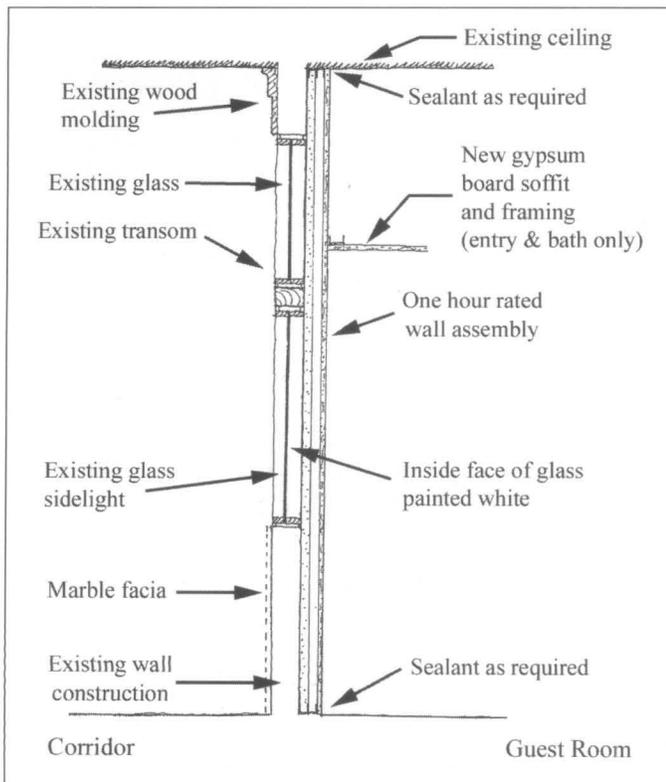
Figure 2. Typical Reliance Building corridor section showing additional wall assembly built behind historic glass sidelight and transom. Drawing: Antunovich Associates.

To retain the transoms and sidelights while complying with code requirements, the architects designed a non-combustible assembly that was integrated into the existing wall on the hotel room side (see figure 2). The 3-1/8" thick wall consisted of two gypsum boards separated by steel studs and sealed to the existing ceiling and doorframe. Back painting the glass white obscured the new wall assembly from the corridor.

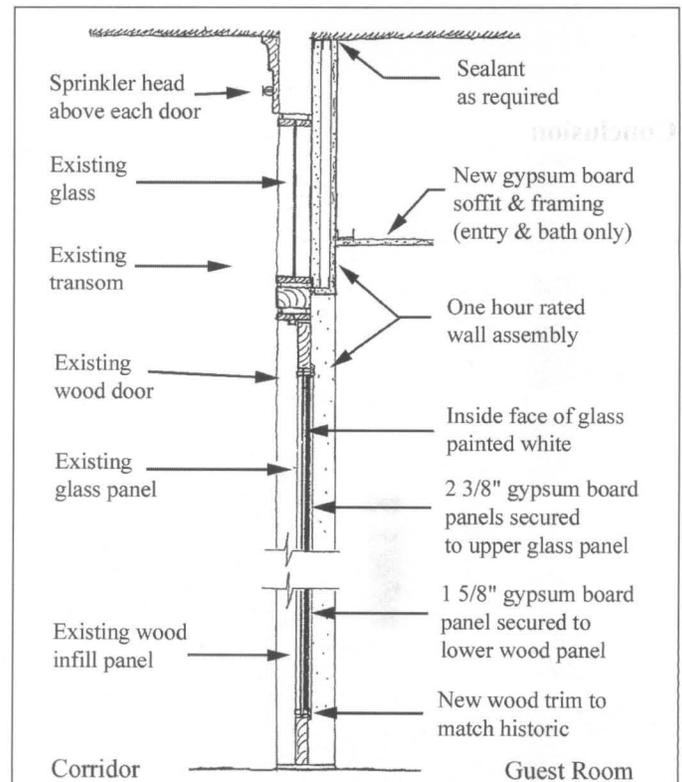
Figure 3. Typical Reliance Building door/transom section showing additional wall assembly and door panels. Drawing: Antunovich Associates.

The mahogany office doors were 2-1/2" thick with upper 1/8" thick glass and lower 1/4" thick wood infill panels. Both glass and wood panels were code deficient. To increase their fire resistance, two 3/8" gypsum boards were secured flush to the inside face of the glass and a single 5/8" sheet was used on the lower wood panel (see figure 3). New wood molding stained to match the original was placed around the border to secure and mask the edge of the added material. Mirrors were installed on upper panels facing the hotel rooms while lower panels were painted brown

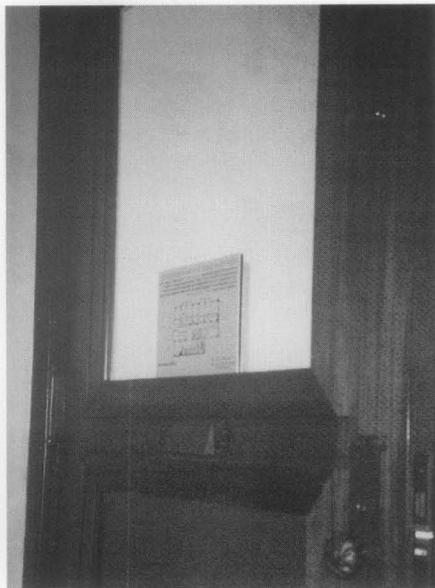
Figure 4. View of a Reliance Building office door from inside guest room. Upper and lower door panels have gypsum board secured to back with new molding. A mirror was affixed to the upper panel while the lower panel was painted to match original material. Photo: Chad Randl.

(see figure 4). Like the sidelights and transoms, the original glass was back painted with a white latex paint to conceal the infill panels from the corridor. Intumescent paint was applied between the door and frame to provide an effective smoke barrier and compensate for small irregularities in the fit of the historic doors. The mail slots were sealed and filled with a fire-rated putty. Further fire protection was provided by the installation of a sprinkler head on the corridor-side wall above each door. These heads were in addition to those specified by the building code.

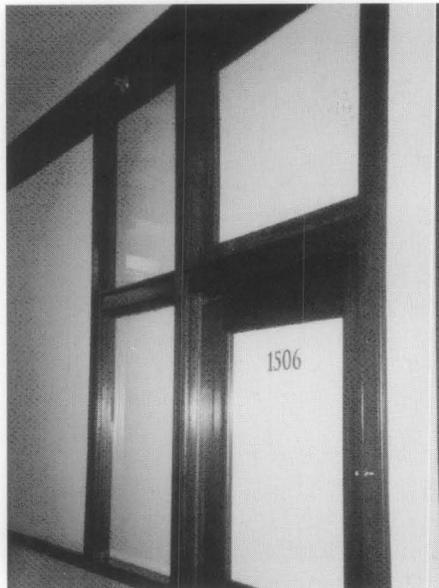
Figure 5. Completed Reliance Building corridor showing historic door panel, sidelight and transom. Photo: Chad Randl.

els, sidelights and transoms (see figure 5). New plain glass was used in locations where the original was cracked or otherwise required replacement. Room numbers were lettered on the glass with gold leaf. Finally, the direction of the door swing was reversed so that they opened inward and automatic closers were added in keeping with standard exiting code requirements.

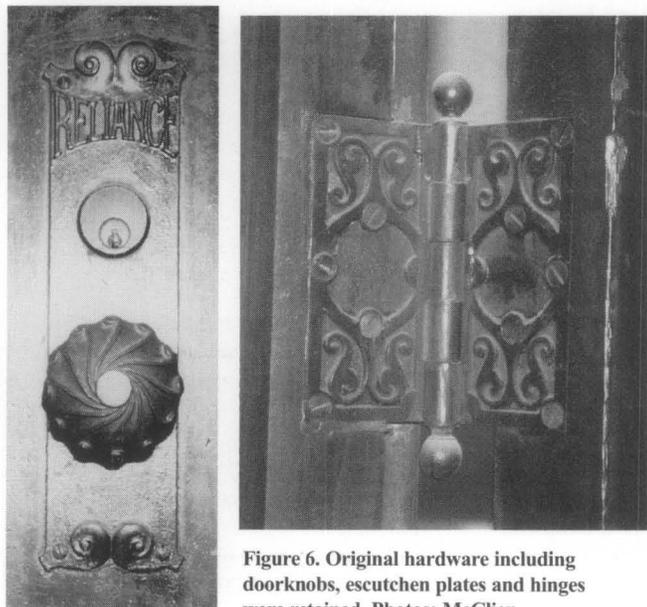
Figure 6. Original hardware including doorknobs, escutcheon plates and hinges were retained. Photos: McClier.

Retaining the doors and corridor glazing led to the preservation of a host of other features, including the mahogany trim found throughout the corridors and unique door hardware (see figure 6). Historic magnetite hinges, mail slots, doorknobs and escutcheon plates (inscribed "Reliance") were also retained.

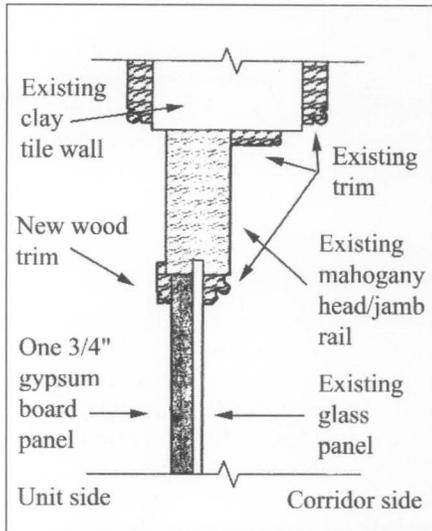
Figure 7. Section of Fisher Building door modified to improve glass panel fire rating. Drawing: Garet Stefanowski, Pappageorge/Haymes.

Door modifications paralleled those made in the Reliance Building. The interior stops were removed from the glazed areas of the doors, the original glass was cleaned and back painted, and a $3/4$ " sheet of gypsum board was secured against the glass (see figure 7). A $5/8$ " sheet of gypsum board was used

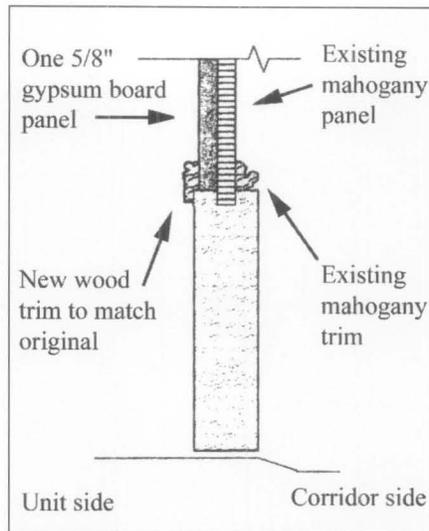
Figure 8. Section of lower wood panel with gypsum board reinforcement. Drawing: Garet Stefanowski, Pappageorge/Haymes.

behind the lower wood panel (see figure 8). Molding with profiles that were similar to those on the original door was attached at the joint between the gypsum and the original doorframe. Intumescent material was also applied to the edges of the door and doorframe (see figure 9).

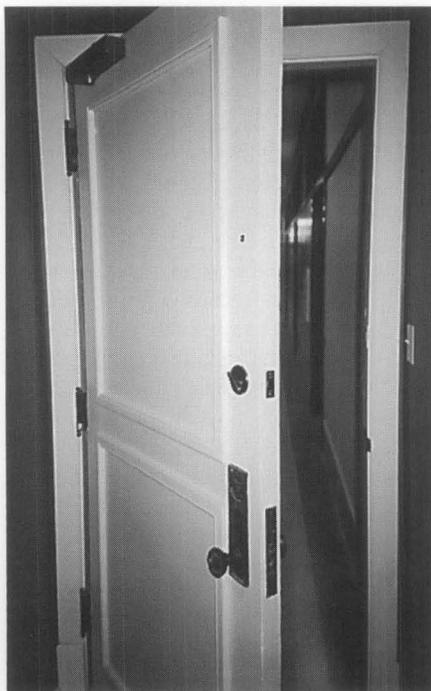
Figure 9. Fisher Building door viewed from apartment showing gypsum board infill panels, new trim and retained hardware. Photo: National Park Service File.

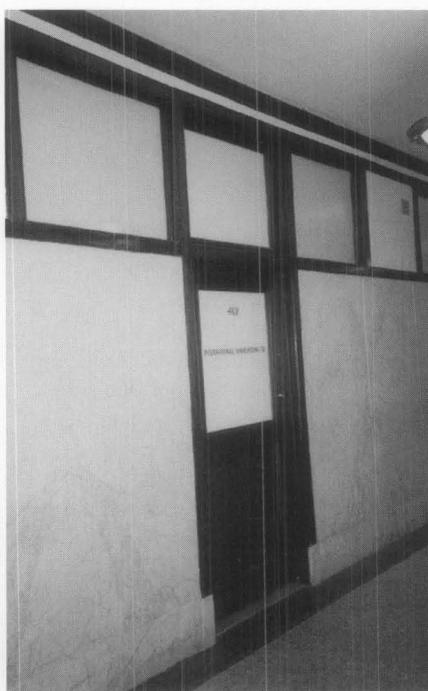
Figure 10. Completed Fisher building corridor with back painted door and tripartite transom. Photo: National Park Service File.

Following the Reliance Building model, all door hardware, including hinges, knobs, escutcheons and mail slots (where present) were preserved and incorporated into the rehabilitated doors (see figure 10). New deadbolt locks and peepholes were added to the door stiles above the original knobs. Automatic closers were added to all doors.

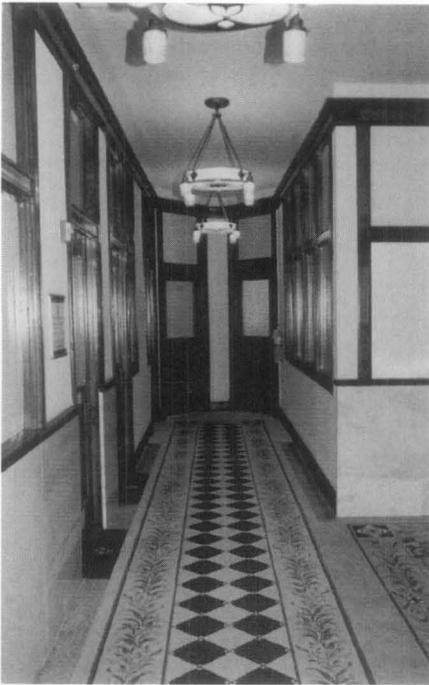
Figure 11. View of the completed Reliance Building corridor. Photo: McClier.

By introducing new fire resistant assemblies and mechanical upgrades in the already altered office spaces, there was no impact upon the scale of the corridors and the views along their length (see figure 11). Although the construction of new interior walls preserved the transoms and sidelights and the continued appearance of the corridor, it did obscure the glazed areas and their moldings from inside the former tenant space. Painting the inside face of the glass panels also resulted in a visual change in the corridor. Back painting was necessary in order to hide the gypsum infill panels, but the result lacked depth and failed to suggest the original office space within. The change was less noticeable in areas with patterned glass where the texture provided some relief from the flat, spandrel-like appearance of the new assembly. Covering the glazed panels with solid materials also darkened what were once daylight-flooded corridor spaces.
