Tech Notes

MUSEUM COLLECTION STORAGE

FORT PULASKI NATIONAL MONUMENT

Museum Collection Storage in an Historic Building Using a Prefabricated Structure

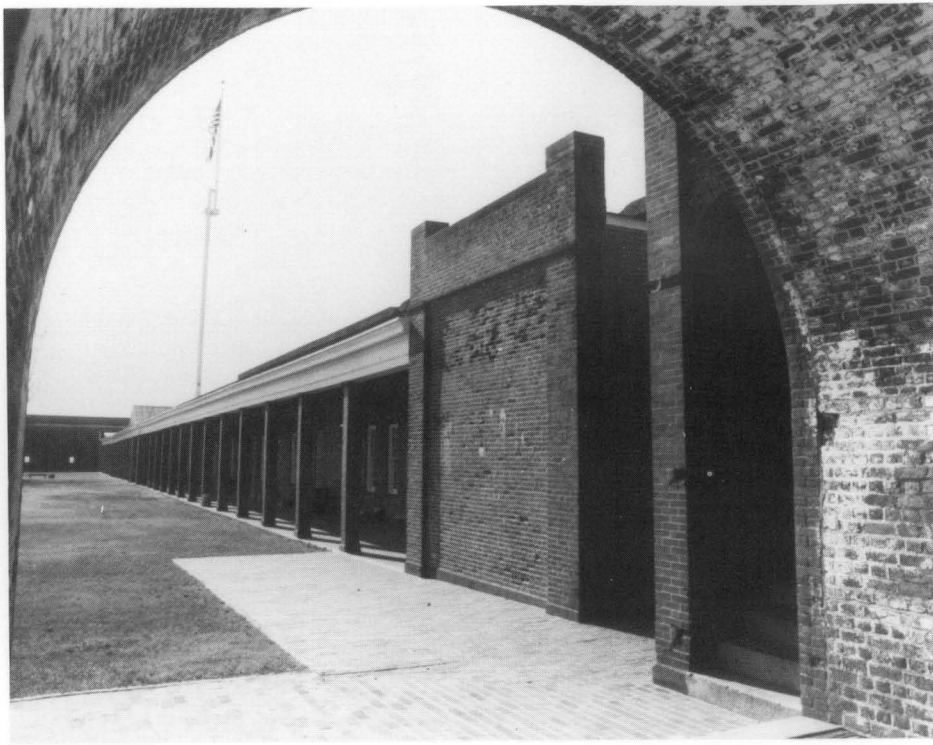
Figure 2. View from one of the open casemates, looking across a portion of the parade ground. The piazza provides a covered access to the enclosed casemates which flank the sally port. It was one of these enclosed casemates (each has a door and one or two windows) that was selected to house the museum object storage facility.

The park staff decided to install within a casemate a free-standing structure that could maintain the appropriate environmental conditions necessary to preserve the collection (see figures 1 and 2). They considered both retrofitting a casemate using conventional construction methods and assembling a prefabricated structure within a casemate. A prefabricated thermally efficient structure was selected because of easy assembly, lower cost, minimal physical and visual impact on the structure, high insulation characteristics, and ease of future removal. With the assistance of the author and the staff curator of the National Park Service, Southeast Regional Office, the park staff assembled a museum storage facility within an historic casemate utilizing a commercially available prefab building system (see figure 3).

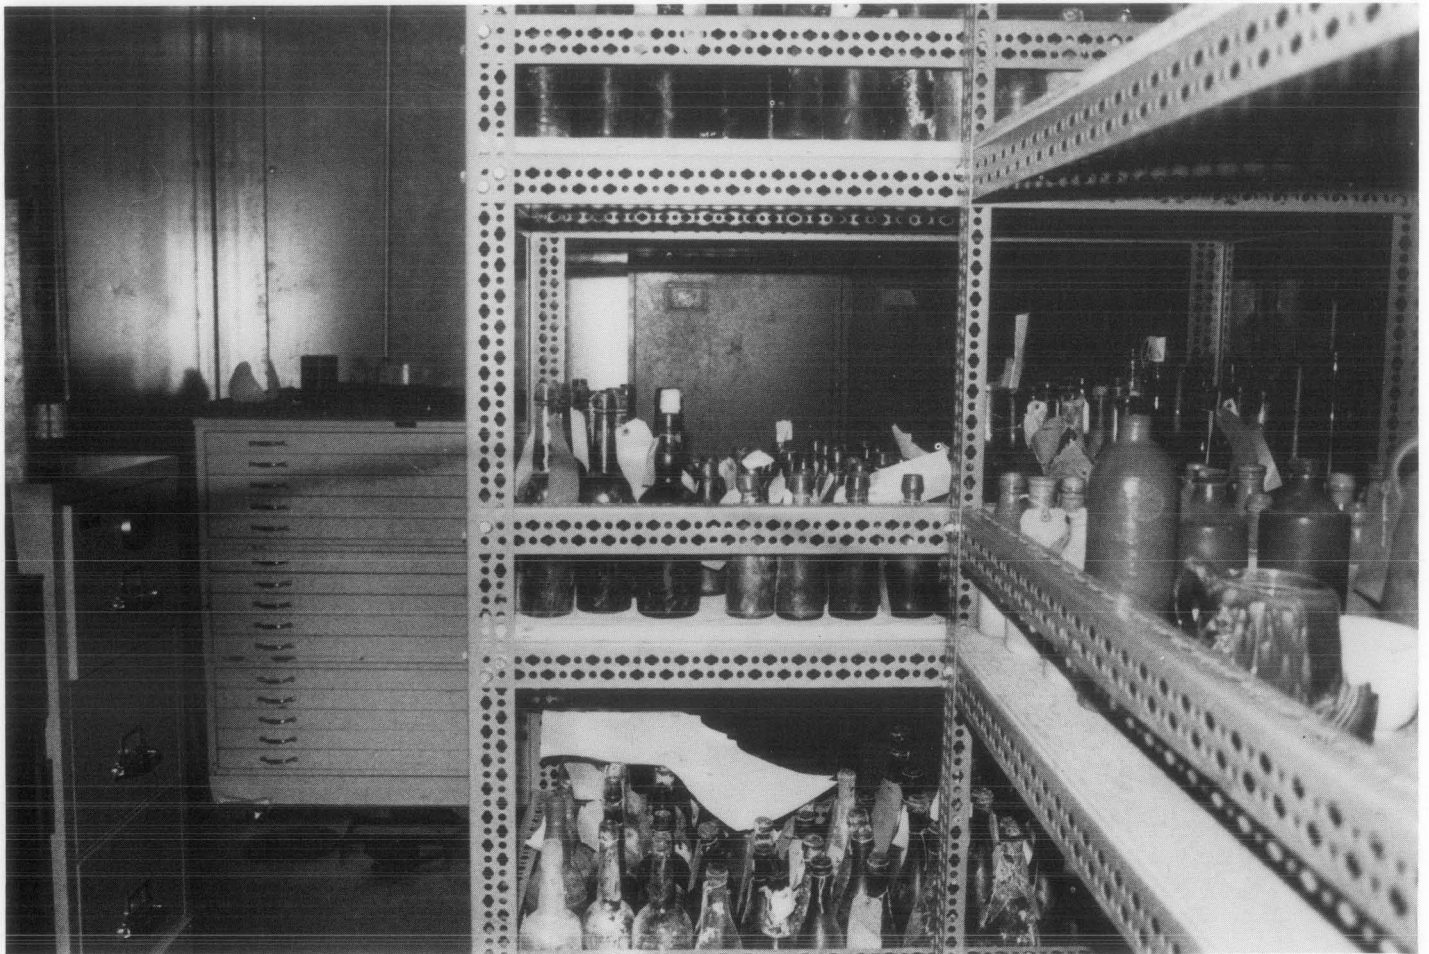
Figure 5. View inside the object storage room, showing the open steel shelving for bottles and similar objects. Beyond are the map and drawing cabinets and the insulated file cabinet for storage of museum documents. Photo: Raymond Powers

This structure provides sufficient space to house the park's museum collections and the necessary storage equipment for containing them (see figure 5). Additional benefits of this system are its flexibility for future enlargement (up to the limits of the historic casemate) if the museum col-
