# TEMPORARY PROTECTION

**NUMBER 2**

Specifying Temporary Protection of Historic Interiors During Construction and Repair

Dale H. Frens, AIA Frens and Frens

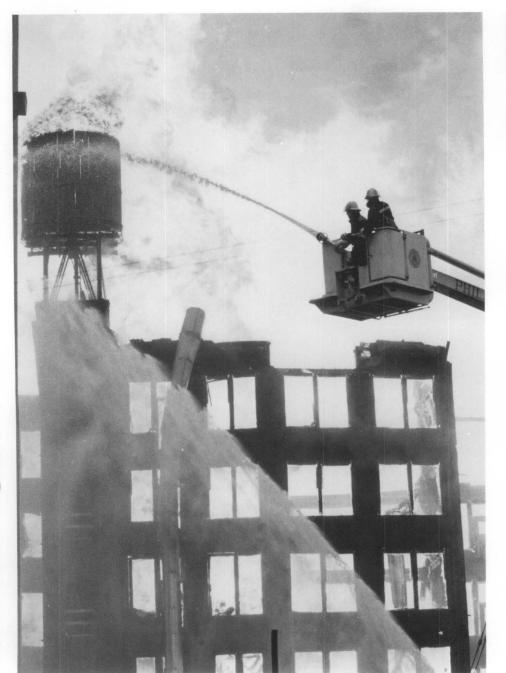
Fire poses the greatest risk of sudden catastrophic loss during construction activities in existing buildings. Just one of numerous examples is the 1985 Harrison Court fire in Philadelphia, in which a blocklong National Register warehouse building undergoing rehabilitation burned to the ground (see cover photo). The fire was caused by sparks from cutting torches that were being used during selective interior demolition work.

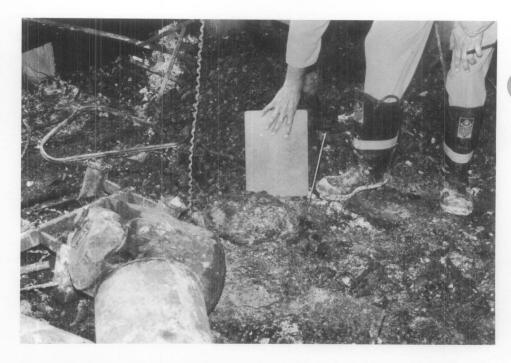
Figure 1. The spontaneous combustion of cloth rags that had been used in applying a common finishing wax caused over \$1 million damage to a historic government office building in 1991. Remains of the trash can where the rags had been stored overnight is indicated by the fireman's notepad. After the cause of the fire was determined, a standard specification provision was developed for future contracts requiring the contractor to remove all material contaminated with finishing products from the site at the end of the day.

struction activities, including new construction, NFPA 241 should be a reference standard in any selective demolition specification, and a foundation for addressing fire safety on building rehabilitation sites. Additional guidance is available in NFPA 914: *Rehabilitation and Adaptive Reuse of Historic Structures*. When these are utilized as reference standards, the historic building owner should obtain and enforce their recommendations (see figure 1).

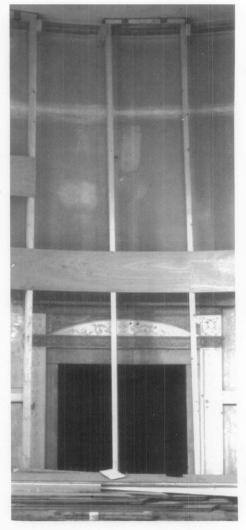
Figure 3. Vibrations generated during construction may necessitate the installation of temporary support for such fragile features as plaster ceiling cornices and soffits. Drawing: Villard Houses — courtesy of Emery Roth & Sons Architects. P.C. Photo: The Octagon, Lonnie Hovey, AIA.

Important architectural features which are easily removed should be stored off site, if possible, to protect them from vandalism, theft and damage during construction. Lighting fixtures, fireplace mantels, and interior doors are typical examples. Less movable architectural material or finishes such as wallpaper are often best retained in place but may require custom-designed protective measures developed and monitored by a conservator (see figure 3).

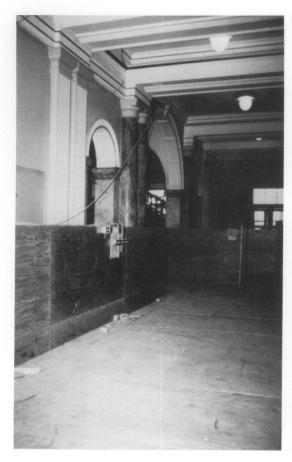
Figure 5. To provide for adequate floor protection in the New Jersey State Capitol, this area was swept clean, then covered with polyethylene sheeting to protect against spills and dirt abrasion. Fiberboard (1/2" thick) was placed over floors and the joints sealed with tape. Finally 1/2" plywood was laid with all joints taped. This floor protection system has been successful over many years of use and is recommended in major construction areas, and where tile, marble, parquetry wood, or other historic flooring is involved. Photo and drawing: Ford Farewell Mills and Gatsch Architects.

Flooring should be protected from damage caused by abrasion, falling objects,

dust and dirt, and spilled liquids (see figure 5). If work in, or traffic through, a particular space does not involve one or more of these risks, temporary protection may be reduced. Damage caused by abrasion can be controlled by means of protective coverings such as canvas tarps or resilient wood fiber panels. Canvas tarps should overlap and be taped at all joints. Resilient wood fiber panels should be carefully fitted with tight seams and laid continuously wall to wall. Joints should be taped to avoid displacement of the panels after setting. For added safety, resilient panels left exposed should also be fire-retardant treated to achieve a UL Class A listing for flame spread and smoke developed. Such a readily available product is N.C.F.R Homasote.

For greater protection from physical force, a layer of plywood can be applied over the Homasote panel underlayment, with joints staggered to stabilize the assembly. In this double layer assembly, the top plywood should be treated with a fire-retardant, but the underlayment need

not be. Where protection from spilled liquids is required, a layer of polyethylene sheeting should be applied between the Homasote panels and the plywood top layer. Care should be taken in planning the protection assembly to ensure that moisture from spilled liquids is not trapped against the historic flooring. Otherwise, the staining, splitting, wood-grain raising, or stone-finish destruction could potentially go undetected for months while concealed from view under the protection assembly. Care should also be taken to avoid sheet coverings such as building felt, which could potentially stain the historic flooring.

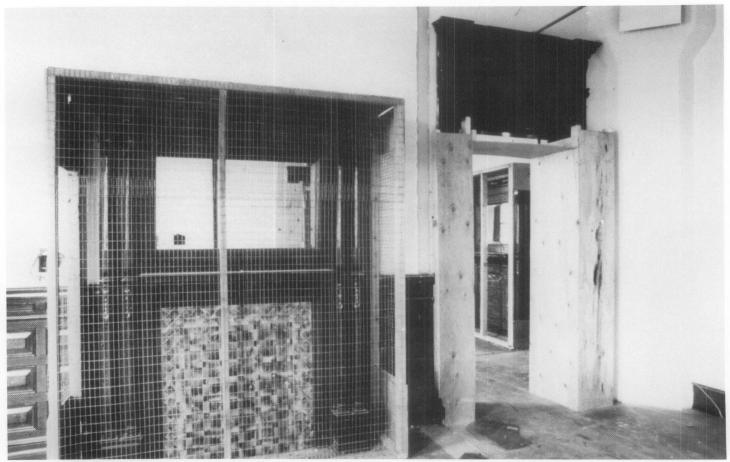
Figure 6. A self-supporting impact cage utilizing wood and wire mesh protects the fireplace. In this project, the long construction process required bidders to have visible access to features such as the fireplace. The wire mesh also facilitated monitoring during the lengthy construction. Photo and drawing: Ford Farewell Mills and Gatsch Architects.

Historic stairways, balustrades, balconies, fireplaces, door surrounds, window surrounds, and other components will also need to be protected from construction damage by combining the techniques described for floors and walls (see figure 6). Horizontal surfaces should be protected as floors, and vertical assemblies treated as walls, with the major difference being the complexity of the framing required.
