**FAIRSTED**  
**Frederick Law Olmsted**  
**National Historic Site**  
**Brookline, Massachusetts**

**Tech Notes**

**NUMBER 1**

**Restoring Vine Coverage to  
Historic Buildings**

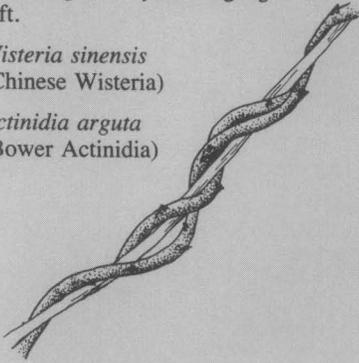
### Twining

Vines may climb by twining from left to right or by twining right to left.

growth habits. *Twining* vines climb by sending out shoots that wrap around objects and grow in both length and width. As the vine grows thicker, it can constrict these objects, causing features such as louver shutters to snap under the increasing pressure. Furthermore, the spreading shoots penetrate openings and crevices. In time, the growing vine can loosen and separate building materials.

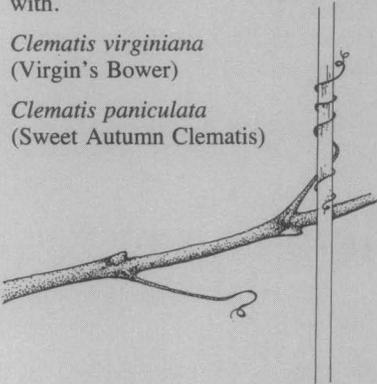
### Tendrils

The tendrils wrap themselves around anything that they come in contact with.

Like twining vines, *tendrils* wrap around objects for support. Because they are actually extended leaves, tendrils do not grow in width, only in length. Both twining and tendril vines, however, can break weather seals on wooden facades, separating wood shingles and siding, as well as fascia and soffit boards on porches. Other vine types include *Aerial* vines which grow small roots along the length of the stem. These rootlets cling to the wall and can force their way into crevices. The fineness and density of the rootlets makes

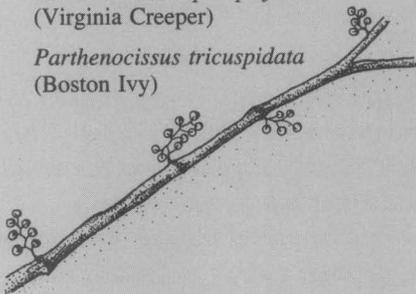
### Creeper

This vine clings by sending out small tendrils with adhesive discs that attach themselves to surfaces.

removal difficult. *Creeping* vines have tiny adhesive pads that cling to the building surface. Commonly found on masonry brick buildings, creeping vines do not generally cause extensive damage to structures while growing, although they may abrade softer mortar. However, they attach themselves so thoroughly to the building surface that paint, mortar, and brick are likely to be damaged when the vines are removed.

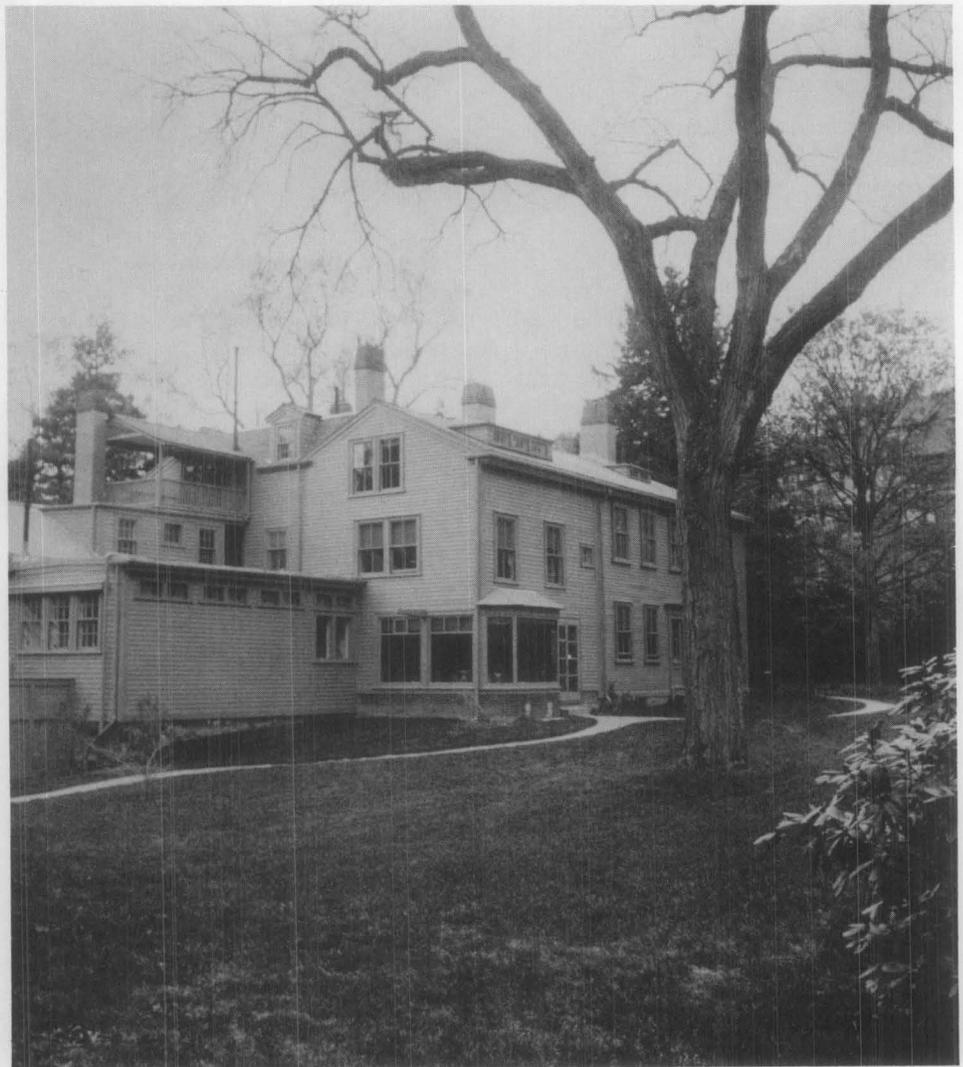
Figure 1. Historic plant materials can be retained while restoration of the historic structure is underway. The *Wisteria* and *Actinidia* vines that were historically used by Olmsted, were cut back during the restoration of Fairsted in 1988. Photo by Charles Pepper, courtesy of the Olmsted National Historic Site.

In 1980, The National Park Service began structural restoration of the house at Fairsted. To facilitate this work, the historic vines were removed from the facade and cut back to the ground. Since the vines were both historic plant material and an important feature of the property, complete removal was avoided. The vines were kept at ground level, but pruned frequently to prevent reattachment to the house. This situation resulted in weakened plant growth and an appearance quite different from

Olmsted's intention (*see figure 1*). Furthermore, long-term frequent pruning risked a higher incidence of pest-related problems to the plants and restricted their natural climbing habit. It was therefore important to the public site that a new trellis system be devised that would protect both the historic vegetation and the historic structure, while re-establishing the appearance of a "vine clad mansion."

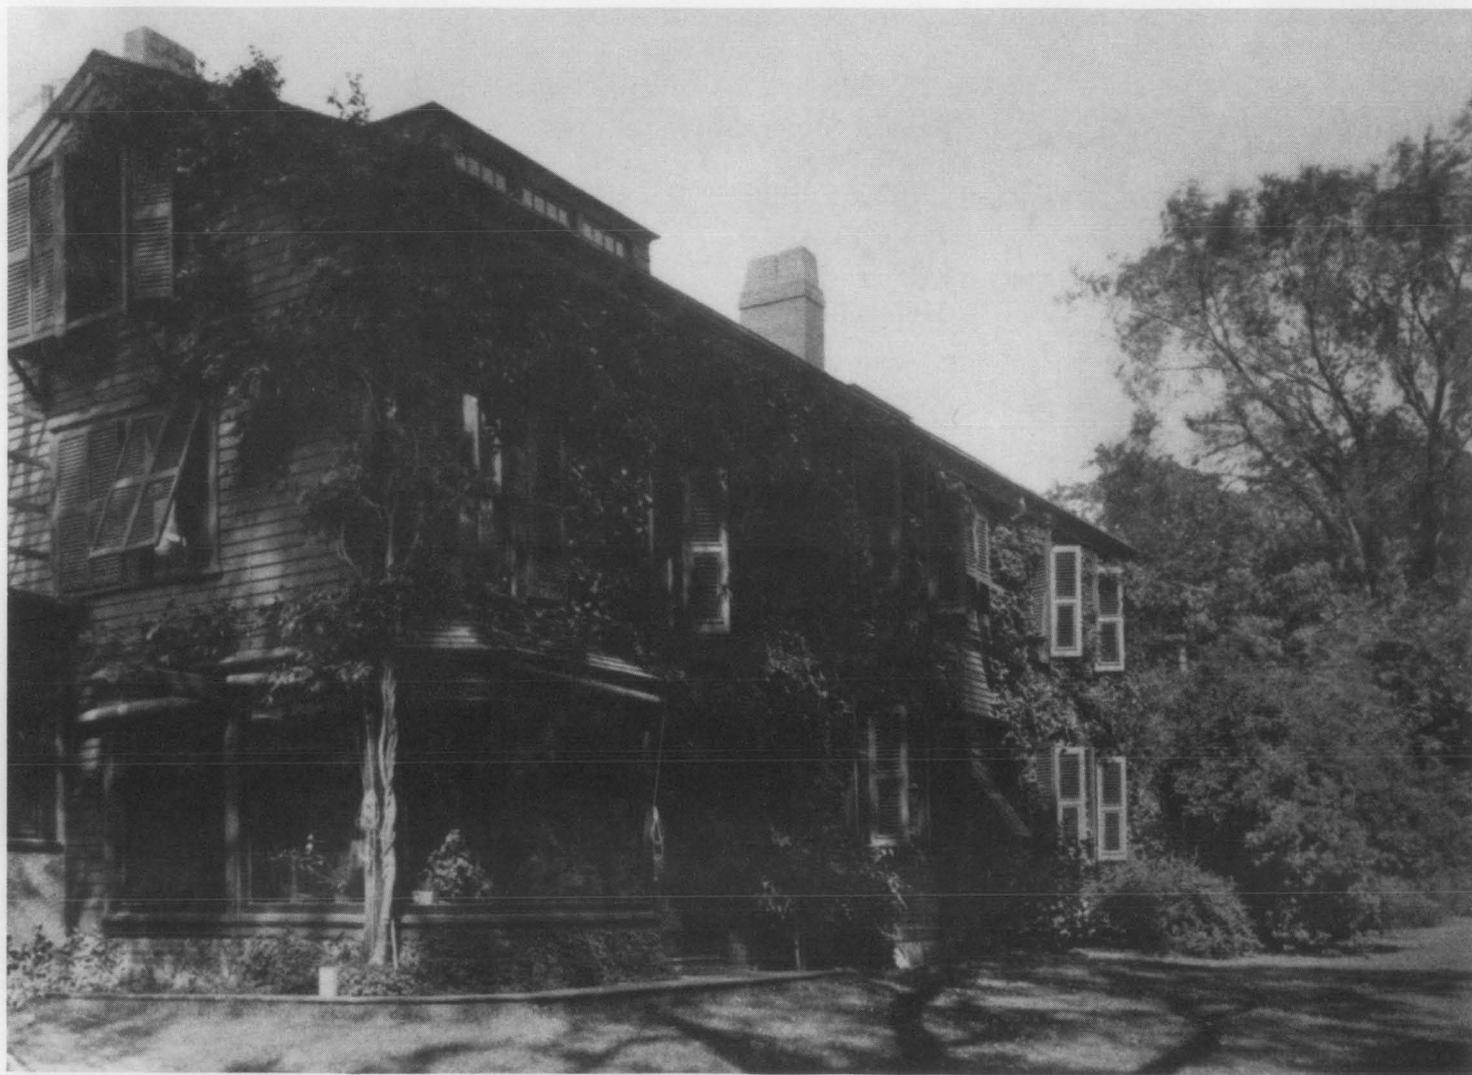
Figure 2. View of the west elevation at Fairsted which shows a steel strapping trellis system built as early as 1884. Photo courtesy of Olmsted National Historic Site.

Development of a new trellis system began with research into the materials, techniques and hardware used in New England between 1880 and 1930, as well as specific investigation into the various techniques used at Fairsted during those years. Historically, the east elevation of the house had two trellis structures supporting *Wisteria sinensis* (Chinese Wisteria). Photographs from as early as 1884 show a wooden trellis system at the entry porch and a spiraled steel strapping system along the house facade (*see figure 2*). Remnants of these

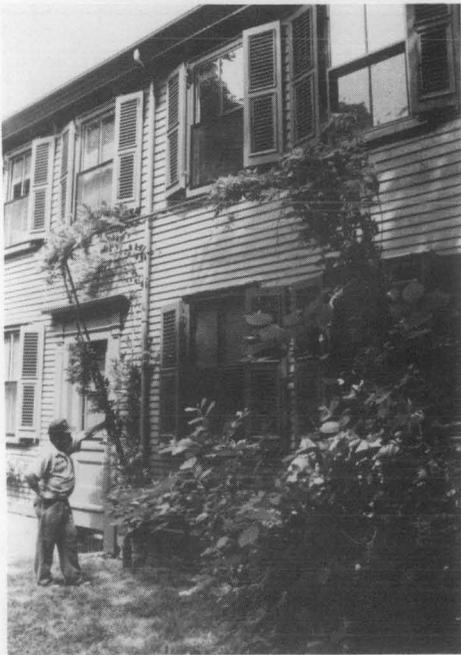
Figure 4. The pipe and strapping system, constructed with swivel sockets, allows the rigid support system to fold down away from the house. The strapping can also be removed from the pipe support for limited maintenance. Photo by Karen Day.

More than one person is required to remove this system. The rigid system folds out away from the house on the swivel sockets near the base of the house (see figure 4).

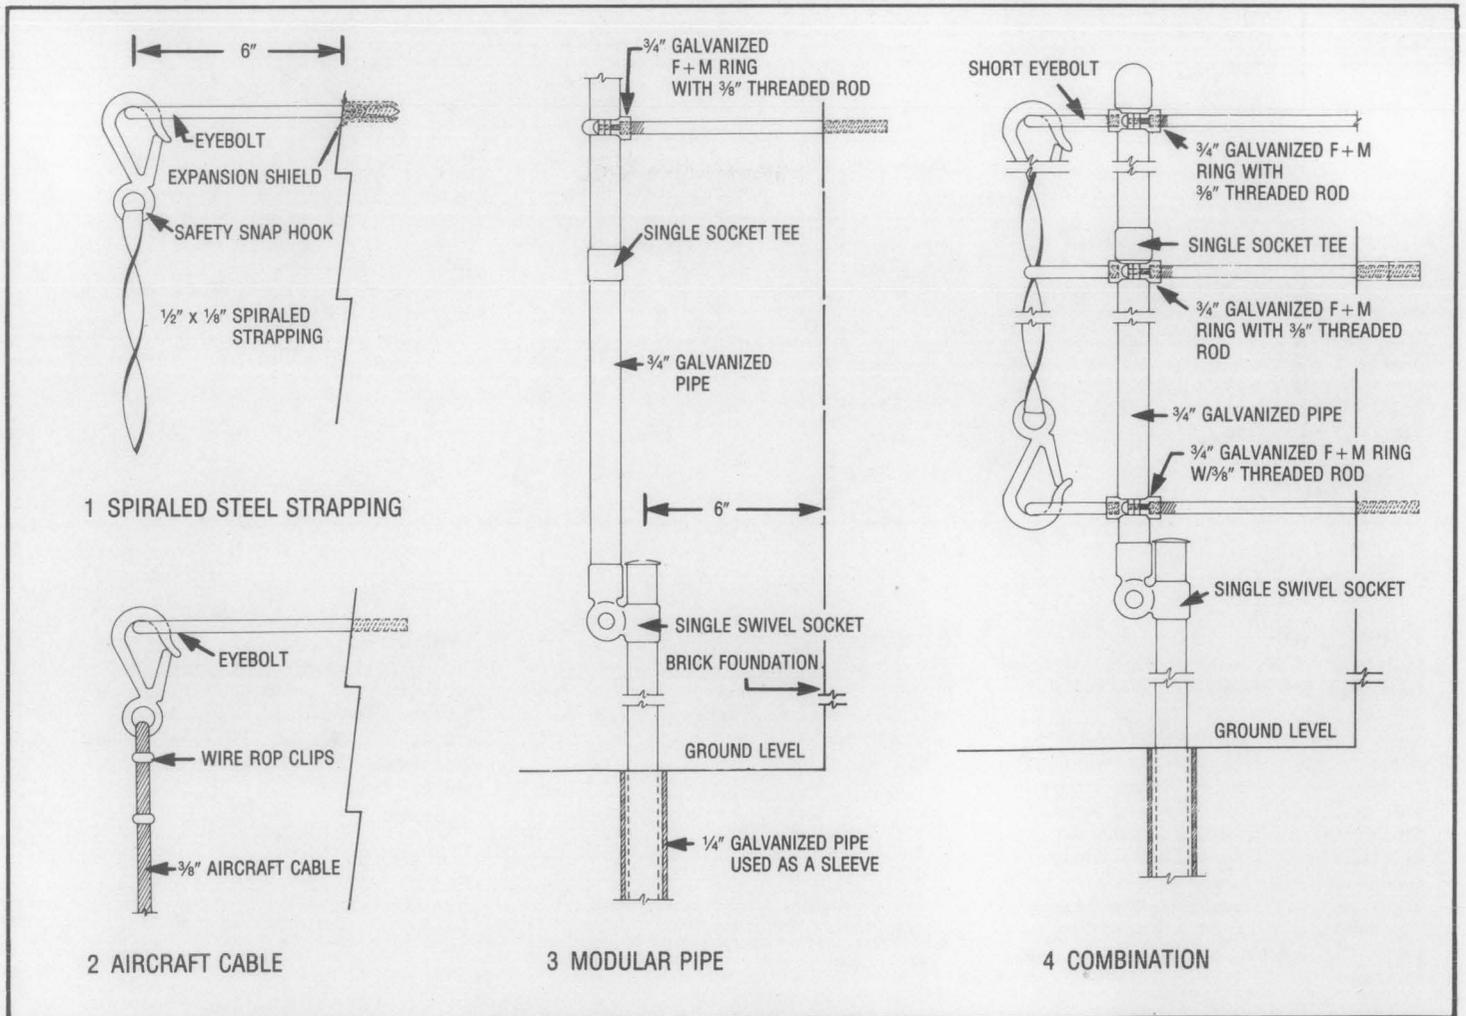
Figure 5. Details of the four experimental trellis systems. Drawings by Sharon Runner, National Park Service.

In order to meet both the above criteria and also to test alternative solutions, four different trellis systems were designed and installed for use in a two-year test phase (*see figure 3*). The first system used spiraled steel strapping; the second, aircraft cable; and the third modular pipe. The fourth system combined strapping and piping.

Materials:  $\frac{1}{8}$ " x  $\frac{1}{2}$ " spiraled steel strapping, hooks, snap hooks, eyebolts, and F & M rings. The steel strapping trellis is modeled after the historic design (c. 1885) developed by Olmsted. Spiraled metal strapping were attached to the house by a series of hooks and metal eyebolts. The eyebolts for this system, as well as the attachment devices for the other trellis systems, are held at least 6" away from the house to allow for air circulation between the plant material, trellis system and building facade. The strapping was fed through intermediate F & M rings located at regular intervals vertically and horizontally along the side of the house.

Materials:  $\frac{3}{8}$ " aircraft cable, eyebolts, and hooks.  $\frac{3}{8}$ " aircraft cable was substituted for the spiraled strapping in the first system. A system of eyebolts and hooks was used to secure the aircraft cable to the house.

Materials: galvanized metal pipe, fittings, eyebolts, and swivel sockets. This modular pipe system is composed of galvanized metal pipe and a series of pipe fittings. This system was hinged at the base to allow the rigid trellis structure to be tilted away from the house. The support pipes were anchored in the ground by inserting them in galvanized metal sleeves that were placed 4' below the ground surface and 6" away from the house. The top portion of the trellis structure was secured to the house by a bolt and clamp combination.

Materials: spiraled steel strapping, galvanized metal pipe, fittings, eyebolts, and swivel sockets. This solution is a combination of spiraled strapping, galvanized metal pipe and fittings. Eyebolts will separate the strapping from the supporting pipe structure. Swivel sockets near the base of the pipe structure allow the trellis to be tilted away from the house. This combination system provides a historic trellis appearance with the addition of rigid support. The vines are physically separated from the house, thus reducing potential damage to the facade.

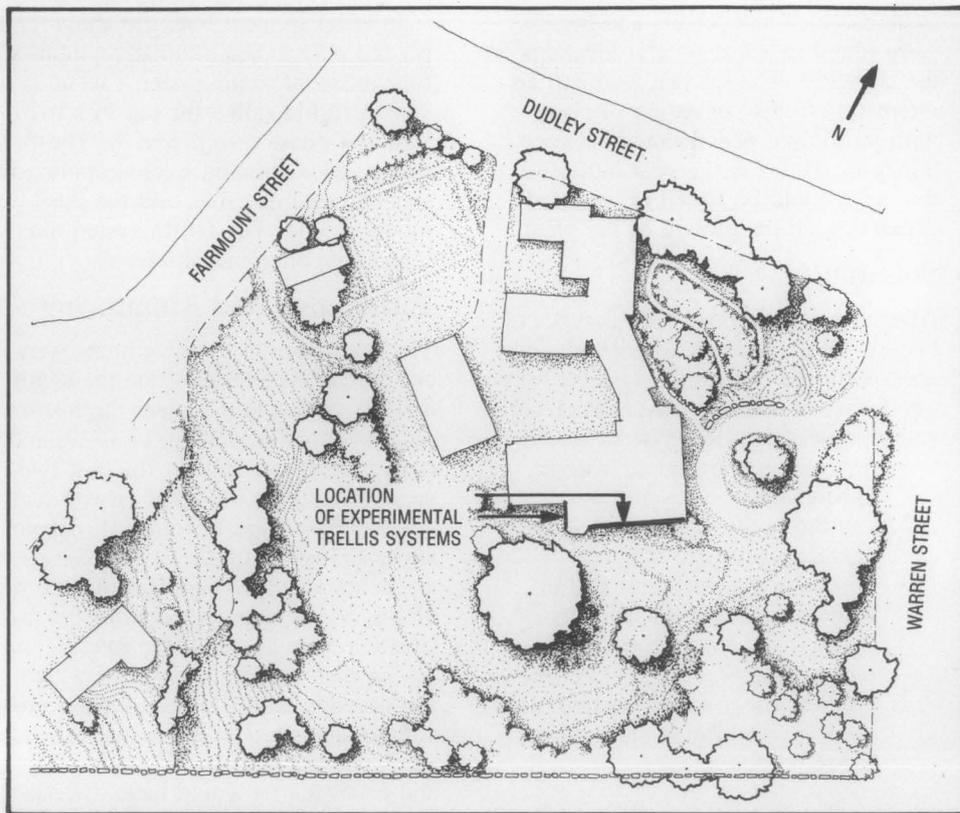
Figure 6. Site plan of Fairsted; the experimental trellis systems were installed on the south and west elevations. Drawing by Karen Day.

The experimental trellis systems were constructed and installed on the south and west elevations (where the historic plant material is located) in 1989, and have been monitored for the past two years (*see figure 6*). Plant growth and development, ease of removal, appearance, and effect on the historic structure are being observed and documented regularly. Some recommendations for modification have already been made.

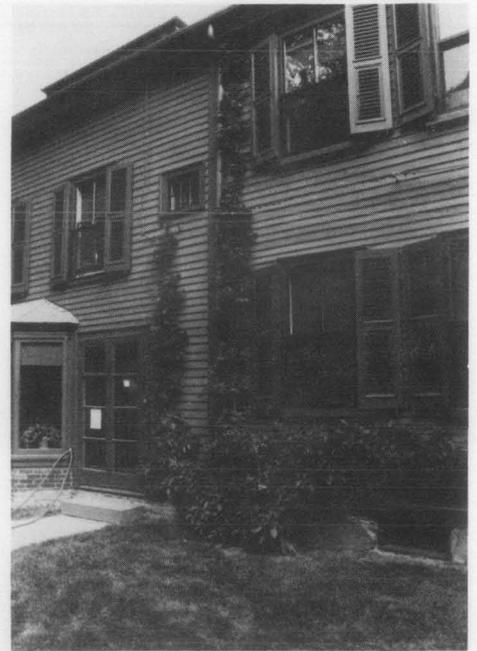
Figure 7. View of south facade, the experimental trellis systems have been in place for two growing seasons. Photo by Karen Day.

aged rapid rusting. The flexible aircraft cable (system 2), with the added weight of a mature vine will make removal and replacement difficult for one person. A temporary pulley system is recommended to aid in hoisting the vines back into place. The third design is a rigid modular pipe system (system 3). Although the rigidity of the system is advantageous to the stability of the vegetation, the weight of the vines may also be prohibitive for easy removal and replacement. The combination strapping and pipe system (system 4) does not recreate a historically accurate appearance. The system was designed in order to remove the vines on the strapping without removing the pipe supporting system. The vines growing on the strapping do not provide sufficient coverage to hide the pipe system behind. Furthermore, additional maintenance is required to keep the vines from growing on the pipe. After the multi-year test period is complete, one of the four systems will be selected, modified as needed, and installed to the east, south and west facades of the house (see figure 7).
