National Park Service Cultural Landscapes Inventory 2011

Cabin Camp 1
Prince William Forest Park

Inventory Unit Summary & Site Plan

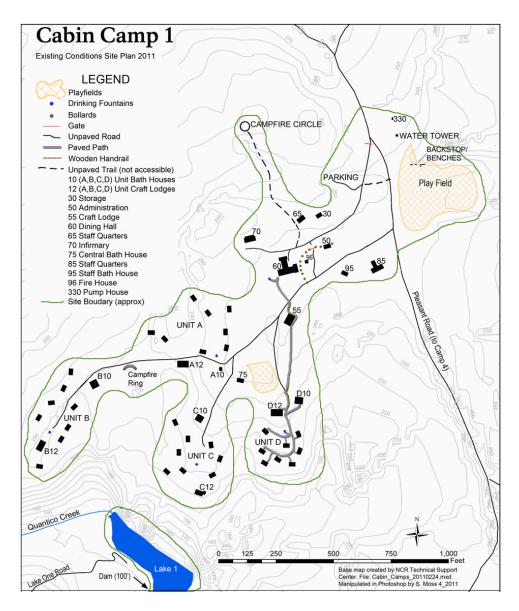
Site Plan

Existing conditions at Prince William Forest Park's Cabin Camp 1 (NCR CLP).

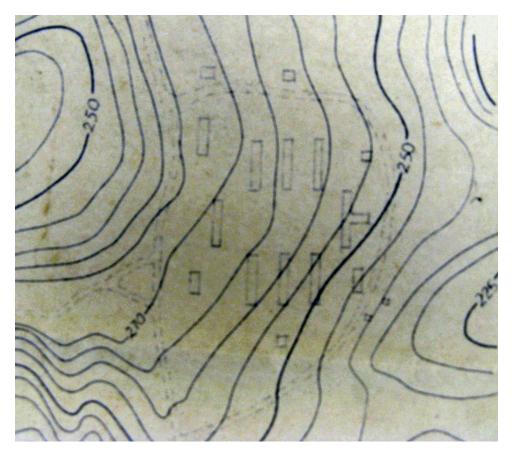
This map illustrates the CCC camp as it was layed out on what is now the play field. It derives from a map titled Chopawamsic SP-22 Boy's Area (PRWI Archives).

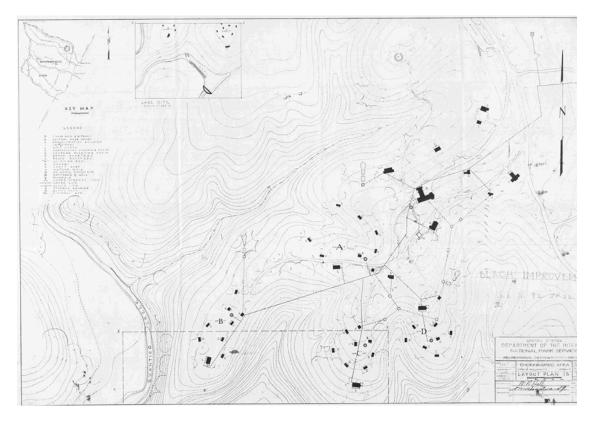
1937 map Chopawamsic Area Layout Plan 1-B illustrates infrastructure, beach improvement and building placement (PRWI Archives).

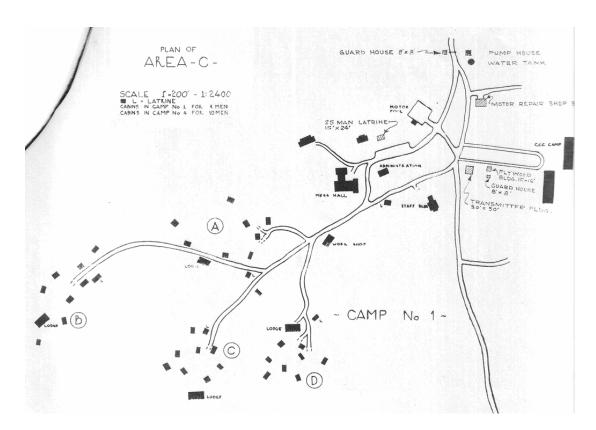
Map of Cabin Camp 1 during OSS occupation. At this time it was known as Training Area C-1. OSS buildings on this map are light in color. CCC buildings are shown in black (PRWI Archives).

"In addition to winterization and other alterations in existing buildings at the cabin camp, the OSS erected several new wooden structures at C-1. A radio repair shop was the largest, a portable, plywood building measured 16 by 16 feet and may have served as a classroom. Smaller new structures included a radio transmitter building and two guard houses, one at the main gate and one at the northern end of Area C-1. As completed for use by OSS's Communications Branch, Area C-1 included an administration building, two buildings serving as quarters for 16 officers, a drivers' quarters holding six enlisted men, a garage, a work shop, five washroom/latrines, a mess hall, a lodge, and a series of huts as well as two, 12-man barracks for enlisted men on the staff. In addition, there was a radio transmitter station in a building in the D cluster of cabins There was also another transmitter station, perhaps the main radio transmitter, in what was identified as an old CCC camp (probably the abandoned CCC work camp SP-22) across the road and a little more than 100 yards east of administration building at the entrance to Area C-1. Both the transmitters and the receiver stations were powered by electrical generators and were equipped with sizable antennas, long poles with radio antenna aerials on them." (Chambers 169, 170)

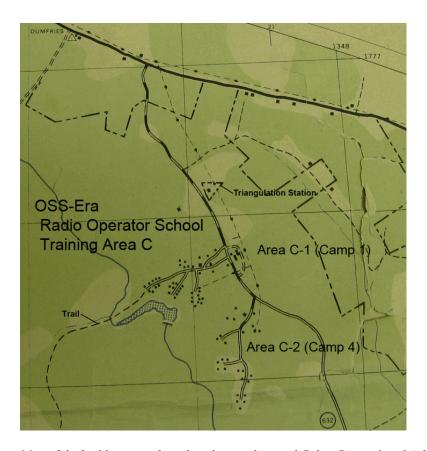
Map of the buildings, roads and trails in and around Cabin Camps 1 and 4, known as Training Area C during the OSS occupation (PRWI Archives).

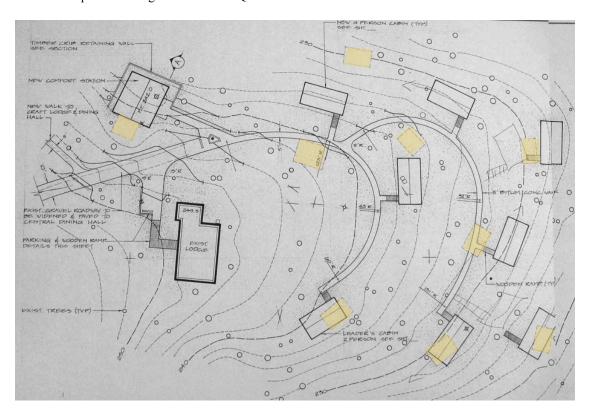
All cabins in Cabin Camp 1 were replaced in the 1980s. Yellow boxes indicate the footprints of the old cabins. Unit D was made accessible with the construction of paved paths. (DWG #860 41,029, 2/1983. PRWI Archives).

In the 1980s two major construction projects impacted Cabin Camp 1. The first was the rehabilitation of 16 buildings in circa 1980. Several ramps, posts and rails were installed, roofs were re-shingled and gutters were put in. The central, staff and Unit A bath houses were also rehabilitated. In circa 1983 a second rehabilitation project was undertaken at Cabin Camp 1. This project called for the demolition of each CCC-built sleeping cabin. The cabins were in poor condition. They were falling down and could not be rented out for group camping. At the time they were not considered historically important. The historic cabins were replaced with the extant cabins on site today. This project also included the replacement of the bath houses in

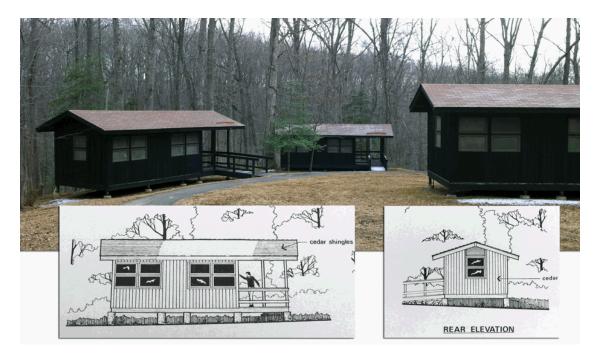
As part of a circa 1983 rehabilitation project, all of the sleeping cabins in Cabin Camp 1 were razed and replaced with the models seen in these photographs taken in Unit D (photos NCR CLP, Drawings 860_41,029 sheet 5 of 7 2/1983. PRWI Archives).

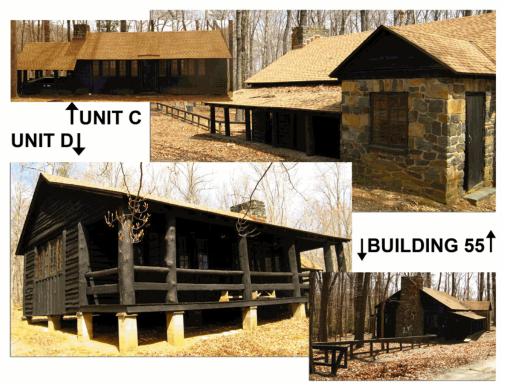
The main craft lodge (building 55) makes the most use of local stone of any CCC-built structure in the entire park. Craft lodges were gathering places with porches that allowed children access to the outside even in inclement weather (NCR CLP 2011).

The most substantial of the craft lodges in PRWI is found in Cabin Camp 1. Located on the main entrance road opposite the Dining Hall, it is a one-story structure with an 'L' plan. Of all of the CCC-built structures within the park, this building displays the most use of local stone (stone was quarried at the Cabin Branch Mine on the eastern border of the park). It is a frame structure, on a concrete foundation, with vertical and horizontal waney board siding. Its main facade features a dropped porch, a shed roof covered with architectural shingles, walks of fieldstone, three pairs of double doors with vertical window, hand-wrought iron strap hinges on the southeast elevation leading to the porch and oversized double wood doors. A stone-clad one-story projecting bay is found on the building's west elevation. It is pierced by paired eight-light wood-sash casement windows. The northern end of the west elevation is fronted by a five-bay shed porch supported by rounded log posts set on a fieldstone retaining wall. A three-bay shed porch is located on the east. The inside boasts two roof trusses with kingpost and iron bracing, a stone hearth and a concrete floor. It was built in 1937 for \$793 (Leach Camp 1 sect 7 page 7, LCS 045265).

The building was altered by the Army in 1942-1943 and by the NPS in circa 1980 when a ramp entry was installed in (A rehab of 16 buildings was undertaken in the early 1980s. Plans were approved in 1980 but the exact date of actual construction is unclear). Some stabilization was completed in 2006c. This included stripping the roof and replacing rotted roof planks, window repair, resetting of the fireplace hearth stone and installation of new siding.

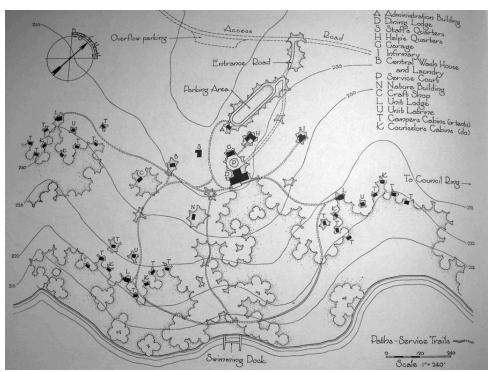
Albert Good's book illustrates the "hub and spoke" layout that can be seen in the relationship between the camp center and the individual units. This layout is repeated at Chopawamsic which was considered a model RDA (Good, plate III H-3, section 3, 116).

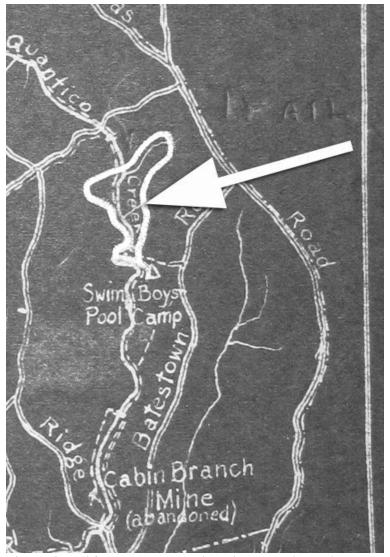
Three mile trail from a 1938 CCC Job Application and Completion Record (PRWI Archives).

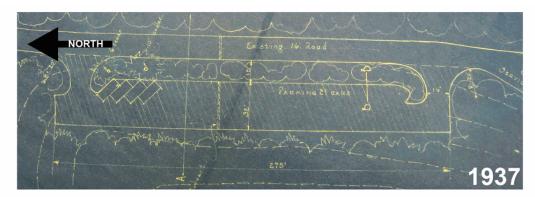
Parking lot as drawn on a 1937 site plan (top) and as seen today (bottom) (Visitors' Parking Area 1-B, PRWI Archives, NCR CLP 2011).

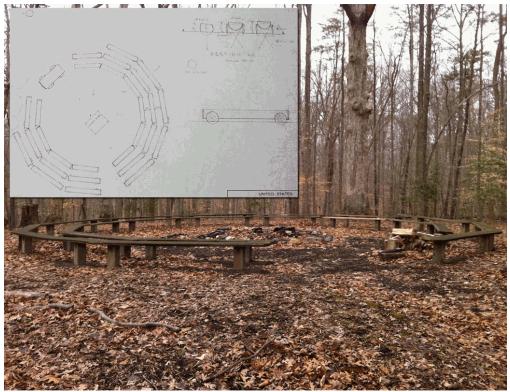
Campfire Circle on the north side of Cabin Camp 1 as it looked in 2011 and in a drawing from 1937 (Campfire Circle 1-B approved 6/30/37 PRWI Archives, NCR CLP 2011).

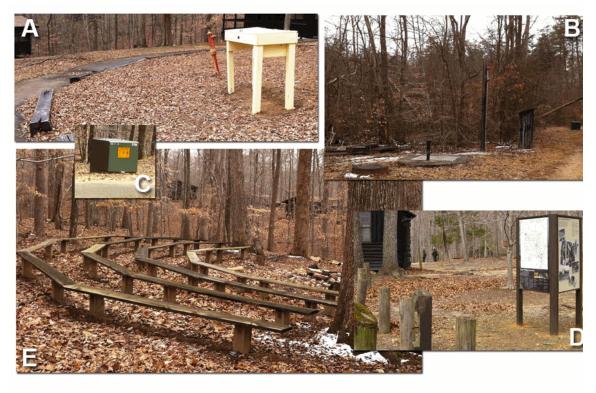
Non historic Small-scale features at Cabin Camp 1 include (A) timber curbing, (B) fire stands and boxes, (C) utility structures, (D) the interpretation panel, bollards and the (E) campfire ring between Units C and B (NCR CLP 2011).

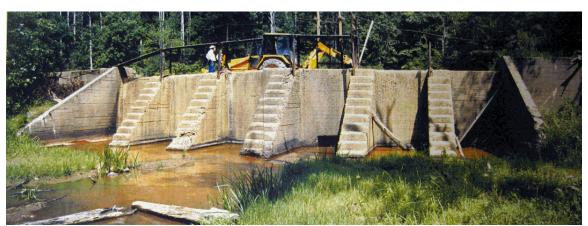
Downstream face of the dam and spillway section (1996 Examination Report PRWI archives).

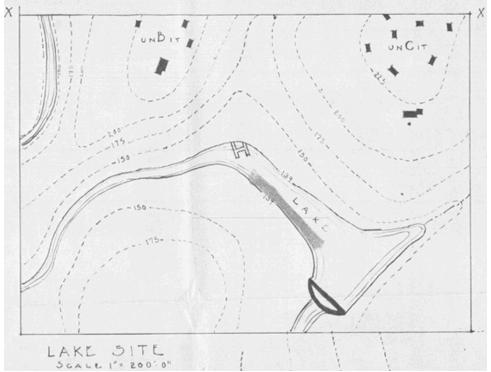
1937 site plan illustrating the lake site at Cabin Camp 1. Here both an H-shaped dock and the dam are evident. There is not, however, a path or a bridge in this drawing (Layout Plan 1-B PRWI Archives).

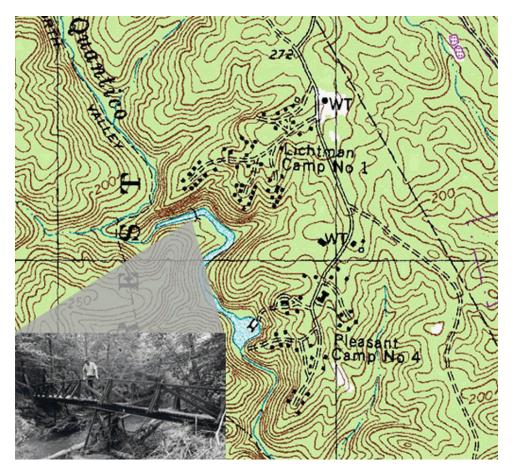
Map with bridge location and inset photograph of what is likely the bridge across Quantico Creek at CC1 (PRWI Archives).

A report of a bridge that reportedly washed away in the late 1980s/early 1990s but was possibly mistakenly inventoried in 1998 was recorded by an LCS team. The

report (titled Camp #4 pedestrian bridge 45253) was moved into the shadow database. This bridge was described as connecting Camps 1 and 4. No more information about the bridge's exact location was given. Under the Management Description section of the LCS report admits that there may have been a mistake with regards to the inventory. At this time no further information has been found on this bridge.
