CULTURAL LANDSCAPES INVENTORY

Elk Prairie Landscape

Redwood National Park

Prairie Creek Redwoods State Park

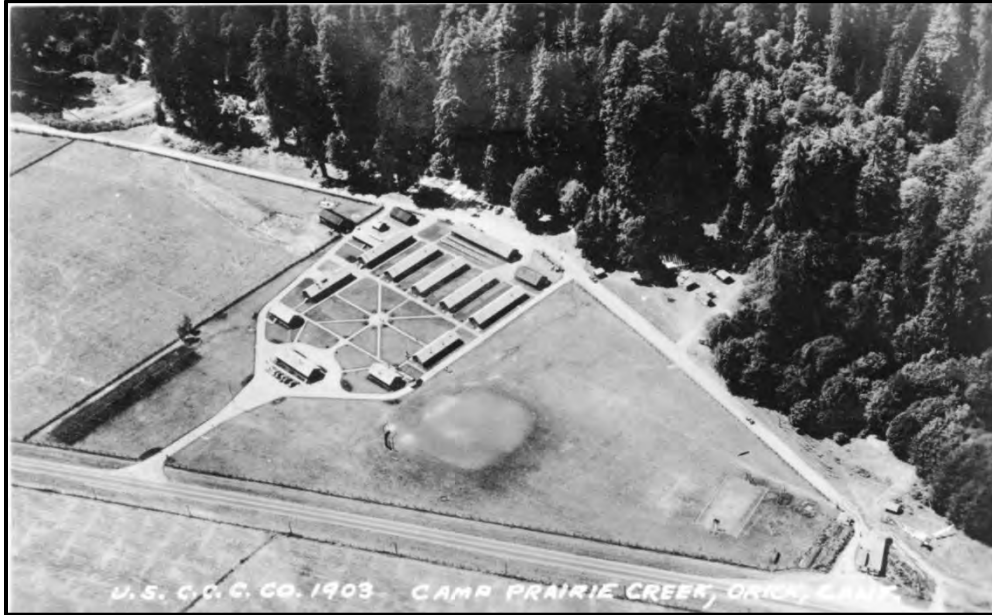
Figure 8. Aerial view of CCC Company 1903's camp, ca. 1934-35. Source: Redwood National and State Parks.

Company 1903’s camp complex included approximately 18 buildings (four barracks, a mess hall, a headquarters building, a supply store, a medical building, a latrine/laundry, and several unidentified buildings) which were arranged around the edges of a rectangular-shaped open space, or courtyard, which was planted with grass. The outer edges of this courtyard were defined by unpaved paths. At its center was an unpaved circle with a flagpole. Paths radiated out from the circle (like spokes on a wheel) dividing the courtyard and providing formal pedestrian connections to the buildings. An unpaved entrance road, which aligned with the center of the building compound, connected the complex to the Redwood Highway; it forked at the east end of the complex and then ran along the north and south sides of the compound. The open field to the north of the CCC complex contained a baseball diamond and a basketball court. A picket fence ran along the south side of the complex, and a split rail fence was added to both sides of the Redwood Highway near the edges of the prairie.<sup>112</sup> Refer to Figures 8, 9, and 10 for photographs of the camp complex and to Figure 11 for a view of the split rail fence.

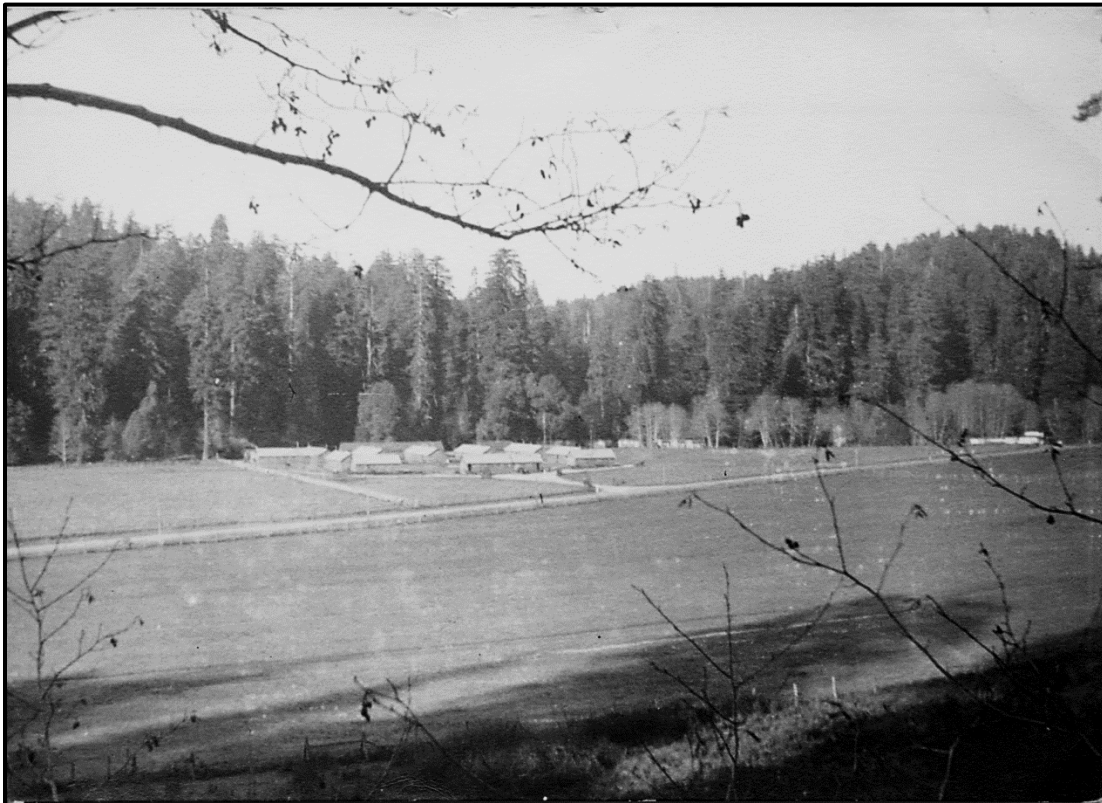
Figure 9. View to the north across the prairie to CCC Company 1903's camp, ca. 1934-35. Source: Redwood National and State Parks.

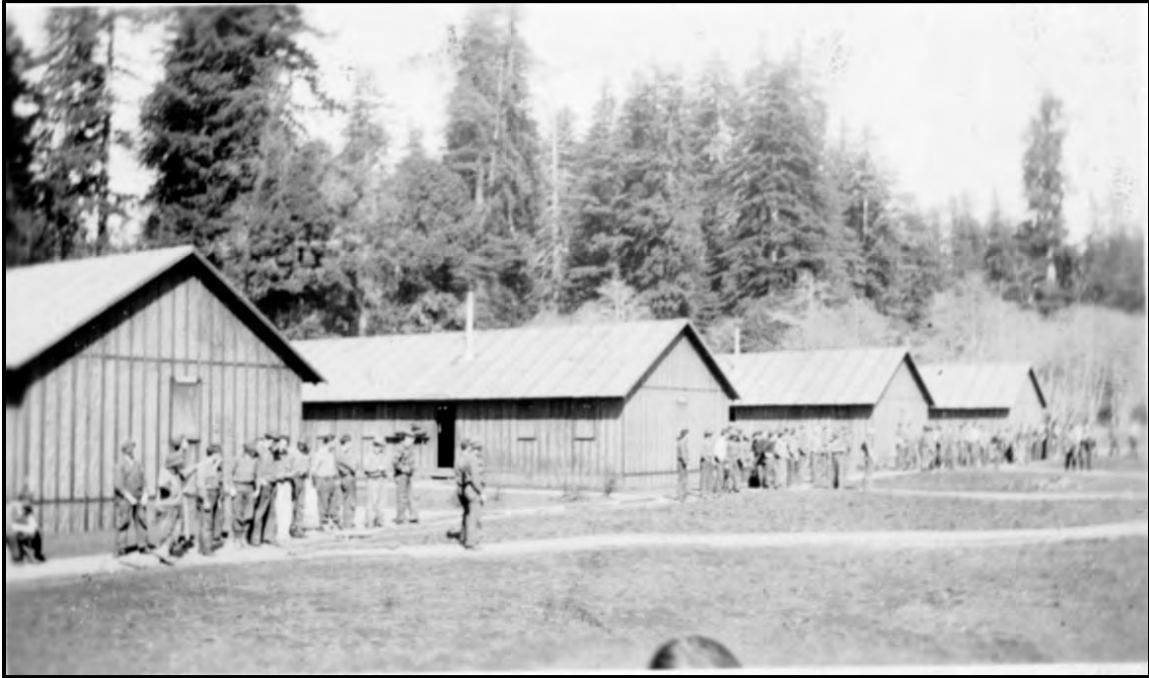
Figure 10. View to the north of the row of barracks in CCC Company 1903's camp, ca. 1934-35. Source: Redwood National and State Parks.

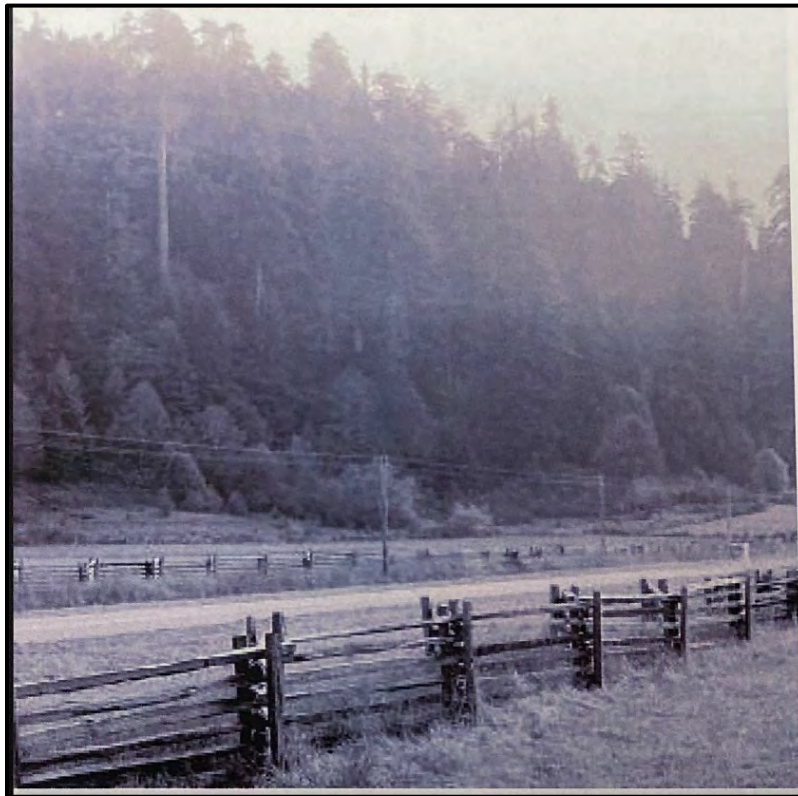
Figure 11. Split rail fence added by CCC along both sides of the Redwood Highway, April 1936. Source: California State Parks, North Coast Redwoods District Collection.

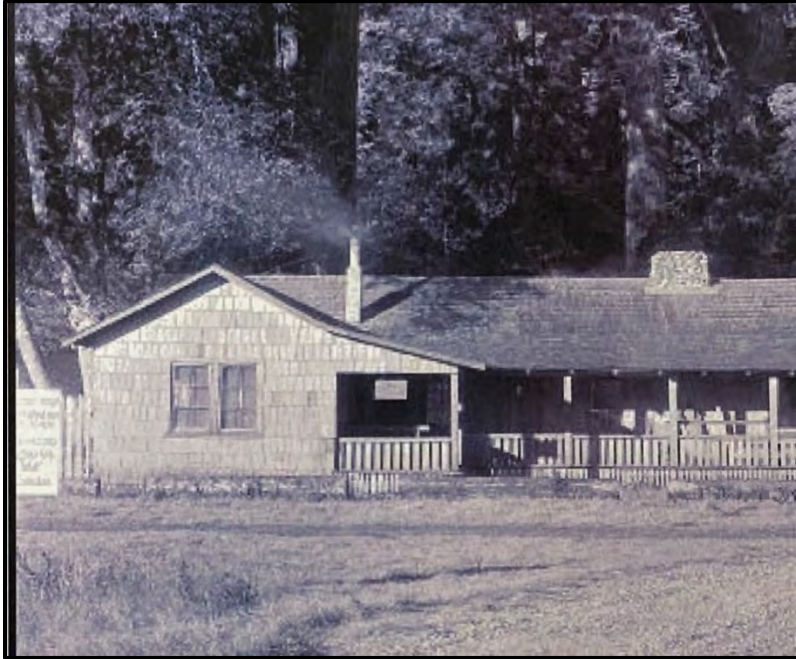
Figure 12. Park Custodian's Residence (Visitors Center), April 1936. Source: California State Parks, North Coast Redwoods District Collection.

The Visitors Center – originally the Park Custodian’s Residence – is a single-story, wood-frame building with an L-shaped plan. It rests on a post-and-pier foundation and has a covered porch located at the inside of the ell. The porch features wood post support and hand-cut wood balusters for the railing. The building has cross-gable roof topped with wood shake, and exterior walls are clad with redwood shingles. A shed roof extension with porch – apparently part of the original construction – is located at the rear of the building. Windows throughout are multiple-light with wood frames in fixed and casement configurations, and there are various types of personnel doors located throughout the building – some possibly original and some recent replacements. Refer to Figure 12 for a photograph of the Visitors Center soon after its construction and Figure 53 for a current of this building.

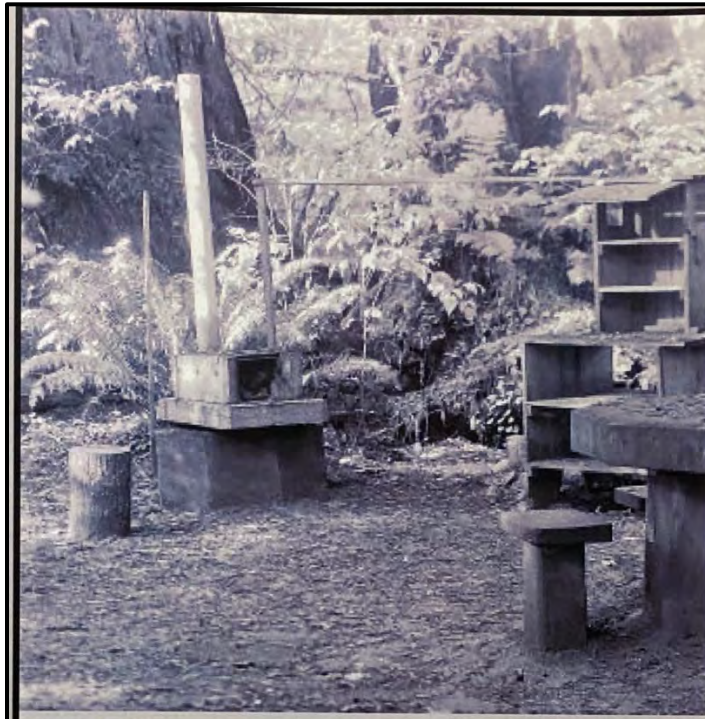
Figure 13. Campsite furnishings in the CCC-era campground, April 1936. Source: California State Parks, North Coast Redwoods District Collection.

The arrangement of the CCC-era campsites was informal; they were laid out along both sides of the road but were placed at random distances from the road. The roads and paths were unpaved, and there were no formal designations for where automobiles parked within each campsite or within the campground. The campground was situated under the forest canopy, and the CCC added native understory vegetation including ferns, rhododendrons, and other native plants and shrubs as part of their work. The CCC hand built the site furnishings and signs from native materials—primarily wood—that gave them a rustic appearance that was consistent with the character of the small toilet buildings and the Visitors Center and Garage. These buildings were constructed of local hand-hewn timber with timber shingles for siding and roof.<sup>114</sup> Refer to Figures 13, 14, and 15 for photographs of the campground and to Figure 16 for the campground's layout.<sup>115</sup>

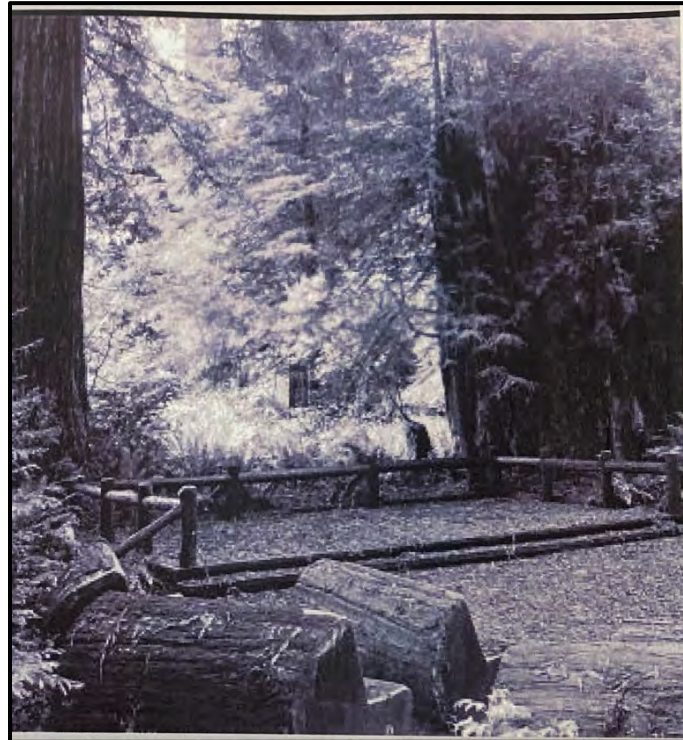
Figure 14. Outdoor stage and log benches in the CCC-era campground, ca. 1935. Source: California State Parks, North Coast Redwoods District Collection.

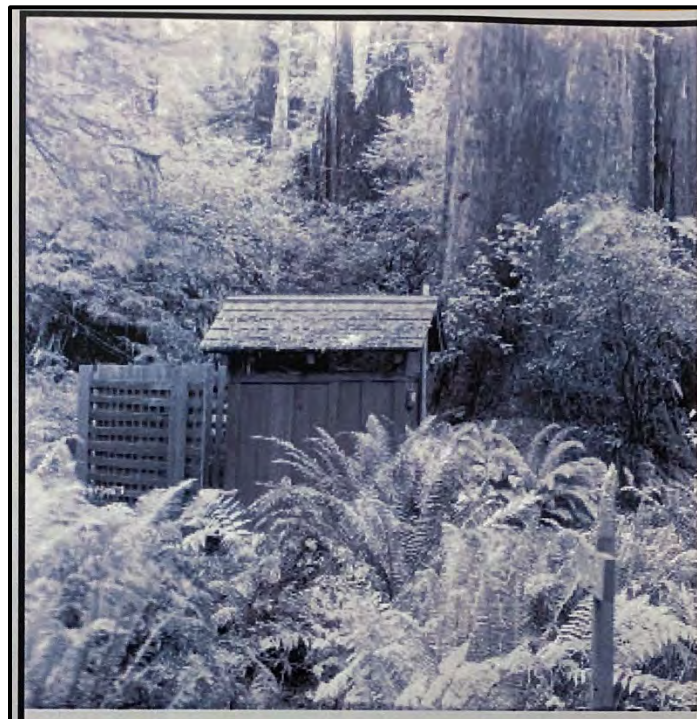
Figure 15. Example of the type of toilet buildings in the CCC-era campground, ca. 1936. Source: California State Parks, North Coast Redwoods District Collection.

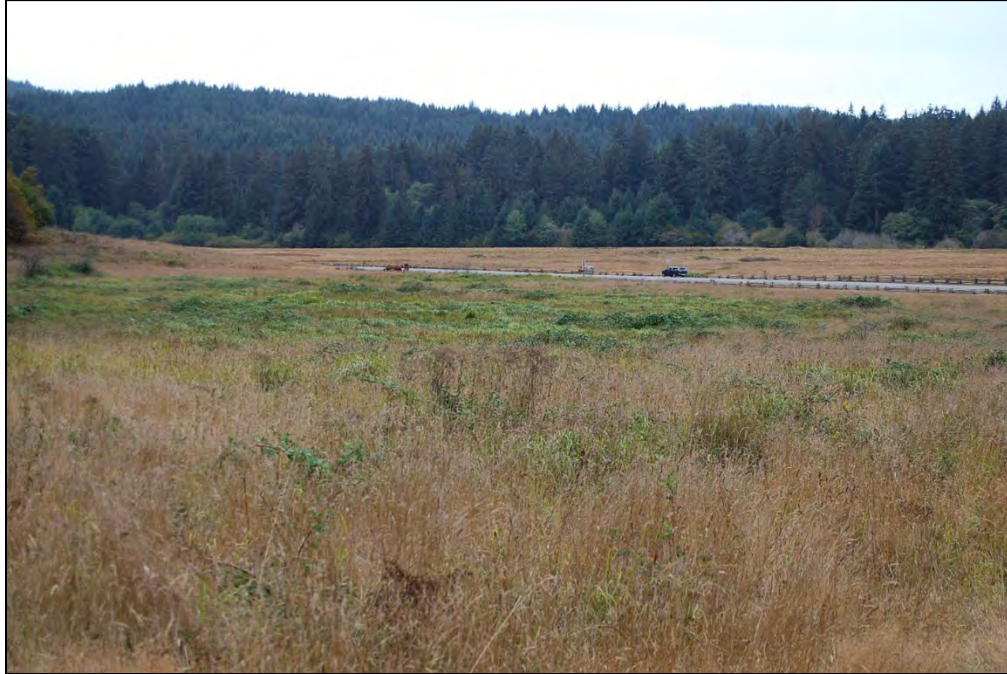
Figure 28. Circulation Features. Drury B. Newton Scenic Parkway, constructed in 1928, bisects the prairie. View to southwest.

A portion of the Newton B. Drury Scenic Parkway (Parkway) runs through Elk Prairie. The road is paved with asphalt and is approximately 50 feet wide with paved shoulders for parking the length of the Parkway through the prairie. Refer to Figure 28 for a photograph of the Parkway.

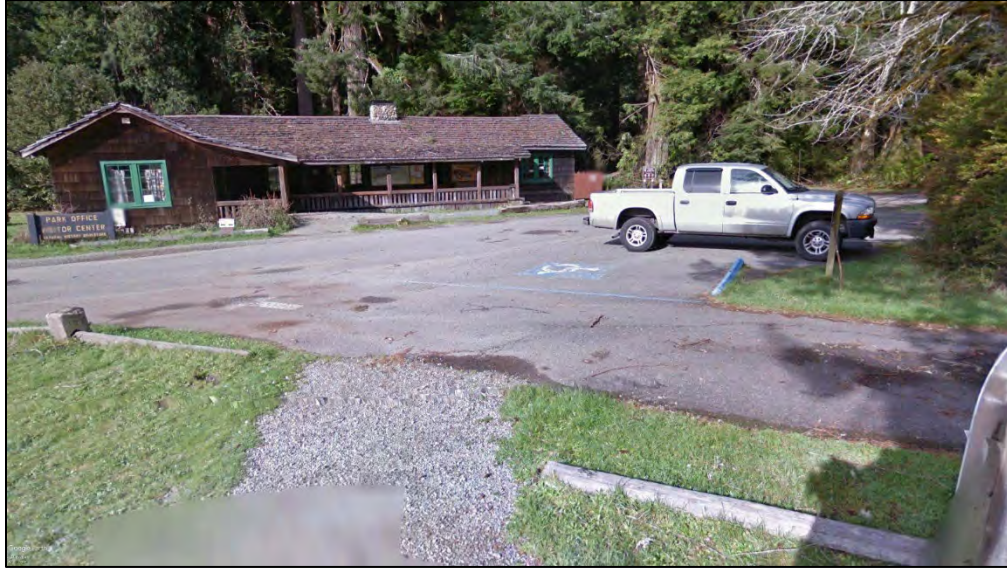
Figure 30. Circulation Features. This configuration for the Visitors Center parking lot dates from the 1960s.

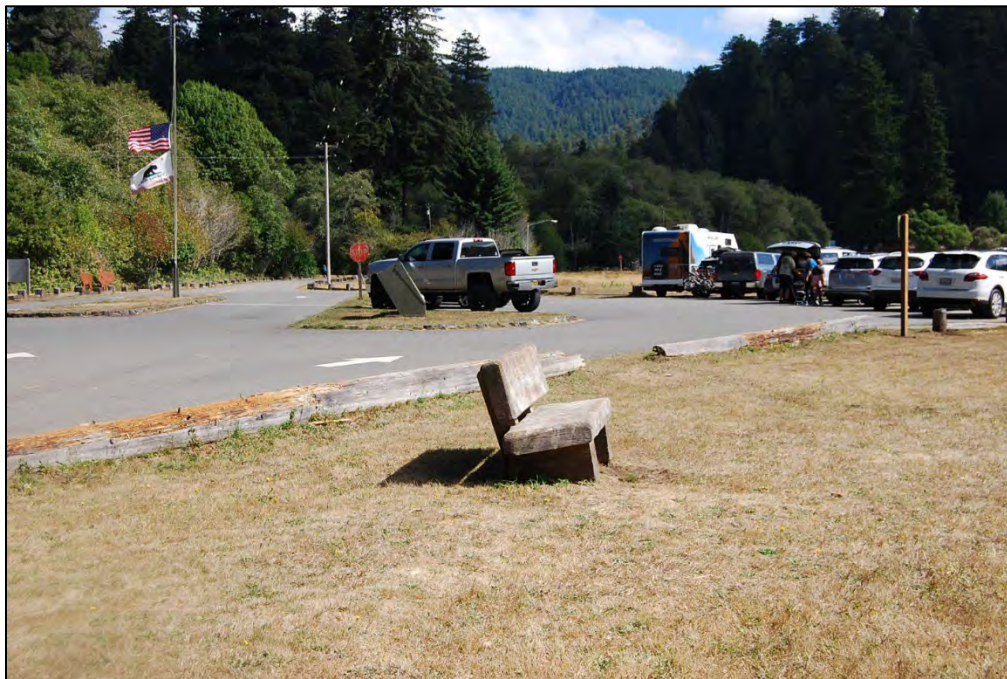
Figure 31. Circulation Features. Entrance parking (added in 1961 and expanded in 1970s).

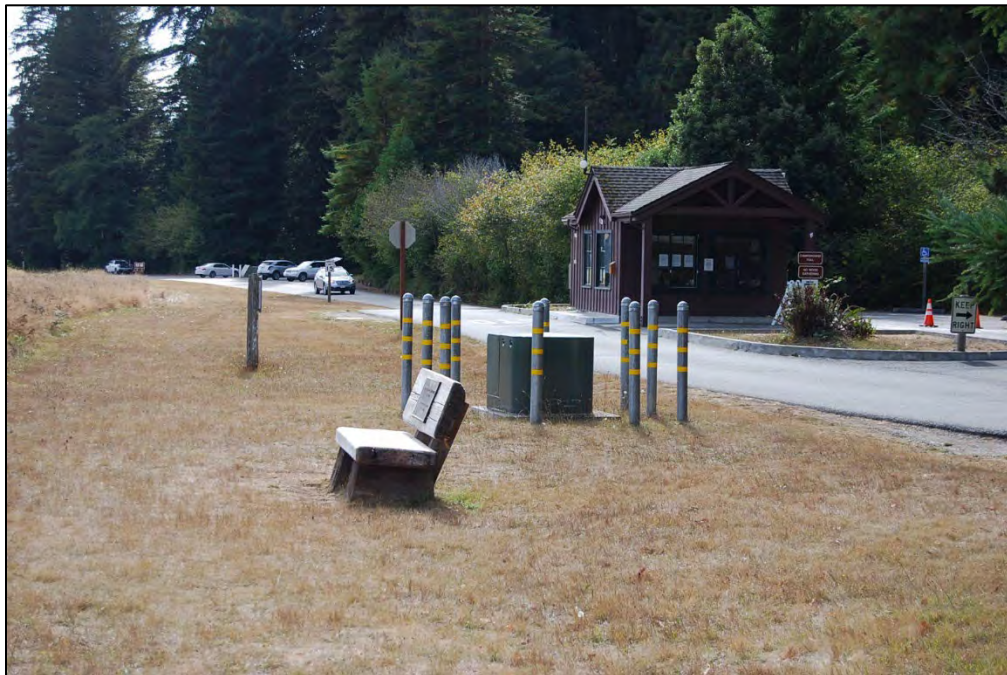
Figure 33. Circulation Features. Prairie Creek Road widened to accommodate the addition of the Entrance Station and median (ca. 2009-2010).

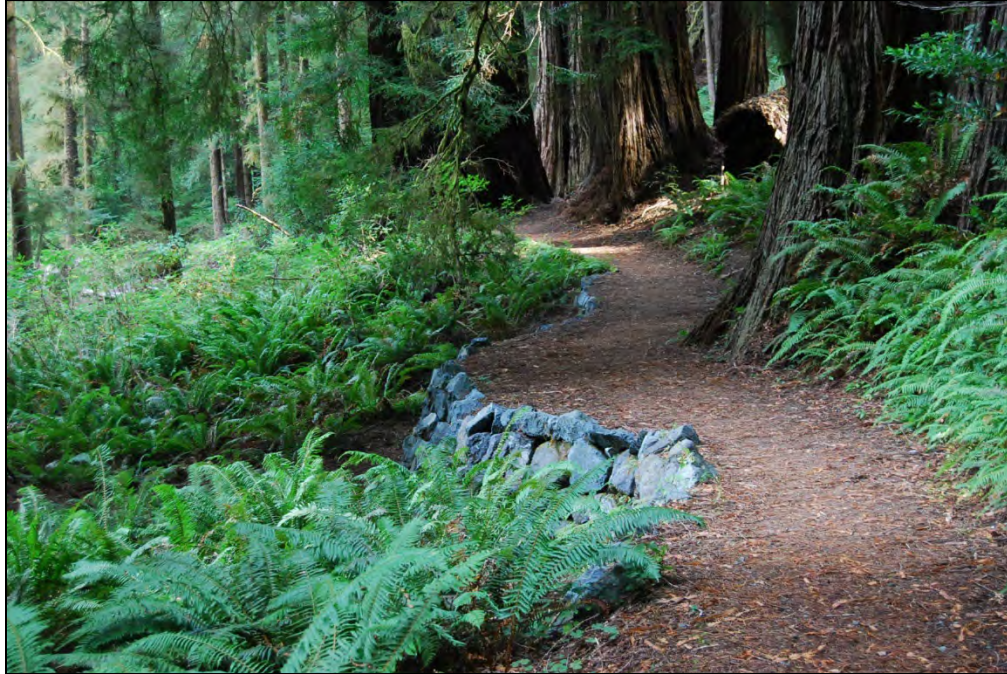
Figure 46. Circulation Features. Example of one of the retaining walls added to Elk Prairie Trail as part of rehabilitation project in the late 1990s.

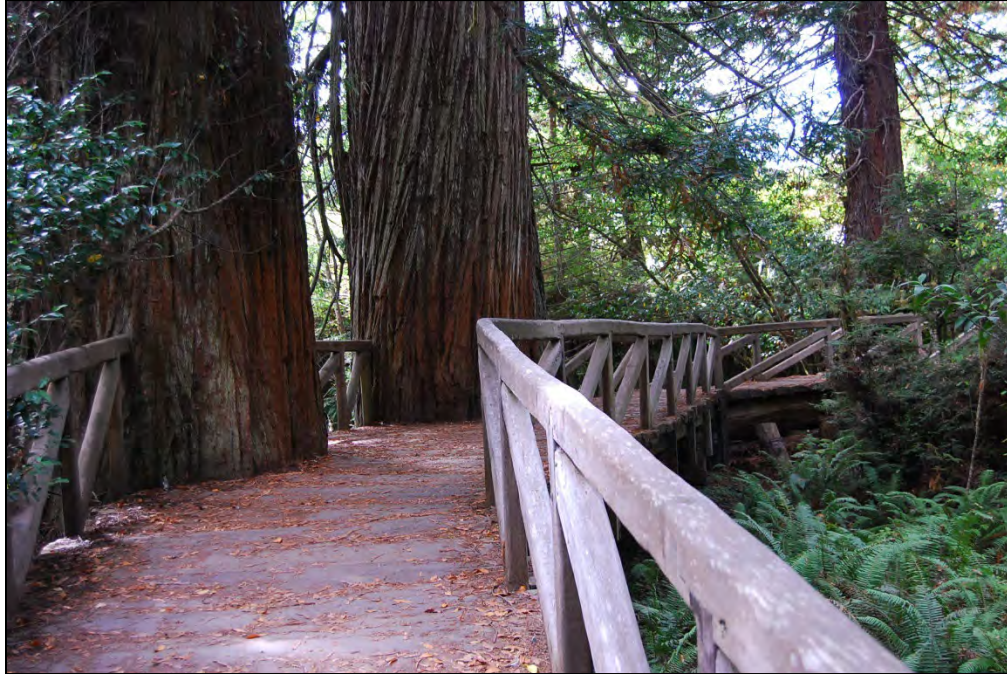
Figure 49. Circulation Features. Bridge over Prairie Creek. A bridge was built in this general location by the CCC in the mid-1930s. The current bridge and its design date from 1982; the bridge was further modified in the early 2000s.

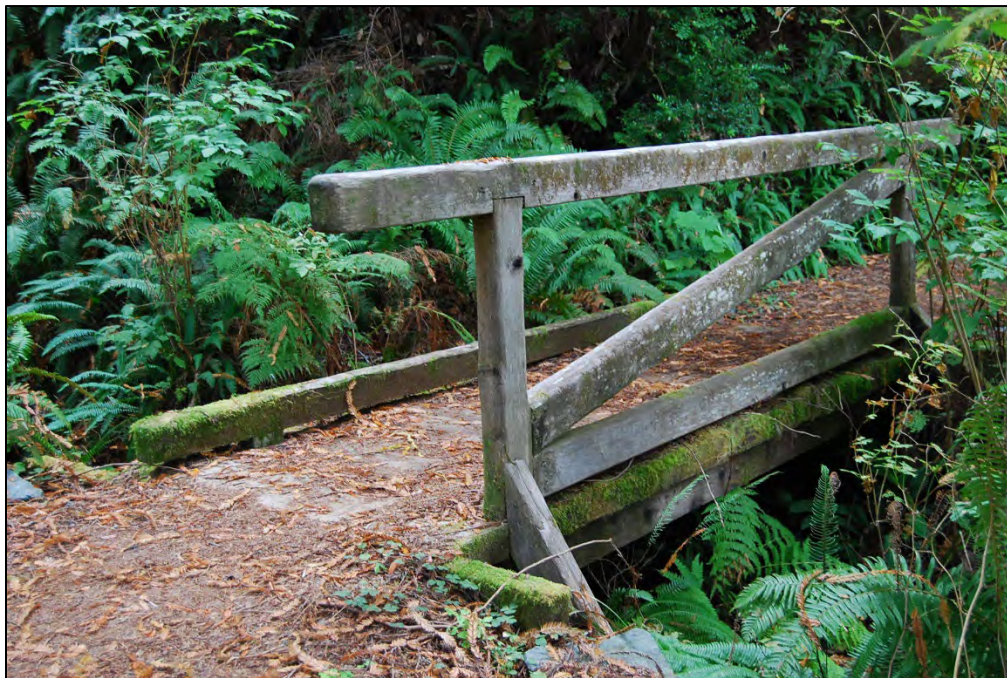
Figure 50. Circulation Features. Representative example of the bridges along Elk Prairie Trail. These bridges were rebuilt in late 1990s.

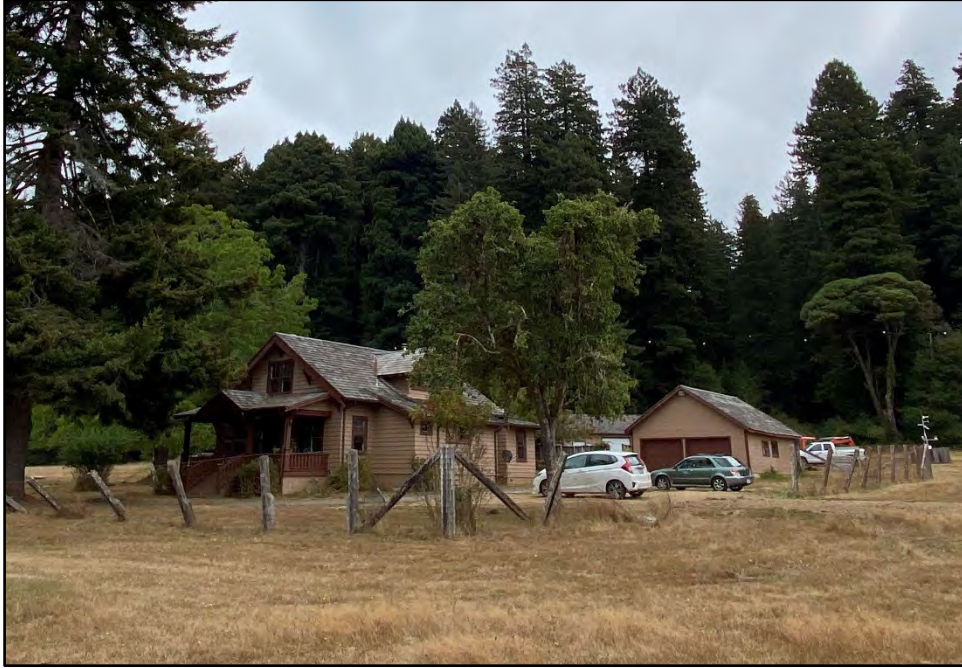
Figure 52. Buildings and Structures. Boyes House (ca. 1924) and detached garage (1949).

enclosed and the front of the house has changed. Refer to Figure 18 for a photograph of the house soon after its construction and Figure 52 for a current photograph.

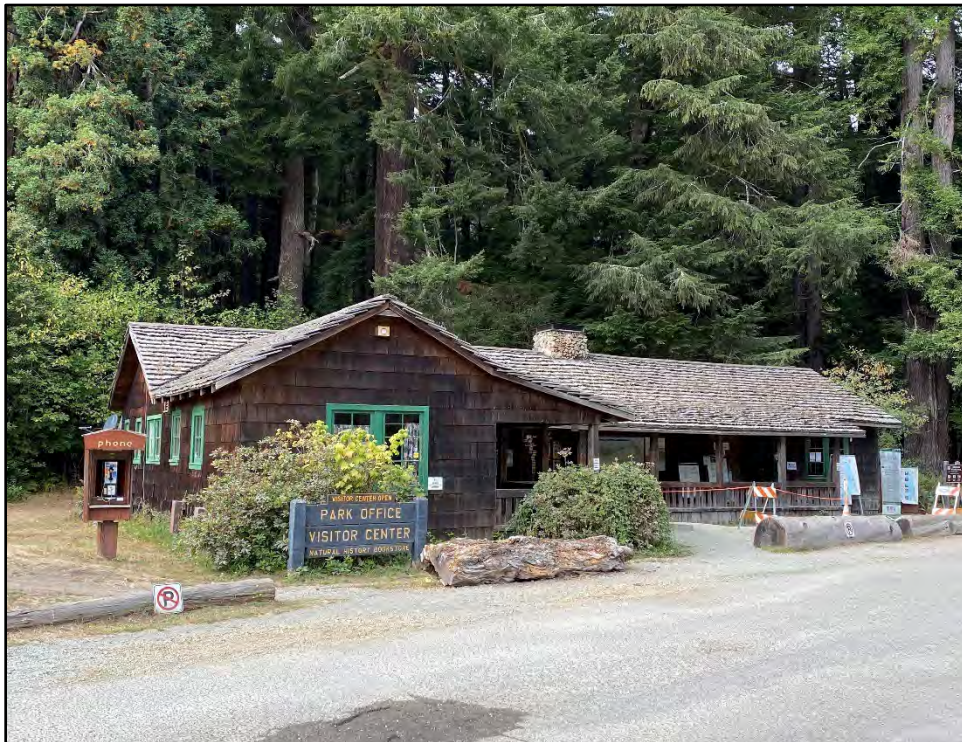
Figure 53. Buildings and Structures. Visitors Center, formerly the CCC-era Park Custodian's Residence (built 1934).

The “Prairie Creek Redwoods State Park Visitors Center and Garage; Historic Structures Report” provided a detailed examination of the condition of the Visitors Center and Garage. This report found the buildings to be in good overall condition.<sup>2</sup> The report noted that the existing conditions issues in these two buildings could be divided into deferred maintenance and necessary upgrades. The deferred maintenance issues were a result of material degradation through moisture exposure, pests, or the building materials reaching the end of their reasonable service lives. Necessary upgrades were required and included structural strengthening to improve seismic performance and building system upgrades to support an eventual reuse of spaces within the Visitors Center or reuse of the Garage. Pages 82-106 of this report provided details on these condition issues. Treatment for the Visitors Center and Garage, which are individually eligible for listing in the National Register, should follow the Secretary of the Interior’s Rehabilitation Standards. Detailed

management and treatment recommendations for both buildings are provided in the “Prairie Creek Redwoods State Park Visitors Center and Garage; Historic Structures Report.”

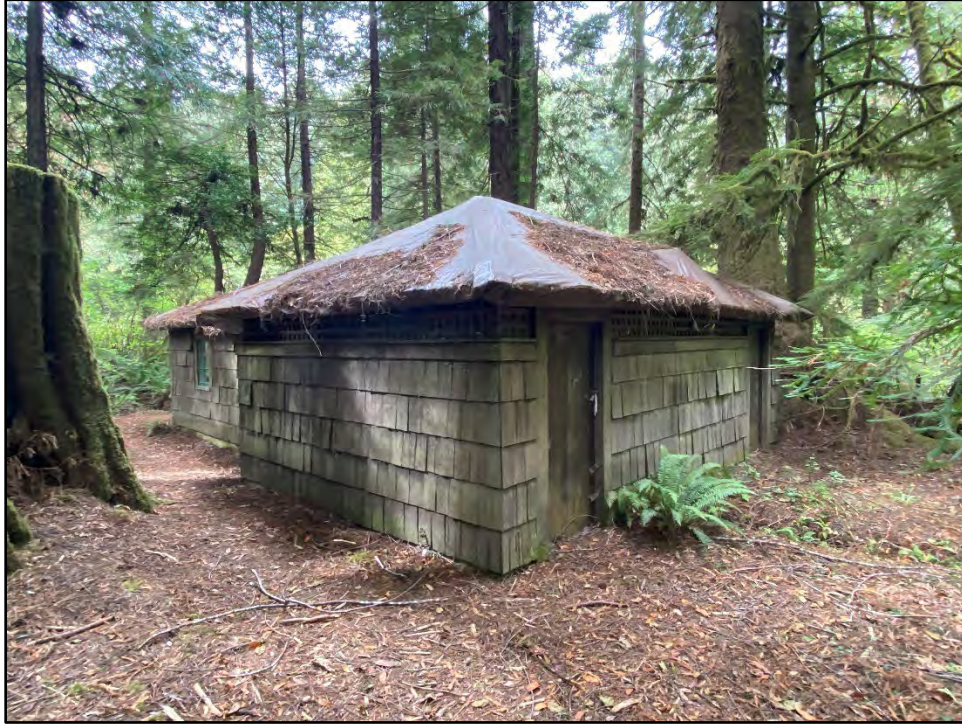
Figure 54. Buildings and Structures. CCC-era Garage near Visitors Center (built ca. 1936).

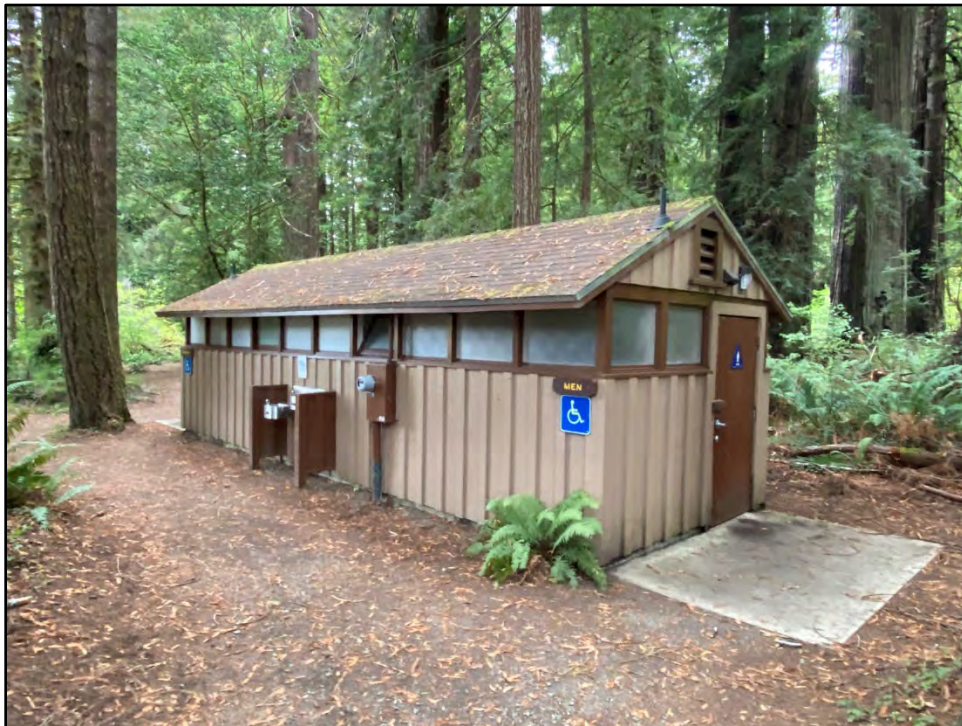
Figure 55. Buildings and Structures. Comfort Building at Revelation Trail (1948).

As a group, the physical integrity of the three buildings has been substantially diminished by the replacement of the original horizontal clapboard wall siding with vertically-oriented board-and-batten; the almost complete replacement of original five-panel doors with steel doors (one survives on the west side of the Revelation Trail Comfort Station); and complete interior remodels. Refer to Figures 55 to 57 for photographs of these buildings.

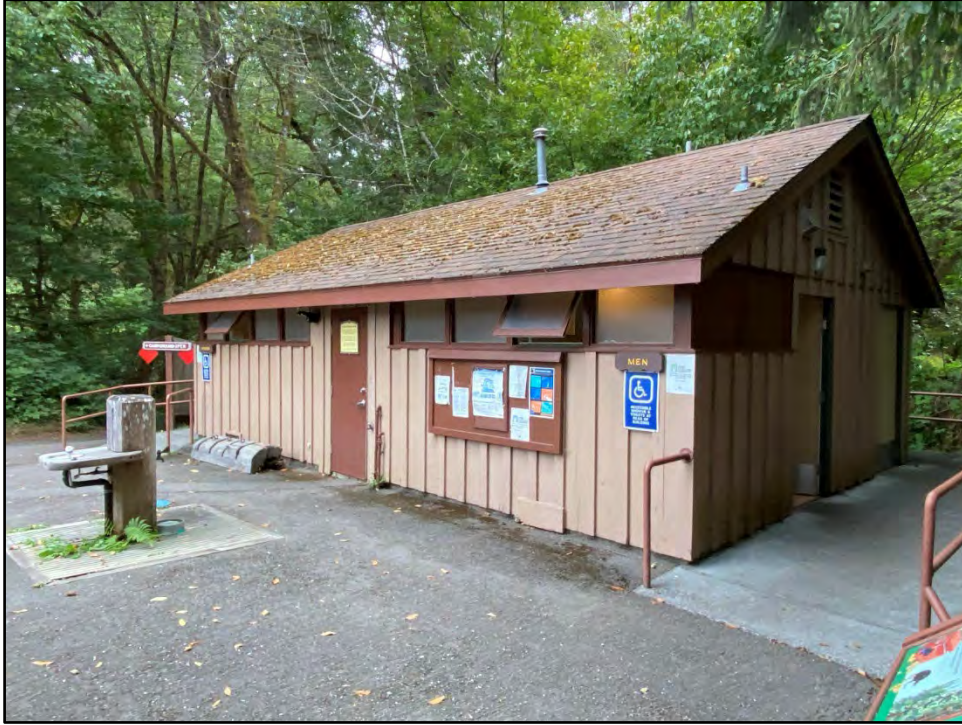
Figure 56. Buildings and Structures. Combination Building #2 (1949) at the Campground.

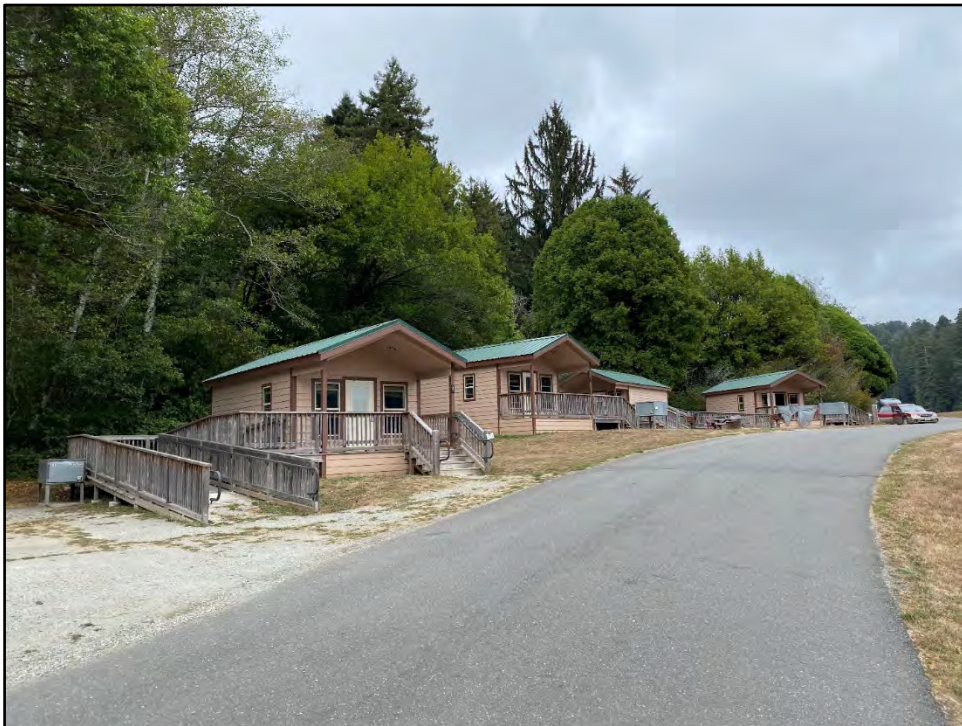
Figure 64. Buildings and Structures. Summer Help Cabin (1961) in the group of public works facilities that are east of the Boyes House.

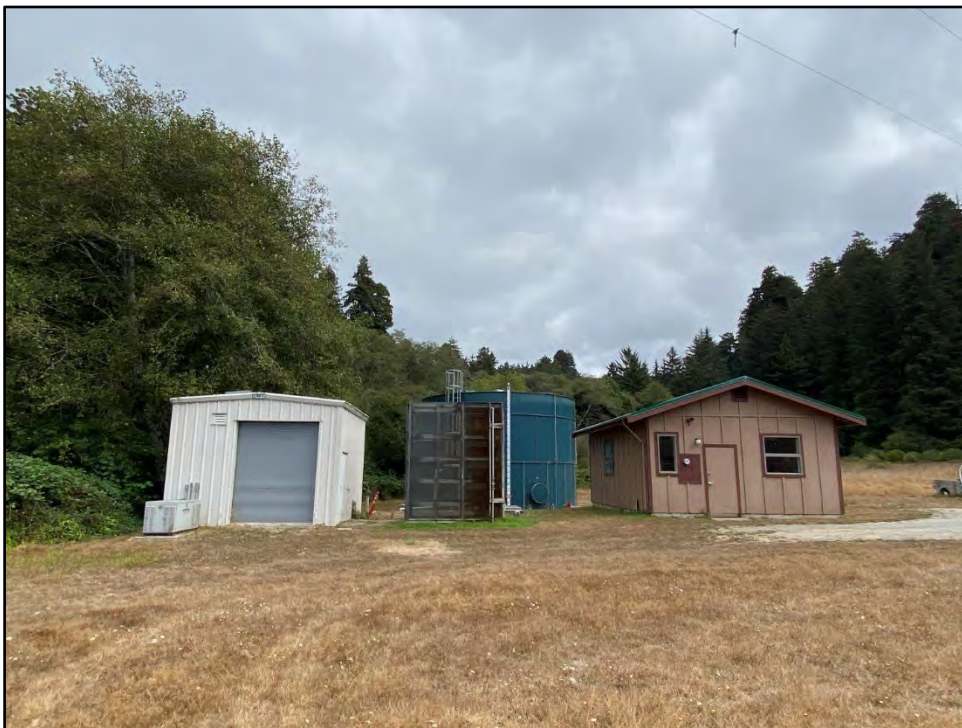
Figure 69. Buildings and Structures. Water Treatment Plant located behind Staff Residences, consisting of pump and water treatment houses, riveted steel tank, and aeration tower.

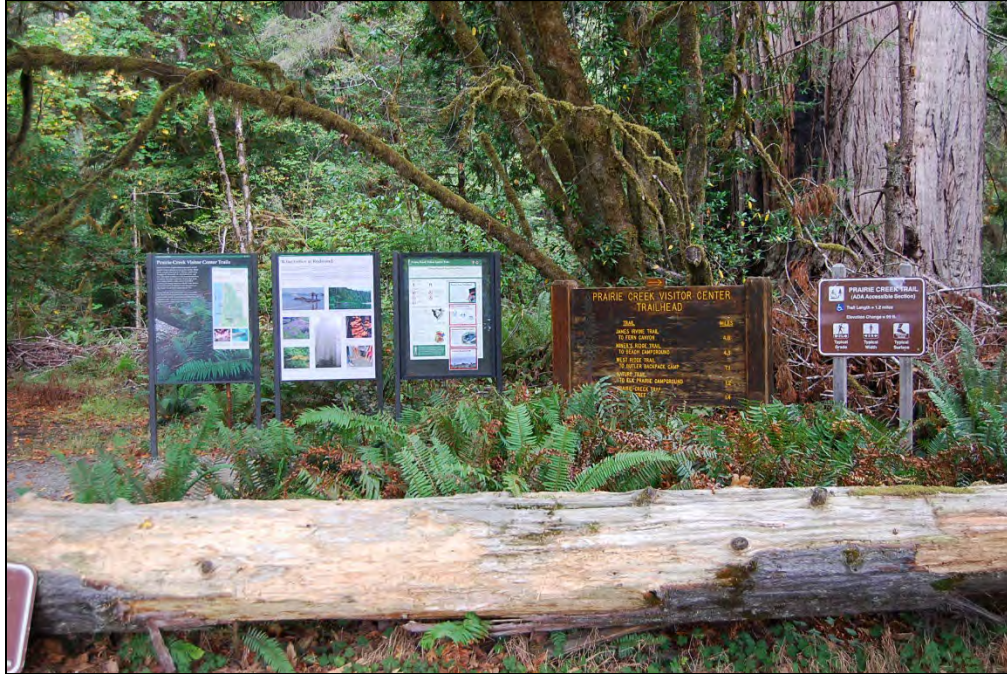
The directional signs and interpretive signs at the Campground and along the trails have varying appearances and were likely added at different times. The oldest extant sign may be the Redwood Access Trail sign which was added in 1981 when the northern portion of this trail was first laid out. Many signs likely date from the 1980s and 1990s (when the trails were rehabilitated) or later. Refer to Figure 72 for a photograph of some of the various types of signs.

Figure 72. Small-Scale Features. Representative examples of signs.

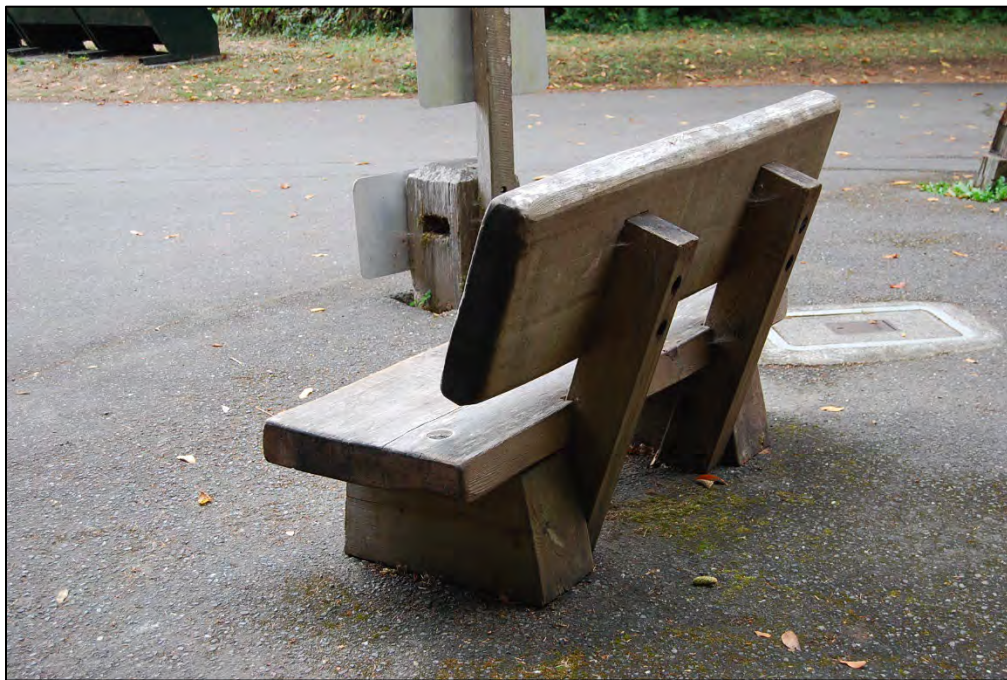
Eleven wooden benches are found along the western edge of the prairie. These benches are about 10 years old or less. They have different designs, each of which is a variation of a bench design developed by the Prairie Creek Redwoods State Park chief of maintenance; several have dedication plaques attached to the backs. The benches are built and pre-assembled by the DPR maintenance crews and then delivered to the site.<sup>166</sup> Similar benches are found along Elk Prairie Trail, in front of the Visitors Center, and in front of Combination Building No. 2 at the Campground. Refer to Figure 73 for a photograph of one of the typical benches.

Figure 73. Small-Scale Features. Representative example of wooden benches that are found along the western edge of the prairie, along trails, at the Visitors Center, and at the Campground.

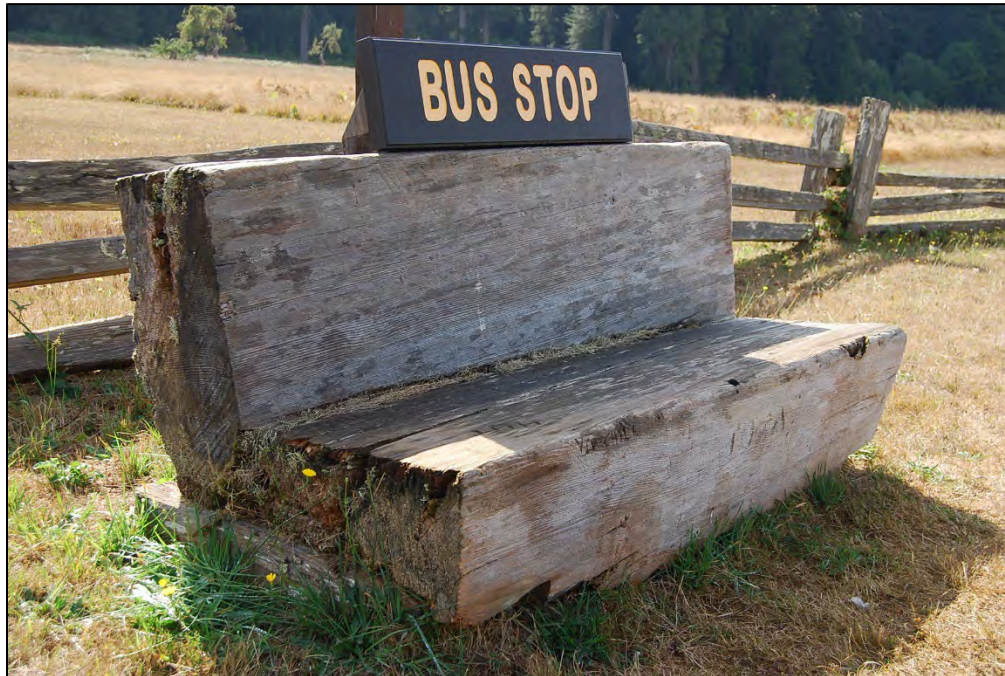
There is a log bench at each of the two bus stops. Each bench consists of a log that is approximately three feet long; a quarter cut in the log forms the bench's backrest and seat. These two log benches are modern, but they are similar in design to ones shown in photographs from CCC-era. This design continued to be made by State Parks maintenance staff and used throughout the park until the last few decades.<sup>167</sup> Refer to Figure 74 for a photograph of one of the log benches.

Figure 74. Small-Scale Features. One of log benches found at the bus stops near entrances to Campground and Park Administration Area.

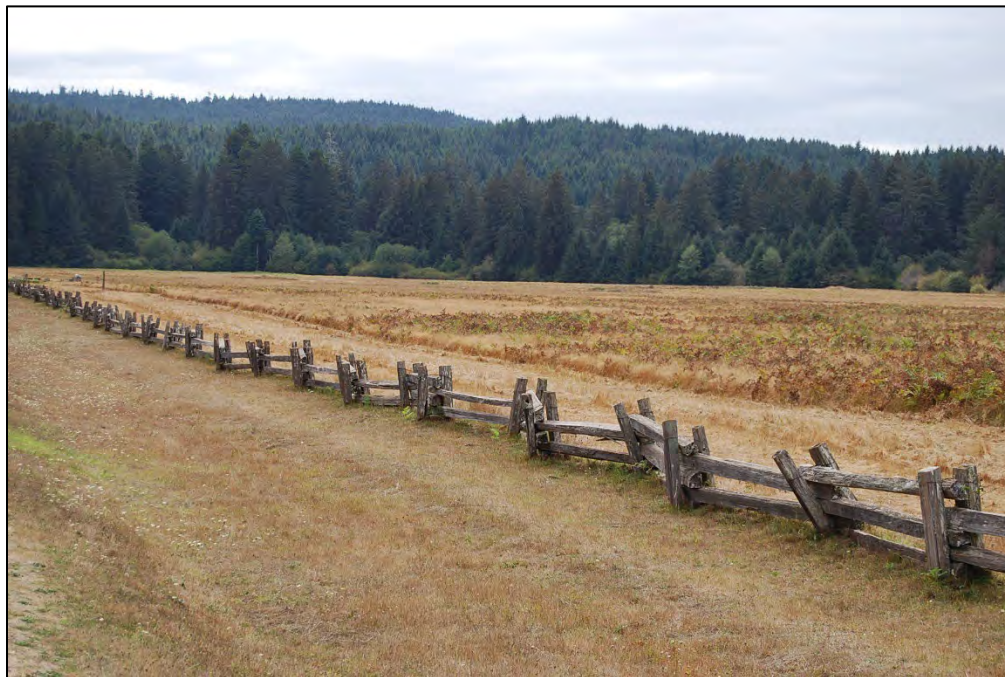
(these displays were removed 2021). On the east side, the alignment similarly veers outward around the Redwood National Park sign and interpretive panels. Refer to Figure 75 for a photograph of this fence.

Figure 75. Small-Scale Features. Split rail fence along Parkway.

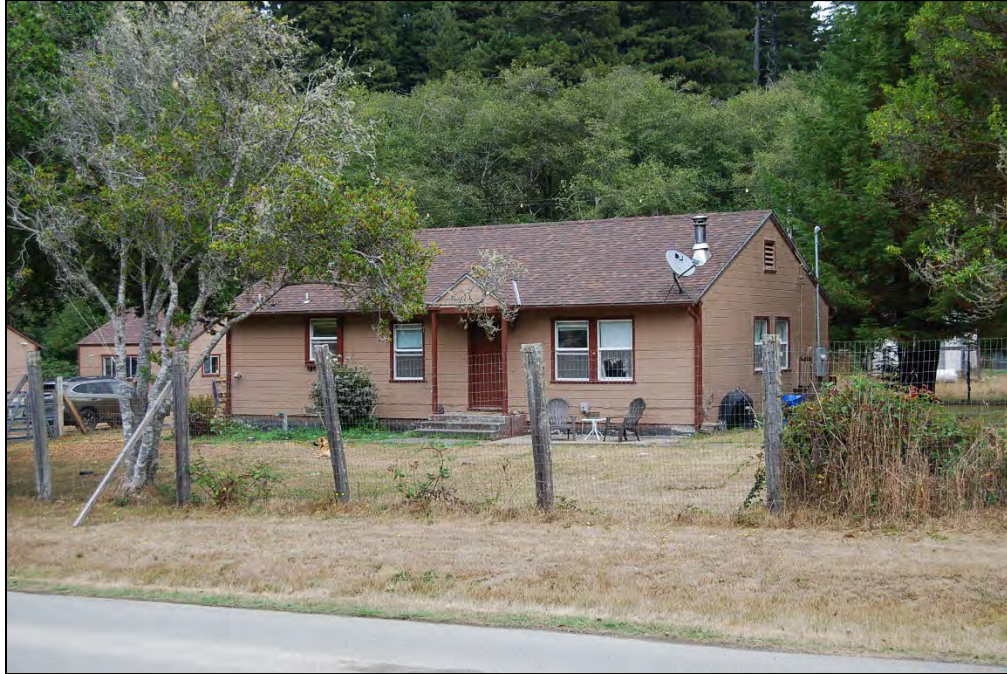
Fences define the yards around Staff Residences # 2 and # 4 and around the Boyes House. Each of these is a variation of woven wire fencing attached to wood or metal posts. The section of fence across the east side of the back yard at the Boyes house has vertical wood slats interwoven with the wire. Refer to Figures 76 to 78 for photographs of these fences.

Figure 76. Small-Scale Features. Example of the type of fences around the yards at Staff Residences #2 and #4 and the Boys House.

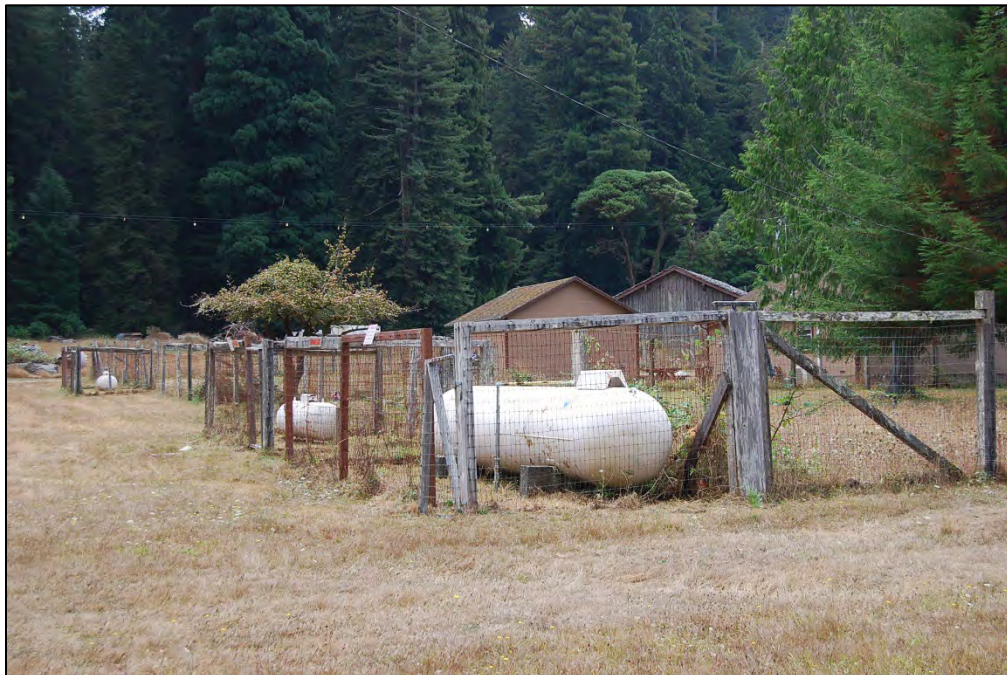
Figure 77. Small-Scale Features. Example of the type of fences around the backyards at Staff Residences #2 and #4.

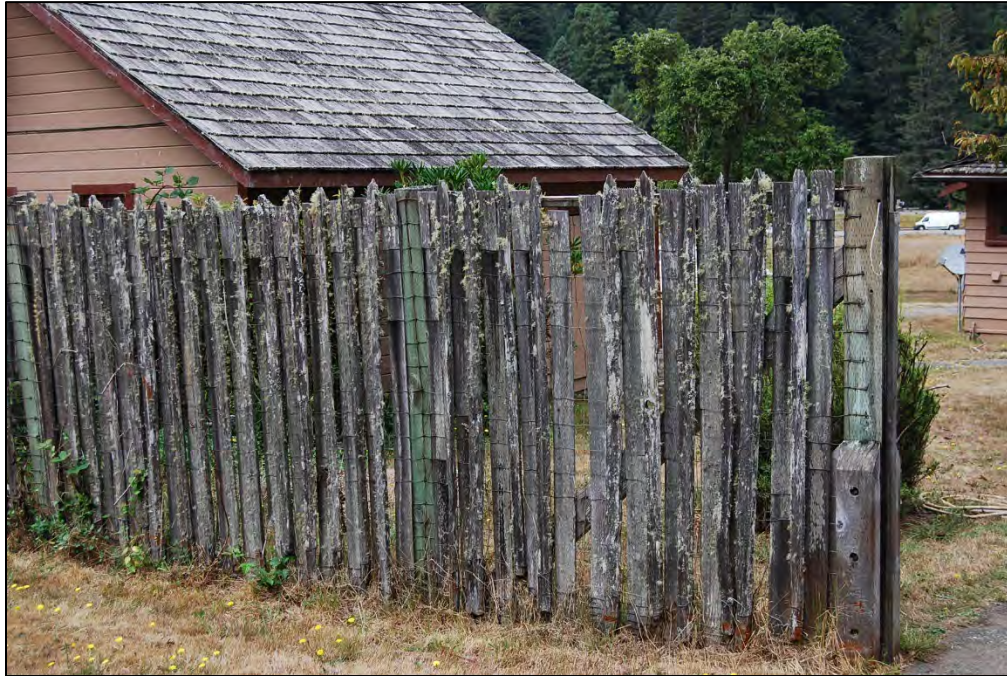
Figure 78. Small-Scale Features. Fence along the backside (east) of the Boyes House.
