CULTURAL LANDSCAPES INVENTORY

Elk Prairie Landscape

Redwood National Park

Prairie Creek Redwoods State Park

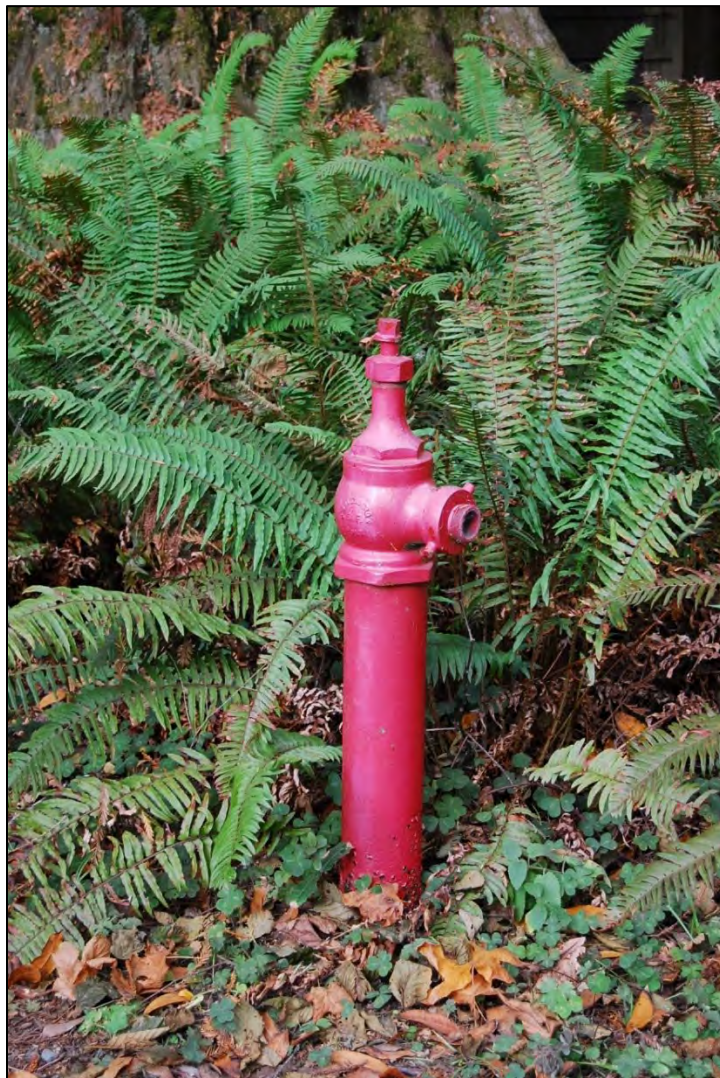
Figure 79. Small-Scale Features. Representative example of one of the fire hydrants found along Prairie Creek Road, at the Campground, and near the Garage. Additional fire hydrants are found near the Staff Residences and Boyes House.

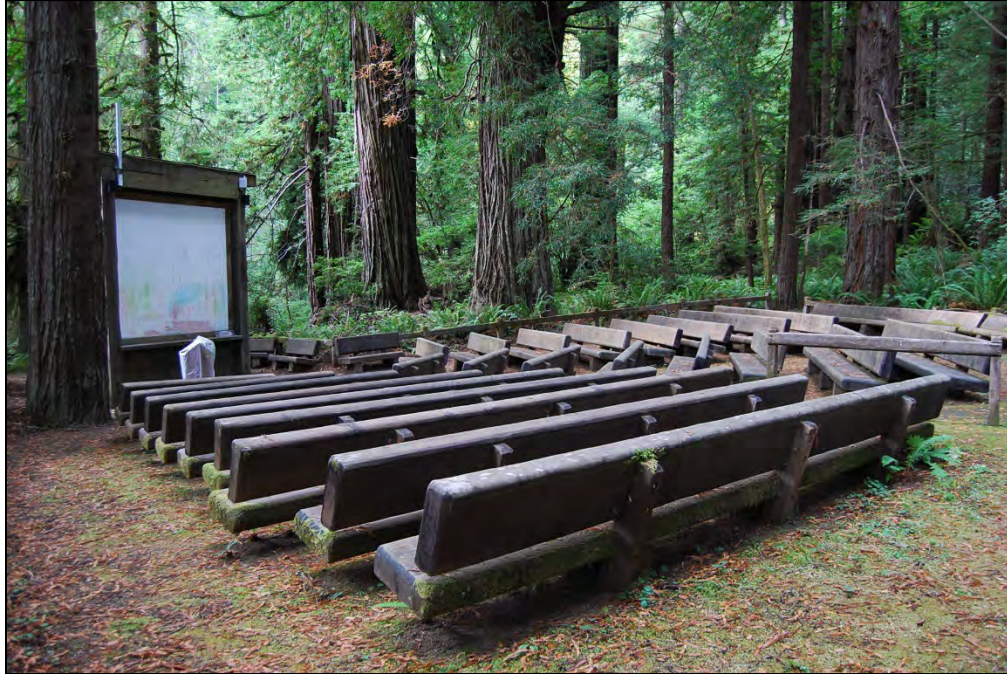
The Campfire Center is located on the west side of Prairie Creek Road under the canopy of the forested area between Revelation Trail and the Picnic Area. It consists of three rows of wood benches set on a slope which face a large projection screen which is located at the base of the slope. A small projection booth is located at the top of the slope. Refer to Figures 80 and 81 for photographs of the Campfire Center.

Figure 80. Small-Scale Features. Campfire Center. View west.

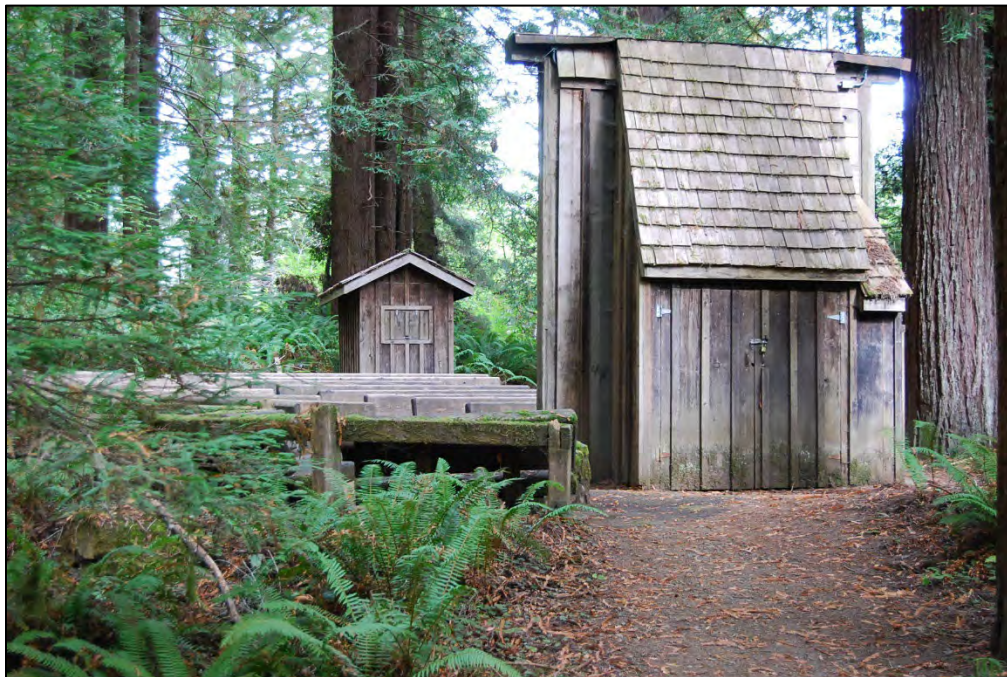
Figure 81. Small-Scale Features. Campfire Center. View east.

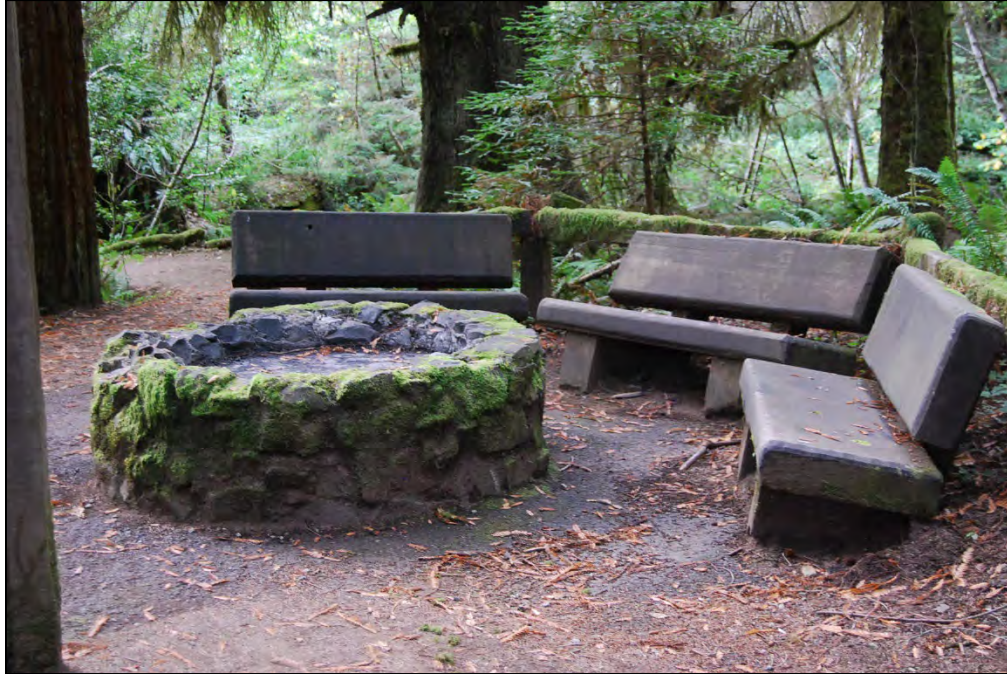
Other small-scale features at the Campfire Center include a water fountain mounted on a stone-and-mortar pedestal (1962) on the north side of the projection booth structure and a round stone and mortar fire pit surrounded by three wood benches (all ca. 1961). The fire pit and benches are located west of the projection screen. Refer to Figure 82 for a photograph of the fire pit and benches. These small-scale features are associated with the original construction of the Campfire Center.<sup>173</sup>

Figure 82. Small-Scale Features. Campfire Center. Stone fire circle and wooden benches.

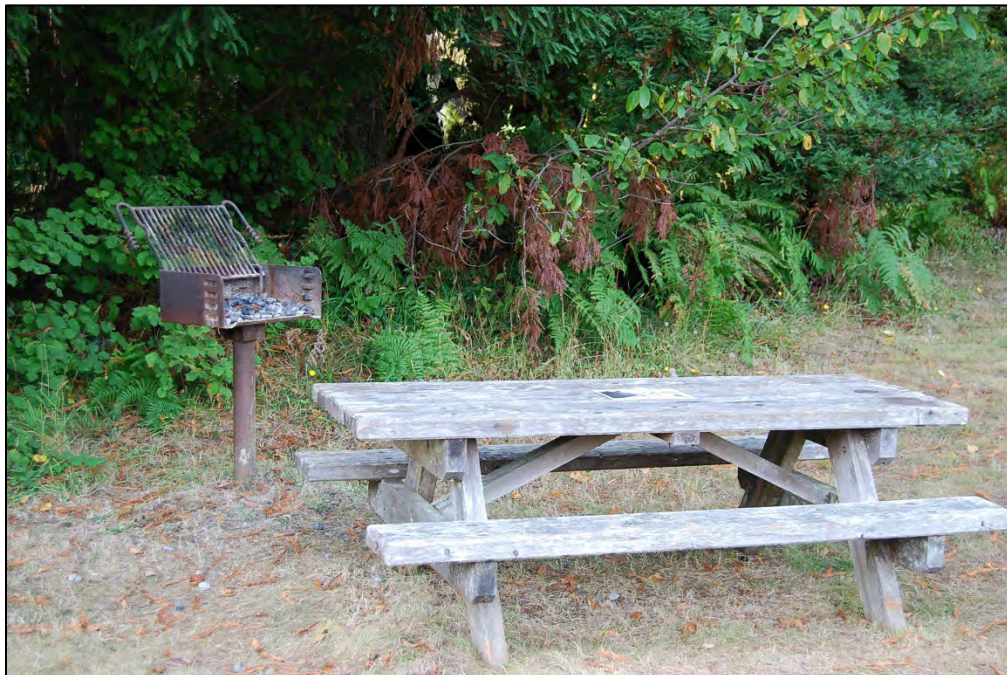
Site furnishings at the Picnic Area include wooden picnic tables and metal grills. Refer to Figure 83 for a photograph of a table and grill.

Figure 83. Small-Scale Features. Representative example of picnic tables and grills at the Picnic Area.

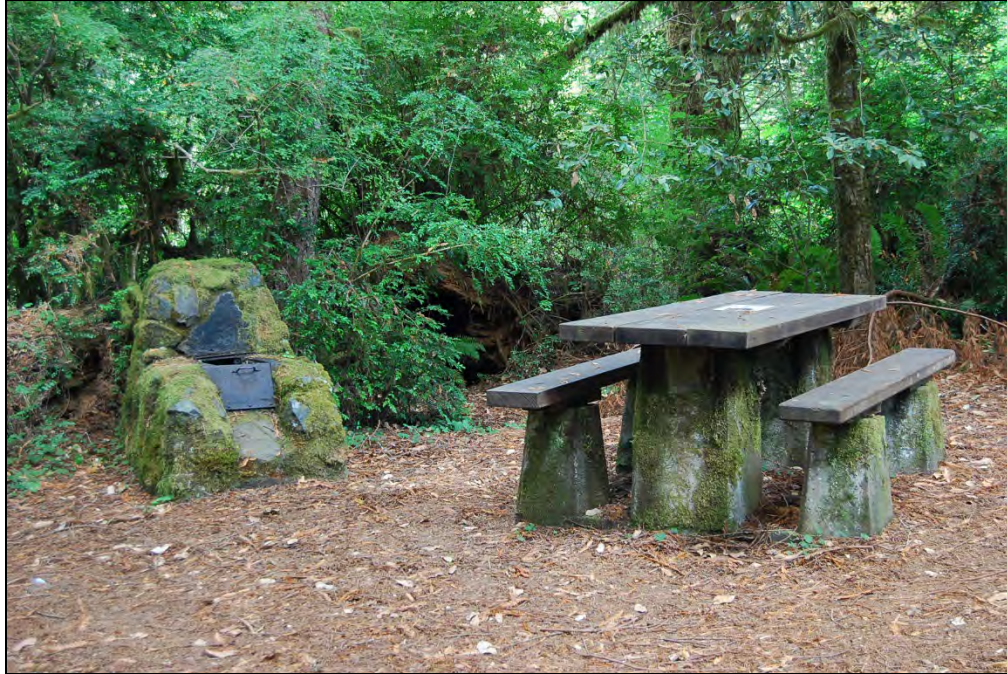
At the north end of the Picnic Area and a little to the west under the tree canopy are four concrete picnic tables and six stone camp stoves. Each picnic table has a concrete pedestal (broader at the base than at the top) at each end; the pedestals support a tabletop constructed of three wooden boards. Each table has two stationary benches—one on each side of the table; each bench consists of two concrete pedestals that support one wooden board seat. Only two of the tables are intact. These tables are similar to a standard State Parks design for a “Camp and Picnic Table Concrete Type” from the mid-1950s, and identical tables in other State Parks were found in photographs from 1950s and early 1960s.<sup>174</sup> Refer to Figure 84 for a photograph of a concrete picnic table.

The six camp stoves in the Picnic Area are constructed of uncut stone and mortar. Five have a similar design. In these, the front of the stove consists of a rectangular-shaped, brick-lined fire box which connects to a chimney at the rear of the stove. In the most intact stove, a metal grate covers the top of the fire box and a hinged metal door covers the front of the fire box. Several of the stoves are missing the metal grates and doors for the fireboxes and have missing or loose stones; the side of one stove has collapsed. These camp stove do not appear to be actively maintained. There are weeds growing next to several of the stoves, and fire-prevention measures such as sand or gravel in front of the fireboxes are missing. One camp stove, located at the eastern edge of this grouping, has a shorter chimney and lower height of the firebox from the ground. The exact date when these stoves were constructed has not been determined. The designs for these camp stoves are similar to those from the CCC era.<sup>175</sup> However, these stoves were not shown on topographic surveys from 1948 and 1950 that identified the location of CCC-era campsite features and do not appear to have

been built by the CCC in their current location.<sup>176</sup> It is possible that CCC-era stoves were moved to this location after the CCC-era campsites were demolished in the 1960s and early 1970s. Or these stoves may have been constructed, after the 1950s, by DPR using a design that was similar to the CCC era stoves.<sup>177</sup> Refer to Figures 84 and 85 for photographs of two of these camp stoves.

Figure 84. Small-Scale Features. Representative example of the stone camp stoves (date unknown) and concrete picnic tables (ca. 1950s) located just west of the Picnic Area.

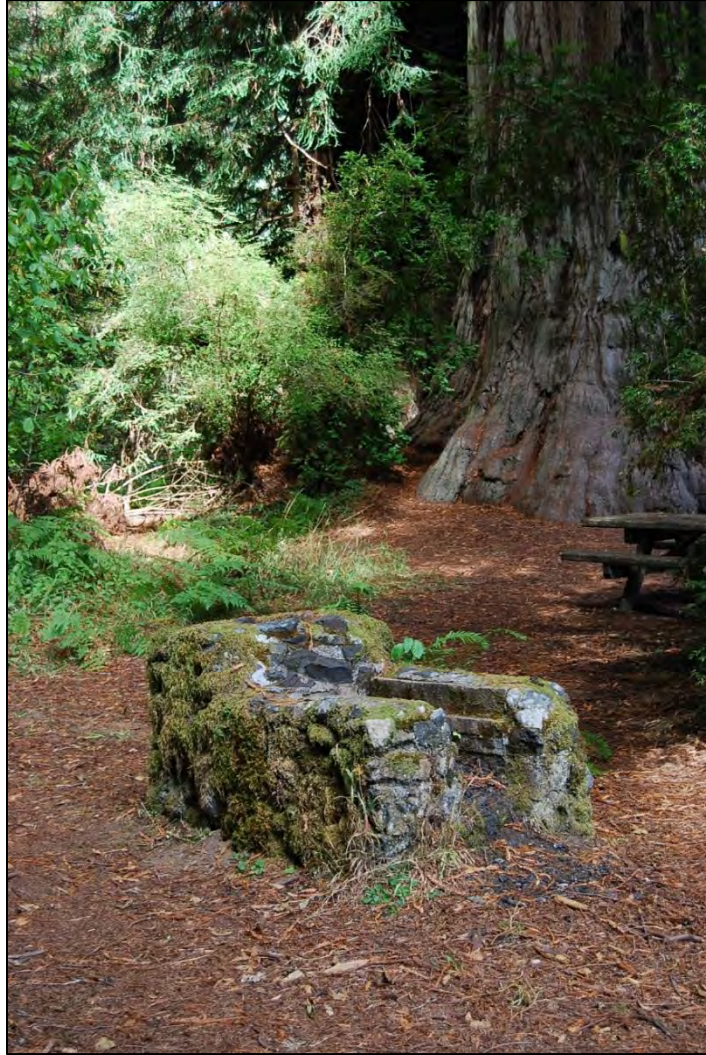
Figure 85. Small-Scale Features. Smaller camp stone stove (date unknown) located at the western edge of the Picnic Area.

The condition of Elk Prairie landscape study area was assessed through a visual inspection of landscape characteristics and features on 22 and 23 September 2020. Overall, the Elk Prairie landscape was in good condition and showed no clear evidence of major negative disturbance or deterioration by natural and/or human forces. Although the Elk Prairie landscape is ineligible for the listing in the National Register, some features and characteristics are sensitive to change. These include the redwood forest and prairie, the Boyes House, the remaining trees in the orchard, and the split rail fence along both sides of the Parkway. These features should be maintained and protected. Additionally, recommendations for the placement of new built features were provided to limit the encroachment of new standing buildings and structures onto the prairie and to protect the views of the prairie and forest. Finally, the exact date when the stone camp stoves in the Picnic Area were constructed was not determined, and additional research and a field review to determine the date of construction and builder for these camp stoves is recommended.

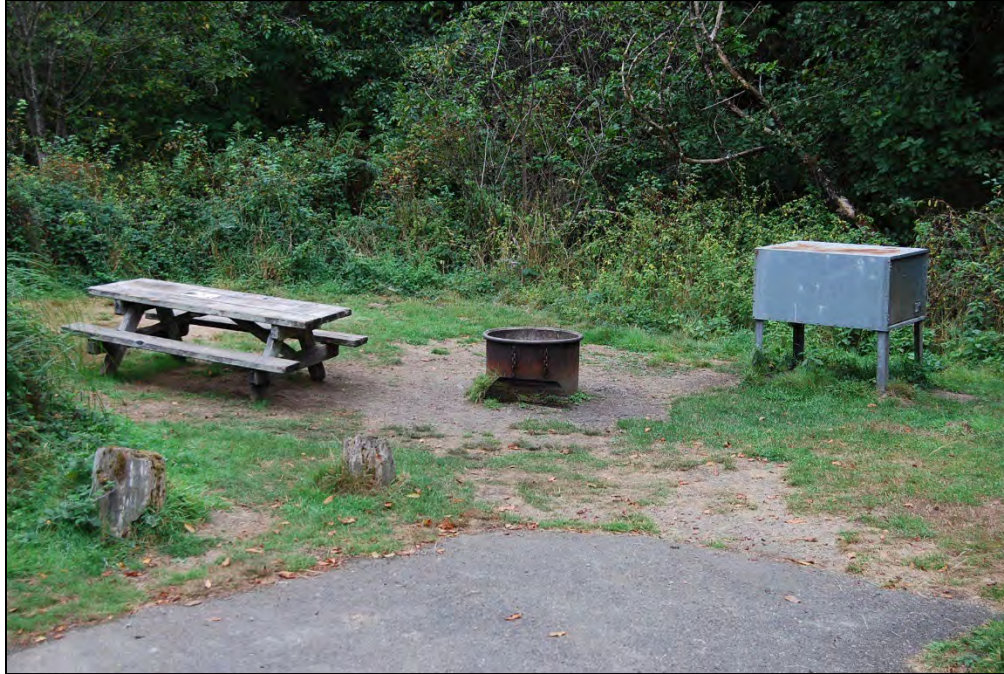
Each campsite in the Campground is furnished with a wooden A-frame picnic table, a metal fire pit, and a metal food storage locker. Refer to Figure 86 for a photograph of the site furnishings at a typical campsite.

Figure 86. Small-Scale Features. Representative examples of site furnishings found at each of the campsites in the Campground.
