THE SHELTON HOUSE at RURAL PLAINS

Historic Structure Report

Richmond National Battlefield Park
Mechanicsville, Virginia

Barbara A. Yocum, Architectural Conservator
Historic Architecture Program
Northeast Region, National Park Service
Lowell, Massachusetts

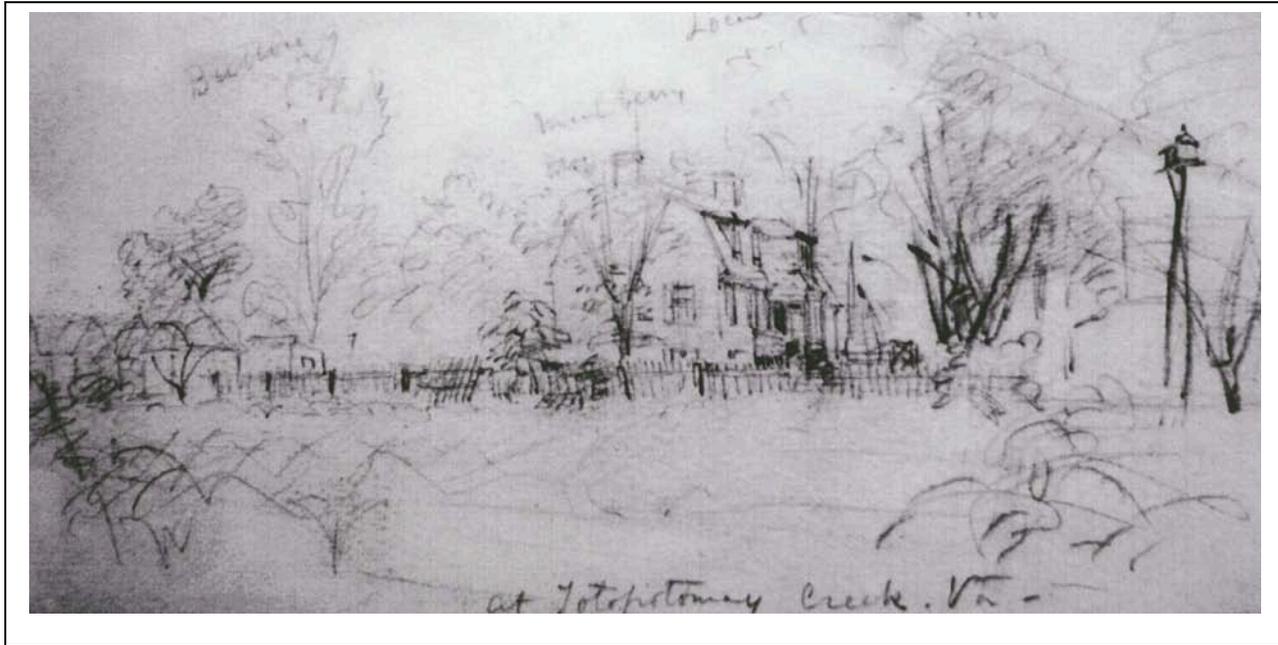
Figure 12. Sketch of the Shelton House looking northwest by Alfred Waud, May 1864.

Another unpublished sketch by Waud, labeled “at Totopotomoy Creek, Va.,” shows the south and east elevations of the Shelton House (fig. 12). Other features include a low picket fence south of the house, a cluster of small cabins to the west, and a larger gable-roofed structure to the east. Mature trees around the house are labeled “Button[wood],” “Mulberry” and “Locust.”¹¹⁸ This is the earliest-known depiction of the Shelton House.

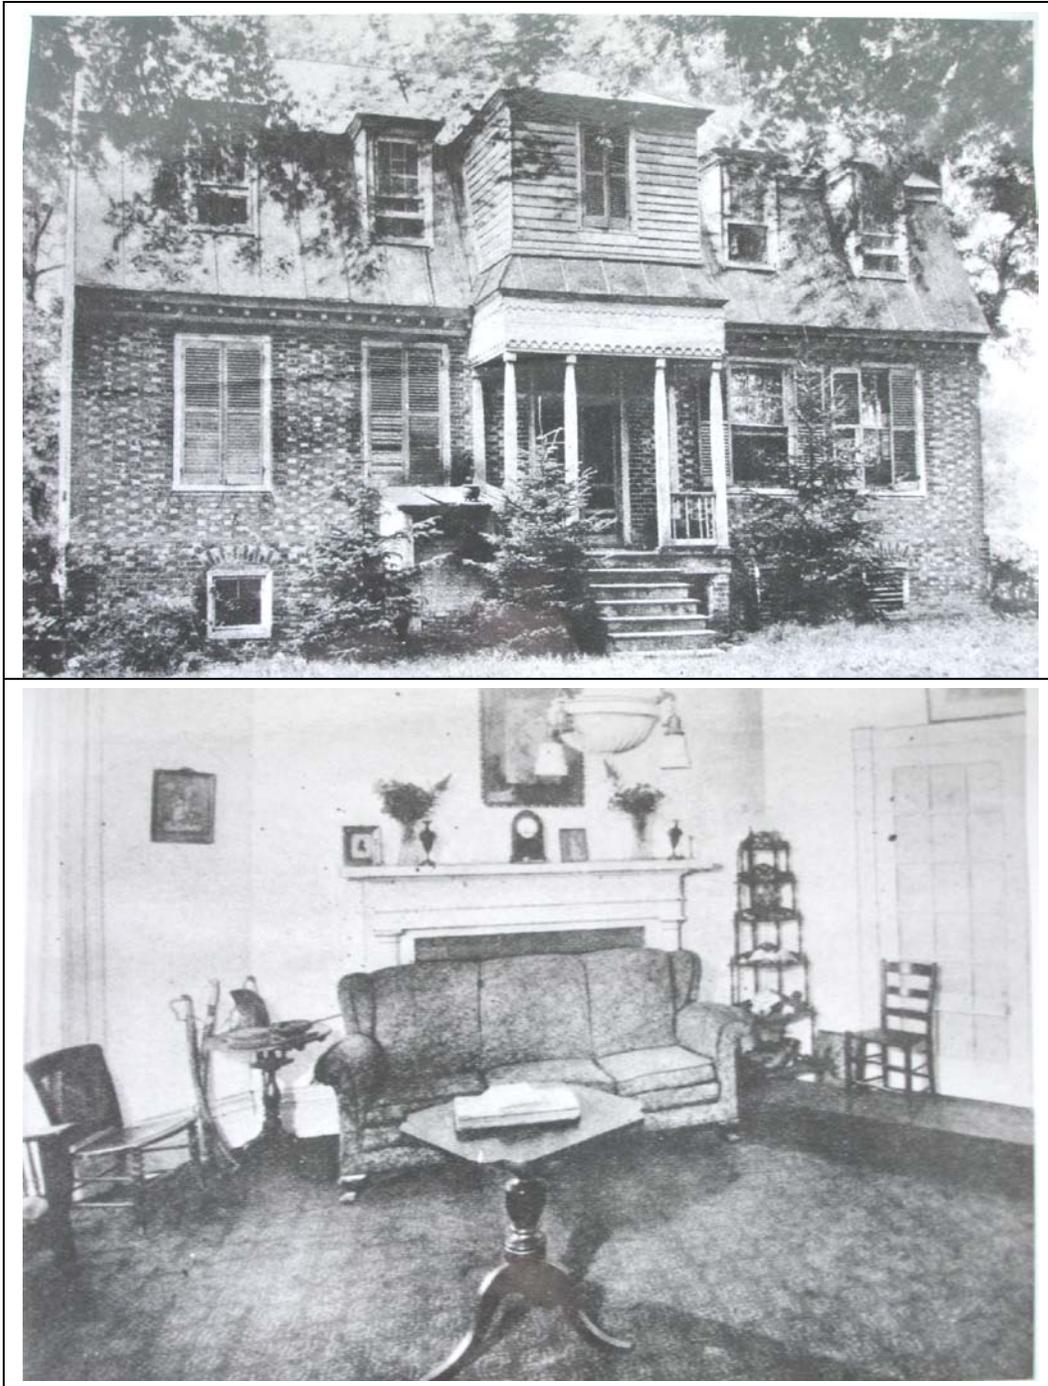
Figure 17. Earliest known photographs of the Shelton House showing the front façade (above) and the parlor (below). New York Times Magazine, August 19, 1928.

the establishment and growing prosperity of Rural Plains Nursery. In 1928, an illustrated article featuring the house was published in *The New York Times Magazine*, entitled “A Mansion Rich in Virginia’s History” (fig. 17). This article wove stories of fact and fiction to dramatize the “romance, tragedy, riches and poverty [that] are in the fabric of Rural Plains.” These included unsubstantiated claims of being “the oldest house in Virginia” and the site of Patrick Henry’s marriage to Sarah Shelton in 1754.¹³⁸

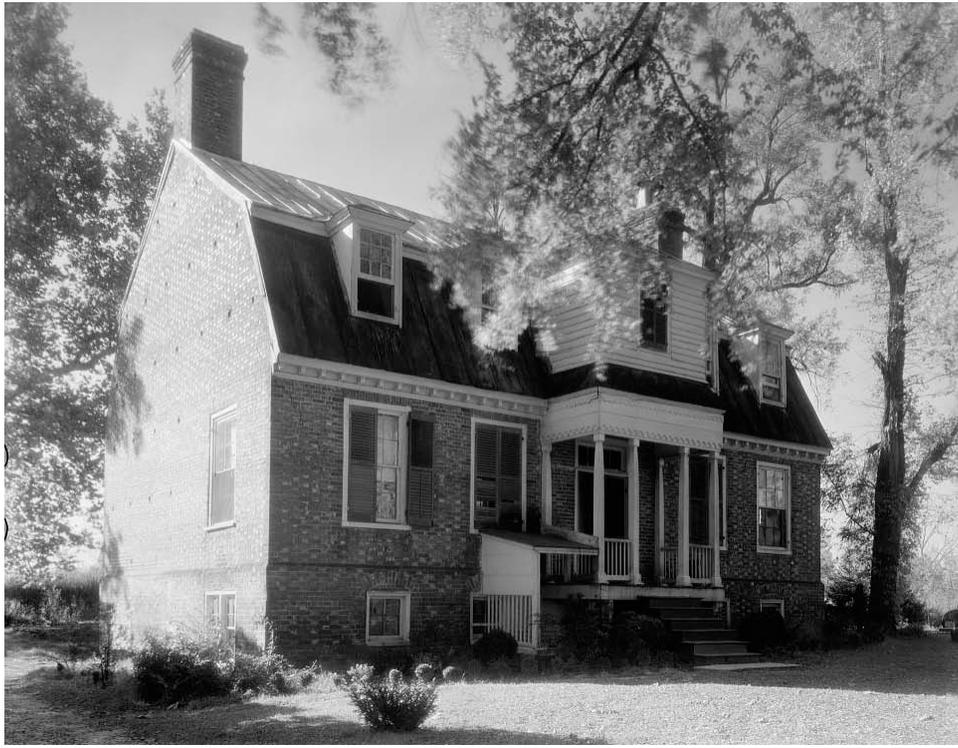
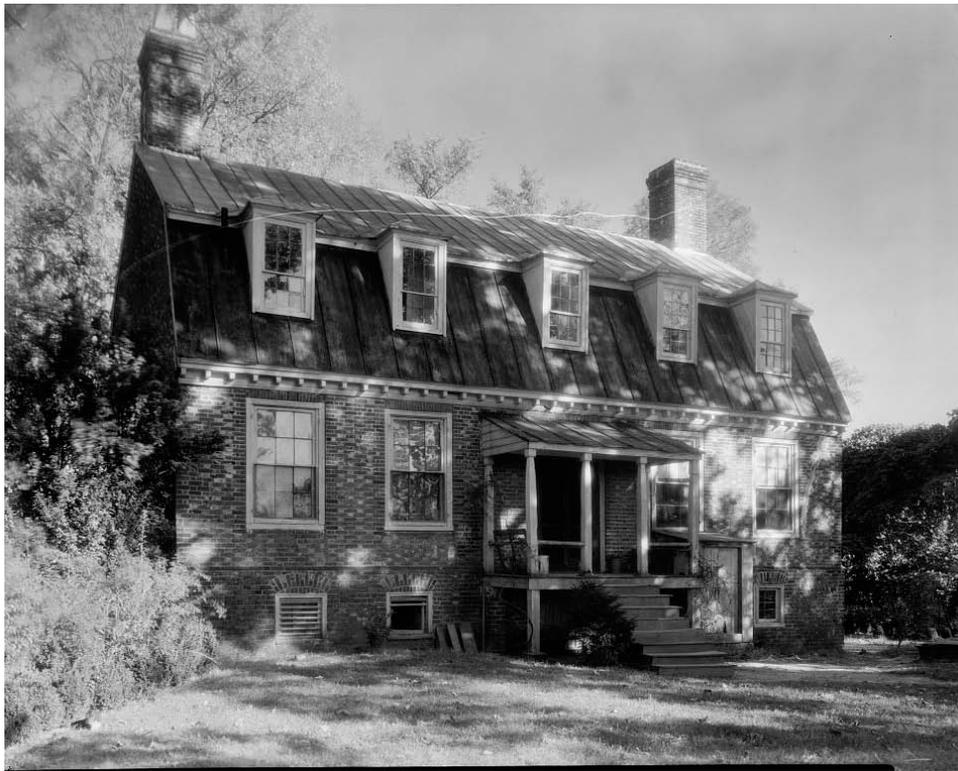
Figure 20. Front and back elevations of the Shelton House at Rural Plains. Photographs by Frances Benjamin Johnston, 1935.

Other secondary roofs that are missing today covered the original main-roof dormers and a porch on the west side of the house. The original dormers presumably had the same pent roofs as the porch chamber and the existing larger dormers that replaced them around 1785. The west porch may have had a shed roof, as seen in photographs of the porch taken in 1936 (figs. 20, 21, and 25).

An open porch at the west entrance is documented by photographs dated 1935 and 1936 (figs. 20, 21, and 24); it was

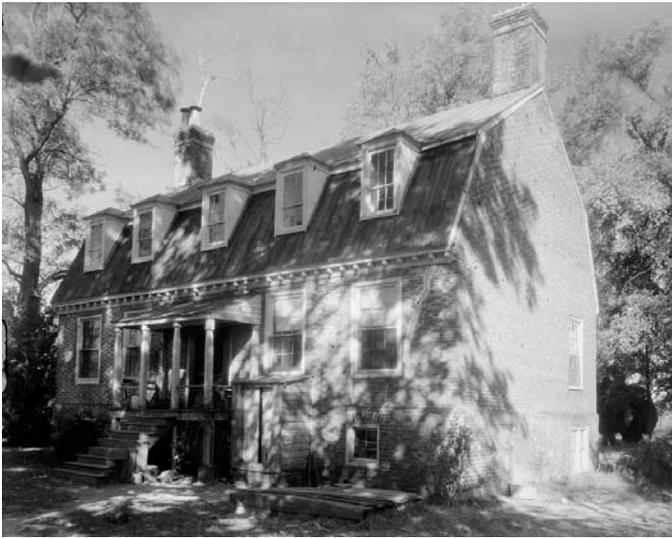
Figure 21. Detail (below) of the Shelton House back porch and cellar shed from a photograph by Frances Benjamin Johnston, 1935.

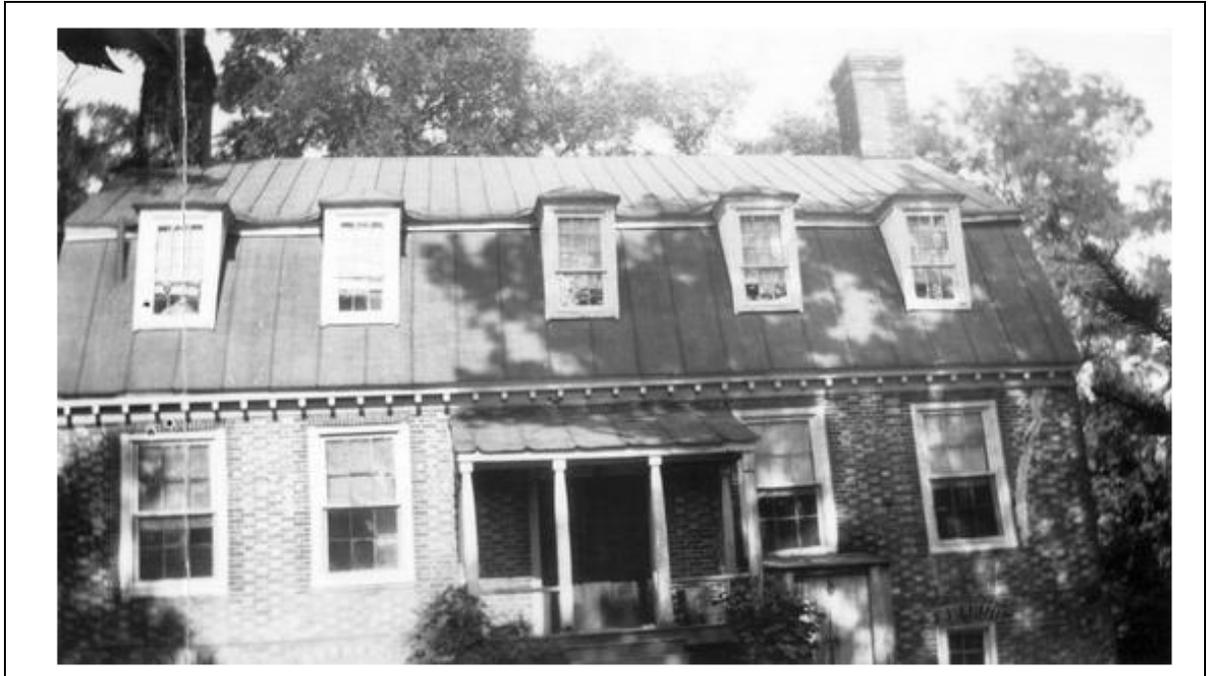
Figure 25. Back (west) elevation of the Shelton House from a historical inventory report on Rural Plains by the Works Progress Administration of Virginia, December 1936.

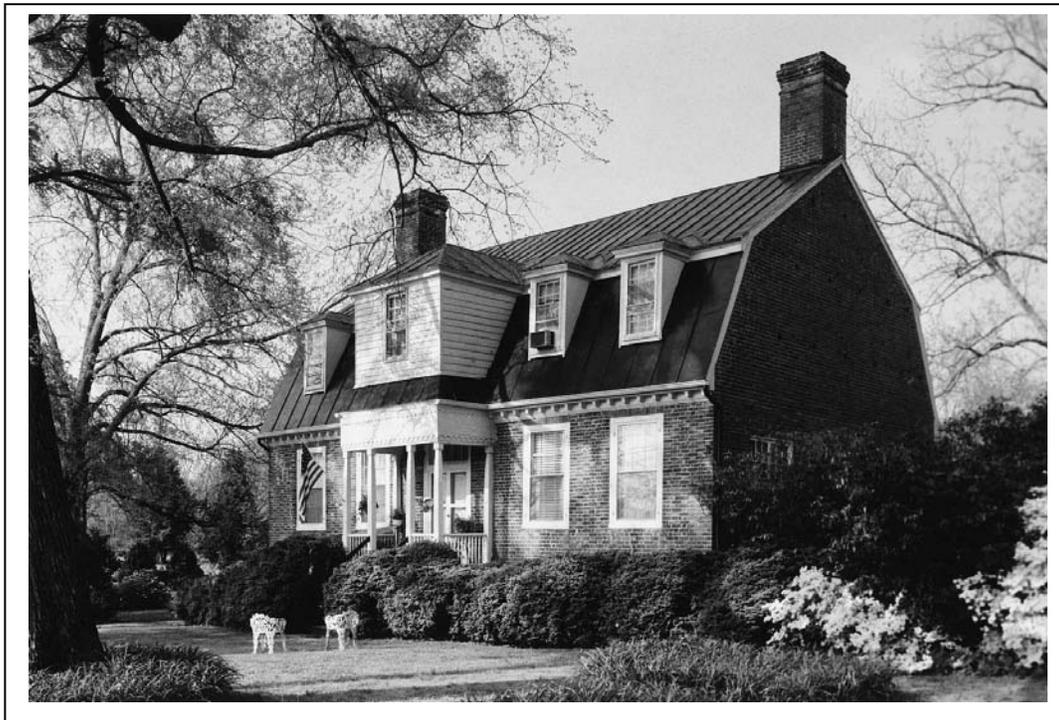
Figure 34. East and north elevations of the Shelton House from the 1975 National Register nomination.

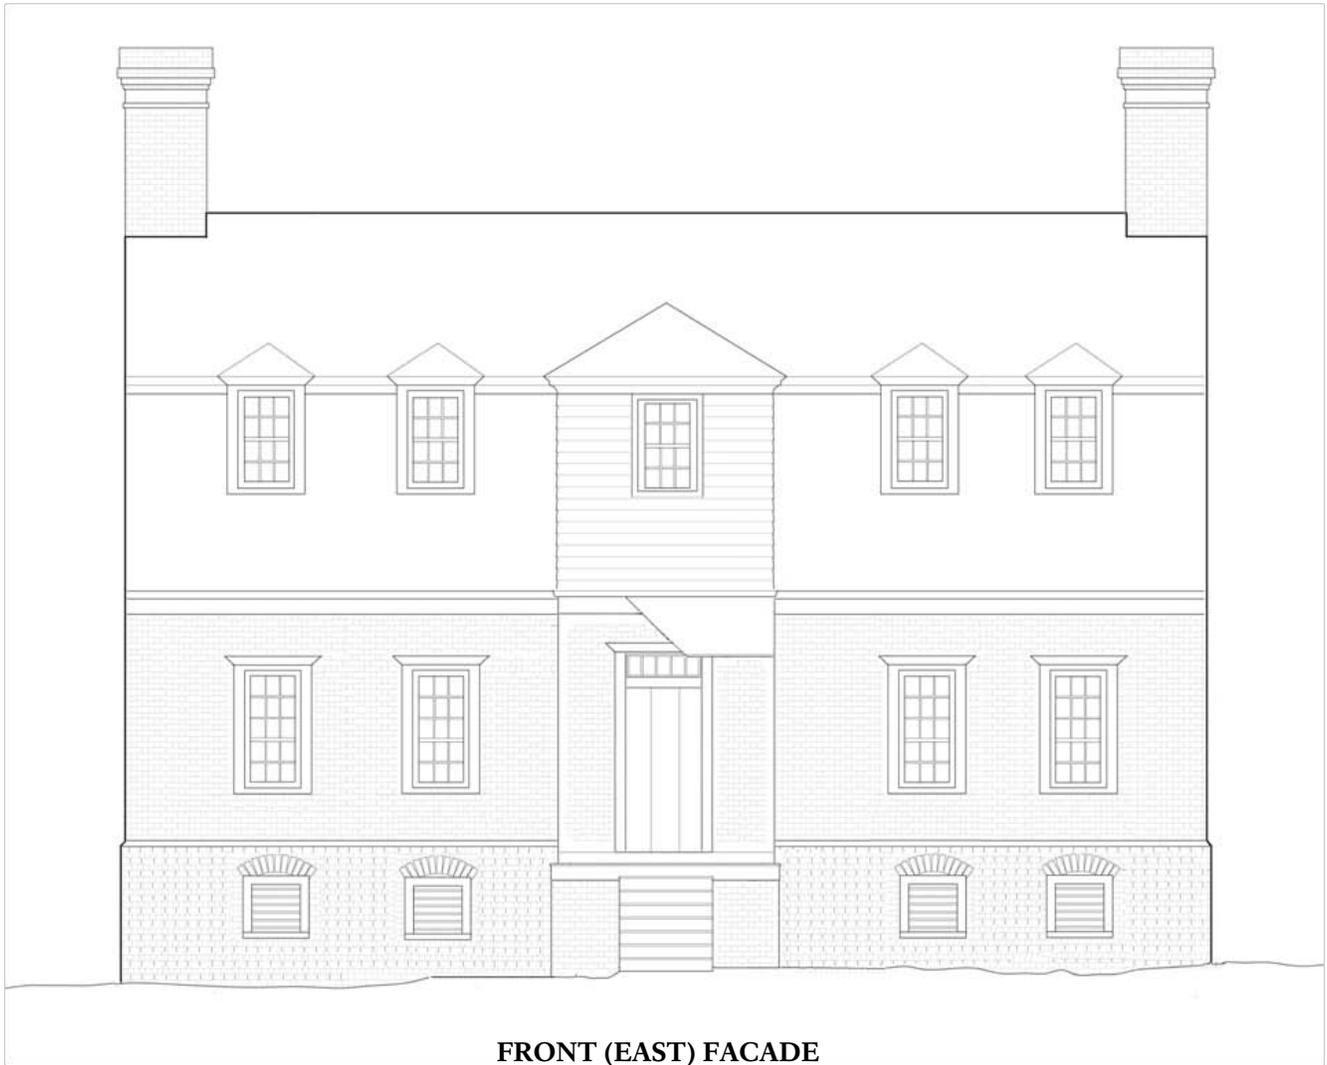
Figure 38. Conjectural east façade of the Shelton House, circa 1725. The symmetrical design with center projecting bay is similar to an image published in the Virginia Gazette, Oct. 8, 1767 (right).

While there was some initial speculation that the Shelton House may have been originally oriented facing Totopotomoy Creek, more compelling evidence suggests that it has always faced east. This includes the placement of the largest rooms on the east side of the house and orientation of detached slave cabins on the west side. Furthermore, the projecting east entrance porch with second-story porch chamber, presenting a center “tower” appearance, was a common feature in 17th- and 18th-century Virginia dwellings (fig. 38).¹⁵⁸

Dormers on the east and west sides of the lower roof had windows that provided natural light to the second-story rooms of the Shelton House. These were undoubtedly smaller than the existing large dormers, which have been dated circa-1785 based on paint analysis. Physical evidence of the original dormers may be preserved within the concealed framing of the lower roof. See figure 38 for a conjectural drawing of the original east dormers.

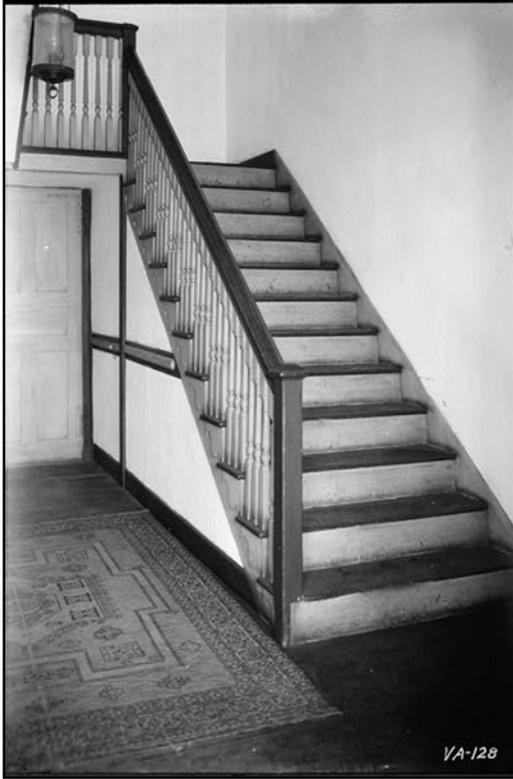
Figure 42. Circa-1742 main stairway at Old Mansion, Bowling Green, Caroline County, Virginia. Photograph by the Historic American Buildings Survey, 1936.

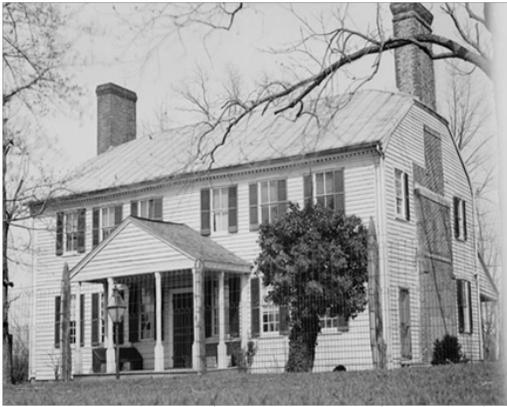
*Figure 44. Marmion, circa 1750,
King George County, Virginia.
Photograph and floor plans by the
Historic American Buildings Survey,
1936.*

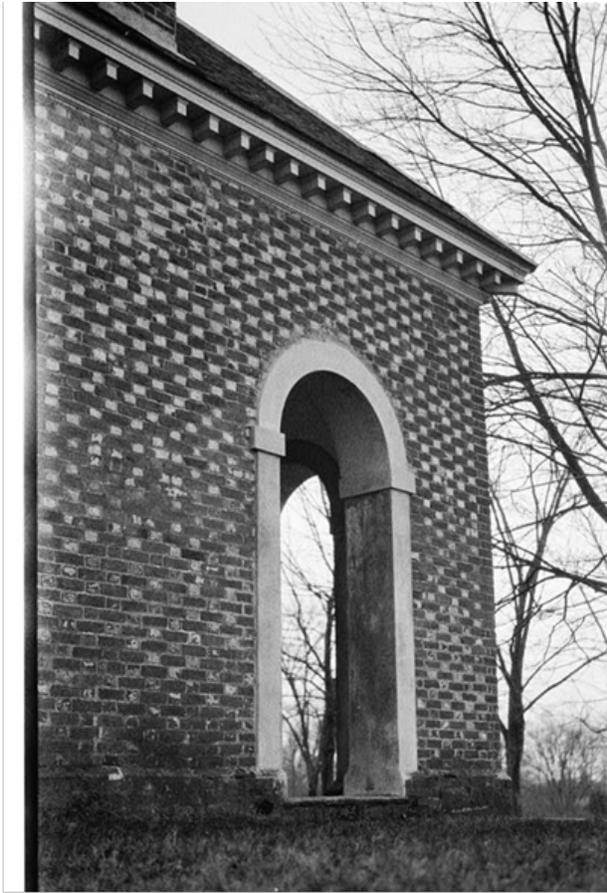
Figure 45. Hanover County Courthouse in Hanover, VA, was constructed in 1735 with brick walls laid in Flemish bond with glazed headers. Photograph by the Historic American Buildings Survey, post-1933.

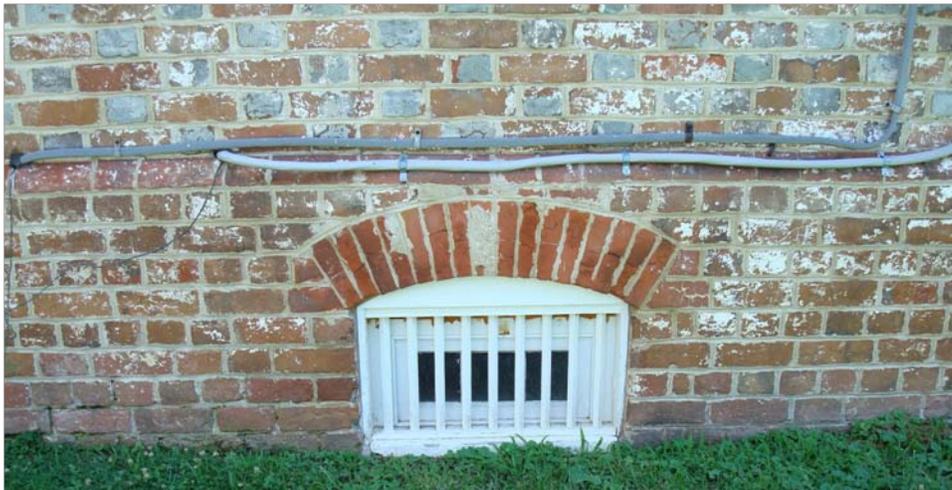
Figure 46. Exterior brick walls of circa-1742 Old Mansion in Caroline County, Virginia, have two patterns: English bond in the ground story and Flemish bond with glazed headers in the upper stories. Photograph June 2009.

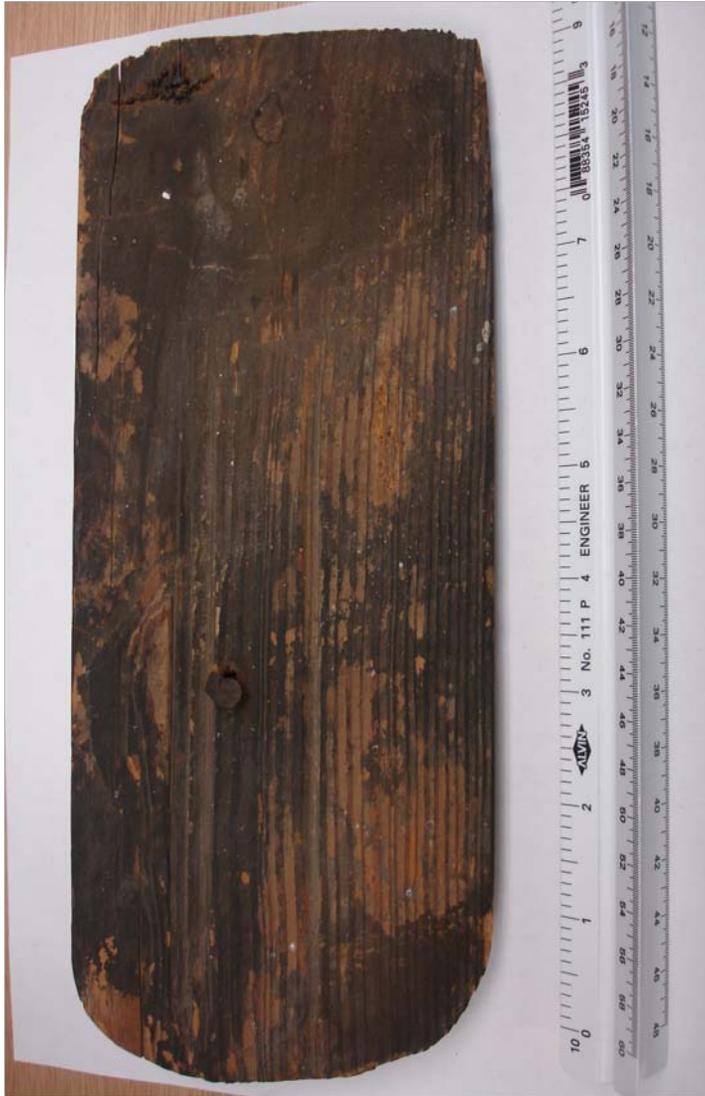
Figure 47. Wood roofing shingle found reused as a shim in the attic of the Shelton House, 2007. The single has been dated circa-1800-15, based on an attached early machine-cut nail. Photograph June 2009.

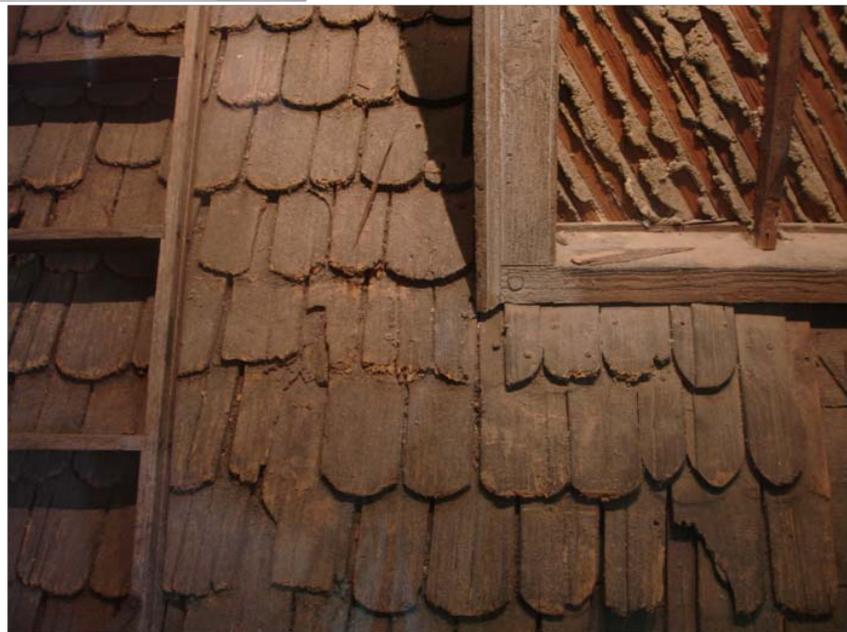
Figure 48. Wooden roofing shingles on the west roof of the circa-1742 Old Mansion, covered by a wing in 1791. Photograph June 2009.

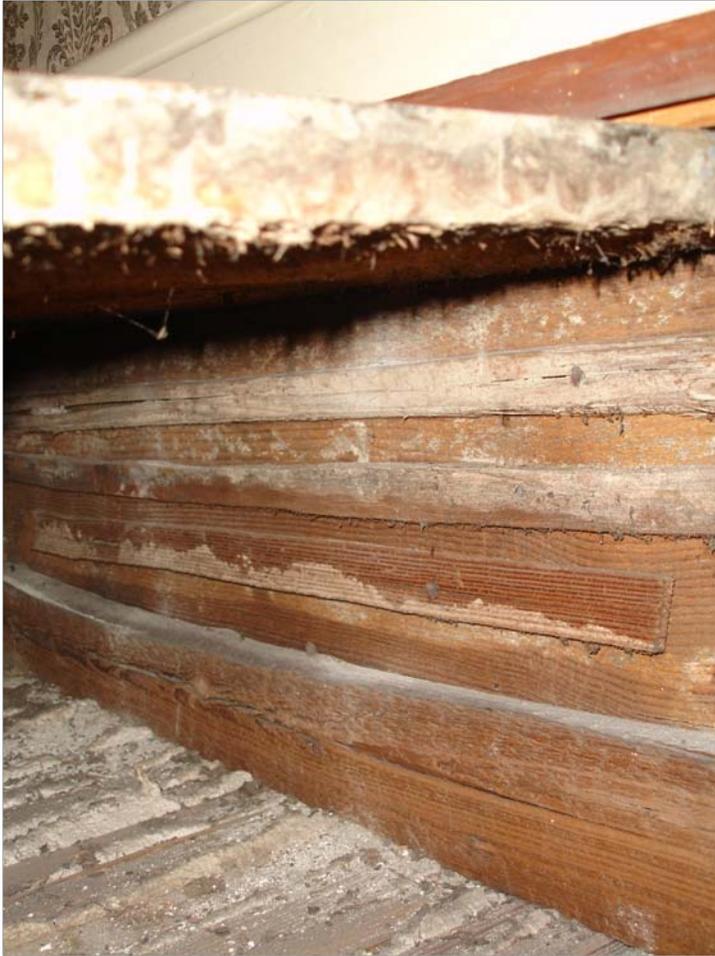
Figure 49. Remnants of original plaster lath preserved beneath the floorboards of the upper hall (Room 201), in the vicinity of the missing hall stairway. Shelton House, June 2009.

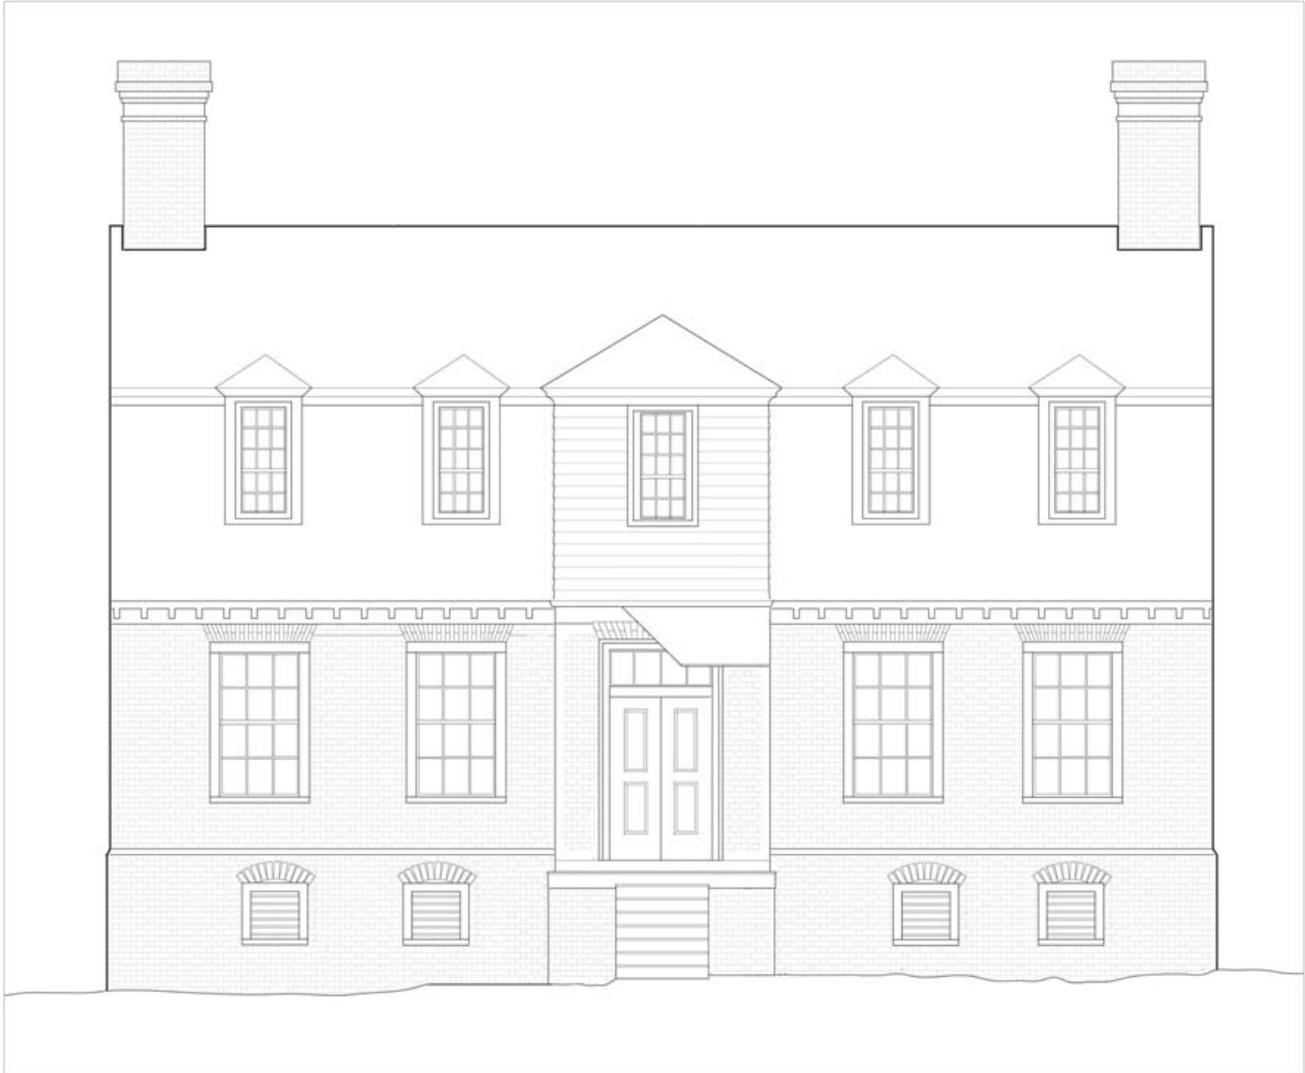
SHELTON HOUSE
Ca. 1785

Figure 50. Conjectural east façade of the Shelton House, circa 1785.

each, making use of new, larger window panes. The windows in the second-story dormers may have been fitted with the old 9-over-6 sashes from the first story. The dormers themselves were reconstructed to accommodate the larger sashes and repositioned to align with the enlarged windows in the first story (fig. 50).

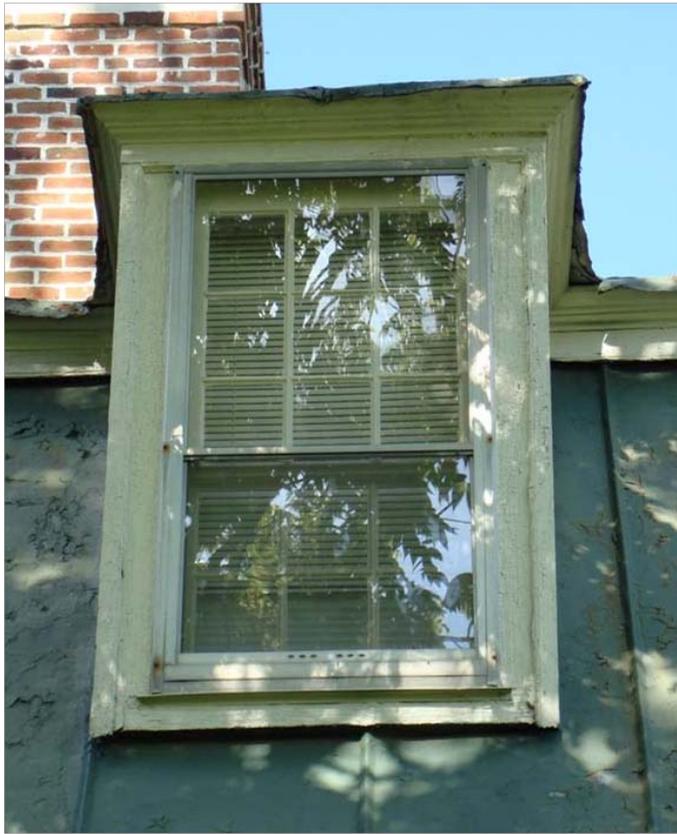
*Figure 51.
Existing dormers,
enlarged windows, and
cornices are circa-1785
alterations.
Shelton House
photographs, 2009.*

New wooden cornices were installed on the Shelton House around 1785. The main cornice on the front (east) side of the house featured decorative modillions with curved shapes, while the back (west) cornice had plain block modillions. Cornices on the enlarged front dormers were also more detailed than those of the back dormers, having deeper and more complex moldings. Dating of the main cornice was confirmed by paint analysis, which identified a first painted finish of red-brown also found on the casings of the enlarged doorways, windows, and dormers.

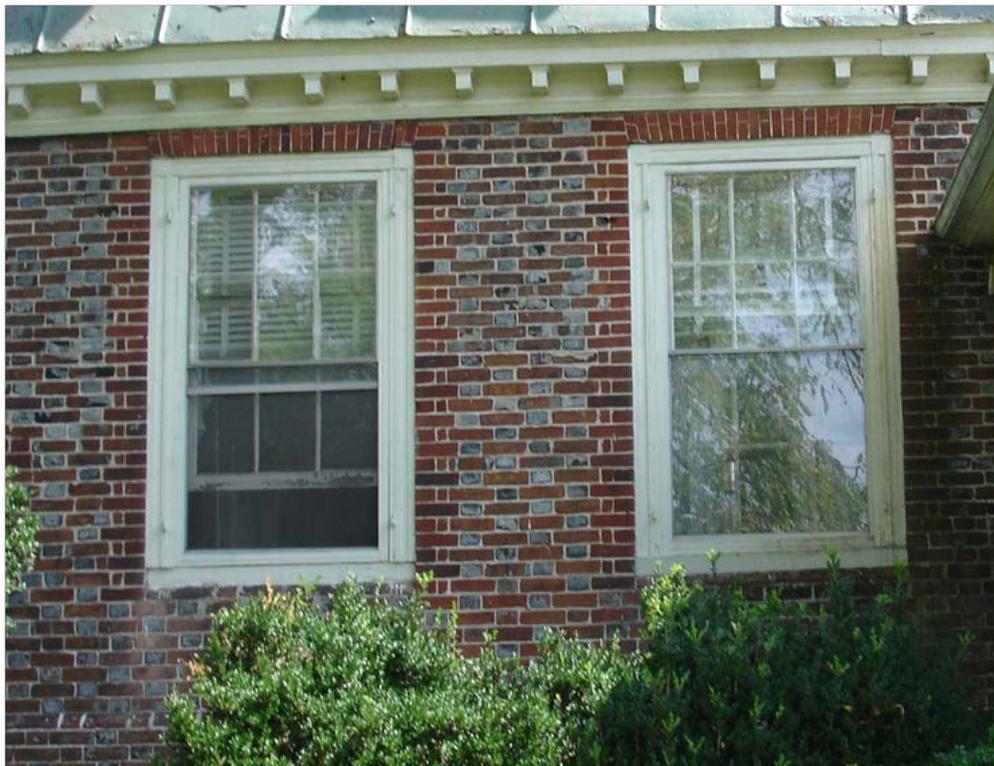
Figure 52. Circa-1785 rubbed bricks at window W108 and the southwest corner of the Shelton House, January 2009.

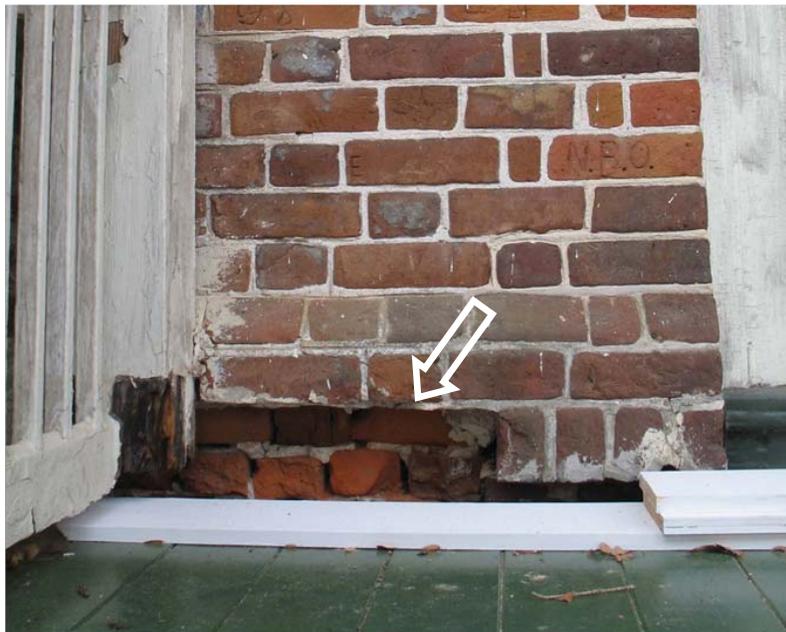
Figure 53. Area of damaged brickwork at the east porch of the Shelton House 2008, revealing what appears to be an earlier brick wall.

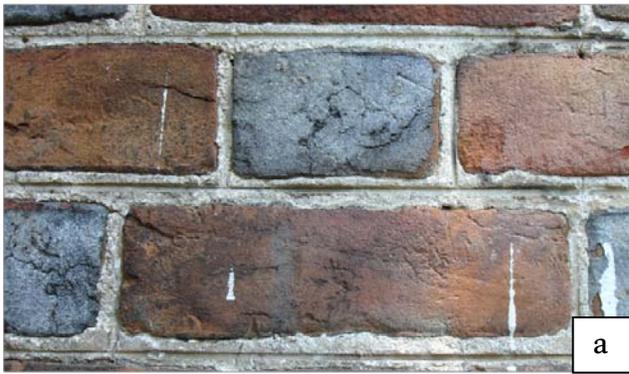
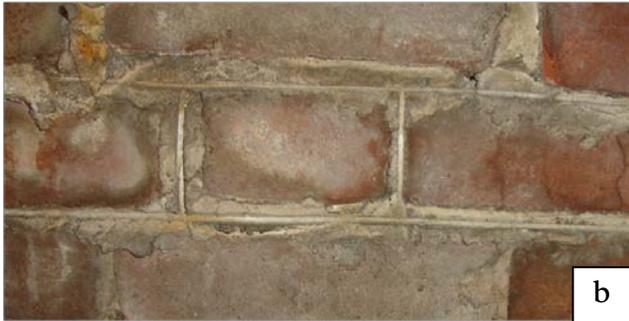
Figure 54. Similar brick size and tooling of mortar joints on the exterior west side of the house (a,) and at the interior north wall of the attic (b), suggest that brickwork at the upper gable ends was rebuilt at a later date. Shelton House, July 2011.

The brickwork at the upper gable ends of the house also appear to have been rebuilt at this time. These walls are only two wythes thick at the north and south elevations of the attic story. Similar brick size and tooling of the lime mortar joints suggest contemporary construction with the new brick veneer (fig. 54). Putlock holes to support horizontal scaffolding were also incorporated into the brickwork of the north and south walls.¹⁸⁷

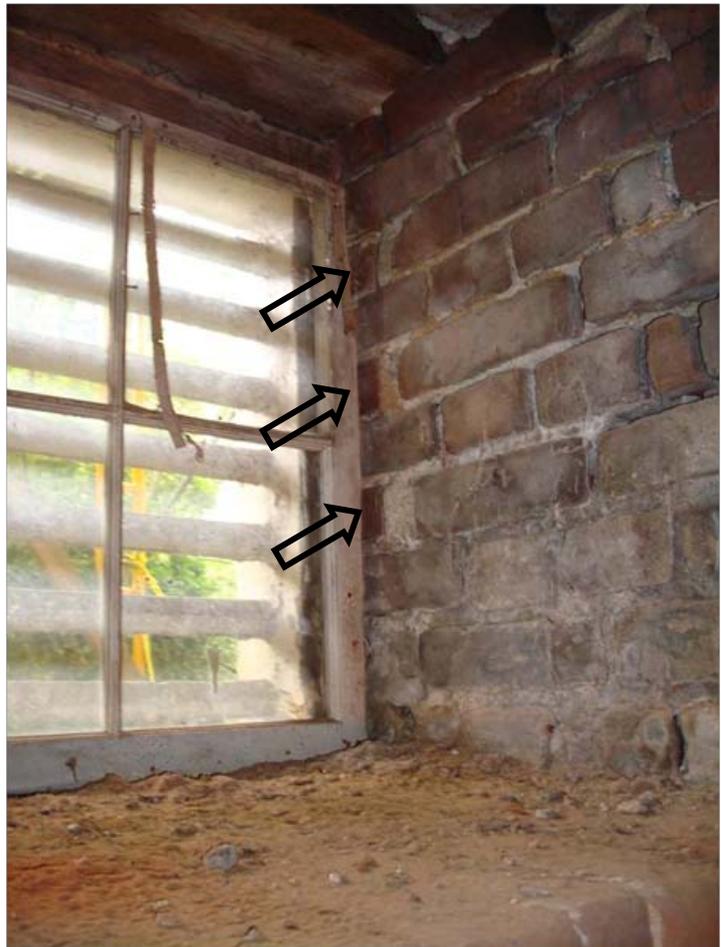
Figure 55. South jamb of cellar window W003 showing what appears to be a later (circa-1785) veneer of Flemish-bond brickwork covering the original English-bond of the foundation wall. Shelton House, September 2009.

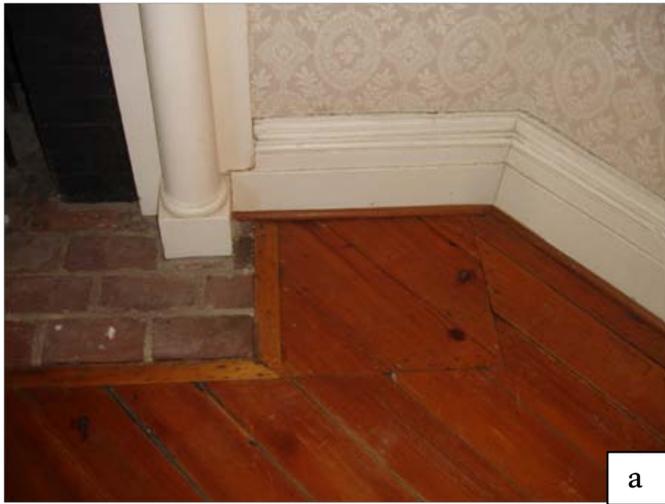
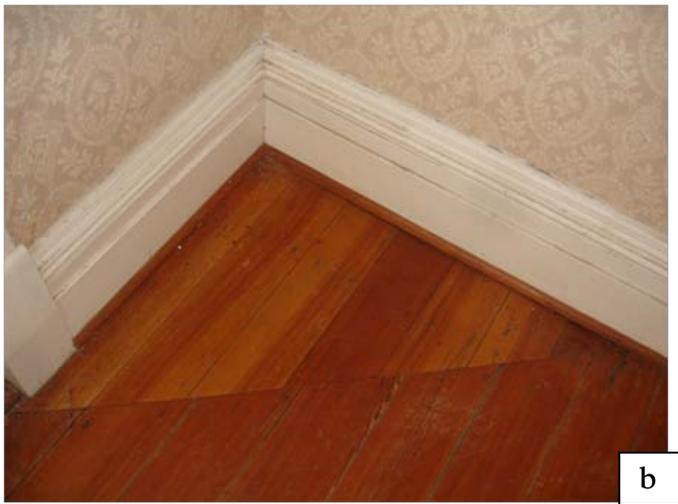
Figure 56. Patches in the circa-1785 floor boards of the parlor (Room 102) provide clues as to the earlier appearance of the room, including the size of the hearth (a) and possible size of the cupboard in the northwest corner of the room (b). Shelton House, July 2011.

Narrow floorboards replaced the original wide floorboards in the first story of the Shelton House circa 1785 (figs 56-57). These later floorboards survive beneath later flooring in most of the first-story

Missing circa-1785 elements of the southeast room (Room 102) are suggested by patches in the circa-1785 floorboards. These include a wider hearth and possible corner cupboard (fig. 56).

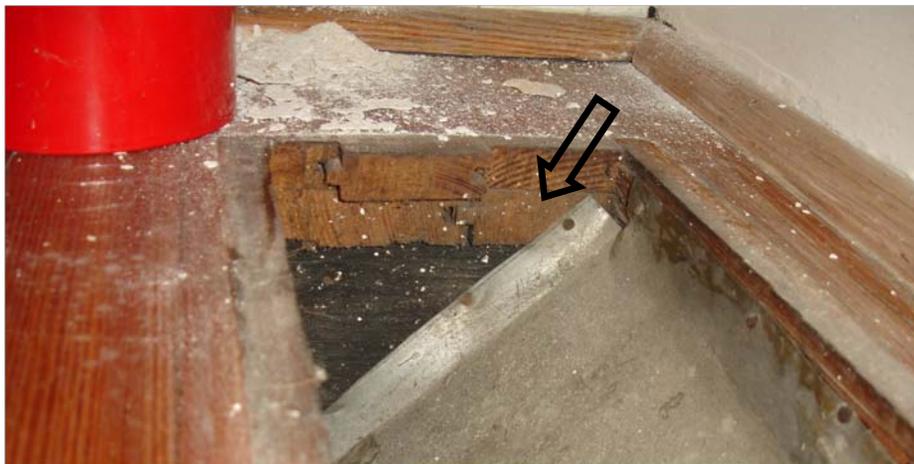
Figure 57. Circa-1785 floorboards preserved beneath later floorboards, as seen at the heat-register opening in the northeast corner of the center hall (Room 101). Shelton House, July 2011.

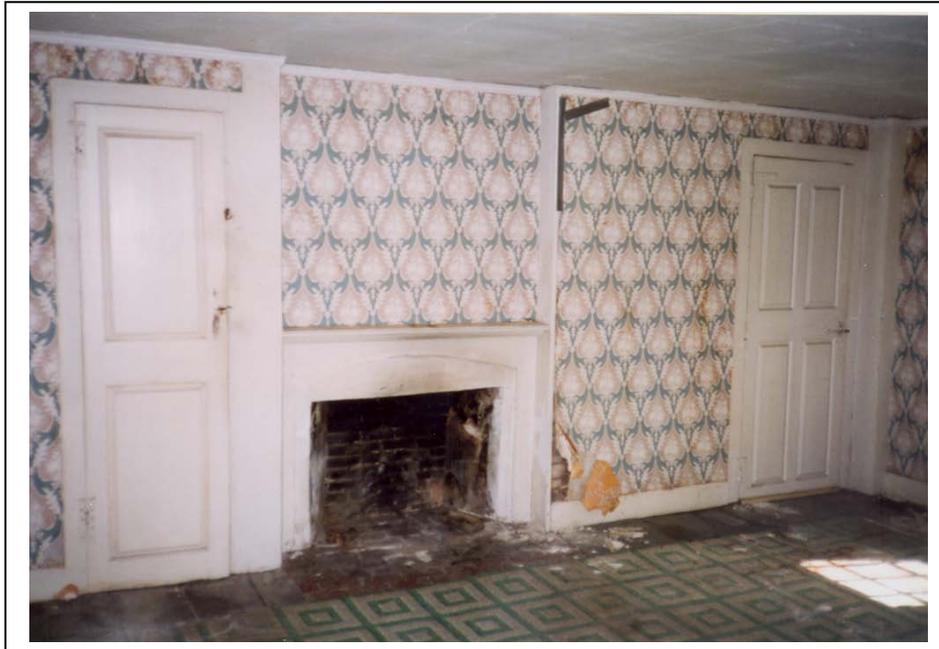
Figure 58. Original doorways in the Stow-Hardy House in Concord, Massachusetts, Minute Man National Historical Park, are similar to early doorways in the Shelton House (fig. 59). The Stow-Hardy house has been dated circa-1786 by dendrochronology. Doorways in the lower photograph are in the first-story parlor; doorways in the upper photograph are in a second-story chamber.

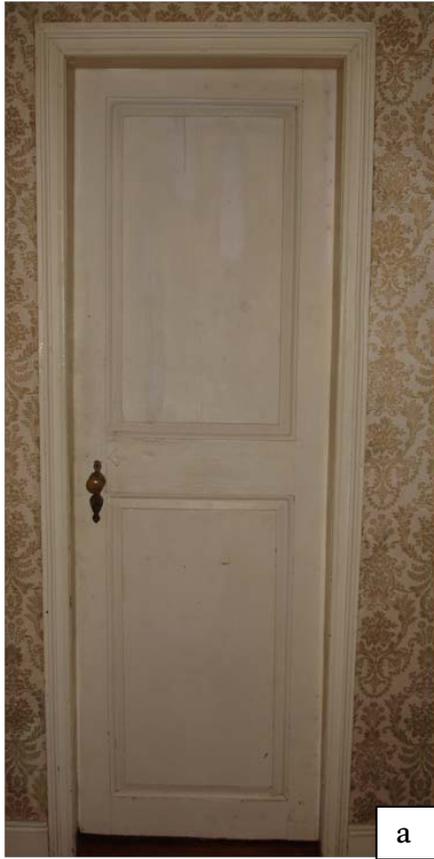
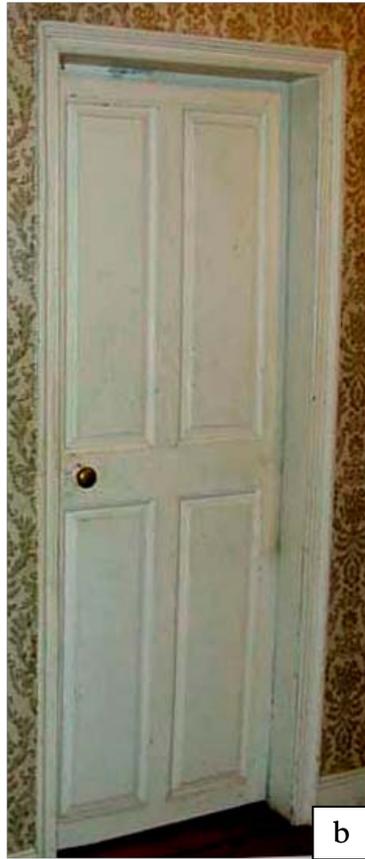
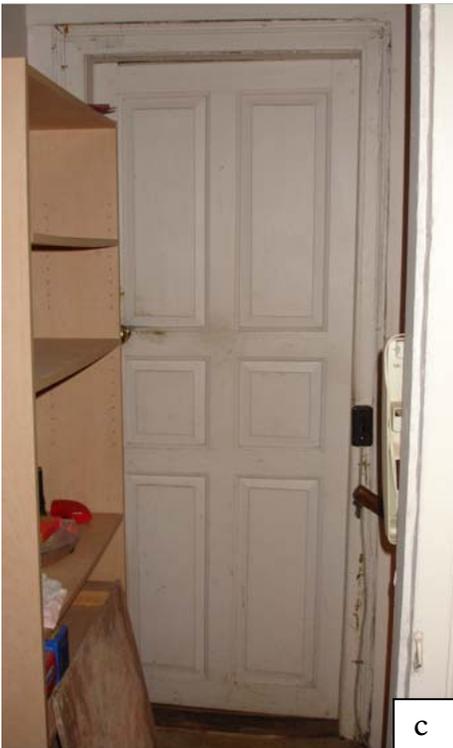
Figure 59. Pictured here are four of six surviving circa-1785 doorways in the Shelton House. Key: (a) D201; (b) D207; (c) D113; and (d) D114. Shelton House, 2009.

Interior remodeling of the Shelton House circa 1785 replaced all interior woodwork and trim with new materials, with the possible exception of the center stair. Paneled doors replaced earlier doors; six of these paneled doors survive in the house today. The doors have two, four, or six panels; were hung on wrought-iron HL hinges; and were originally equipped with thumb latches (fig. 59). Similar doors are in the Stow-Hardy House in Minute Man National Historical Park in Concord, MA, which has been dated circa 1786 by dendrochronology (fig. 58). Both doorways and windows were trimmed with new interior casings with moldings in the Federal style (fig. 60). Other circa-1785 wall trim included baseboards with simple bead detail and chair rails (fig. 62).

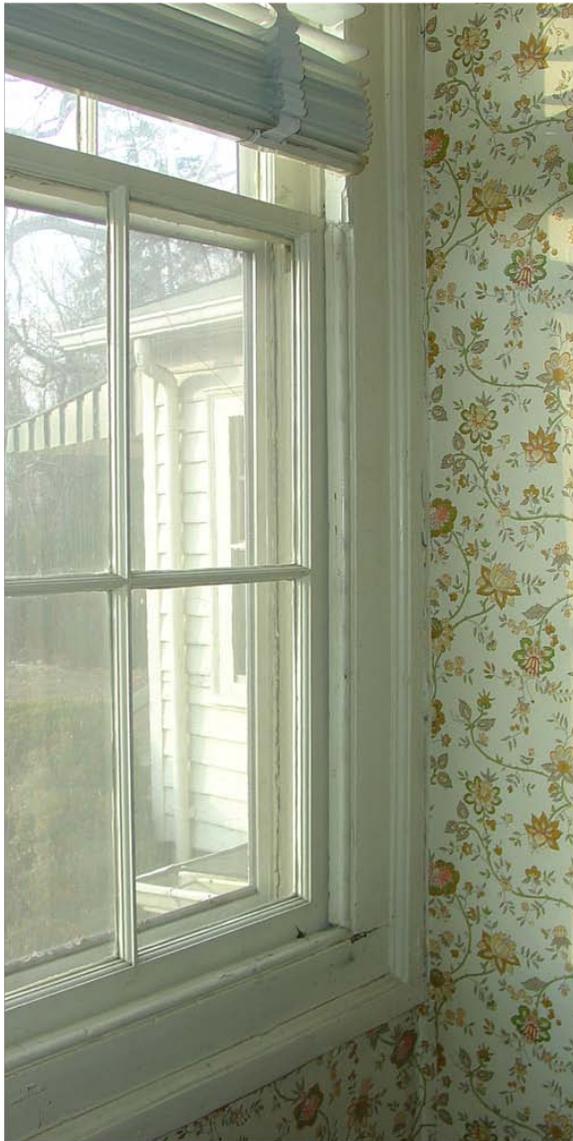
Figure 60. Circa-1785 window casing at W111 in Room 103. Similar window casings are in Rooms 106 and 107. Shelton House, 2009.

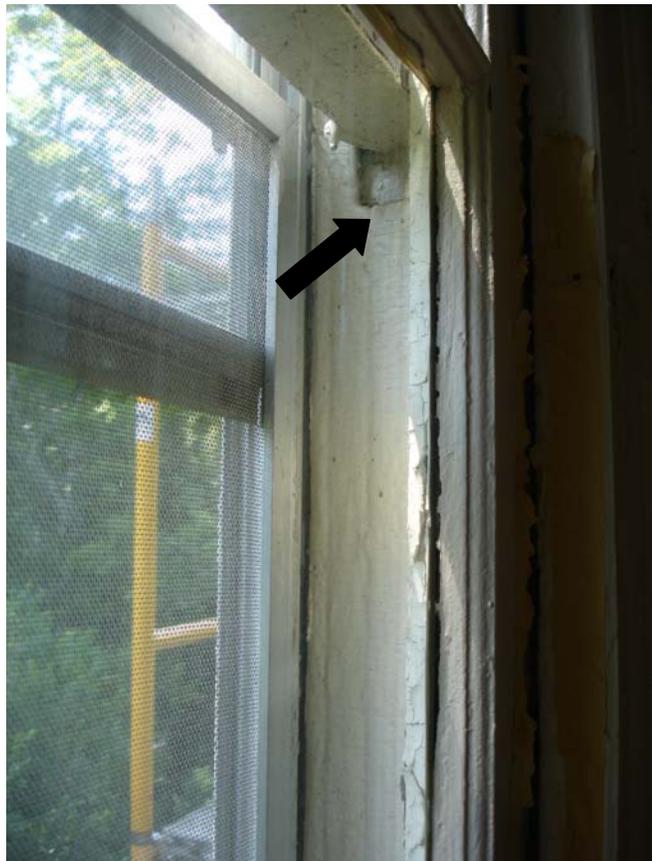
Figure 61. Circa-1785 window jamb at W106 in Room 106. Similar window jambs are in Rooms 103 and 107. A gap in the jamb (at arrow) beneath the existing circa-1835 upper sash indicates the earlier, circa-1785, sashes were a different size. Shelton House, July 2011.

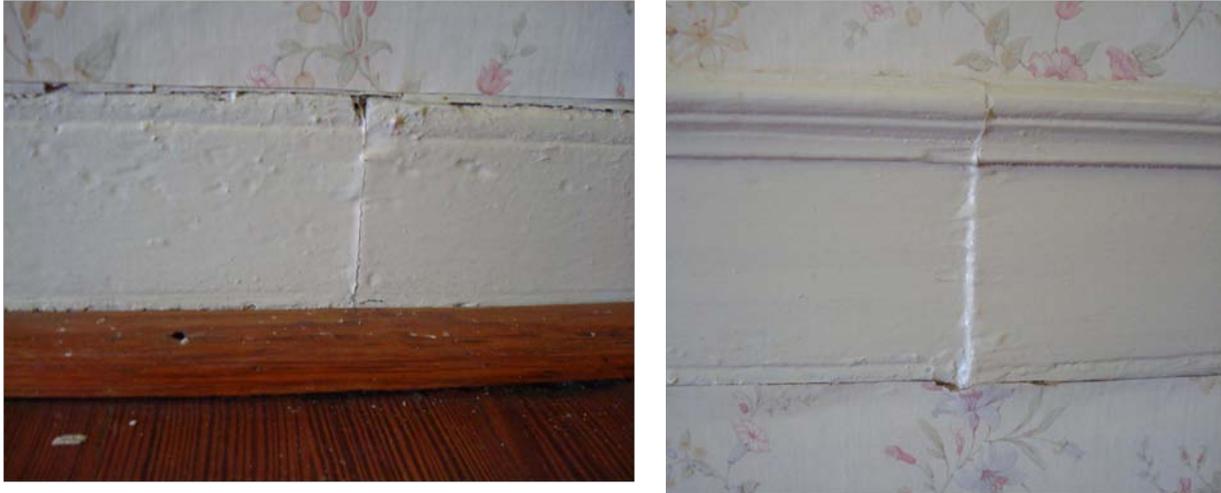
Figure 62. Details of circa-1785 baseboard (left) and chair rail (right) in Room 101 (the first-story hall). Note that the quarter-round molding at the base of the baseboard is later. Shelton House, 2009.
