THE SHELTON HOUSE at RURAL PLAINS

Historic Structure Report

Richmond National Battlefield Park
Mechanicsville, Virginia

Barbara A. Yocum, Architectural Conservator
Historic Architecture Program
Northeast Region, National Park Service
Lowell, Massachusetts

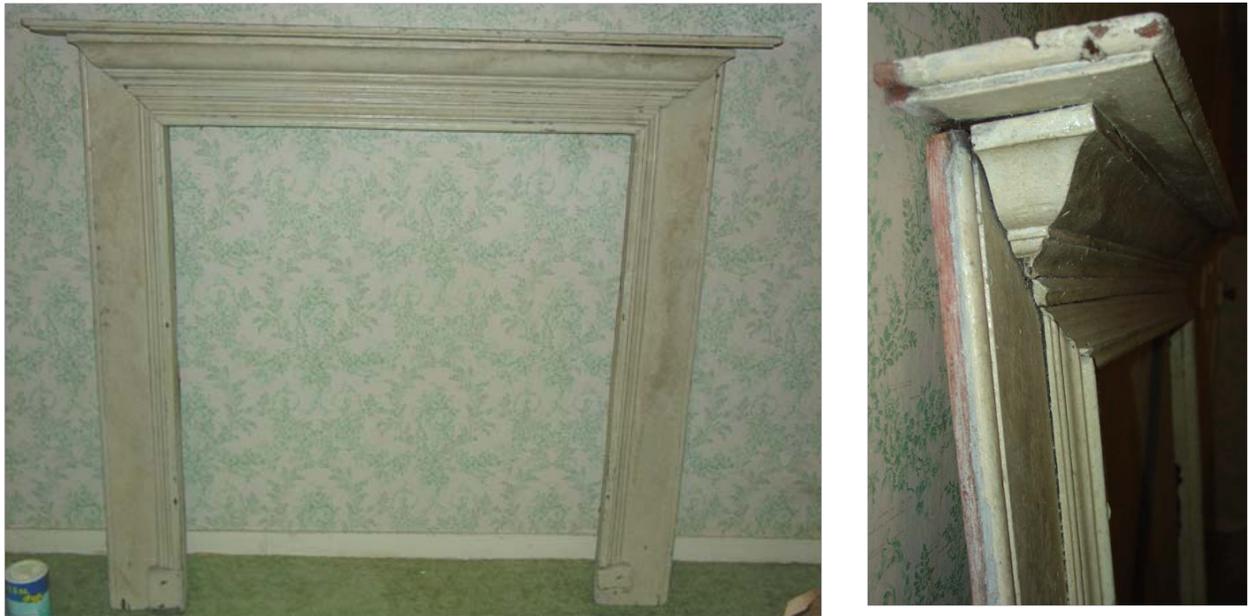
Figure 63. Detached circa-1785 mantel stored in Room 207. Shelton House, 2009.

Of the new fireplace mantels, only one remains in the house today. This is a simple wooden surround with shelf and Federal-style moldings (fig. 63). Found detached in one of the second-story bedrooms, paint analysis suggests it was originally located in the first-story dining room (Room 107), and later moved to the chamber above (Room 207).

chamber above (fig. 63), based on the paint evidence.

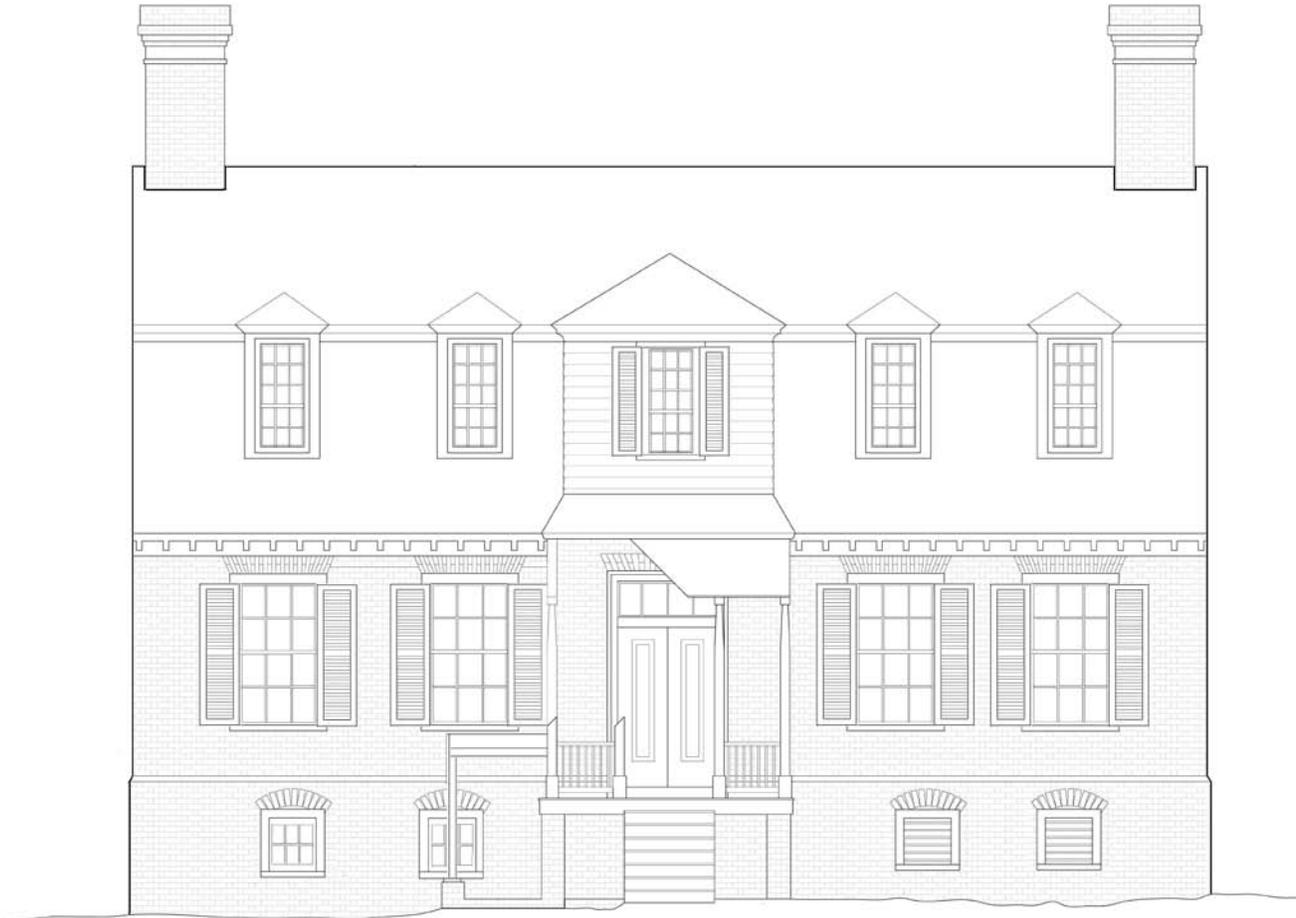
FRONT (EAST) ELEVATION

Figure 64. Conjectural east façade of the Shelton House, circa 1835.

Many changes were made to the doorways of the Shelton House circa 1835. Outside, the exterior entrance to the cellar was moved from the south elevation to the front (east) façade, beneath the front porch. Here, a former cellar window was enlarged and fitted with casings and a 6-panel door. The two main-entrance doorways were updated with new Greek-style doors and transom sashes. Each doorway had a pair of doors with long, vertical panels (figs. 64 and 67a).

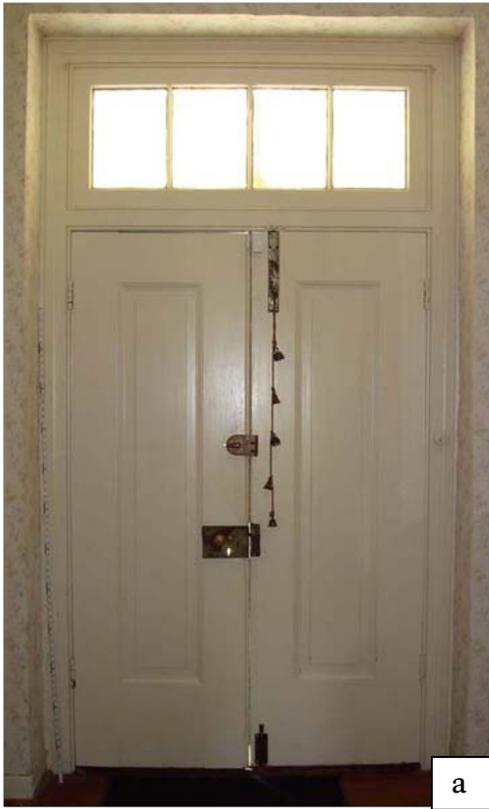
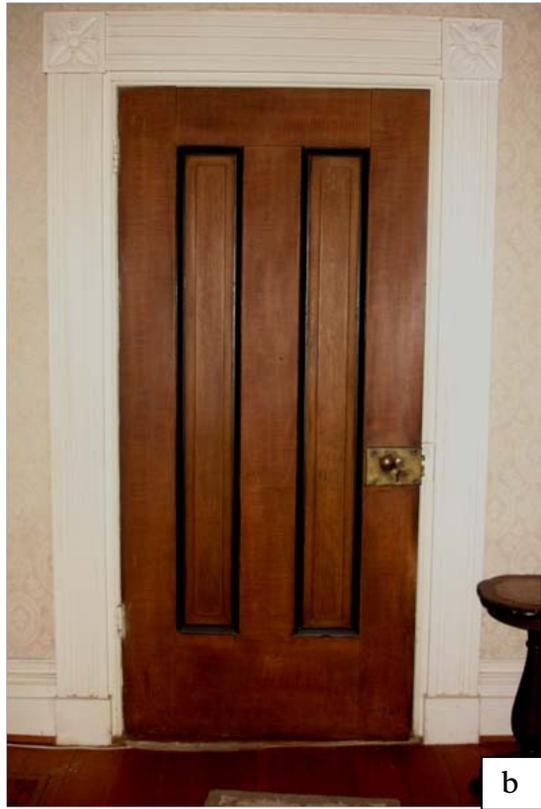
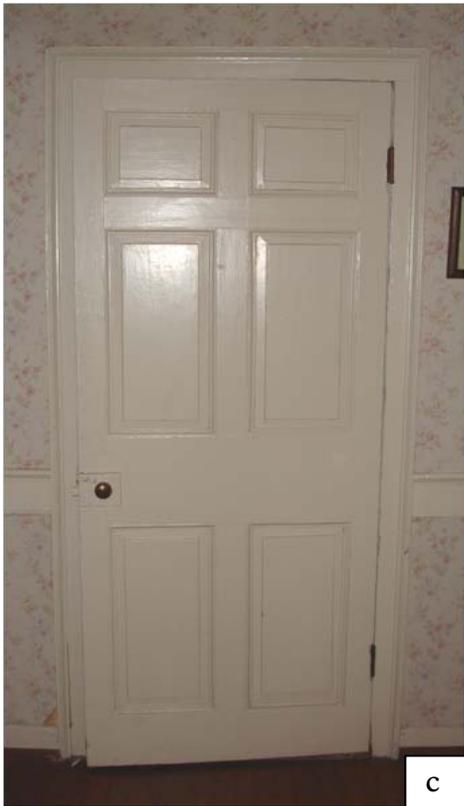
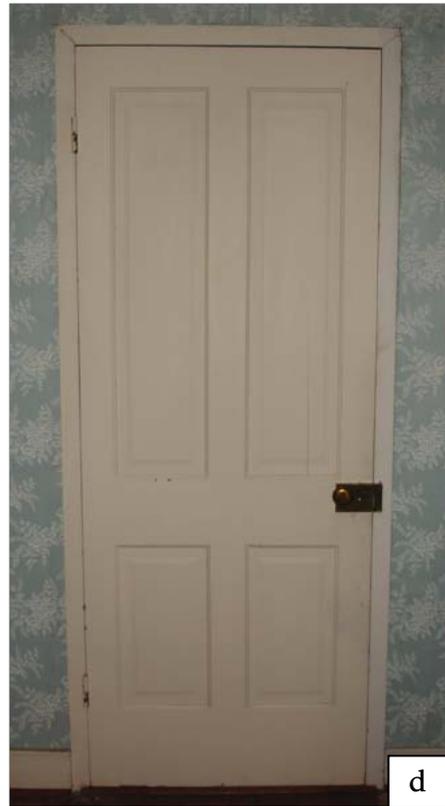
Figure 67. Many doorways were updated with new doors and casings circa 1835, including the four pictured here. Key: (a) D101, (b) D103, (c) D107, (d) D202. Shelton House, 2009.

Inside, most of the doors in the cellar and first story were replaced with new doors. Doors with six panels opened on the new kitchen, while other cellar doors were a simpler board-and-batten style. Upstairs in the first story, some of the existing (circa-1785) doorway casings and doors were reused at the new corner stairway and in the north rooms. Other first-story rooms were outfitted with new 6-panel doors and casings, except in the parlor where a door with two vertical panels was installed (fig. 67b). Fewer changes appear to have been made to the doors in the second story, where only one 4-panel door appears to date to circa 1835 (fig. 67d).

The door hardware of circa-1835 included closed-butt hinges, box latches, and small metal knobs. Carpenter latches, imported from England, were used on the exterior doors and parlor door only. Doorway casings were also updated at this time. The most formal casings were those with carved corner blocks that were installed in the parlor (figs. 67b and 70).

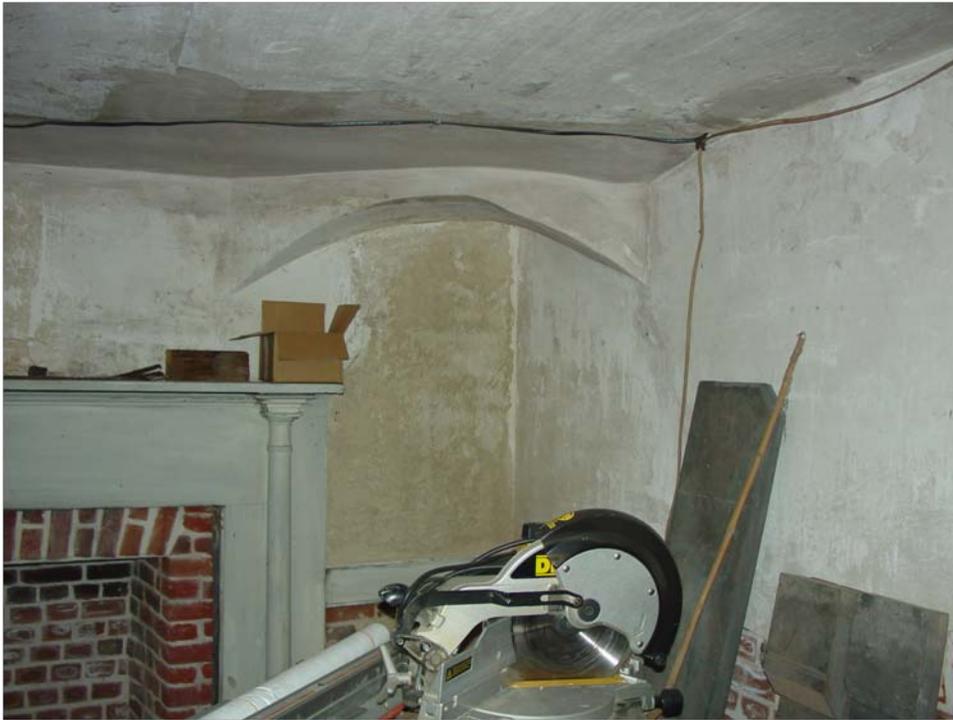
Figure 69. The rooms of the cellar story were plastered circa-1835, including the new dining room (Room 001). Shelton House, 2009.

As previously mentioned, the walls and ceiling of the new cellar dining room were plastered circa 1835, as was the former stairway opening in the first-story passage, the framed walls of the new stairway, and the enlarged exterior walls of the south chambers. The ceilings of the other cellar rooms, which had previously been painted black or whitewashed, were also plastered at this time. The exact extent of other plaster work, such as plaster repairs, is unknown.

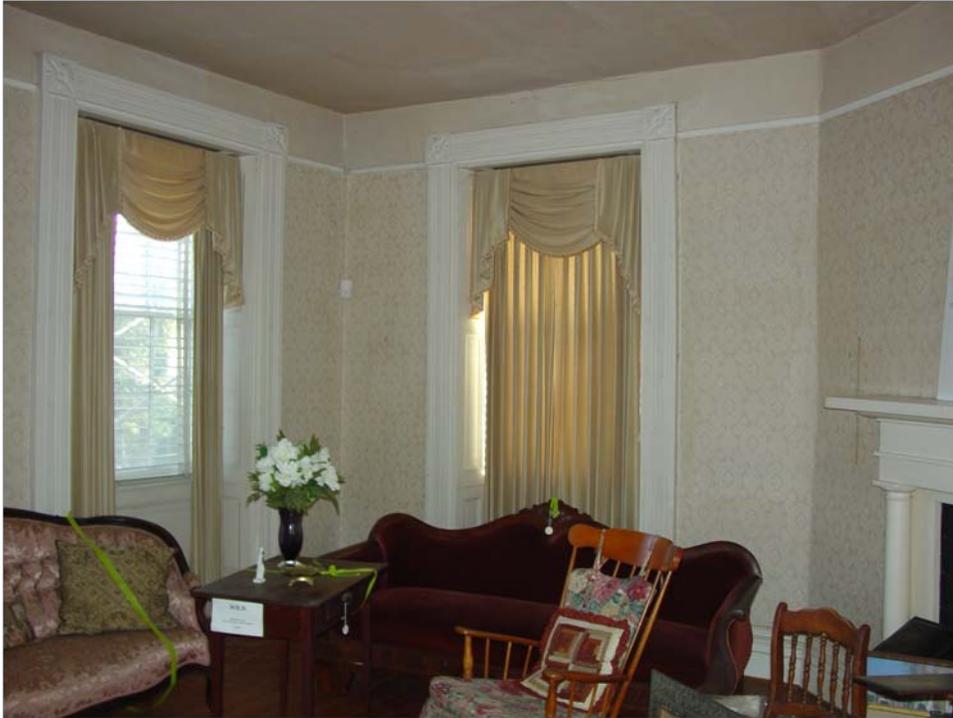
Figure 70. The parlor (Room 102) was updated circa 1835 with a new window in the south wall (above, right), stylish casings trimming the doorways and windows, and a new fireplace mantel. Shelton House, 2009.

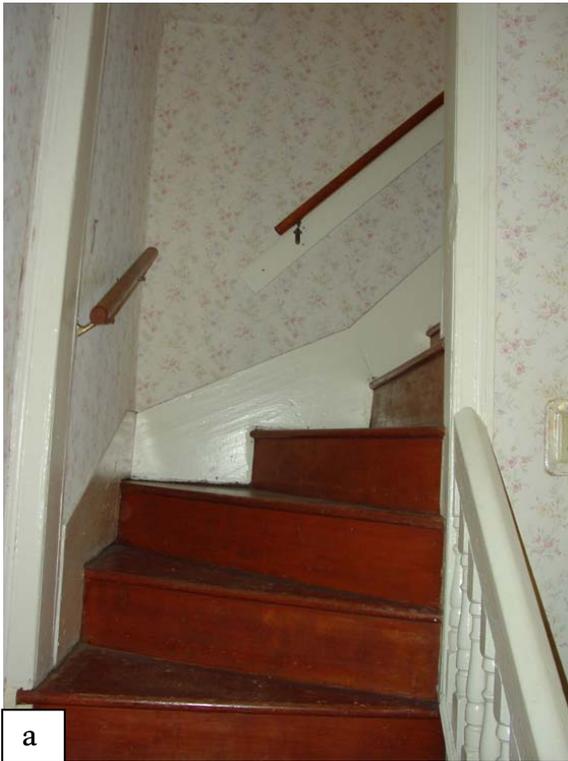
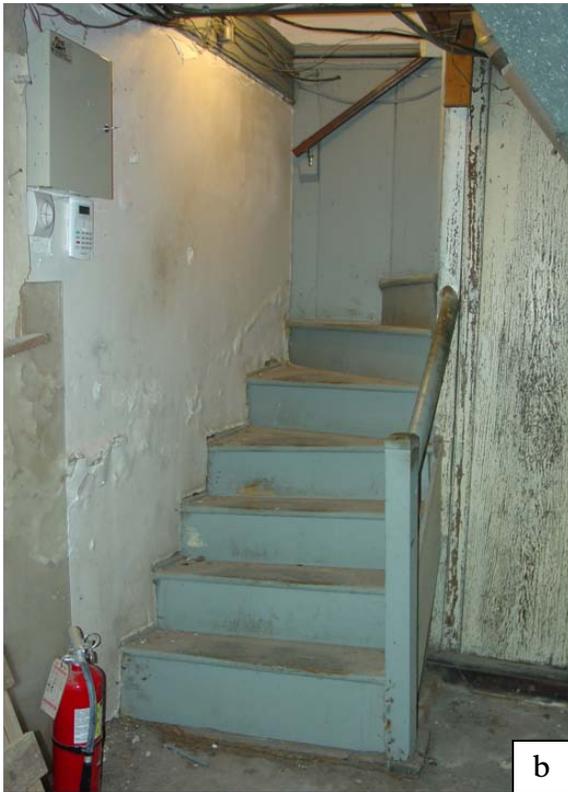
Figure 71. A stairway in the center hall was removed and replaced by the existing stairs tucked in a corner off the hall circa 1835. Pictured here are the stairs connecting the first and second stories (a), and the cellar stairs (b). Shelton House, 2009.

Another significant alteration circa 1835 was the replacement of the stairways in the center passage with the existing stairs off the passage (fig. 71). The reason for relocating the cellar stairway was to enlarge the cellar kitchen as a dining room, as discussed in the previous section. It is less clear why the main stairway connecting the first and second stories was removed, unless it was to use the space of the wide passage as a room. The former stairways were enclosed with ceiling plaster and floorboards and eventually forgotten. It was not until the 2009 investigation for this report that the remnants of the missing main stairway were rediscovered.

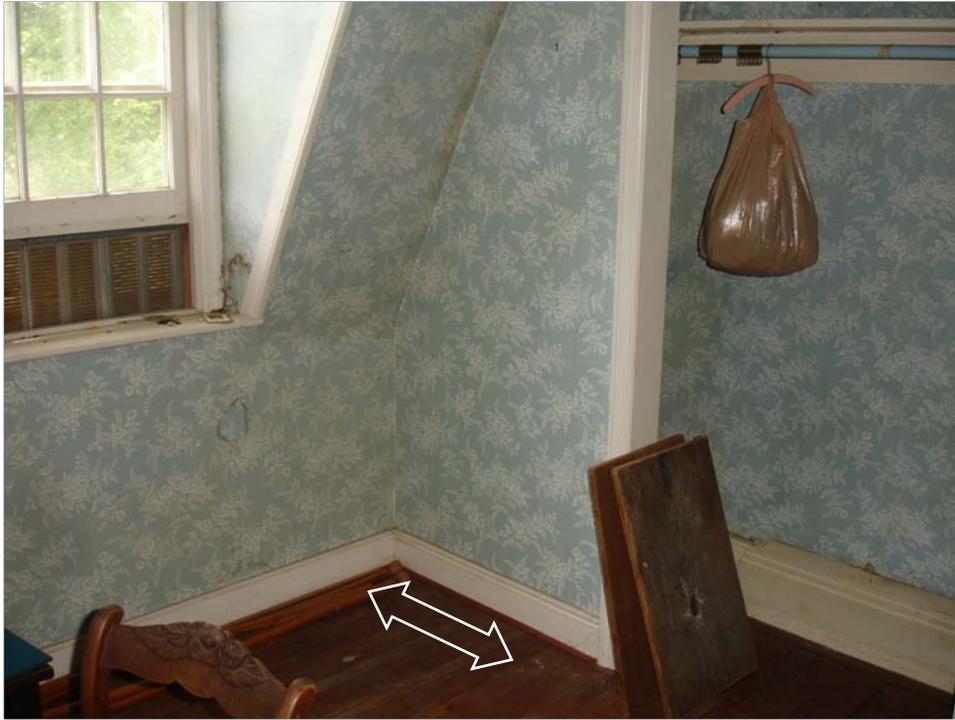
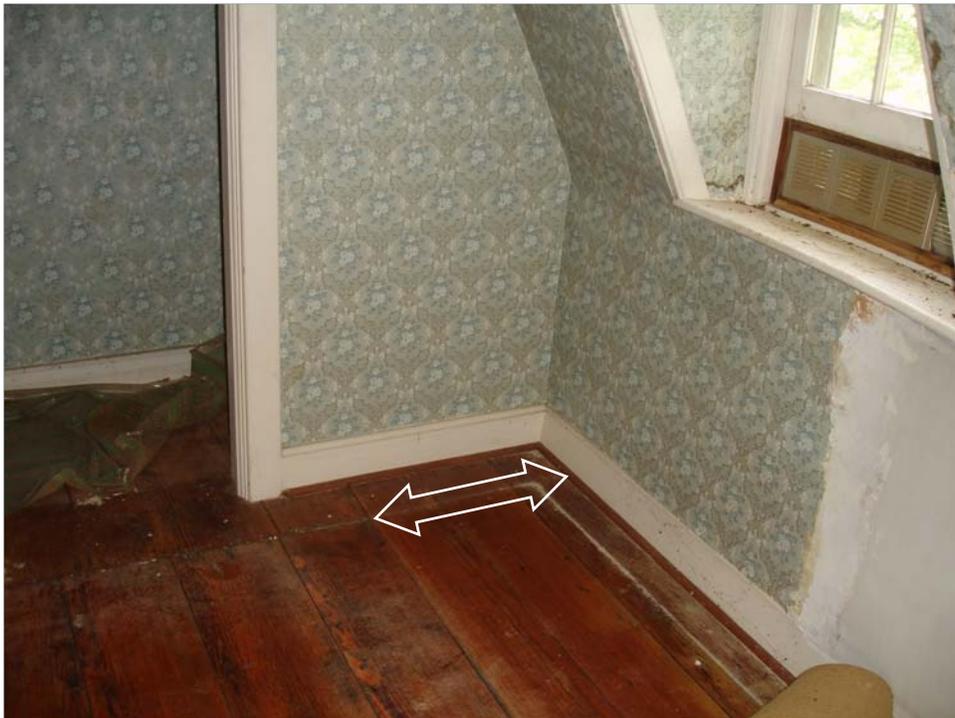
Figure 72. The two south bedrooms (Room 203 above, and 204 below) were enlarged circa 1835 by repositioning the interior wood framing of the east and west walls. New floorboards (at arrows) clearly demarcate the locations of the original walls, which were unchanged in the north bedrooms (Rooms 206 and 207). Shelton House, July 2011.

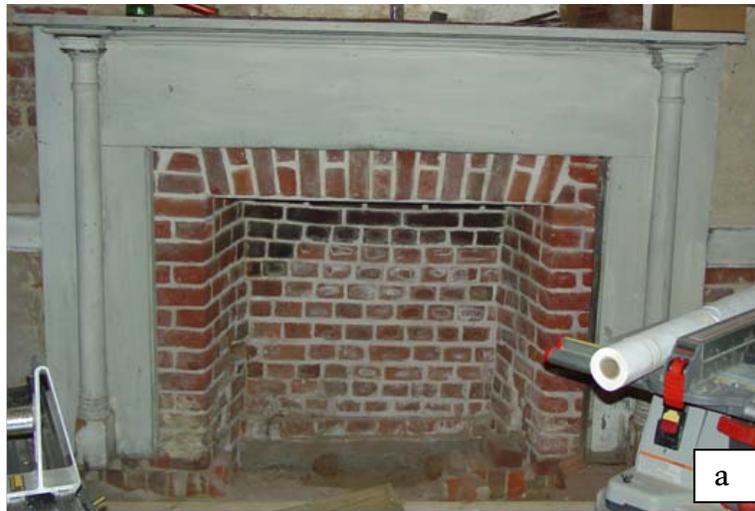
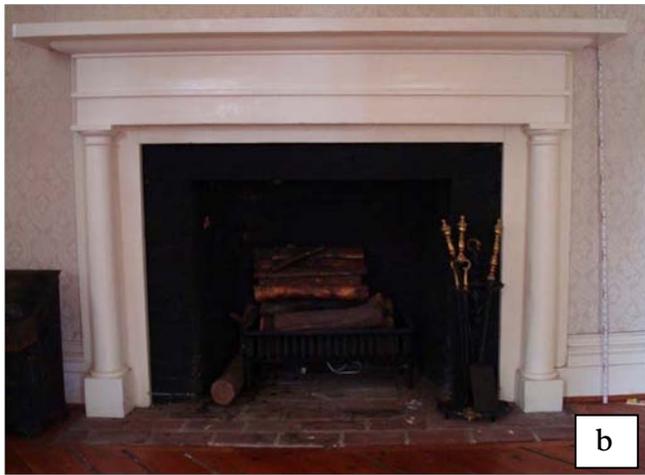
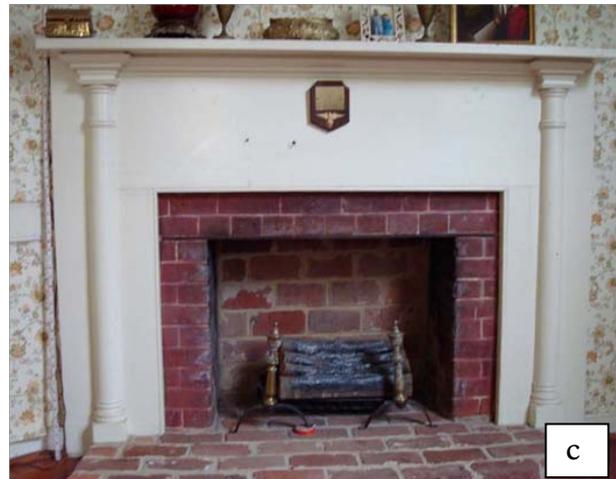
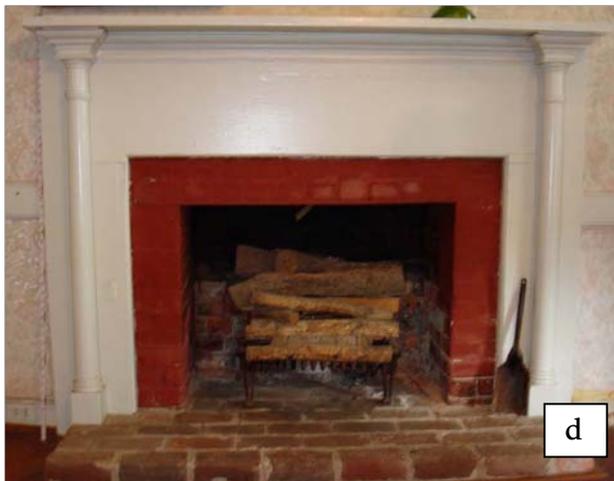
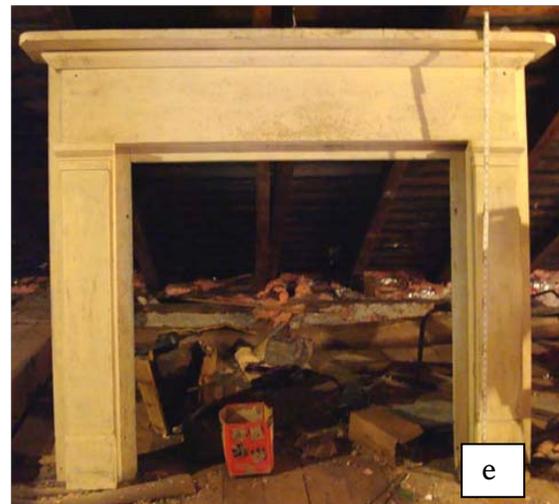
Figure 73. New fireplace mantels circa 1835 replaced earlier mantels in the following rooms: (a) cellar dining room (Room 001), (b) parlor (Room 102), (c) back room (Room 103), and (d) dining room (Room 107). A loose mantel in the attic (e) appears to have been located in the southeast bedroom (Room 203). Shelton House, 2009.

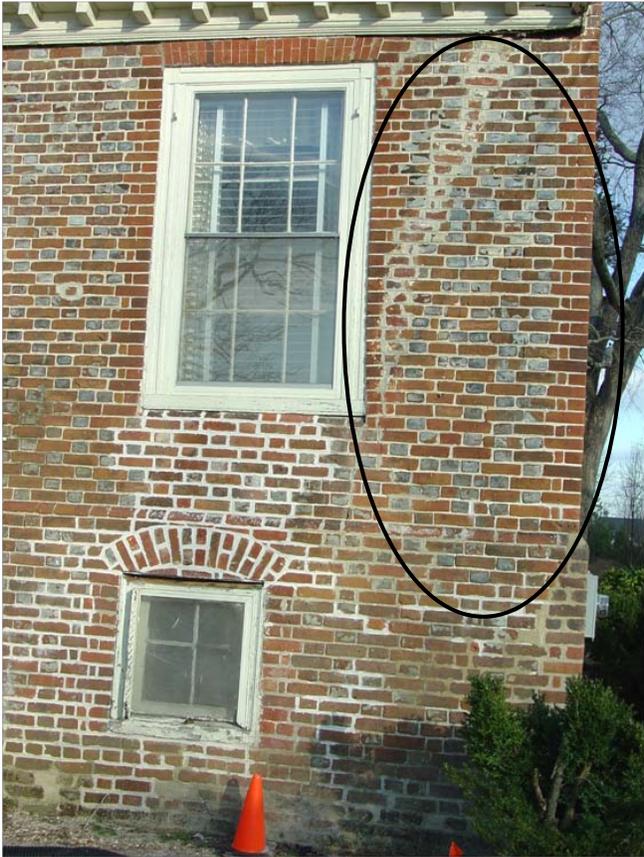
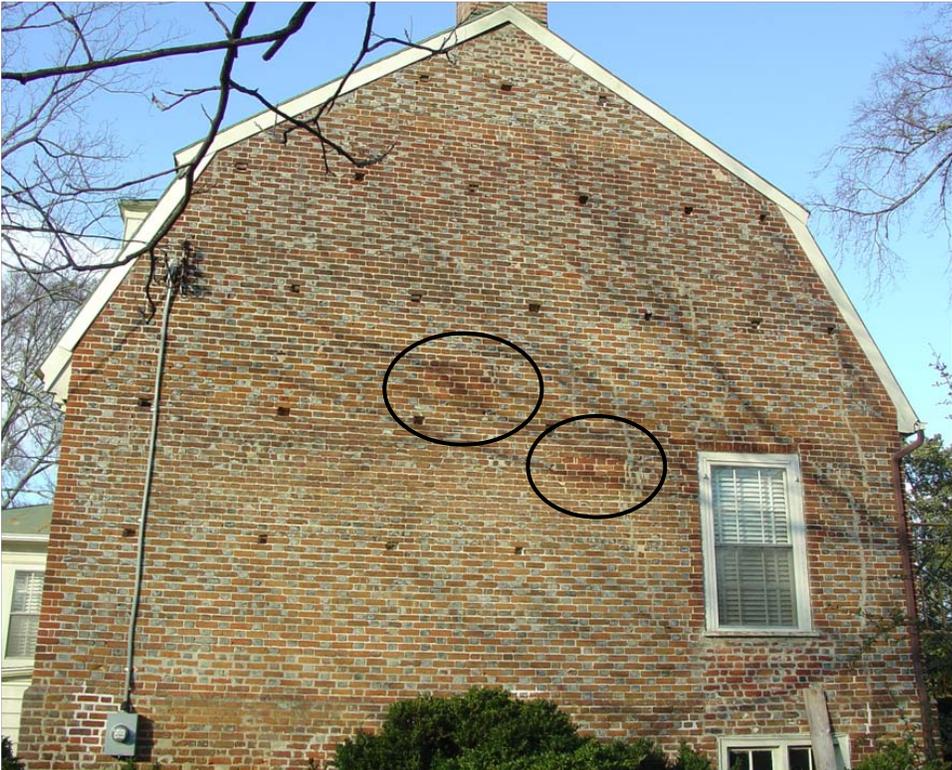
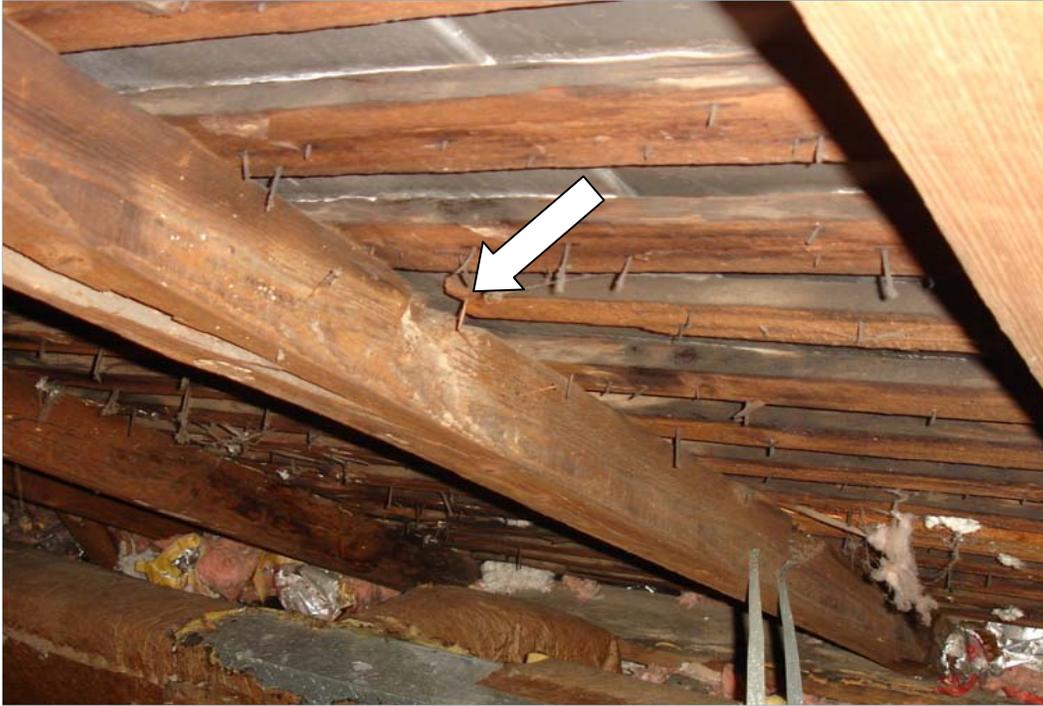
Figure 74. Areas of brickwork repairs that may have been damaged by shelling during the Battle of Totopotomoy Creek in May 1864. Pictured here are the south elevation (below), and the southwest corner of the west elevation (right). Shelton House, 2009.

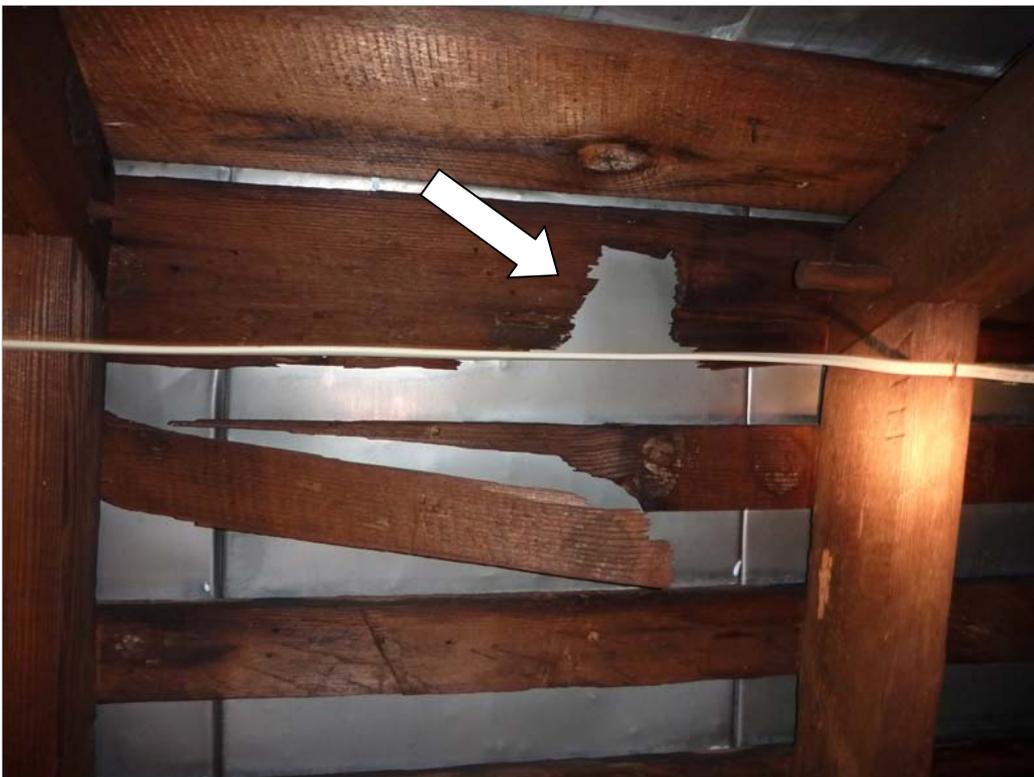
The Shelton House served as the headquarters for Union troops during the Battle of Totopotomoy Creek in May 1864. During that engagement, Union General Winfield Hancock’s Second Army Corps entrenched near the Shelton House, facing General Robert E. Lee’s forces on the opposite banks of the creek. Union infantry launched repeated assaults in a failed attempt to carry the Confederate lines. Two signal officers posted on the roof of the house counted 51 artillery strikes by Confederate troops, the damage from which can still be seen in the attic today.

Figure 75. Damage to attic rafters and roof sheathing boards (at arrows) may have been caused by shelling during the Battle of Totopotomoy Creek in May 1864. Shelton House, July 2011.

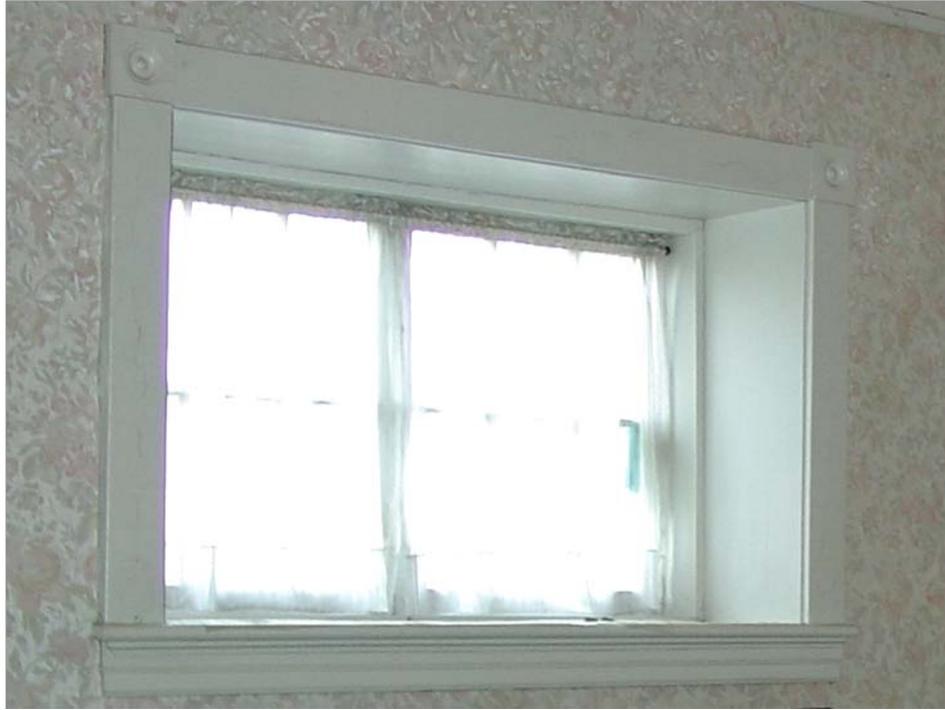
Figure 77. Window W105 was installed by Bill Shelton's uncle in the north wall of the dining room (Room 107) in 1915. Shelton House, 2009.

William R. Shelton made some improvements to the house upon his marriage in 1915, as recalled in a 2005 interview with his son, William (Bill) R. Shelton, Jr. (1920-2006). These included cutting a window in the north wall to provide more light to the northeast room in the first story. The window, which was installed by Bill Shelton’s uncle, was trimmed on the interior side with bull’s-eye corner blocks (fig. 77). Similar trim was used at two wide doorways connecting rooms on the south side of the house in the first and second stories, suggesting that these also date to this time (fig. 78). Each doorway was also equipped with a pair of glazed doors.

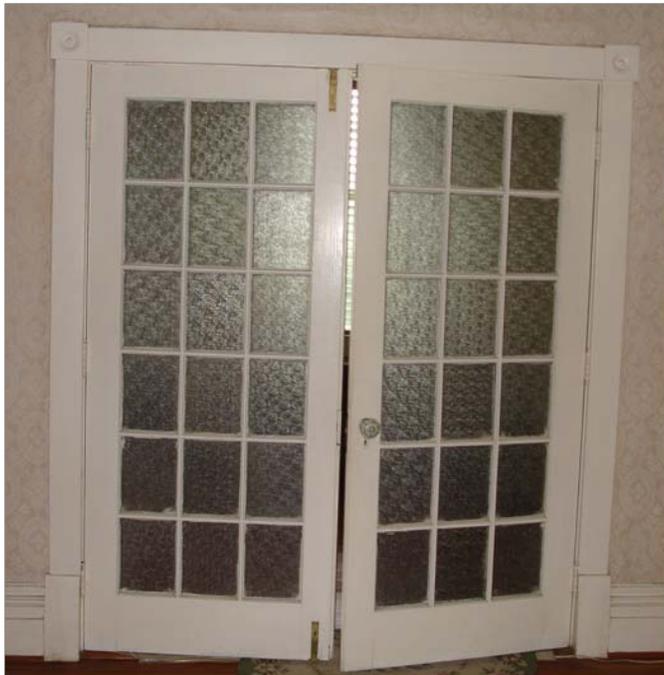
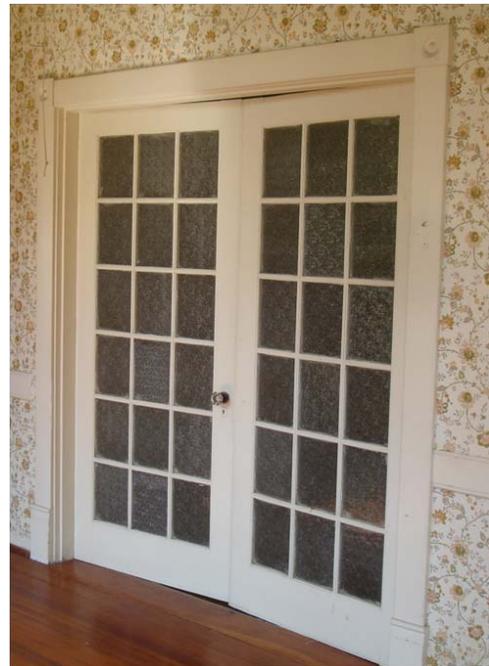
Figure 78. Casings identical to those of window W105 above were used to trim doorway D109, connecting Rooms 102 (left) and 103 (right), thus dating the doorway to 1915. Shelton House, 2009.

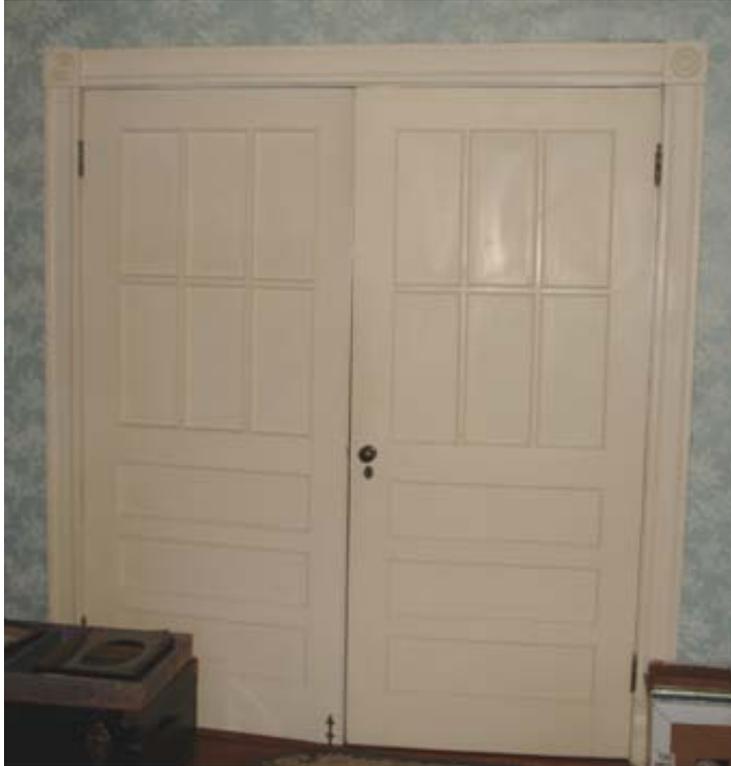
Figure 79. Doorway D208, connecting south bedrooms 203(above) and 204 (below), is also believed to date to 1915. Shelton House, 2011.

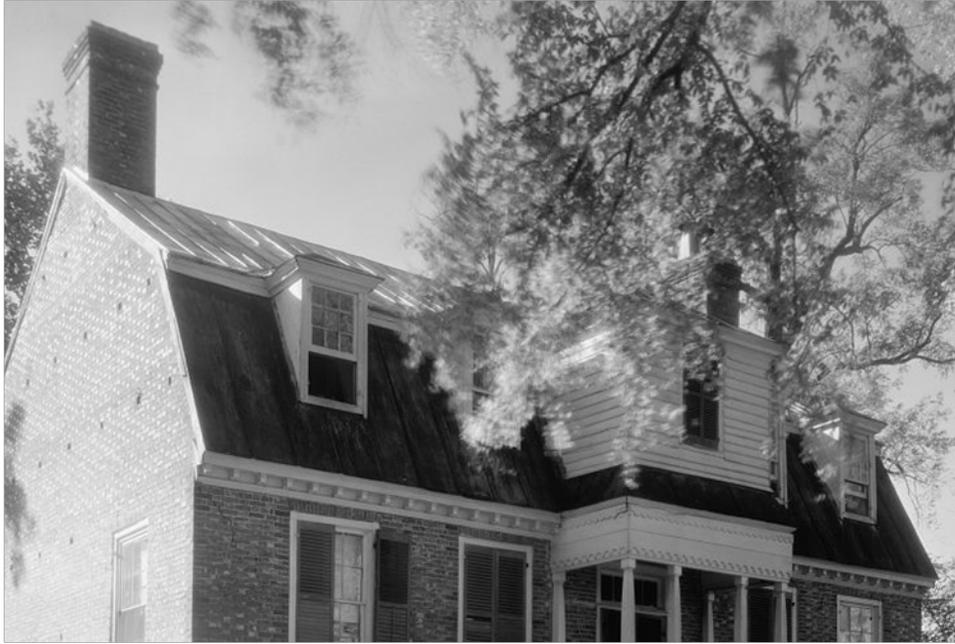
Figure 80. The upper portion of the standing-seam metal roof appears to have been fairly new when this photograph of the Shelton House was taken by Frances B. Johnston in 1935.

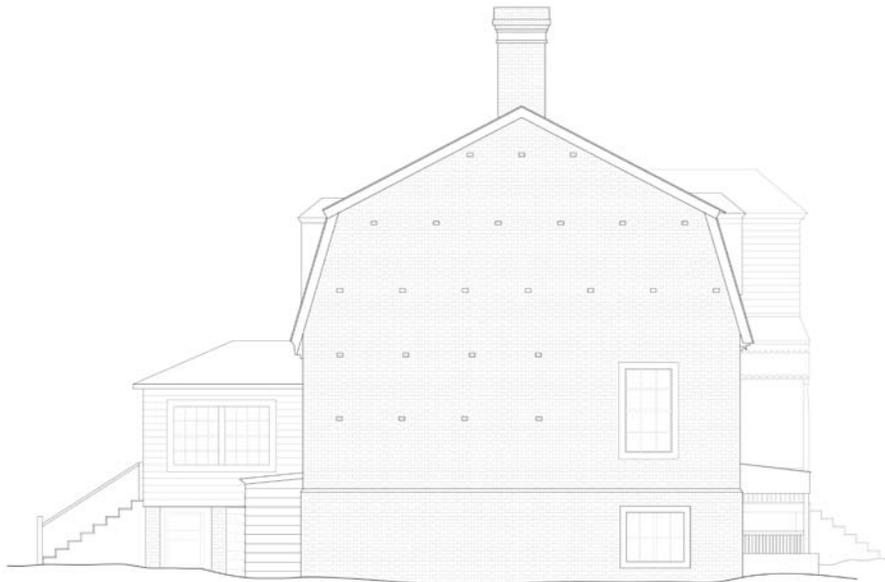
SOUTH ELEVATION

Figure 81. Rear (west) and south elevations of the Shelton House showing the wing that replaced the west porch circa 1948.

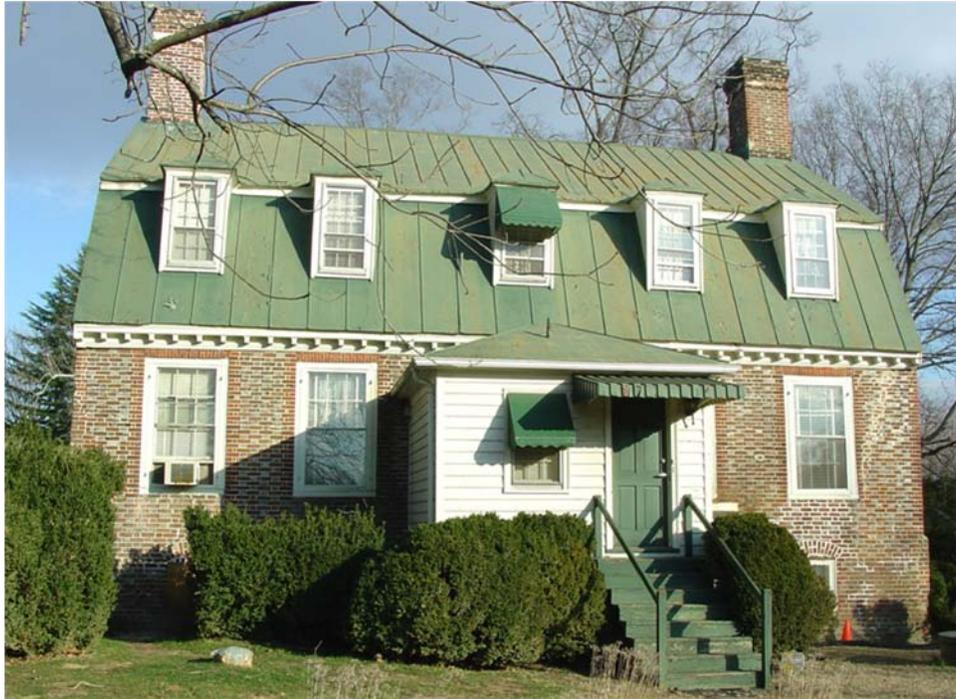
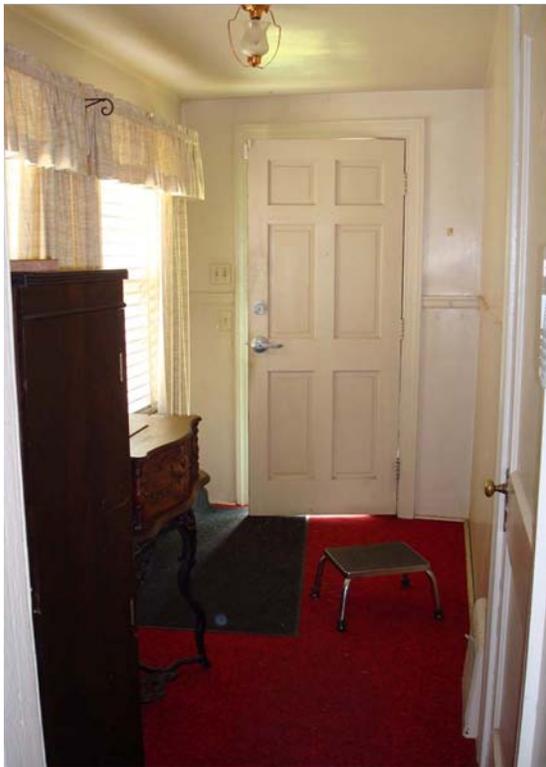
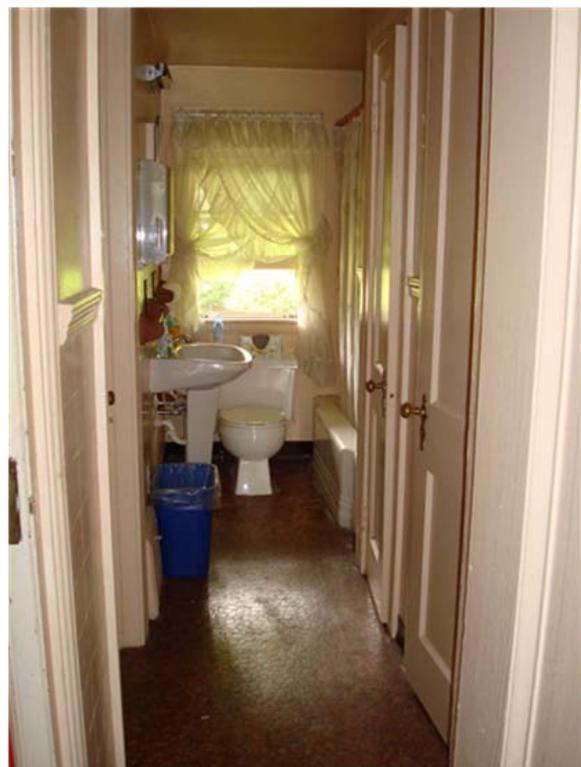
Figure 83. A new wing replaced the back porch on the west side of the house circa 1948. Within the wing are two rooms: an entry on the south side (Room 104, left) and a bathroom on the north side (Room 105, right). Shelton House, 2009.

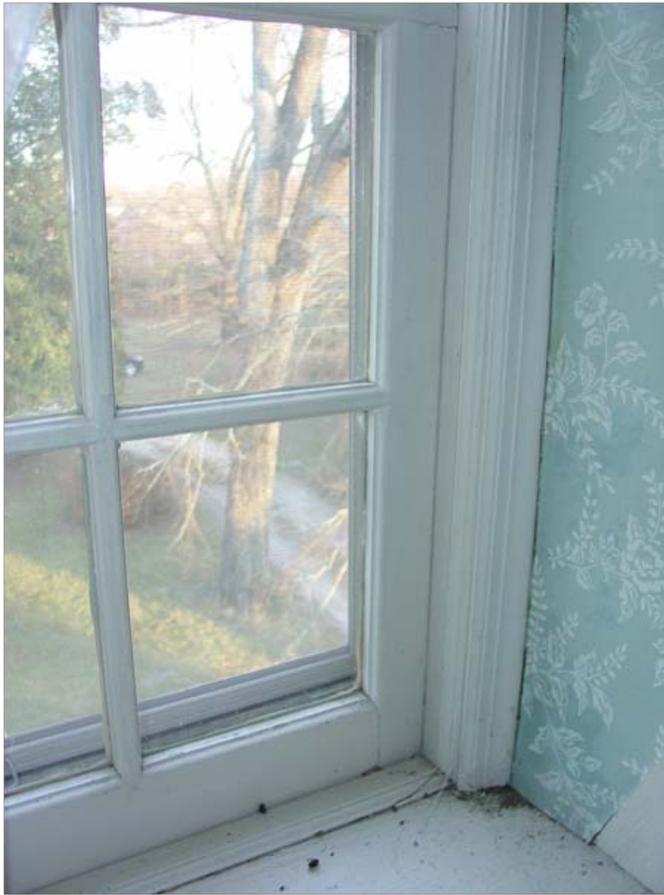
Figure 86. New 9-over-6 window sashes and interior casings in the second-story windows have been dated circa 1960. Exterior aluminum storm windows may also date to that time. Shelton House, 2009.

* Dormer window sashes were replaced in-kind with wooden 9-over-6 sashes (fig. 86).

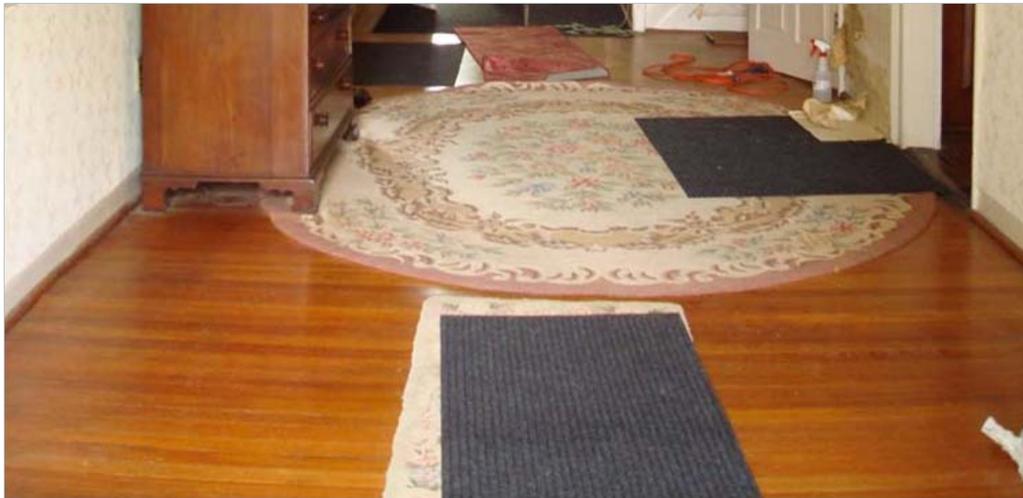
Figure 87. Narrow floorboards were installed around 1980 over existing flooring in Rooms 101 (above), 103, and 107. Shelton House, 2009.

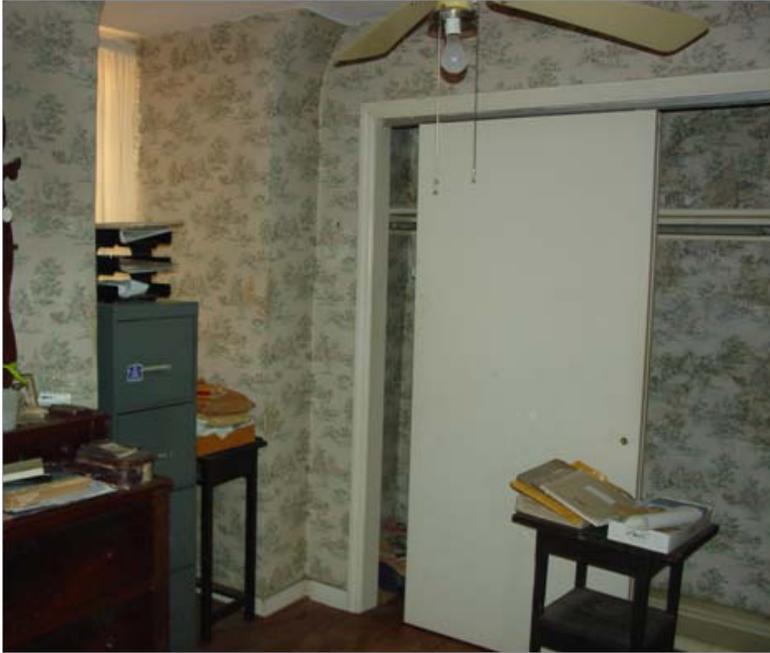
Figure 88. New bedroom closets were added circa 1965 in Rooms 203, 206 (left) and 207. Shelton House, 2009.

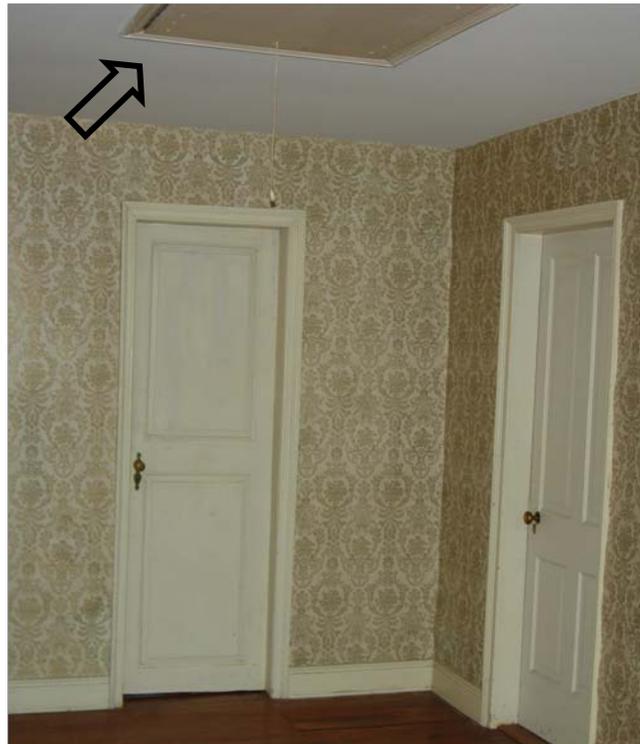
Figure 89. A folding attic stair in the hall ceiling (right) replaced a ceiling hatch in Room 206 circa 1965. Shelton House, 2009.

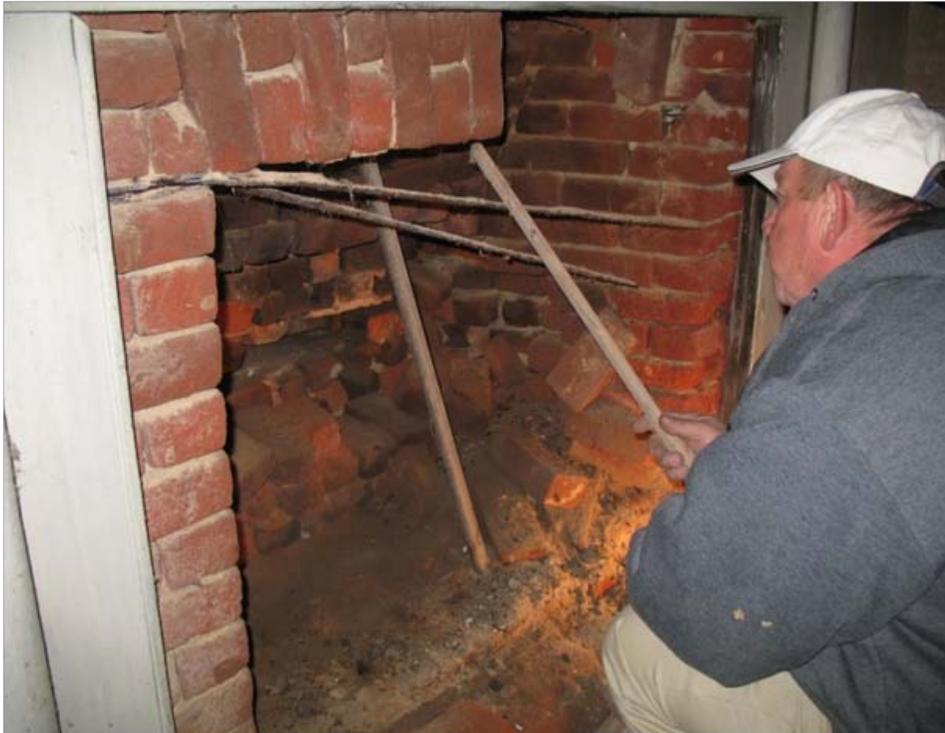
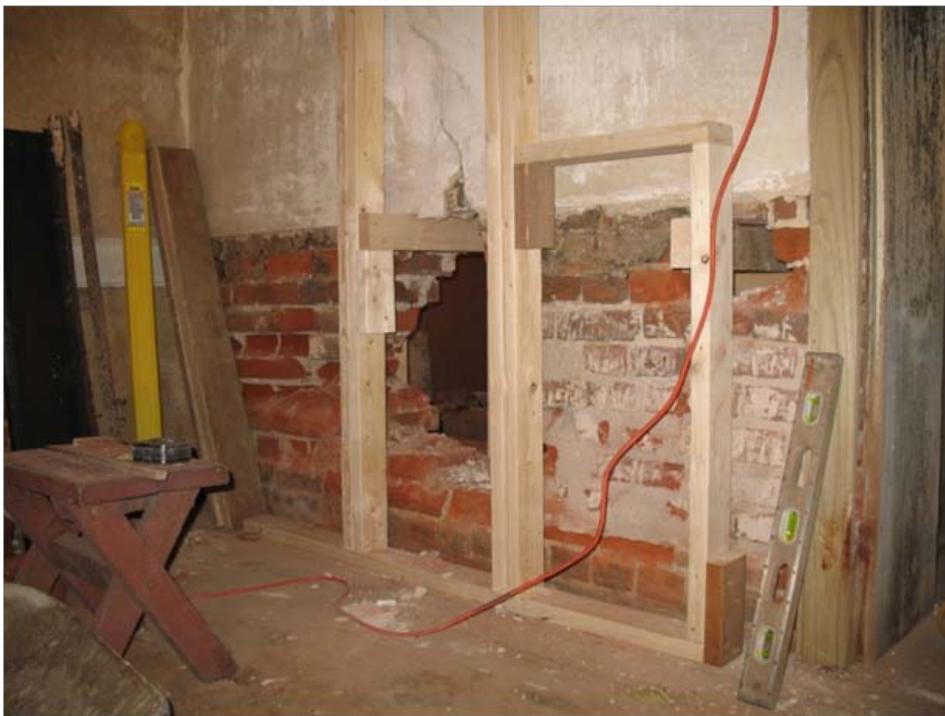
Figure 90. Brickwork repairs were made to the fireplace opening and west wall (south end) in cellar Room 001 by the NPS Historic Preservation Training Center, 2007. Shelton House, 2007.
