THE SHELTON HOUSE at RURAL PLAINS

Historic Structure Report

Richmond National Battlefield Park
Mechanicsville, Virginia

Barbara A. Yocum, Architectural Conservator
Historic Architecture Program
Northeast Region, National Park Service
Lowell, Massachusetts

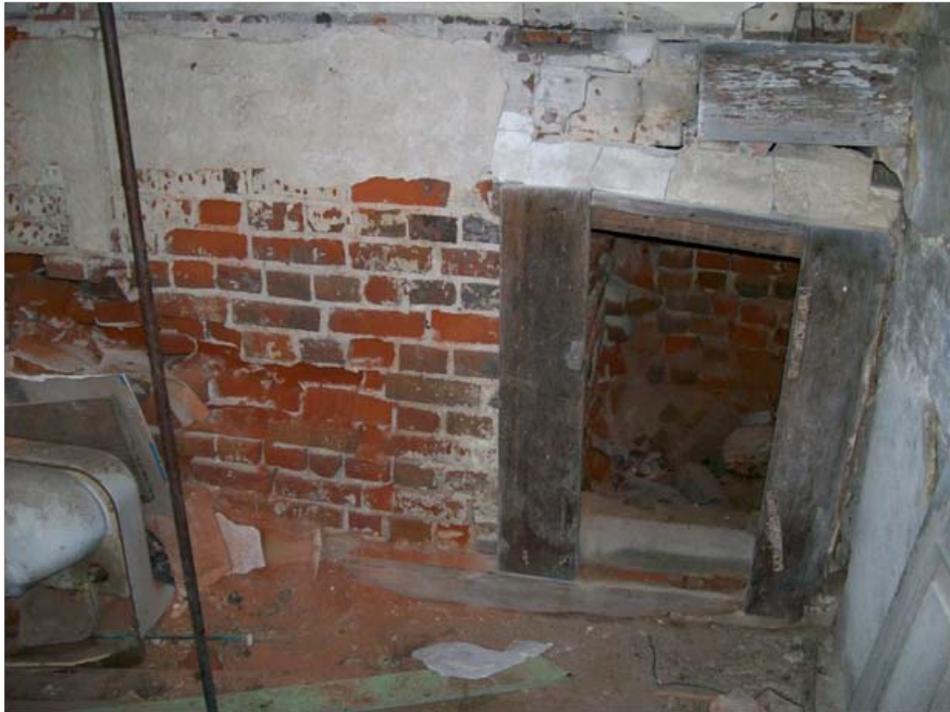
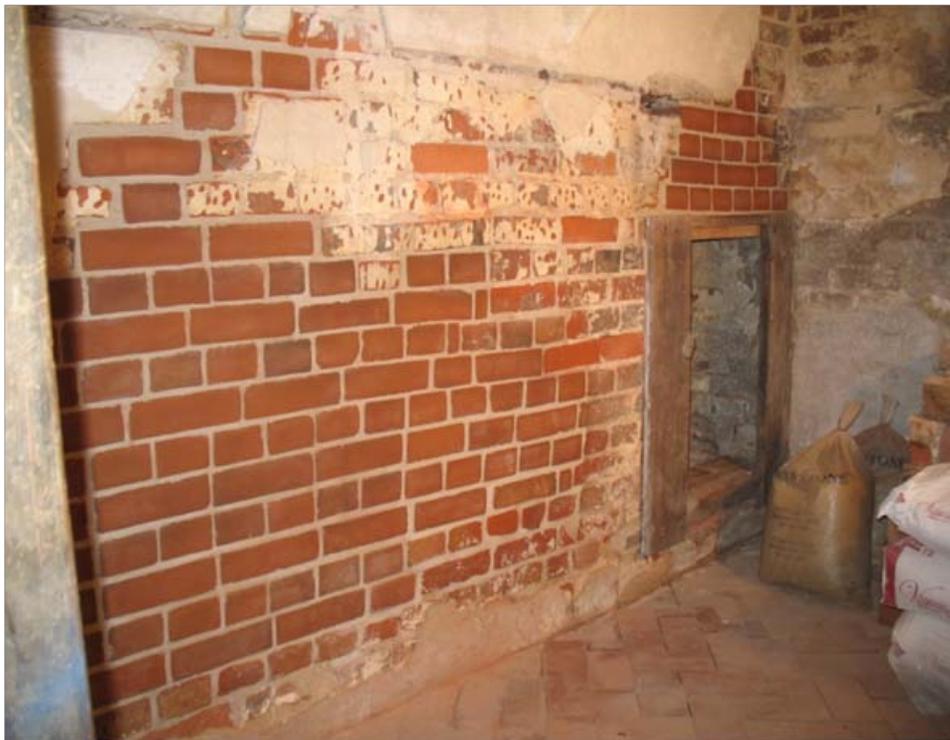
Figure 91. East brick wall of cellar Room 002 before (upper photograph) and after repairs (lower photograph) by the NPS Historic Preservation Training Center in 2007. Shelton House, 2007.

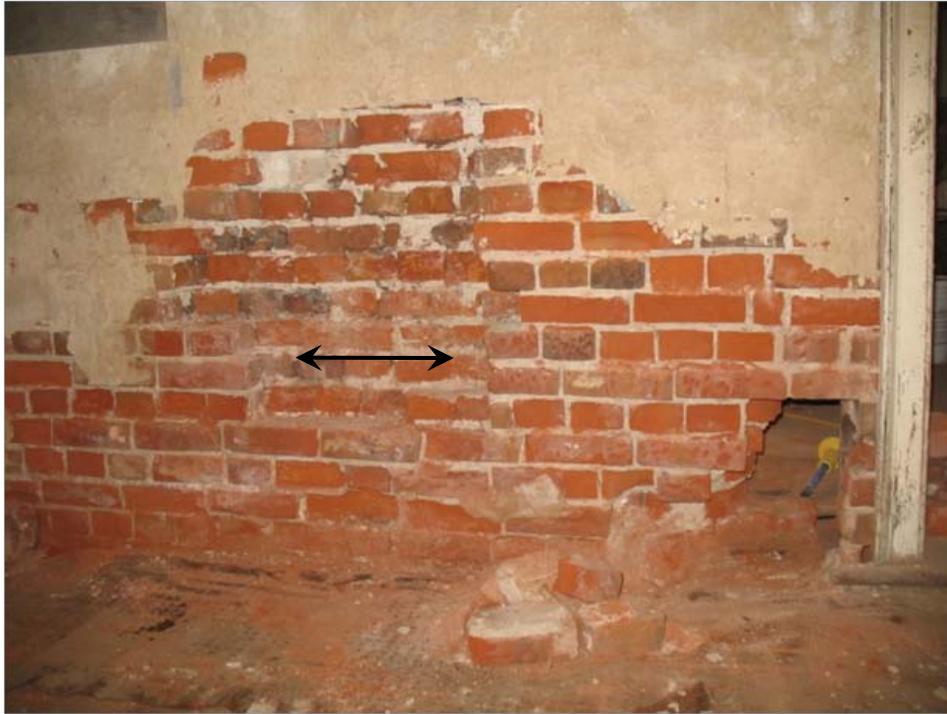
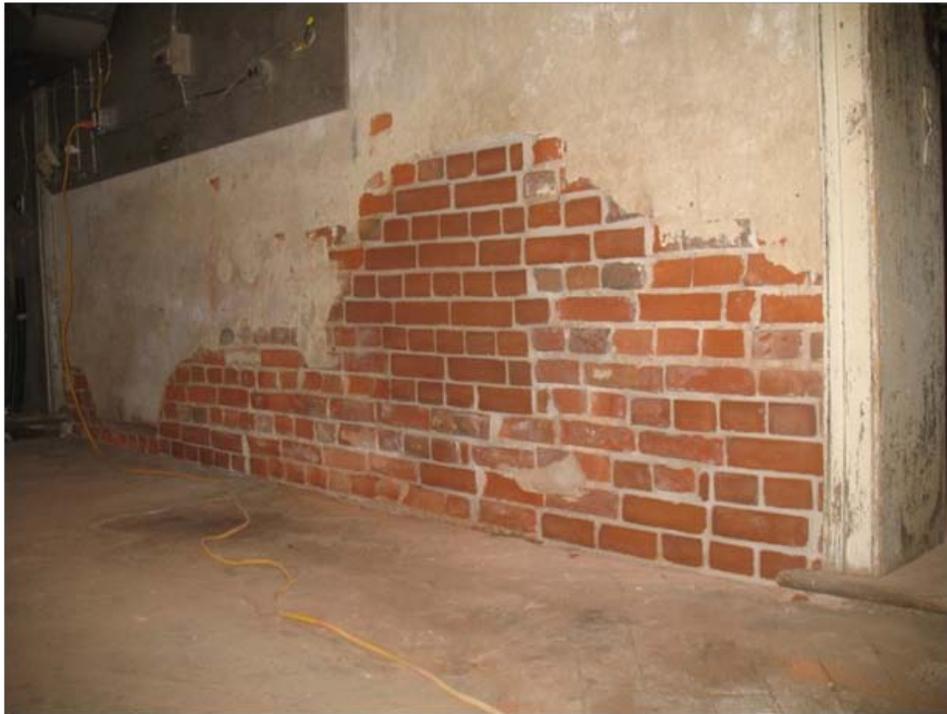
Figure 92. East wall of cellar Room 003 during repairs (upper photograph) and after repairs (lower photograph) by the NPS Historic Preservation Training Center, 2007. Seams in the brickwork (at arrow above) define what may be remnants of an earlier wall. Shelton House, 2007.

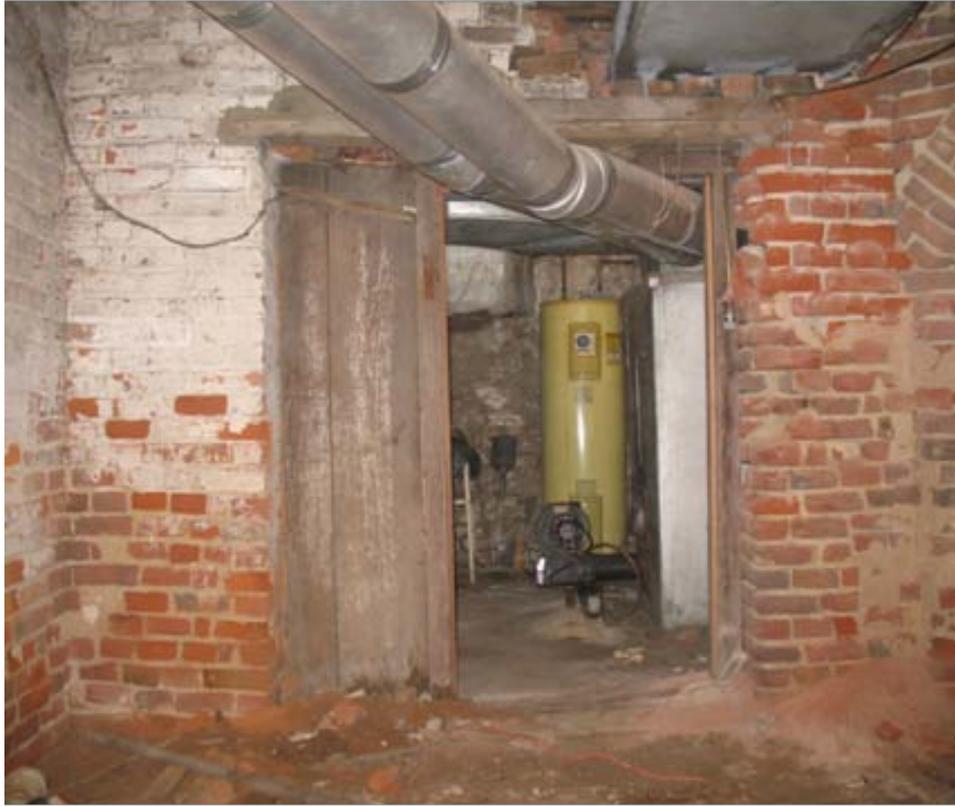
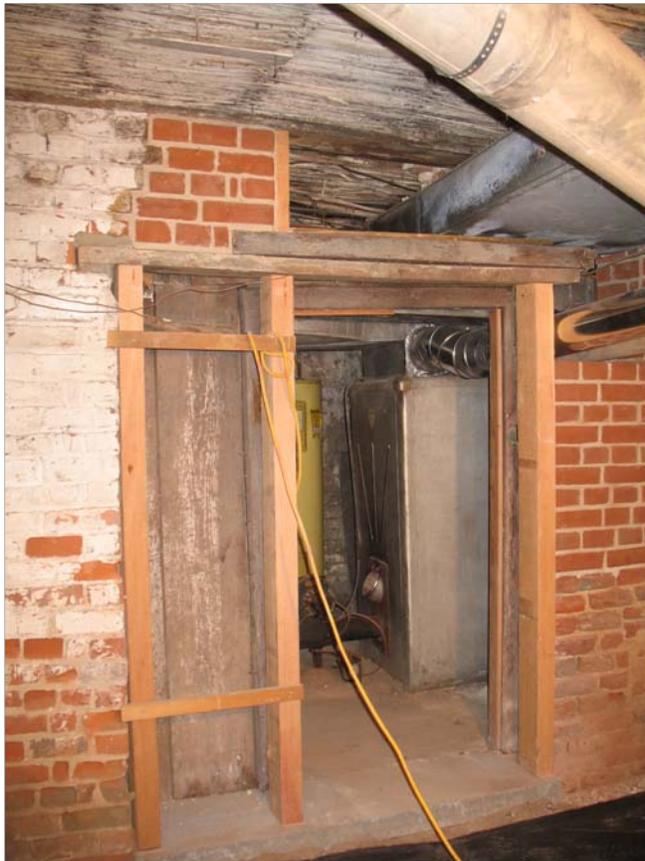
Figure 93. Doorway D008, at the west wall of cellar Room 005 before (upper photograph) and after repairs and shoring (left photograph) by the Historic Preservation Training Center, 2007. A loose board-and-batten door found stored in the cellar (below right) may have been removed from this doorway. Shelton House, 2007.

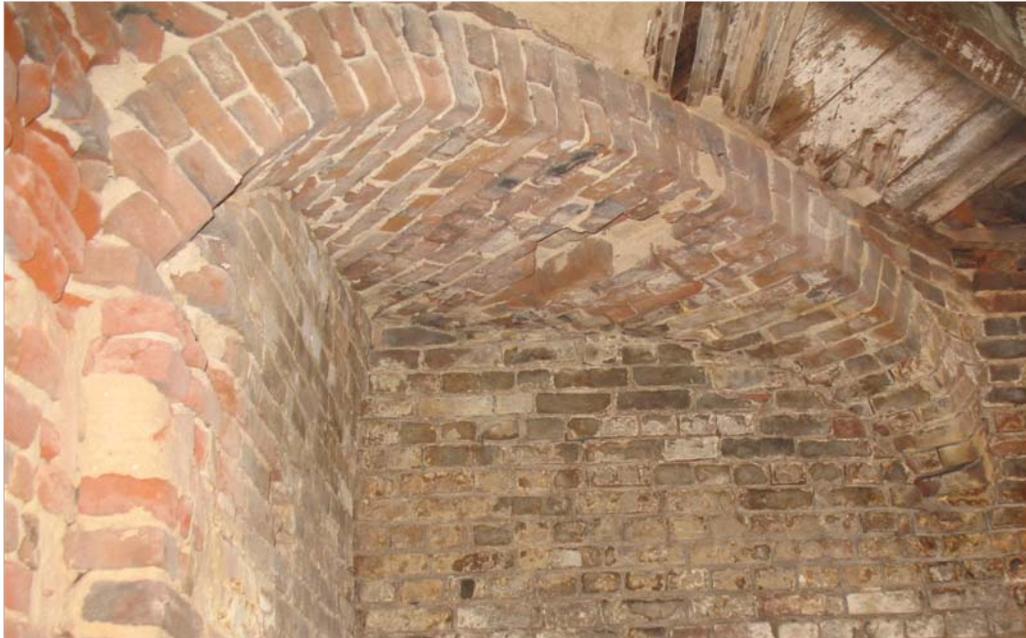
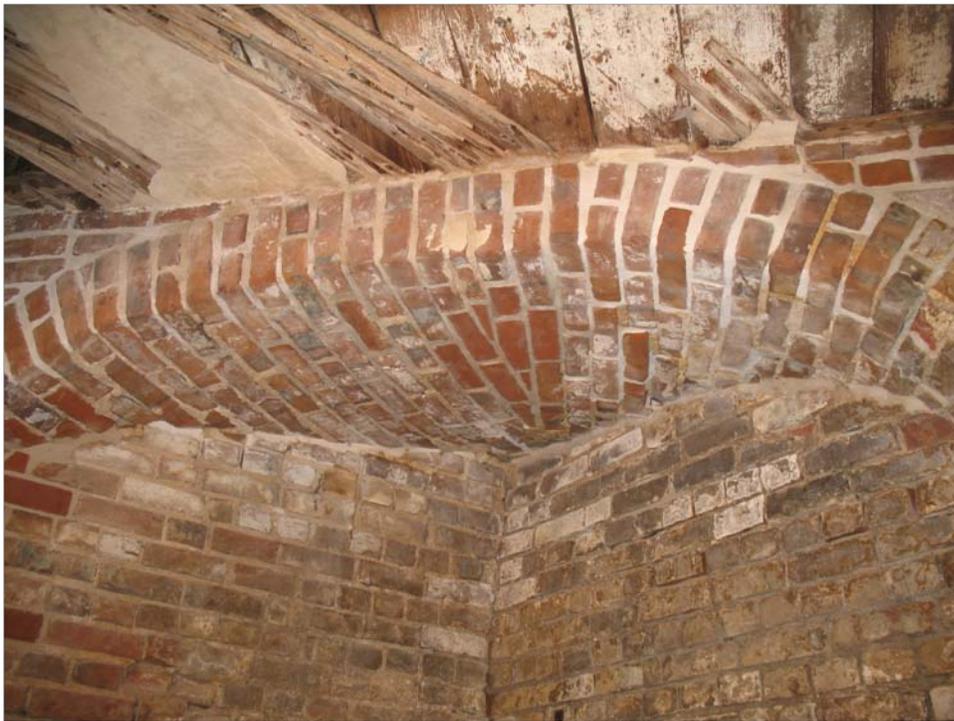
Figure 94. Brickwork arch in cellar Room 005 before (upper photograph) and after repairs (lower photograph) by the NPS Historic Preservation Training Center in 2007. Shelton House, 2007.

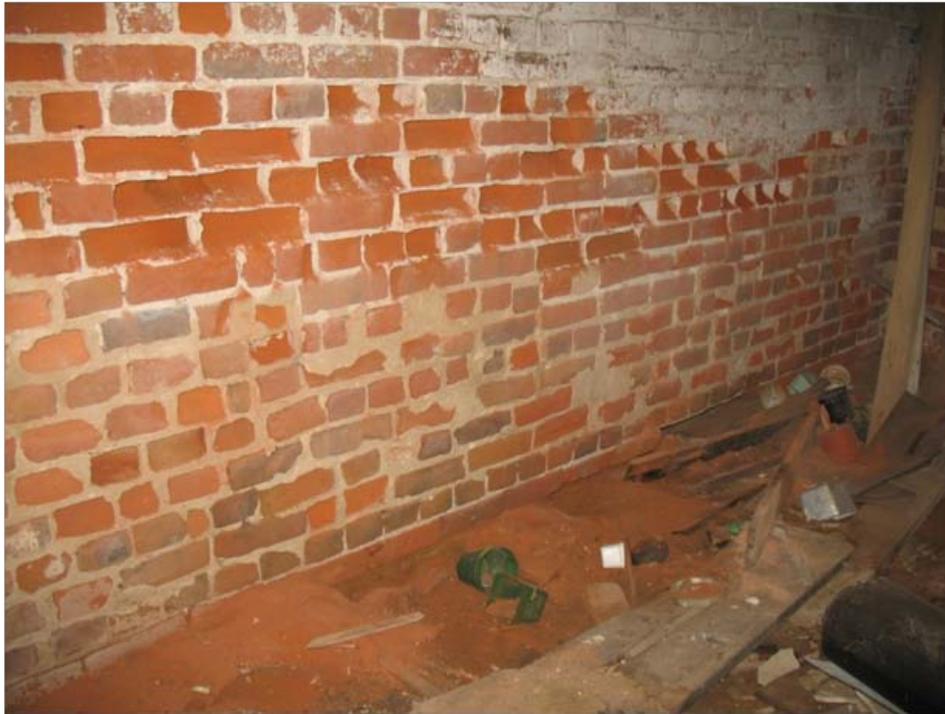
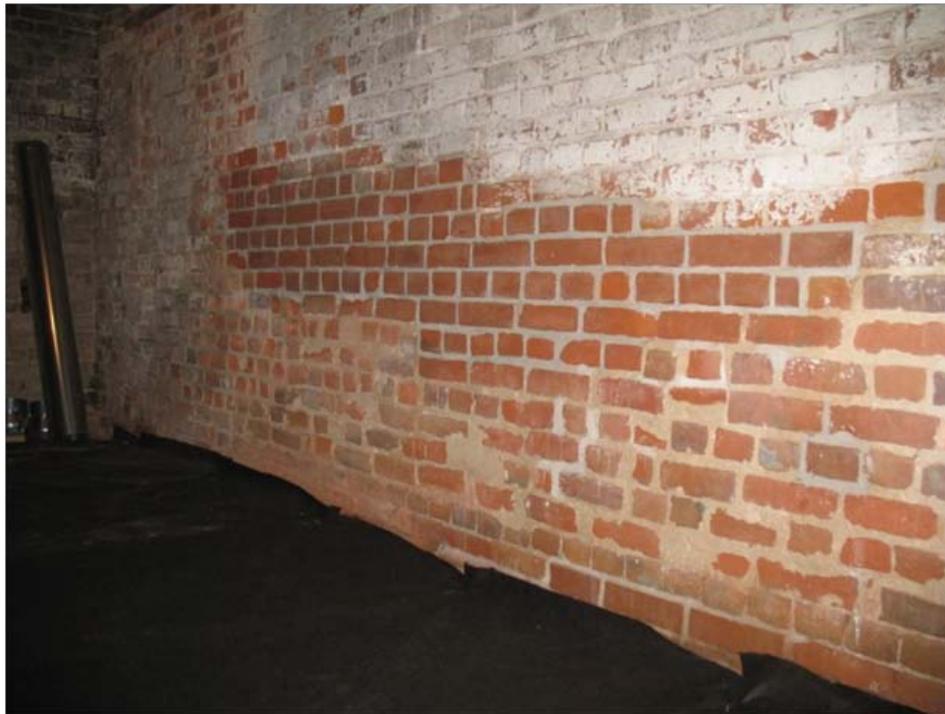
Figure 95. South wall of cellar Room 005 before (upper photograph) and after repairs (lower photograph) by the Historic Preservation Training Center, 2007. Shelton House, 2007.

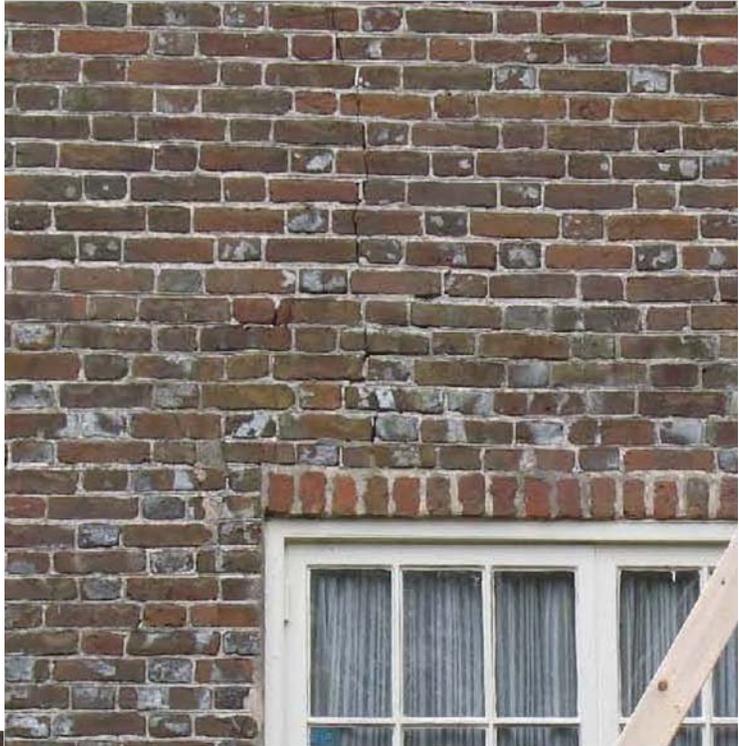
Figure 96. North wall above window W105 before (upper photograph) and after repairs (lower photograph) by the NPS Historic Preservation Training Center in 2008 (left). Shelton House, 2008.

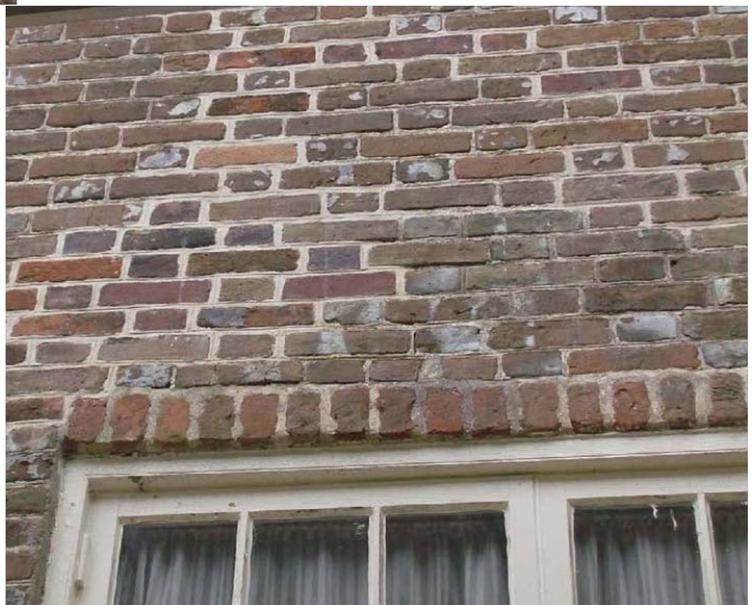
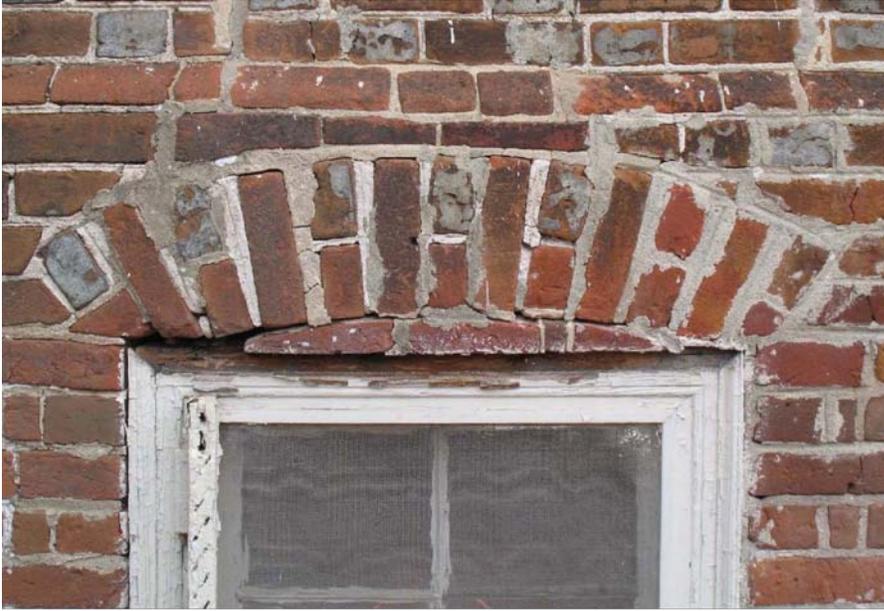
Figure 97. Cellar window W008 on the west side of the house before (upper photograph) and after repairs (right and below) by the NPS Historic Preservation Training Center in 2008. Note the difference in height and number of bricks in the reconstructed arch. Shelton House, 2008.

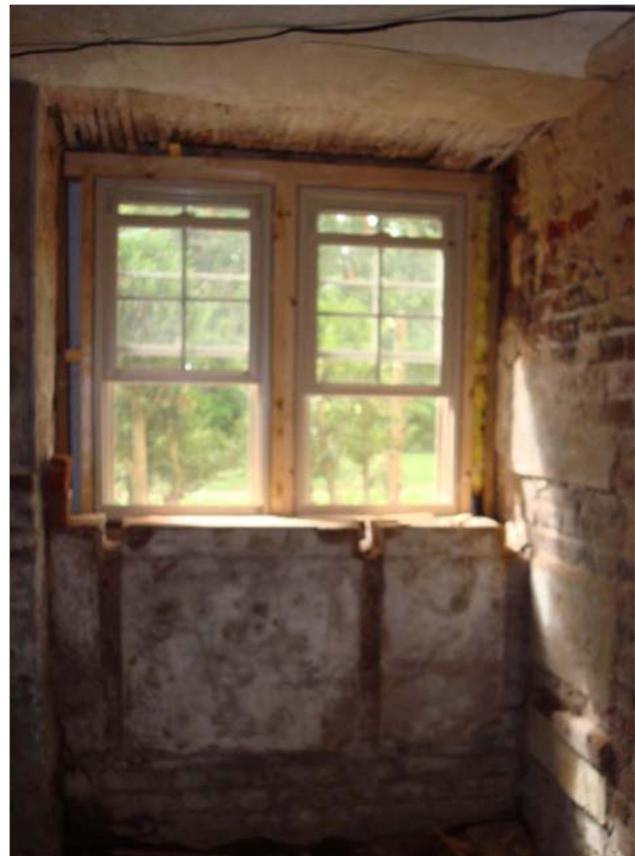
Figure 100. Cellar window W009 in the south wall of Room 001 (right) was reconstructed by Preservation Carpenter William Reese, Richmond National Battlefield Park. Shelton House, 2009.

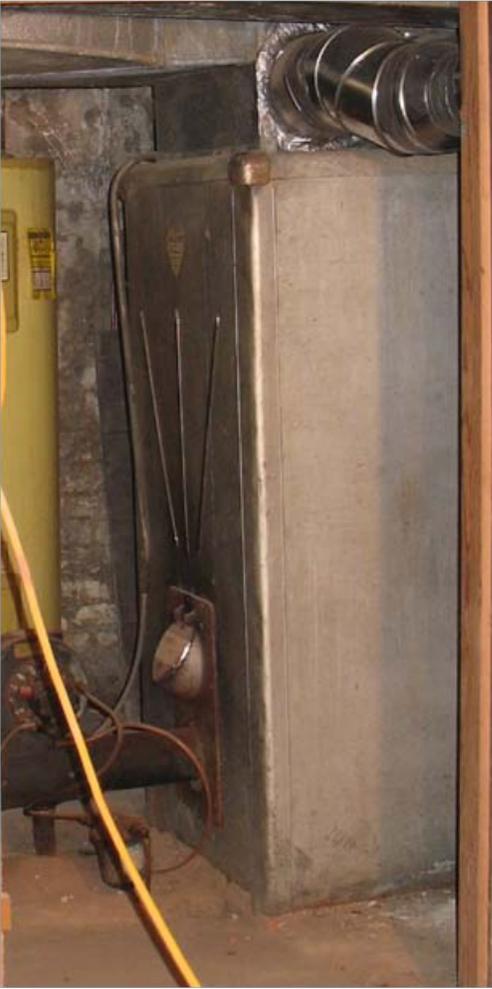
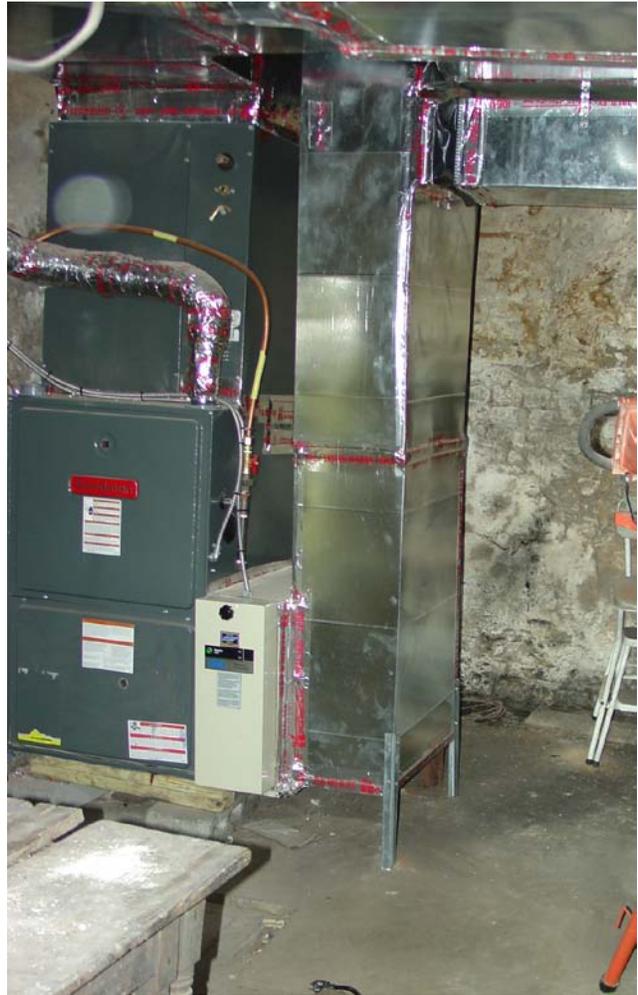
Figure 101. A new “Goodman” furnace (right) replaced an existing furnace (left) in cellar Room 004 in 2008. Shelton House, 2007 and 2009.

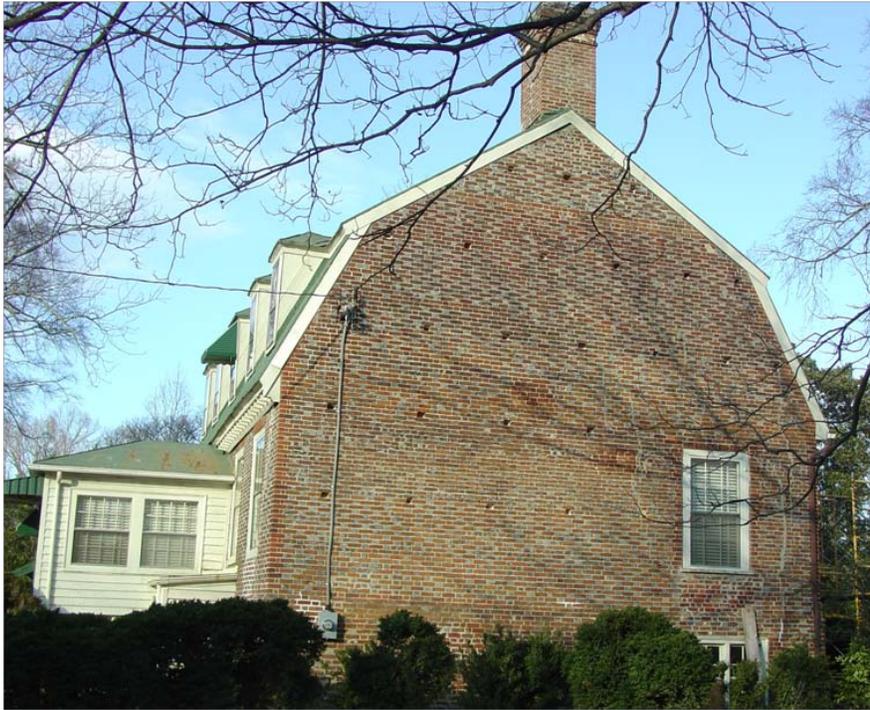
Figure 102. South wall of the Shelton House, January 2009. Masonry construction was used for the north and south end walls, and up to the first story only of the east and west walls.

The foundation and exterior walls of the Shelton House are constructed of brick masonry. The walls vary in thickness, being six wythes thick in the cellar story, four wythes in the first story, three wythes in the second story, and two wythes in the attic story (figs. 102 and 103).

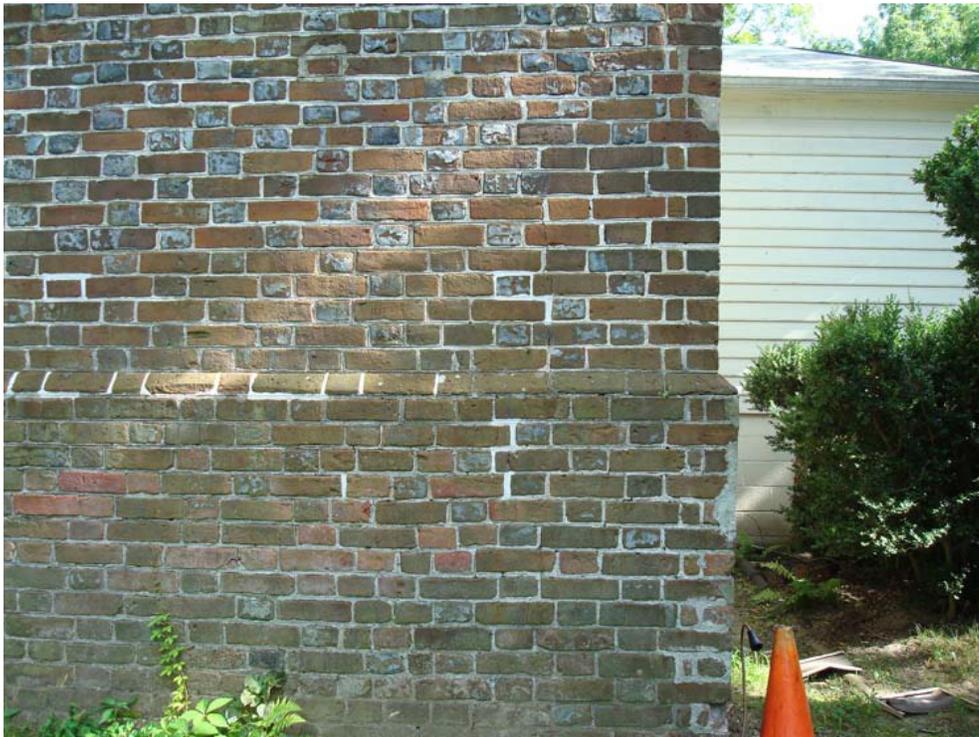
Figure 103. Detail showing the foundation of the Shelton House at the northwest corner. The cellar wall is six wythes thick; the first-story wall is four wythes. Shelton House, June 2009.

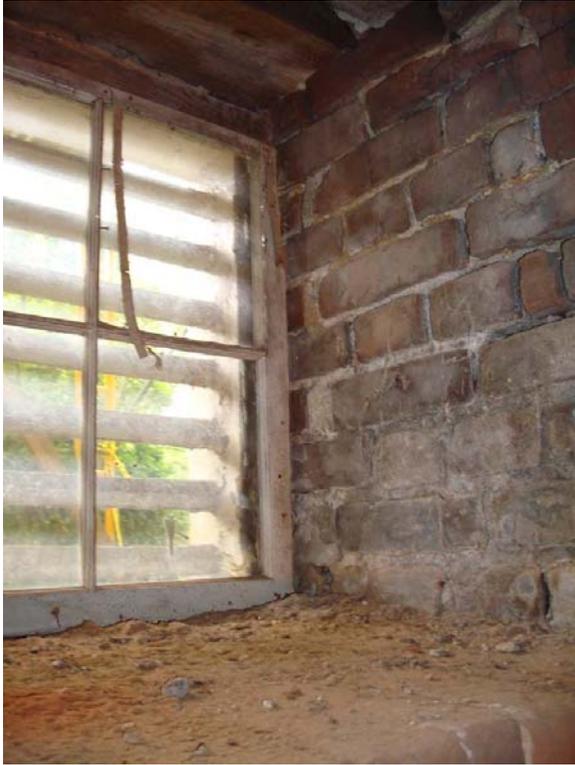
Figure 104. Detail showing the thickness of the east brick wall at the jamb of window W003 in cellar Room 005. Shelton House, September 2009.

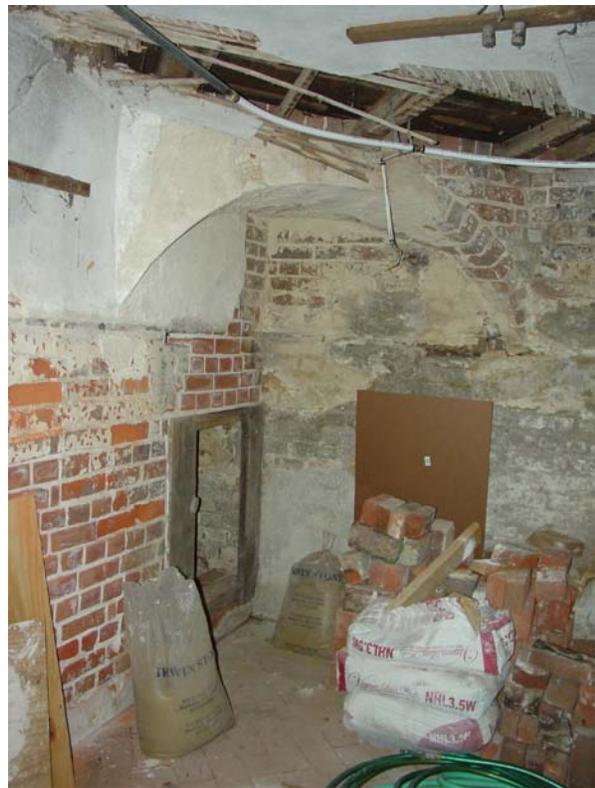
Figure 105. Brick-arch support of the south chimney in the southeast corner of cellar Room 002. Shelton House, January 2009.

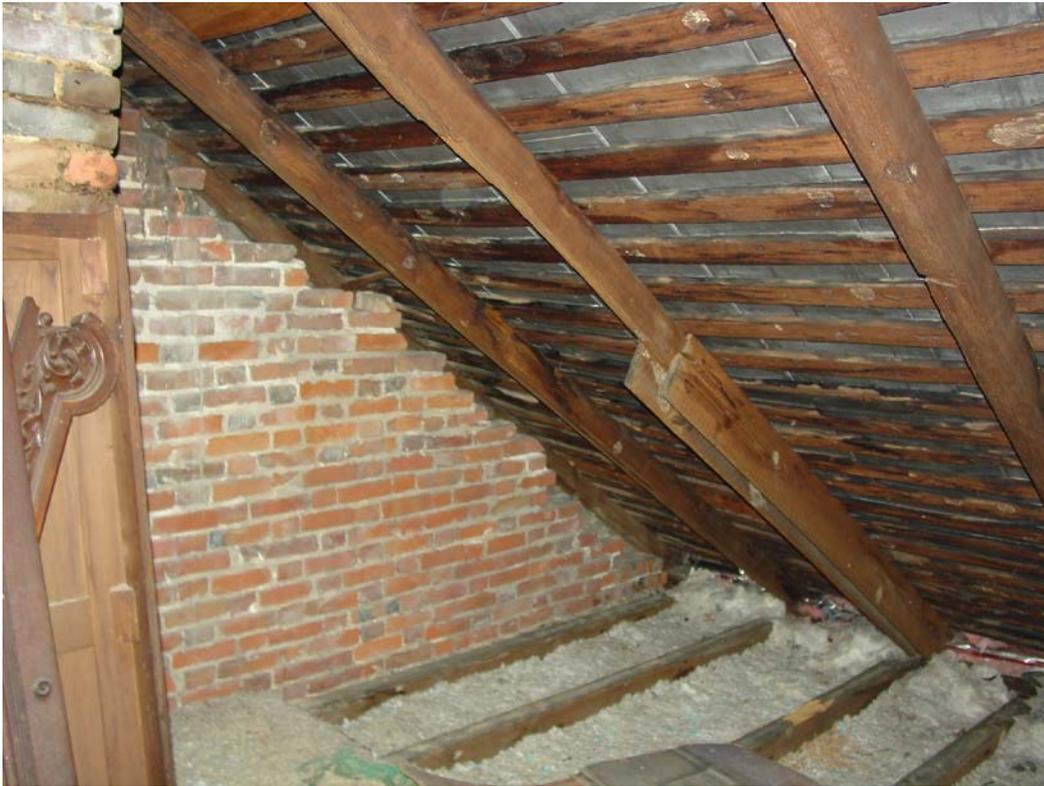
Figure 108. Southwest corner of the attic showing the south brick wall, floor joists, and roof rafters. Shelton House, January 2009.

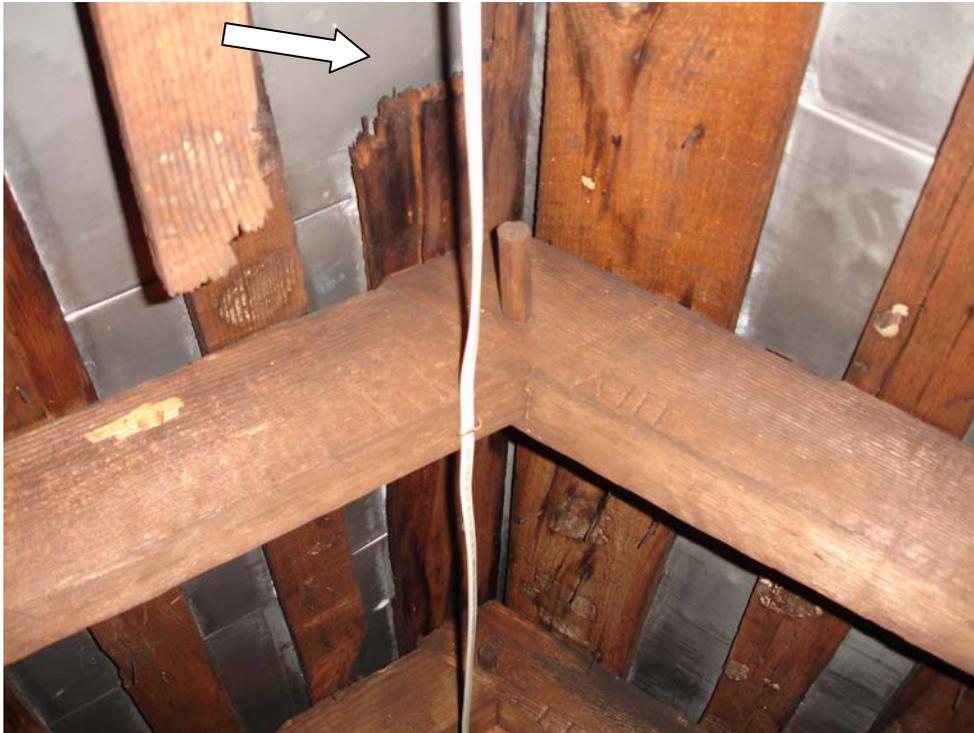
Figure 109. Detail showing joining of main roof rafters at the ridge. Note damaged roof sheathing board (at arrow), possibly caused by shelling of the house in 1864. Shelton House, June 2009.

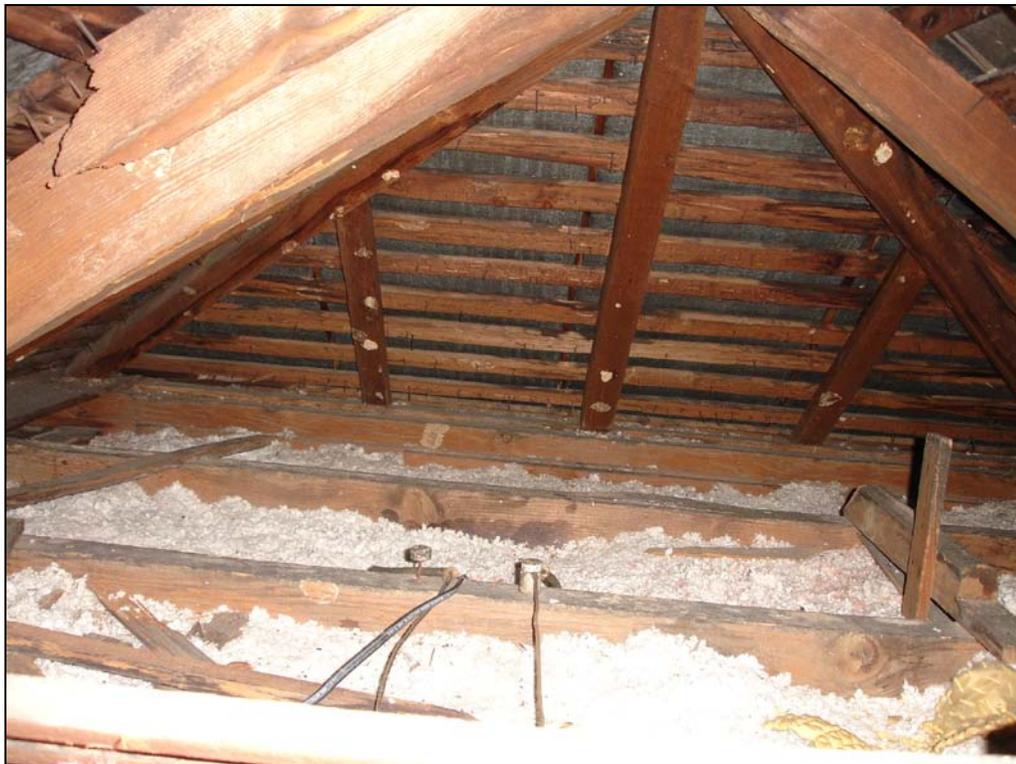
Figure 111. Framing of the hipped roof above the porch chamber (Room 202), view looking east. Shelton House, June 2009.

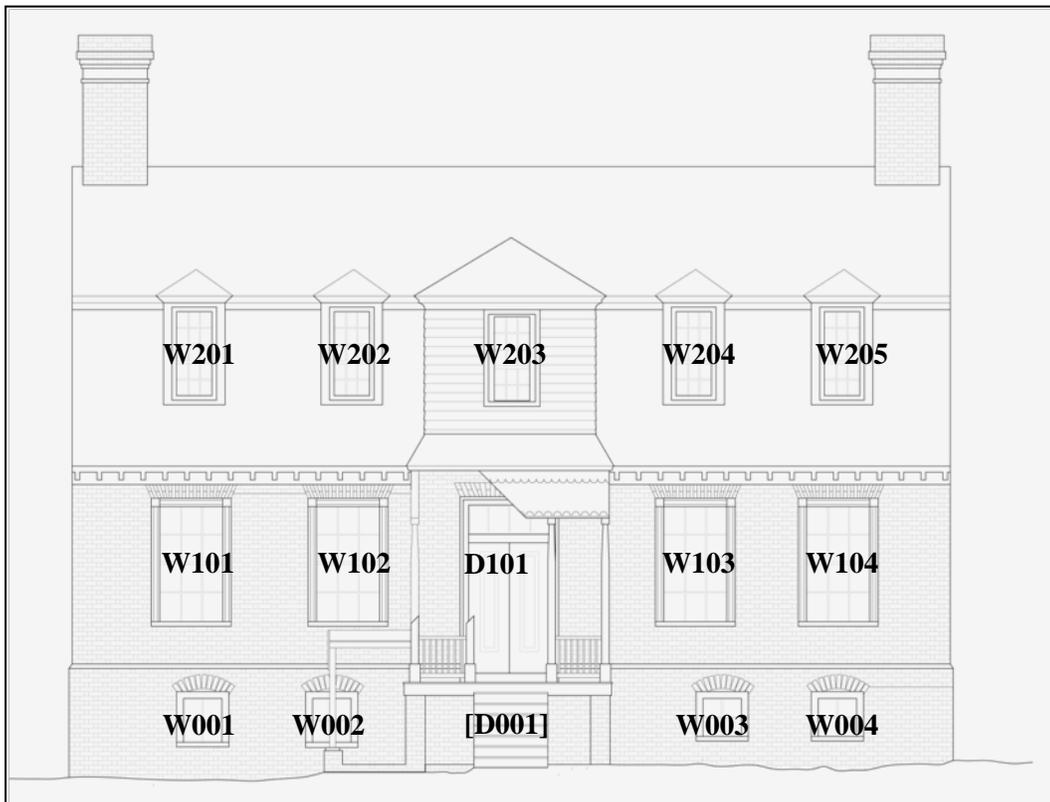
Figure 113. East elevation drawing annotated with doorway and window numbers.

Four exterior doorways provide access to the cellar and first story of the Shelton House today. Two are in the front façade and two are in the west elevation. Doorways have been assigned numbers to facilitate descriptions (see figs. 113 and 117). Of these four doorways, only the location of the front entrance (D101) dates to the original construction of the house circa 1725. The original rear entrance

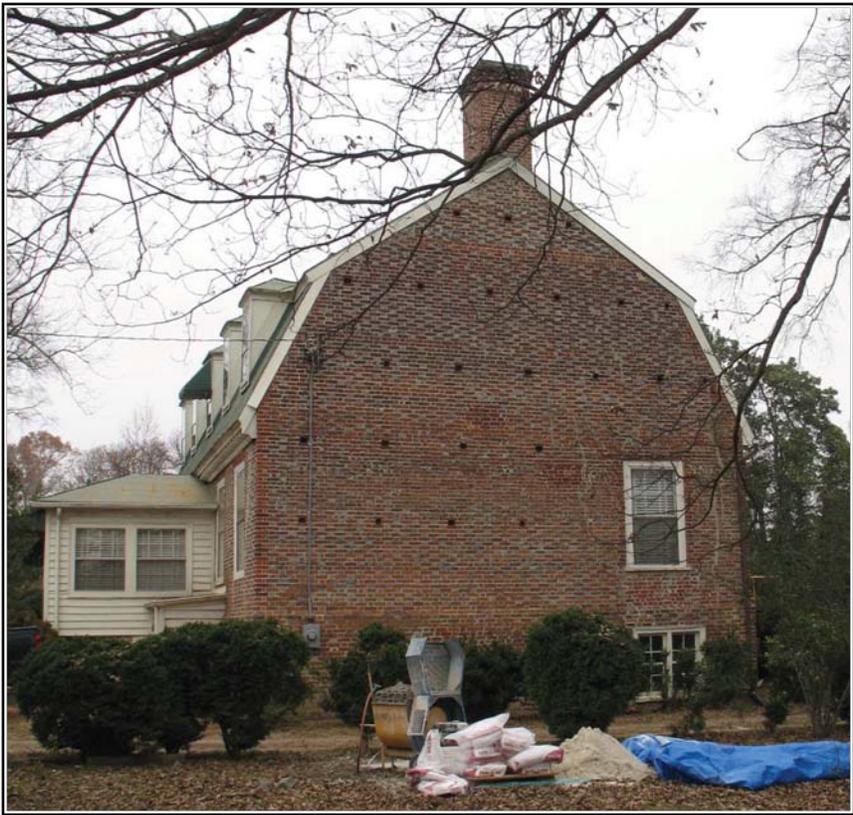
Figure 114. South elevation of the Shelton House, January 2009.

The house was connected to electrical service in the 1940s, according to Bill Shelton,²²¹ which may have coincided with building of the west wing circa 1948. Electrical service enters the house on the south side, where an electric meter is mounted (fig. 114). Exterior illumination is provided by two light fixtures: a chain-suspended light at the front (east) doorway, and a wall-mounted light at the back doorway (fig. 147). A conjectural date for both light fixtures is circa 1948.

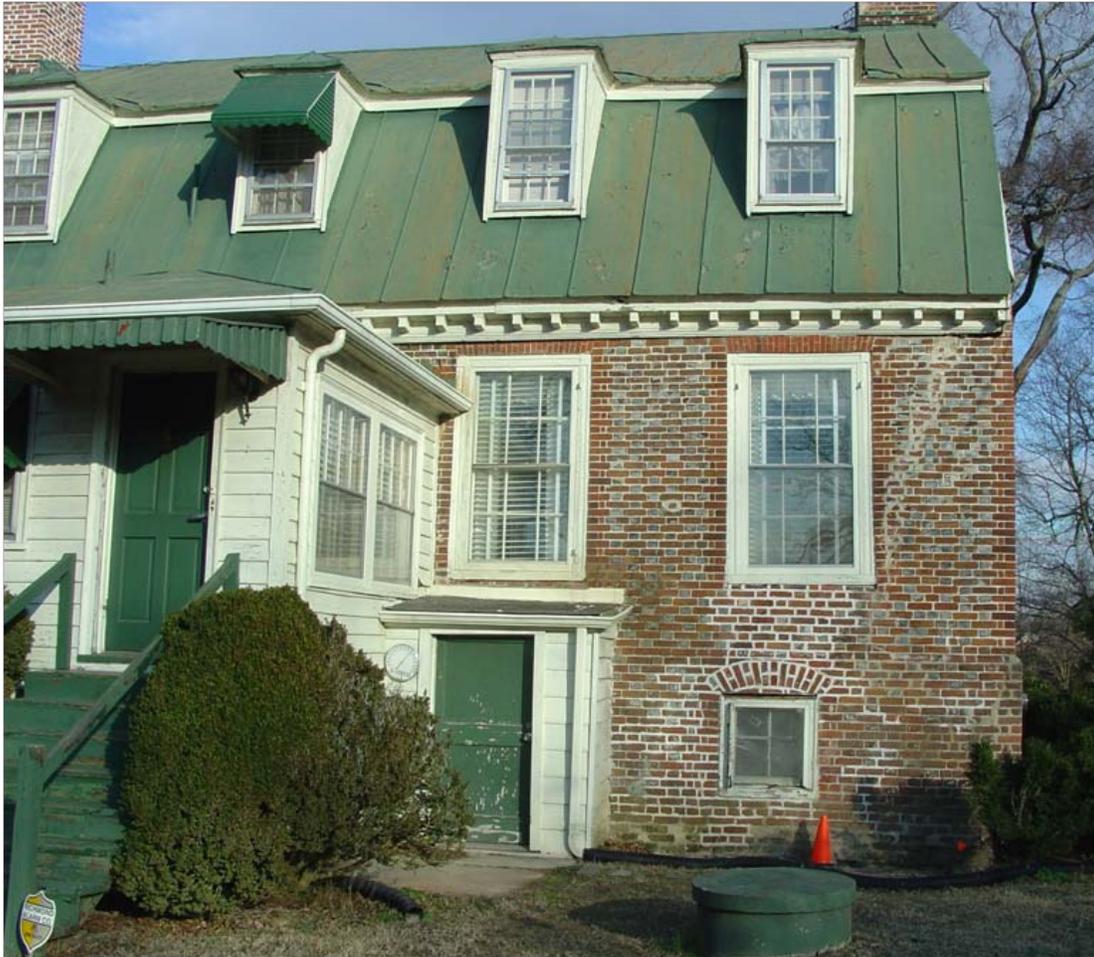
Figure 120. Detail showing circa-1948, wood-framed additions on the back (west) side. Shelton House, January 2009.

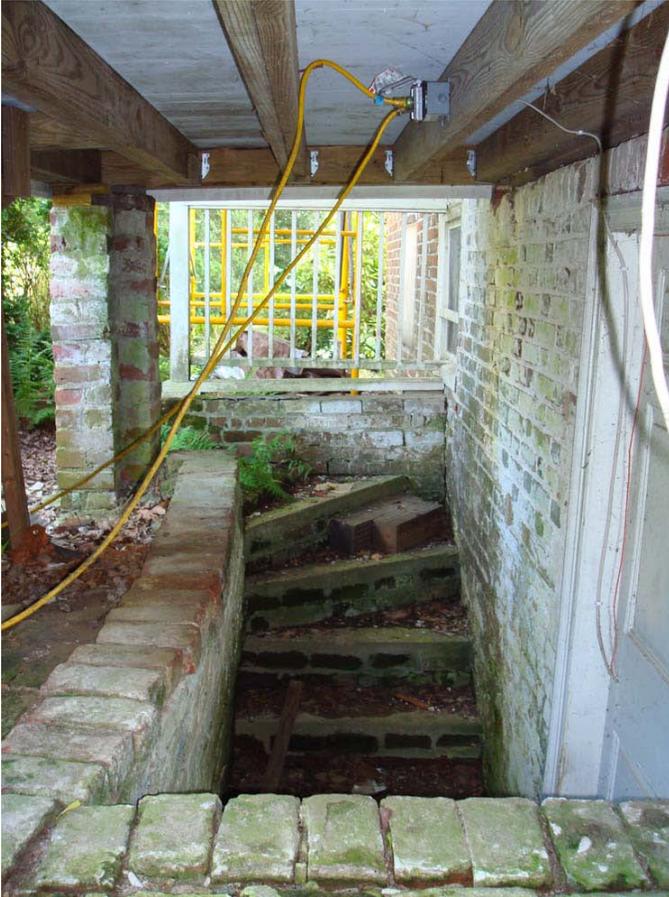
Figure 121. Cellar entrance on the east side, view looking south. Shelton House, September 2009.

The east doorway to the cellar is located beneath the front porch. This opening was converted from an original cellar window circa 1835, when the cellar kitchen was enlarged as a dining room. The subterranean entrance is particularly significant for having served as the headquarters of Union General Hancock during the 1864 Battle of Totopotomoy Creek.²¹⁷ The doorway retains its original, ca.-1835, 6-panel door and casing, both in the Greek-Revival style (figs. 121, 122 and 129). An original box lock has been replaced by a modern mortised lockset.

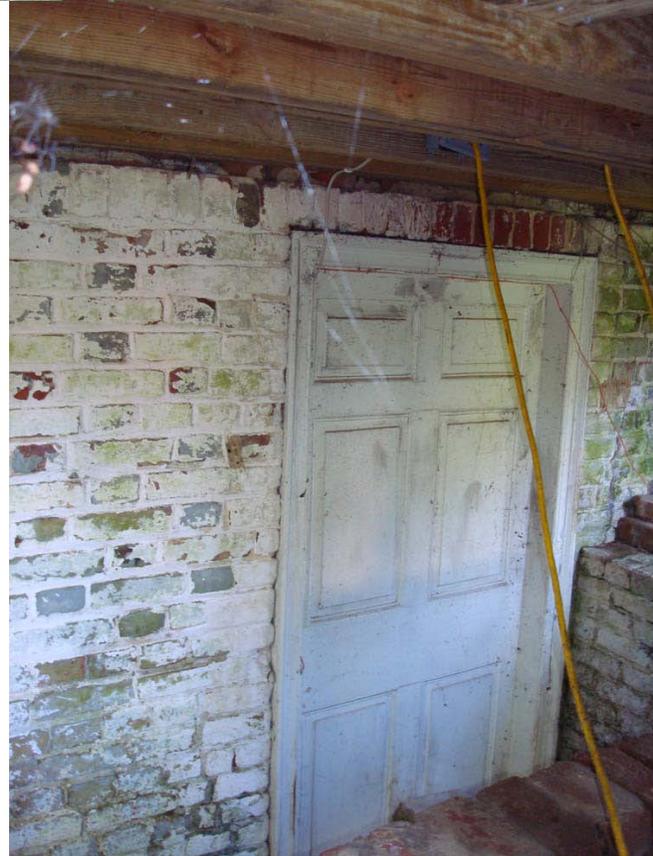
Figure 122. Exterior east foundation of the Shelton House beneath the entry porch at cellar doorway D001. Shelton House, September 2009.

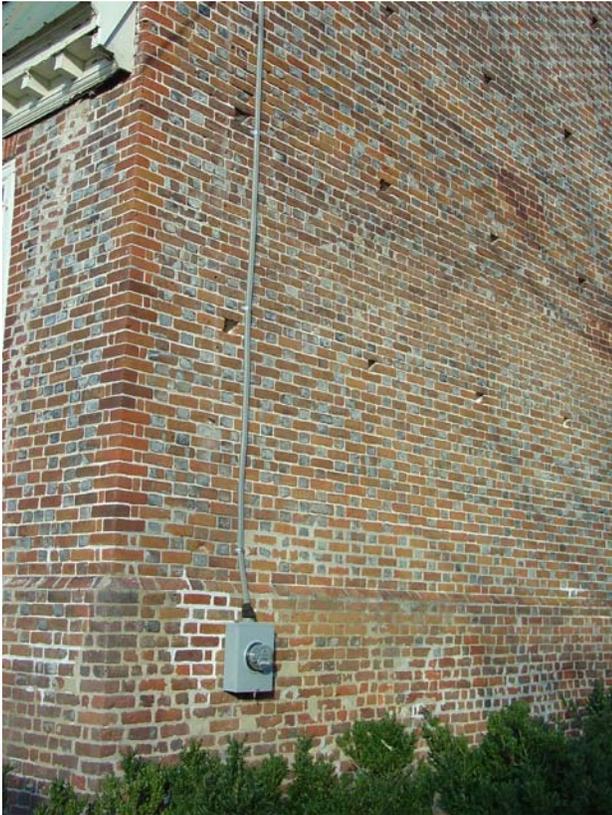
Figure 123. Detail of the exterior southwest corner of the Shelton House, January 2009. Note the following historic features:

- *Flemish-bond brickwork with glazed headers*
- *Putlog holes*
- *Rubbed corner bricks*
- *Projecting lower wall*

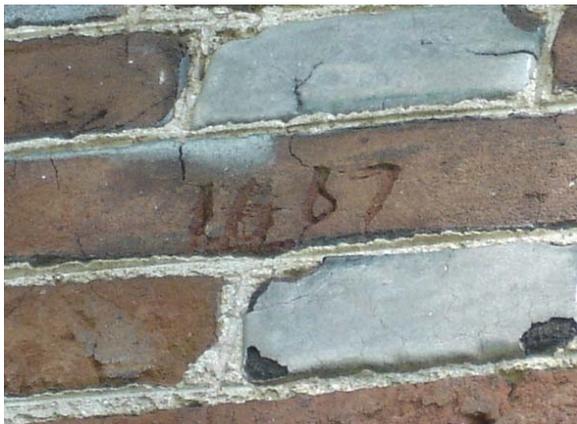
Figure 124. Detail showing the date "1667" chiseled on a brick at the upper northwest corner. Shelton House, September 2009.

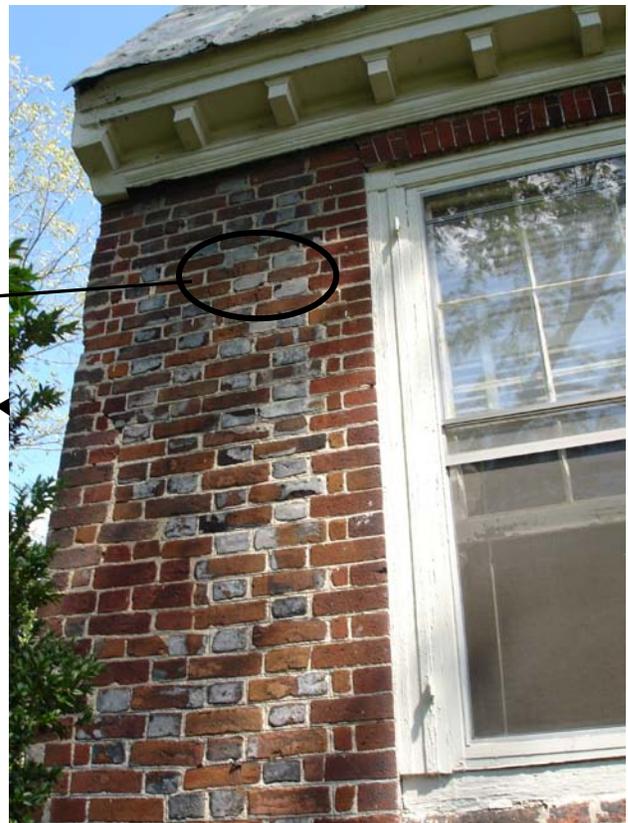
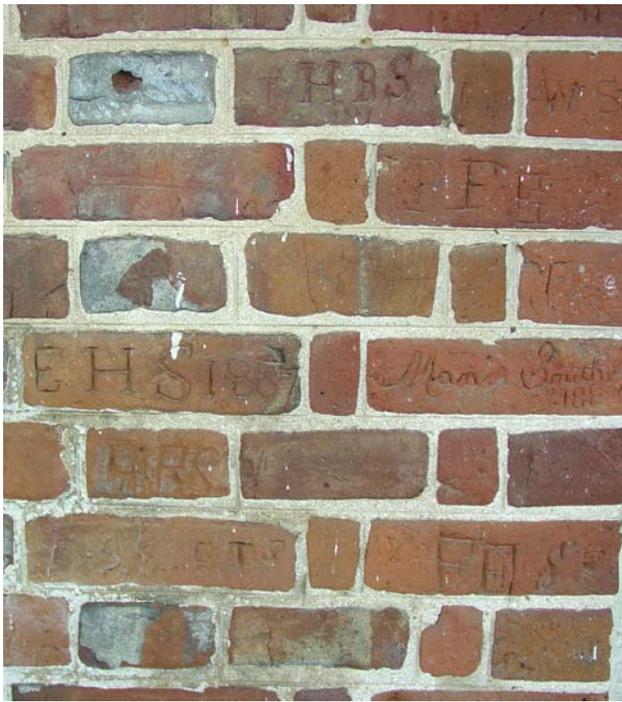
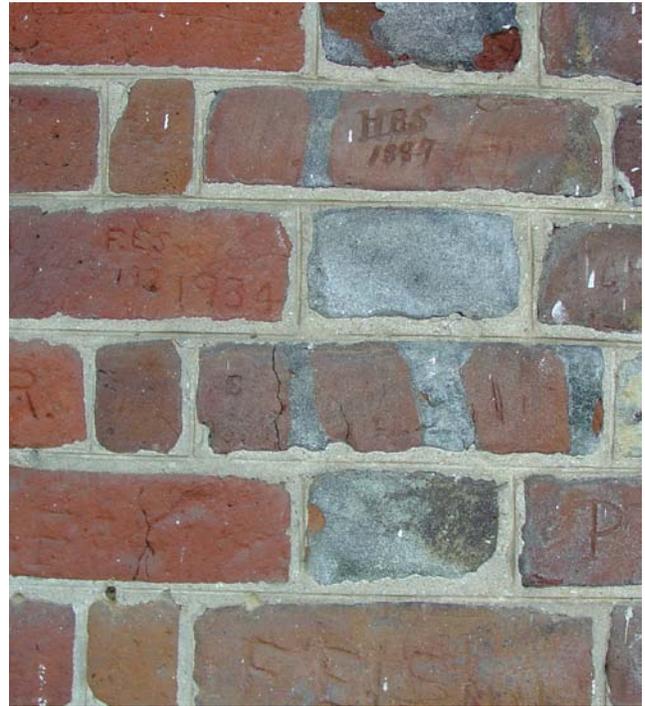
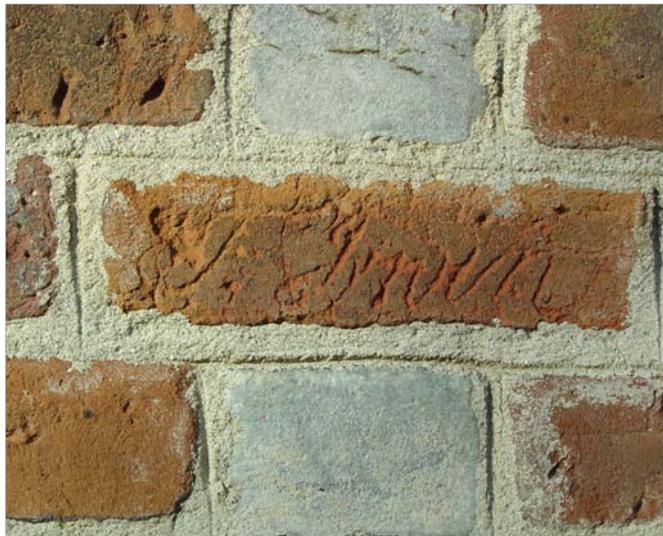
Figure 125. Graffiti engraved on the exterior brickwork of the Shelton House. Upper views are on either side of the front (east) doorway—note dates “1887” and “1934.” Lower left: “T” or “F. Irwin,” is on the lower south wall near the southeast corner. Lower right: “1831,” is on the lower north wall near the northwest corner. Shelton House, January 2009.
