THE SHELTON HOUSE at RURAL PLAINS

Historic Structure Report

Richmond National Battlefield Park
Mechanicsville, Virginia

Barbara A. Yocum, Architectural Conservator
Historic Architecture Program
Northeast Region, National Park Service
Lowell, Massachusetts

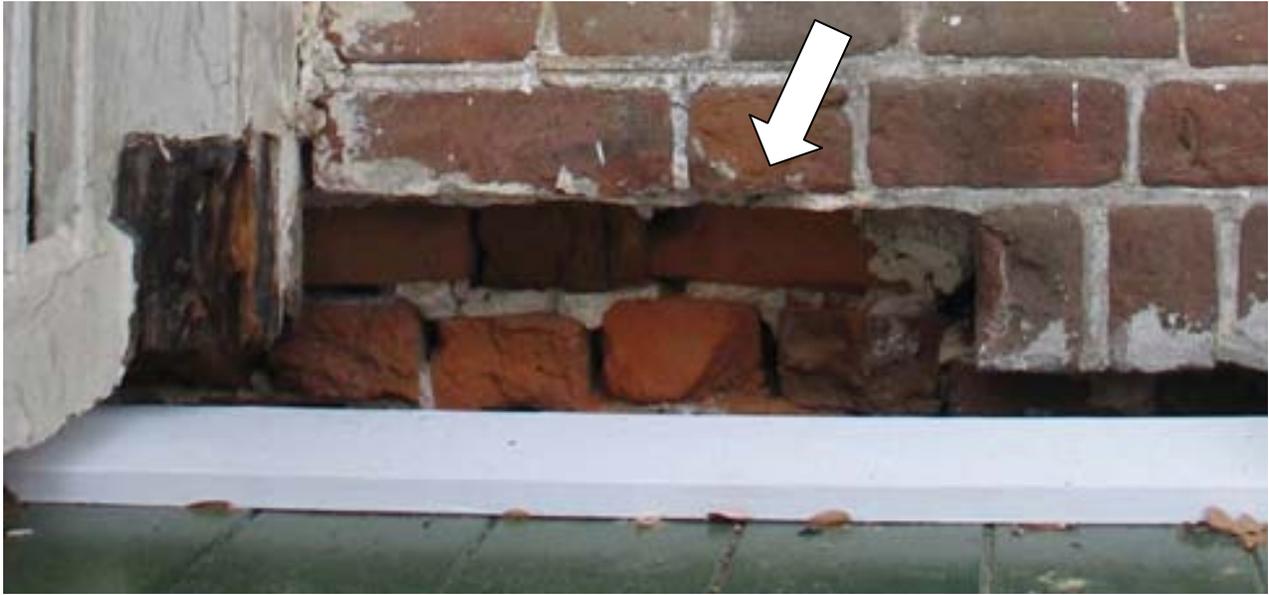
Figure 126. Area of disrepair (at arrow) reveals what appears to be earlier finish brickwork at the lower wall of the east porch. Shelton House, 2008.

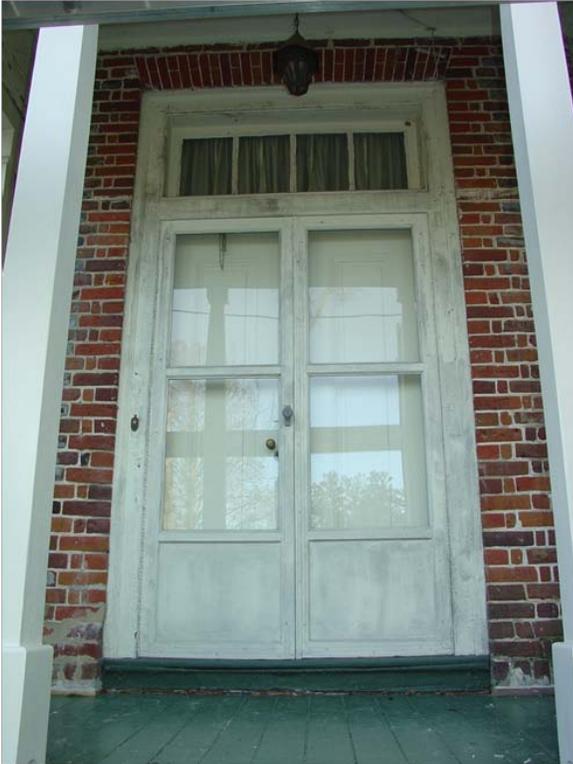
Figure 127. Front doorway D101 in the east façade. The casing dates to circa 1785; the paneled doors are circa 1835. Shelton House, September 2009.

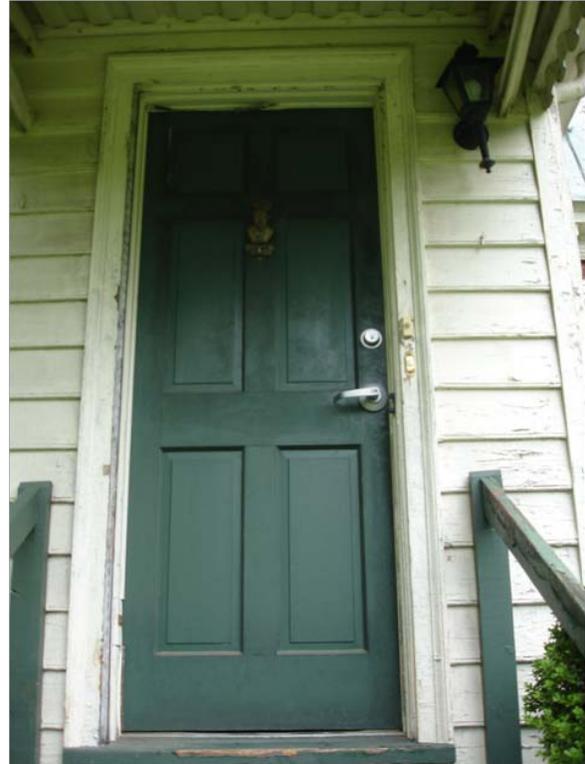
Figure 128. Back doorway D102 in the circa-1948 west wing. Shelton House, June 2009.

The west wing measures approximately 11' 4 ½" long by 11' 11 ½" wide. Openings include an exterior doorway (fig. 128) with flanking single window in the west elevation, and a wide window in the south

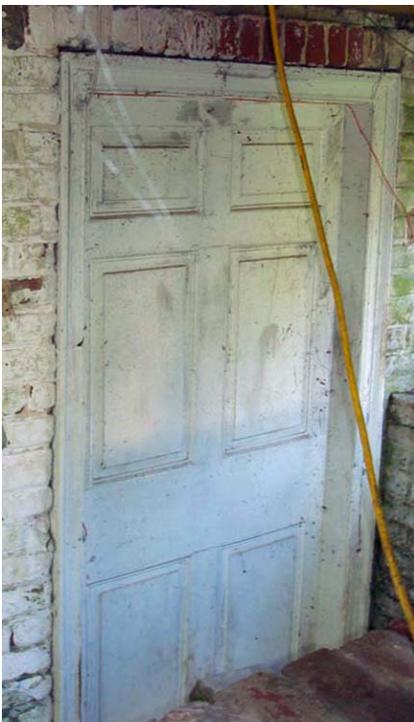
Figure 129. Cellar doorway D001 beneath the front porch. The casing and 6-panel door replaced a window circa 1835. Shelton House, September 2009.

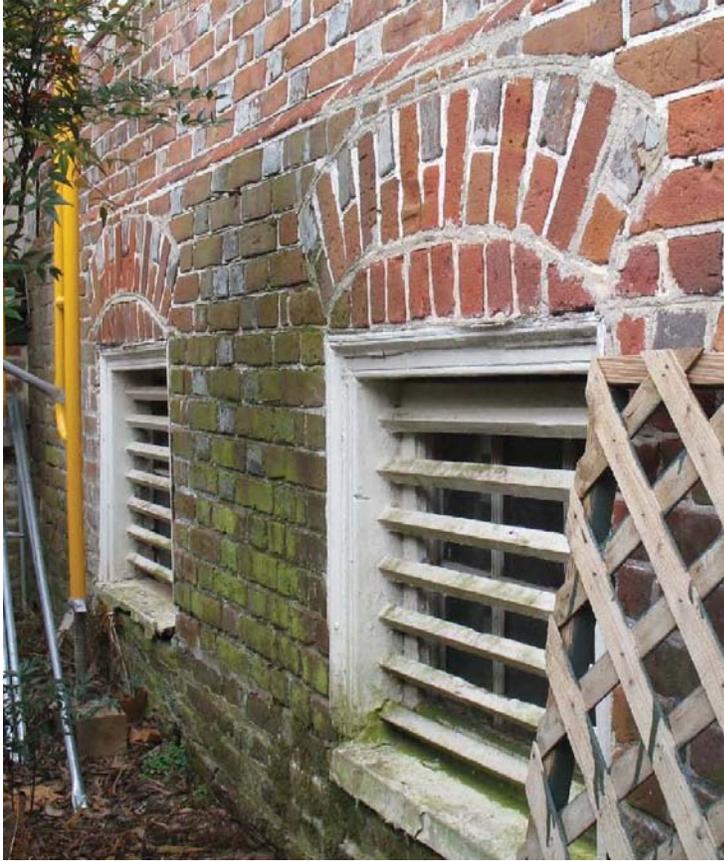
Figure 131. Cellar windows W003 (left) and W004 (right) in the east façade. The brick jack arch is contemporary with the circa- 1785 brickwork; the existing casing, wooden bars, and sashes date to circa 1835. Shelton House, September 2009.

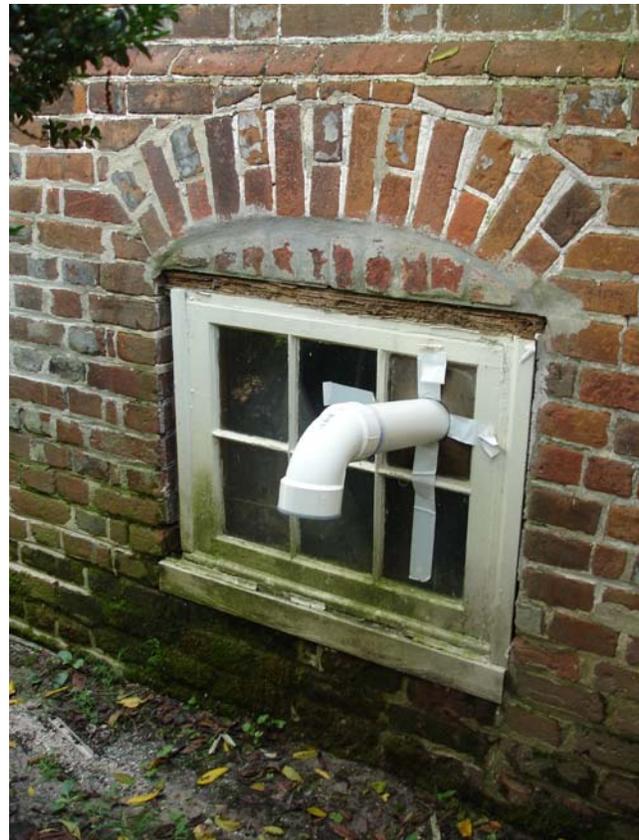
Figure 132. Woodwork at cellar window W006, in the west wall of the Shelton House, has been modified to accommodate a furnace vent; the brick jack arch is contemporary with the circa-1785 brickwork. Shelton House, September 2009.

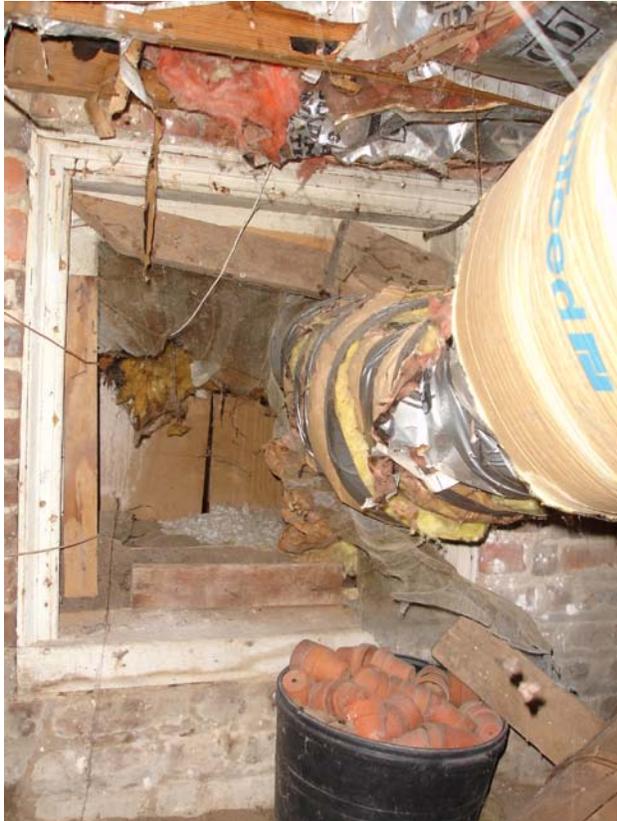
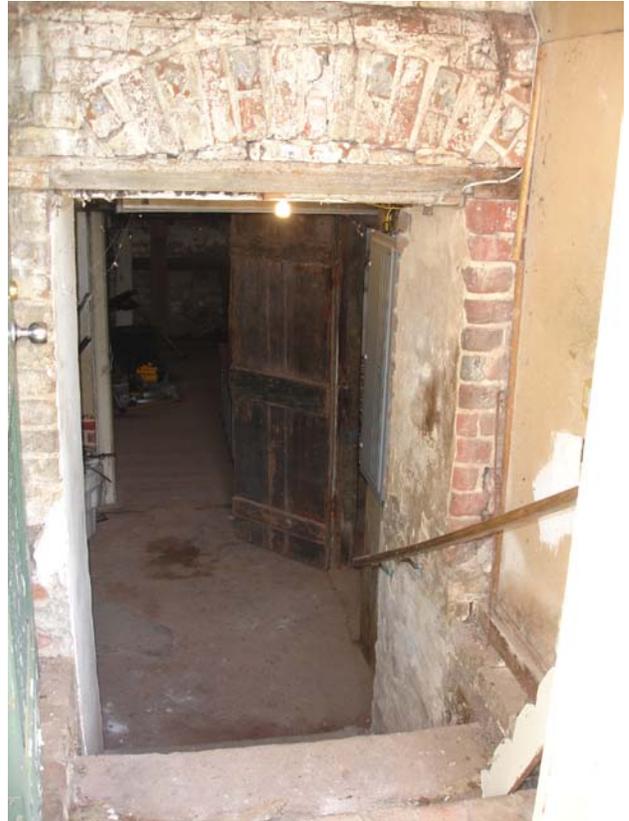
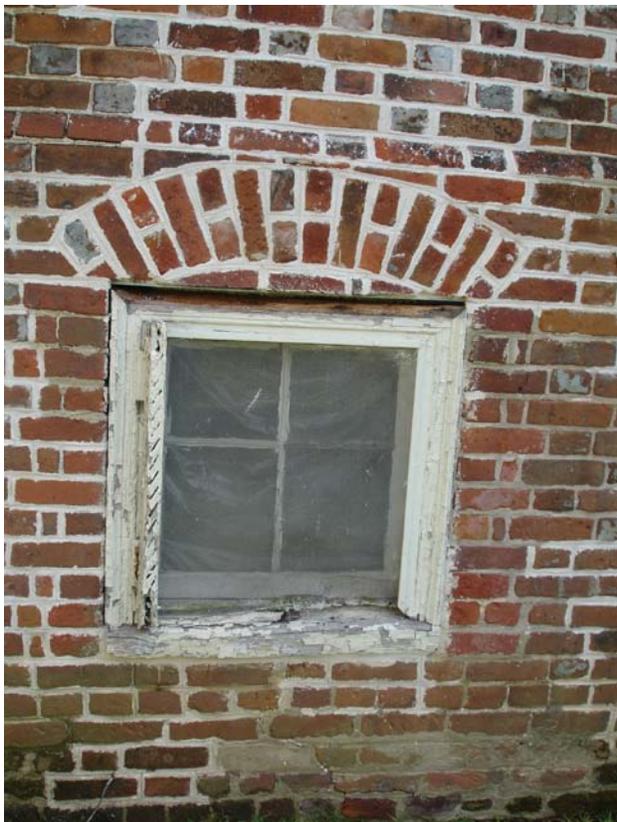
Figure 133. Three cellar windows in the west wall that have undergone alterations. Shelton House, September 2009.

Upper Left: W007, beneath the circa-1948 west wing, now used as an opening for heating system ductwork.

Upper Right: Former cellar window enlarged circa 1930 as doorway D004.

Lower Left: W008, inaccurately rebuilt in 2008 with an additional brick in the jack arch.

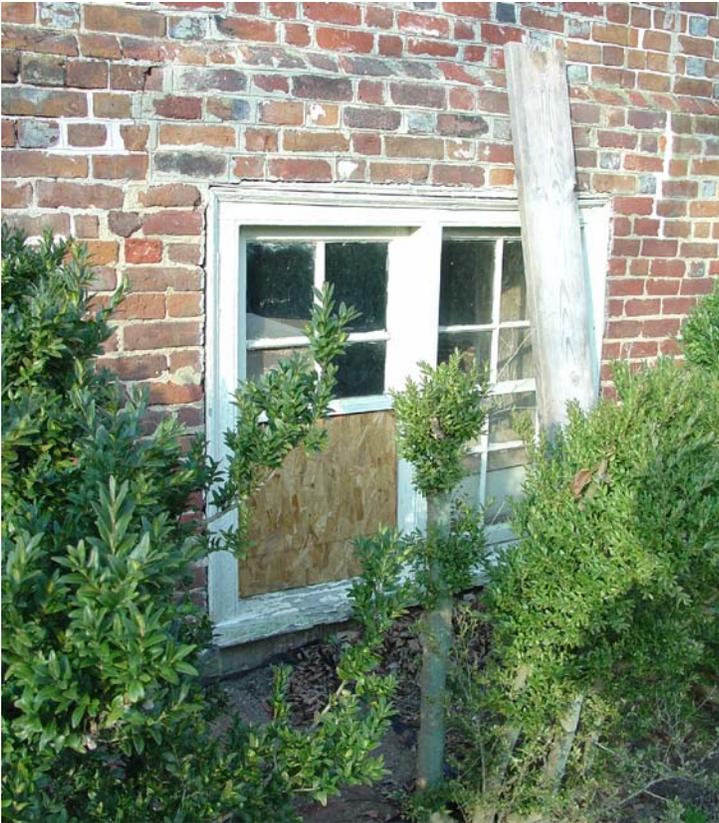
Figure 134. Cellar window W009 in the south wall of the Shelton House. Archeological evidence suggests this was originally a bulkhead cellar entrance. The doorway is believed to have been converted to a window circa 1835. Shelton House, January 2009.

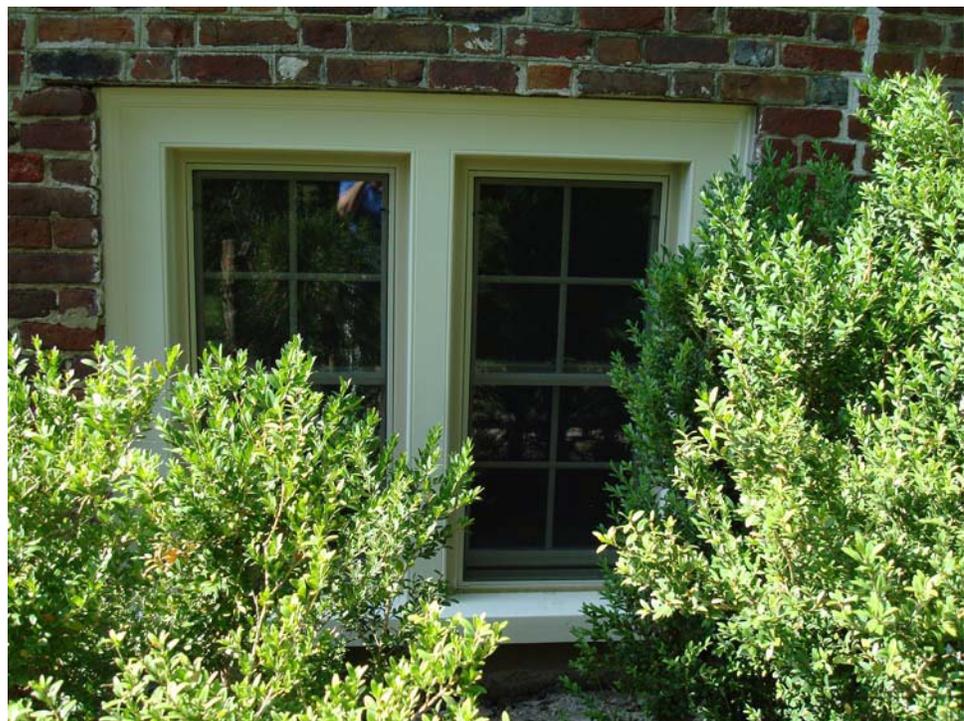
Figure 135. Cellar window W009 rebuilt in 2009 by William Reese, NPS. The original circa-1835 woodwork shown in fig. 134 is in storage at the Park. Shelton House, June 2009.

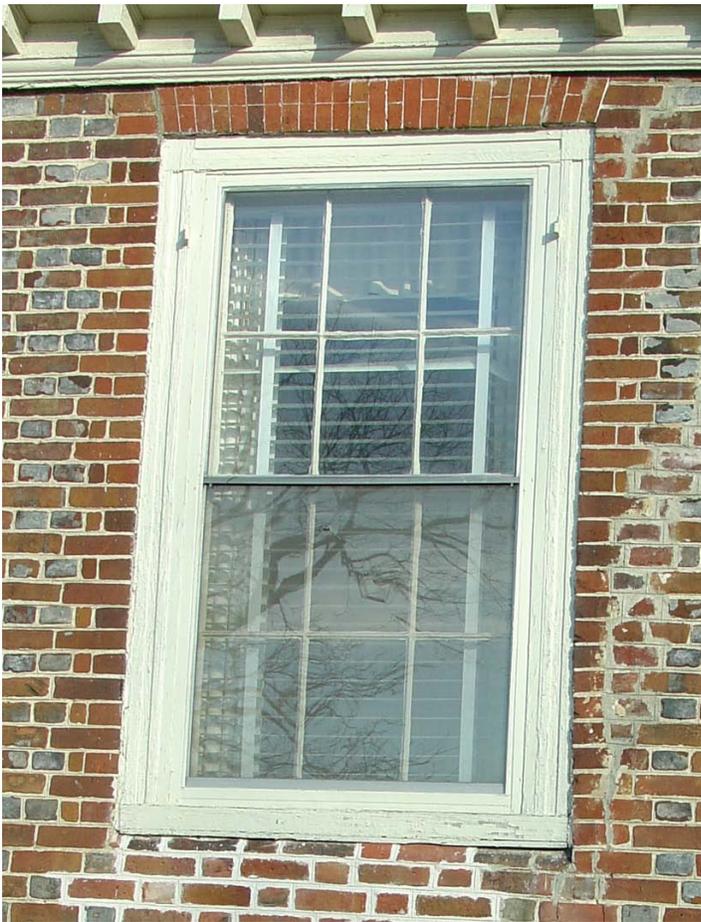
Figure 136. Window W111 in the west elevation is representative of all the first-story windows in the east and west walls of the Shelton House. Existing openings were enlarged circa 1785; casings and some 6-over-6 sashes date to circa 1835. Shelton House, January 2009.

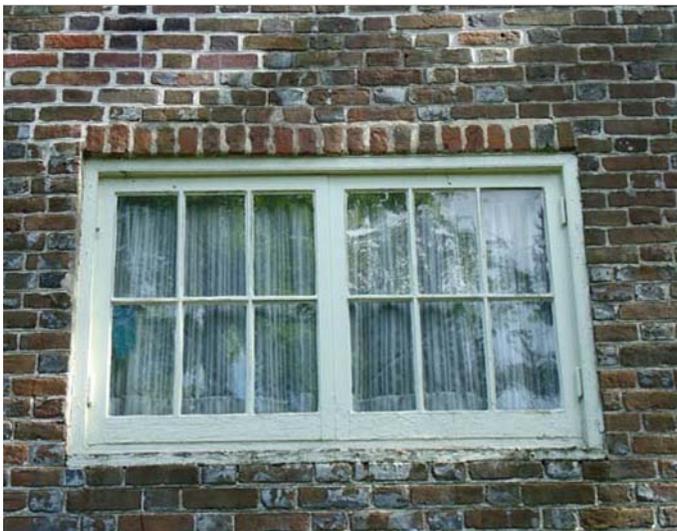
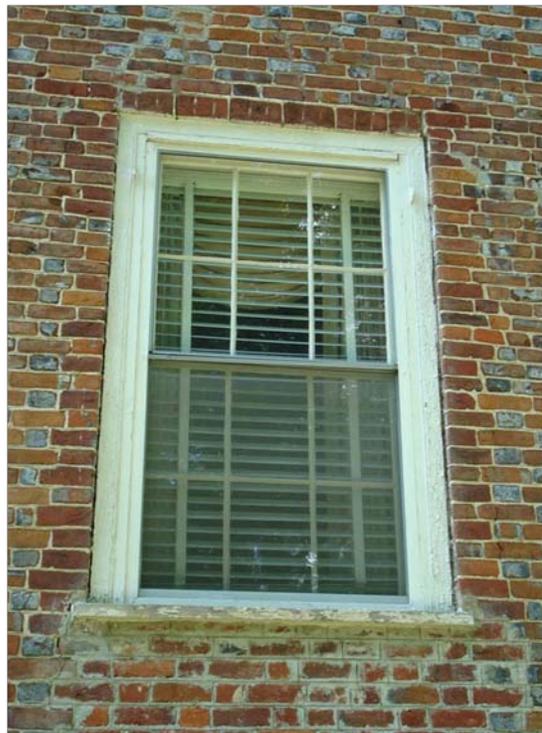
Figure 137. Two later windows include window W105 in the north end wall (above, 1915), and window W112 in the south end wall (right, circa 1835). Shelton House, June 2009.

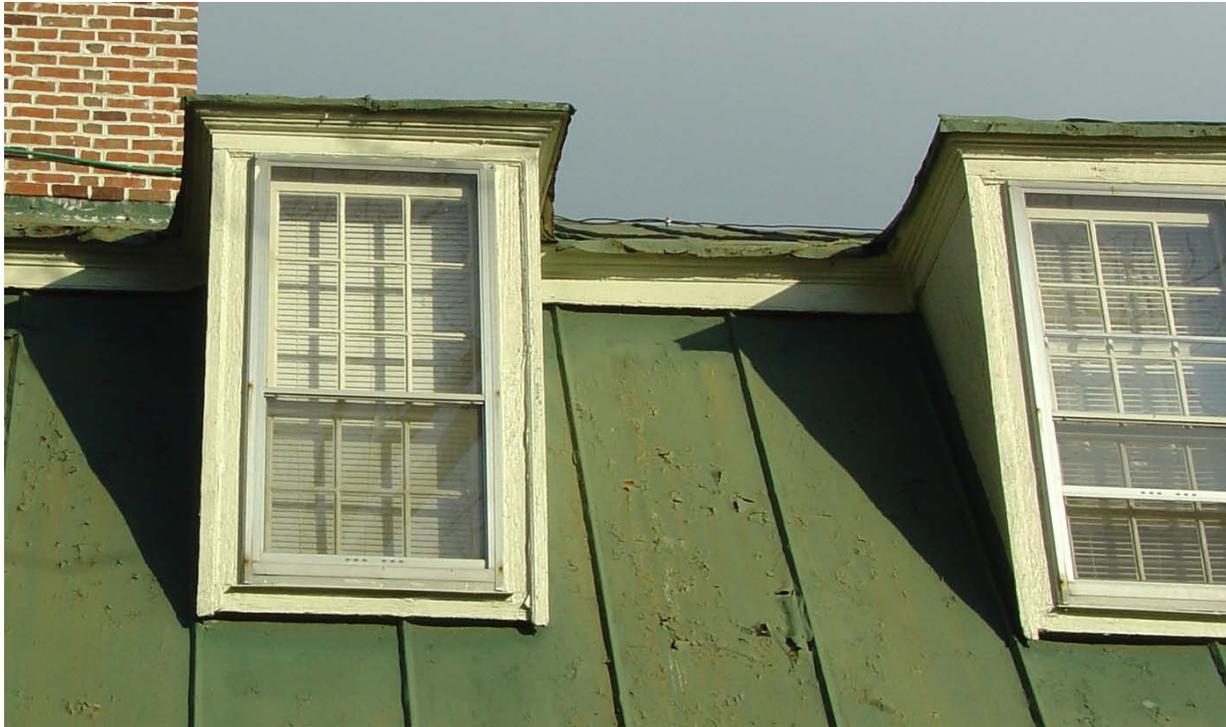
Figure 138. Dormer windows W206 (left) and W207 (right) on the back (west) side. Also note the standing-seam metal roof and north chimney that was rebuilt in 2008. Shelton House, January 2009.

Nine dormer windows provide natural light to the second-story rooms of the Shelton House (fig. 138). These are in the steep lower portion of the gambrel roof. Four dormer windows are in the east elevation and five are in the west elevation. The findings of the paint analysis suggest that the dormers were rebuilt, and their windows enlarged, circa 1785 (at the same time as the first-story windows). The

Less elaborate cornices trim the upper portions of the dormers, the porch chamber, and the horizontal intersection of the upper and lower roofs (figs. 138 and 139). Projecting coved moldings incorporated in the cornice on the front façade create a more formal appearance than on the back side of the house.

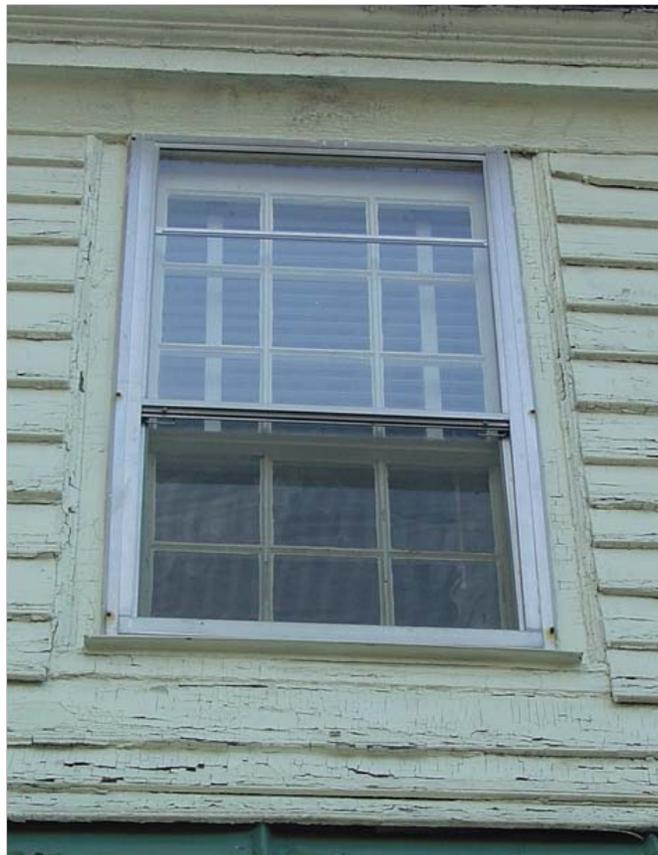
Figure 139. Window W203 in the east elevation of the wood-framed porch chamber. Shelton House, January 2009.

There is one window (W203) in the east elevation of the porch chamber (fig. 139). Like the other second-story windows, this opening appears to have been enlarged circa 1785. The 9-over-6 sashes date to circa 1965.

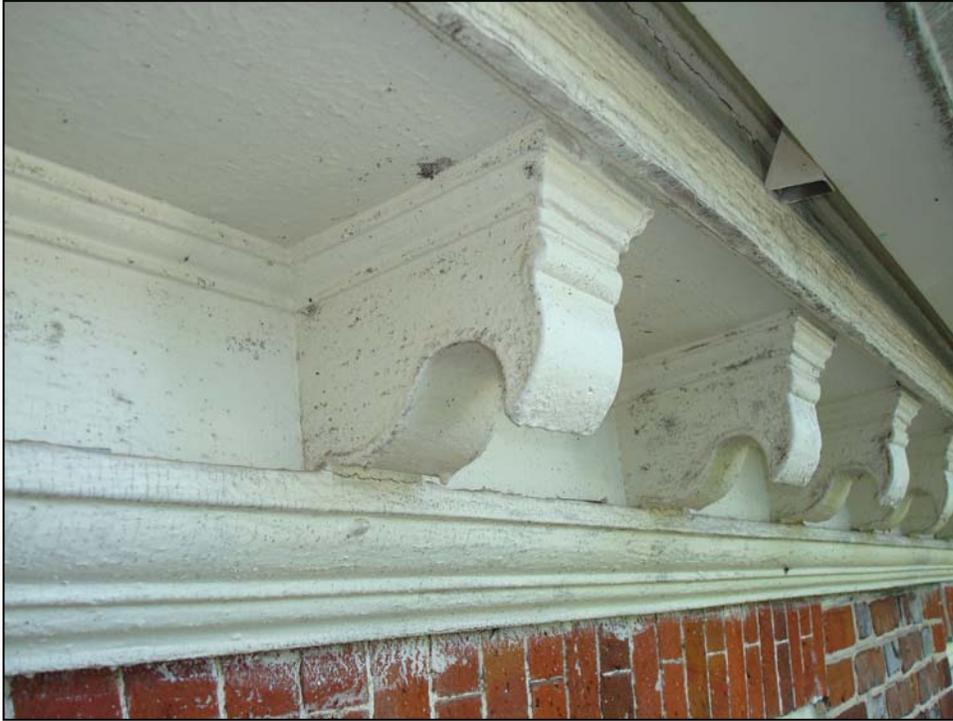
Figure 140. The circa-1785 east cornice of the Shelton House features decorative modillions. Shelton House, September 2009.

The main cornice is located below the roof line and partially covers the circa-1785 jack arches of the first-story windows. This cornice features curved modillions on the front side (fig. 140), and plain block-style modillions on the back side (fig. 141). A small portion of the west cornice was

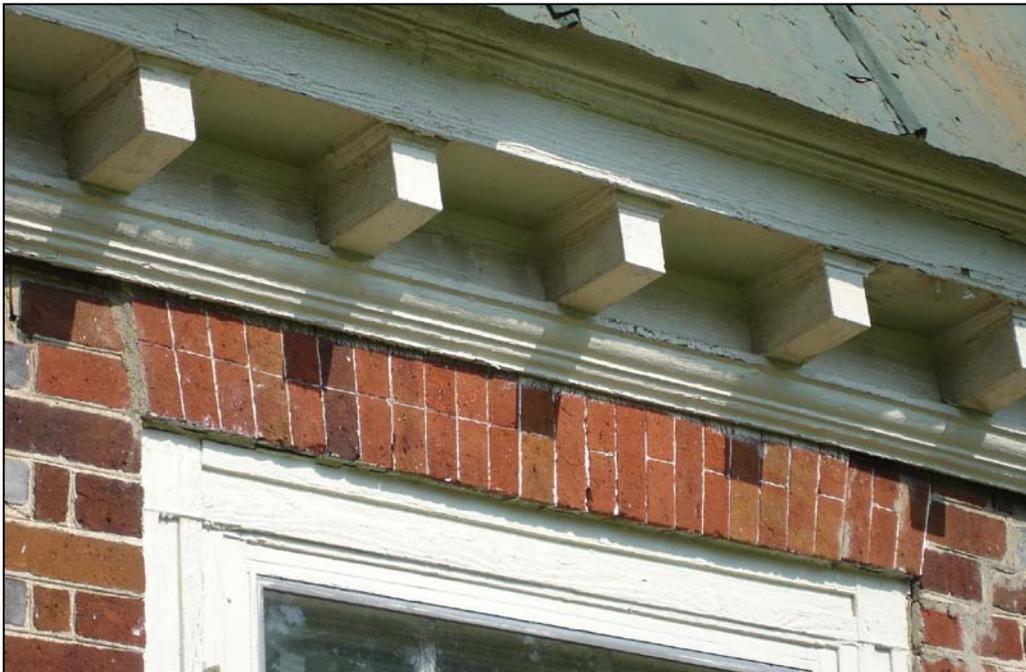
Figure 141. The circa-1785 west cornice of Shelton House has plain-block modillions. Shelton House, August 2009.

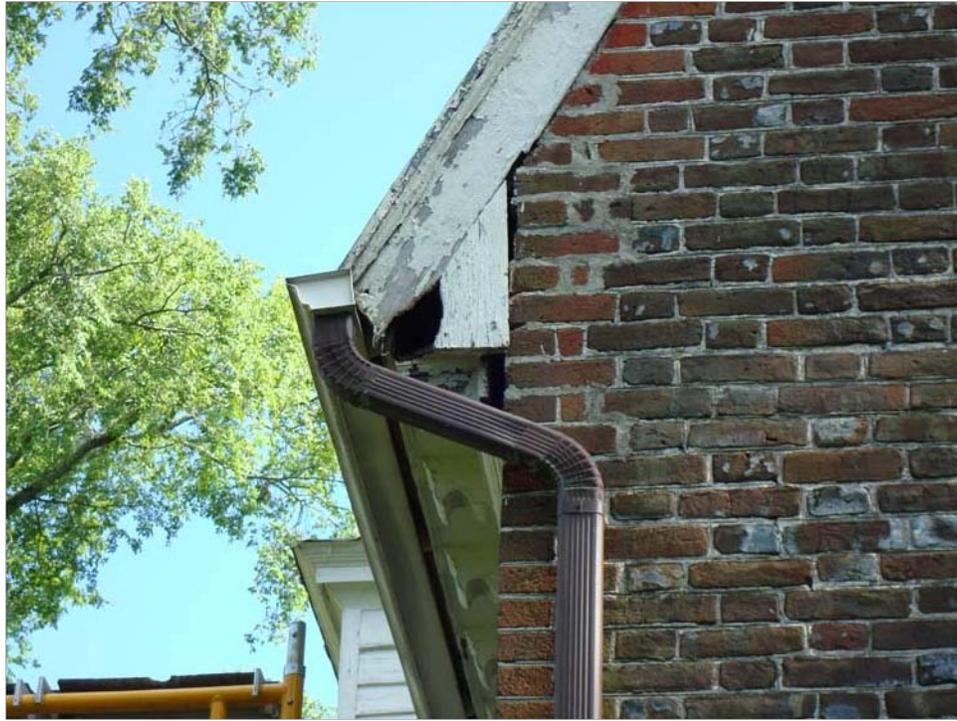
Figure 142. Modern gutter and leader at the northeast corner of the Shelton House, June 2009. (For detail of cornice interior, see figure 110). A similar gutter and leader are at the southeast corner of the house.

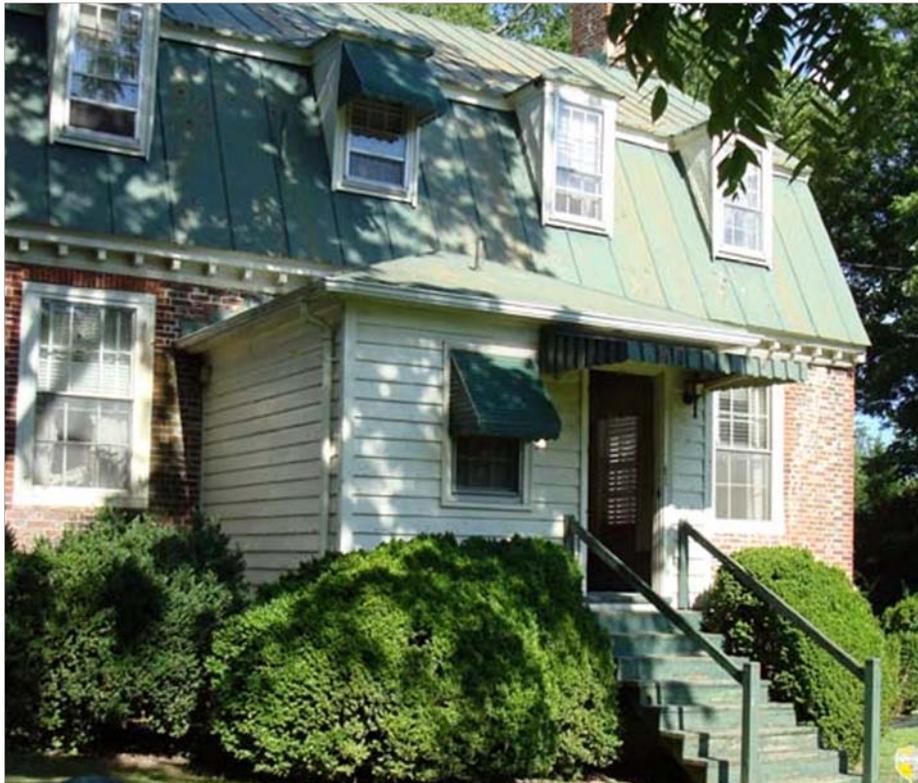
Figure 143. The circa-1948 west wing of the Shelton House replaced an earlier porch. Shelton House, June 2009.

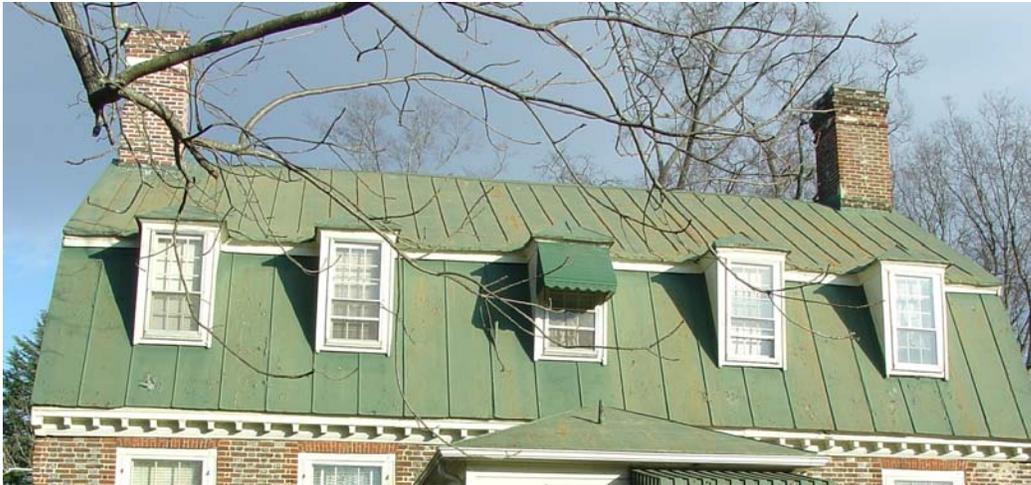
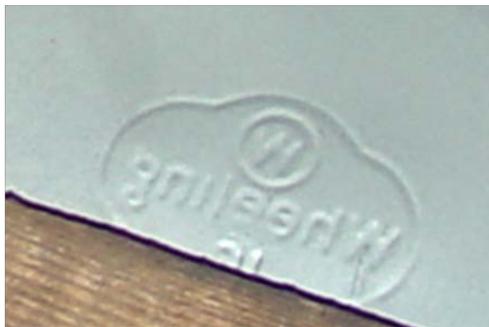
Figure 144. Standing-seam metal roofing on the west elevation of the roof (above). The upper portion was replaced circa 1930 with sheet steel made by the “Wheeling” company, based on a manufacturing stamp visible in the attic (left). Shelton House, 2009.

The main gambrel roof of the Shelton House is covered by metal roofing with standing seams. This appears to have been installed at two different times, based on different spacing of the seams. The seams on the upper slope of the roof are more narrowly spaced than the lower slope. William (Bill) Shelton recalled during an interview in 2005 that the "upper roof," had been changed from "galvanized iron" to "tin" during his lifetime (1920-2006). Furthermore, the metal roofing of the upper roof looks comparatively new in photographs of the house dated 1935 and 1936 (figs. 20, 21, and 23-25). A plausible date for this roofing is therefore circa 1930. A manufacturing stamp visible from the attic indicates the roofing was made by the "Wheeling" company of Wheeling, West Virginia (fig. 144).²¹⁸

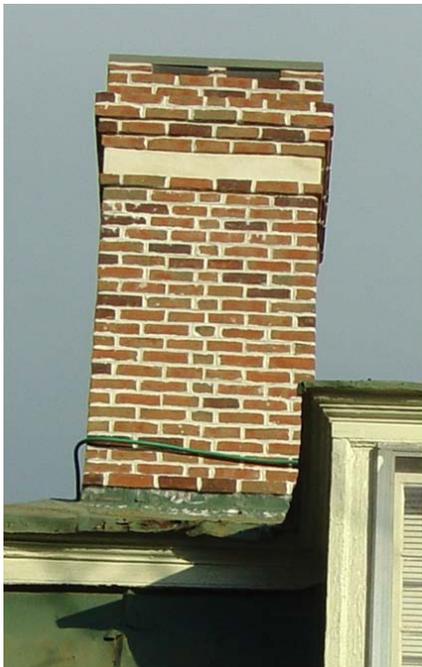
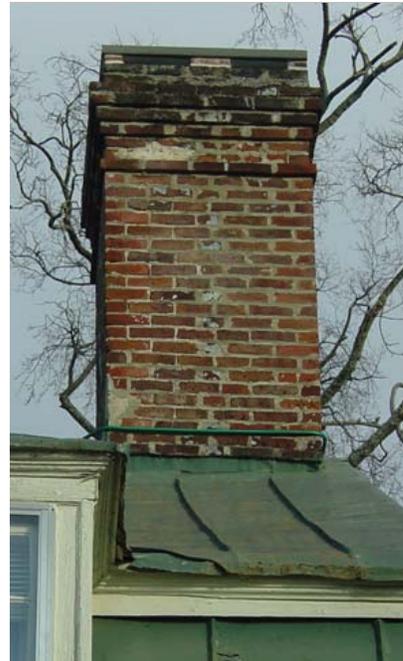
Figure 145. West elevations of the north chimney (left) and the south chimney (right). The west chimney was rebuilt by the Historic Preservation Training Center (HPTC) in 2008; stone caps were installed on both chimneys by HPTC in 2008. Shelton House, 2009.

The Shelton House has two brick chimneys: one at the south wall, the other at the north wall (fig. 145). Each chimney has a decorative brick pattern, brick corbelling above a band of stucco,

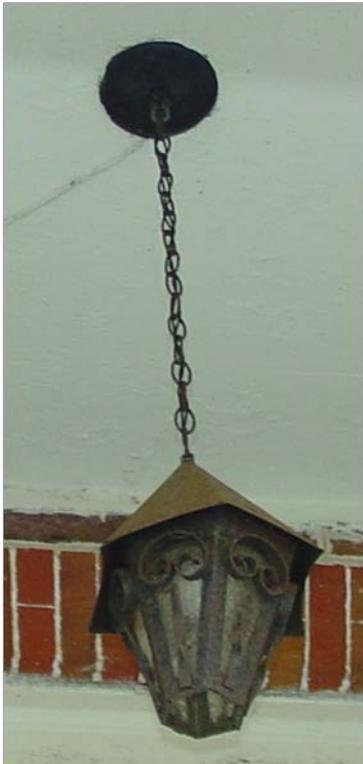
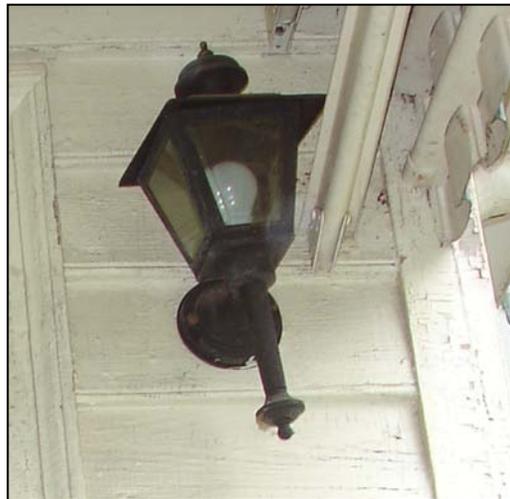
Figure 147. Exterior light fixtures at the east porch ceiling (left) and west doorway (above). Shelton House, January and June 2009.

The house was connected to electrical service in the 1940s, according to Bill Shelton,²²¹ which may have coincided with building of the west wing circa 1948. Electrical service enters the house on the south side, where an electric meter is mounted (fig. 114). Exterior illumination is provided by two light fixtures: a chain-suspended light at the front (east) doorway, and a wall-mounted light at the back doorway (fig. 147). A conjectural date for both light fixtures is circa 1948.

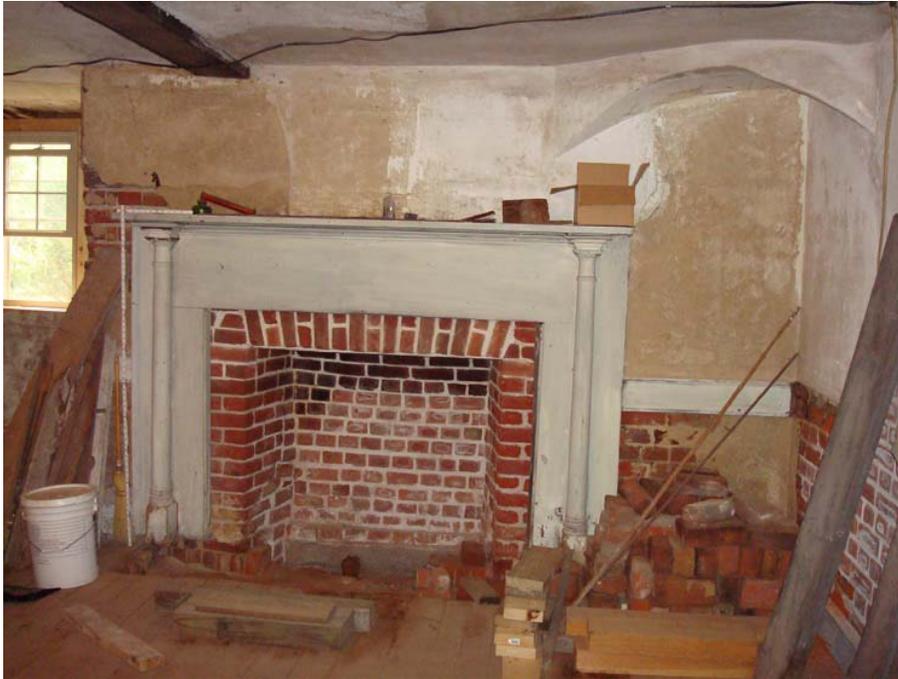
Figure 149. Room 001 (Cellar Dining Room): Circa-1835 fireplace mantel at the south wall. Shelton House, September 2009.

A brick arch supporting the east side of the south chimney is located in the upper southwest corner of Room 001 (fig. 149). This is an original feature of the house dating to circa 1725.

An original kitchen fireplace with bake oven and/or smoke chamber is at the south wall of Room 001 (fig. 149). The large opening of this fireplace was modified circa 1835, and the opening of the bake oven/smoke chamber in the west jamb enclosed with brickwork. The brick

hearth was also raised to the level of the new wood floor, and a Greek-Revival-style mantel installed with a shelf supported by two Doric-style columns. Later repairs have been made to the fireplace brickwork walls, floor, and iron lintel at the opening by the NPS Historic Preservation Training Center in 2007.

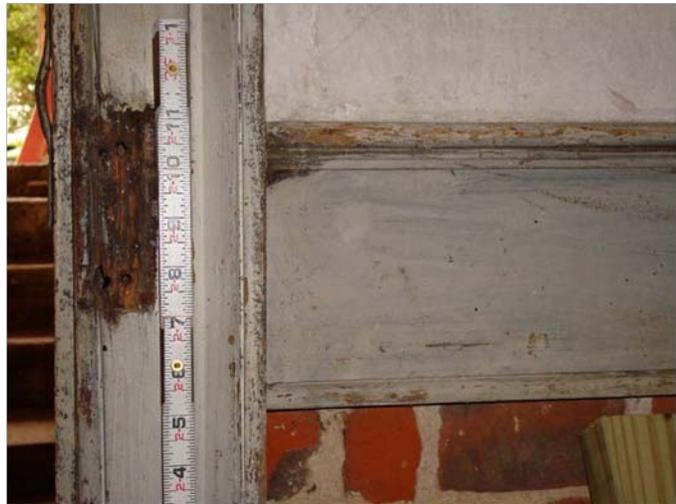
Figure 150. Room 001 (Cellar Dining Room): Doorway D006 at the west wall. Detail at right shows shadow evidence of missing door latch on the circa-1835 casing. Shelton House, September 2009.

cellar hall—Room 003 (fig. 150). It was created when the dining room was enlarged to its present size circa 1835. The molded casing dates to that time; the missing door most likely had 6 panels.

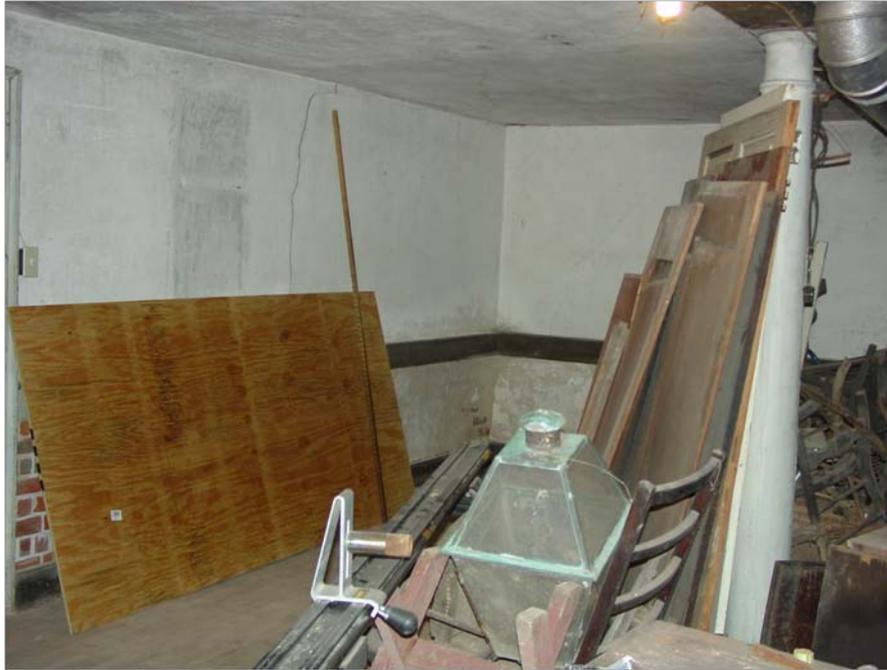
Figure 151. Room 001 (Cellar Dining Room): View looking northwest. Note the wooden column in the center of the room that replaced an earlier brick partition circa 1835. Shelton House, January 2009.

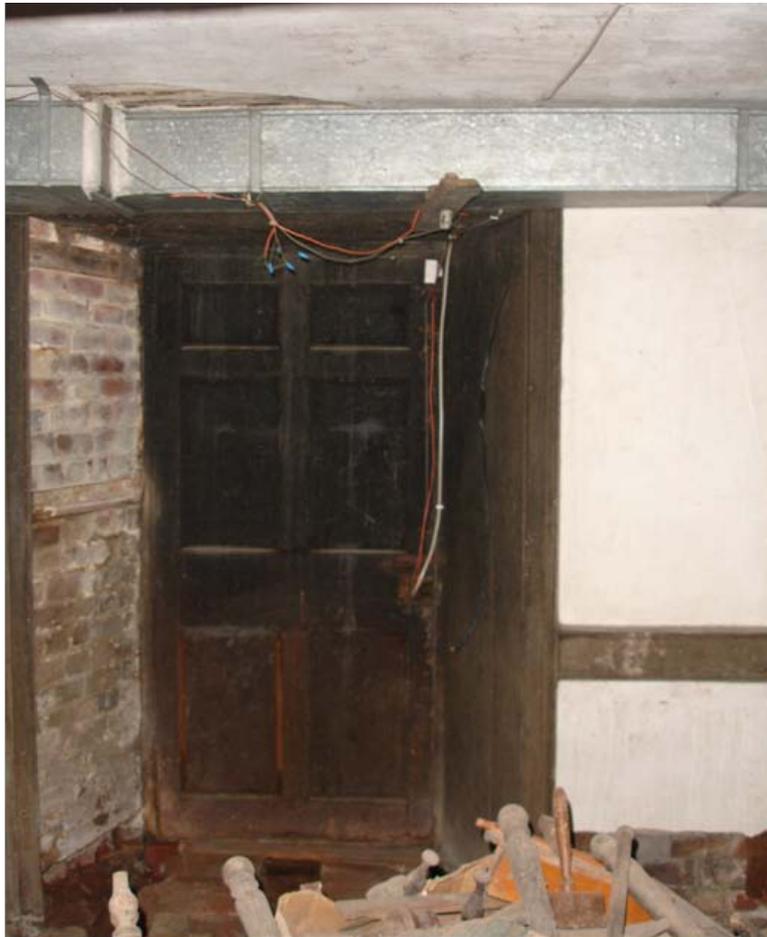
Figure 152. Room 001 (Cellar Dining Room): Exterior doorway D001 at the east wall, northeast corner. Shelton House, January 2009.

East Doorway (D001). A doorway at the north end of the east wall connects Room 001 with the exterior (fig. 152). This opening was enlarged from an original cellar window circa 1835. The deep jambs are splayed and cased, similar to two adjacent windows in the east wall. The Greek-Revival-style door has 6 panels.

Sheet-metal ductwork of unknown date is mounted to the ceiling of Room 001 (figs. 152 and 154). Central heating was first installed in the Shelton House around 1915.

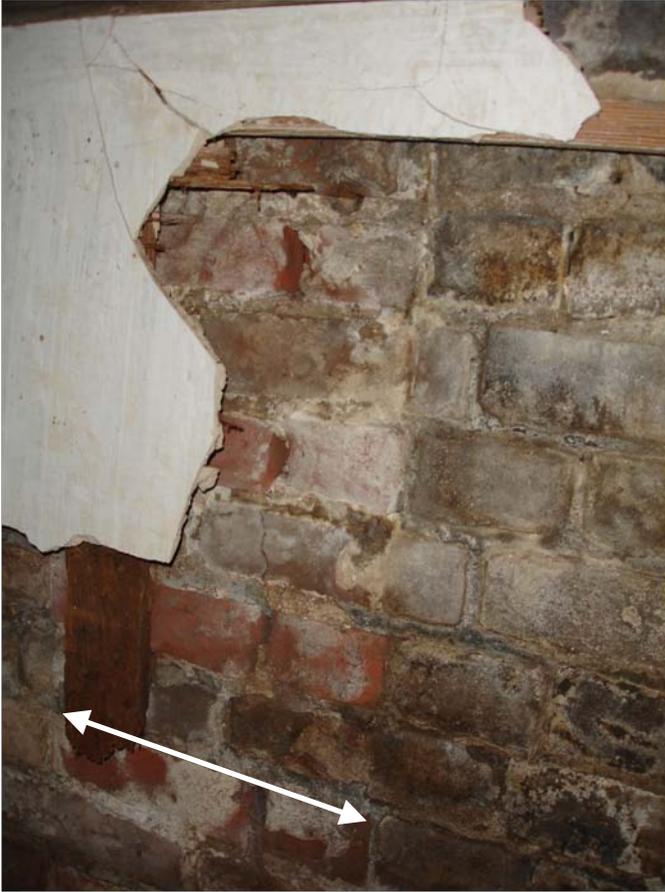
Figure 153. Room 001 (Cellar Dining Room): Detail of east brickwork wall showing shadow evidence of missing north-south brick partition (at arrow). Shelton House, June 2009.

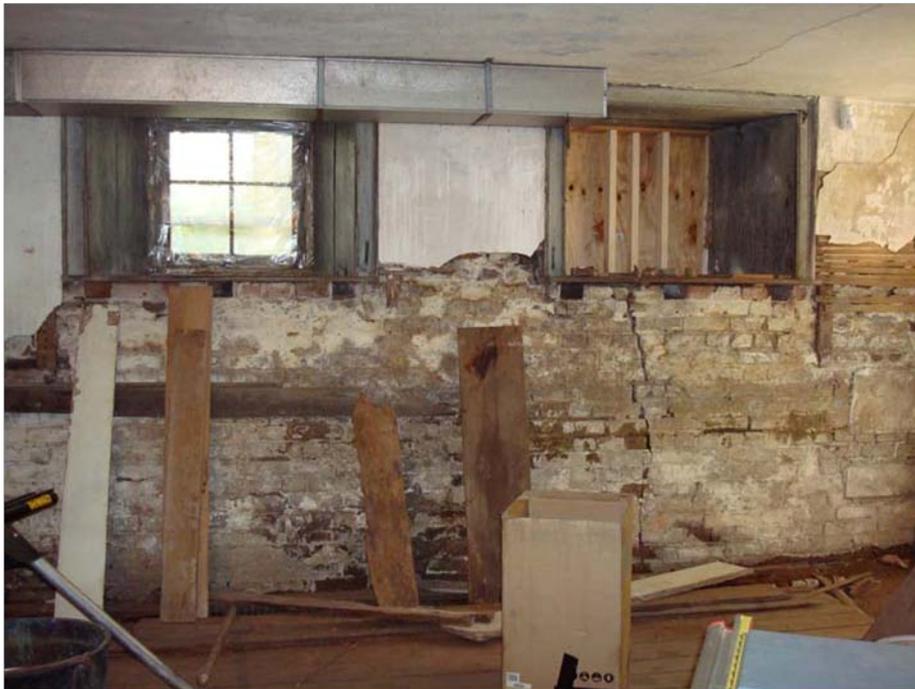
Figure 154. Room 001 (Cellar Dining Room): East wall featuring windows W001 and W002. Shelton House, September 2009.

East Windows (W001 and W002). The two windows in the east wall are original windows that were enlarged circa 1835 to their present size, with splayed jambs cased with wood paneling (fig. 154). Photographic documentation indicates that the existing 4-light sashes existed by 1928.

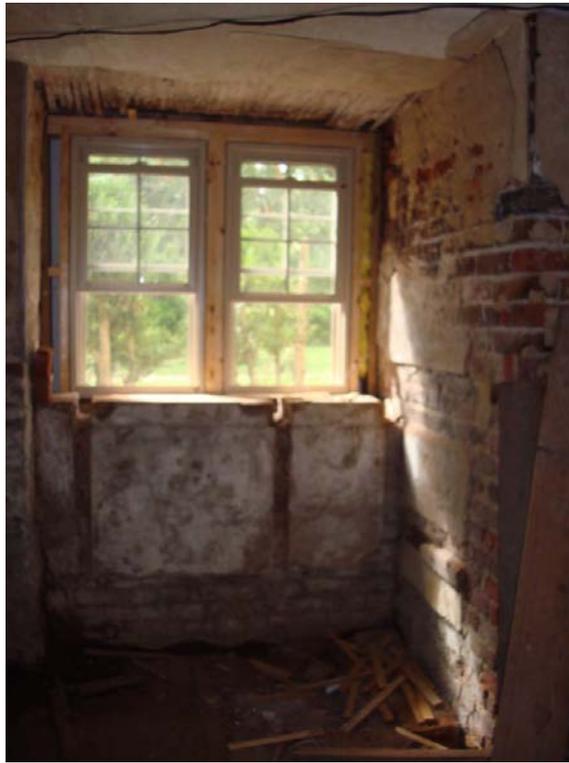
Figure 155. Room 001 (Cellar Dining Room): Circa-1835 window bay at the south wall, southeast corner. Archeological evidence suggests this was originally a bulkhead entrance. Shelton House, January 2009.

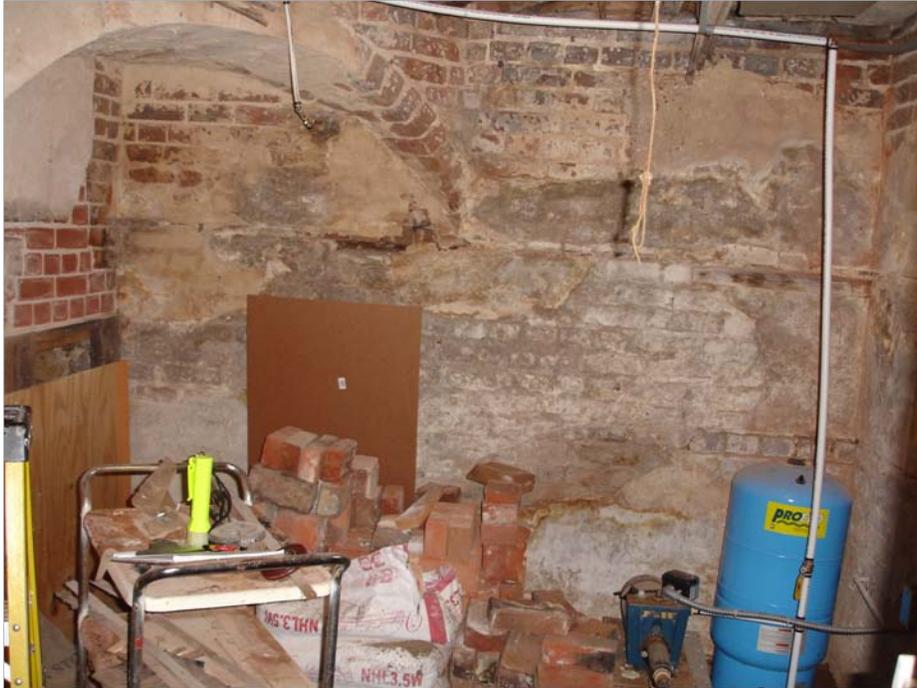
Figure 156. Room 002 (Pump Room): View of the south wall. Shelton House, September 2009.

A brick arch supporting the west side of the south chimney is located in the upper southeast corner of Room 002 (figs. 156 and 157). This is an original feature of the house dating to circa 1725.

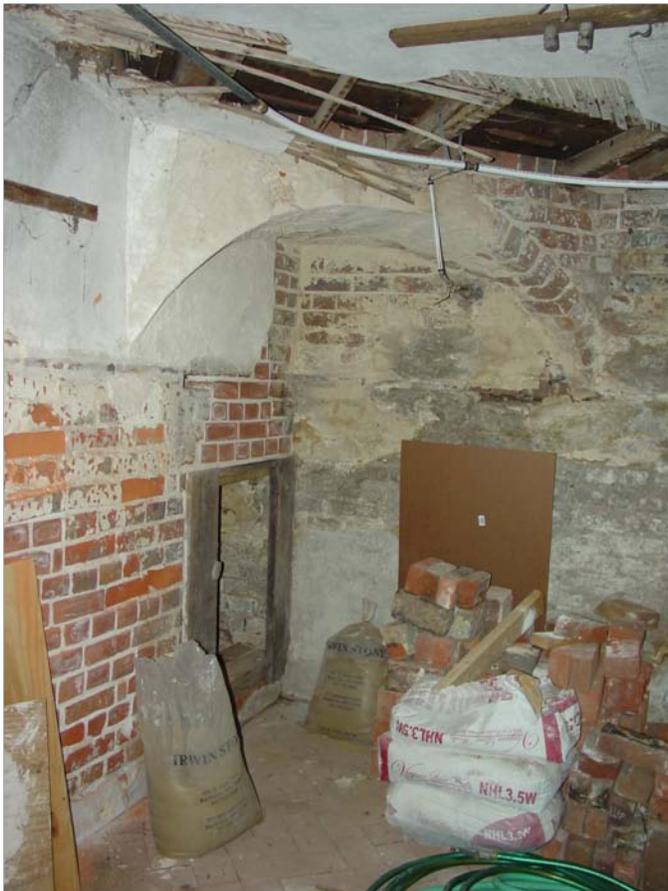
Figure 157. Room 002 (Pump Room): Detail of the southeast corner. Note the following brickwork features: floor paving, later (circa-1835) east wall, and arch supporting the south chimney. Shelton House, September 2009.

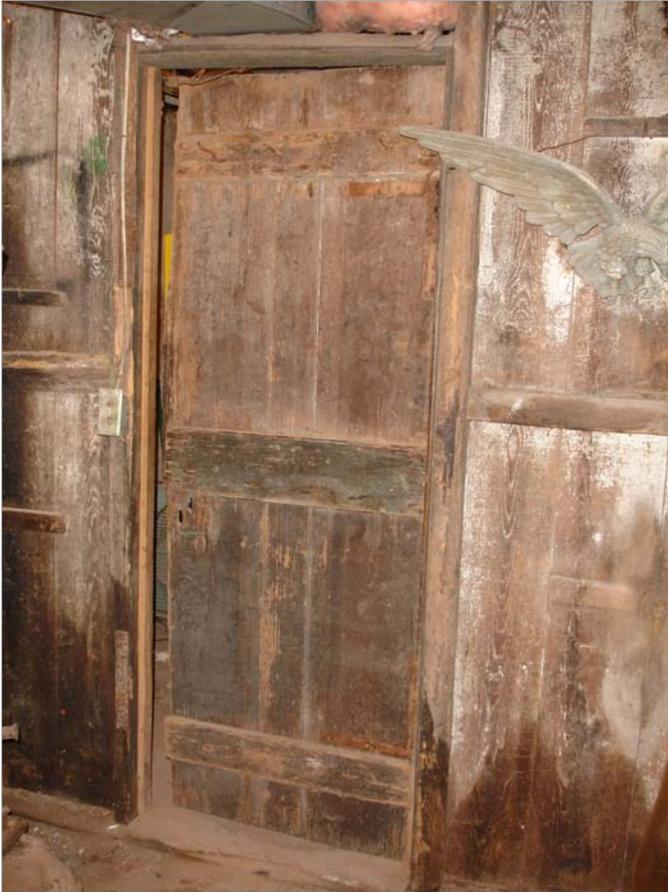
Figure 158. Room 002 (Pump Room): North board partition featuring doorway D005. The wall and doorway both appear to be later elements installed around 1835. Shelton House, June 2009.

North Wall. The north partition is made of wide beaded-board paneling and horizontal battens located on the Room-002 side of the wall (fig. 158). This wall is believed to be contemporary with the circa-1835 brick flooring and plaster ceiling, which it abuts. Similar beaded boards were also used for the sidewalls of the circa-1835 corner stair in Room 003. Horizontal wooden strips on either side of a center doorway supported shelves that are missing today (fig. 159).

North Doorway (D005). One doorway in the north wall of Room 002 leads to the back cellar hall--Room 003 (fig. 158). The doorway is centered in the north board partition, which has been dated circa 1835. The door is a board-and-batten type, clinched with hand-wrought nails. It is hung with wrought H-L hinges, which may predate the door. The hinges are similar to those of surviving circa-1785 doors in the first and second stories of the house. Holes in the door suggest it originally had a thumb latch that was later replaced by a simple wooden swivel latch, and most recently a metal slide bolt, on the Room-003 side of the door.

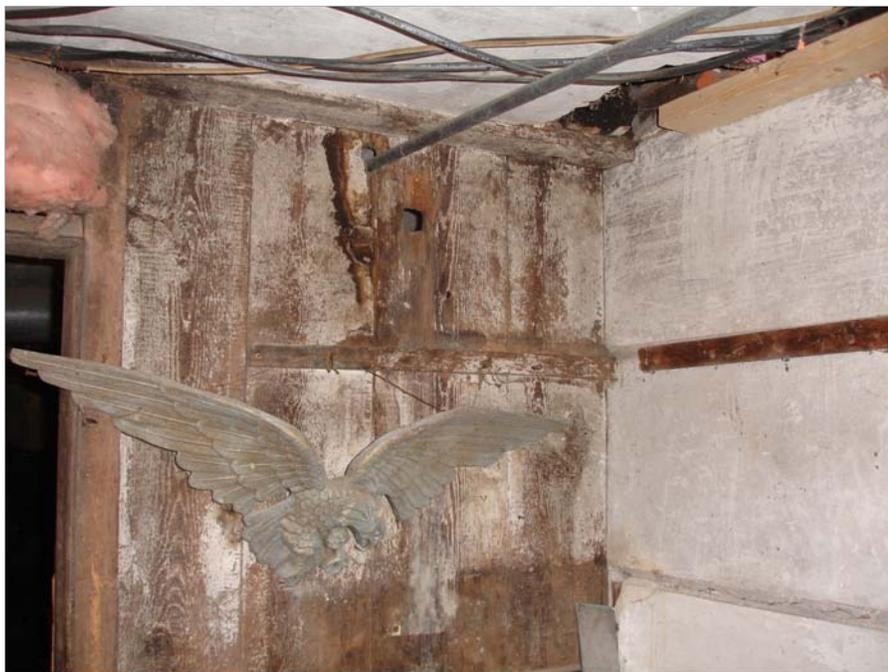
Figure 159. Room 002 (Pump Room): View of the upper northeast corner. Shelton House, September 2009.
